# Pre-Sale Building & Timber Pest Inspection Report

7 Long Street Hendra 4011 Queensland Australia

## Pre-Sale Building and Timber Pest Inspection - ASBIR Pre-Sale Building & Timber Pest Inspection Report

08 Jul 2026

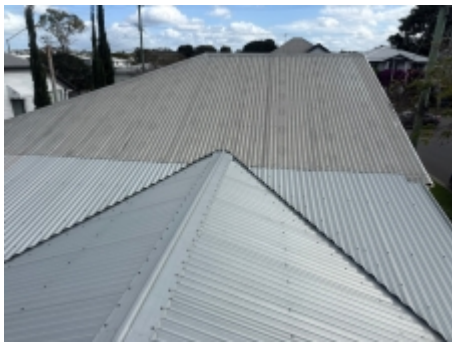
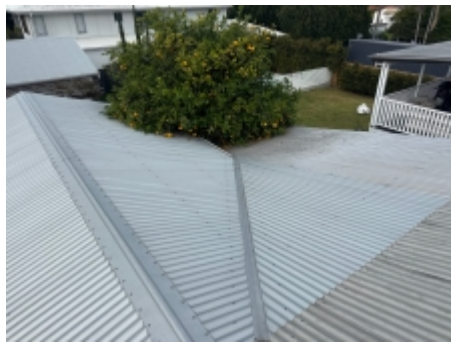
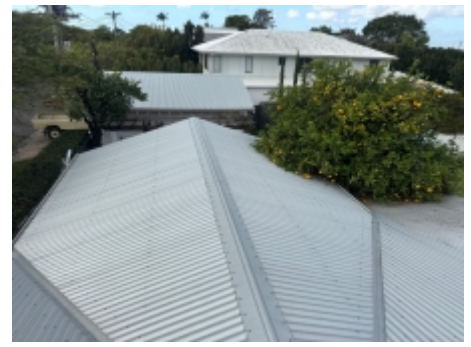
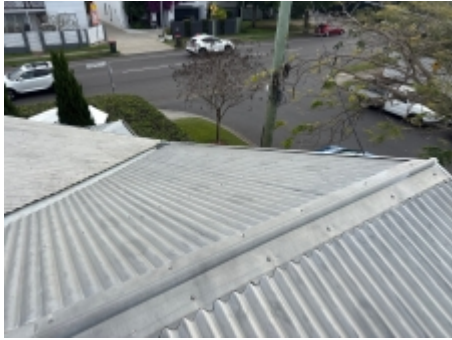
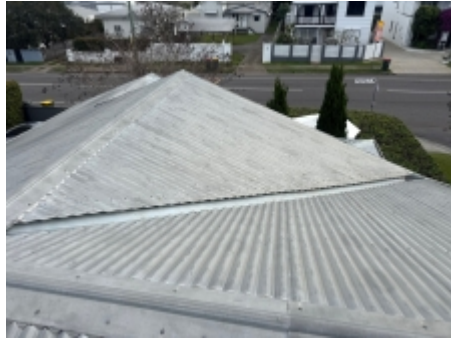
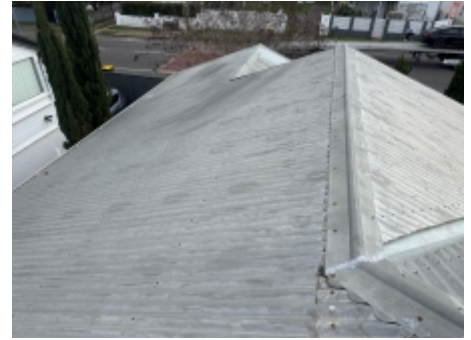
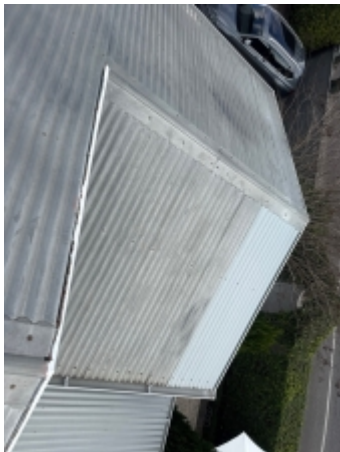
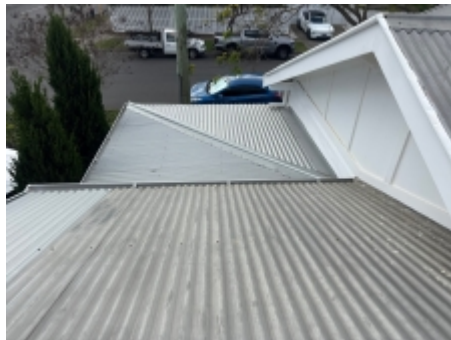
No defects found on the roof exterior at the time of the inspection

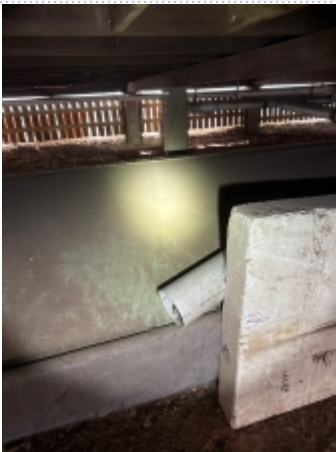
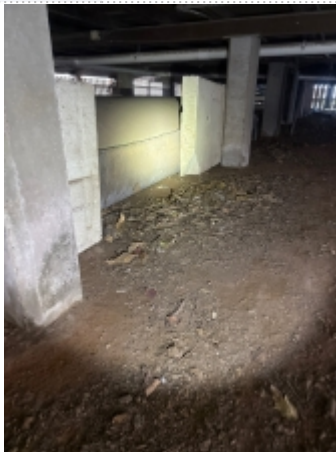
Was a water tank(s) located at the time of inspection? **Yes**

Is there a need for work to be carried out to rectify overflow drainage: **No**

It is recommended that suitable drainage is in place to prevent any retained water or buildup of moisture.
