# Pre-Sale Building & Timber Pest Inspection Report

7 Long Street Hendra 4011 Queensland Australia

08 Jul 2026

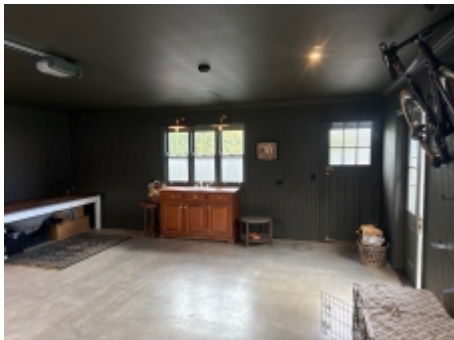
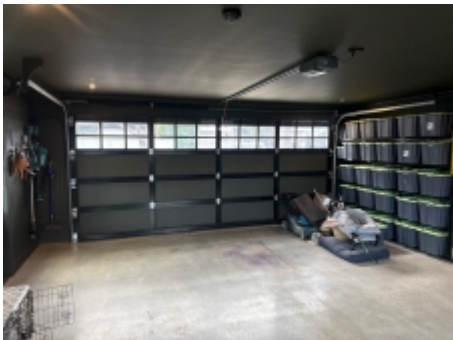
Garage

| Defect Severity | Minor Defect |

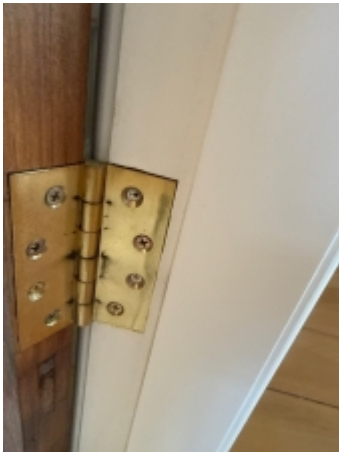
Bathroom 1

| Defect Severity | Minor Defect |
| Comment | 3 screws missing from door hinge |

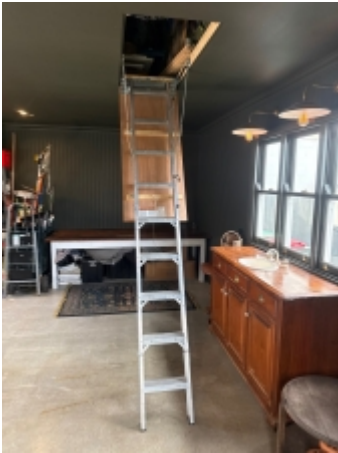
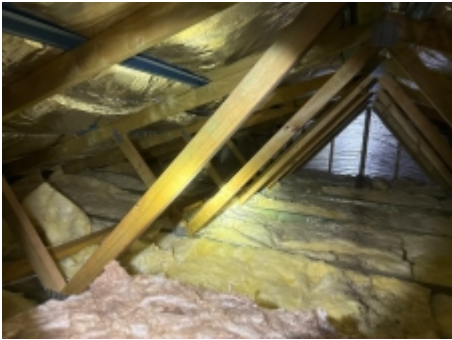
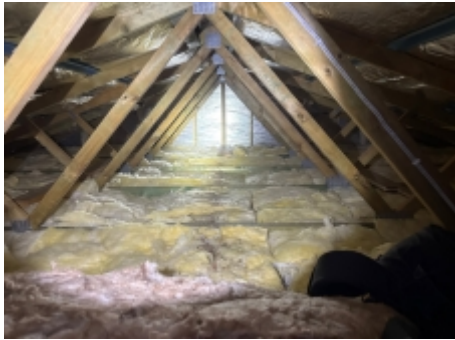
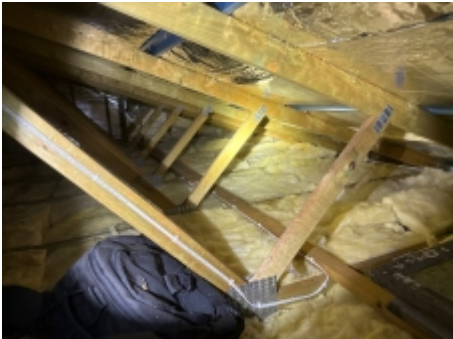
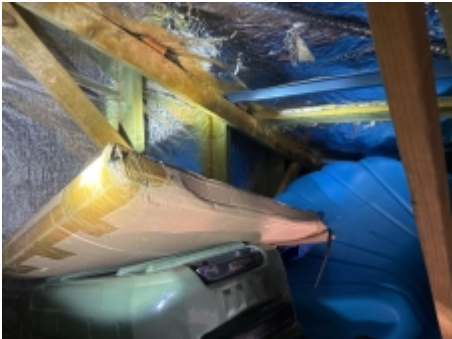
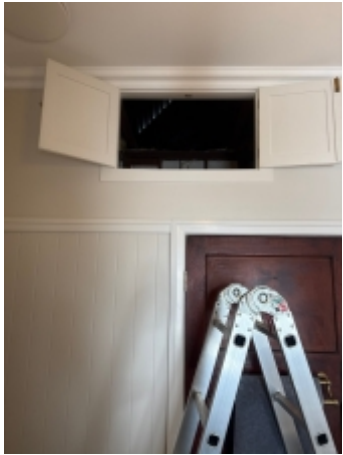
| Comments for Roof Space | Garage roof space pictures first<br>House roof space access via main bath |
| The Following Observations Are Noted With The Roof Space | Insulation is present<br>Ventilation is adequate<br>Roof framing is adequately supporting the roof covering |

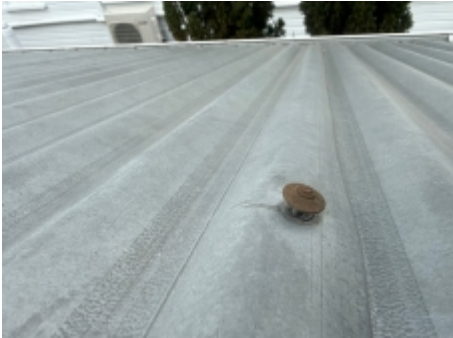
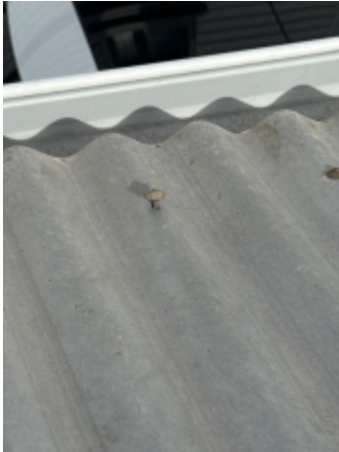
| Defect Severity | Minor Defect |
| Comment | A few nail heads are protruding |

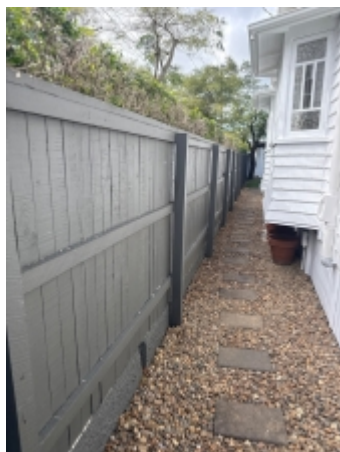
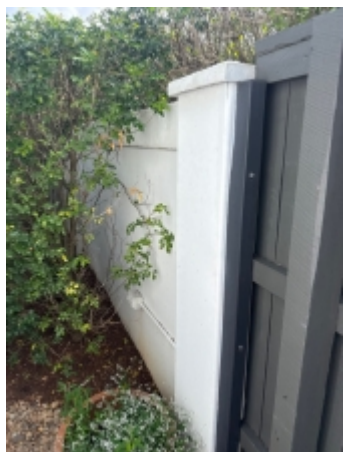
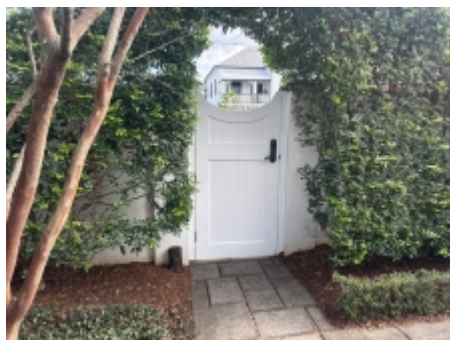
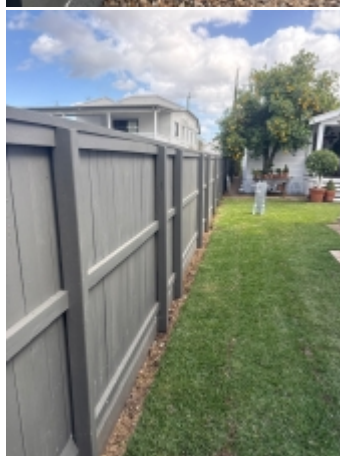
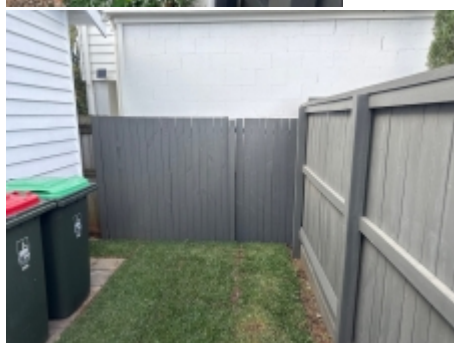
Site Area Photo

No defects found at the time of the inspection

This site should be monitored during heavy rainfall to confirm whether there are drainage issues that are not apparent at the time of inspection.
