Building and Pest Report

Property Address:
75 North St, Kedron

BUILDING & TIMBER PEST INSPECTION REPORT TO AS4349.1 2007 & AS4349.3 2010

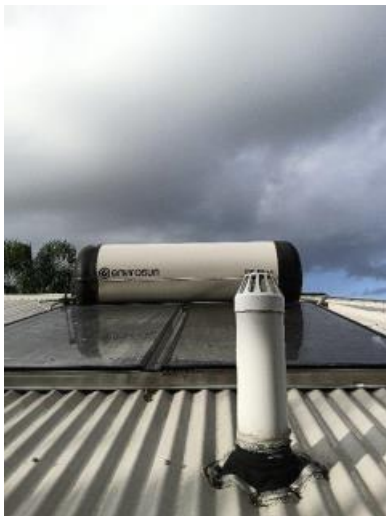
SHEET ROOFING

Satisfactory

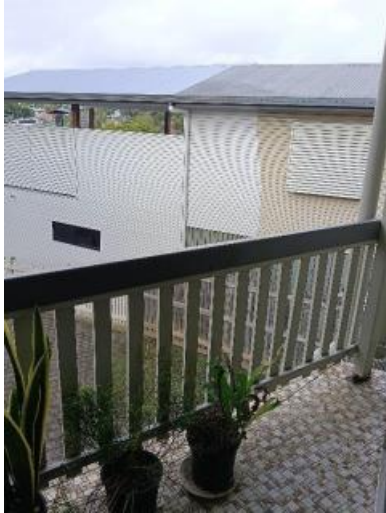
TIMBER STRUCTURES / DECKING / BALCONIES / VERANDAHS / PATIOS / STAIRS & HANDRAILS

General Condition:
Satisfactory

Sever rust noted to steel post on the right corner of the house. Treatment or replacement recommended.

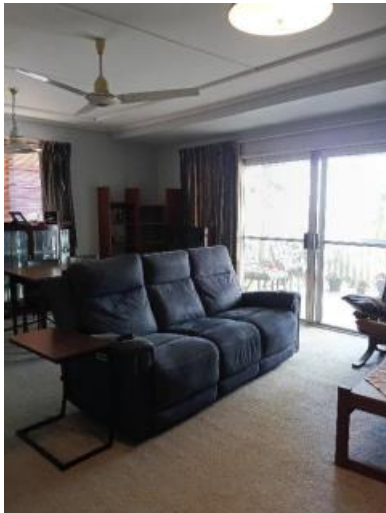
LIVING ROOM2

Good

Moderate undulations were noted to the ceiling lining. This is to be expected in a house of this age. Periodic maintenance will be required.

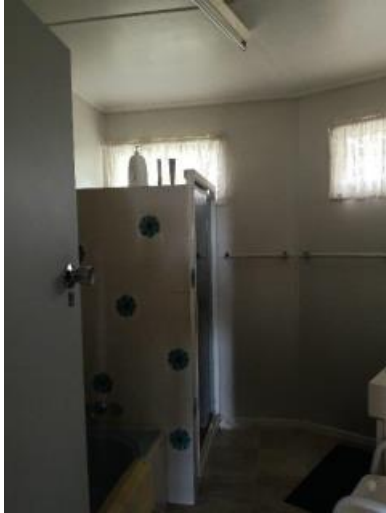
BATHROOM

Fair

Bathroom tiles have been replaced over the shower combination. The current owner should be asked for more information regarding this.

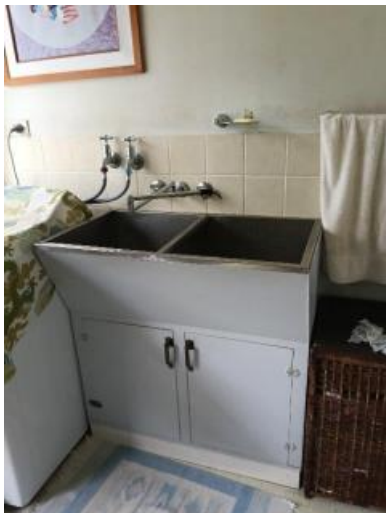
LAUNDRY

Fair

Tap leaks at o-ring/seals. Repairs are required.

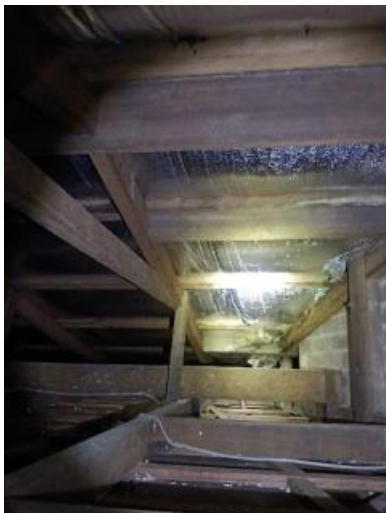
Roof Space & Framing - Condition

Satisfactory
