# VISUAL TIMBER PEST INSPECTION & REPORT

Complies with Australian Standard AS 4349.3-2010

80 Commodore Crescent  
Port Macquarie, NSW  
2444, Australia

Inspection Date: 18 Jun 2026  
T: 0423 559 129

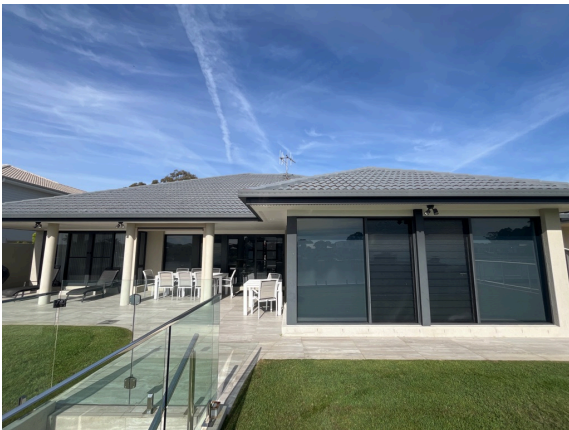
Photograph 3

✗ Yes, HWS overflow pipe. The hot water system overflow pipe may discharge moisture adjacent to the structure. We recommend the overflow be directed into a drain. This should be rectified as moist soil conditions are highly conducive to timber pest attack and can also break down termite barriers quicker than their expected life span.

Photo Ref #3: The hot water system pressure relief valve should be redirected into a downpipe or away from the house as high moisture levels are conducive to timber pest activity.
