# Property and Timber Pest Report

Inspection Date: 22 Jun 2026

Property Address: 25 Astronomers Terrace Port Macquarie 2444

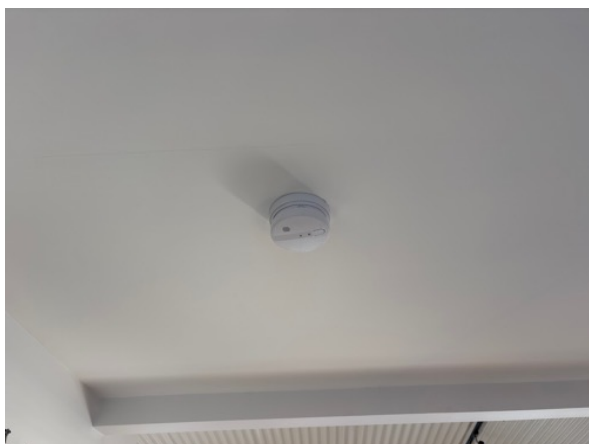
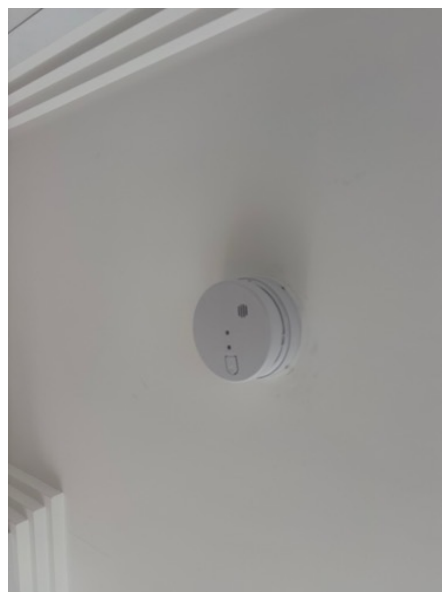
**Finding:** Smoke Detectors and Alarms

Reporting on Smoke Detectors or Alarms, including hard wired smoke detection systems and their legislative requirements, is outside the Scope of this Report.
