# PEST AND BUILDING PRE-PURCHASE REPORTS

## Standard Visual Timber Pest Detection Report In Accord With AS4349.3-2010

<b>Date of Inspection:</b>	Thursday 23 April 2026
<b>Address of Property Inspected:</b>	885 Dulguigan Road North Tumbulgam NSW 2490
<b>Name of Client:</b>	[REDACTED]
<b>Client Email Address:</b>	[REDACTED]
<b>Contact Phone:</b>	[REDACTED]
<b>Time of Inspection:</b>	10.00 AM

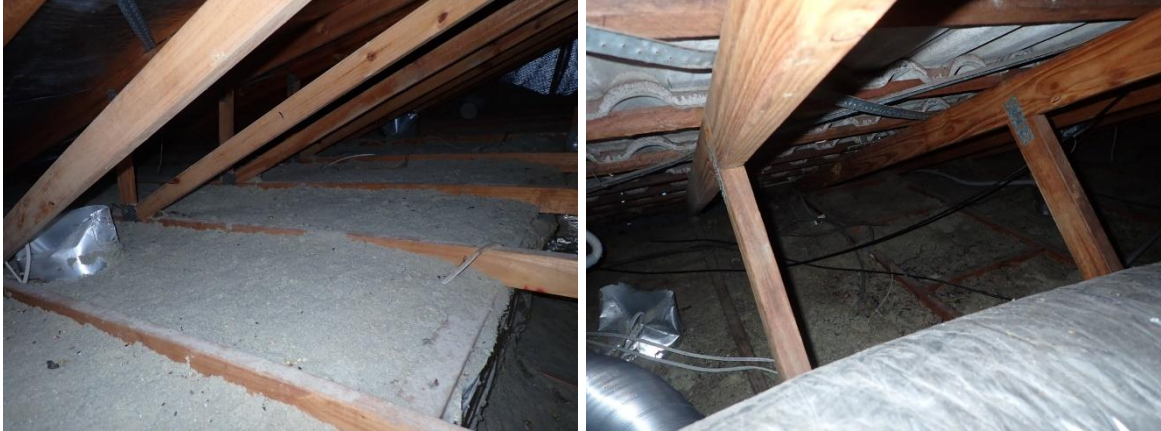
- Thermal insulation in the roof space obscured top plates of the wall frames and the bottom cords of the trusses for inspection. This may conceal evidence of termite infestation and/or damage. Removal of the insulation is not within the scope of this report.

- Removing insulation material from the roof void to inspect roof timbers.
- Removing wall sheeting from where past termite activity has been seen.

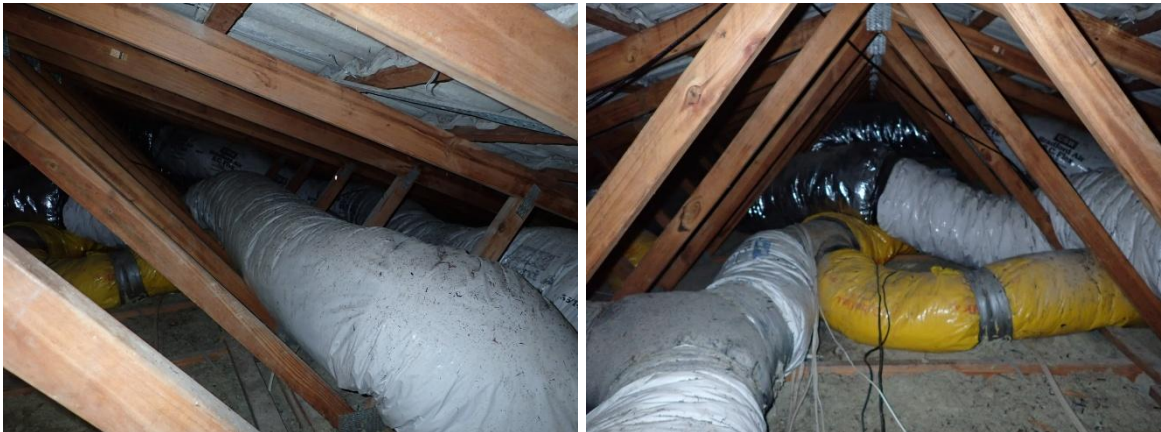
- Sarking obscured timber roof battens for inspection.
- Restricted access to some areas in roof space for inspection due to roof configuration and design.
- No access above skillion roof areas for inspection.
- Visual inspection was obstructed and restricted to the roof space due to air conditioning duct work.

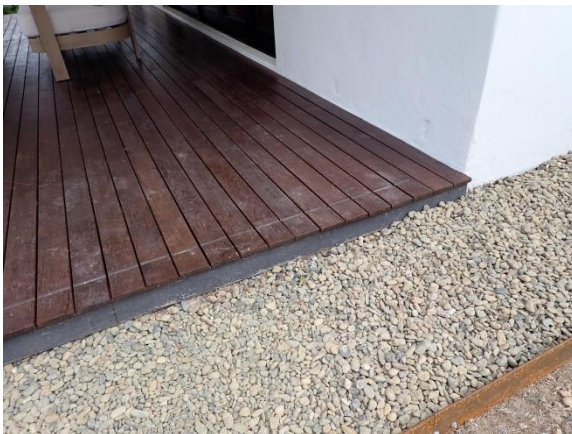
- No access below ground level deck for inspection due to building design.

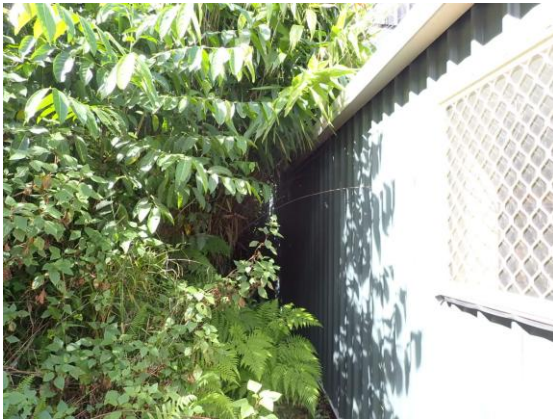
10. Trees, tree roots, vines or shrubs are close to or abutting the free-standing shed external walls of the structure. This can allow concealed termite entry and they should be removed immediately.

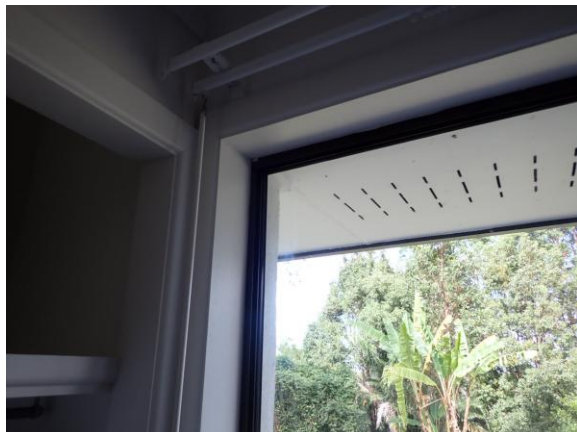
- It is strongly recommended to obtain all relevant documentation to any termite inspection reports for the results immediately from the vendor prior to contracts being signed.
- The bedroom 3 window frame has been repaired, more information is required in regard to these repairs as this may have resulted from a previous termite attack and subsequently termite damage may exist in concealed areas.

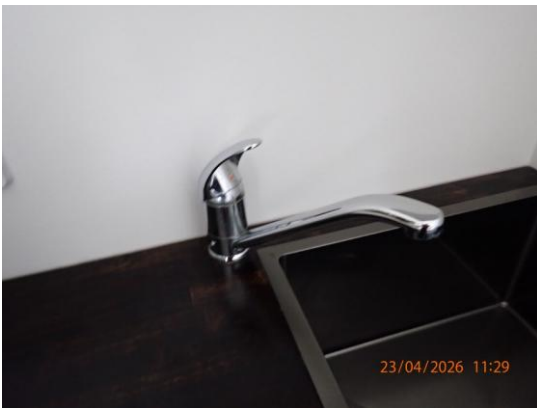
- The Studio laundry flick mixer to the tub is loose and requires maintenance (see photo below).

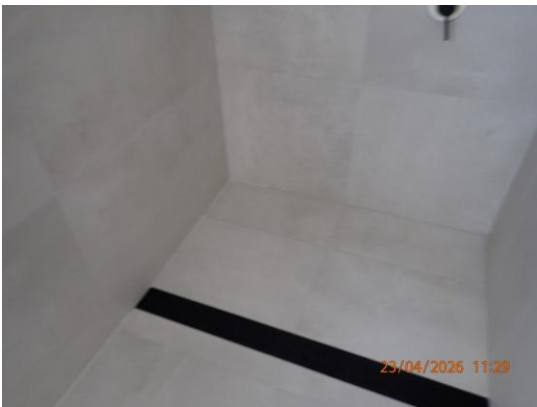
1

- The junctions of the wall and floor tiles in the Studio shower and around the vanity and laundry tub require sealing with a flexible sealant to prevent water build up behind the tiles or in the cavity (see photos below).

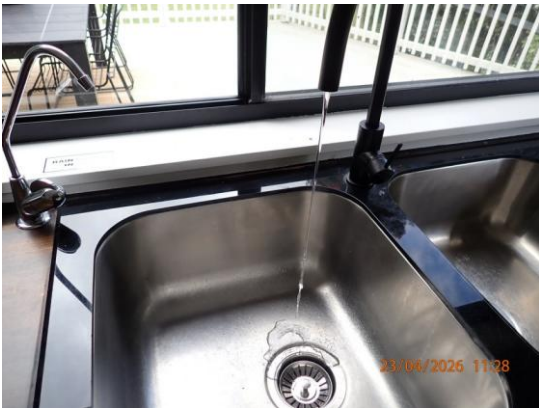
- The junction between the bench top/window and splashback of the Studio kitchen requires sealing with a flexible sealant to prevent water build up behind the tiles or in the cavity (see photo below).

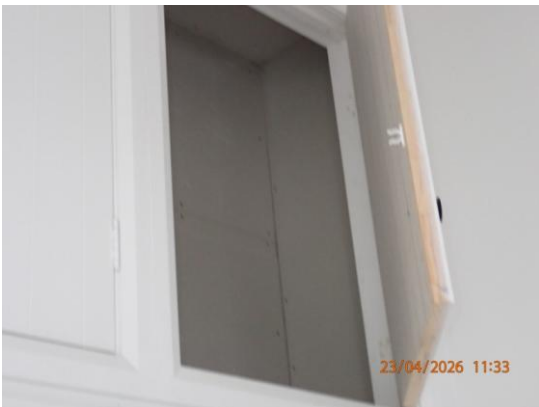
1

- The wall linings to the Studio bedroom robes are incomplete and require completion (see photos below).

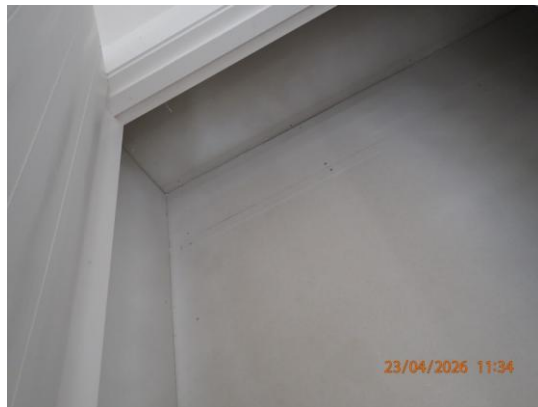
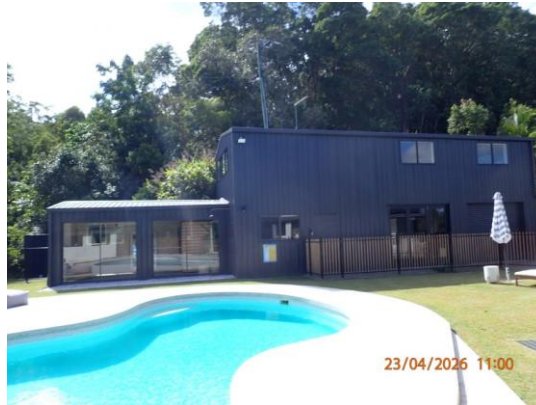
- The vegetation should be cleared away from the Shed/Studio to prevent undetected access for termites into the Shed/Studio as well as premature deterioration of some building elements (see photos below).

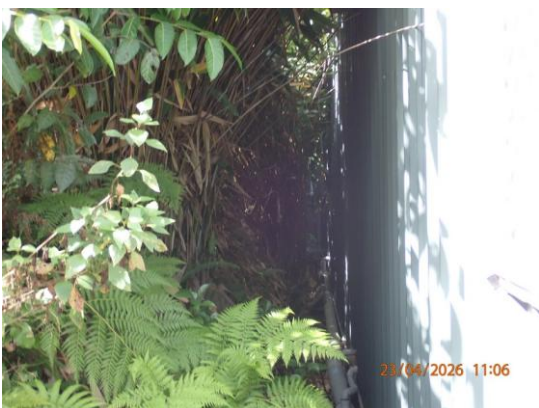
- The inspection to the complete exterior of the Shed/Studio was limited due to vegetation growing close to the Shed/Studio (see photo below).

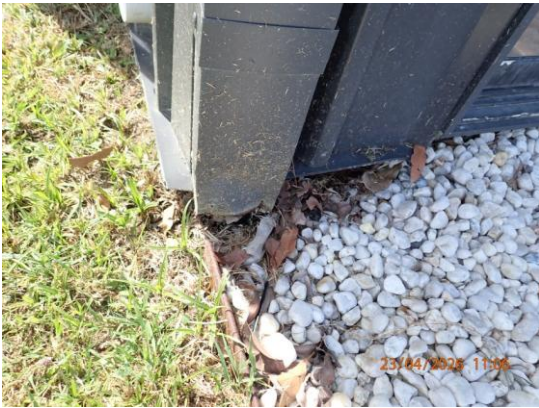
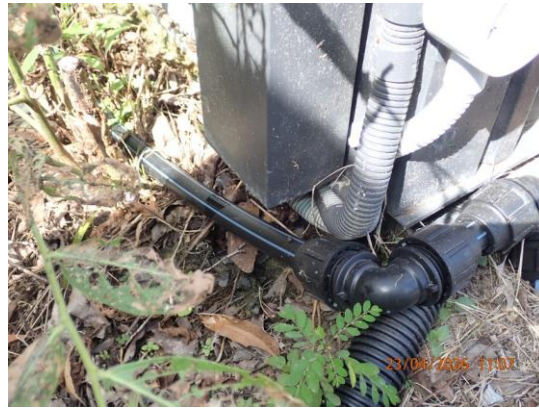
- The downpipes to the Shed/Studio are directed onto the ground and should be connected to a stormwater system discharging to the street or away from the building (see photos below).

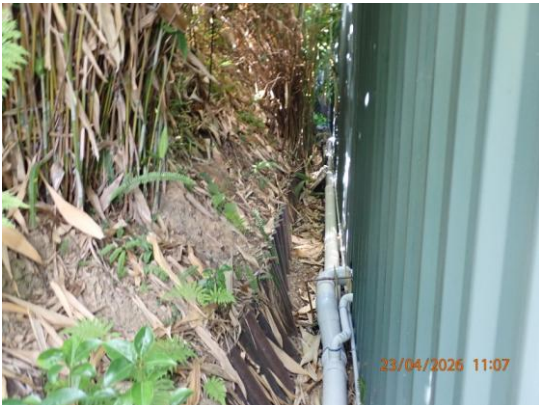
- There is evidence of surface/ground water runoff with wash outs to the eastern side of the Shed/Studio (see photo below). All surface water should be redirected clear of the building foot print and where necessary the ground levels altered and/or additional surface drains installed and connected to the stormwater system.

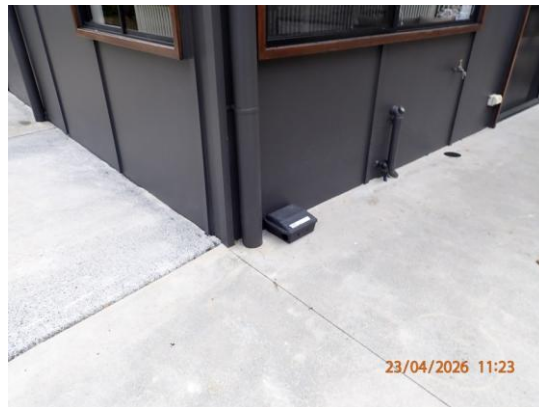
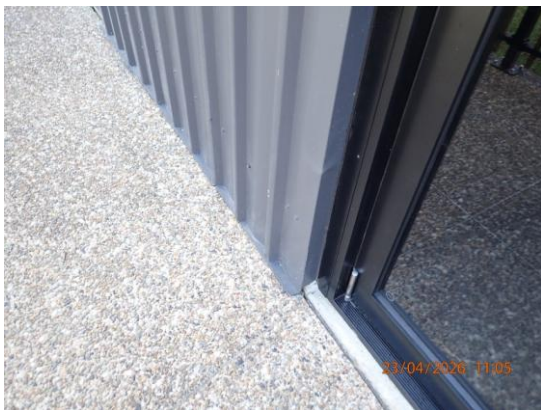
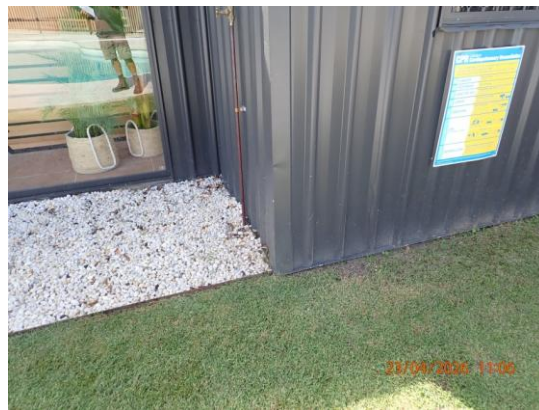
The cladding to the Studio (see photos 1 & 2) and Shed/Studio (see photos 3 & 4) were in contact with the ground and there should be a minimum clearance of 75 millimetres between the base of the cladding and the ground level to prevent undetected access for termites into the structure as well as premature deterioration of the building elements.

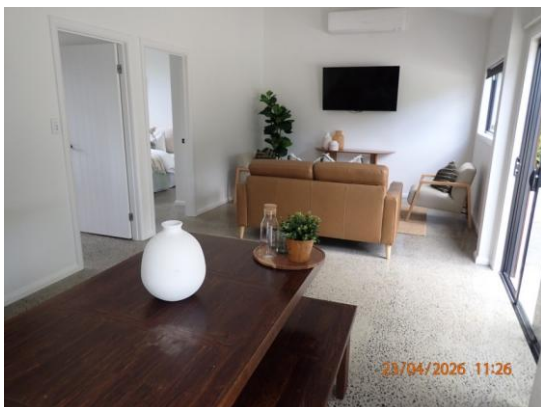
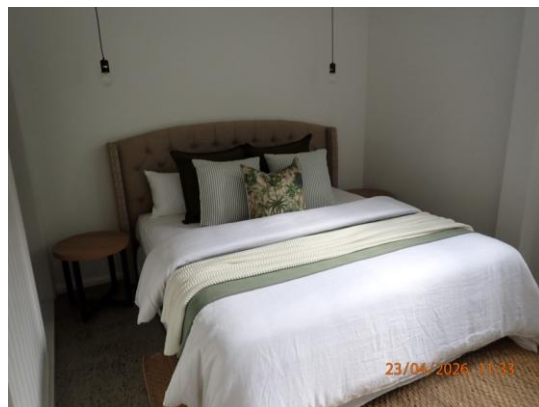
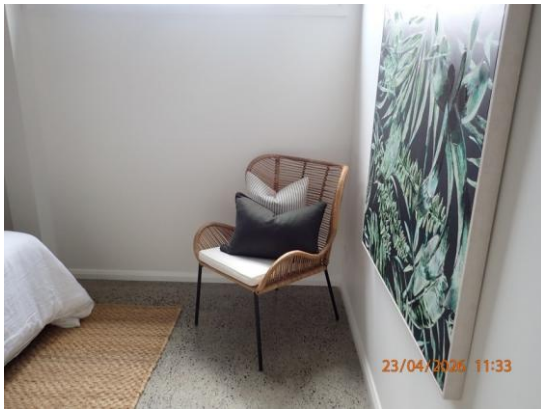
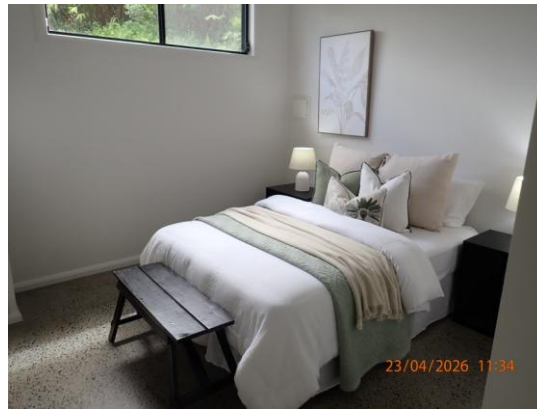
The inspection to the Studio was limited due to stored items and furnishings (see photos below).

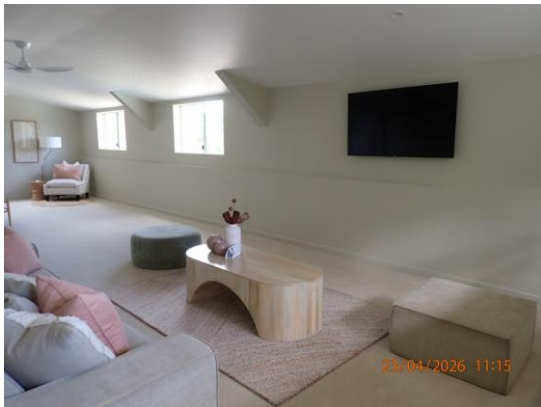
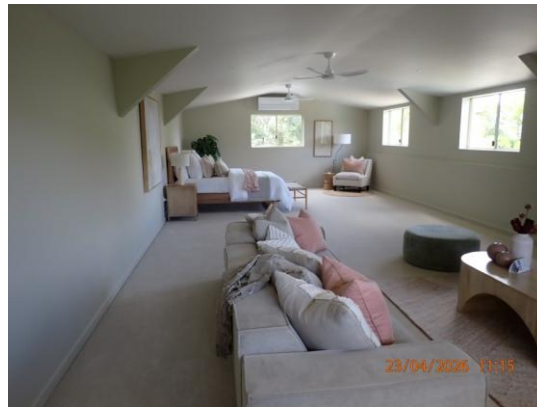
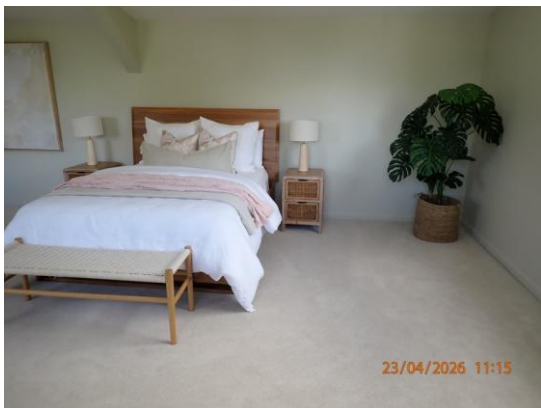
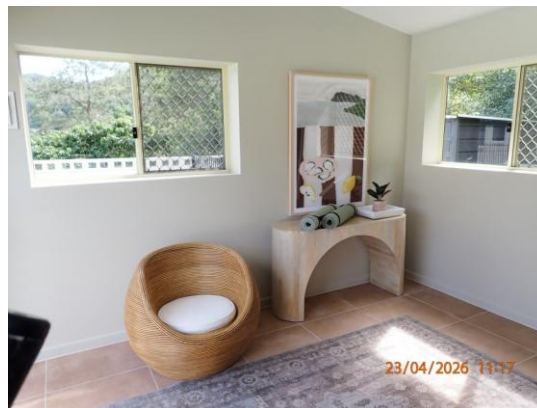
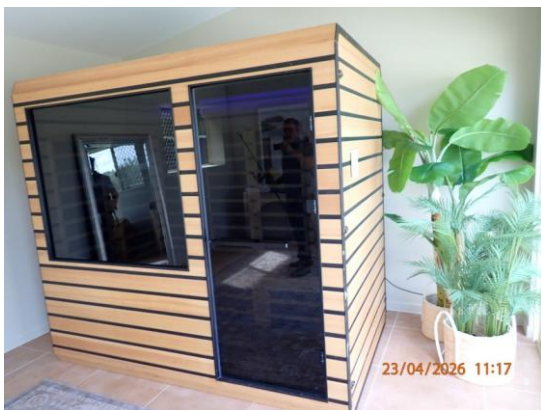
The inspection to the Shed/Studio was limited due to stored items and furnishings (see photos below).

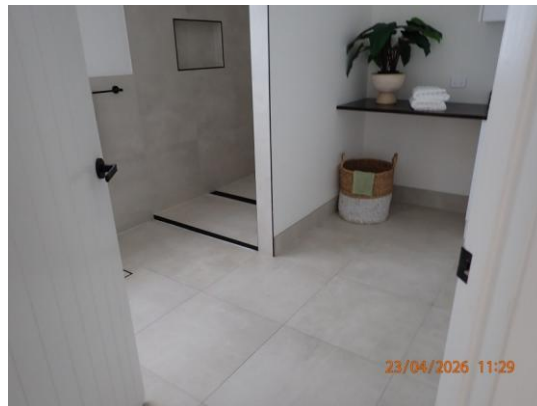
The Studio kitchen and bathroom/laundry have been renovated at some stage and it is recommended that the relevant documentation be obtained in regard to the renovations (Water Proofing Certificate) see photos below.

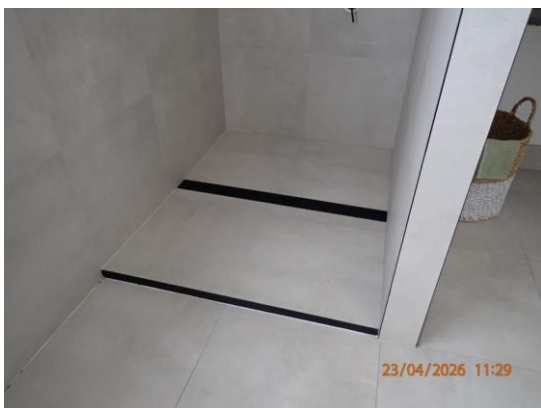
Due to the design of the Studio shower, water could come out of the opening when in use (see photo below).

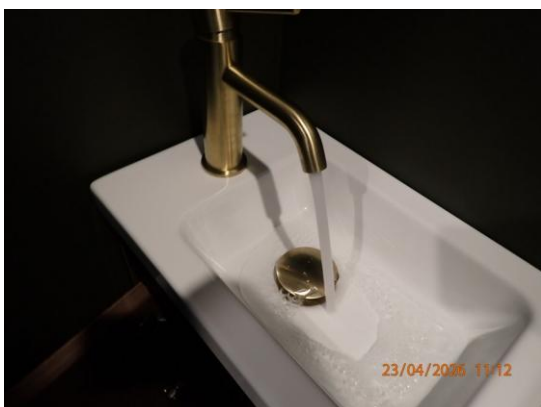
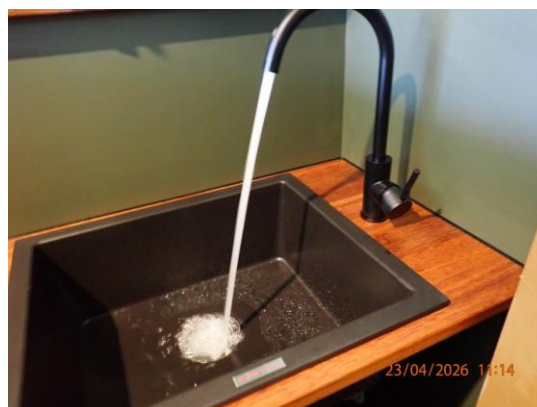
The Shed/Studio taps and toilet to the games room were operational at the time of the inspection. **Please Note:** cold water only has been supplied to the vanity of the toilet and bar sink (see photos below).

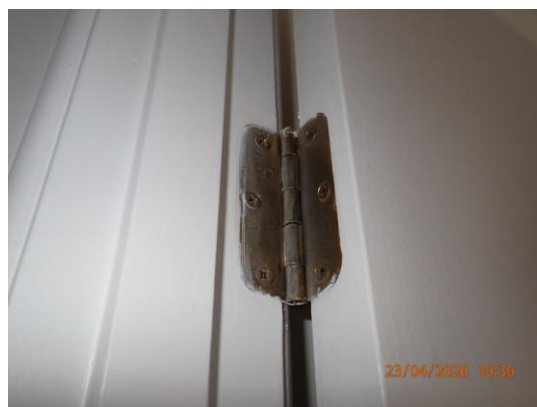
It is recommended that Lift Off Hinges be provided to the toilet door and ensuite toilet door for safety reasons (see photos below).

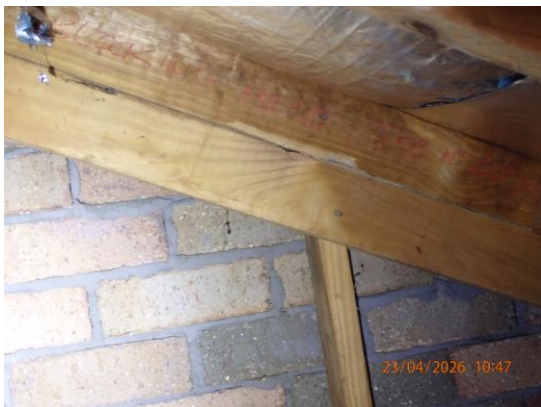
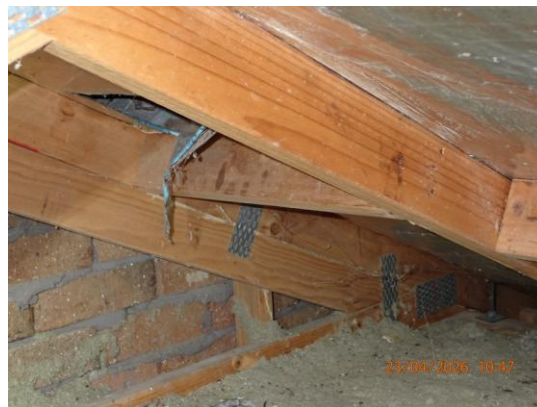
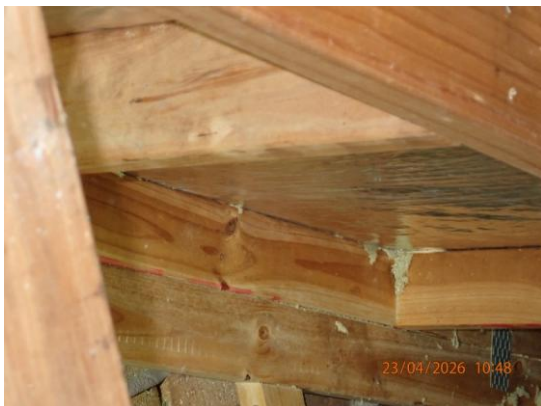
There is evidence of previous termite workings and damage to the roof framing (see photos below). The affected timbers require repair and/or replacement where necessary. Due to the limits of the visual inspection, it is hard to determine if there is damage to the framing members covered by the cladding, wall and ceiling linings. It is recommended that a more invasive inspection be undertaken. If damage is found the affected timber members should be repaired and/or replaced. Please engage a Licenced Builder to inspect, give advice and carry out repairs and rectification works where necessary.

It is recommended that a Licensed Pest Control Operator carry out regular inspections of the Dwelling/building to assist in the early detection of termites.

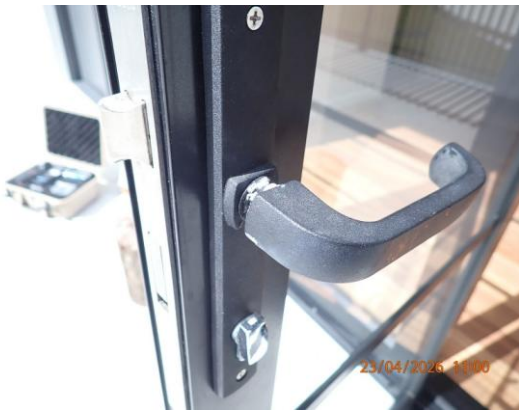
- The lock/handle to the bifold door is coming away/loose and requires repair (see photo below).

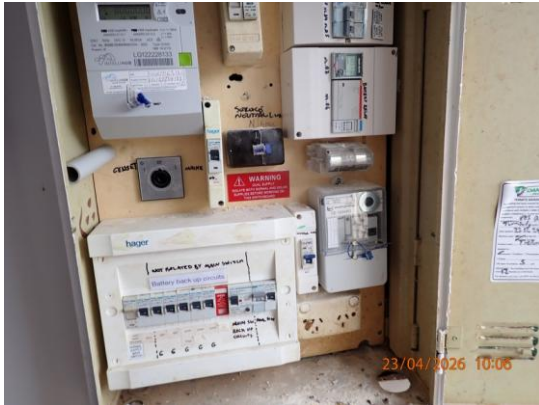
A safety switch has been provided to the meter box (see photo below). It is recommended that a Licenced Electrician be engaged to inspect and check the operation of safety switches and electrical circuits.

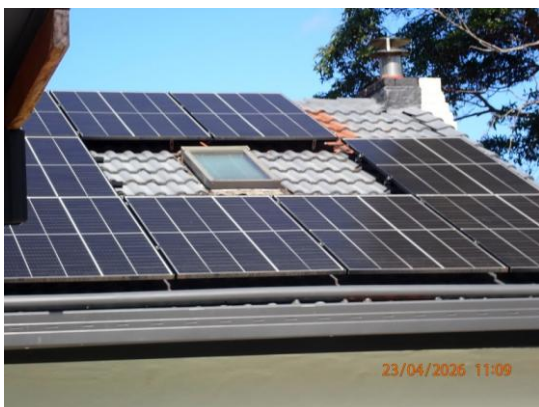
There is evidence of repairs to the roof covering with different tiles in areas (see photos below).

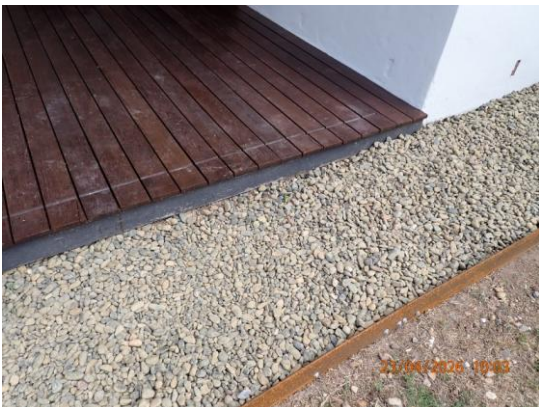
The timber members of the patio/deck are in contact with the ground and there should be a minimum clearance of 75 millimetres between the base of the members and ground level to prevent undetected access for termites into the structure as well as premature deterioration of the building elements (see photos below).

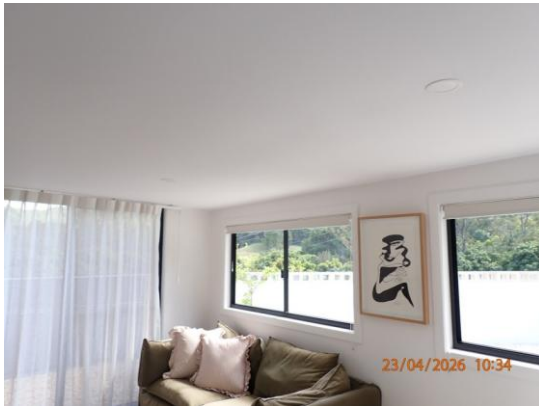
The head/ceiling height to the enclosed patio/bedroom appears to be low which would deem the affected areas uninhabitable (see photo below). Verification can be confirmed by a Building Certificate from Tweed Shire Council.

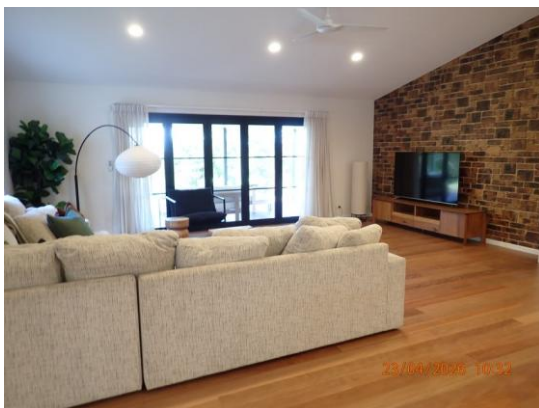
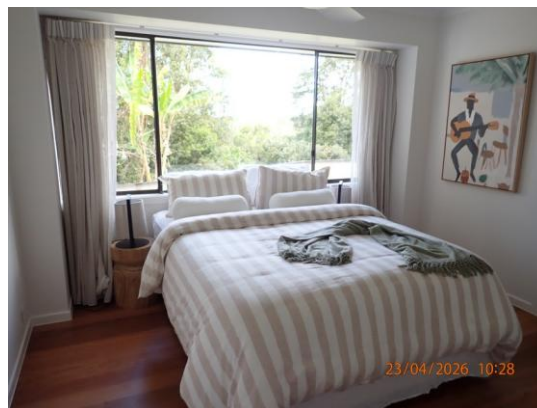
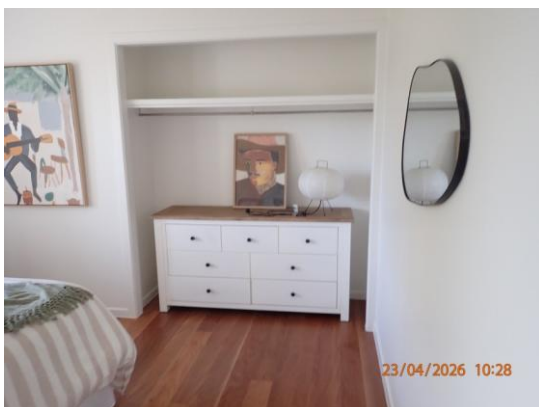
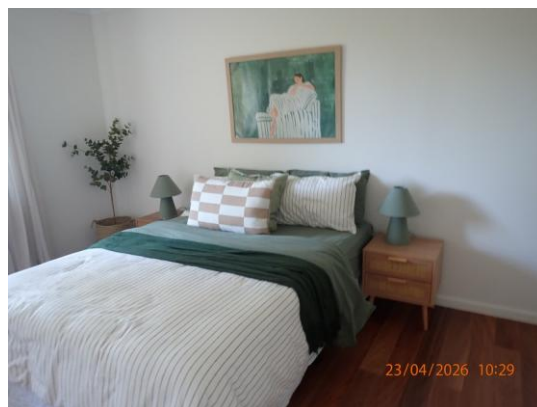
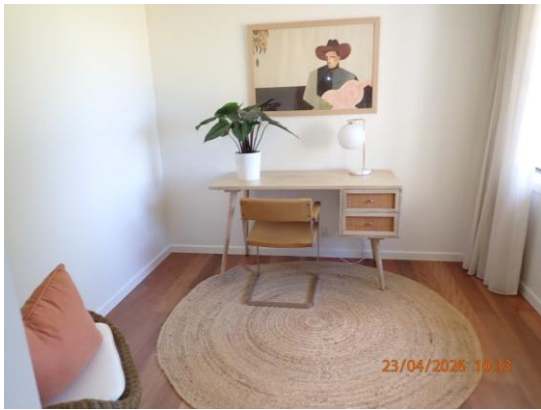
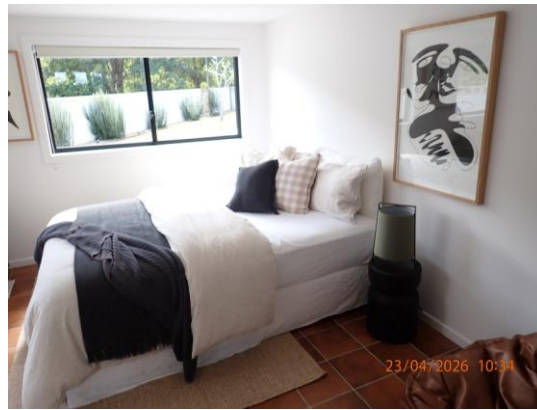
The inspection was limited due to excessive stored items and furnishings (see photos below).

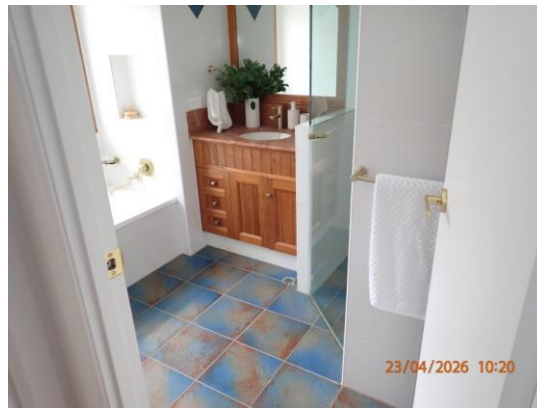
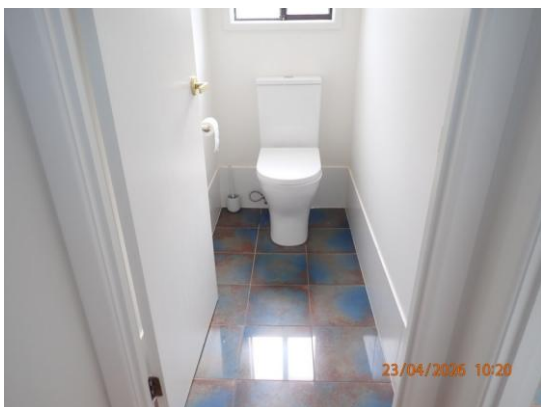
The kitchen, bathroom and toilet have been renovated at some stage and it is recommended that the relevant documentation be obtained in regard to the renovations (Water Proofing Certificate) see photos below.

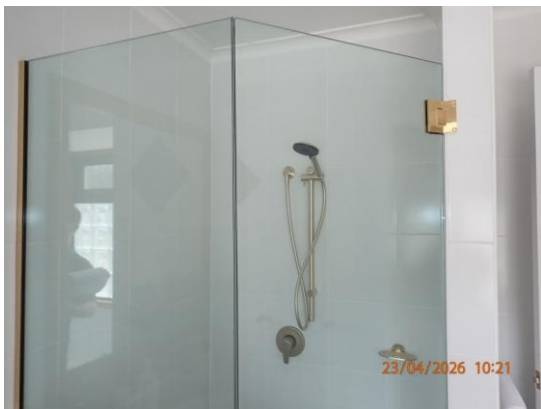
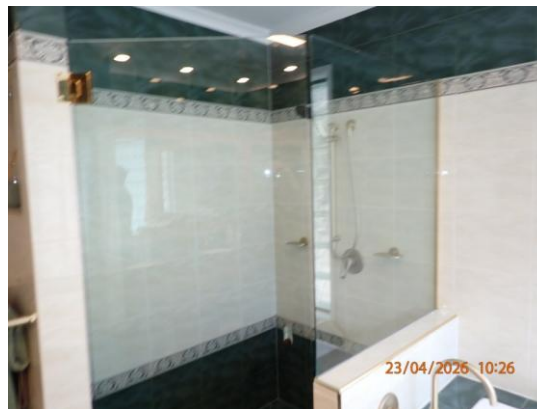
Due to the design of the frameless glass shower screens, water could come out of the opening and gaps in the glass when in use (see photos below).

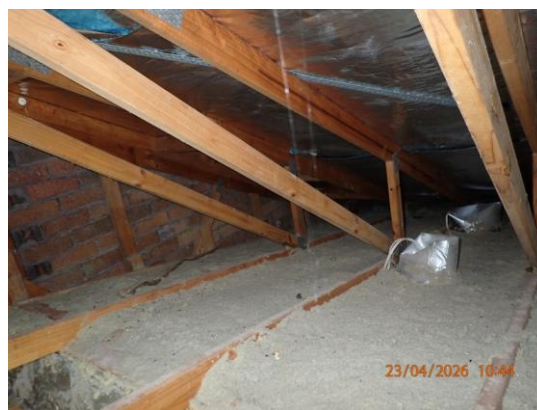
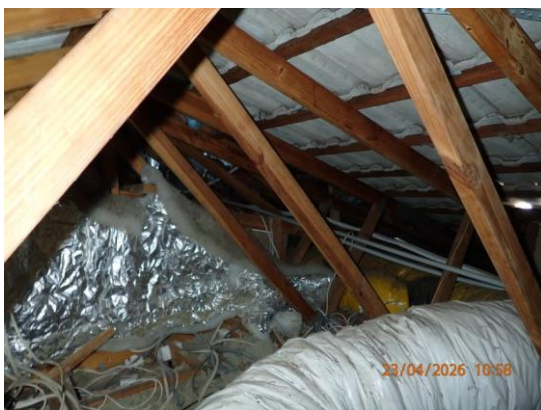
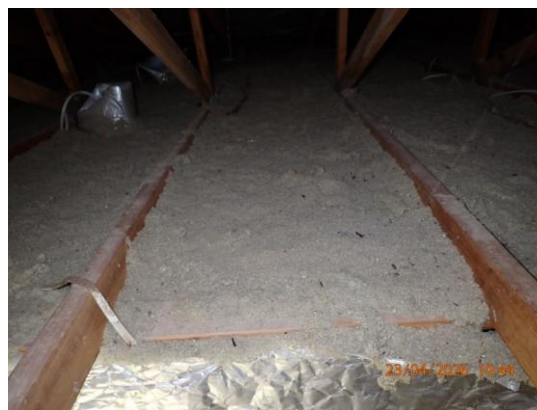
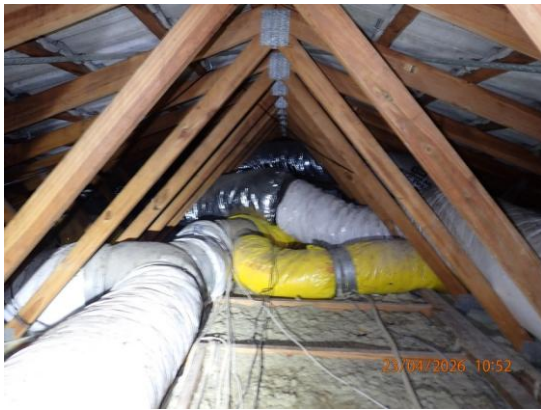
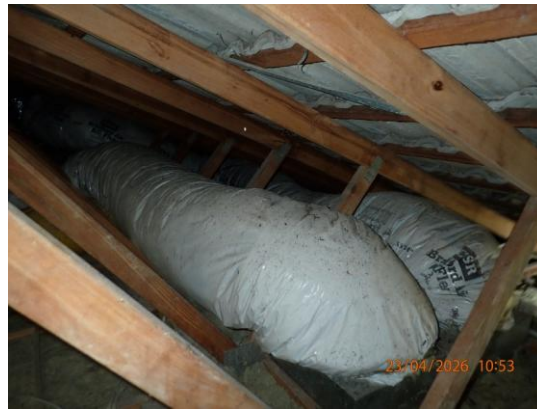
The inspection of the roof void was limited due to the truss configuration, low crawl space, insulation, air conditioning duct work and sarking (see photos below). There was no access to the skillion roof areas for inspection.

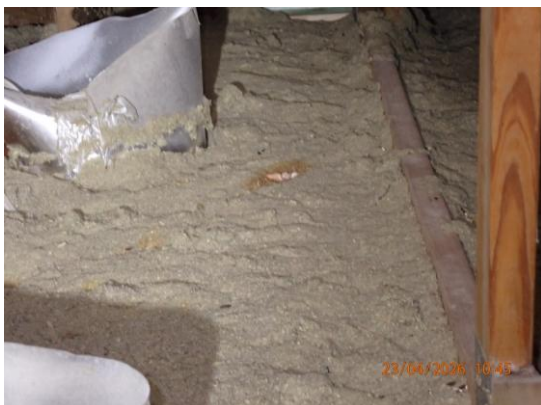
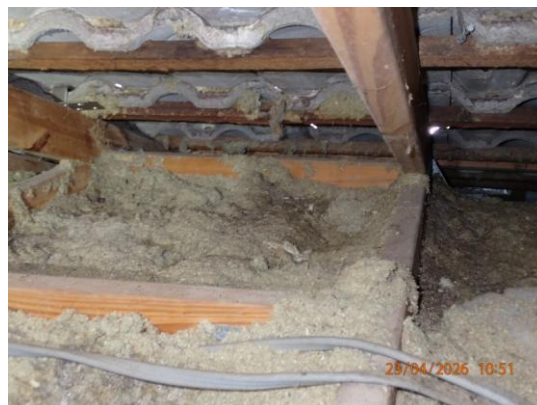
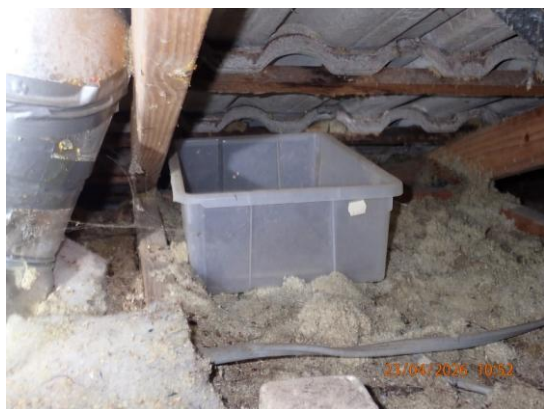
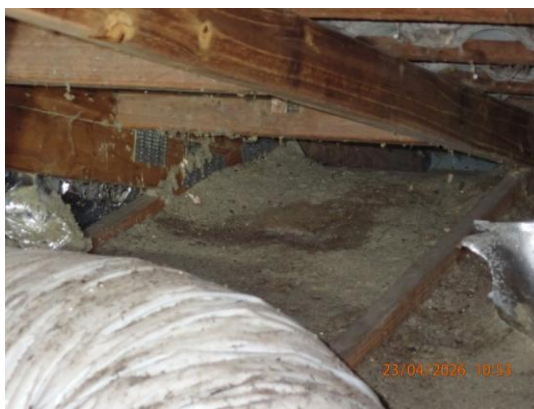
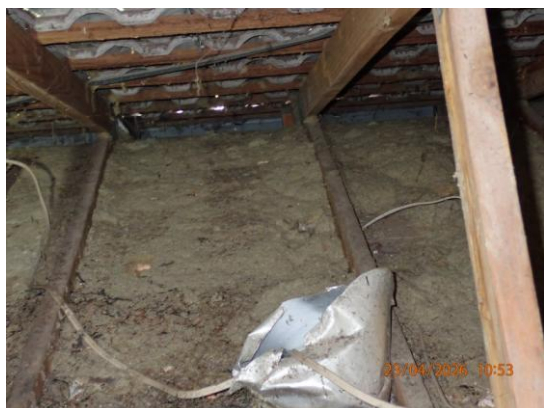
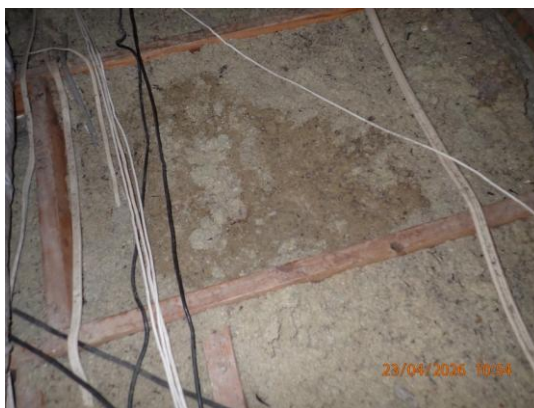
There is evidence of previous water leaks with stains to the insulation and a container in the roof void (see photos below). There was no evidence of recent leaking at the time of the inspection, it is recommended that the affected area be monitored to be sure there are no further leaks and if so the leaks need to be located and repairs made to prevent premature deterioration of the building elements.
