**PRE SALE  
STANDARD PROPERTY REPORT**

Report number: PPI2025442

Inspection date: Monday 25<sup>th</sup> August 2025

Property address: 15 and 15a Peppermint Place Banora Point NSW

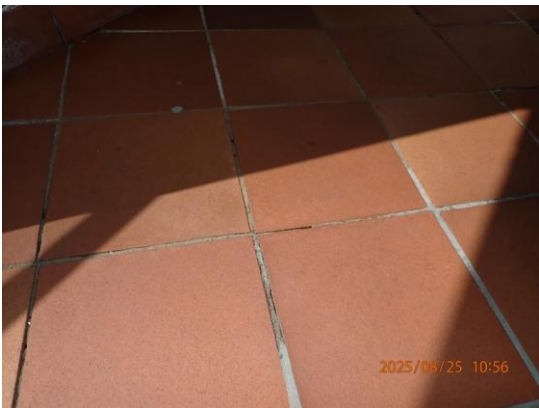
- There are dummy, broken and cracked floor tiles to the main dwelling entry stairs and landing (see photos 1 & 2) and drummy floor tiles to the main dwelling main bedroom balcony (see photos 3 & 4) which require refixing and/or replacement where necessary.

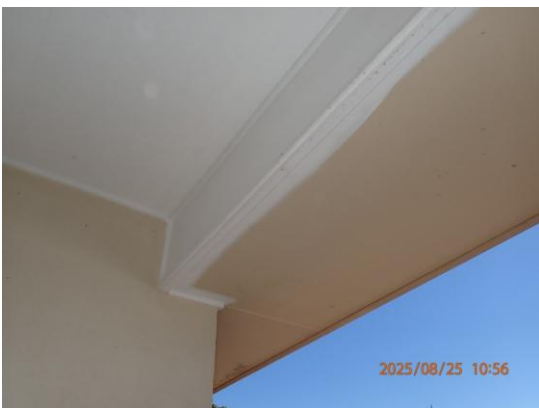
- The painting to the eave lining of the main dwelling above the main bedroom balcony is incomplete and requires completion (see photo below).

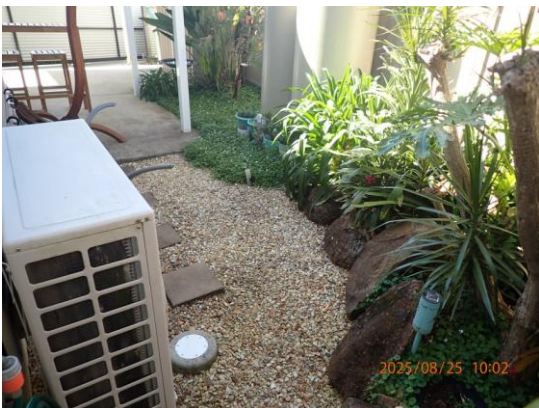
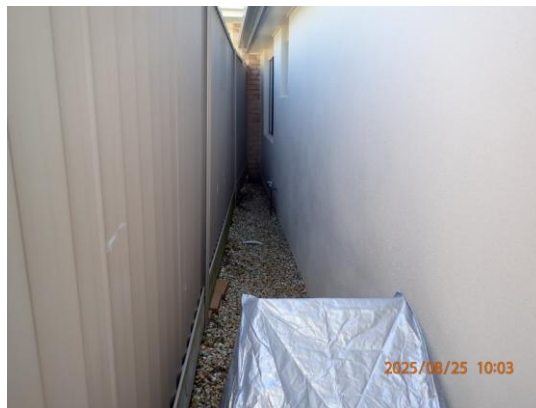
At the time of the inspection there was no visible evidence of water ponding against the building (see photos below). If damp conditions become obvious, it is recommended that all surface water should be redirected clear of the building footprint and where necessary the ground levels altered and/or additional surface drains installed and connected to the stormwater system.

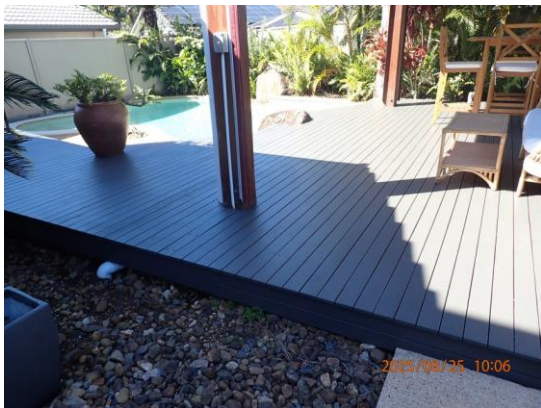
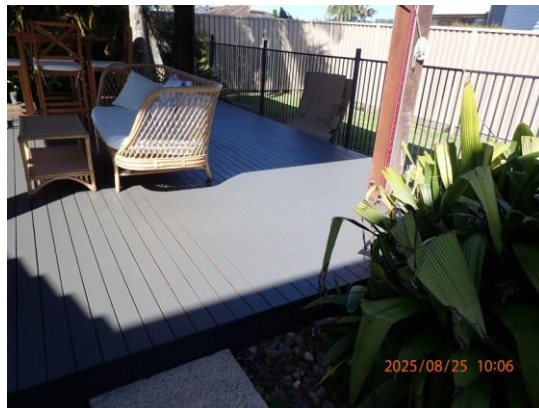
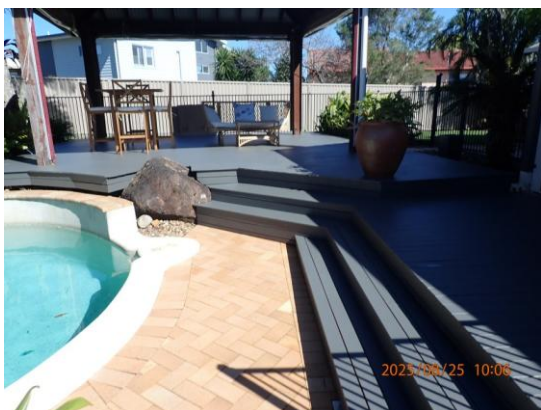
There was no access below the pool deck for inspection (see photos below).

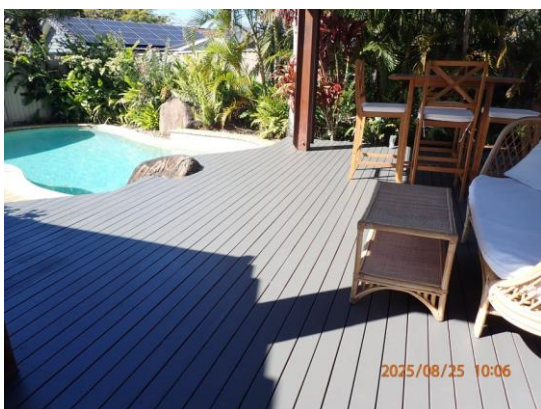
The pool deck has been repainted at some stage (see photo below).

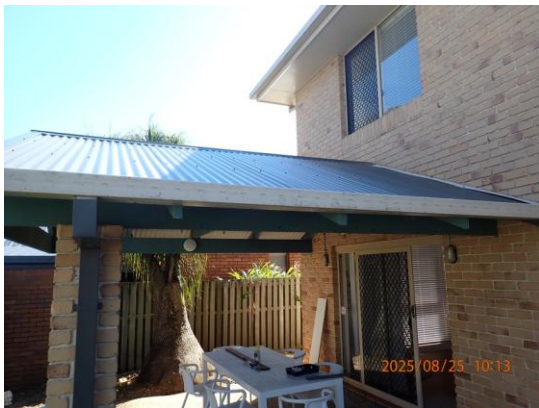
The roof to the main dwelling pergola has been replaced at some stage (see photo below).

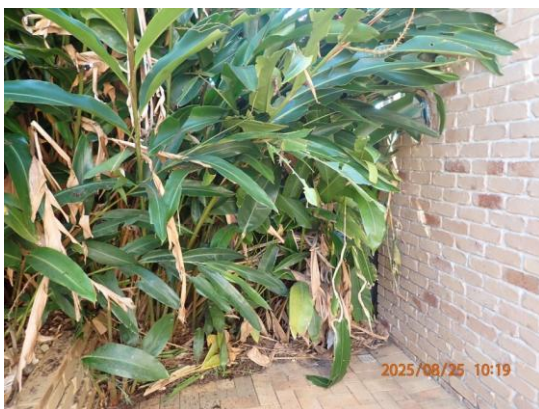
The vegetation obscured the fencing in some areas (see photo below).

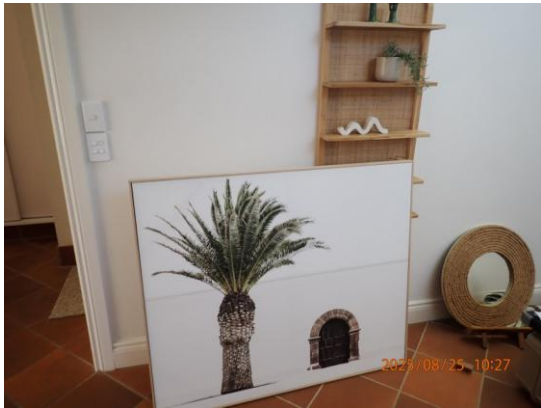
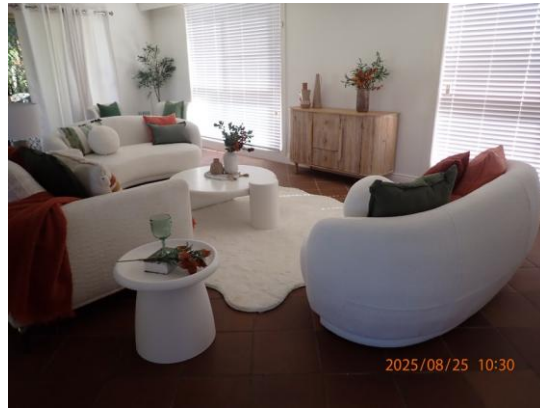
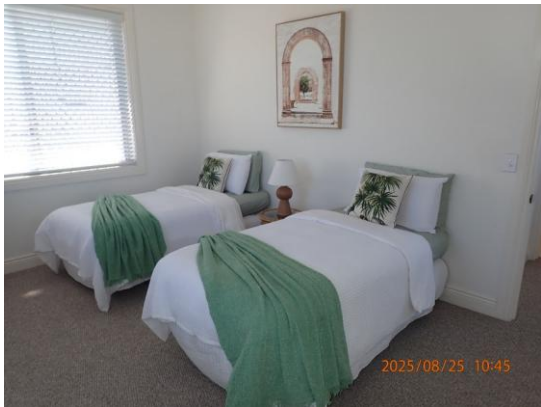
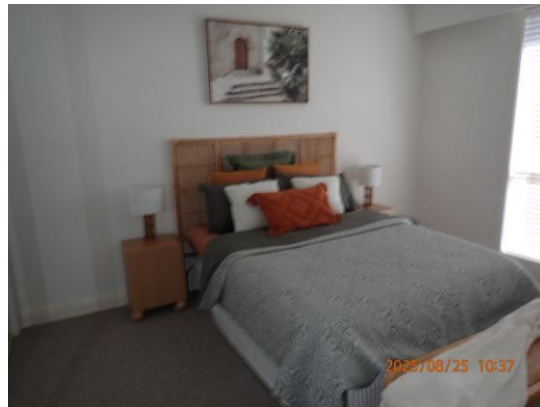
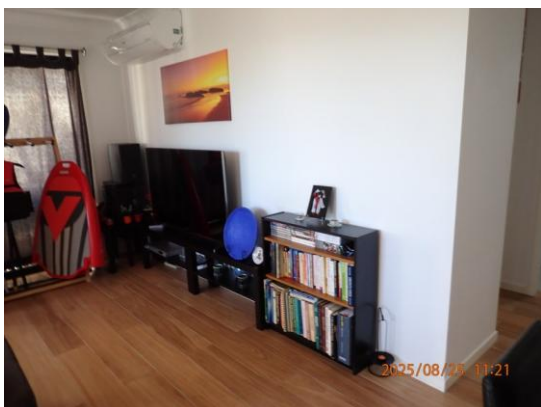
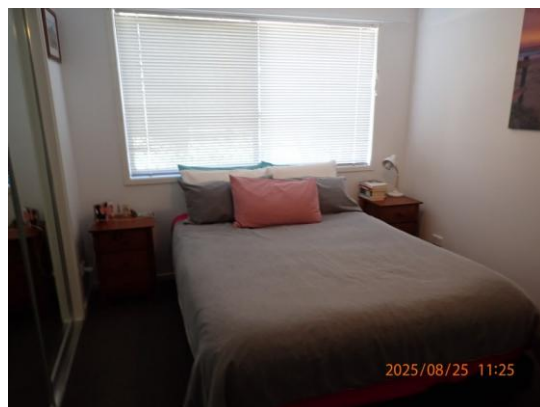
The inspection was limited due to excessive stored items and furnishings in areas (see photos below).

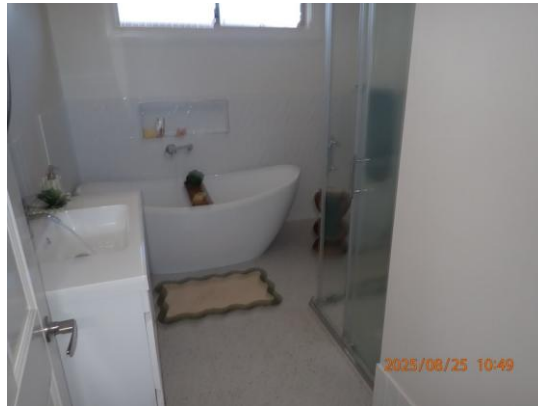
2

The bathrooms, ensuite and upper level toilet to the main dwelling have been renovated at some stage and it is recommended that the relevant documentation be obtained in regard to the renovations (Water Proofing Certificate) see photos below.

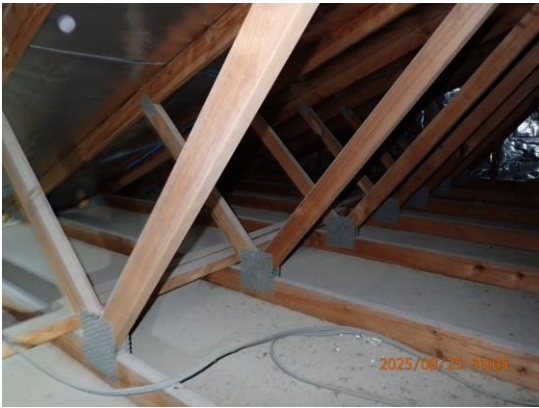
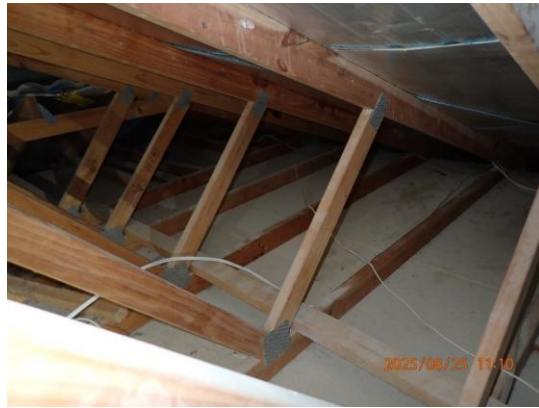
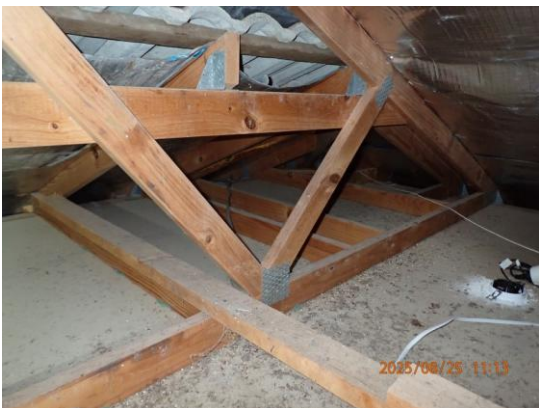
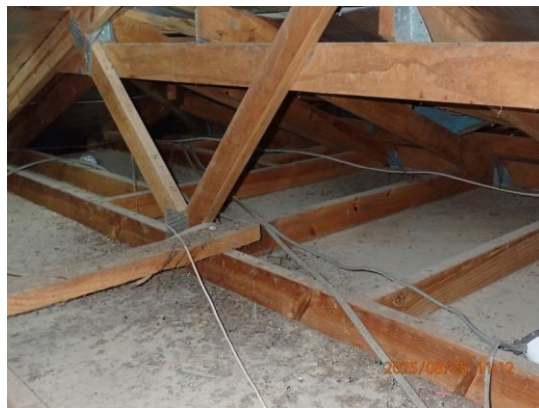
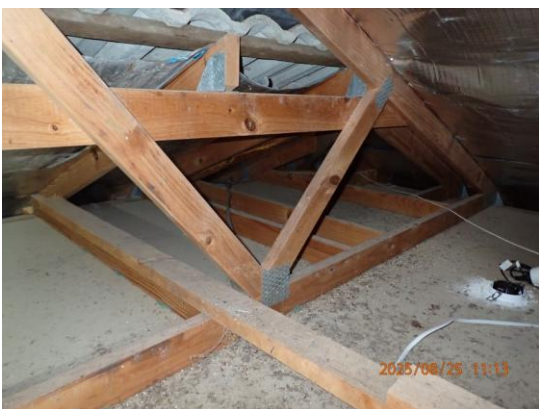
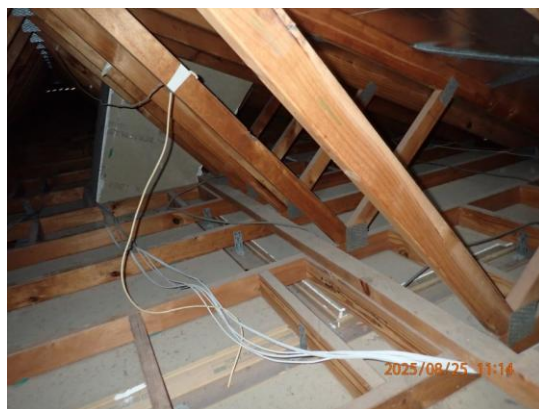
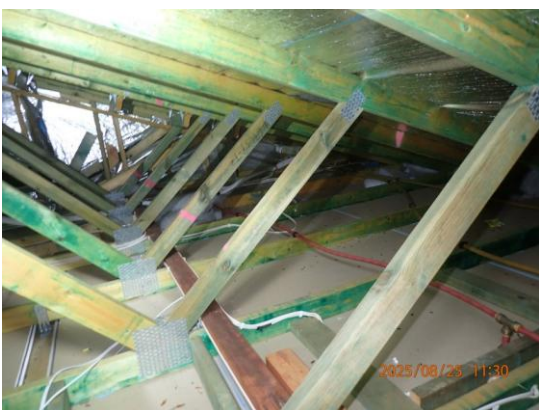
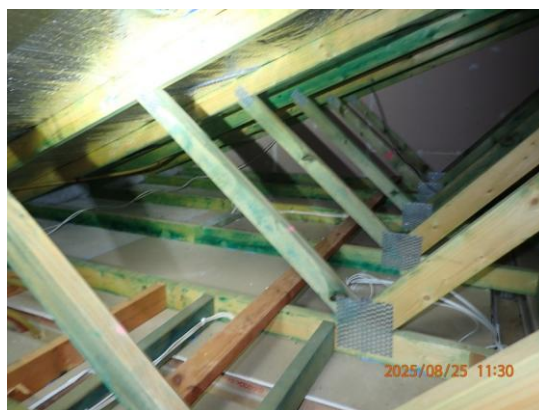
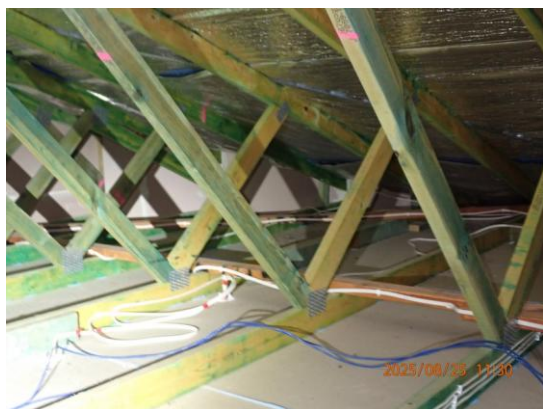
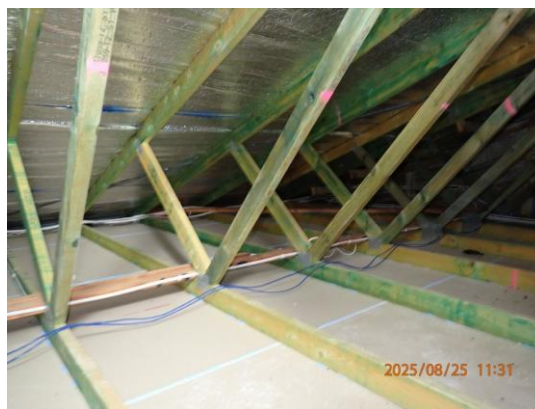
The inspection of the roof void of the Dwelling (see photos 1 to 6) and Studio (see photos 7 to 10) was limited due to the truss configuration, low crawl space and sarking.

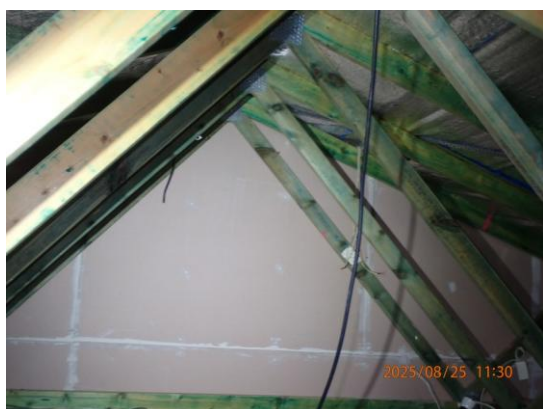
The dividing wall between the Studio and Dwelling carries through to the underside of the roof covering (see photo below).
