**PRE SALE
STANDARD PROPERTY REPORT**

Report number: PPI202687

Inspection date: Monday 9th March 2026

Property address: 34 Laura Street Banora Point NSW

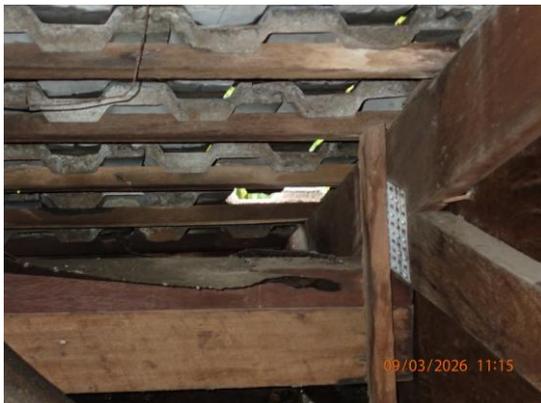
The roof tile is broken/missing above the eave at the south west corner which requires replacement for weather proofing purposes (see photo below).

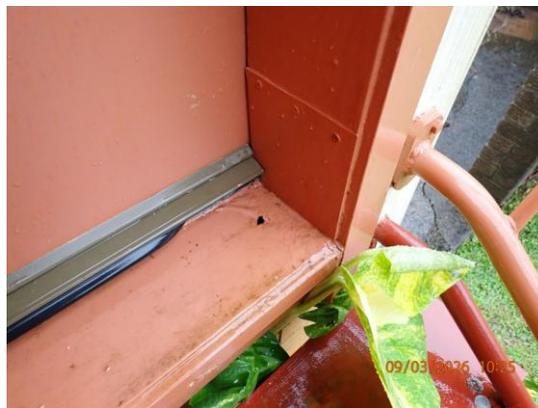
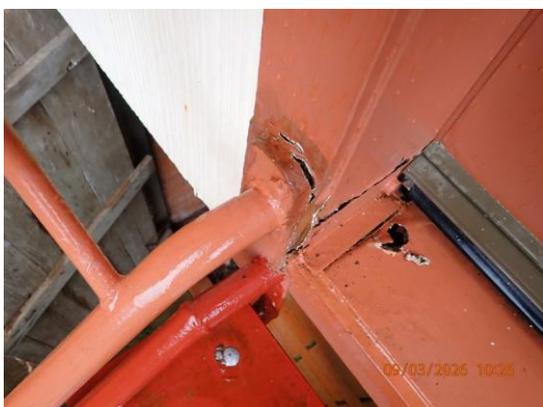
There is decay to the door jamb and sill (see photos 1 & 2) and decay to the timber mouldings and framing at the handrail fixing (see photo 3) of the enclosed rear entry balcony. The affected areas require repair and/or replacement. Due to the limits of the visual inspection it is hard to determine if there is damage to the framing members covered by wall linings and cladding. It is recommended that a more invasive inspection be undertaken. If damage is found the affected timber members should be repaired and/or replaced.

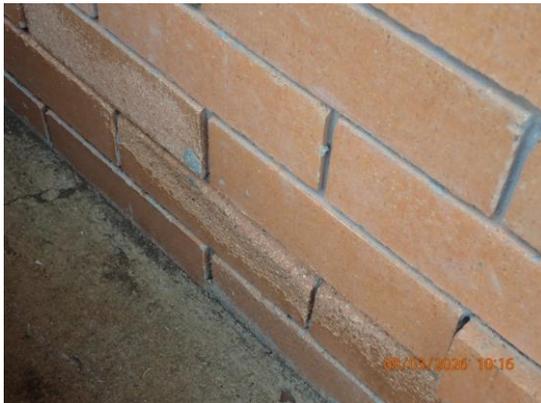
- There is erosion to the bricks in areas due to age and the type of bricks used at the time of construction (see photo below). The affected areas require treatment with a suitable sealant to prevent further deterioration.

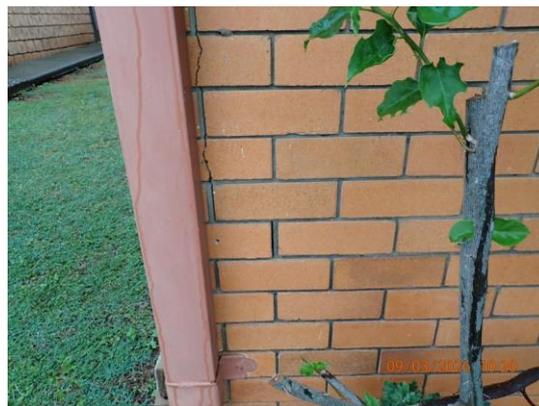
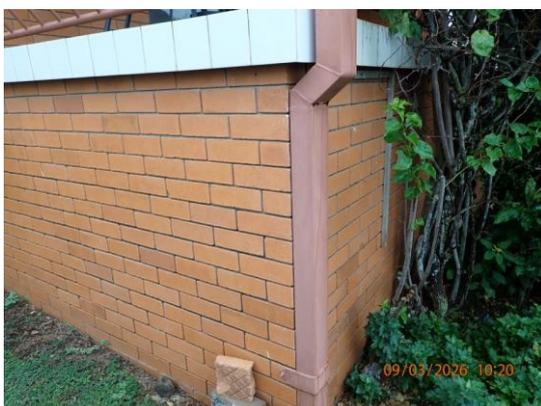
- There is cracking to the brickwork at the balcony handrail junction (see photo 1) and below the balcony (see photos 2 & 3). The cracks appear to have been there for some time and show no signs of recent movement. It is recommended that the affected areas be monitored to ensure there is no further movement, and if so the services of a Practising Structural Engineer be sought to assess the adequacy of the building, determine the risk of further settlement, recommend measures to counter any such movement, and if required, provide a specification for rectification works.

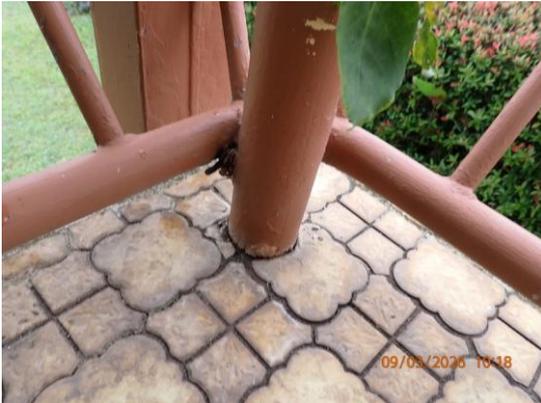
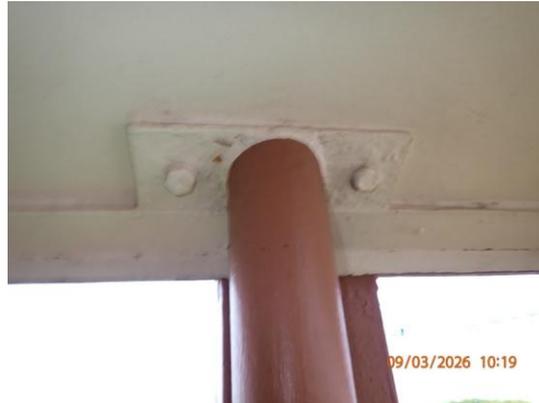
- There is rusting to the metal support posts and handrails of the balcony which require repair, maintenance and/or treatment with a rust inhibiting paint to prevent further deterioration (see photos below).

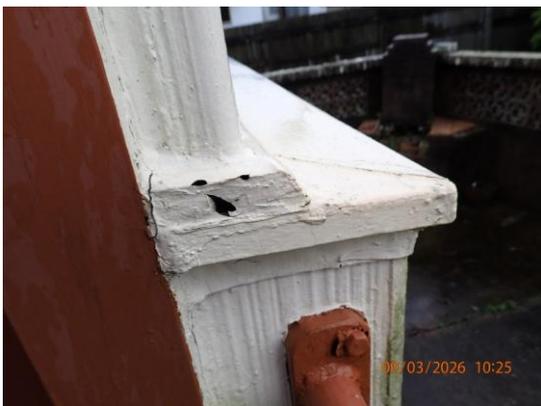
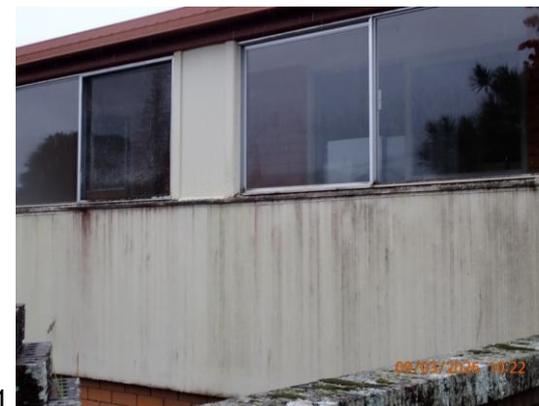
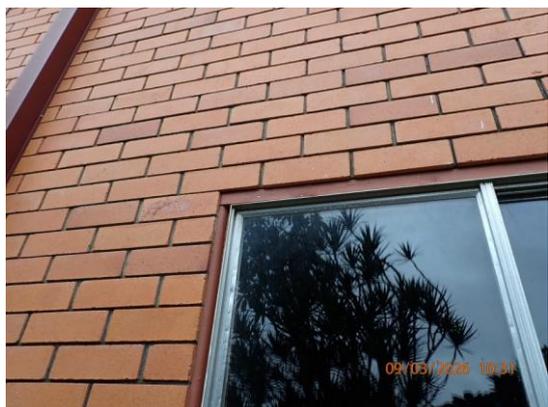
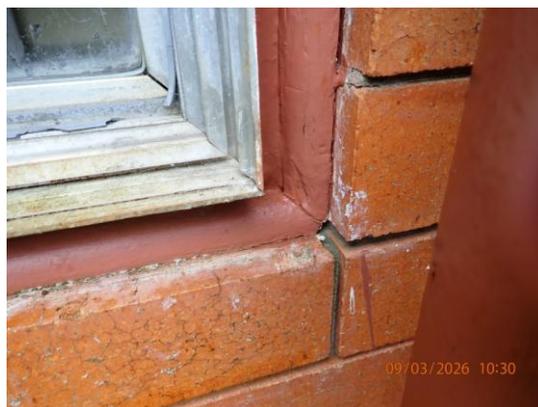
- There is decay to the timber mouldings of the sheeting and windows which requires repair, maintenance and/or treatment to prevent deterioration (see photos below).

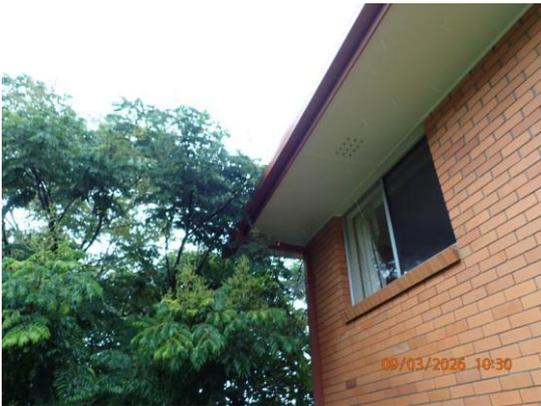
- All debris should be removed from the guttering to allow water flow during times of rain and to prevent premature deterioration of the guttering (see photo below).

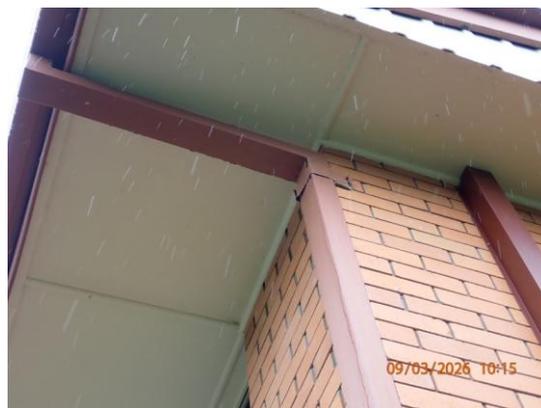
2

- There are leaks to the joins of the guttering and downpipes in areas, which require sealing with a flexible sealant.
- There is rusting to the gutters and downpipes, which requires repair, maintenance and/or treatment with rust inhibiting paint to prevent further deterioration (see photos below).

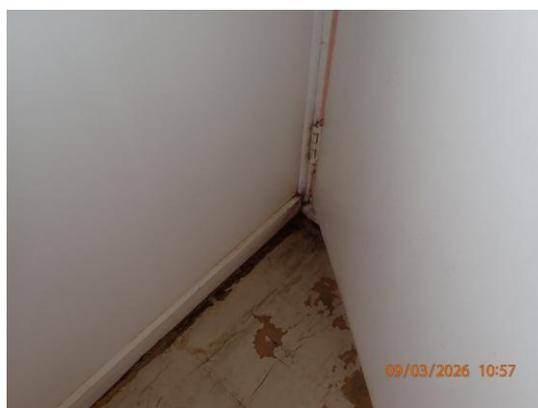
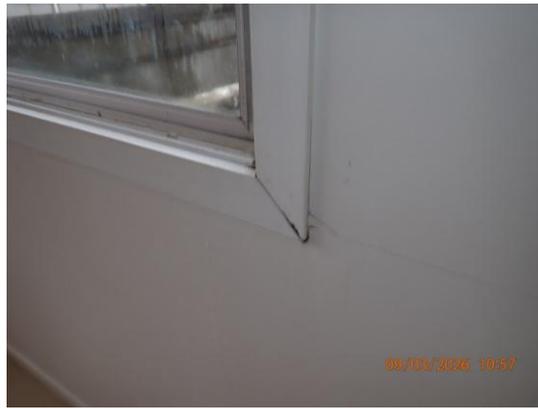
- There is decay to the timber mouldings and skirting of the enclosed rear entry balcony which requires repair, maintenance and/or treatment to prevent deterioration (see photo below). The decay is due to moisture. There was no evidence of recent leaking. It is recommended that the affected areas be monitored to ensure there are no further leaks and if moisture becomes obvious. The leaks need to be located and repairs made. Due to the limits of the visual inspection it is hard to determine if there is damage to the framing members covered by wall linings and cladding. It is recommended that a more invasive inspection be undertaken. If damage is found the affected timber members should be repaired and/or replaced.

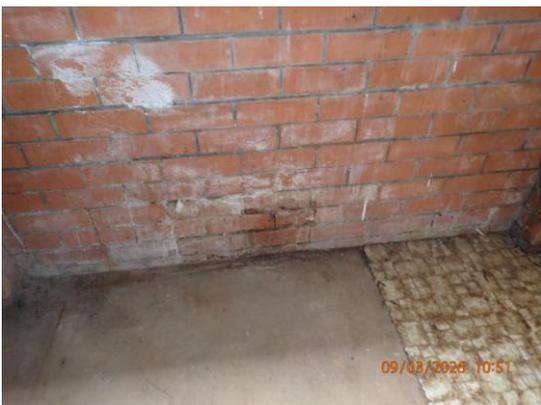
- There is evidence of stains and moisture to the bricks of the sub floor/garage due to the outside ground being higher than the inside floor level (see photo below). Due to the outside ground level being higher than the inside floor level, water/moisture could enter the room in times of rain. It is recommended that the area be monitored to ensure damp conditions do not continue, and if so the ground levels may require altering and/or additional surface drains provided.

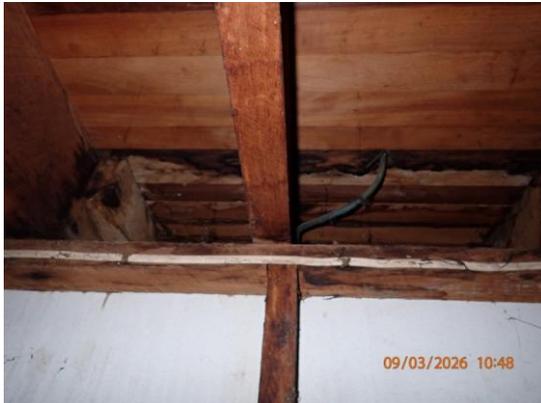
- There are stains to the upper level flooring at the pipe penetration visible from the sub floor/garage (see photo below). The stains are indicative of a water leak. There was no evidence of recent leaking at the time of the inspection. It is recommended that the affected area be monitored to be sure there are no further leaks and if so the leaks need to be located and repairs made to prevent premature deterioration of the building elements.

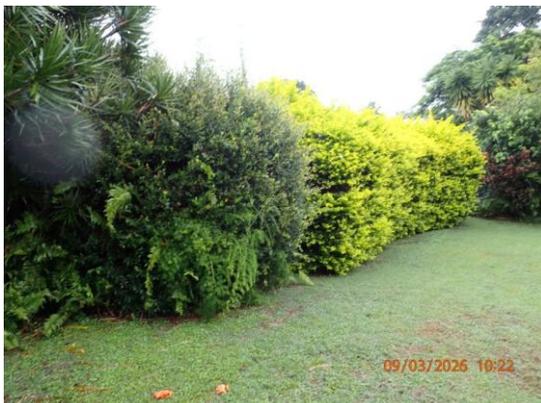
- The vegetation obscured the fencing in some areas (see photo below).

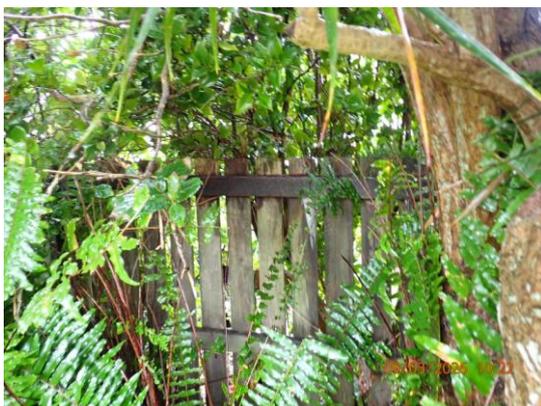
- There is decay to the timber members of the fencing, which require repair, maintenance and/or treatment to prevent further deterioration (see photo below).

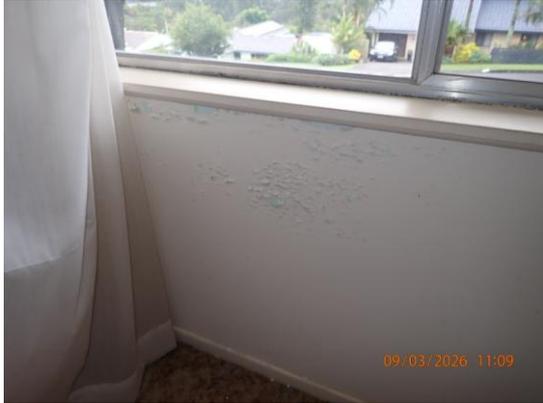
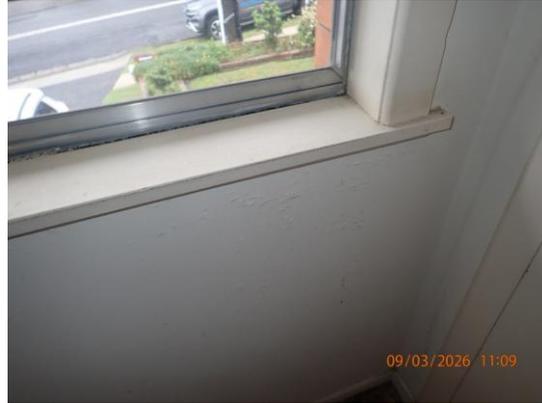
- The timber floor appears to be out of level and uneven in some areas, which may be caused by shrinkage of unseasoned floor timbers used at the time of construction and the age of the building.
- The paint finish below bedroom 3 window is blistering and coming away and requires patching and repainting (see photos below).

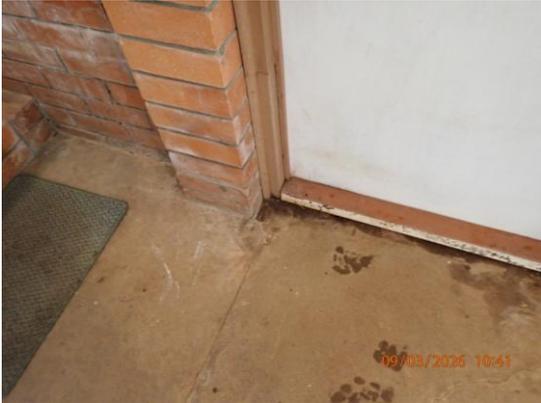
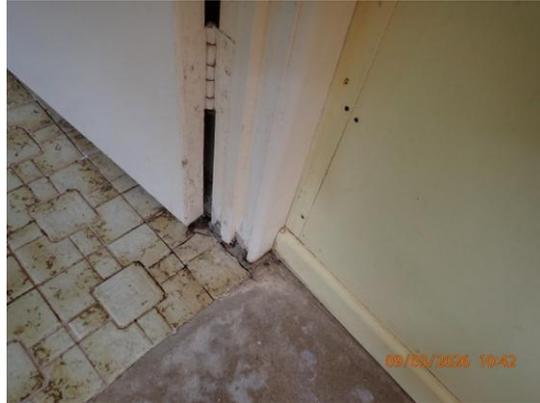
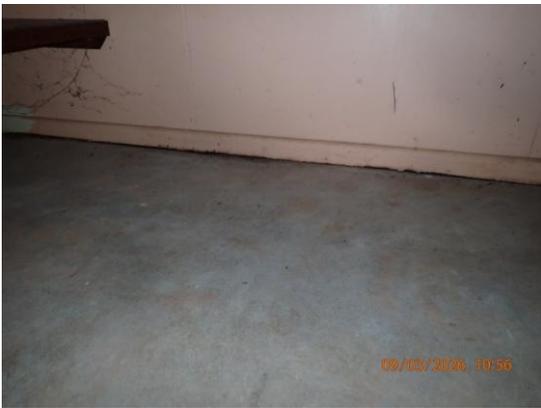
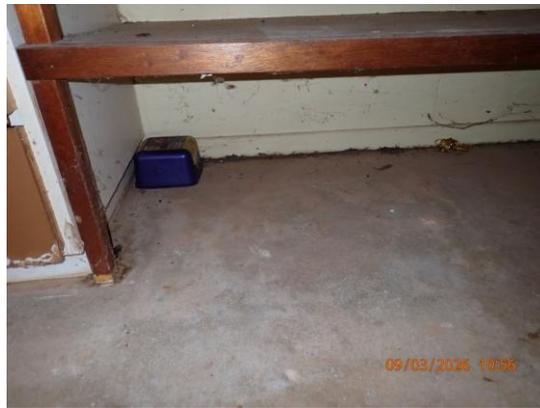
- There is decay to the external door and jambs (see photo 1), wall framing and door jambs (see photo 2) and decay to the skirting below the stairs (see photos 3 to 5) of the laundry/bathroom which requires repair, maintenance and/or treatment to prevent deterioration.

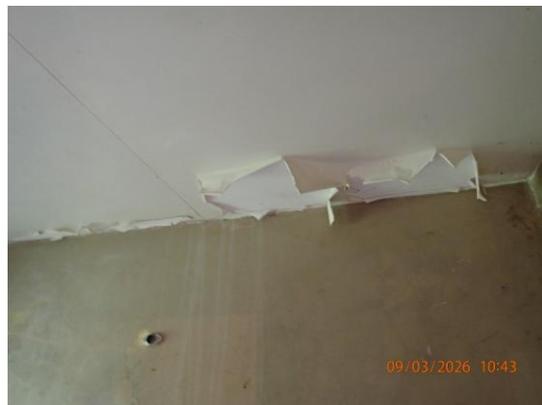
- The paint finish to the laundry/bathroom is blistering and coming away which could be due to poor paint preparation prior to painting and the type of paint used (see photos below). Please engage a Licenced Painter to inspect, give advice and carry out repairs and rectification works.

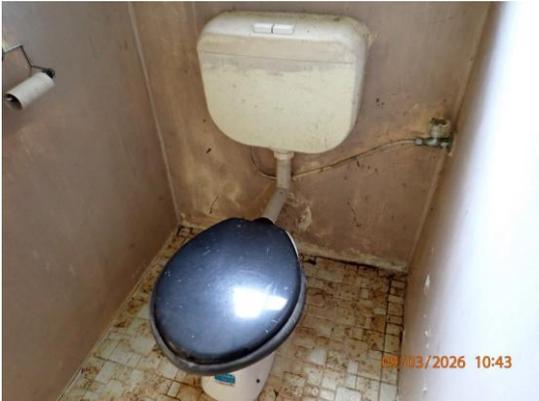
- The laundry/bathroom toilet was not operational at the time of the inspection (see photo below). Please engage a Licenced Plumber to inspect, give advice and carry out repairs where necessary.

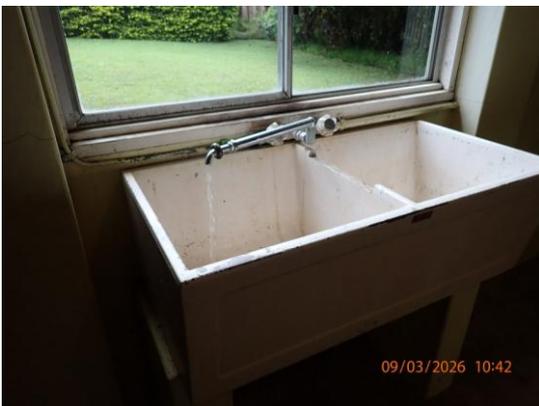
- The laundry tub is loose and requires securing into position (see photo below).

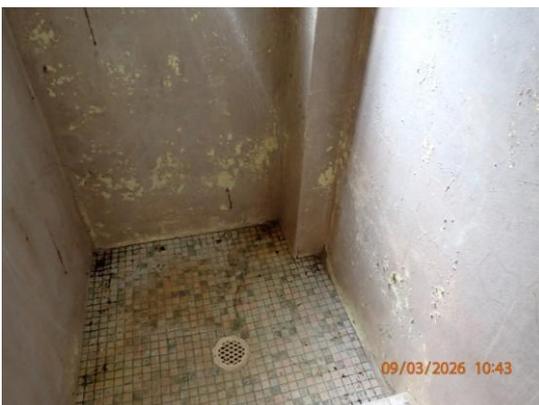
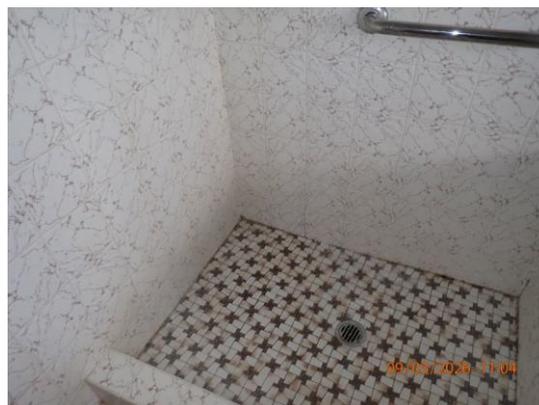
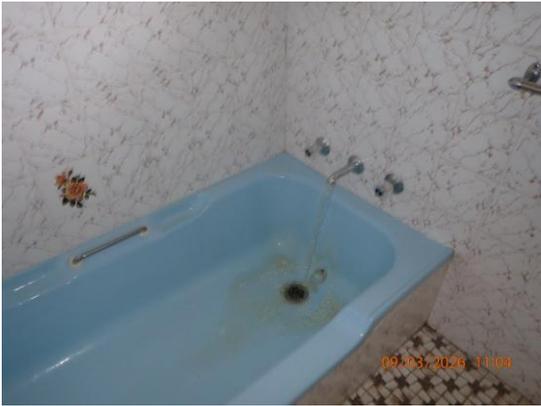
- The junctions of the wall and floor tiles in the laundry bathroom shower, bathroom shower and over the bathroom bath require sealing with a flexible sealant to prevent water build up behind the tiles or in the cavity (see photos below).

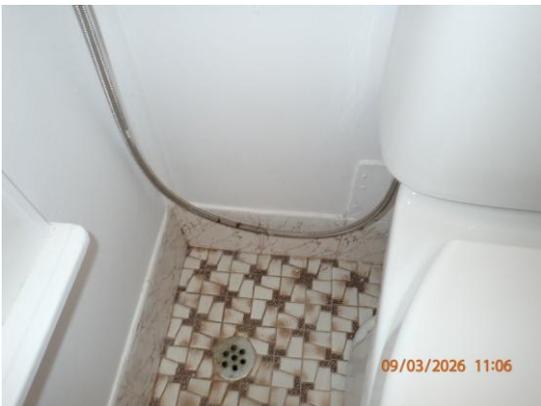
- The taps to the bathroom and laundry/bathroom require maintenance due to age and wear and tear.
- There is rusting to the flexible water hose to the main toilet which requires attention to prevent further deterioration (see photo below).

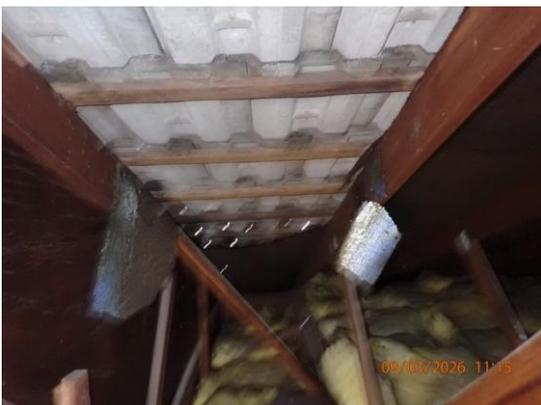
- The sarking below the roof tiles is damaged/torn should be retaped to gain maximum benefit from its installation (see photos below).

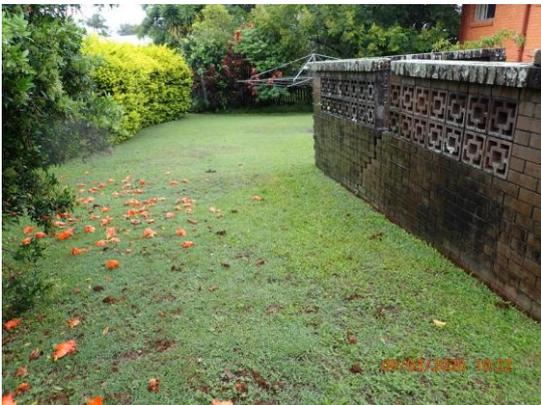
At the time of the inspection there was no visible evidence of water ponding against the building (see photo below). If damp conditions become obvious, it is recommended that all surface water should be redirected clear of the building footprint and where necessary the ground levels altered and/or additional surface drains installed and connected to the stormwater system.

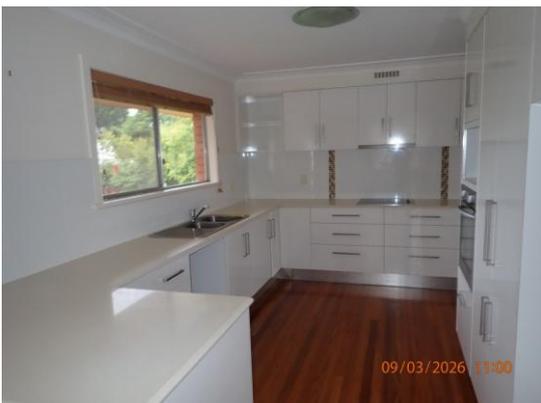
The kitchen has been renovated at some stage and it is recommended that the relevant documentation be obtained in regard to the renovations (see photo below).

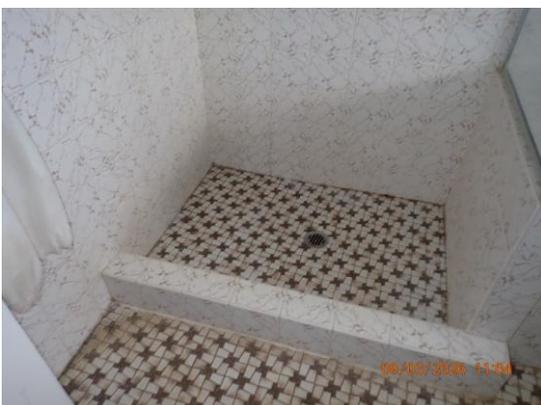
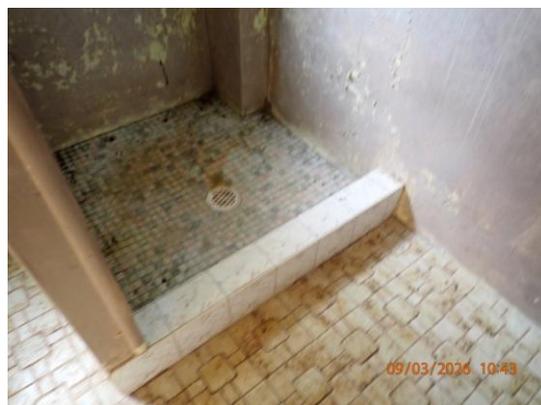
Due to the design of the showers, water could come out of the opening when in use (see photos below).

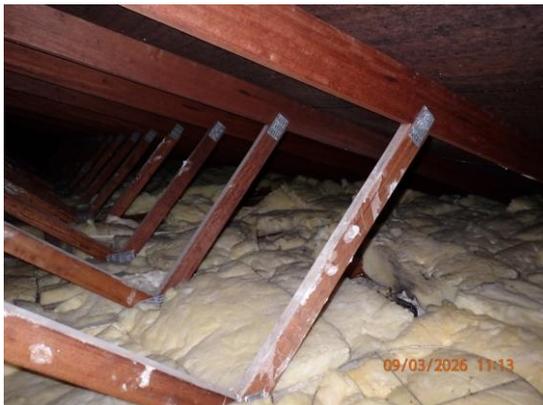
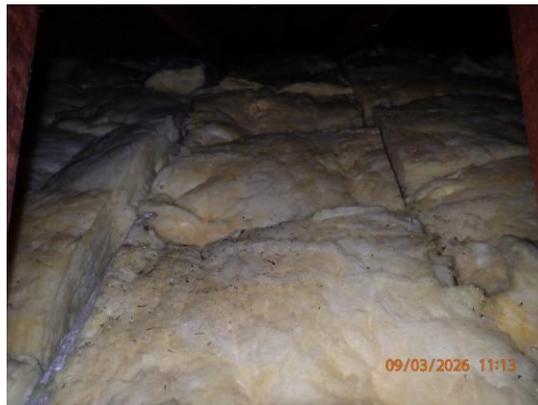
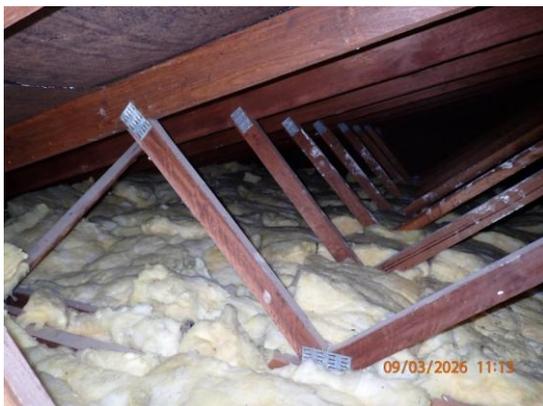
The inspection of the roof void was limited due to the truss configuration, low crawl space, insulation and sarking (see photos below).

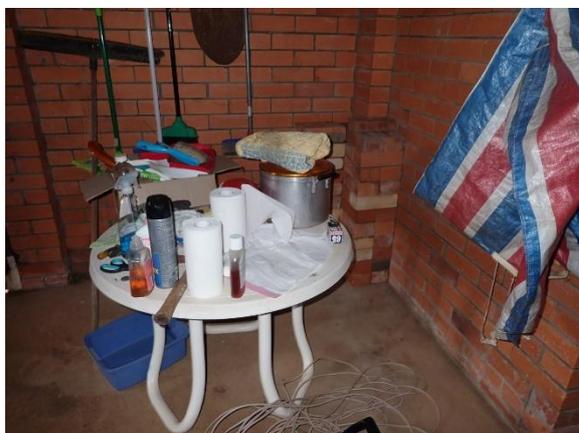
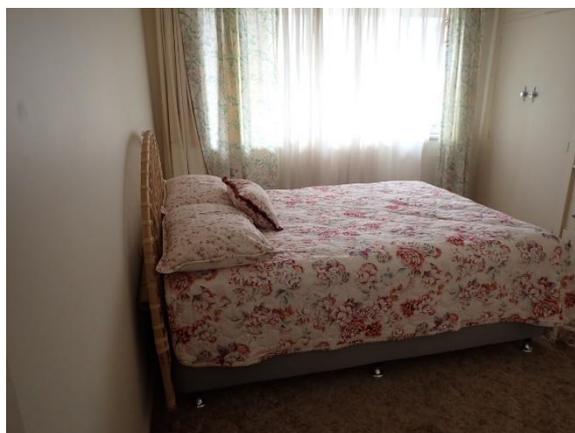
- No access to wall cavities due to fixed wall coverings.
- Floor coverings.
- No access to areas under kitchen cupboards, vanities and any fixed cupboards or bathtub.
- No physical access to roof space eaves due to design.
- General furnishings, stored and personal items against internal walls present and restrict inspection within these areas, pest activity and or damage and building defects may be present behind household furnishings.

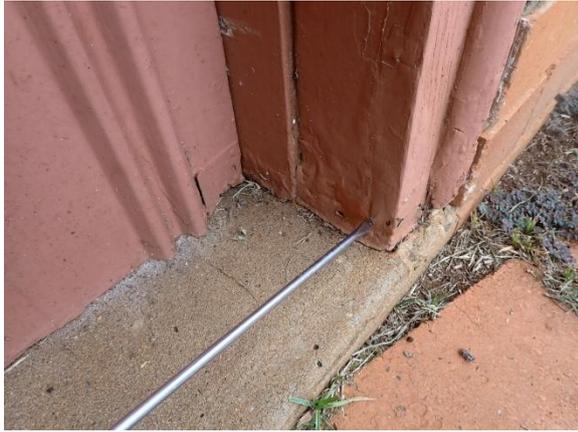
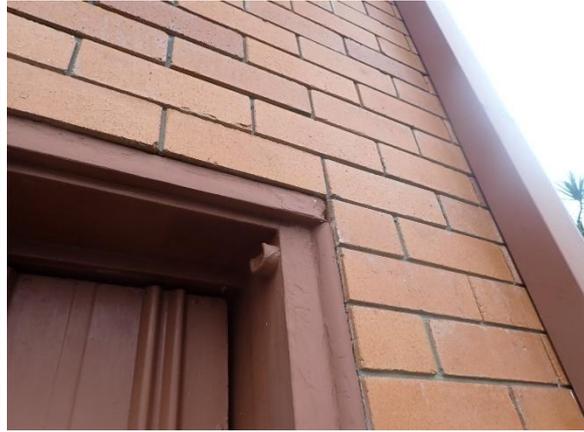
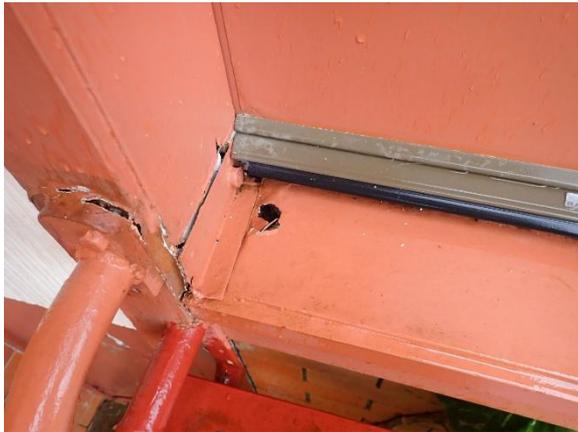
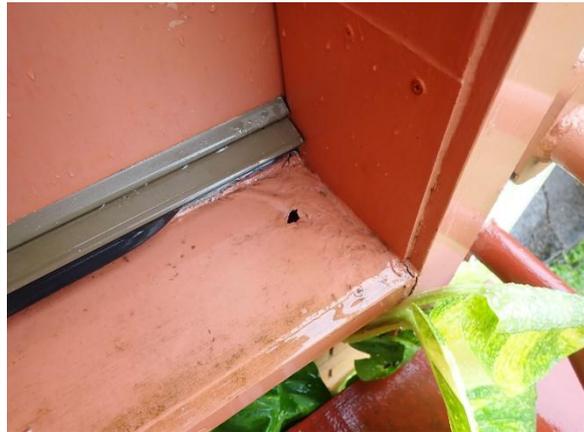
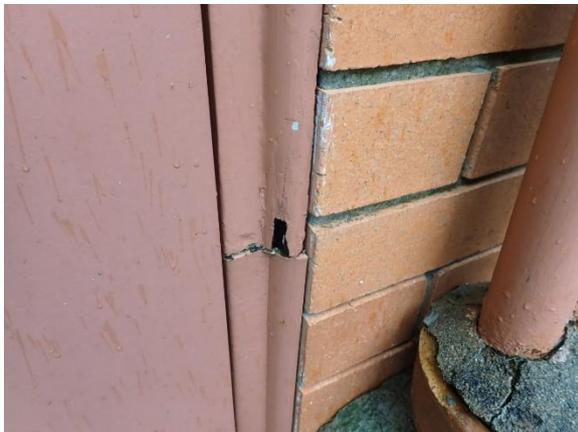
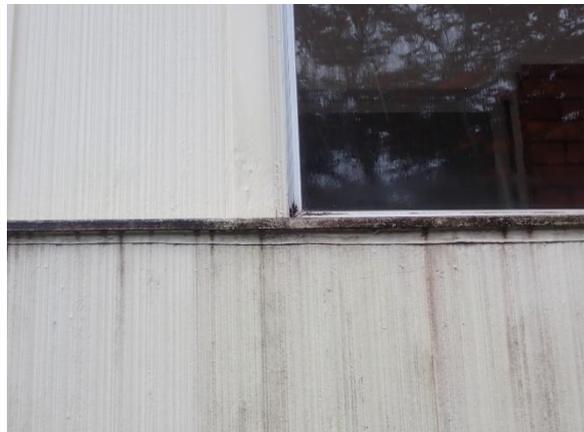
(Normal for the age of the structure). It is recommended that these timbers be replaced to prevent further damage to adjoining timbers. Fungal decay may be present in concealed areas behind wet areas that can only be located by the removal of wall linings.

While we are not builders the fungal decay damage appears to be: S-M-E

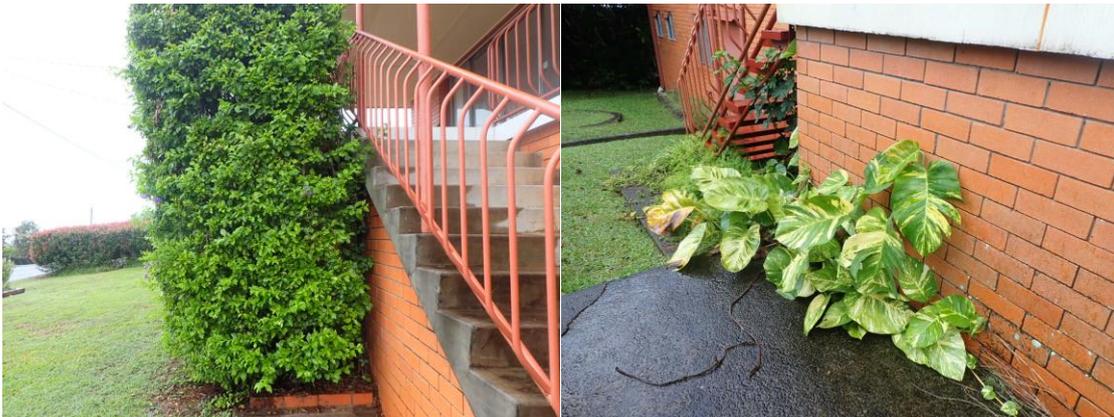
- Trees, tree roots, vines or shrubs are close to or abutting the external walls of the structure. This can allow concealed termite entry and they should be removed immediately.
