# PEST AND BUILDING PRE-PURCHASE REPORTS

# STANDARD PROPERTY & TIMBER PEST REPORT

Report number: **1781038478656**  
Inspection date: **10-06-2026**  
Client:  
Property address: **6 Clancy Pl, Terranora NSW 2486, Australia**

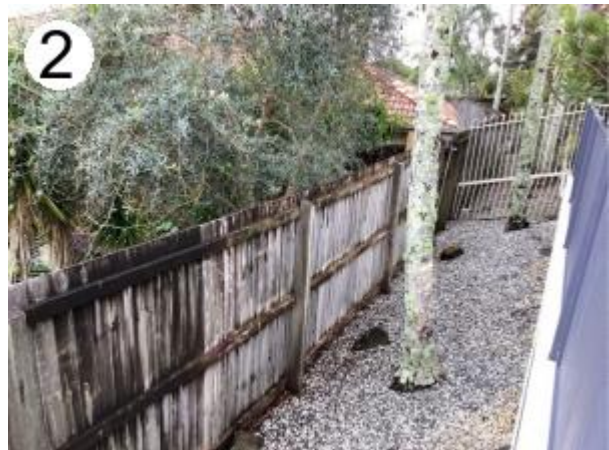
#2

#1. Various wood decay and deterioration / movement has occurred to the timber fencing around the perimeter of the property. A further detailed investigation by a competent person, e.g. a licensed building / fencing contractor is recommended to determine the cause, method and extent of any remedial work required, and associated costs. The above recommendation should be implemented as soon as possible.

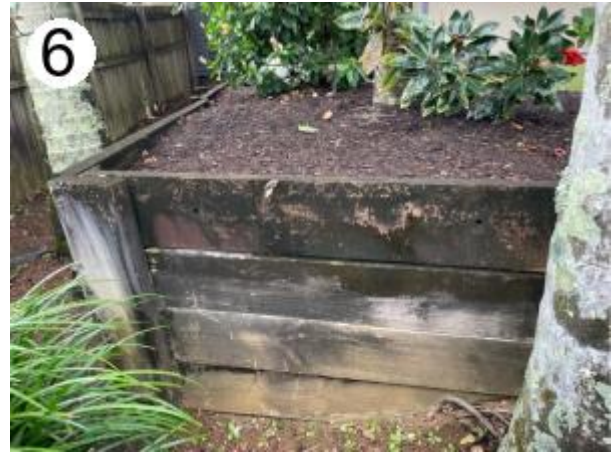
#6

#5. Various wood decay and deterioration / movement has occurred to retaining wall timbers. A further detailed investigation by a competent person, e.g. a licensed building contractor / retaining wall specialist is recommended to determine the cause, method and extent of any remedial work required, and associated costs. The above recommendation should be implemented as soon as possible.

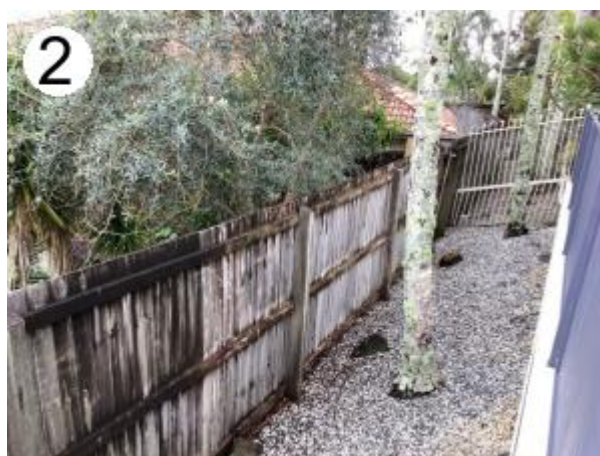
#2

#1. Various wood decay and deterioration / movement has occurred to the timber fencing and timber retaining walls around the perimeter of the property. A further detailed investigation by a competent person, e.g. a licensed building / fencing contractor is recommended to determine the cause, method and extent of any remedial work required, and associated costs. The above recommendation should be implemented as soon as possible.
