# **BUILDING AND TIMBER PEST INSPECTION REPORT**

431 Lawrence Hargrave Drive, Scarborough.

# BUILDING AND TIMBER PEST INSPECTION REPORT TO AS4349.1 2007 & AS4349.3 2010

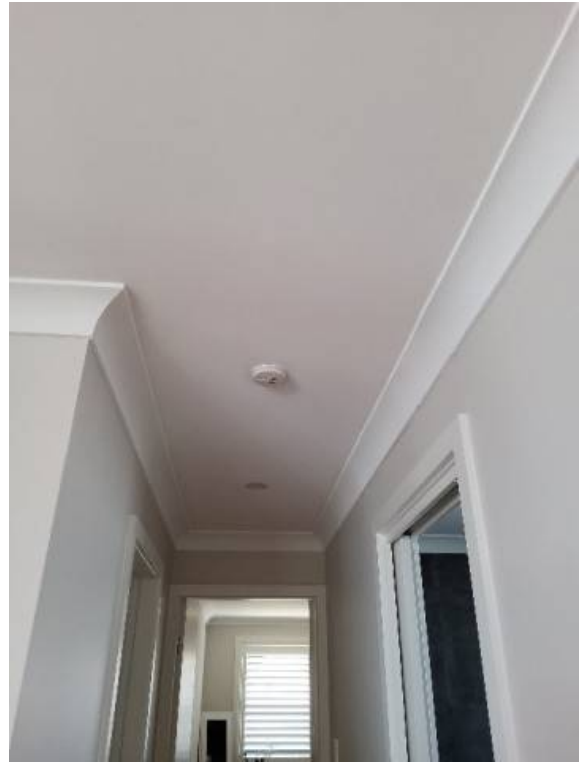
- Smoke alarms are present within the house and located at the - Hallway

*An electrician should be consulted to advise on those installed or install new detectors / alarms if / where required.*

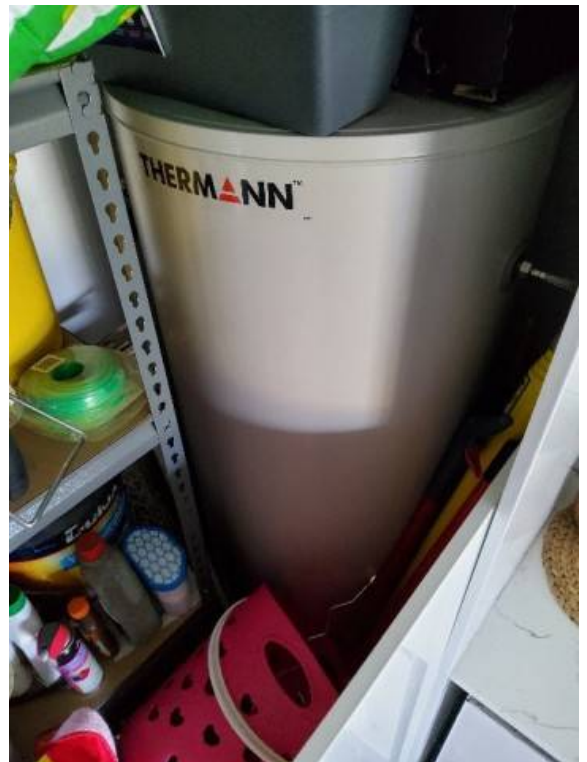
Electrical Hot Water Service. (In general Electric Hot water storage services have a life expectancy of 10-15 years. Have a licenced plumber further inspect and comment on operation / service)

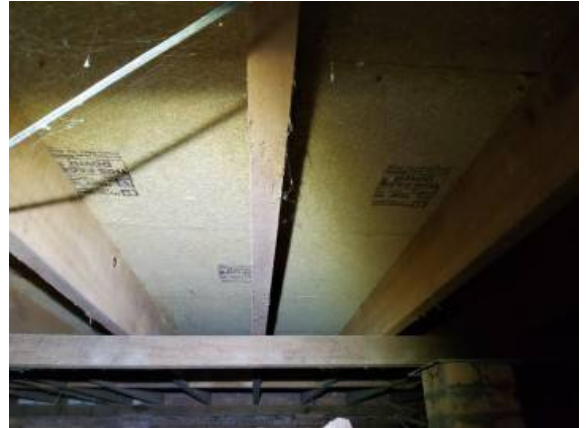
Older sub floor frames do not comply with current wind ratings. This framing is in satisfactory / typical condition for the age / construction date. Some sections show of deflection / movement away from their seated position. Some areas may require re-bracing, fitting in the future.
