SDB Inspecta Homes T/A

Pre Purchase Visual Inspection Report

8 Maitland St Norah Head

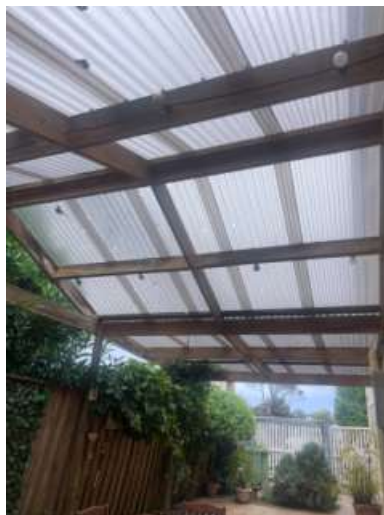
Roof Covering Condition Detail:

The overall condition of the roof coverings is poor. Roof and/or flashings are allowing water to penetrate the interior of the building. Concealed internal roofing members may be damaged and require repair or replacement. This should be investigated further by a licensed contractor and rectified.

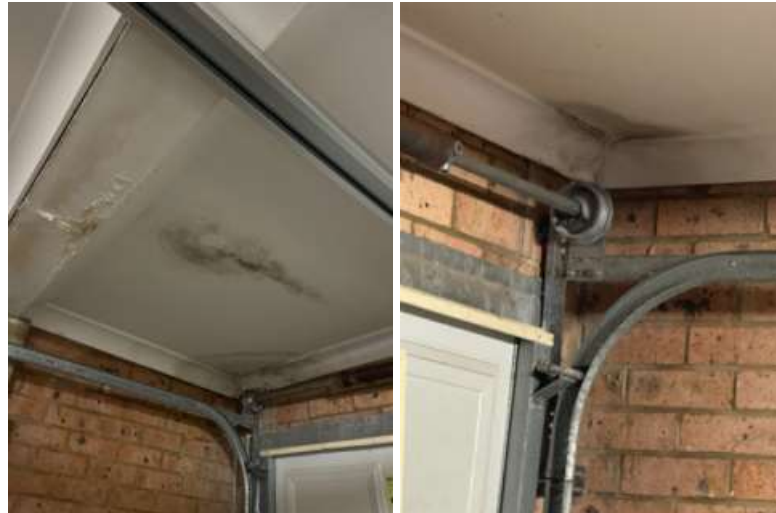
Ceiling Condition:

The condition of the ceilings is generally poor. There was evidence of water penetration through the ceiling and this area will require repair.
