Inspection Report

Coastal Building Inspections

15 Mimosa Road , Budgewoi, NSW, 2262

Pest And Building Inspection

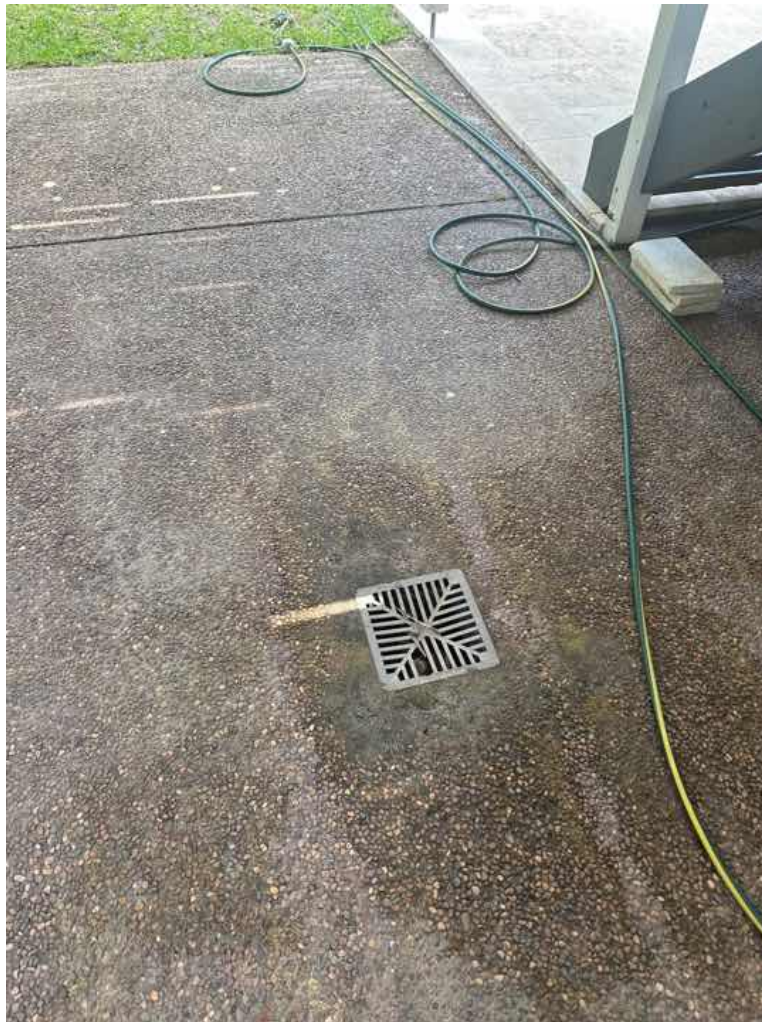
No evidence of slow or blocked drains at the time of inspections.

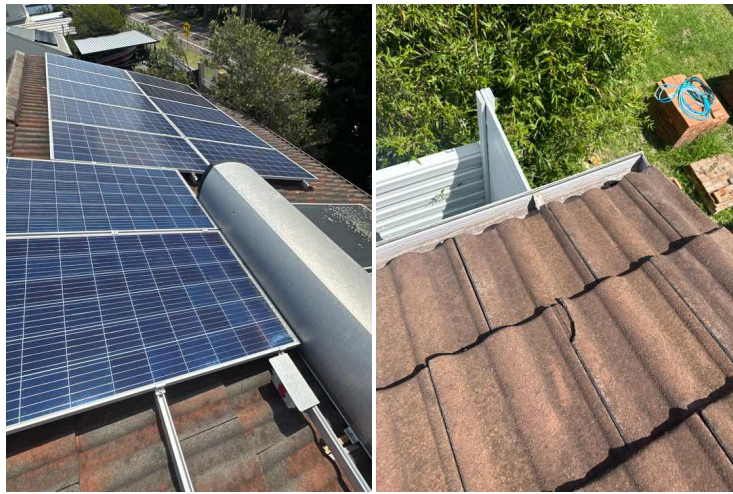
Some Cracked tile ends visible - Recommendations: A qualified roof tiling contractor should be engaged for advice and recommendations.

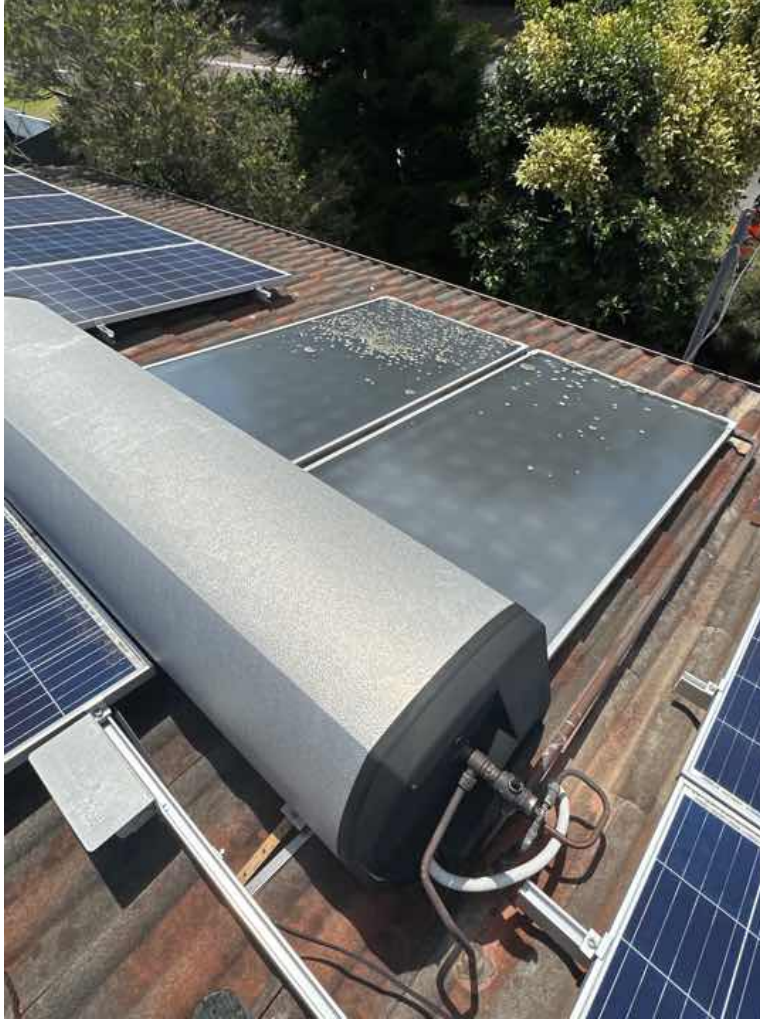
The hot water system appears to be in a serviceable condition. No specific tests other than running the hot water from a tap was carried out. No determination has been made as to the suitability or adequacy of the hot water system in relation to capacity or otherwise.

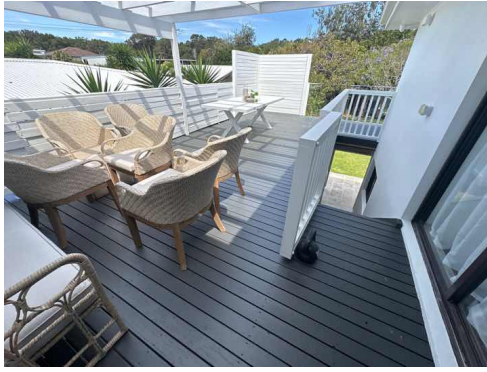
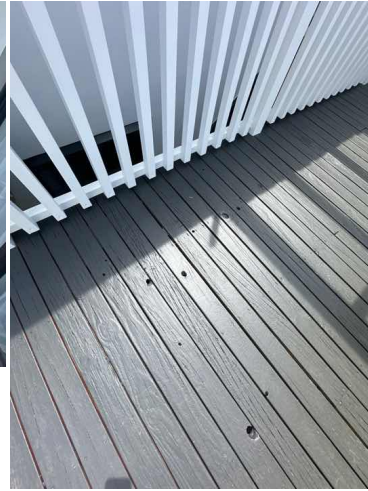
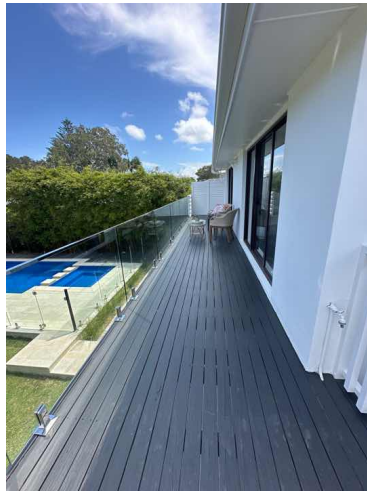
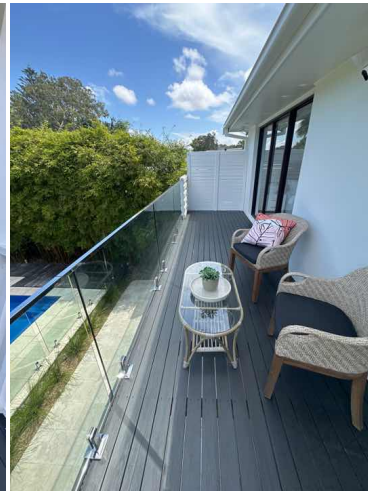
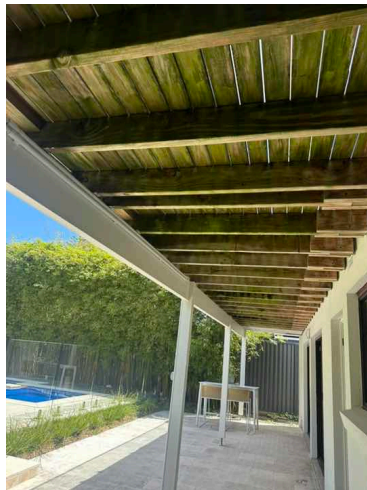
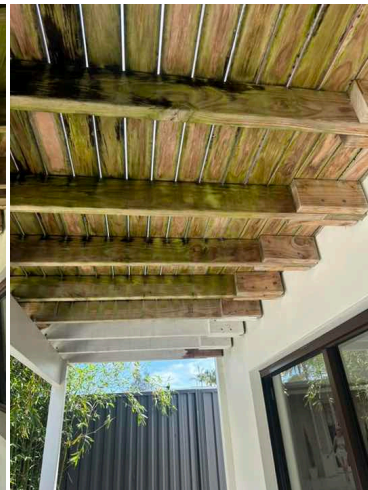
Decking board surfaces are weathered - Recommendations: We recommend cleaning and maintenance as needed.

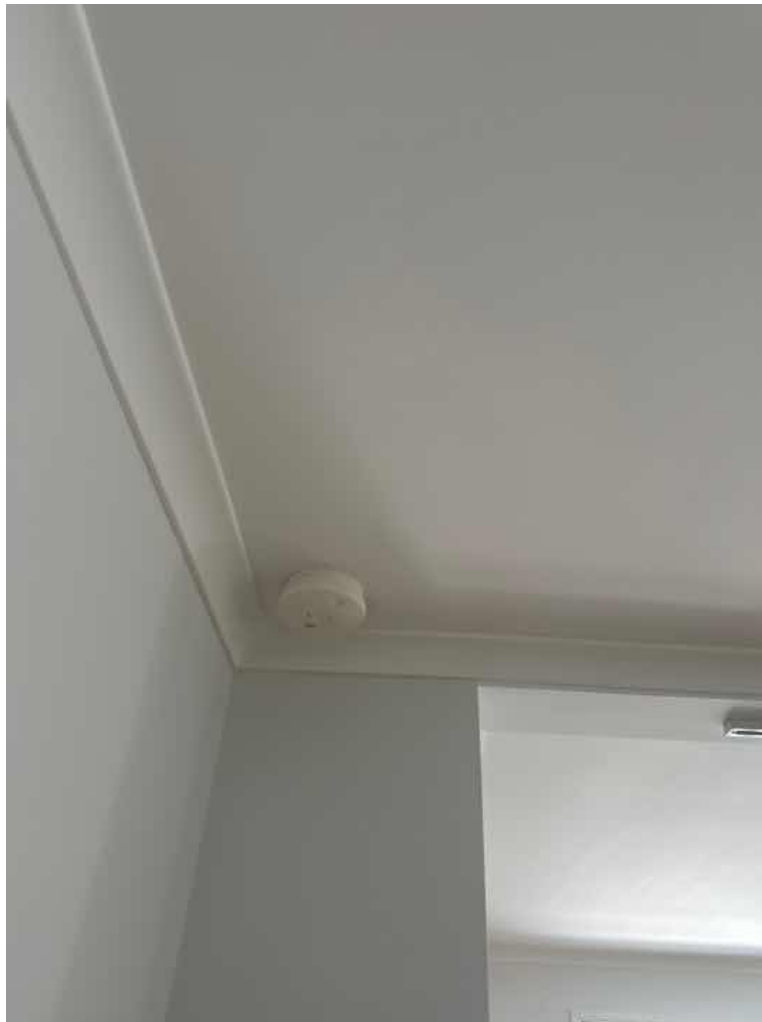
Yes a smoke alarm was sighted but not tested.

Legislation requires smoke Alarms to be installed. Check with your local council regarding type, locations and other related requirements.

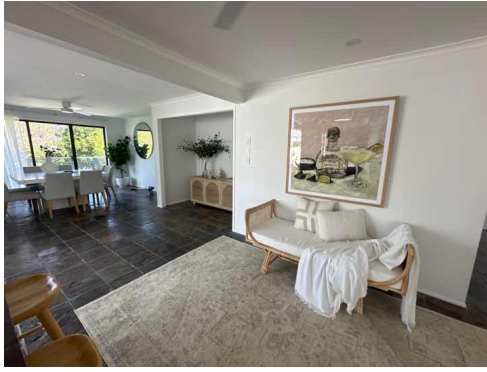
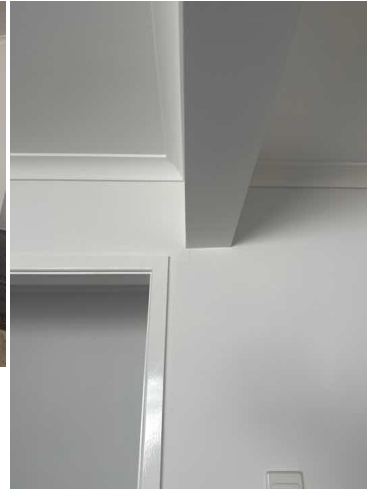
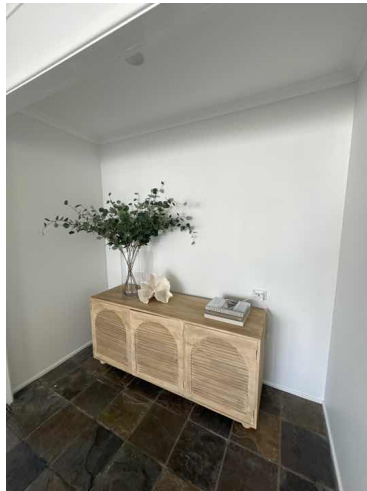
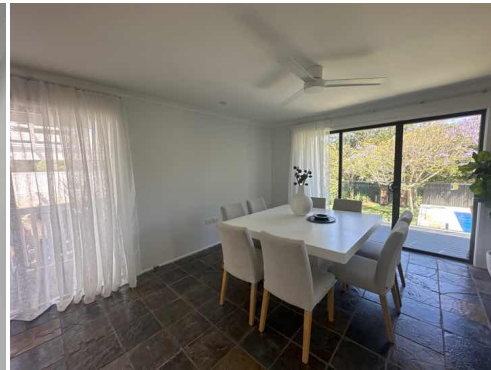
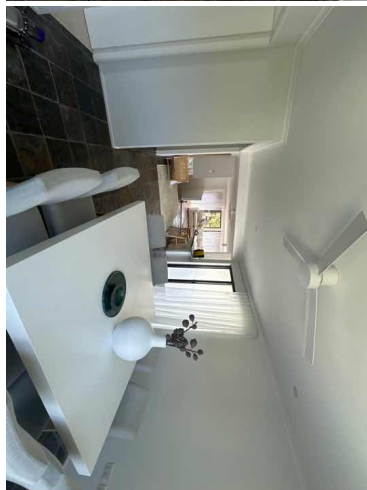
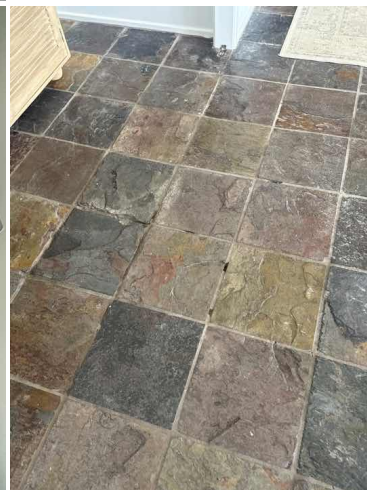
Settlement Cracks Noted. These are typical and generally patch and paint will suffice

General Wear and tear noted to the floor covering

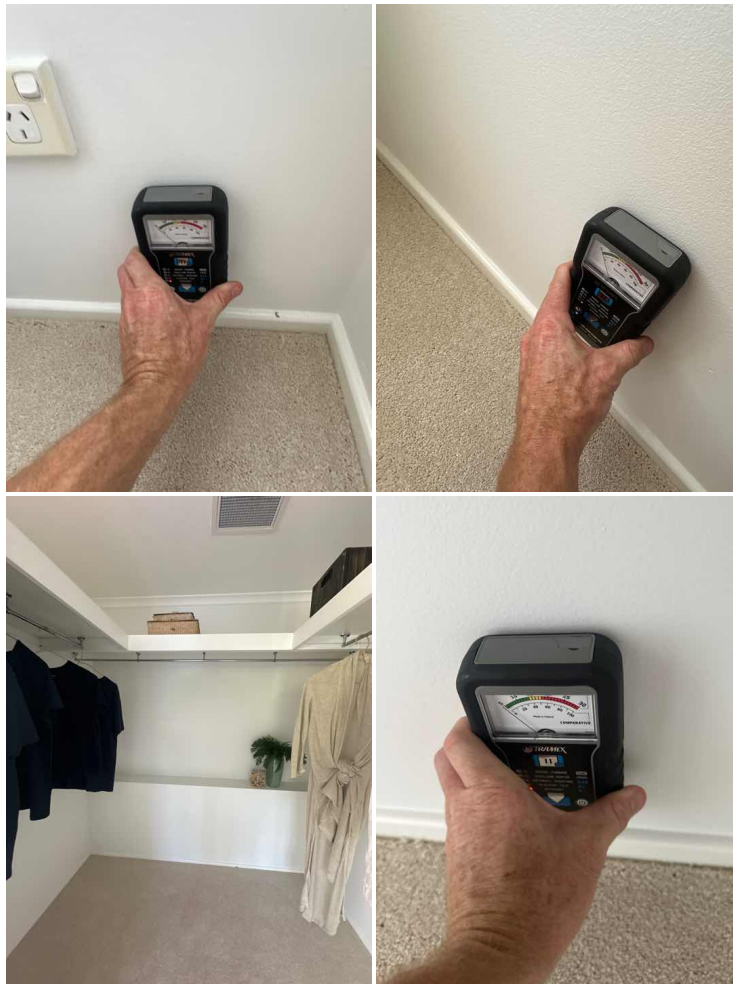
This bedroom is in serviceable condition for the age with no notable structural defects sighted.

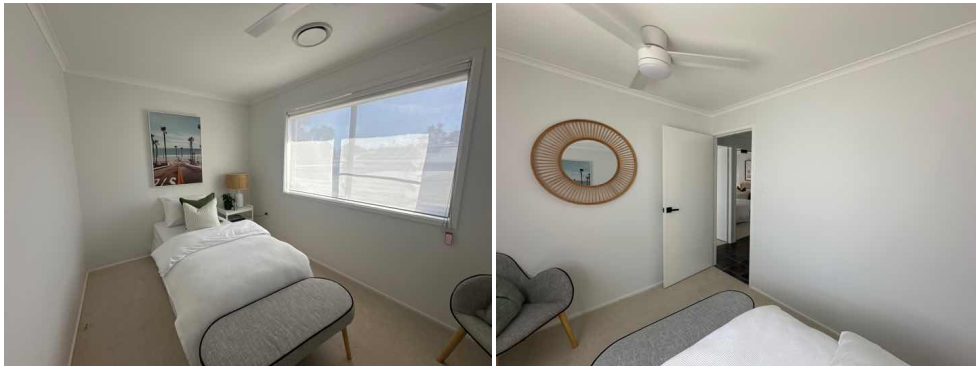
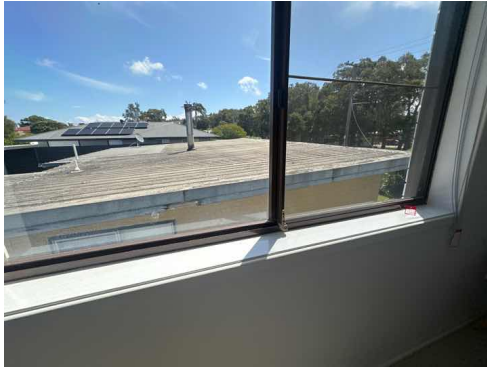
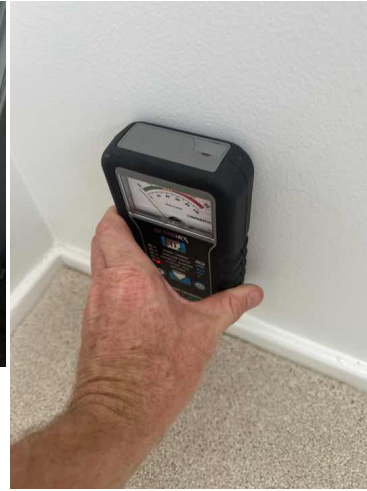
Bedroom 2

This bedroom is in serviceable condition for the age with no notable structural defects sighted.

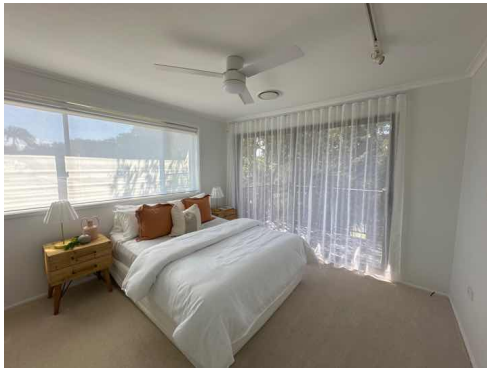
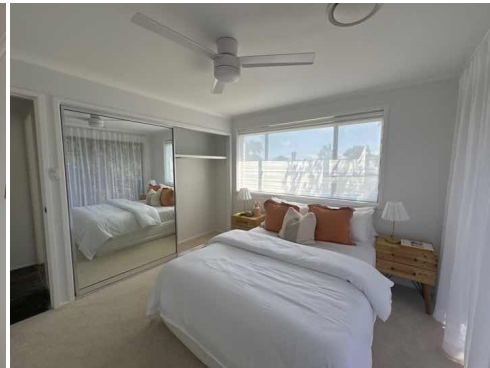
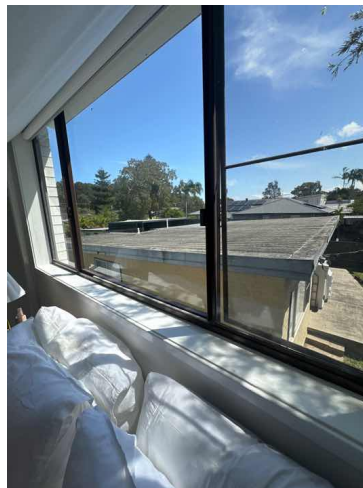
Bedroom 3

This bedroom is in serviceable condition for the age with no notable structural defects sighted.

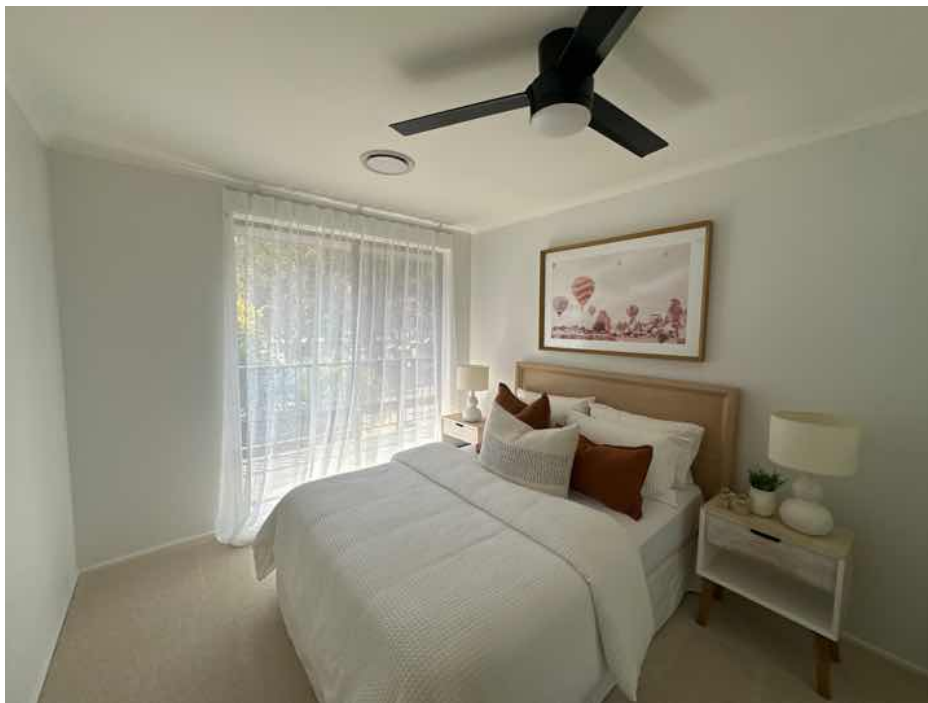
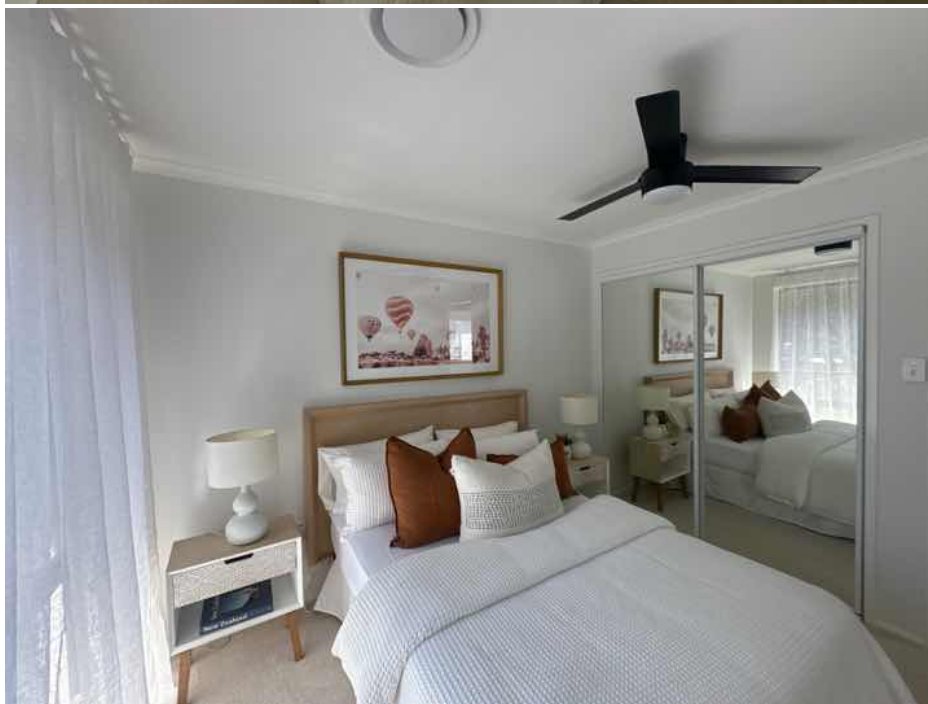
Bedroom 4

This bedroom is in serviceable condition for the age with no notable structural defects sighted.

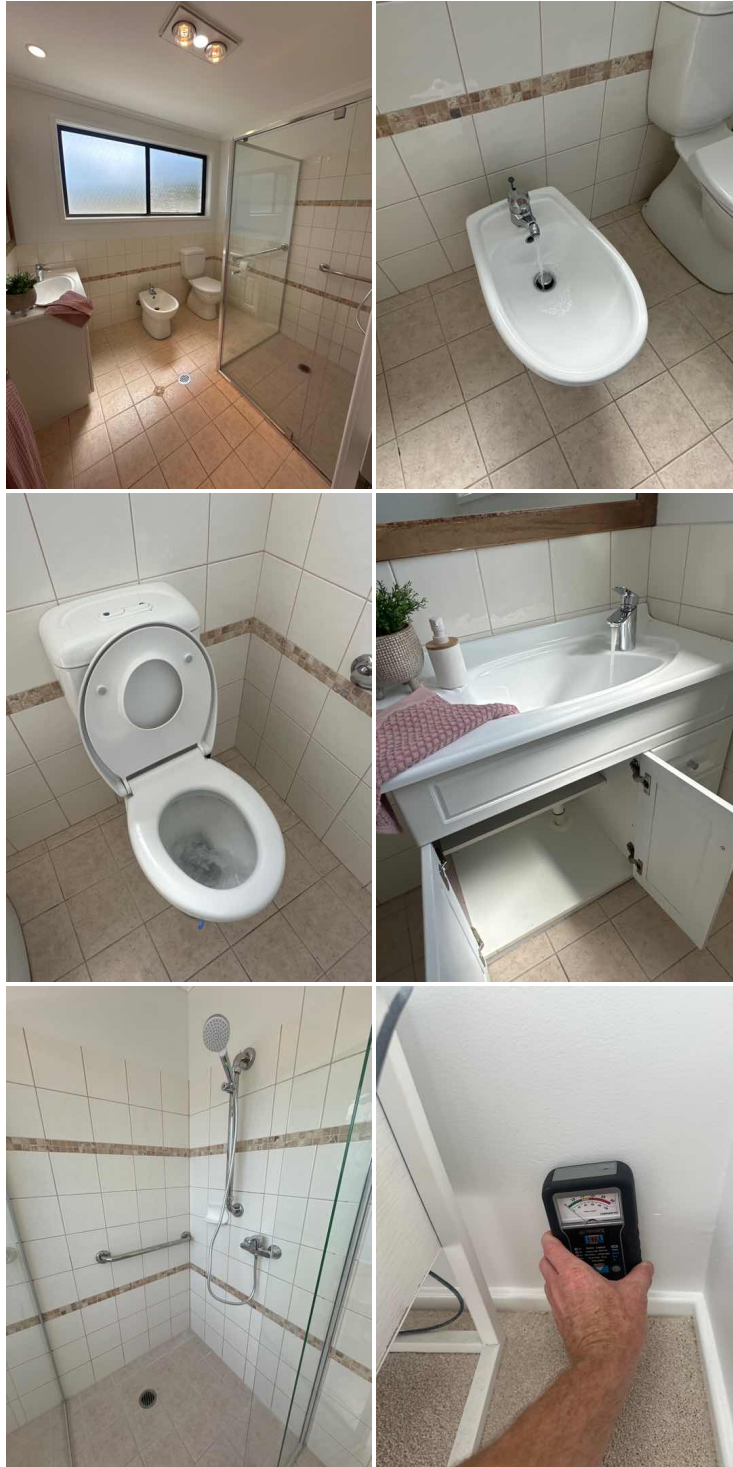
Of the visible areas, the general condition of this bathroom is serviceable or in reasonable condition for age of dwelling.

No moisture obtained from the back of the shower

An exhaust fan is present and operable in the bathroom

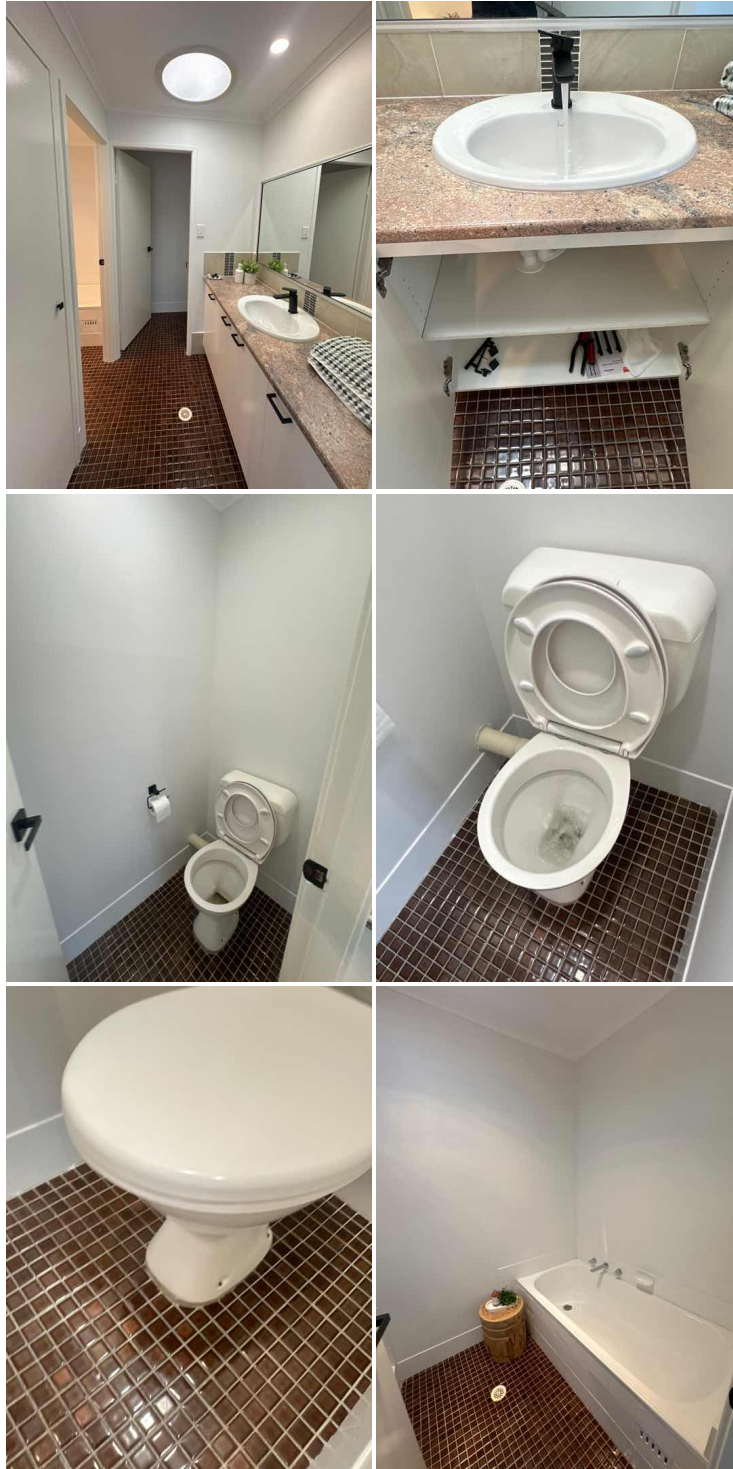
No moisture obtained from the back of the shower

An exhaust fan is present and operable in the bathroom

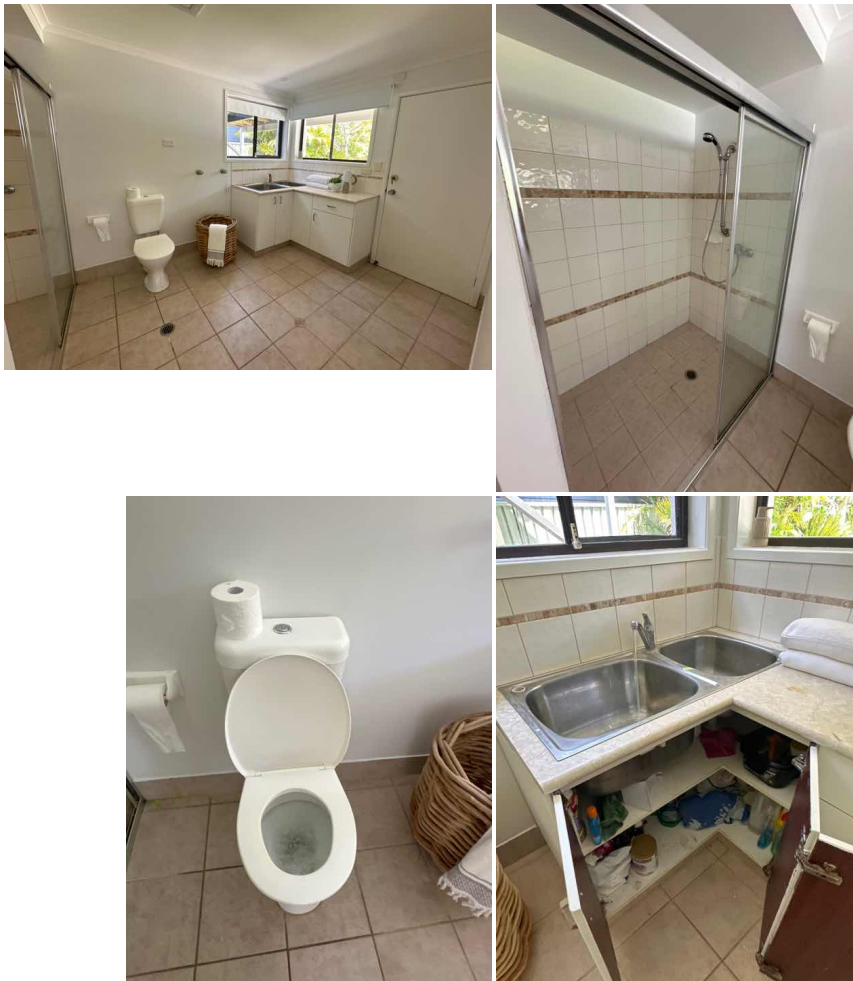
Pan is loose at the base. Contact a licensed plumber for repairs.

Of the visible areas, the general condition of the Toilet is serviceable or in reasonable condition for age of dwelling.

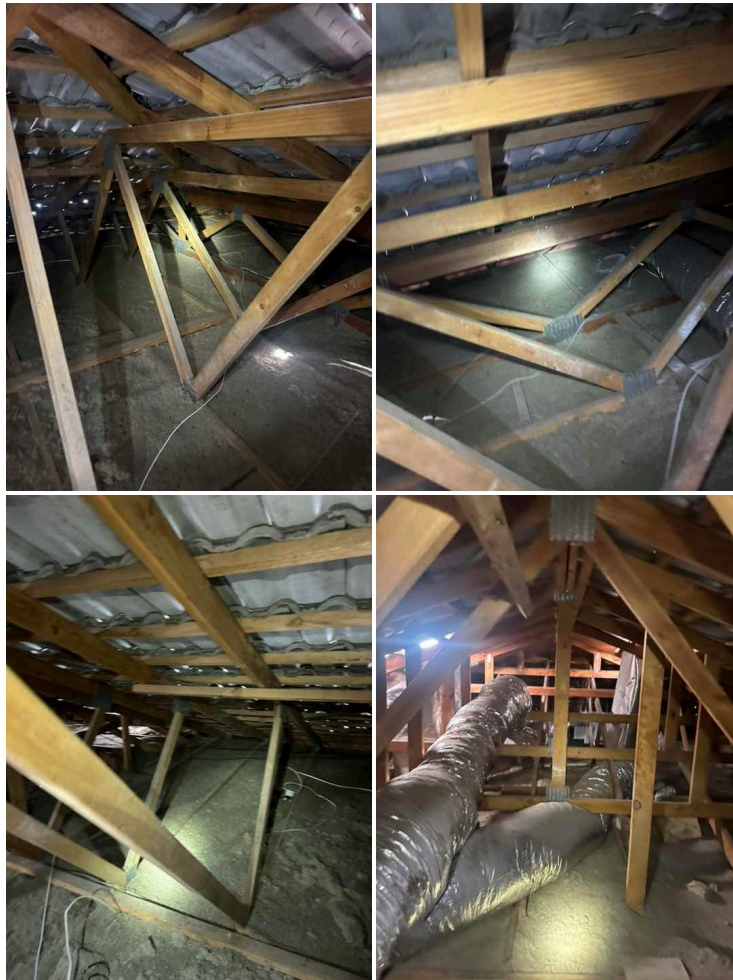
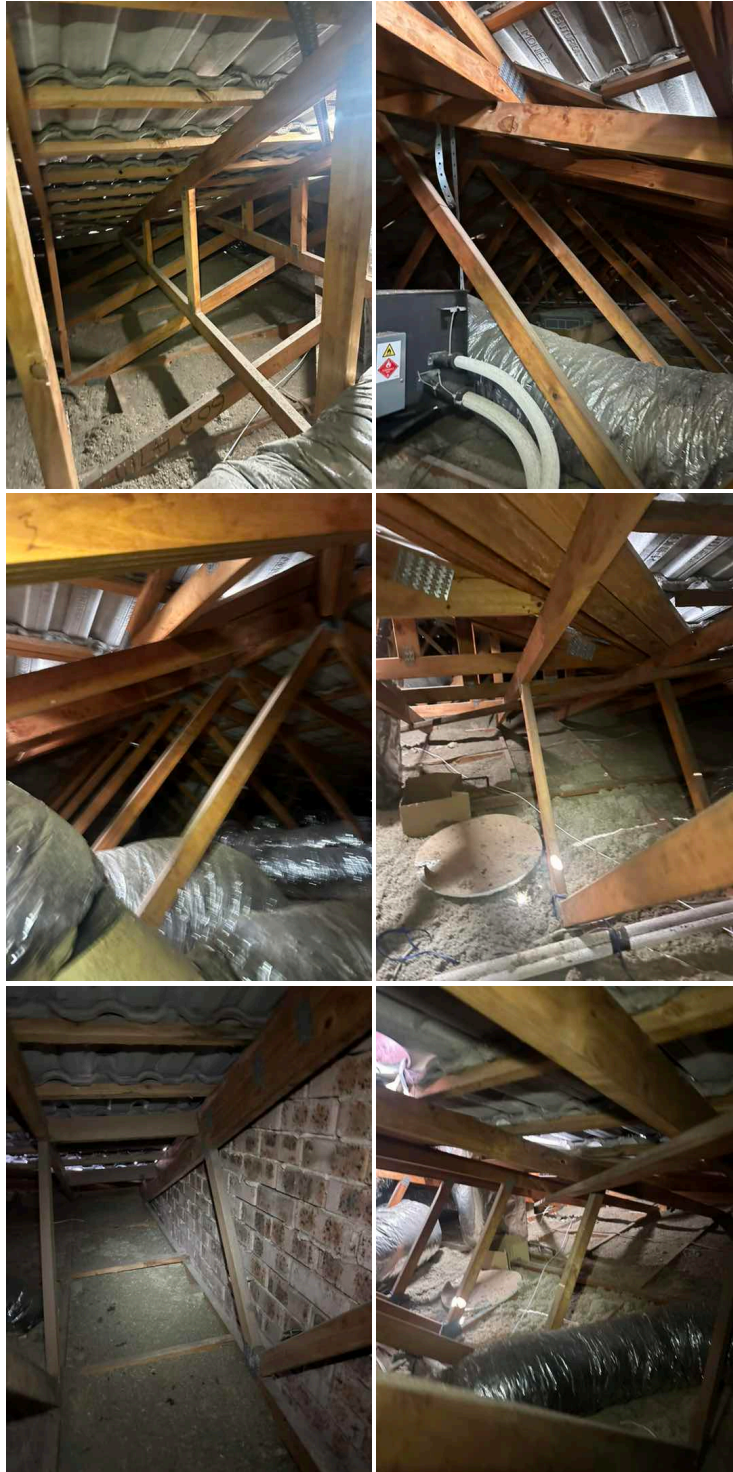
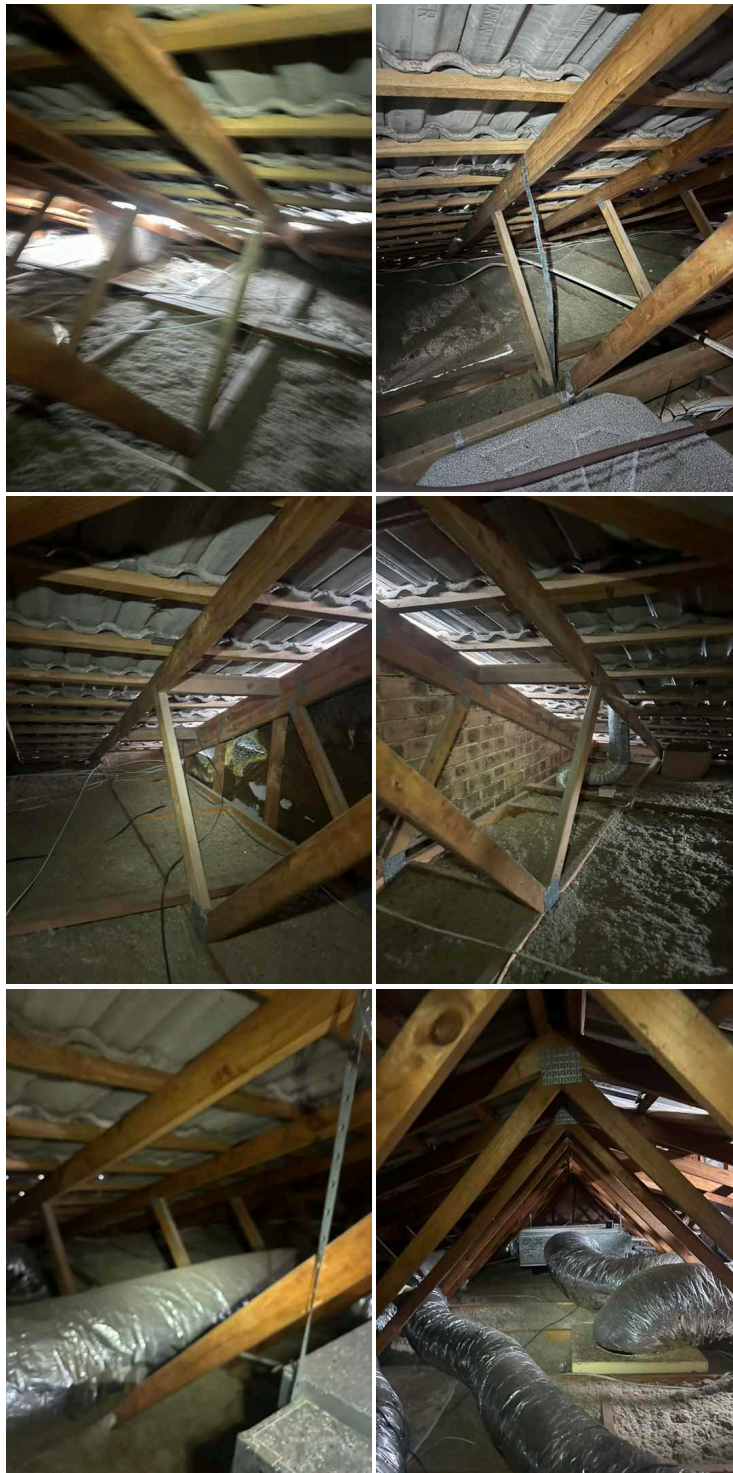
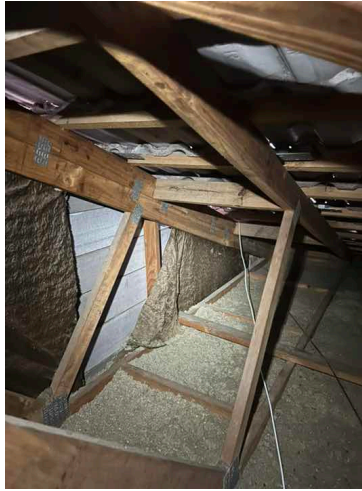
Visible sections of the roof void is in a serviceable condition for age of this dwelling.

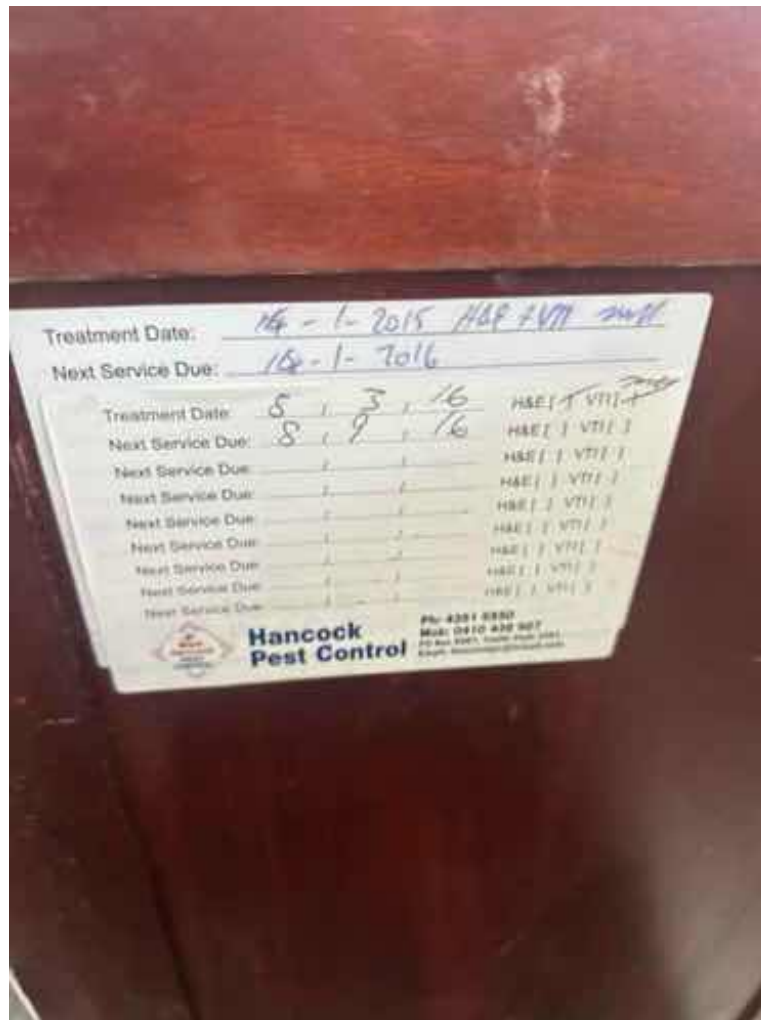
Yes, a durable notice was found during the inspection.

This firm can give no assurances with regard to work that may have been previously performed by other firms. You should obtain copies of all paperwork and make your own inquiries as to the quality of the treatment, when it was carried out and warranty information. In most cases you should arrange for a treatment in accord with "australian standard 3660" be carried out to reduce the risk of further attack.
