# Inspection Report

## Coastal Building Inspections

**19 Kallaroo Rd San Remo, New South Wales, Australia, San Remo, New South Wales, Australia**

### Pest And Building Inspection

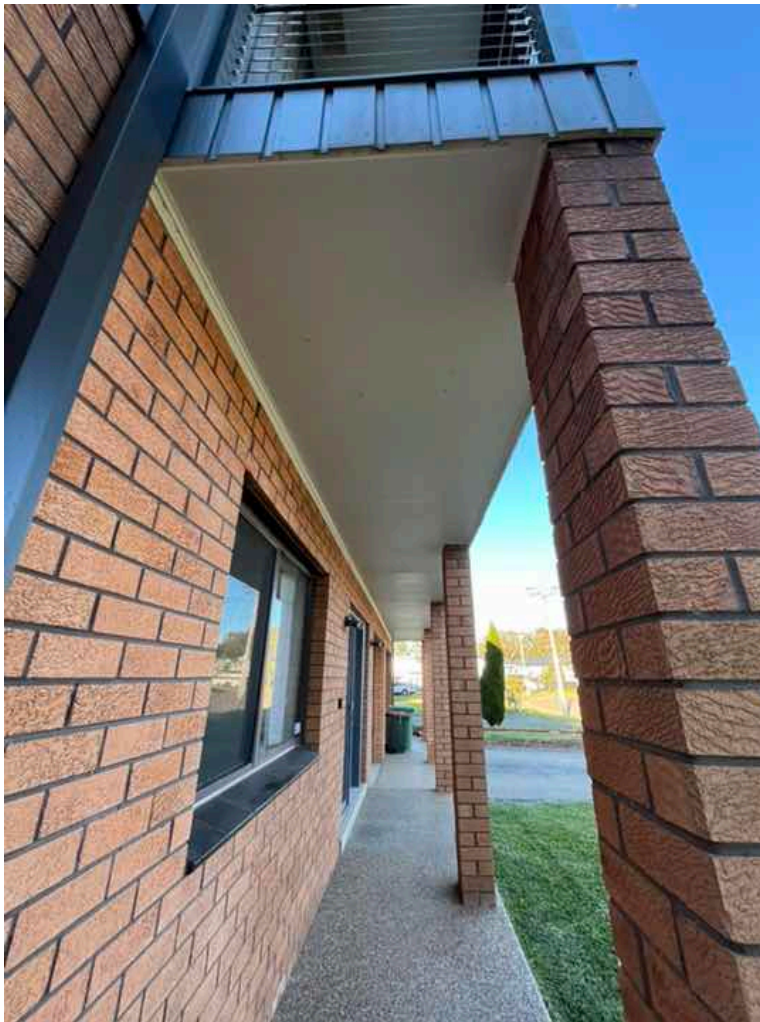
The entry porch serviceable or in reasonable or condition for the age of this dwelling.

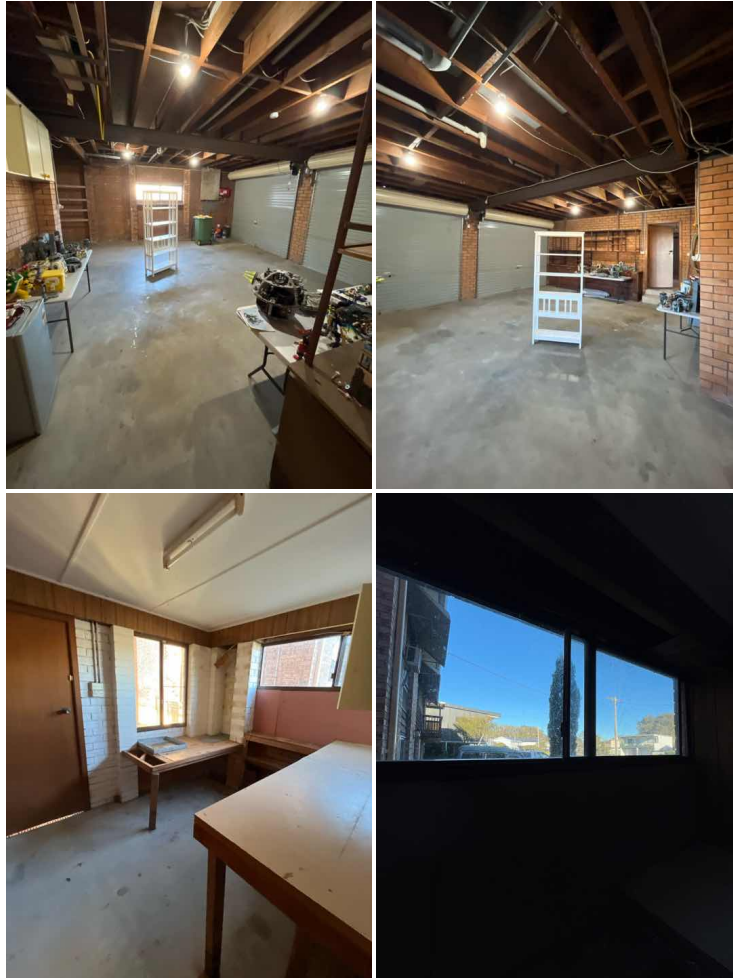
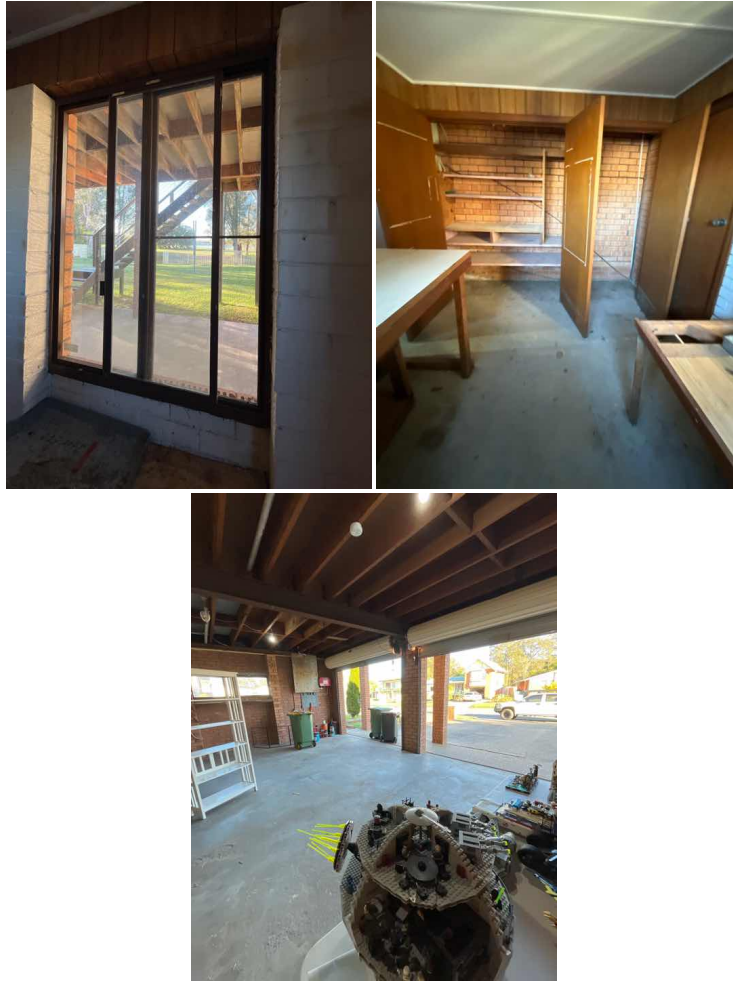
Stored items restricted a full and thorough inspection of this area. Defects may exist in the obstructed and inaccessible areas. It is strongly recommended that full access be granted to enable a thorough inspection as there may be timber pest activity, damage or defects. Note: Where vehicles and storage has restricted a full inspection it is advised that this area be cleared so a full and unobstructed inspection can be carried out.

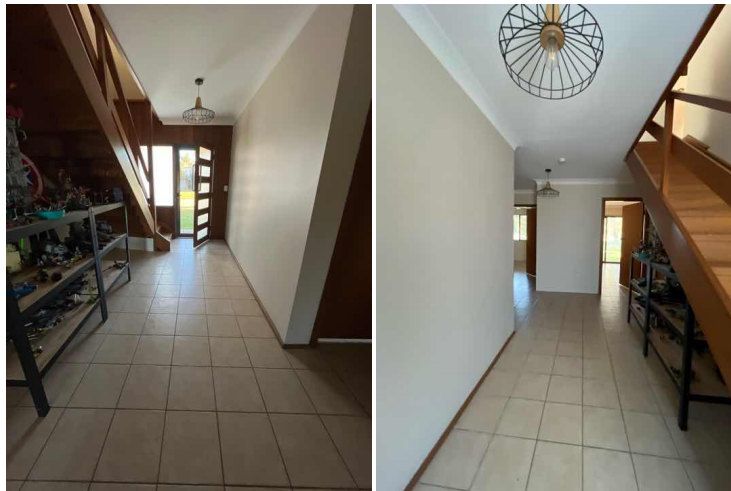
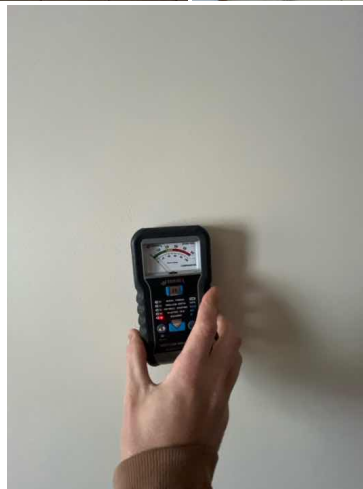
From the visible and accessible areas, this area appears to be in a serviceable condition for the age of the property with no notable structural defects sighted.

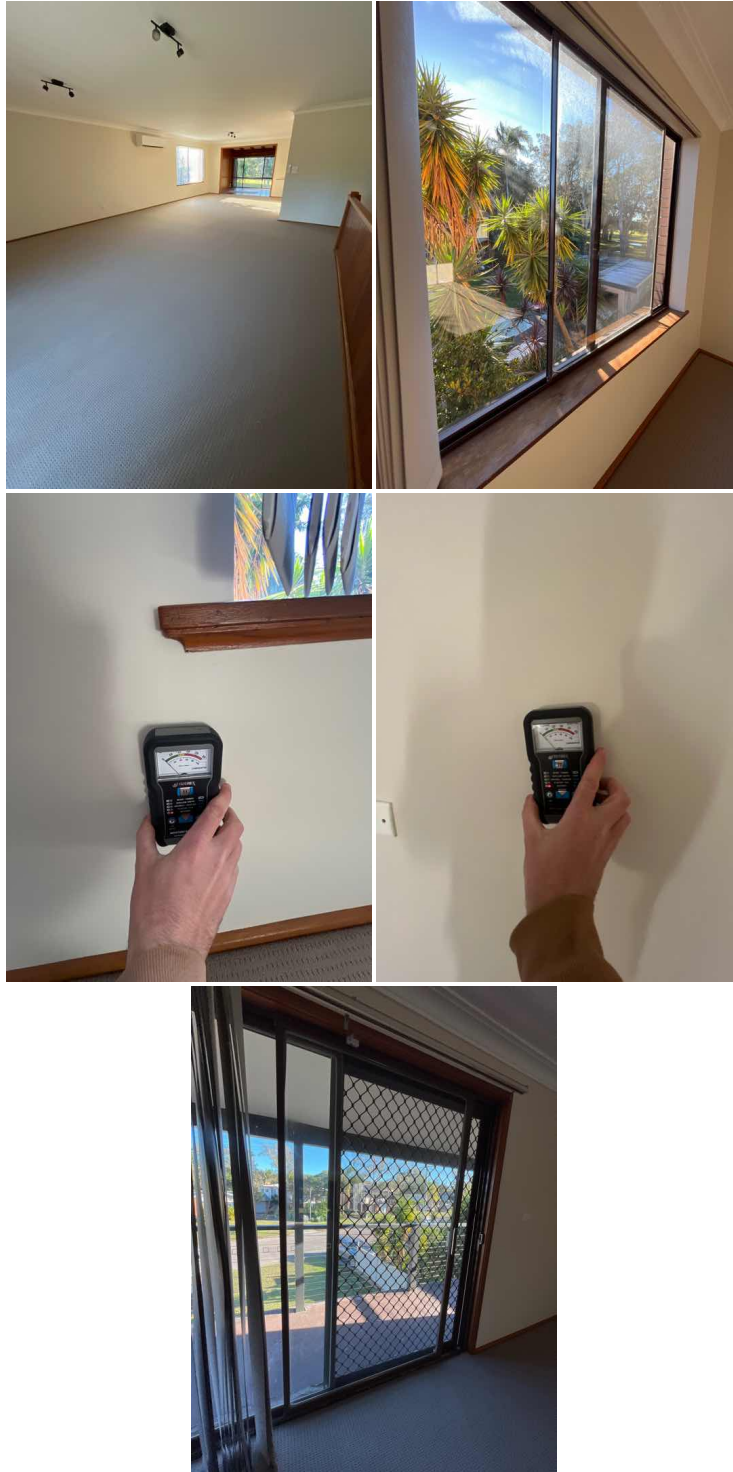
From the visible and accessible areas, this room appears to be in a serviceable condition for the age of the property with no notable structural defects sighted.

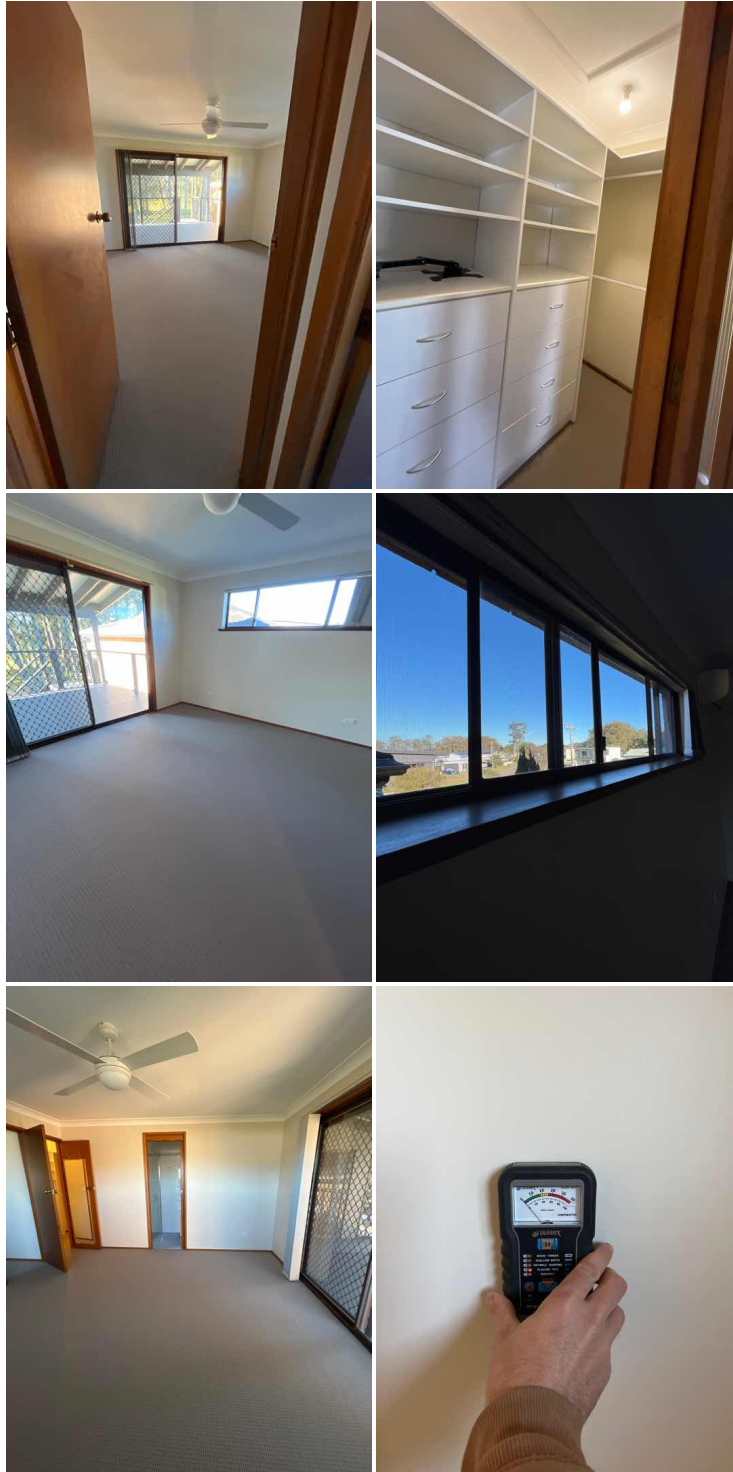
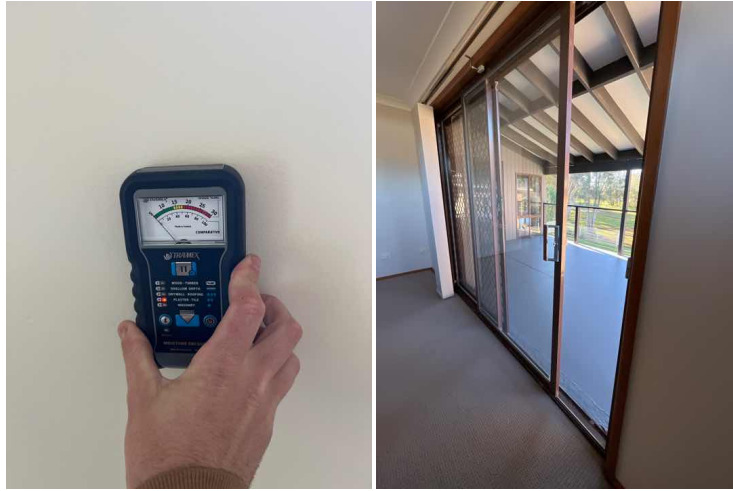
From the visible and accessible areas, this bedroom appears to be in a serviceable condition for the age of the property with no notable structural defects sighted.

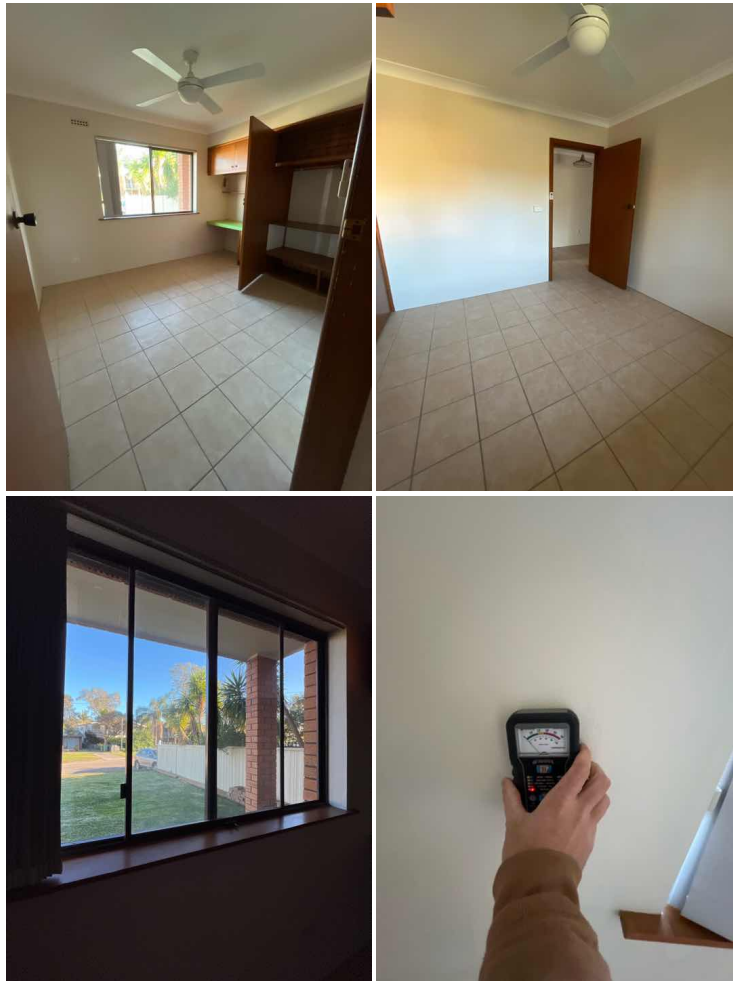
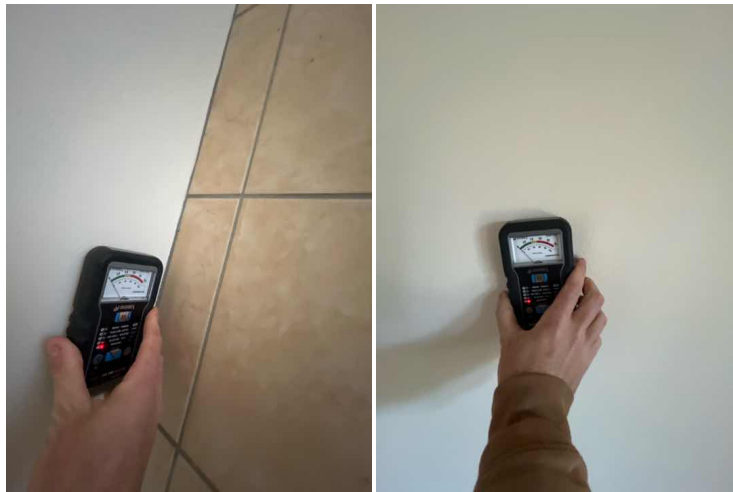
From the visible and accessible areas, this bedroom appears to be in a serviceable condition for the age of the property with no notable structural defects sighted.

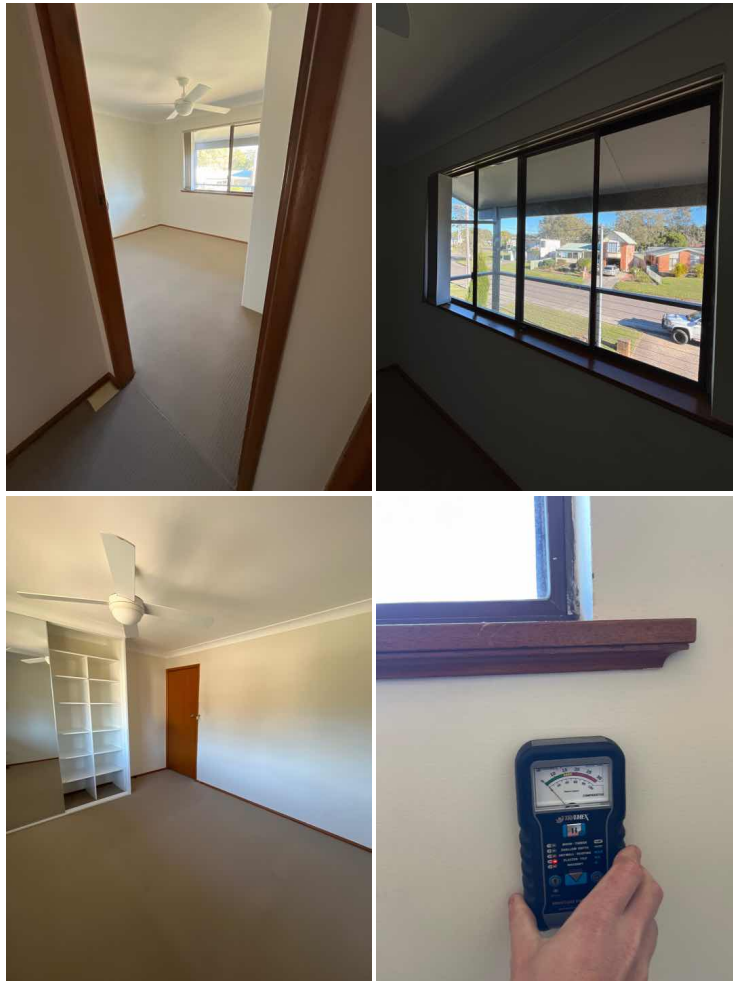
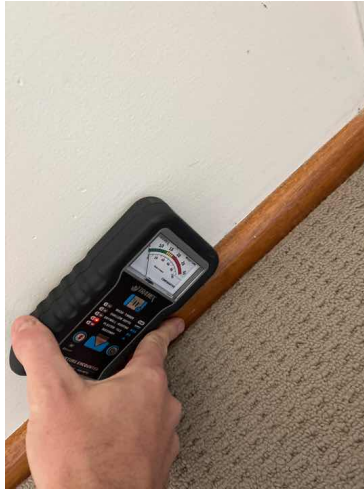
From the visible and accessible areas, this bedroom appears to be in a serviceable condition for the age of the property with no notable structural defects sighted.

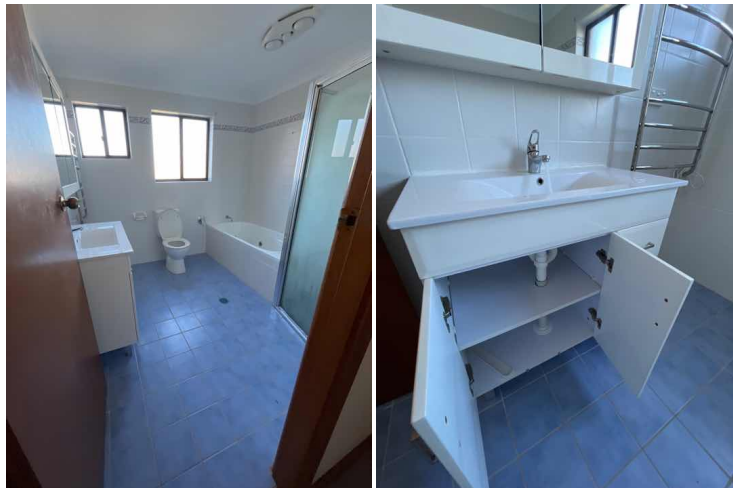
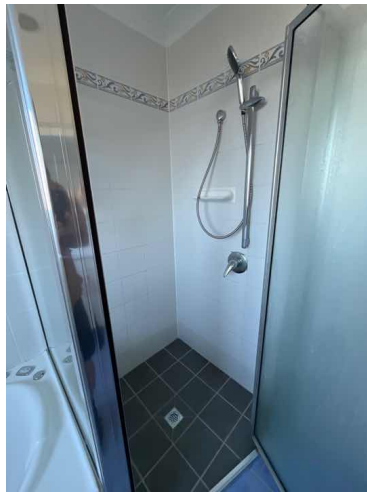
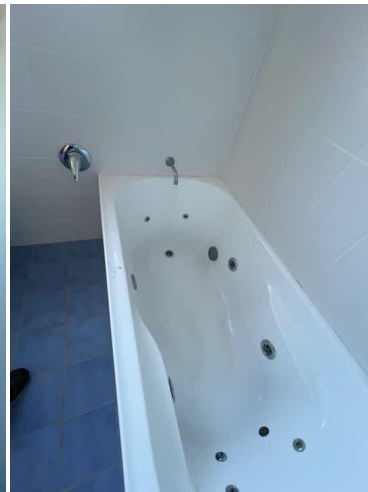
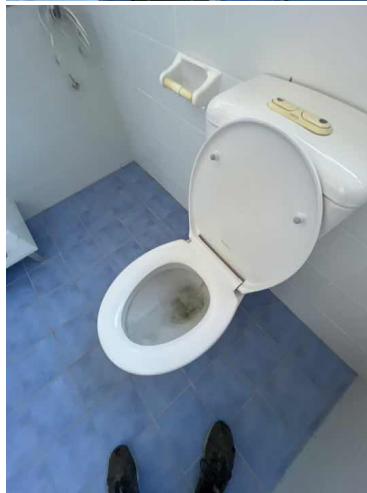
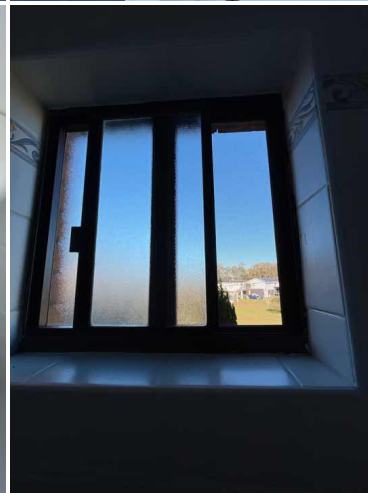
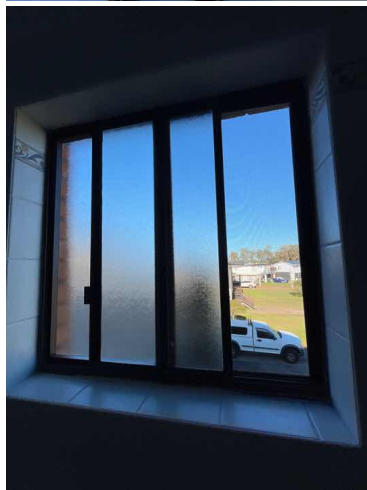
General ageing and/or denting and/or wear and/or previous patching and the like is evident on ceiling linings -  
Recommendations: A qualified painter should be engaged to assess and repair as required.

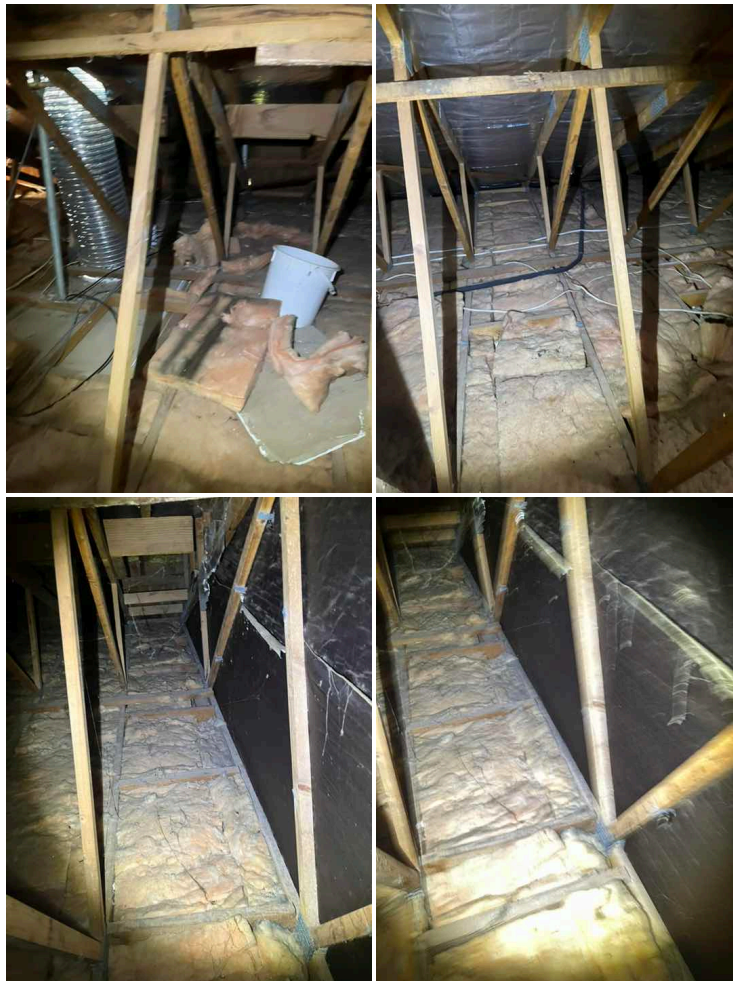
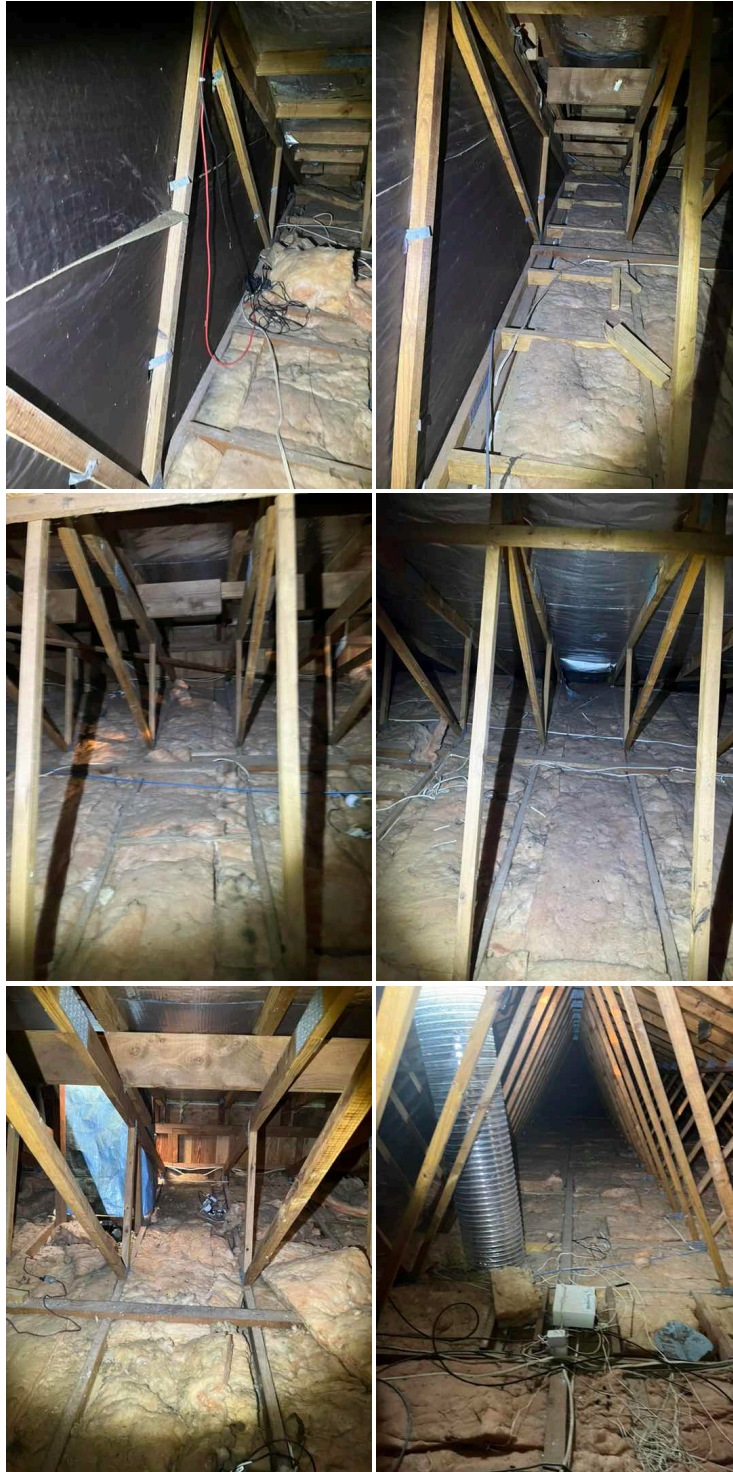
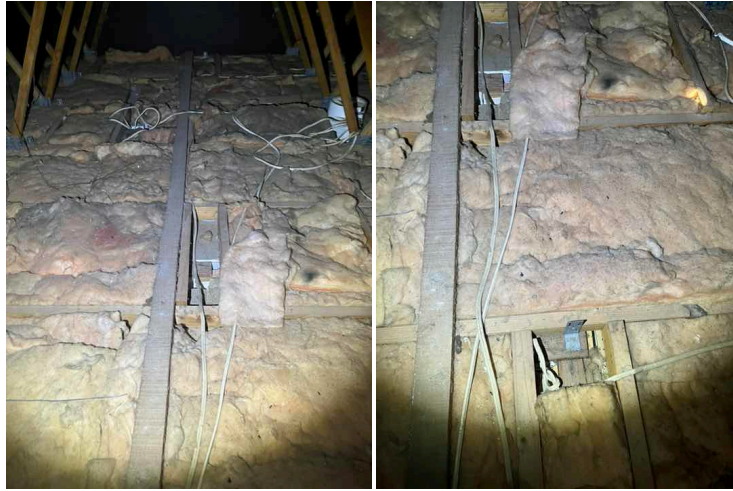
Visible sections of the roof void is in a serviceable condition for age of this dwelling.
