# BUILDING SURVEY

92 JOHN WHITEWAY DRIVE,  
GOSFORD NSW 2250

QUAY NORTH APARTMENTS

# General Building Survey Report

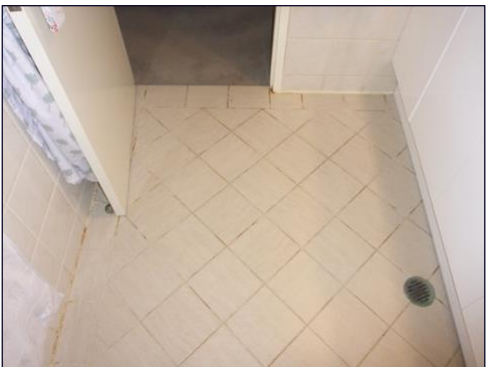
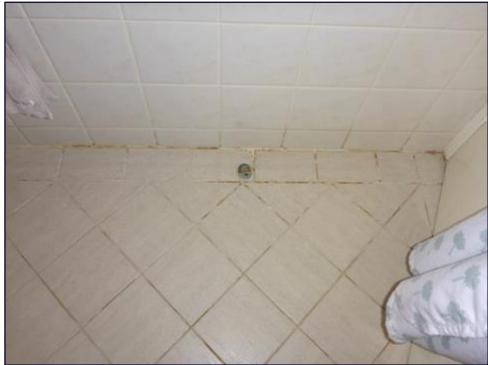
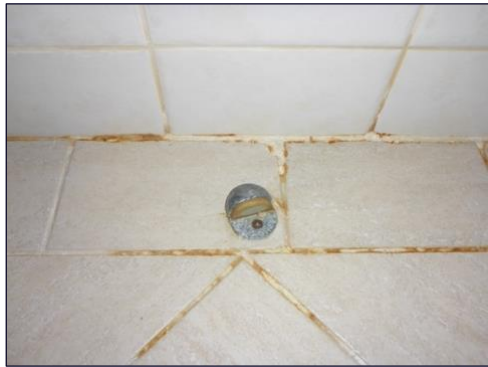
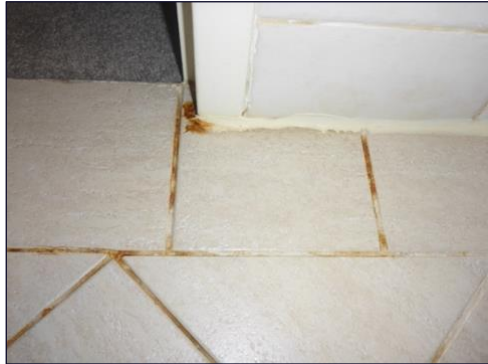
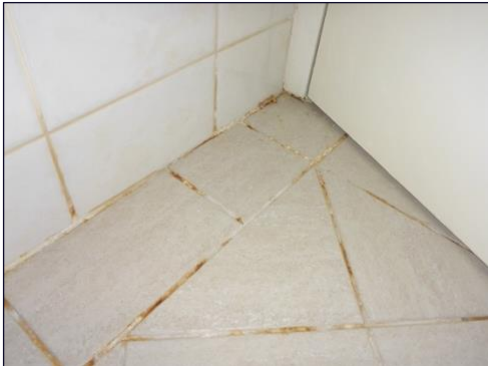
| ITEM | LOCATION | DESCRIPTION & PHOTOGRAPH(S) |
|---|---|---|
| 2 | Ensuite | <ol style="list-style-type: none"> <li>Rust and corrosion staining to the ceramic floor tiling and grouted perpendicular joints in the vicinity of the threshold.</li> <li>The lot occupant advised that previous localised re-waterproofing and retiling work has been completed within the shower recess. This was evident in the form of mismatching floor tiles, including isolated tiles in the first row of wall tiles.</li> </ol> |

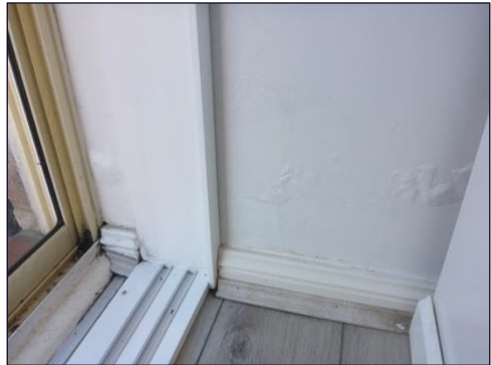
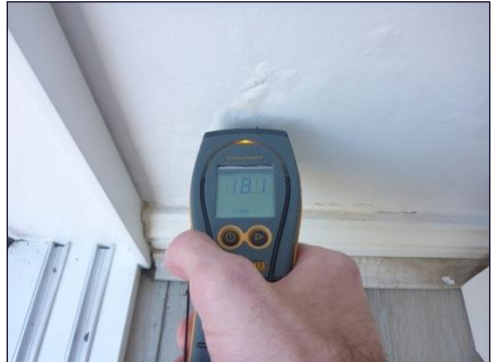
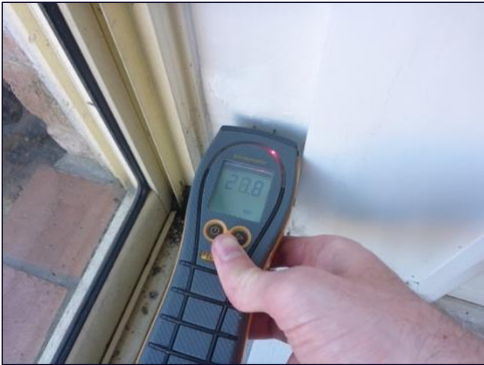
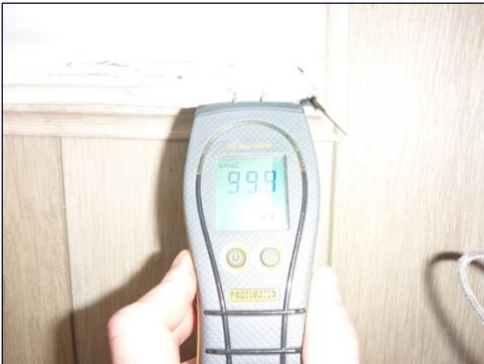
| ITEM | LOCATION | DESCRIPTION & PHOTOGRAPH(S) |
|---|---|---|
| 3 | Living room | <ol style="list-style-type: none"> <li>1. Evidence of water penetration in the form of rotten skirting boards and blistering and bubbling paint at the base of the western wall. The wall was wet to touch in this location at the time of inspection.</li> <li>2. High-level moisture meter readings in the vicinity of 99.9% were recorded in the skirting board at the time of inspection.</li> <li>3. High-level moisture meter readings ranging between 18.1% and 27.8% were recorded in the bubbling paintwork at the time of the inspection. High-level moisture meter readings are generally &gt;16.0%.</li> </ol> |

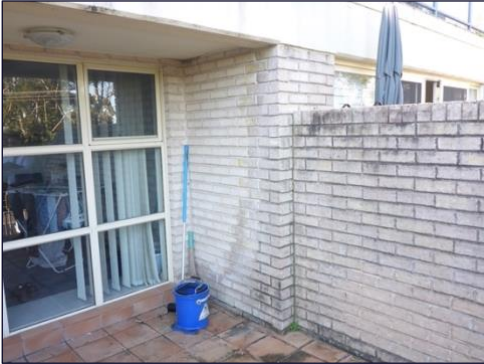
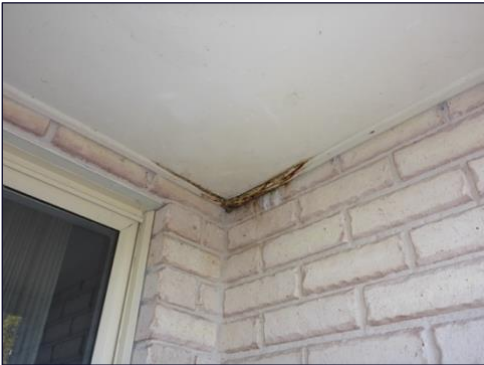
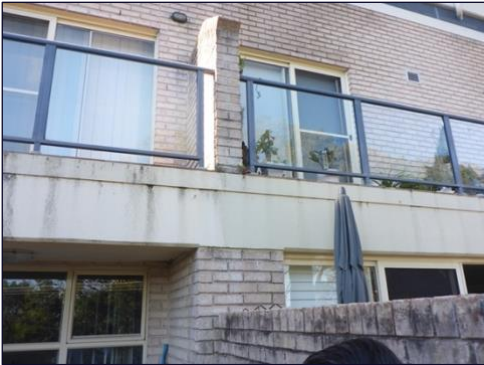
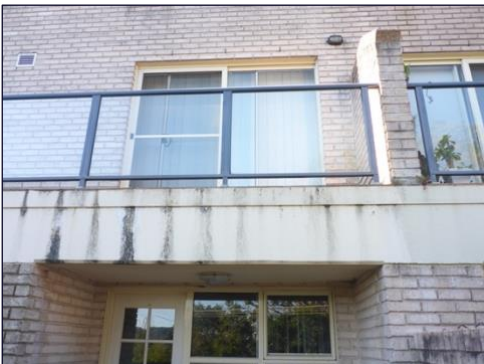
| ITEM | LOCATION | DESCRIPTION & PHOTOGRAPH(S) |
|---|---|---|
| 4 | Unit 2 southern terrace (located adjacent) | <ol style="list-style-type: none"> <li>1. Rot affects the timber quad mouldings at the perimeter of the fibre-cement (FC) sheet soffit lining, which is also stained in the north-eastern corner.</li> <li>2. The FC sheet lining encloses the void created by the slab edge beam bearing on the external brickwork.</li> <li>3. The source of the water penetration appears to be related to a possible cavity drainage issue and/or associated failed waterproofing provisions to the two separate balconies above (belonging to Units 2 and 3), and/or a stormwater drainage issue.</li> <li>4. Further investigation is warranted given the seriousness of the leak affecting Unit 3 living room.</li> </ol> |

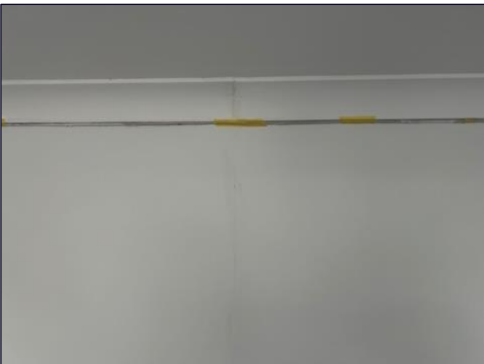
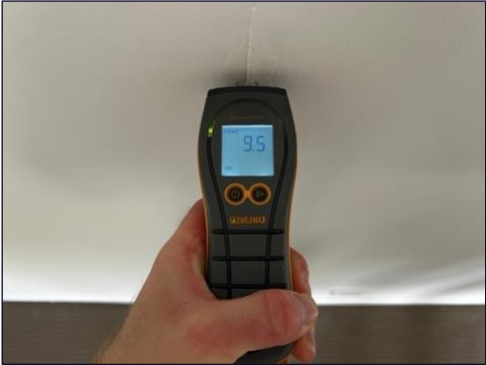
| ITEM | LOCATION | DESCRIPTION & PHOTOGRAPH(S) |
|---|---|---|
| 6 | Living room | <ol style="list-style-type: none"> <li>1. Vertical cracking to the southern wall surrounding the vertical movement joint.</li> <li>2. Evidence of water penetration in the form of staining, mould growth and deteriorating paintwork.</li> <li>3. Low-level (normal) moisture meter readings in the vicinity of 9.5% were recorded in this location at the time of inspection. Low-level (normal) moisture meter readings are typically &lt;16.0%.</li> <li>4. The lot occupant advised the affected wall had been recently painted.</li> <li>5. This issue is also apparent in the adjoining common foyer and carpark along the same movement joint.</li> </ol> |

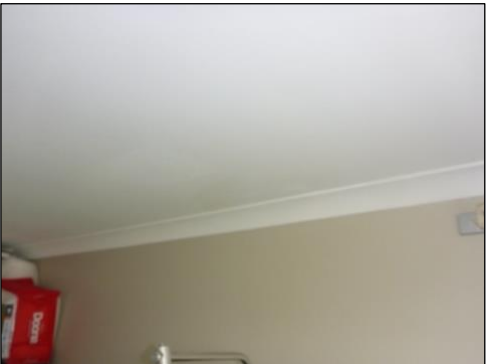
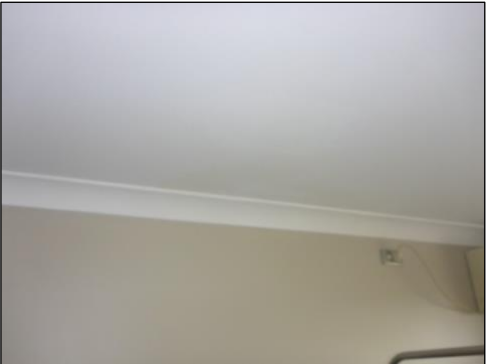
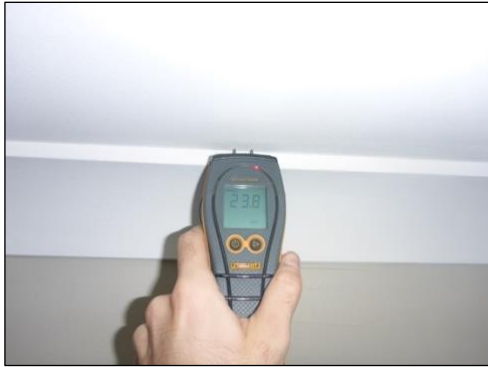
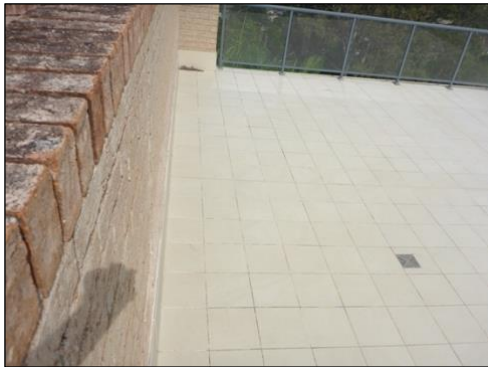
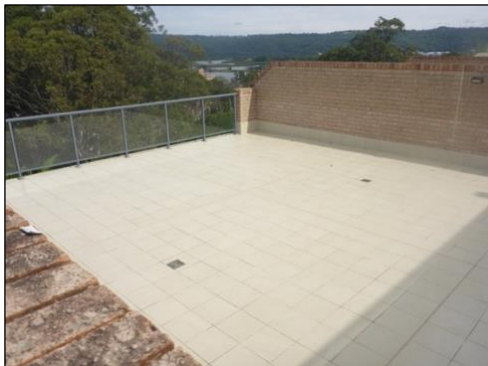
| ITEM | LOCATION | DESCRIPTION & PHOTOGRAPH(S) |
|---|---|---|
| 8 | Living room | <ol style="list-style-type: none"> <li>1. Evidence of water penetration in the form of staining to the suspended plasterboard ceiling lining adjacent to the eastern wall.</li> <li>2. High-level moisture meter readings in the vicinity of 23.8% were recorded in this location at the time of inspection.</li> <li>3. Instructed by the lot occupant at the time of inspection that <i>Unit 17</i> southern balcony (located directly above) was repaired approximately two years ago.</li> <li>4. <i>Unit 17</i> southern balcony has a free-draining edge to a slab edge-mounted gutter.</li> <li>5. <i>Unit 17</i> southern balcony has been retiled (with white-coloured tiles as opposed to the typically terracotta-coloured tiles throughout <i>Quay North Apartments</i>).</li> <li>6. A damp-proof course (DPC) is not apparent within the 230mm face brickwork dividing wall separating <i>Unit 17</i> southern balcony from the eastern Level 5 Intercom 4, eastern terrace/walkway/stairwell. It is therefore possible water is bypassing the waterproofing provisions.</li> </ol> |

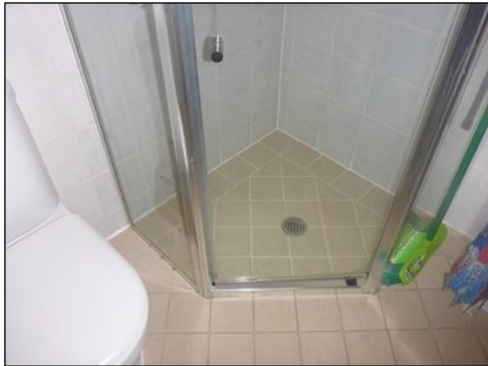
| ITEM | LOCATION | DESCRIPTION & PHOTOGRAPH(S) |
|---|---|---|
| 9 | Ensuite | <ol style="list-style-type: none"> <li>1. The shower recess has received a silane/siloxane <i>Megasealed</i>®-type surface coating as a temporary solution to the water penetration defect affecting the adjoining internal common foyer.</li> <li>2. Refer to Item 84, indicating that the temporary waterproofing has not proven successful.</li> <li>3. <i>Unit 10</i> ensuite requires re-waterproofing in full to achieve a positive outcome.</li> </ol> |

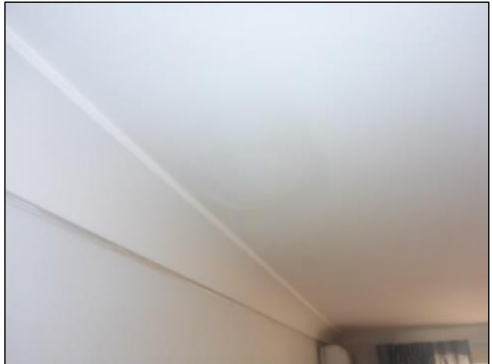
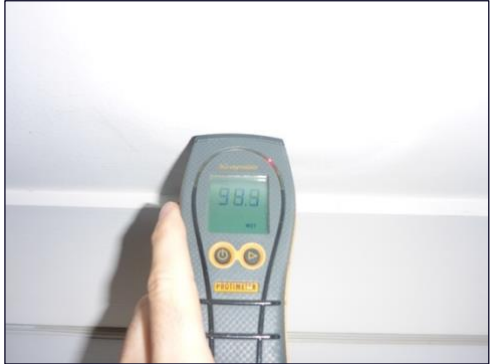
| ITEM | LOCATION | DESCRIPTION & PHOTOGRAPH(S) |
|---|---|---|
| 11 | Living room | <ol style="list-style-type: none"> <li>Evidence of water penetration in the form of blistering and bubbling paintwork to the suspended plasterboard ceiling lining adjacent to the eastern wall.</li> <li>Very high-level moisture meter readings in the vicinity of 98.9% were recorded in the ceiling linings.</li> <li>Instructed by the lot occupant at the time of inspection this has been occurring for at least 18 months.</li> <li>A stormwater pipe servicing <i>Unit 20</i> southern balcony is located directly above.</li> </ol> |

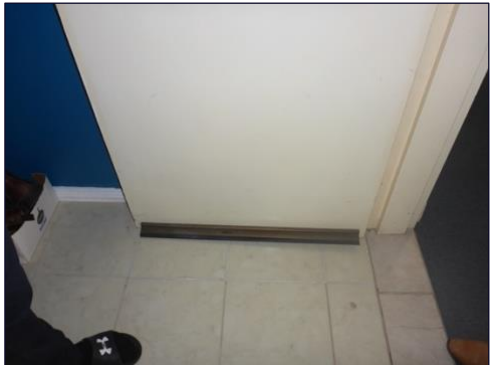
| ITEM | LOCATION | DESCRIPTION & PHOTOGRAPH(S) |
|---|---|---|
| 12 | Entry | <ol style="list-style-type: none"> <li>The fire-rated entry door binds on the floor tiles.</li> <li>The threshold tiles are cracked, drummy and delaminating.</li> </ol> |

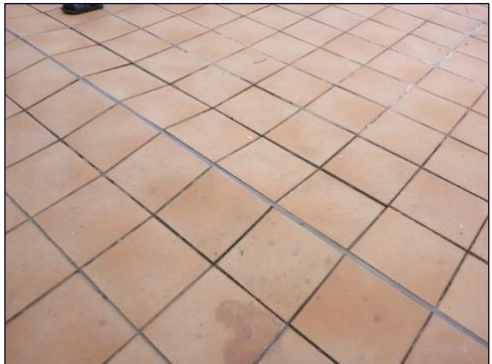
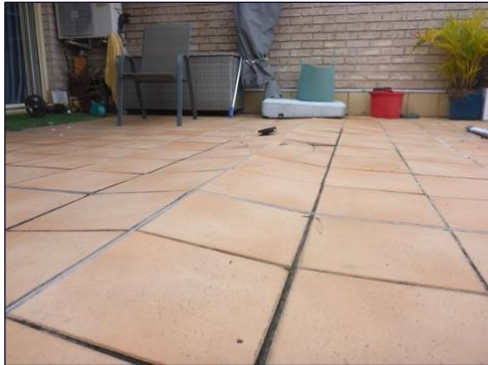
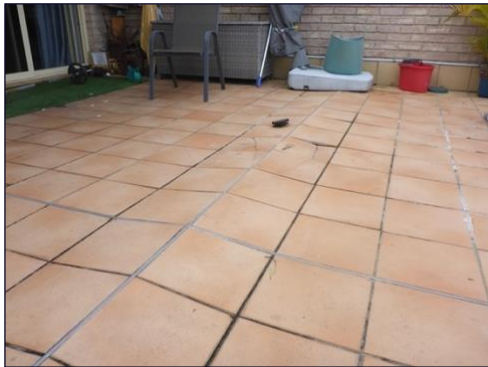
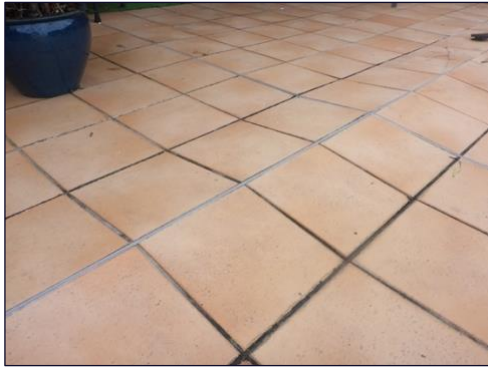
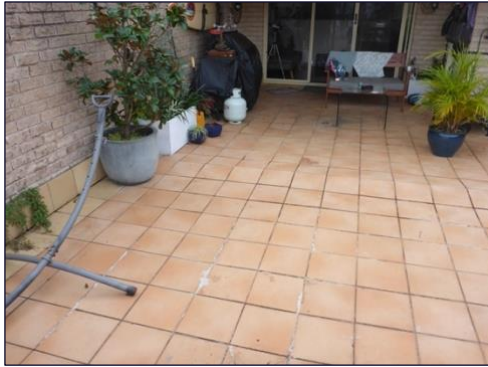
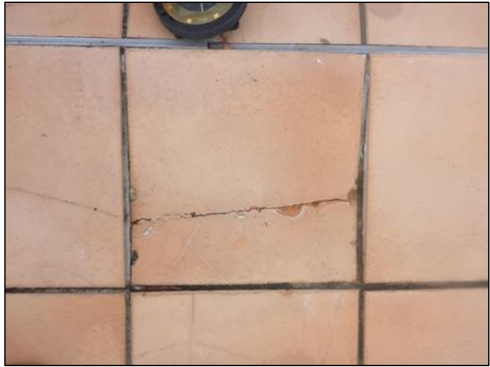
| ITEM | LOCATION | DESCRIPTION & PHOTOGRAPH(S) |
|---|---|---|
| 13 | Southern terrace | <ol style="list-style-type: none"> <li>Tenting/hogged terracotta tiles along the transverse and intermediate movement joints.</li> <li>Various cracked, broken, and chipped tiles are located throughout the terrace.</li> <li>The damaged floor tiling presents a trip hazard and personal injury hazard to those traversing the terrace.</li> </ol> |

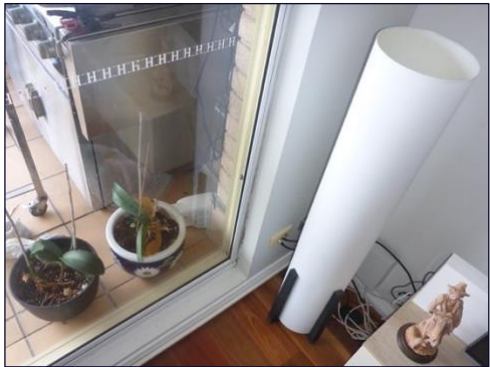
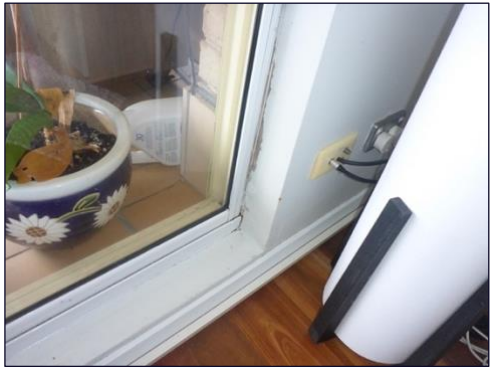
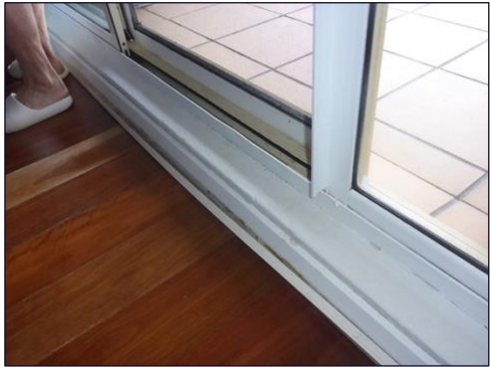
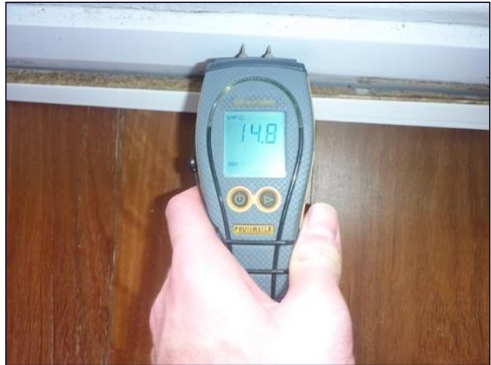
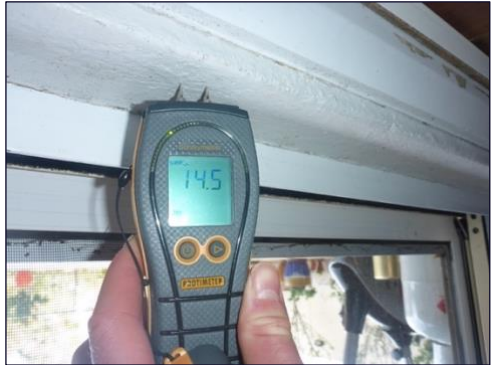
| ITEM | LOCATION | DESCRIPTION & PHOTOGRAPH(S) |
|---|---|---|
| 14 | Living room | <ol style="list-style-type: none"> <li>1. Complaint received from the lot occupant at the time of inspection regarding previous water penetration from around the south-facing glass sliding door assembly.</li> <li>2. Evidence of minor water penetration in the form of blistering and flaking paint to the western reveal of the south-facing glass sliding door assembly.</li> <li>3. Low-level (normal) moisture meter readings ranging from 14.5% to 14.8% were recorded in the skirting board and rendered masonry sill at the time of inspection.</li> </ol> |

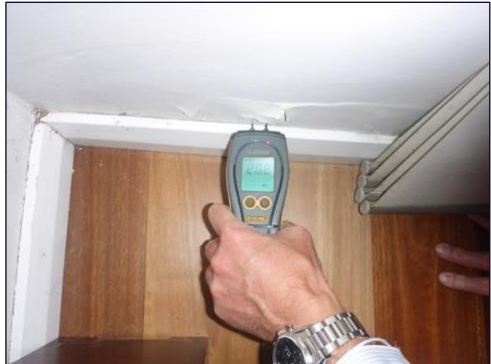
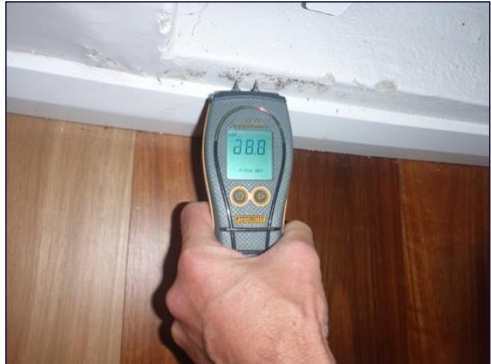
| ITEM | LOCATION | DESCRIPTION & PHOTOGRAPH(S) |
|---|---|---|
| 15 | Dining room | <ol style="list-style-type: none"> <li>1. Evidence of water penetration in the form of blistering and flaking paint at the base of the southern wall and adjoining glass sliding door hob.</li> <li>2. Evidence of water penetration in the form of blistering and bubbling paint and delaminating set plaster above the skirting board in the south-eastern corner.</li> <li>3. High-level moisture meter readings ranging from 20.8% to 26.8% were recorded in the rendered masonry hob and southern wall in the south-eastern corner.</li> <li>4. The southern terrace is located immediately adjacent. Instructed by the lot occupant at the time of inspection that it was re-waterproofed approximately seven years ago.</li> <li>5. A reinforced concrete column is located in the north-eastern corner of the terrace adjacent to the water penetration damage in the south-eastern corner of the dining room suggesting a possible cavity flashing deficiency or sliding door aperture defect.</li> </ol> |

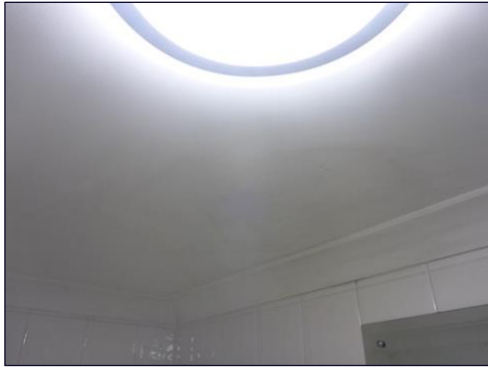
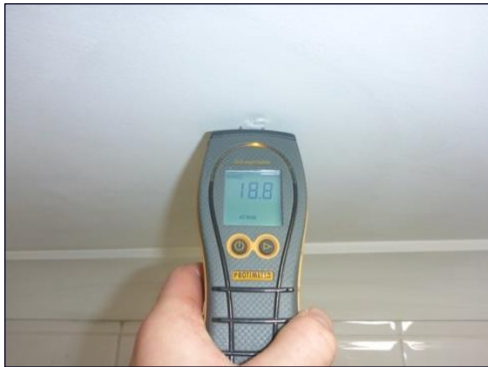
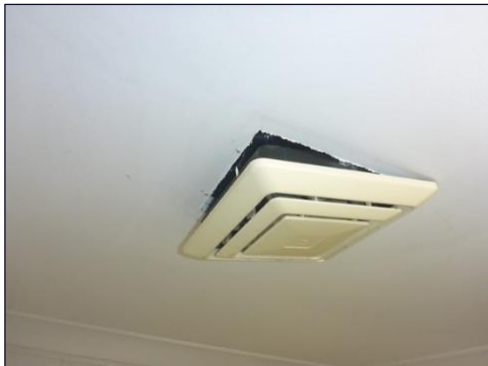
| ITEM | LOCATION | DESCRIPTION & PHOTOGRAPH(S) |
|---|---|---|
| 16 | Bathroom | <ol style="list-style-type: none"> <li>1. Evidence of water penetration in the form of staining to the suspended plasterboard ceiling lining.</li> <li>2. Elevated moisture meter readings in the vicinity of 18.8% were recorded in the ceiling lining.</li> <li>3. The water penetration issue is likely related to a wet area waterproofing deficiency within the bathroom or laundry located directly above.</li> </ol> |

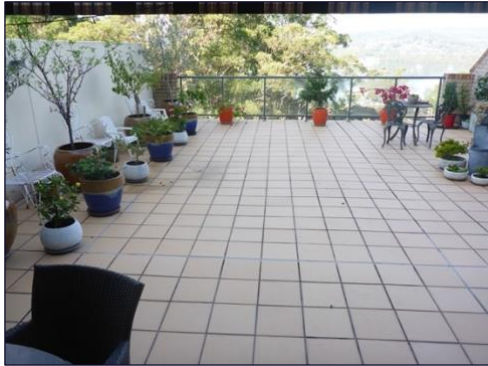
| ITEM | LOCATION | DESCRIPTION & PHOTOGRAPH(S) |
|---|---|---|
| 17 | Southern terrace | <ol style="list-style-type: none"> <li>1. <i>Pinnacle</i> understands the terrace was re-waterproofed and retiled approximately seven years ago.</li> <li>2. The recent nature of these works may warrant further investigation in the form of flood/spray-testing in the areas adjacent to the internal water penetration damage.</li> </ol> |

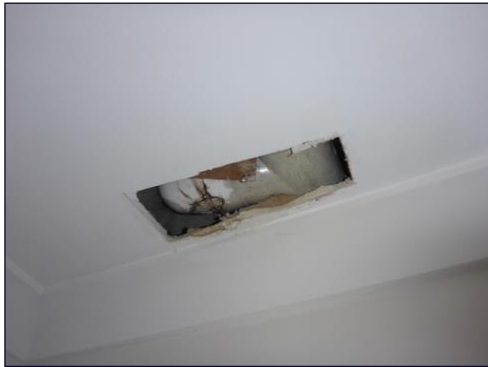
| ITEM | LOCATION | DESCRIPTION & PHOTOGRAPH(S) |
|---|---|---|
| 18 | Living room | <ol style="list-style-type: none"> <li>1. A hole has been cut into the suspended plasterboard-lined ceiling to expose a leaking stormwater pipe.</li> <li>2. The stormwater pipework services <i>Unit 22</i> southern balcony located directly above.</li> </ol> |

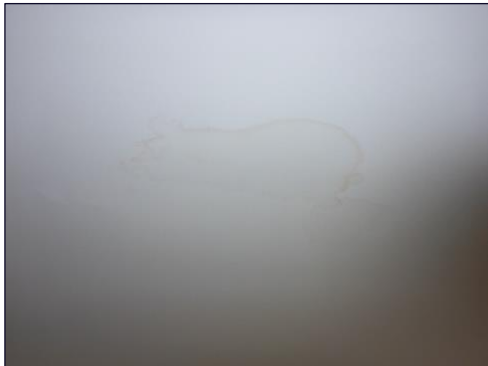
| ITEM | LOCATION | DESCRIPTION & PHOTOGRAPH(S) |
|---|---|---|
| 19 | Dining room | <ol style="list-style-type: none"> <li>1. Evidence of water penetration in the form of staining to the suspended plasterboard ceiling lining adjacent to the living room.</li> <li>2. The water penetration is likely related to defective waterproofing to <i>Unit 22</i> southern balcony located directly above.</li> </ol> |

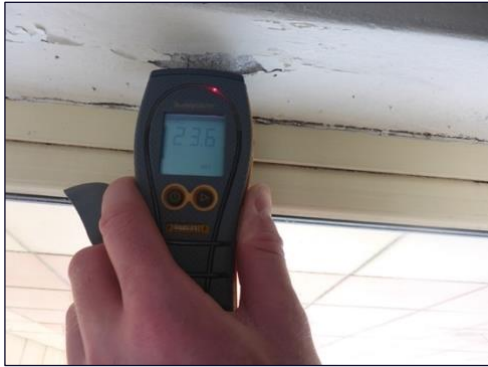
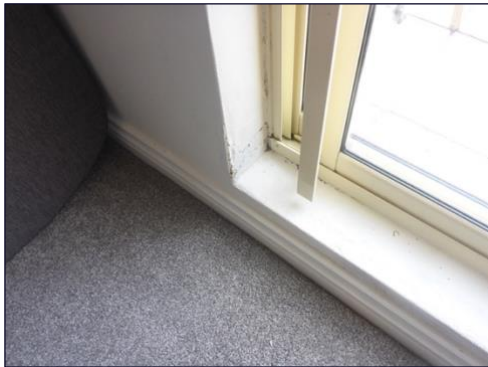
| ITEM | LOCATION | DESCRIPTION & PHOTOGRAPH(S) |
|---|---|---|
| 21 | Living room | <p>1. Evidence of water penetration in the form of blistering and flaking paint at the lower left-hand and right-hand sides of the south-facing glass sliding door assembly.</p> <p>2. High-level moisture meter readings in the vicinity of 23.6% were recorded in the rendered masonry hob.</p> |

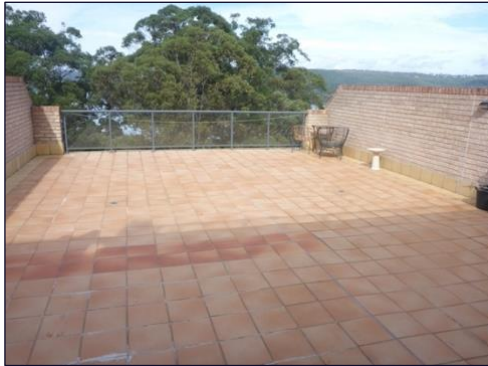
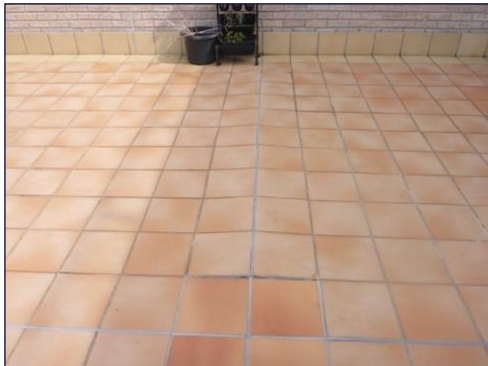
| ITEM | LOCATION | DESCRIPTION & PHOTOGRAPH(S) |
|---|---|---|
| 22 | Southern terrace | <ol style="list-style-type: none"> <li>1. Tenting/hogged terracotta tiles adjacent to the east-west intermediate movement joints (northern and southern east-west joints).</li> <li>2. The terracotta floor tiles are drummy and delaminating adjacent to the north-south intermediate movement joint, and delaminating skirting tiles exist in various locations around the perimeter of the terrace.</li> <li>3. The dimensions of a typical Level 5 southern terrace are 11.1m x 7.5m (83.25m<sup>2</sup>).</li> </ol> |

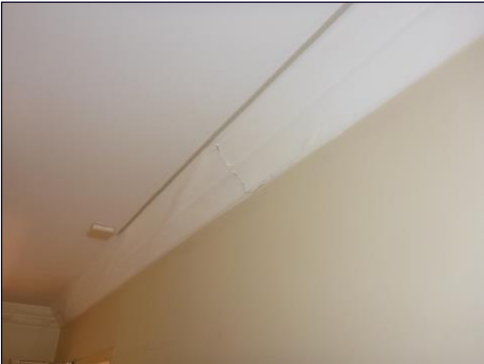
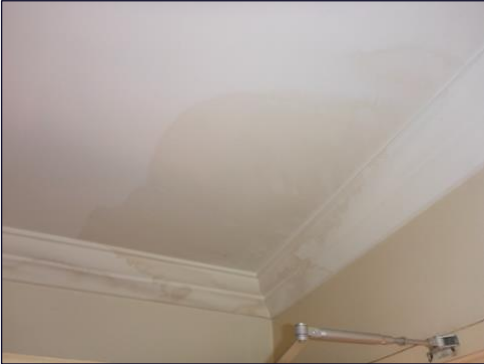
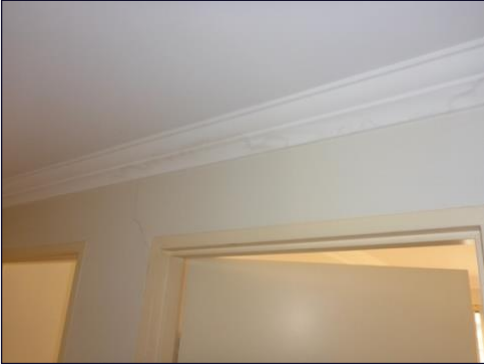
| ITEM | LOCATION | DESCRIPTION & PHOTOGRAPH(S) |
|---|---|---|
| 27 | Entry hallway | <ol style="list-style-type: none"> <li>Evidence of water penetration in the form of blistering and flaking paint, staining and mould growth to the cornice along the eastern wall. The cornice is also separating in this location.</li> <li>Instructed by the lot owner at the time of inspection that the water penetration damage first became apparent during early 2020, and during the various east-coast low-pressure system (ECLPS) storm events throughout 2022.</li> </ol> |

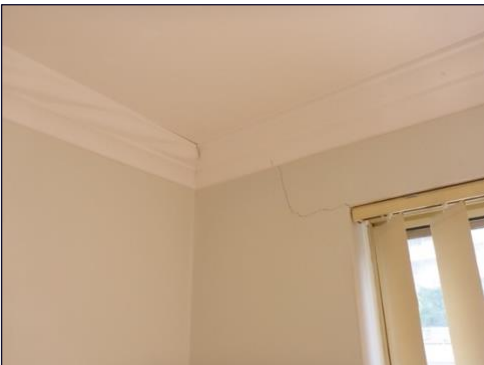
| ITEM | LOCATION | DESCRIPTION & PHOTOGRAPH(S) |
|---|---|---|
| 28 | Third bedroom | <ol style="list-style-type: none"> <li>Evidence of water penetration in the form of blistering and flaking paint and disturbed set plaster to the cornice along the western wall.</li> <li>Stepped cracking to the northern wall at the upper left-hand side of the window aperture, extending upwards towards the cornice.</li> <li>2.5mm wide vertical cracking at the junction of walls in the north-eastern corner extending from floor-to-ceiling.</li> <li>0.75mm wide vertical cracking to the southern wall within the built-in-robe (BIR).</li> </ol> |

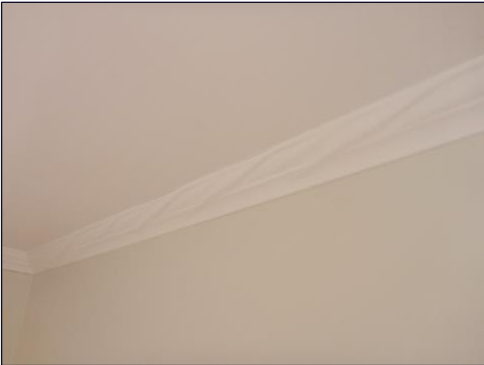
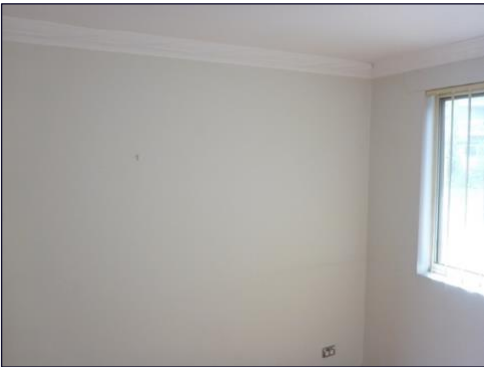
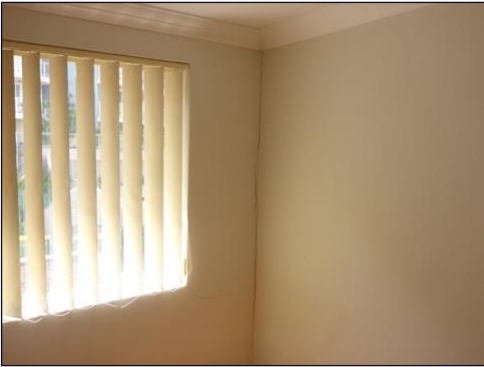
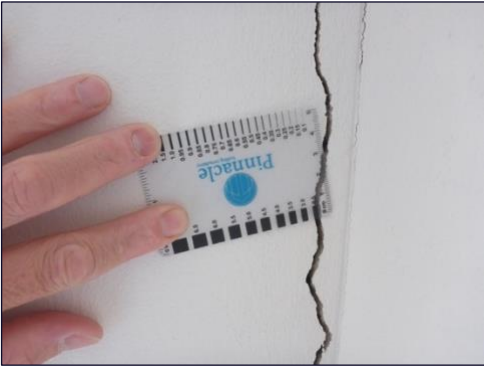
| ITEM | LOCATION | DESCRIPTION & PHOTOGRAPH(S) |
|---|---|---|
| | | <p>5. Various other horizontal and stepped cracking to the northern, southern, eastern and western walls.</p> |

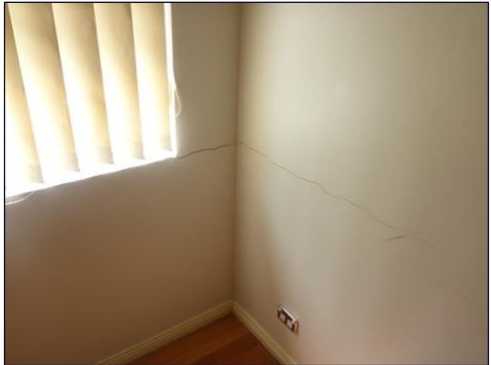
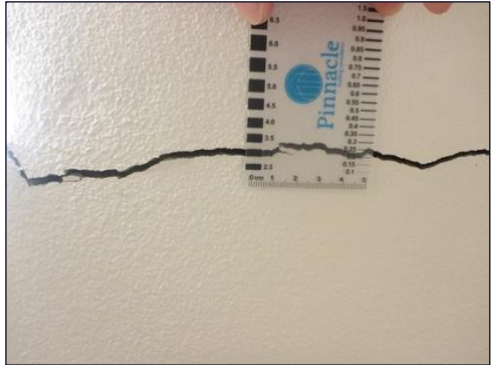
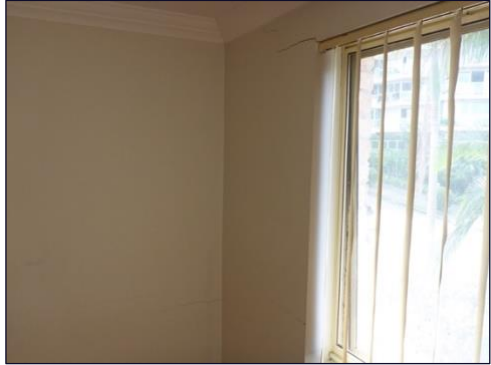
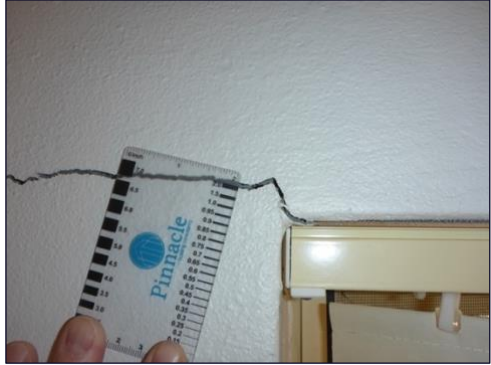
| ITEM | LOCATION | DESCRIPTION & PHOTOGRAPH(S) |
|---|---|---|
| 29 | Second bedroom | <ol style="list-style-type: none"> <li>3.0mm wide horizontal cracking to the northern and eastern rendered masonry walls in the north-eastern corner at the lower right-hand side of the north-facing window aperture.</li> <li>2.0mm wide stepped cracking to the northern wall at the top left-hand side of the north-facing window aperture.</li> </ol> |

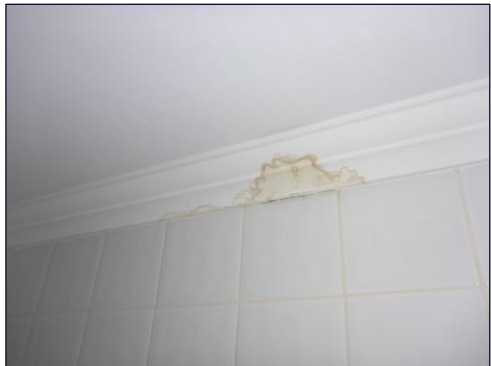
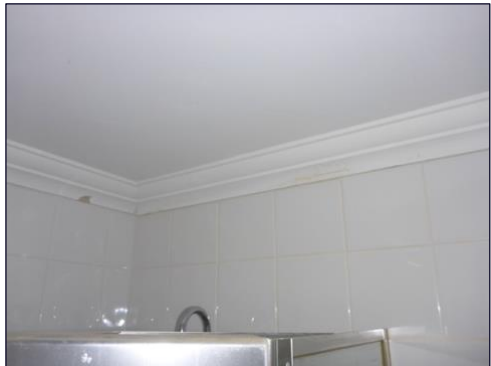
| ITEM | LOCATION | DESCRIPTION & PHOTOGRAPH(S) |
|---|---|---|
| 31 | Ensuite | <p>1. Evidence of water penetration in the form of staining and mould growth to the suspended plasterboard ceiling lining and cornice along the northern wall.</p> <p>2. The curved-sprung metal-deck roof is located immediately above.</p> |

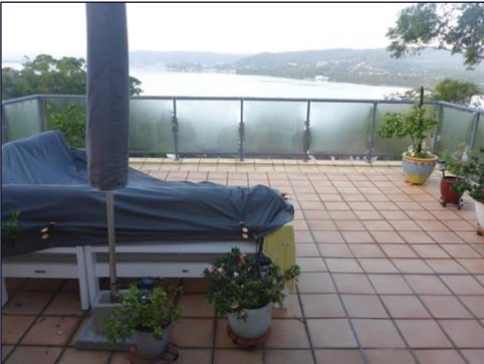
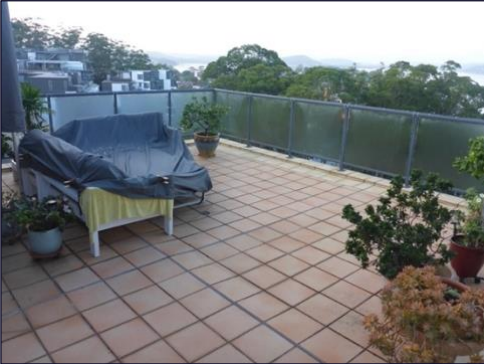
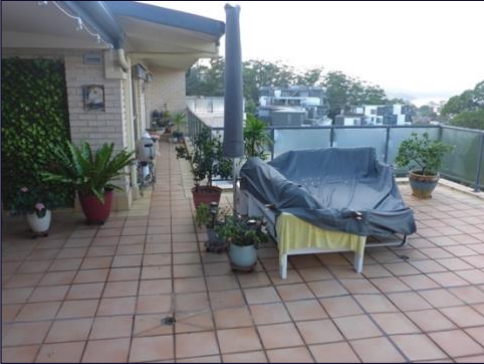
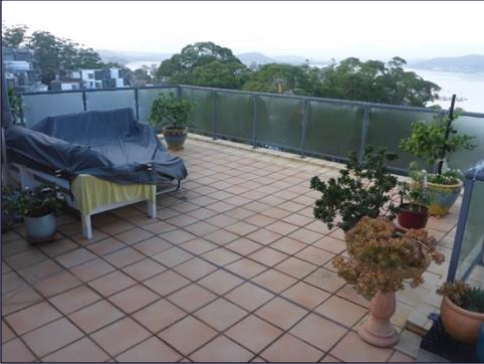
| ITEM | LOCATION | DESCRIPTION & PHOTOGRAPH(S) |
|---|---|---|
| 33 | Level 8 rooftop terrace | <ol style="list-style-type: none"> <li>1. Large areas of tenting/hogged, drummy, and delaminating terracotta tiles in the vicinity of the proprietary movement joints.</li> <li>2. The skirting tiles conceal any weepholes in face cavity brickwork walls of the southern and western building facades.</li> <li>3. There is an approximate 80mm set-down from the rear of the glass sliding door to the finished floor level (FFL) of the rooftop terrace.</li> <li>4. The hob-mounted balustrades were measured at 1060mm above the FFL (compliant with the current requirements of the Building Code of Australia (BCA) 2022 Volume 1).</li> <li>5. There are several floor wastes throughout the terrace, with positive fall provided in the terracotta floor tiling.</li> <li>6. There are at least three overflows provided throughout the terracotta tiled perimeter hob.</li> </ol> |

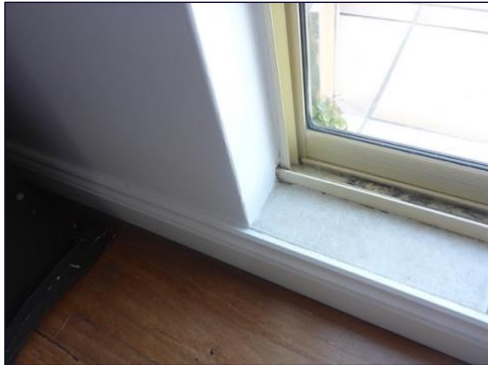
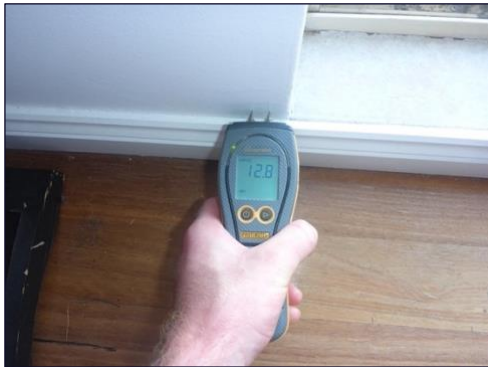
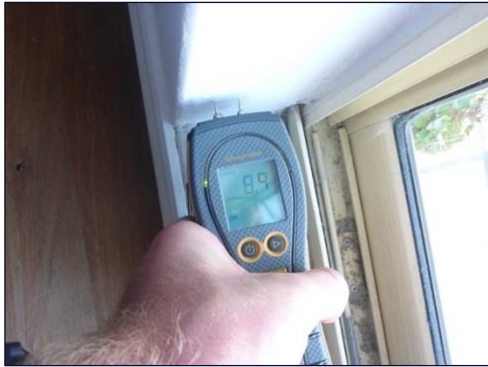
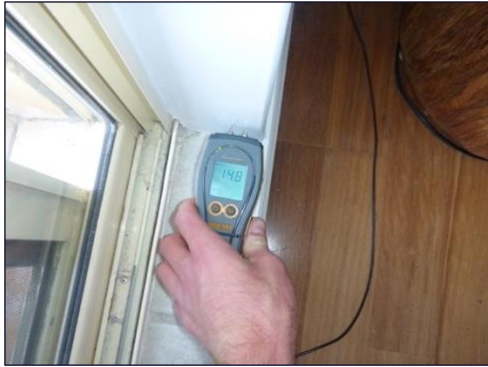
| ITEM | LOCATION | DESCRIPTION & PHOTOGRAPH(S) |
|---|---|---|
| 36 | Living room | <ol style="list-style-type: none"> <li>Evidence of water penetration in the form of blistering and bubbling paint at the lower left-hand and right-hand side of the south-facing glass sliding door assemblies.</li> <li>Low-level (normal) moisture meter readings ranging between 8.9% and 14.8% were recorded in this location at the time of inspection.</li> <li>Instructed by the lot owner at the time of inspection that the south-facing glass sliding door assemblies have been spray-tested and found to leak.</li> </ol> |

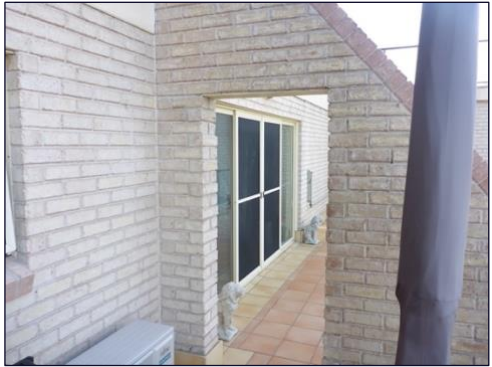
| ITEM | LOCATION | DESCRIPTION & PHOTOGRAPH(S) |
|---|---|---|
| 37 | Southern terrace | <ol style="list-style-type: none"> <li>1. Evidence of surface water runoff from <i>Unit 30</i> southern balcony, above, in the form of efflorescence to the southern face brickwork façade at the western end.</li> <li>2. <i>Unit 30</i> southern balcony and the adjoining narrow southern return of <i>Unit 30</i> eastern terrace are located above.</li> <li>3. The eastern terrace has been provided with what appears to be a painted bituminous sheet apron that has been loosely dressed down over the slab edge and onto the face brickwork façade. Surface water runoff is/or has possibly charged the wall cavity during extended periods of heavy, wind-driven rainfall (for example, an east-coast low-pressure system (ECLPS) storm event).</li> <li>4. One weephole exists at the western side of the south-facing glass sliding door servicing the living room, and generally throughout the southern façade.</li> </ol> |

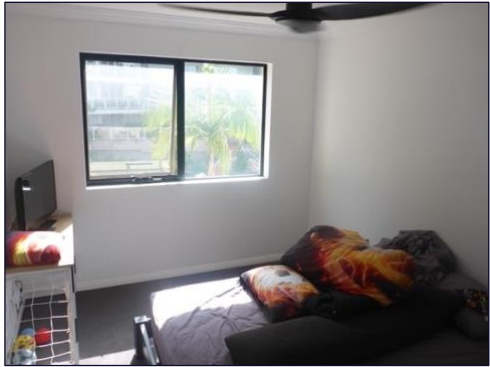
| ITEM | LOCATION | DESCRIPTION & PHOTOGRAPH(S) |
|---|---|---|
| 39 | Second bedroom | <ol style="list-style-type: none"> <li>Instructed by the lot owner at the time of inspection of previous water penetration and staining adjacent to the eastern wall during extended periods of heavy rainfall.</li> <li>The eastern wall was dry at the time of inspection.</li> <li>A full-height construction joint exists in the building façade immediately adjacent, and it is likely the weatherproofing provisions associated with this joint have failed.</li> <li>Rainwater penetrates into the Level 4 carpark in the vicinity of the full-height construction joint.</li> </ol> |

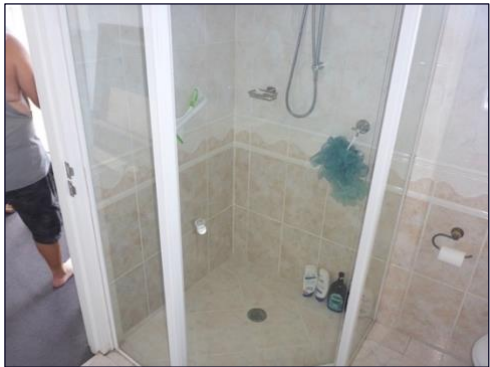
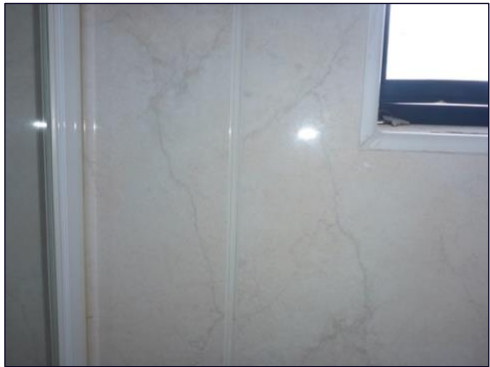
| ITEM | LOCATION | DESCRIPTION & PHOTOGRAPH(S) |
|---|---|---|
| 40 | Ensuite | <ol style="list-style-type: none"> <li>Cracked grout and drummy tiles to the eastern and southern walls within the shower recess.</li> <li>Instructed by the lot owner at the time of inspection that water leaks from the base of the shower recess.</li> </ol> |

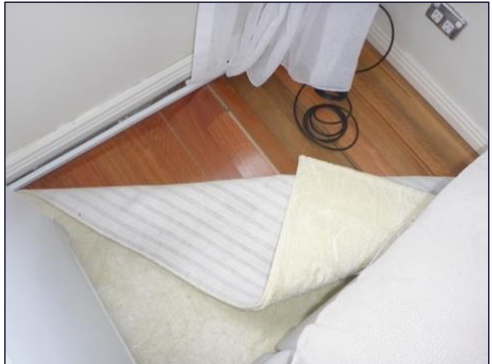
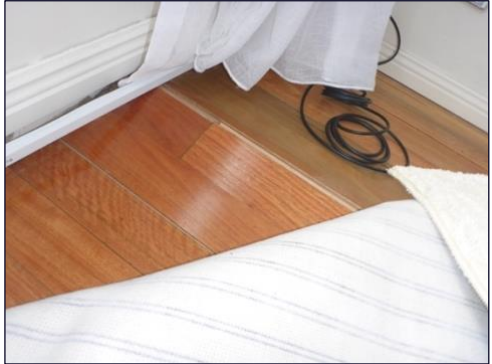
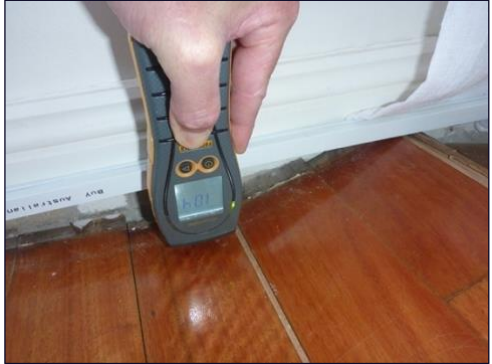
| ITEM | LOCATION | DESCRIPTION & PHOTOGRAPH(S) |
|---|---|---|
| 41 | Living room | <ol style="list-style-type: none"> <li>Evidence of water penetration in the form of buckled solid tongue-and-groove Blackbutt flooring adjacent to the southern wall.</li> <li>Instructed by the lot occupant at the time of inspection that the buckling timber floorboards occurred within the past month.</li> <li>Low-level (normal) moisture meter readings in the vicinity of 10.4% were recorded in the floorboards.</li> </ol> |

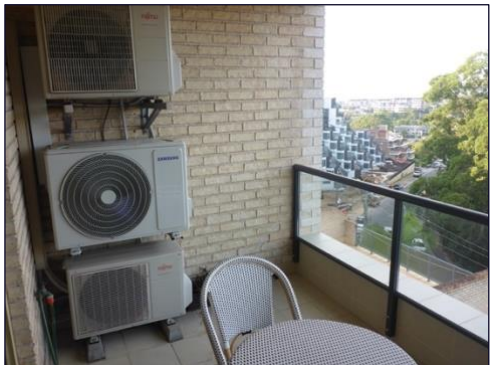
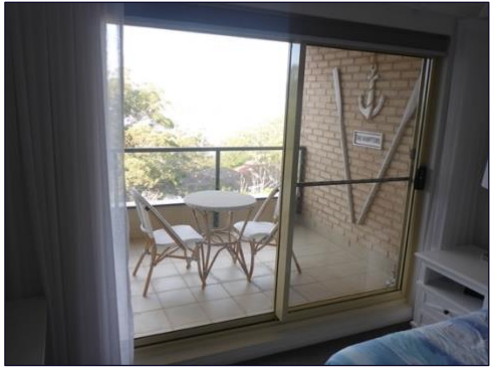
| ITEM | LOCATION | DESCRIPTION & PHOTOGRAPH(S) |
|---|---|---|
| 42 | Southern balcony | <ol style="list-style-type: none"> <li>Instructed by the lot occupant at the time of inspection that significant remedial work was completed approximately 2 years ago involving: <ol style="list-style-type: none"> <li>Installation of new windows and masonry to the southern façade of the living room;</li> <li>Re-waterproofing and retiling the southern balcony;</li> <li>Provision of a new glass sliding door assembly to the southern façade.</li> </ol> </li> </ol> |

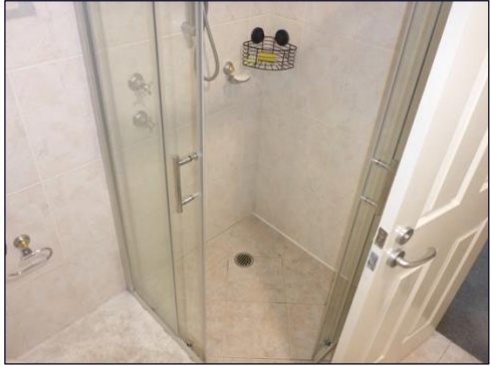
| ITEM | LOCATION | DESCRIPTION & PHOTOGRAPH(S) |
|---|---|---|
| 43 | Ensuite | <ol style="list-style-type: none"> <li>1. Instructed by the lot occupant at the time of inspection that water leaks from the shower tray into the walk-in robe (WIR).</li> <li>2. Evidence of previous repair attempts in the form of sealant application at the wall-floor junction adjoining the WIR.</li> </ol> |

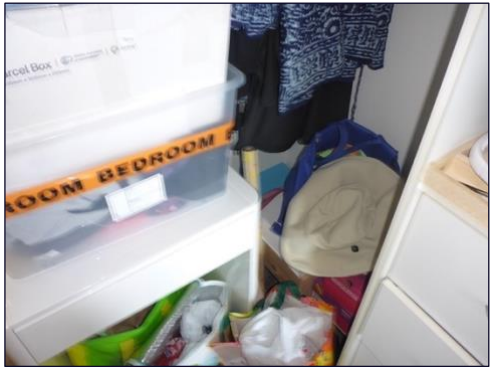
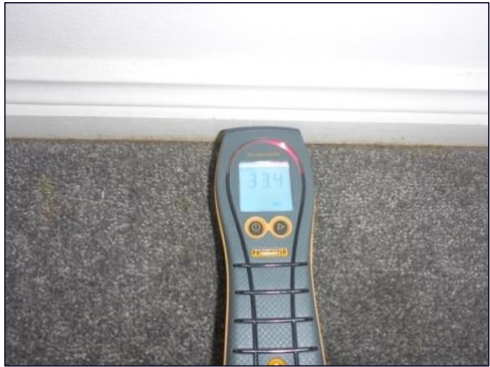
| ITEM | LOCATION | DESCRIPTION & PHOTOGRAPH(S) |
|---|---|---|
| 44 | Walk-in-robe | <ol style="list-style-type: none"> <li>1. Evidence of water penetration in the form of moist and damp carpet, and staining to the skirting board along the wall adjoining the ensuite shower recess.</li> <li>2. High-level moisture meter readings in the vicinity of 33.4% were recorded in the skirting board.</li> </ol> |

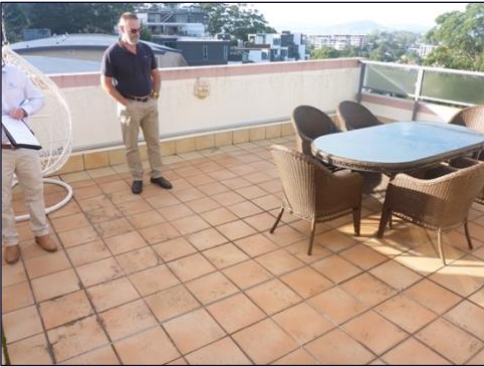
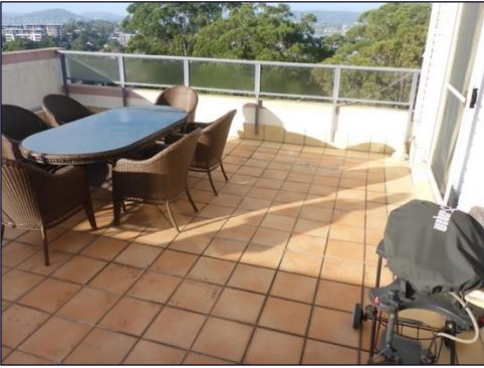
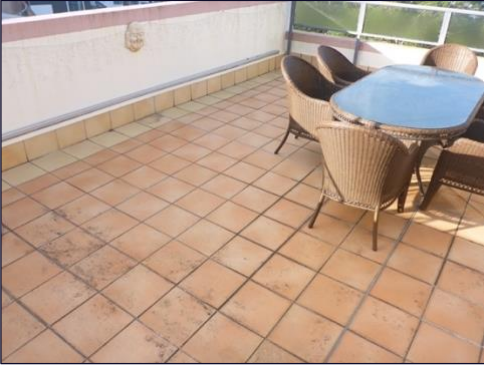
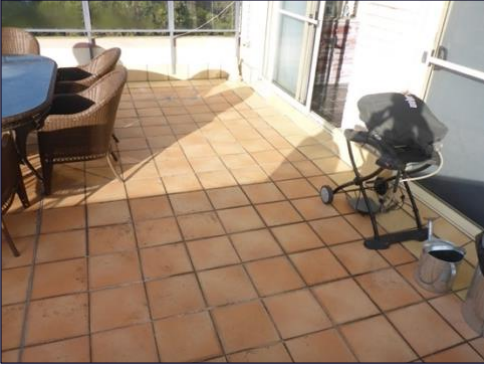
| ITEM | LOCATION | DESCRIPTION & PHOTOGRAPH(S) |
|---|---|---|
| 48 | Eastern terrace | <ol style="list-style-type: none"> <li>1. Tenting/hogged tiles in the vicinity of the central movement joint.</li> <li>2. Instructed by the lot occupant that water is penetrating into <i>Unit 23</i> main bedroom immediately below.</li> <li>3. The position of the terrace does not align directly with the main bedroom of <i>Unit 23</i>, and the northern curved-sprung metal-deck roof weatherproofing provisions are the likely cause of the water ingress.</li> <li>4. The skirting tiles conceal any weepholes in the eastern façade.</li> </ol> |

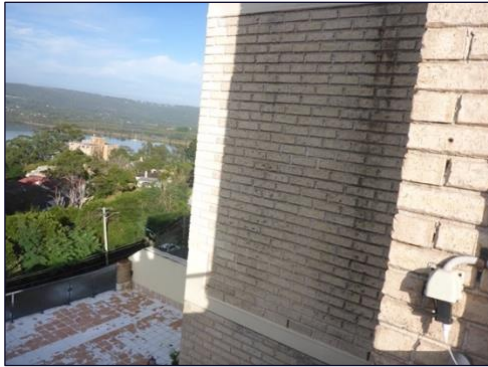
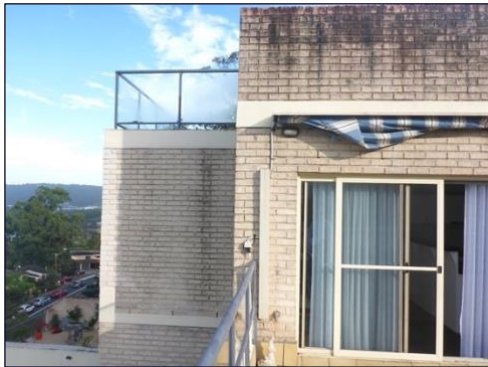
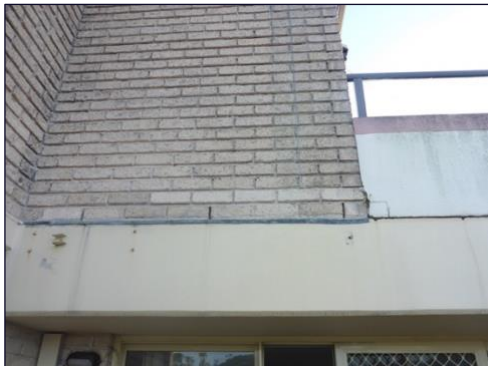
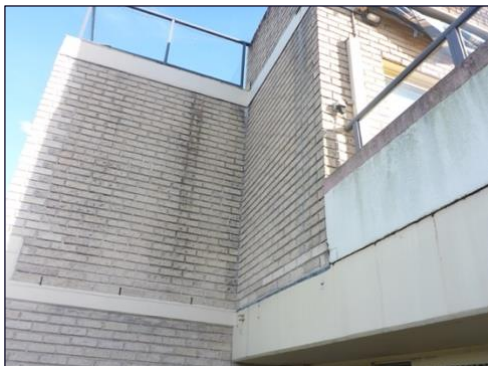
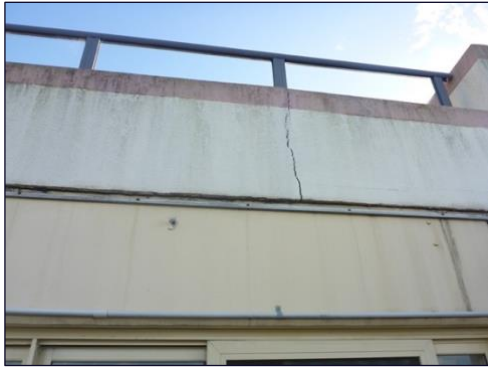
| ITEM | LOCATION | DESCRIPTION & PHOTOGRAPH(S) |
|---|---|---|
| 49 | Eastern and southern façades | <ol style="list-style-type: none"> <li>1. A large section of brickwork has been rebuilt on the southern elevation over the reinforced concrete upstand.</li> <li>2. New cavity flashings have been built into the new sections of masonry, and weepholes provided every third brick.</li> <li>3. New windows have been installed in this section of the southern façade.</li> </ol> |

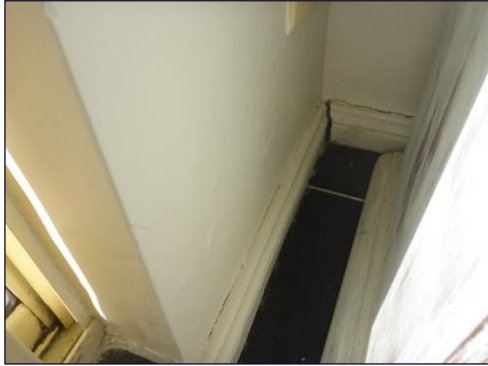
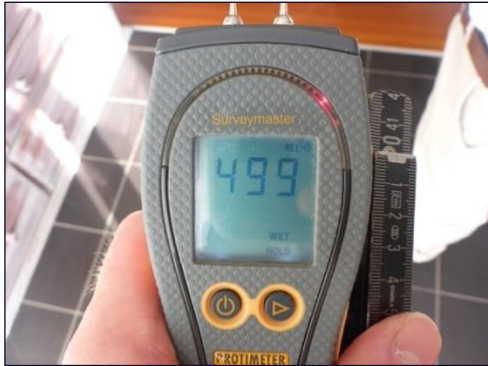
| ITEM | LOCATION | DESCRIPTION & PHOTOGRAPH(S) |
|---|---|---|
| 50 | Kitchen, living room and entry | <ol style="list-style-type: none"> <li>1. Evidence of water penetration in the form of blistering and bubbling paint to the southern and eastern walls in the south-eastern corner.</li> <li>2. High-level moisture meter readings in the vicinity of 49.9% were recorded in the skirting boards.</li> <li>3. The eastern terrace is located immediately adjacent.</li> </ol> |

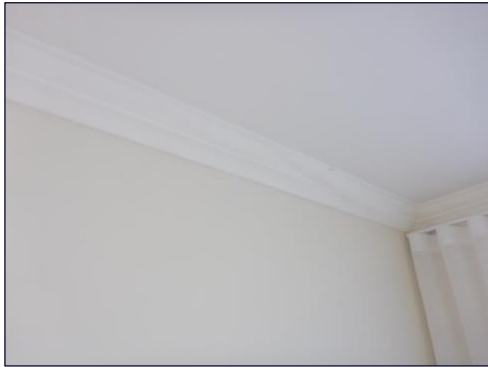
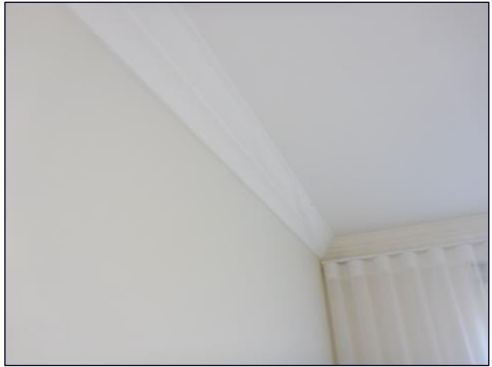
| ITEM | LOCATION | DESCRIPTION & PHOTOGRAPH(S) |
|---|---|---|
| 51 | Living room | <ol style="list-style-type: none"> <li>1. Evidence of water penetration in the form of blistering and bubbling paintwork to the cornice along the northern and eastern walls.</li> <li>2. <i>Unit 30</i> eastern tiled terrace is located directly above.</li> </ol> |

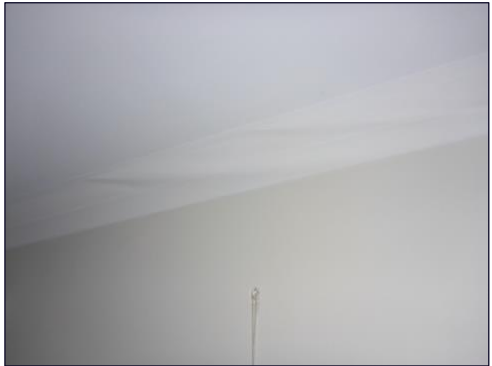
| ITEM | LOCATION | DESCRIPTION & PHOTOGRAPH(S) |
|---|---|---|
| 52 | Second bedroom | <ol style="list-style-type: none"> <li>Evidence of water penetration in the form of bubbling/disturbed paintwork to the cornice along the western wall in the north-western corner.</li> <li>A step in the floor slab above (red box) exists externally.</li> <li>A full-height construction joint (blue box) exists in the face cavity brickwork façade in this location.</li> <li>Likely defective weatherproofing provisions in the vicinity of the construction joint within the rainscreen façade.</li> <li>The disturbed section of cornice within the second bedroom may also be movement-related.</li> </ol> |
