# BUILDING SURVEY

92 JOHN WHITEWAY DRIVE,  
GOSFORD NSW 2250

QUAY NORTH APARTMENTS

# General Building Survey Report

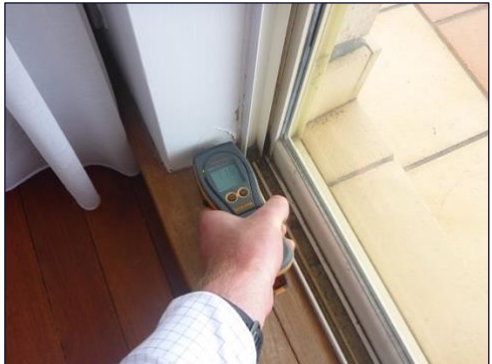
| ITEM | LOCATION | DESCRIPTION & PHOTOGRAPH(S) |
|---|---|---|
| 53 | Dining room | <ol style="list-style-type: none"> <li>Evidence of water penetration in the form of minor blistering and bubbling of the paintwork at the lower left-hand side of the south-facing glass sliding door.</li> <li>Low-level (normal) moisture meter readings in the vicinity of 11.8% were recorded in the LHS reveal.</li> </ol> |

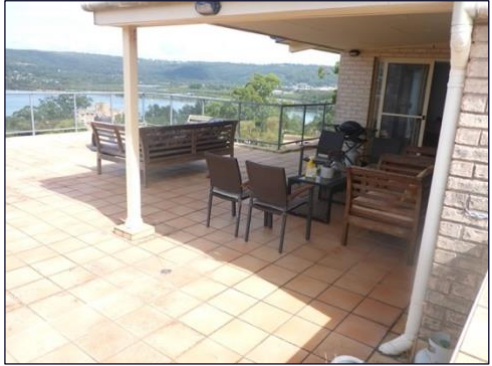
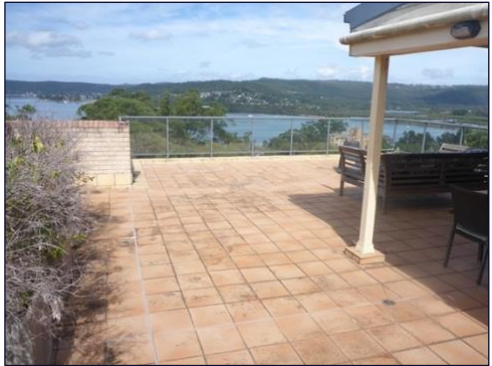
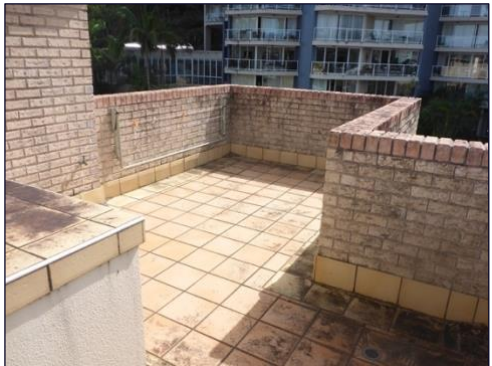
| ITEM | LOCATION | DESCRIPTION & PHOTOGRAPH(S) |
|---|---|---|
| 55 | South-eastern terrace | <p>1. Tenting/hogged tiles adjacent to the movement joint and overflow along the narrow southern return.</p> |

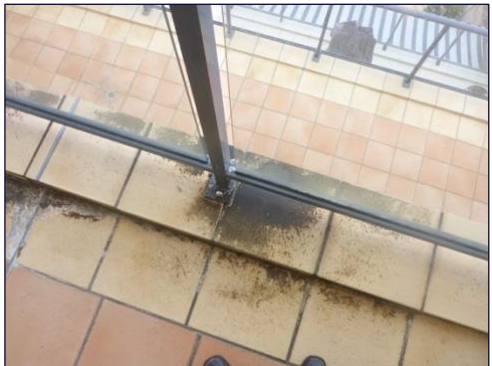
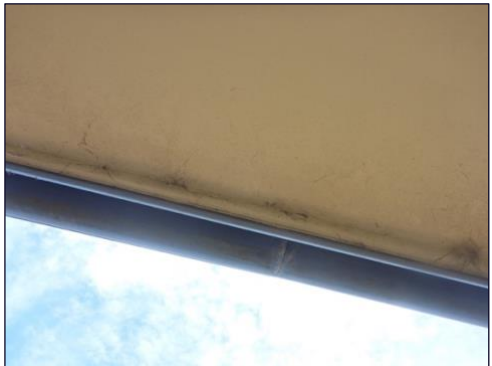
| ITEM | LOCATION | DESCRIPTION & PHOTOGRAPH(S) |
|---|---|---|
| 57 | Southern narrow return of south-eastern terrace | <ol style="list-style-type: none"> <li>1. The balustrade hob tiles are stained.</li> <li>2. Rainwater is dripping from the half-round eaves-mounted gutter above, and onto the hob tiles below.</li> </ol> |

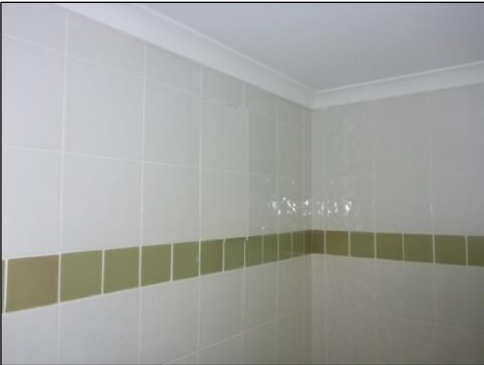
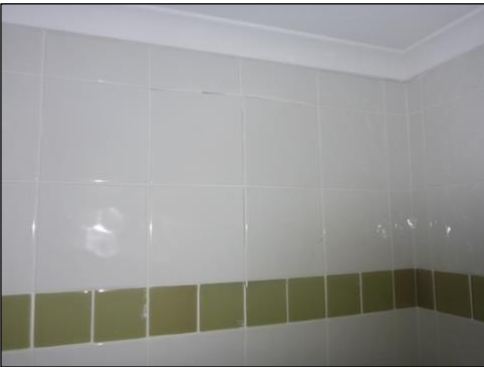
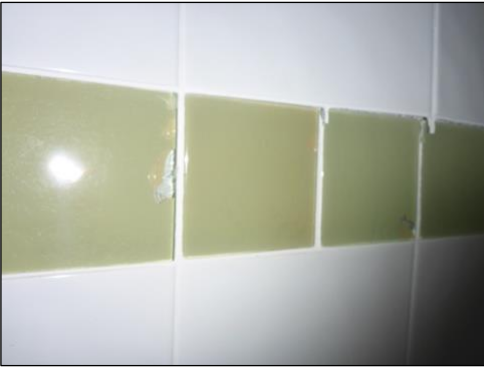
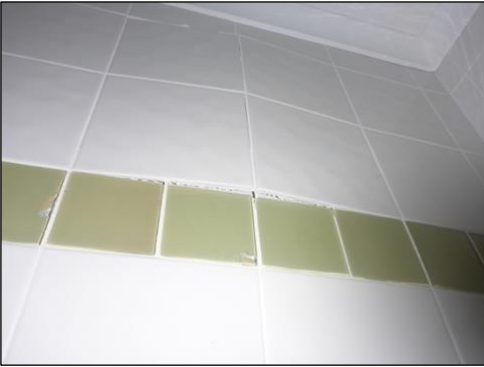
| ITEM | LOCATION | DESCRIPTION & PHOTOGRAPH(S) |
|---|---|---|
| 60 | Bathroom | <ol style="list-style-type: none"> <li>1. Tenting/hogged tiles to the northern wall above the bathtub, and drummy tiles along the eastern wall.</li> <li>2. The delaminating wall tiles present a personal injury hazard to the lot occupants.</li> <li>3. These walls are common property walls.</li> <li>4. Instructed by the lot occupant at the time of inspection that this issue was reported to the Strata Committee approximately two years prior to our inspection.</li> </ol> |

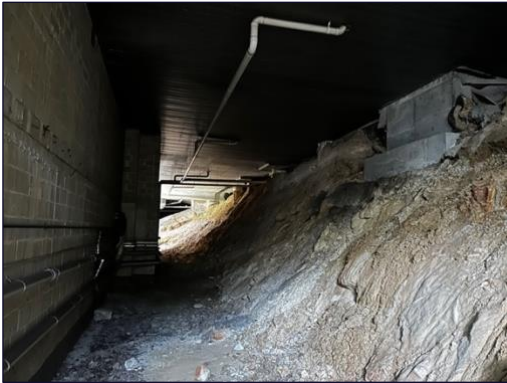
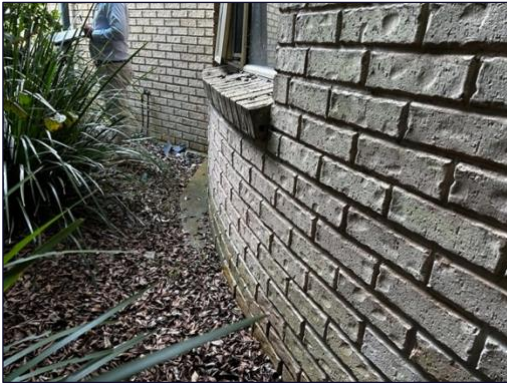
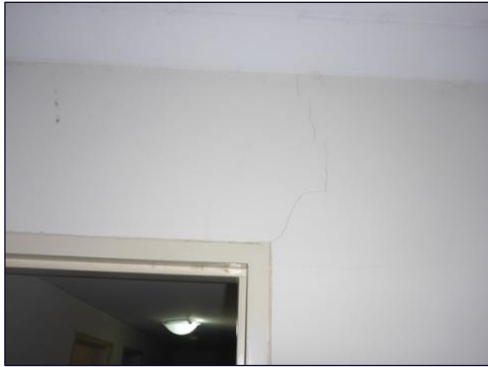
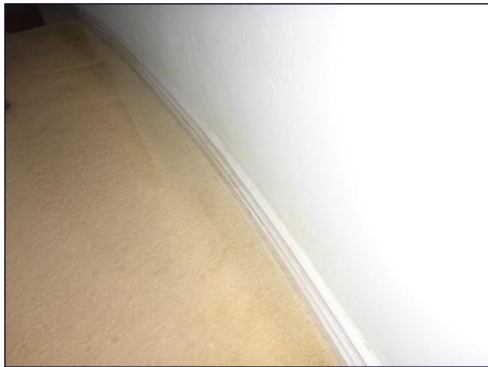
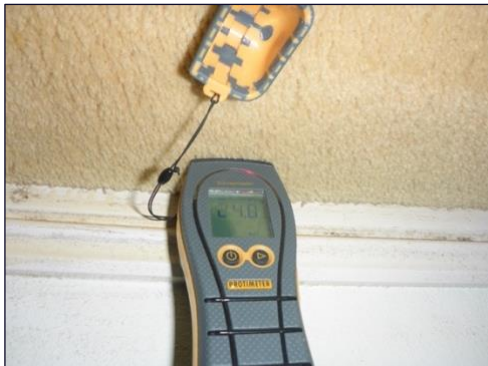
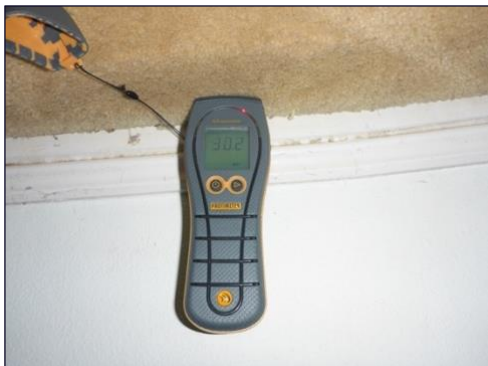
| ITEM | LOCATION | DESCRIPTION & PHOTOGRAPH(S) |
|---|---|---|
| 61 | Main bedroom | <ol style="list-style-type: none"> <li>Evidence of water penetration in the form of mould growth and general dampness, discolouration and staining of the carpet at the base of the curved south-eastern rendered masonry wall and northern rendered masonry wall.</li> <li>High-level moisture meter readings ranging from 24.8% to 30.2% were recorded in the carpet at the time of inspection.</li> <li>Minor horizontal and vertical cracking to the northern, and curved south-eastern walls.</li> <li>This room is positioned on the building's lowest floor (Level 1) adjoining the heavily shaded, benched side of the site.</li> <li>Leaf litter and debris adjoins the curved south-eastern face brickwork façade, however, it is possible that a step in the floor slab exists, and that the concrete protrusion at the base of the façade indicates the lower courses are "wet courses".</li> <li>Instructed by the lot occupant at the time of inspection that the dining room has been previously flooded, however the adjoining building façade was "damp-proofed". The exact scope of these works was not disclosed.</li> <li>Possible ground water issue.</li> <li>Possible bridging of the cavity flashings in the external face cavity brick façade.</li> <li>The following photographs depict the site conditions to the north and east of <i>Unit 34</i>:</li> </ol> |

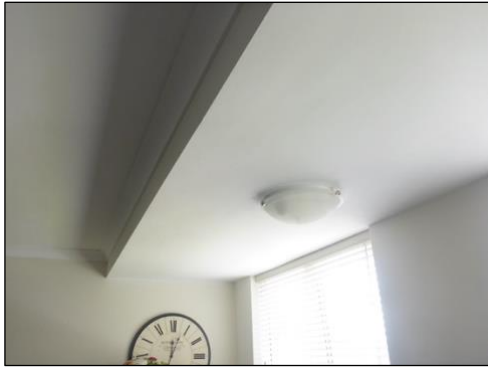
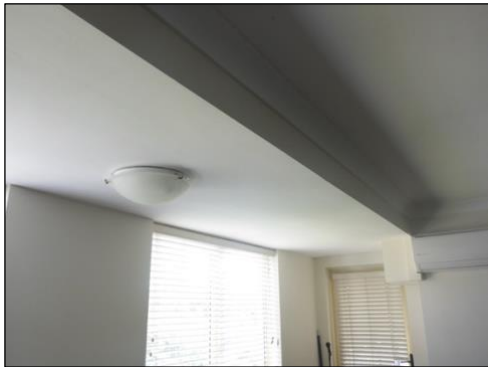
| ITEM | LOCATION | DESCRIPTION & PHOTOGRAPH(S) |
|---|---|---|
| 63 | Living room | <ol style="list-style-type: none"> <li>Evidence of minor mould growth at the head of the southern wall in the south-western corner adjacent to the casement door servicing the southern balcony.</li> <li>Low-level (normal) moisture meter readings in the vicinity of 10.7% were recorded in this location at the time of inspection.</li> <li>Instructed by the lot occupant at the time of inspection that mould growth regularly occurs on the suspended plasterboard bulkhead, however it is regularly removed.</li> <li>There was no evidence of mould growth on the suspended plasterboard bulkhead at the time of inspection.</li> </ol> |

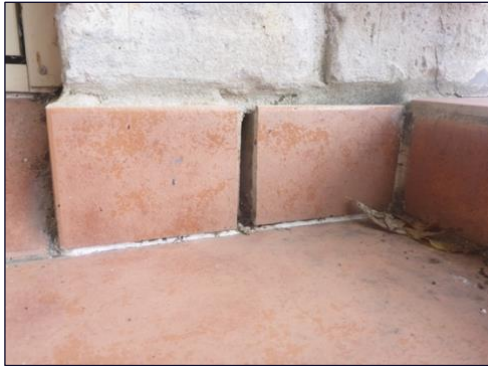
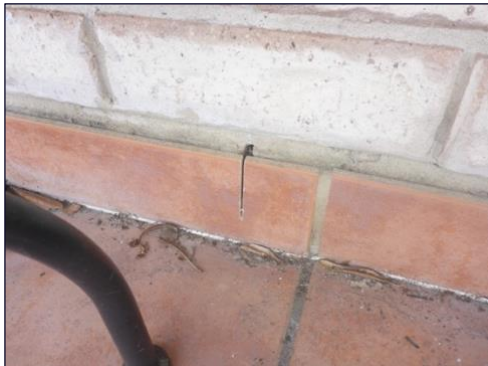
| ITEM | LOCATION | DESCRIPTION & PHOTOGRAPH(S) |
|---|---|---|
| 64 | Southern balcony | <ol style="list-style-type: none"> <li>1. The weepholes are positioned in the course of masonry above the finished floor level (FFL) of the tiled balcony.</li> <li>2. <i>Pinnacle</i> observed no stormwater floor waste on the balcony.</li> <li>3. The balcony appears to be drained via a penetration in the concrete hob set approximately 30mm above the FFL.</li> </ol> |

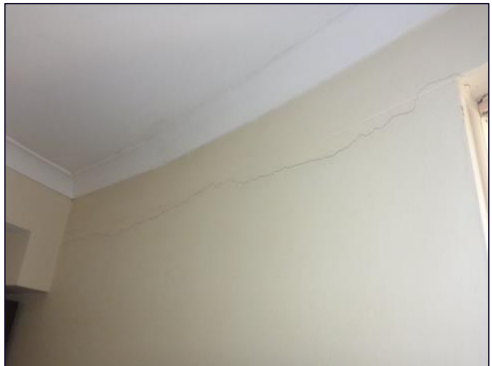
| ITEM | LOCATION | DESCRIPTION & PHOTOGRAPH(S) |
|---|---|---|
| 66 | Main bedroom | <ol style="list-style-type: none"> <li>1. Horizontal and stepped cracking at the head of the splayed south-eastern wall extending from the top left-hand and right-hand sides of the window aperture.</li> <li>2. The V-joint provided at this interface between building elements has not been scribed through the full depth of the render, and the predictable building movement in this location has not been sufficiently accommodated.</li> </ol> |

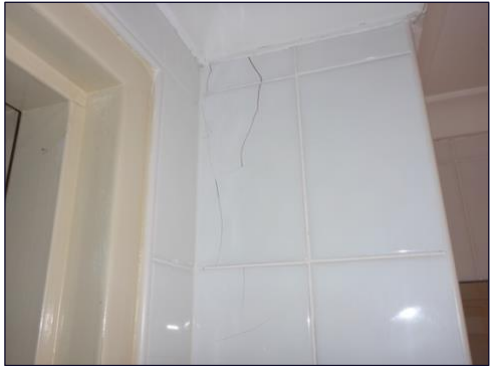
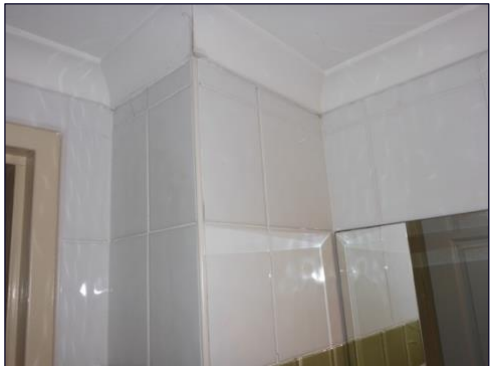
| ITEM | LOCATION | DESCRIPTION & PHOTOGRAPH(S) |
|---|---|---|
| 67 | Ensuite | <p>1. Minor vertical cracking to the wall tiles at the head of the wall in the south-eastern corner.</p> |

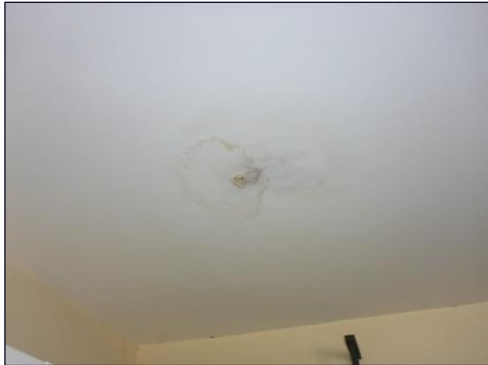
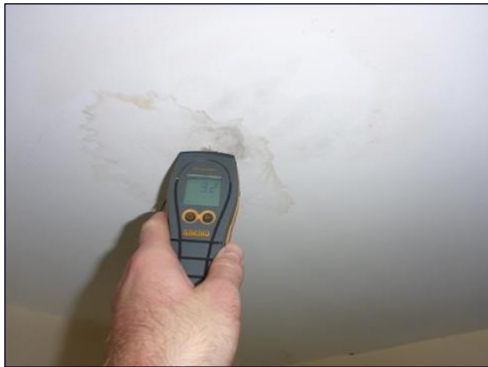
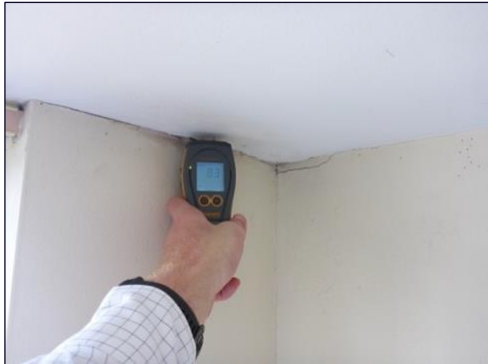
| ITEM | LOCATION | DESCRIPTION & PHOTOGRAPH(S) |
|---|---|---|
| 68 | Kitchen | <ol style="list-style-type: none"> <li>Evidence of water penetration in the form of staining and mould growth to the suspended plasterboard ceiling lining in the north-western and south-western corners.</li> <li>Low-level moisture meter readings ranging between 8.2% (south-western corner) and 9.7% (north-western corner) were recorded in these locations.</li> </ol> |

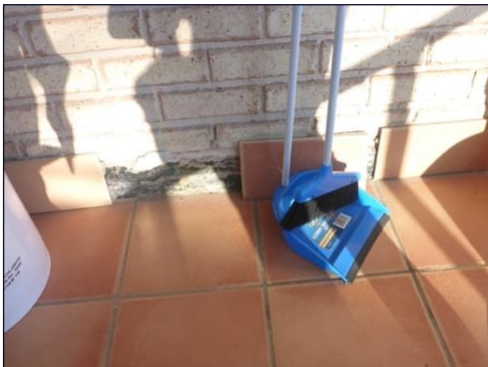
| ITEM | LOCATION | DESCRIPTION & PHOTOGRAPH(S) |
|---|---|---|
| 69 | Southern balcony | <ol style="list-style-type: none"> <li>Evidence of water penetration in the form of staining to the floor waste penetration through the soffit of the reinforced concrete balcony slab above (<i>Unit 41</i> southern balcony).</li> <li>Delaminating skirting tiles at the eastern end of the balcony.</li> <li>The skirting tiles conceal any weepholes in the façade.</li> <li>There are no overflow provisions throughout the perimeter balcony hob.</li> </ol> |

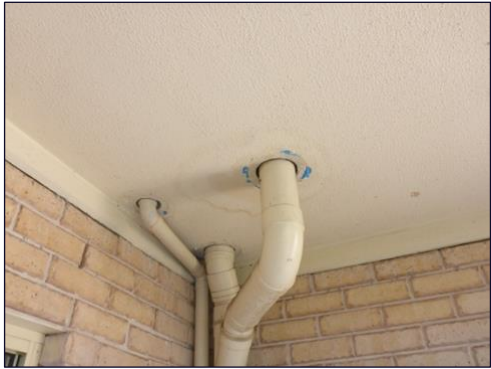
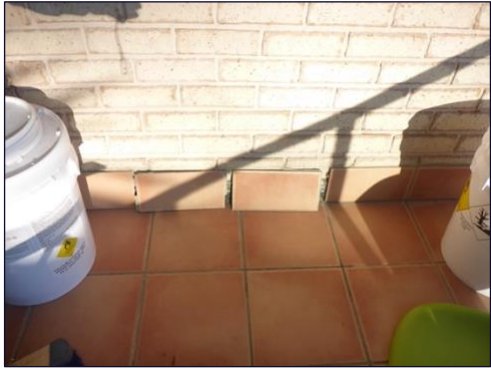
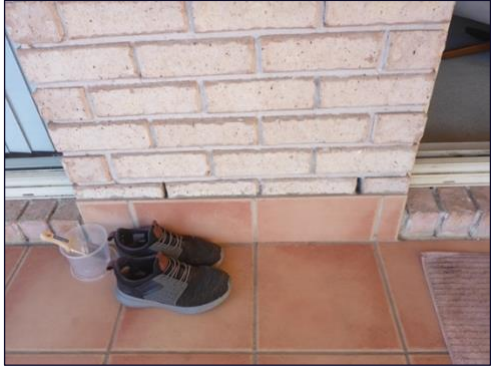
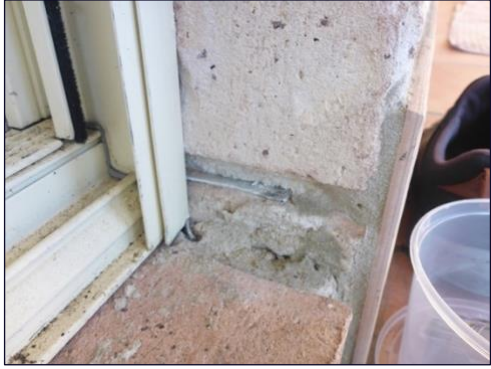
| ITEM | LOCATION | DESCRIPTION & PHOTOGRAPH(S) |
|---|---|---|
| | | <p>5. The cavity flashings have been laid visibly short of the outer face of the external skin of masonry. This action risks any rainwater entering the wall cavity being directed into the extrusions of the course(s) of brickwork beneath the cavity flashing, and bypassing the balcony waterproofing provisions.</p> <p>6. A liquid-applied black polyurethane or bitumen waterproofing membrane exists beneath the retrofitted (peach-coloured) ceramic floor tiles.</p> <p>7. Instructed by the lot occupant at the time of inspection that there is no internal water penetration.</p> |

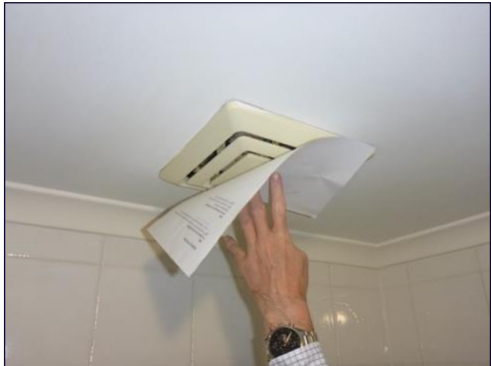
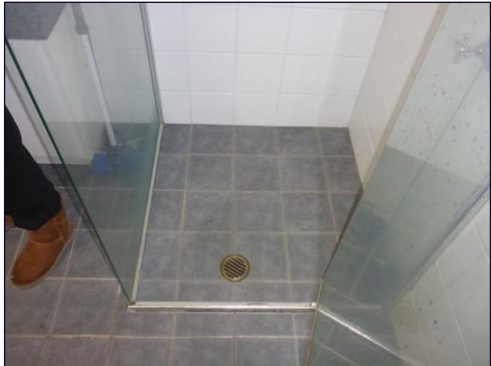
| ITEM | LOCATION | DESCRIPTION & PHOTOGRAPH(S) |
|---|---|---|
| 70 | Bathroom | <ol style="list-style-type: none"> <li>1. The mechanical ventilation is inoperable.</li> <li>2. This was tested using a sheet of A4 paper, which failed to be drawn to the register.</li> <li>3. Water ponds on the surface of the floor tiles within the shower recess due to inadequate falls, resulting in a loss of amenity, a potential slip hazard and unnecessarily elevated humidity.</li> </ol> |

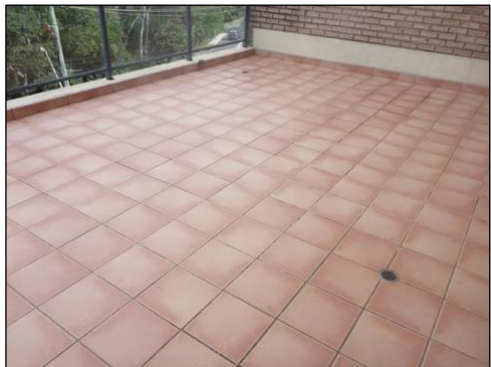
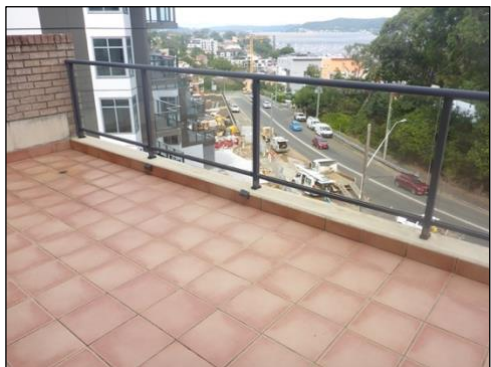
| ITEM | LOCATION | DESCRIPTION & PHOTOGRAPH(S) |
|---|---|---|
| 72 | Southern balcony | <ol style="list-style-type: none"> <li>1. The southern balcony appears to have been retiled approximately 20 years ago as indicated by the (peach-coloured) ceramic tiles.</li> <li>2. Sound fall has been provided to the ceramic floor tiling.</li> <li>3. There are no overflow provisions throughout the perimeter balcony hob.</li> <li>4. There were no visible internal water penetration issues apparent at the time of inspection.</li> </ol> |

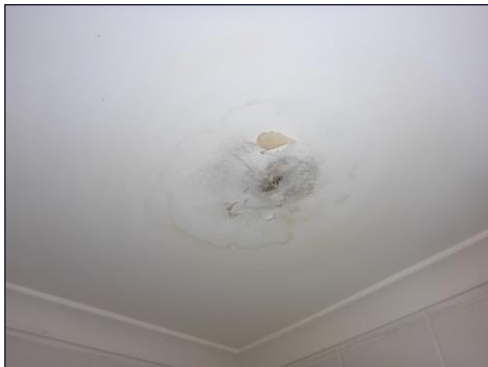
| ITEM | LOCATION | DESCRIPTION & PHOTOGRAPH(S) |
|---|---|---|
| 73 | Ensuite | <ol style="list-style-type: none"> <li>1. Evidence of significant water penetration in the form of mould growth, staining and rot-affected plasterboard to the ceiling above the shower recess.</li> <li>2. Low-level (normal) moisture meter readings in the vicinity of 10.3% were recorded in the ceiling linings.</li> <li>3. Instructed by the lot occupant at the time of inspection that previous remedial work was undertaken, however the damage has since reoccurred.</li> </ol> |

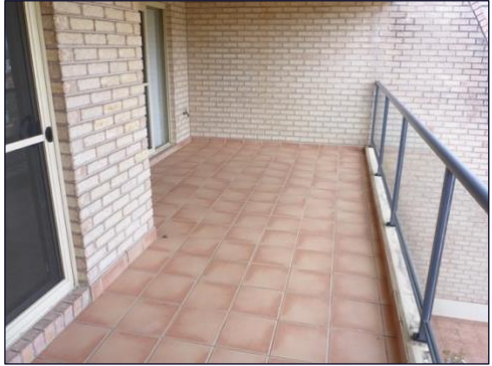
| ITEM | LOCATION | DESCRIPTION & PHOTOGRAPH(S) |
|---|---|---|
| 74 | Southern balcony | <ol style="list-style-type: none"> <li>1. The southern balcony appears to have been retiled approximately 20 years ago as indicated by the (peach-coloured) ceramic tiles.</li> <li>2. There are no overflow provisions throughout the perimeter balcony hob.</li> </ol> |

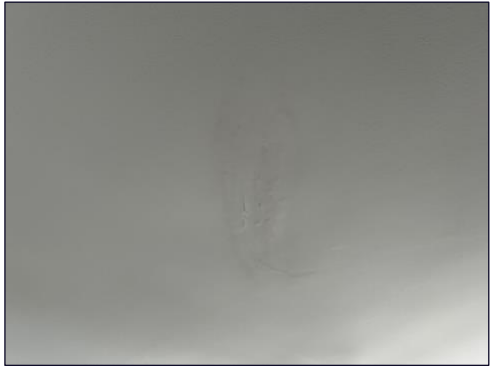
| ITEM | LOCATION | DESCRIPTION & PHOTOGRAPH(S) |
|---|---|---|
| 76 | Main bedroom | <ol style="list-style-type: none"> <li>1. Evidence of previous water penetration in the form of blistering and flaking paint and staining to the suspended plasterboard ceiling lining.</li> <li>2. Low-level (normal) moisture meter readings in the vicinity of 0.0% were recorded in this location at the time of inspection.</li> <li>3. This damage appears to be consequential only, however the curved-sprung metal-deck roof is located above.</li> </ol> |

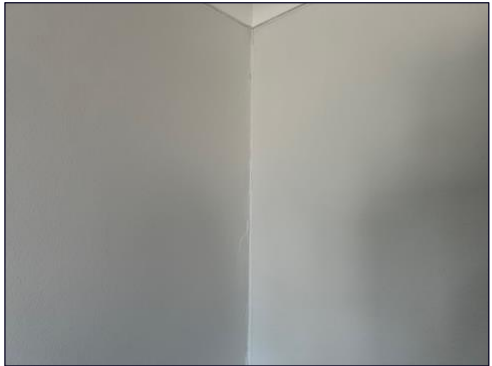
| ITEM | LOCATION | DESCRIPTION & PHOTOGRAPH(S) |
|---|---|---|
| 78 | Living room | <ol style="list-style-type: none"> <li>1. Cracked, drummy and delaminating render at the junction of walls in the south-eastern corner.</li> <li>2. Evidence of previous repairs to the rendered masonry walls in this location.</li> <li>3. The cracking is reflected in the north-eastern corner of the adjoining bathroom.</li> </ol> |

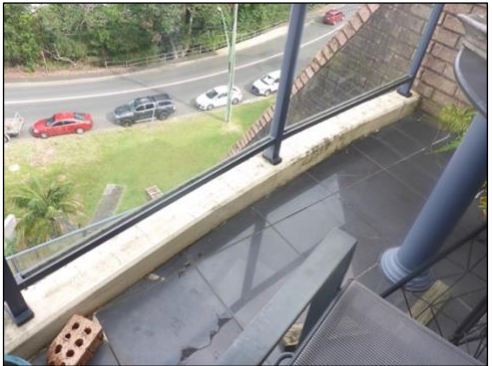
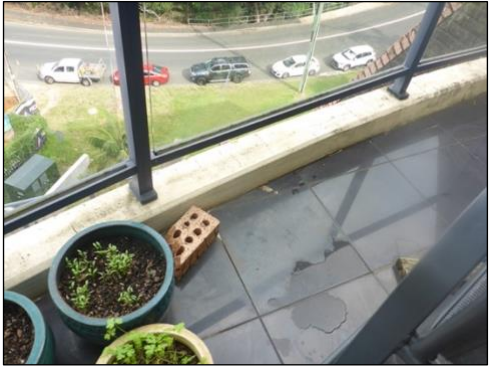
| ITEM | LOCATION | DESCRIPTION & PHOTOGRAPH(S) |
|---|---|---|
| 79 | Southern balcony | <ol style="list-style-type: none"> <li>1. There are no overflow provisions throughout the perimeter balcony hob.</li> </ol> |

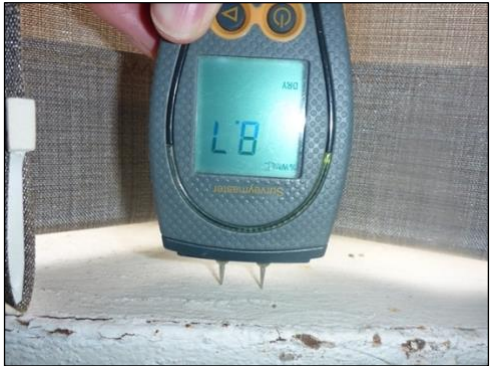
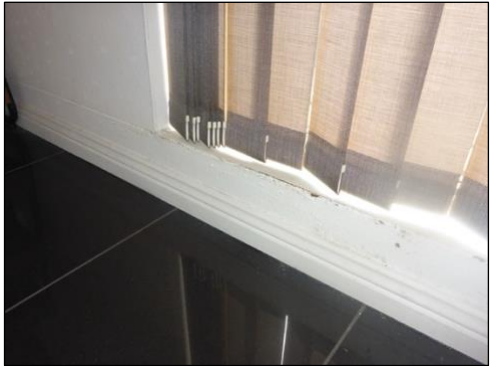
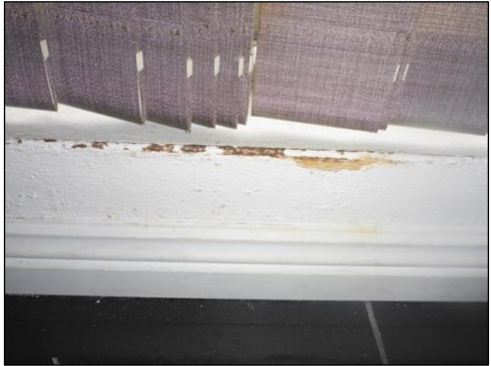
| ITEM | LOCATION | DESCRIPTION & PHOTOGRAPH(S) |
|---|---|---|
| 80 | Living room | <ol style="list-style-type: none"> <li>Evidence of previous water penetration in the form of blistering and flaking paint and corroding metal angle beading to the rendered masonry hob at the base of the western, south-facing glass sliding door assembly.</li> <li>Low-level (normal) moisture meter readings in the vicinity of 8.7% were recorded in the rendered masonry hob.</li> </ol> |

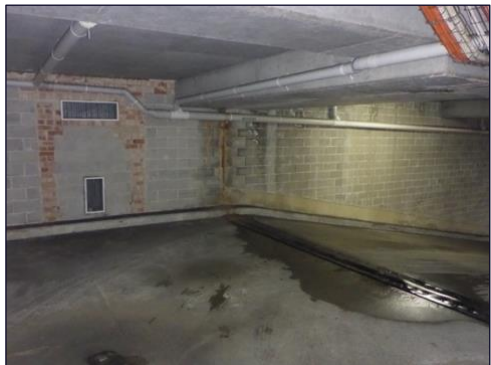
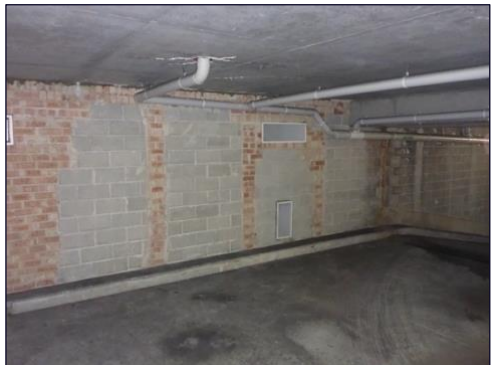
| ITEM | LOCATION | DESCRIPTION & PHOTOGRAPH(S) |
|---|---|---|
| 81 | Level 4 | <ol style="list-style-type: none"> <li>1. Evidence of significant water penetration in the form of water actively dripping from the construction joint extending through the Level 5 reinforced concrete slab and load-bearing core-filled reinforced blockwork and speed (schooner) brick walls.</li> <li>2. Water is penetrating through the construction joint between the reinforced concrete beams and dripping onto the Level 4 floor slab before running down the driveway ramp to the Level 3 carpark.</li> <li>3. Shrinkage/deflection cracking to the soffit of the Level 5 reinforced concrete slab adjacent to the northern masonry wall at the head of the driveway/ramp slab.</li> <li>4. Water is actively dripping from the shrinkage/deflection cracking onto the Level 4 floor slab in this location.</li> <li>5. Stalactite formation, calcification and efflorescence staining in the vicinity of the shrinkage/deflection cracking and stormwater pipe penetrations adjacent to the northern masonry wall at the top of the driveway/ramp.</li> </ol> |

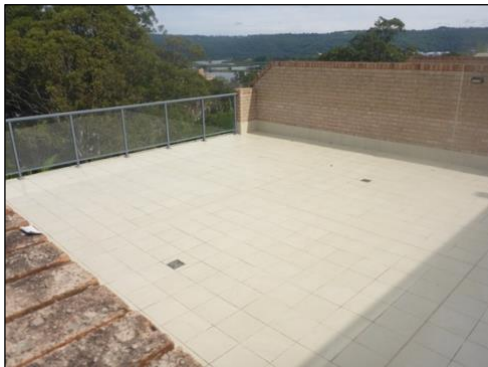
| ITEM | LOCATION | DESCRIPTION & PHOTOGRAPH(S) |
|---|---|---|
| 82 | Intercom 4, Level 5 eastern terrace, walkway and stairwell | <ol style="list-style-type: none"> <li>1. Significant efflorescence and calcification staining to the terracotta tiled surfaces adjoining <i>Unit 17</i> southern balcony, which we understand has been recently re-waterproofed and retiled.</li> <li>2. Water appears to be seeping beneath the 230mm face brickwork boundary wall and causing or contributing to the leak adjacent to the eastern wall in <i>Unit 10</i> living room.</li> </ol> |

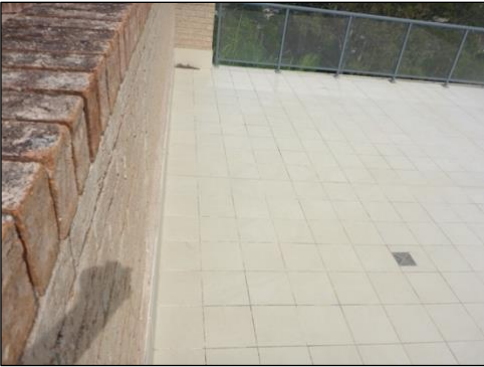
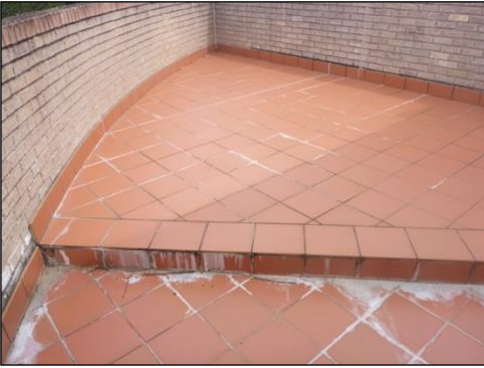
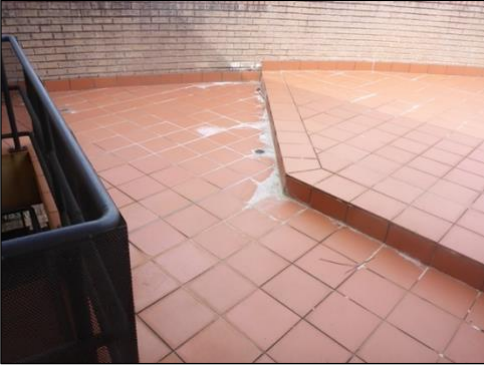
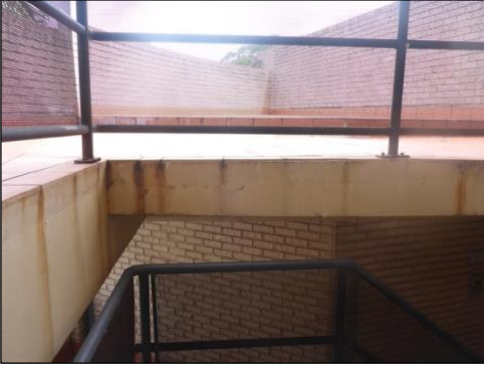
| ITEM | LOCATION | DESCRIPTION & PHOTOGRAPH(S) |
|---|---|---|
| | | <p>3. The vertical movement joints in the 230mm brickwork boundary wall have split and separated, which may also be compromising the waterproofing system on <i>Unit 17</i> southern balcony.</p> <p>4. Evidence of water penetration in the form of stalactite formation and efflorescence staining to the southern stormwater pipe penetration through the Level 5 common area slab, and water actively dripping onto the Level 4 floor tiles below.</p> <p>5. The terracotta floor tiles are tenting/hogged along the movement joints at the northern end of the Level 5 walkway. These movement joints have perished due to long-term compression, exposure and age-related deterioration.</p> |

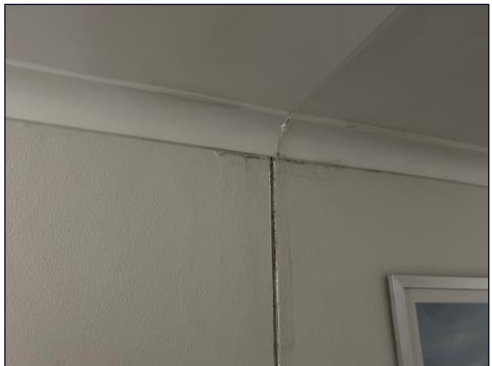
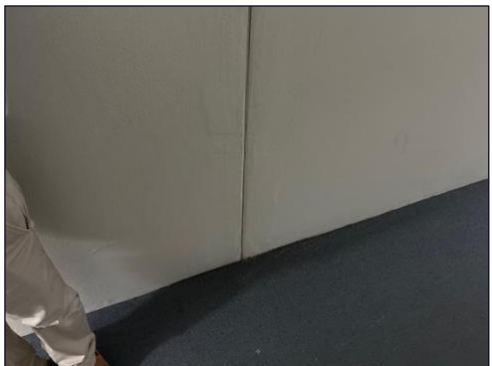
| ITEM | LOCATION | DESCRIPTION & PHOTOGRAPH(S) |
|---|---|---|
| 83 | Level 4 foyer | <ol style="list-style-type: none"> <li>1. Evidence of water penetration in the form of staining, mould growth, blistering and flaking paint and staining to the northern and southern walls, cornice and suspended plasterboard ceiling lining.</li> <li>2. The carpet is also stained in this location.</li> <li>3. The southern wall of the Level 4 foyer forms the northern wall of <i>Unit 9</i> immediately adjacent.</li> <li>4. The units featuring the large southern terraces are located immediately above, and it would appear the waterproofing provisions have failed in the vicinity of the construction joint.</li> </ol> |

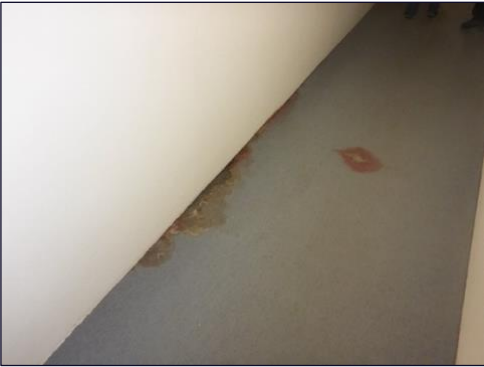
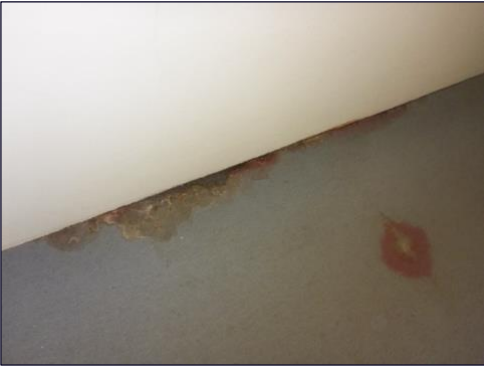
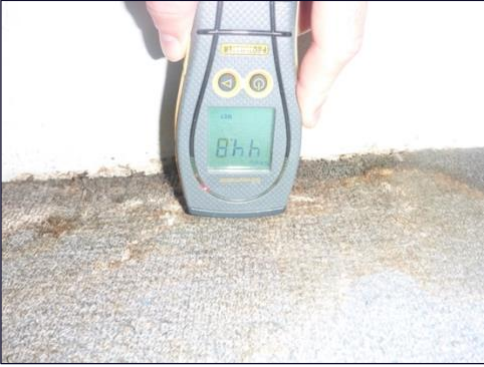
| ITEM | LOCATION | DESCRIPTION & PHOTOGRAPH(S) |
|---|---|---|
| 84 | Intercom 4,<br>Level 4<br>Internal<br>common<br>foyer | <ol style="list-style-type: none"> <li>1. Evidence of water penetration in the form of staining, mould growth and rot-affected carpet approximately midway along the corridor outside <i>Unit 10</i>.</li> <li>2. Previous dye-testing (red) staining affects the carpet immediately adjacent to <i>Unit 10</i> ensuite.</li> <li>3. High-level moisture meter readings in the vicinity of 44.8% were recorded in the carpet at the time of inspection.</li> <li>4. <i>Unit 10</i> ensuite requires re-waterproofing.</li> </ol> |
