## Visual Pre-Purchase Building Condition Report

To comply with Australian Standard  
Building - AS4349.1-2007

CLIENT & INSPECTION DETAILS:	
Client	Georgie K
Address:	9 Walker Ave Wyoming
Contact Phone:	Details withheld
Contact Email:	Details withheld
Inspection Date / Report Number:	28 <sup>th</sup> November 2025
Inspection Time:	11:00am
Weather Conditions	Sunny
Building Furnished:	Yes
Building Tenancy:	Occupied
Persons present at time of inspection:	Vendor

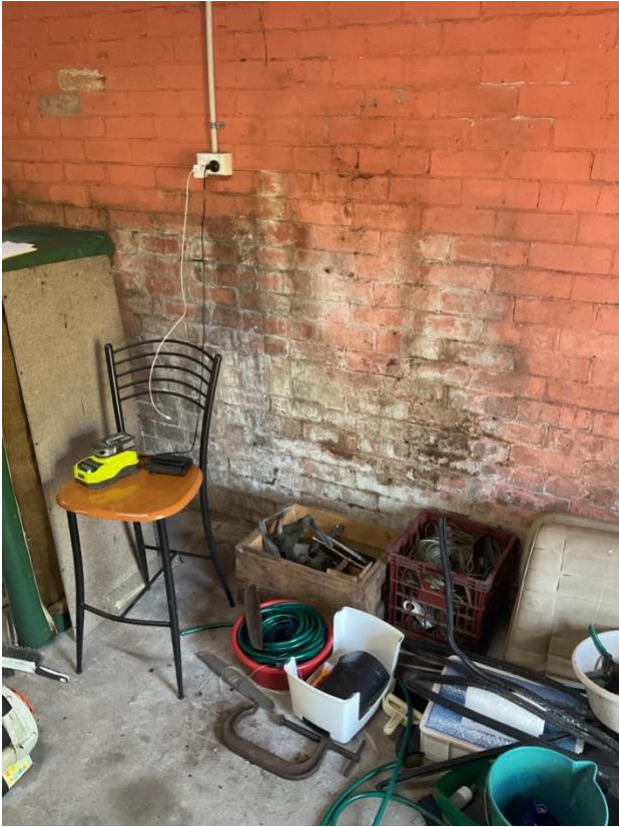
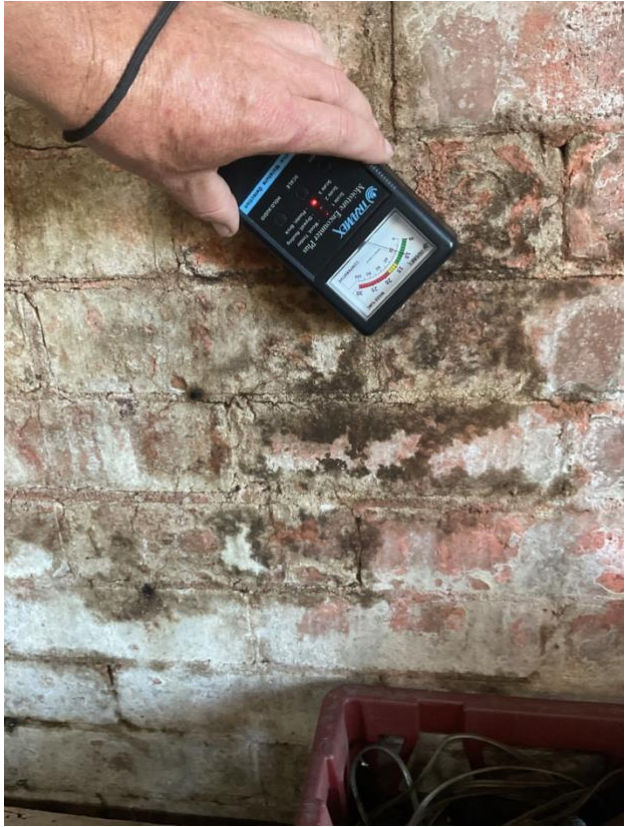
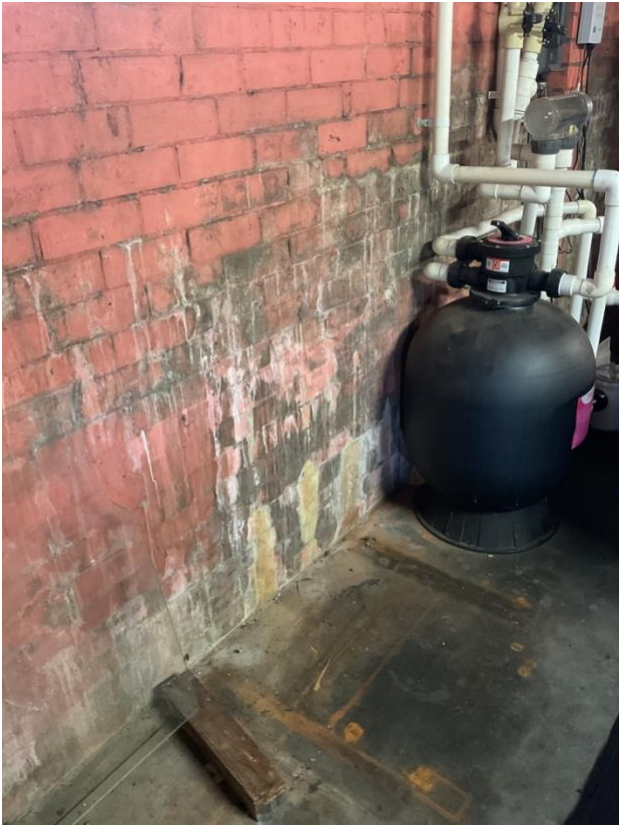
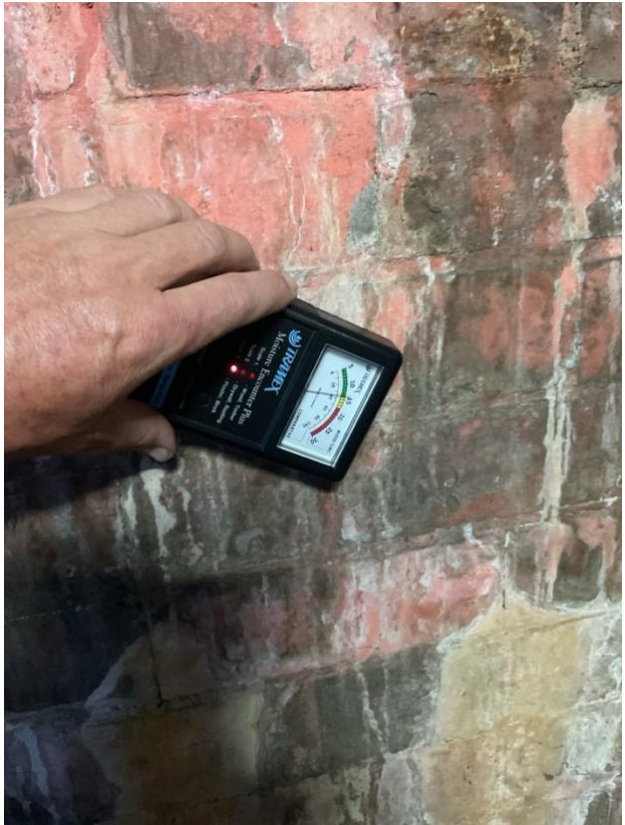
GARAGE	CONDITION & COMMENTS
Access	Satisfactory
Floor	Satisfactory
Walls	(Garage) Evidence of moisture staining to internal brick work face various locations. This is most likely related to the subsidence of concrete paths externally which is allowing rain to seep through the walls. High moisture readings not detected at time of inspection, however this may change during rain events. Please refer to external section of report under "paths" for more details
Ceilings	Satisfactory
Windows	Satisfactory
Door	Satisfactory
Garage Door	Satisfactory

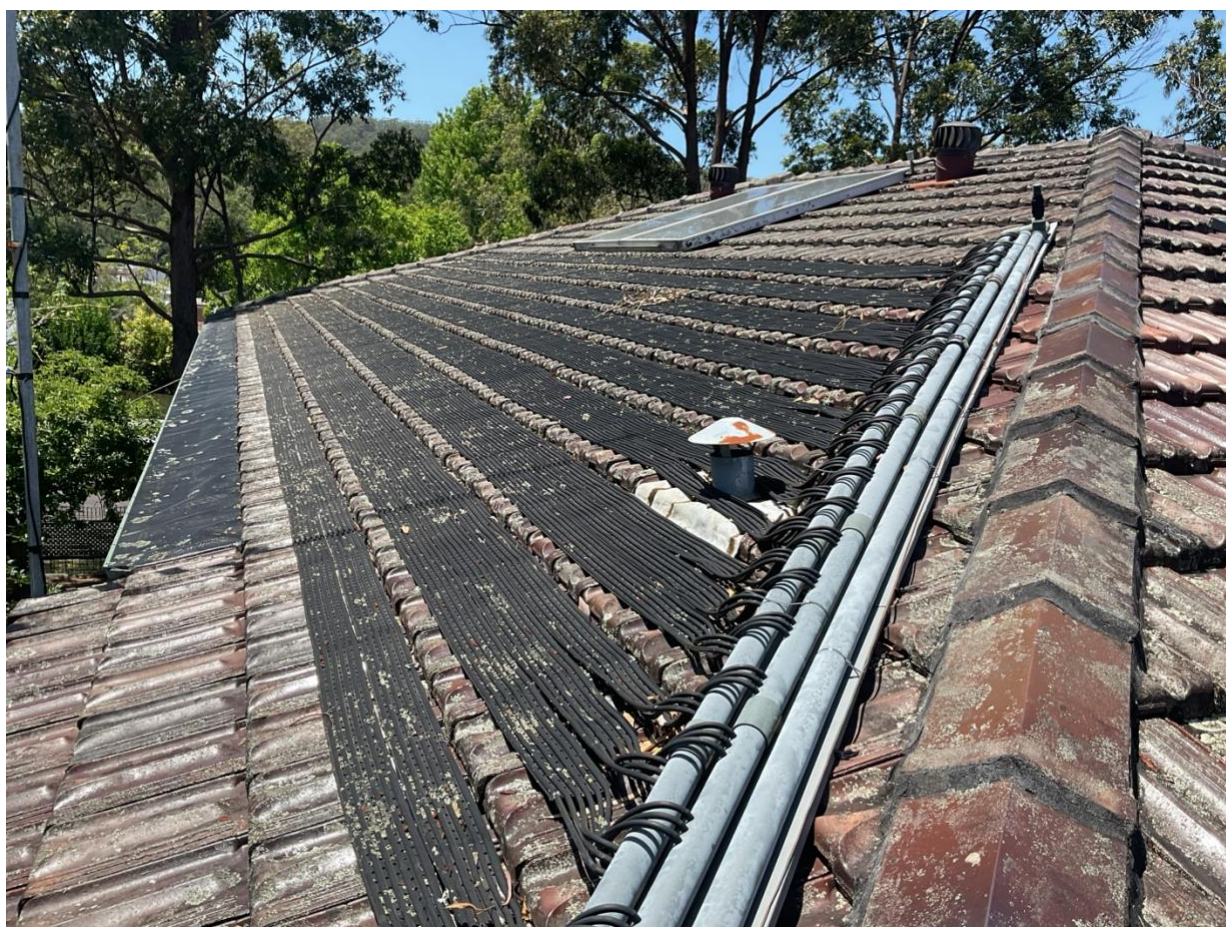
ROOF EXTERIOR:	
EXTERIOR ROOF ITEMS	CONDITION & COMMENTS
Access	Satisfactory
Roof	Satisfactory
Cement Pointing	(Roof exterior) Evidence of cracking to cement pointing of roof capping tiles various locations recommend to re-point all capping tiles
Valley Gutters	NA
*Perimeter Gutters / Spouting	Satisfactory
*Roof Flashing	Satisfactory
Gutter Guard	Yes
<p><b>*Chimney Note:</b> If evident, all flashings, and brick deterioration, any mortar erosion and any lack of support or loss of vertical plumb <u>may not</u> be visible due to this dwelling's height and access restriction.</p>	
<p><b>Fireplaces</b> are not tested. This test is outside the scope of this inspection, and it is recommended that you have these units fully tested prior to purchase.</p>	
<p><b>*All plumbing</b> must be inspected and certified by a qualified plumber or drainage engineer. Visual defects found by the inspectors are subject to a re-inspection by a licensed plumber with the appropriate certifications.</p>
