Inspection Report

Thorough Check Building Inspections

67 Georgia Avenue , Wyoming, NSW, 2250

Pest And Building Inspection

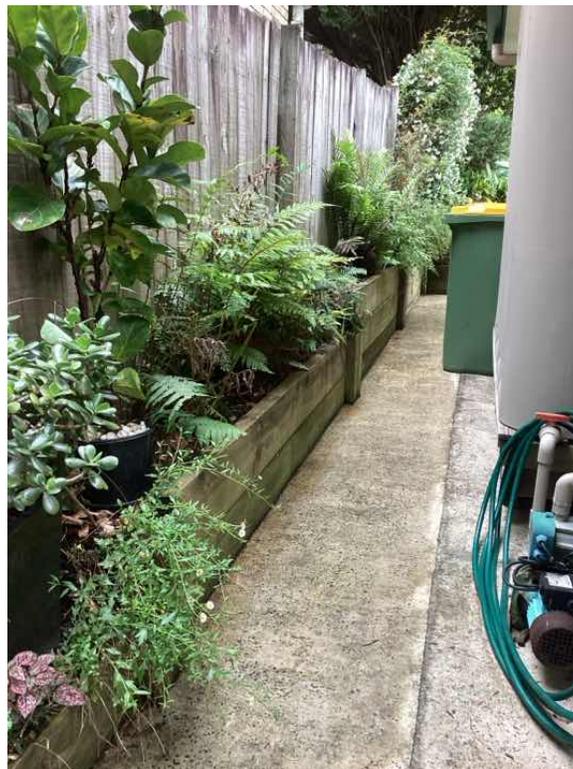
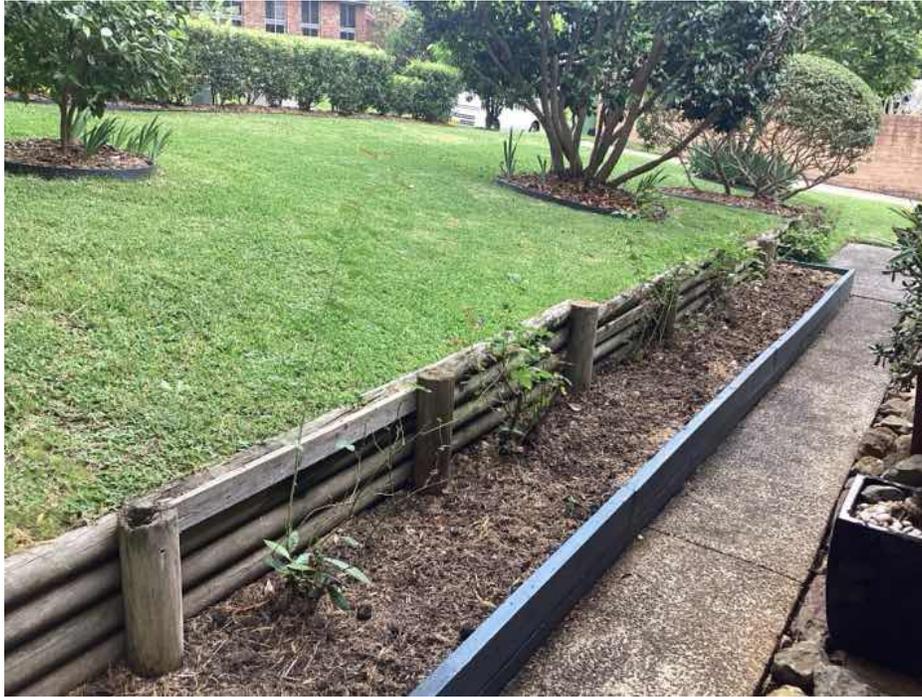
Retaining Walls

Timber fungal decay evident. Recommendations: A qualified landscaping contractor should be engaged for repairs and recommendations.

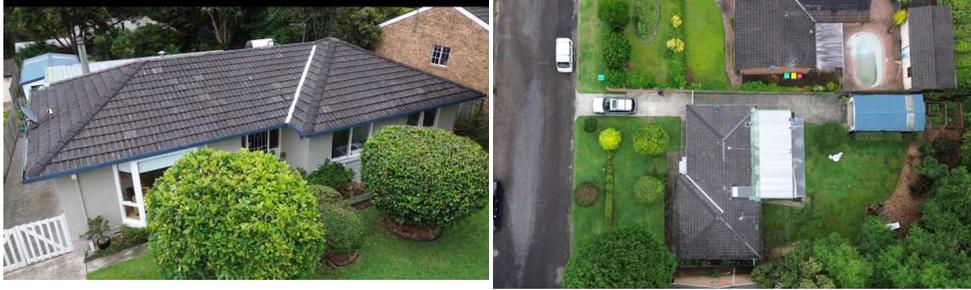
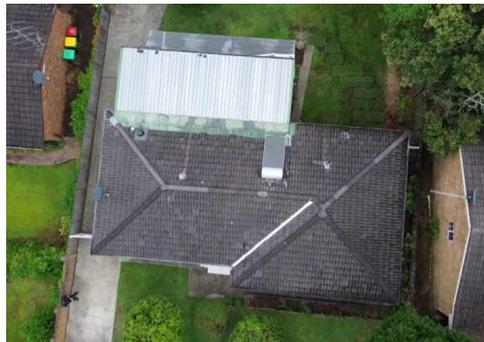
Roof Clad Condition

Cracked tiles visible. Contact a roof tiler for repairs. This has potential to become a serious issue if repairs aren't carried out due to water ingress into the roof cavity.

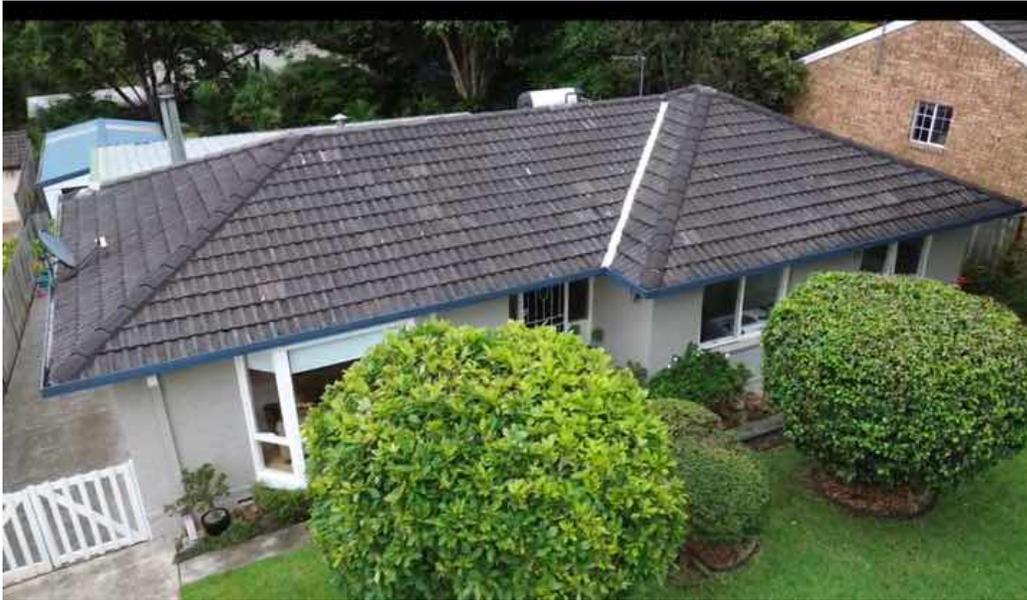
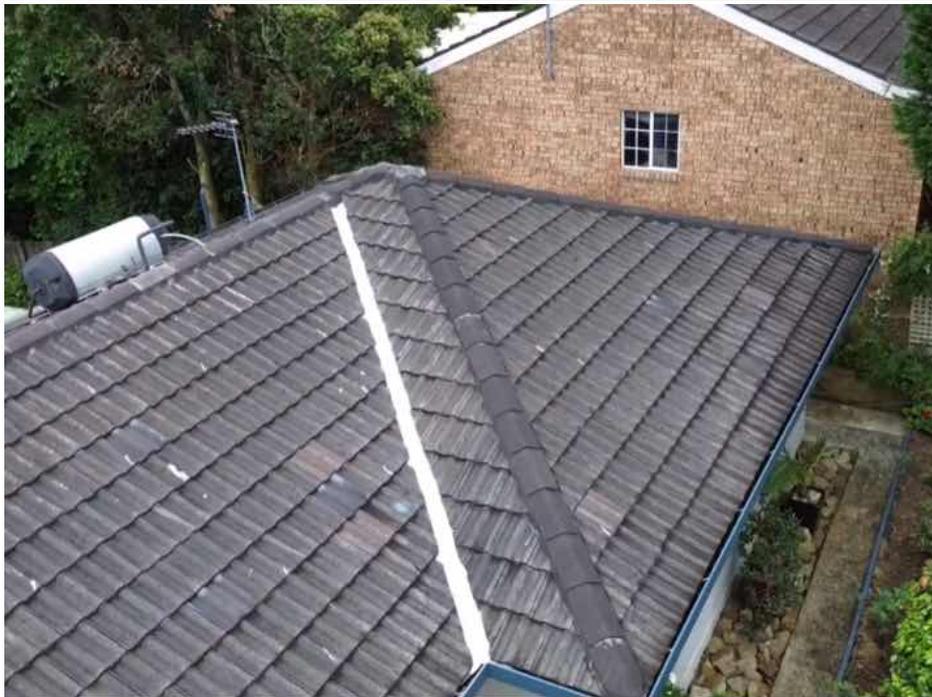
Gutter Findings

Debris in guttering areas- this requires cleaning out to prevent blocking of downpipes and leaking into eaves and fascia. Have gutters cleaned and assessed by a plumber for adequate fall. Regularly clean to prevent ponding. Ponding water will contribute to rust.

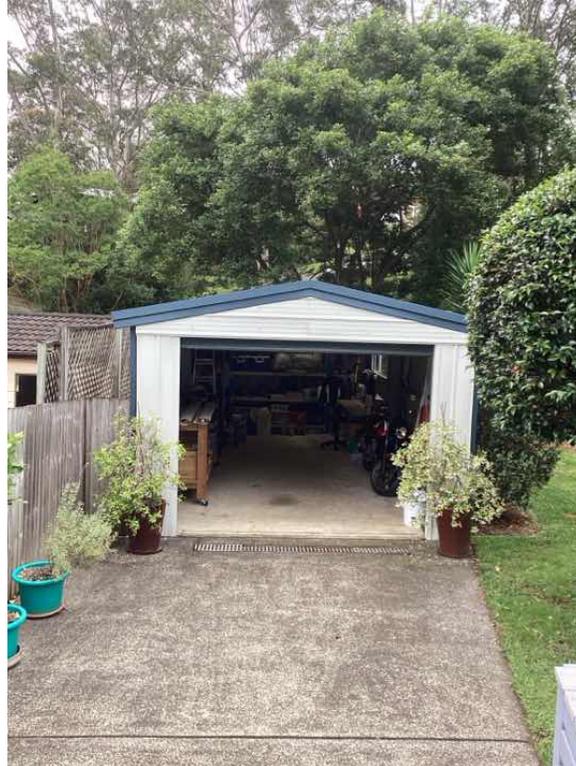
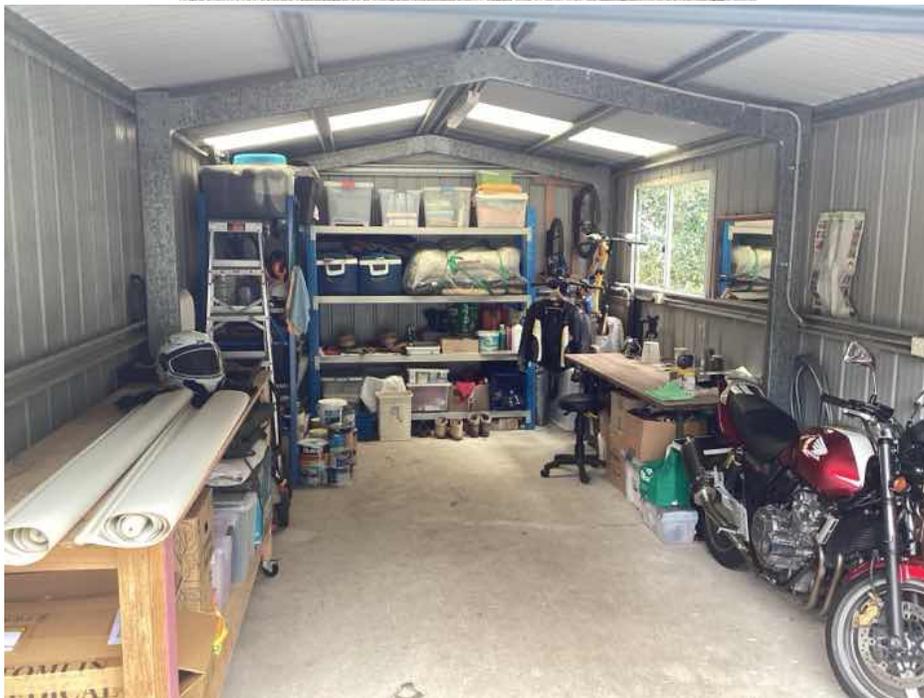
GARAGE

Stored items restricted a full and thorough inspection of this area. Defects may exist in the obstructed and inaccessible areas. It is strongly recommended that full access be granted to enable a thorough inspection as there may be timber pest activity, damage or defects. Note: Where vehicles and storage has restricted a full inspection it is advised that this area be cleared so a full and unobstructed inspection can be carried out.

On inspection, defects were present that will require further assessing and recommendations by qualified trades persons, please read below for details.

Minor hairline slab cracks - Note. Whilst these cracks appeared to be minor at the time of inspection, we strongly recommend you monitor these cracks and if worsening occurs contact a qualified concreter for further advice.

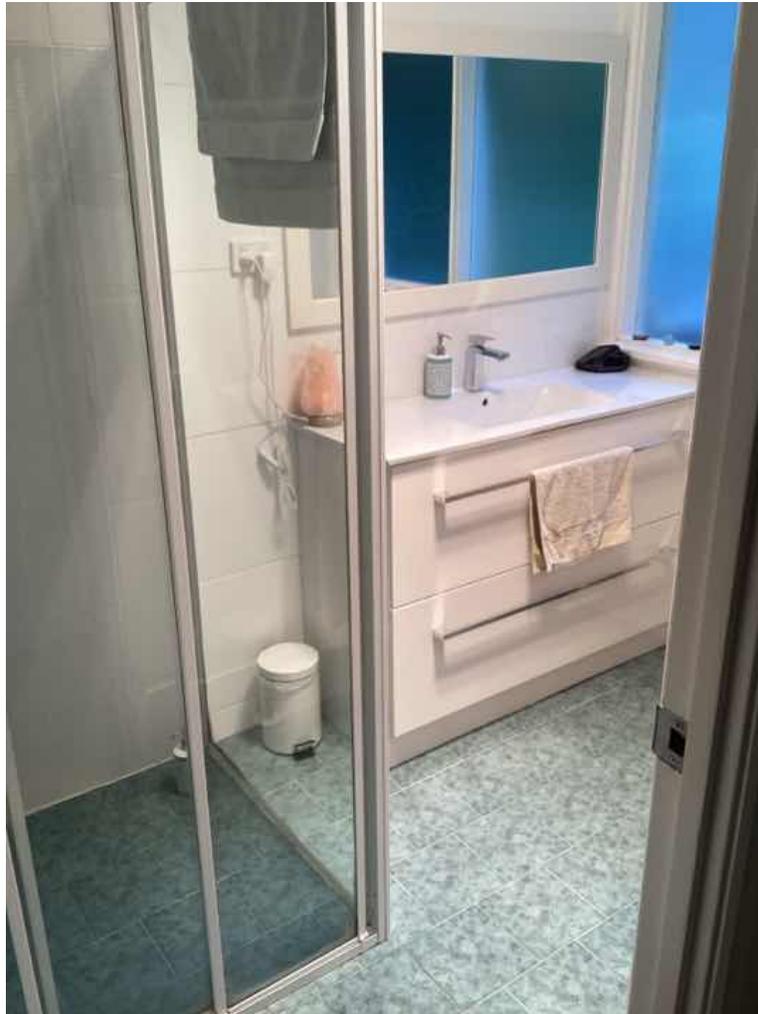
This bathroom is located in the hallway.

Cracked tile/s noted. This can cause extensive floor and floor frame damage and is conducive to termite infestation if water is leaking through the cavity. A qualified tiler should be engaged for advice and recommendations.

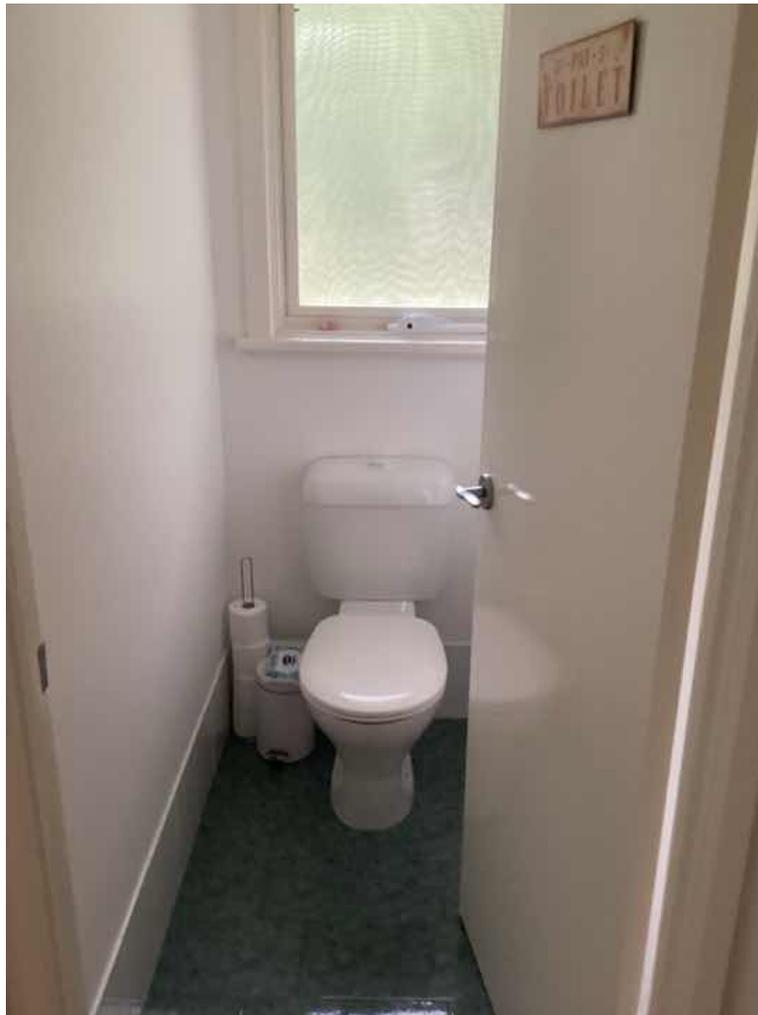
This bathroom is located in the hallway.

Of the visible areas, the general condition of this bathroom is serviceable or in reasonable condition for age of dwelling.

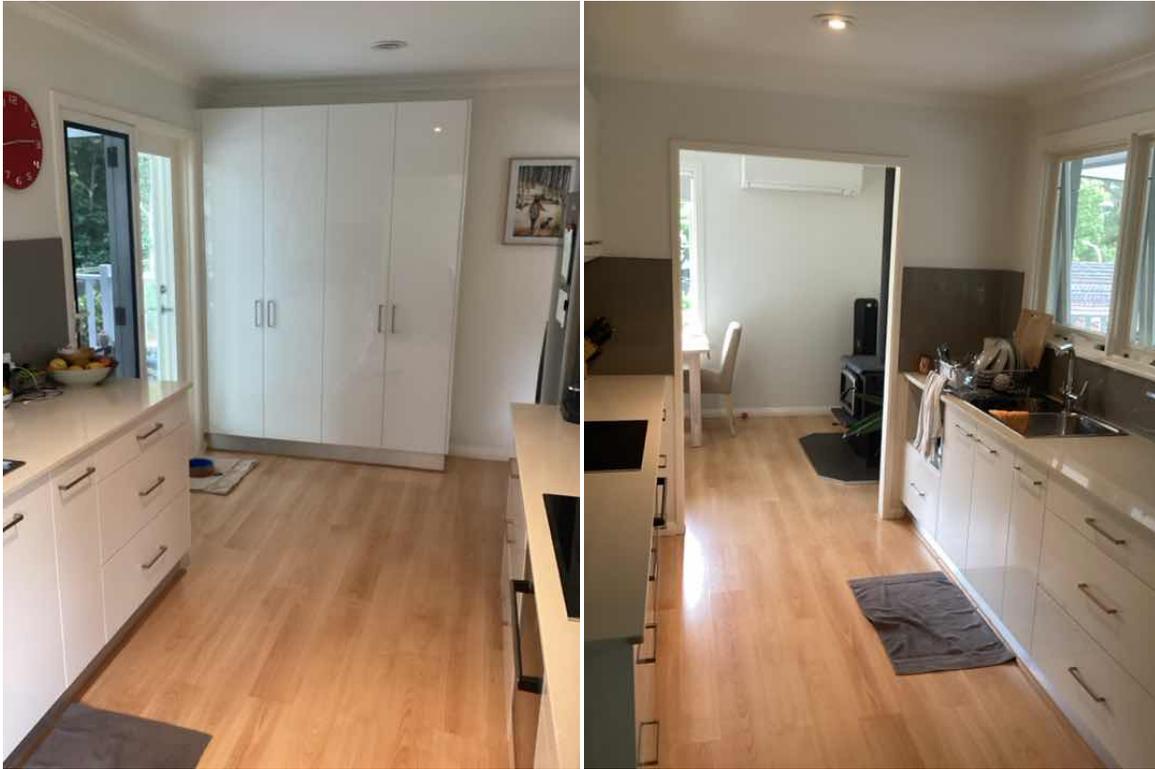
Of the visible areas, the general condition of the kitchen is serviceable or in reasonable condition for age of dwelling.

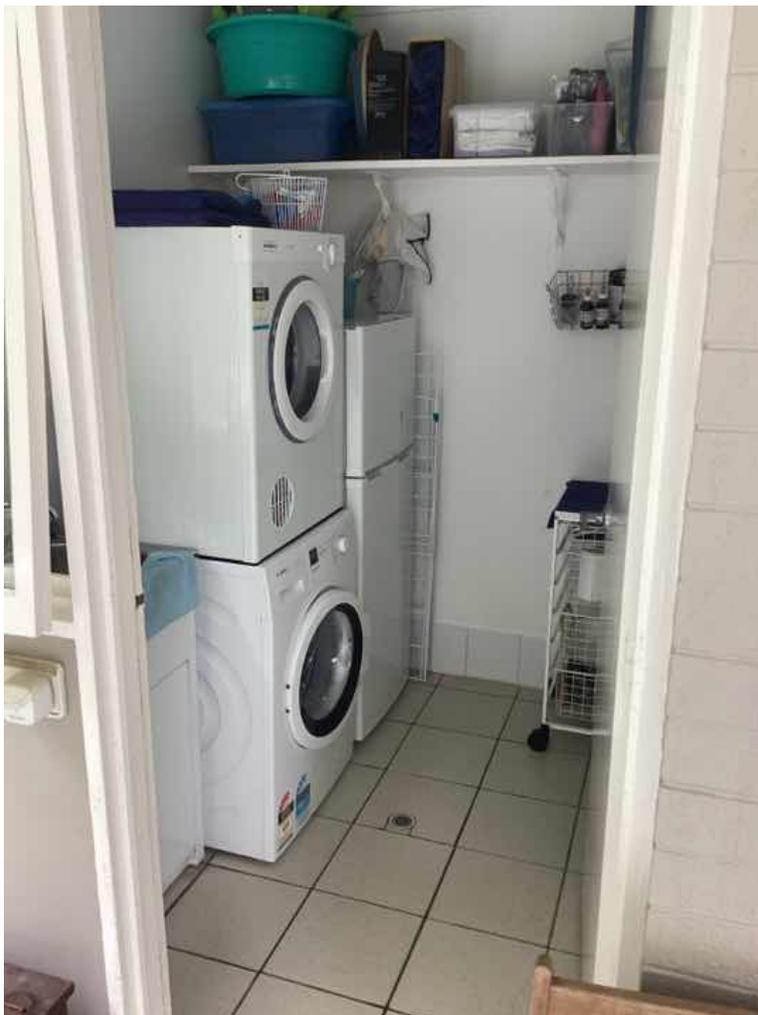
Of the visible areas, the general condition of the laundry is serviceable or in reasonable condition for age of dwelling.

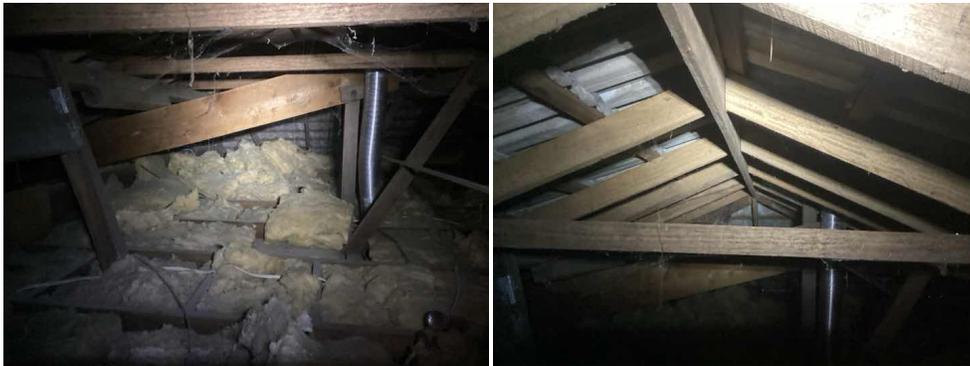
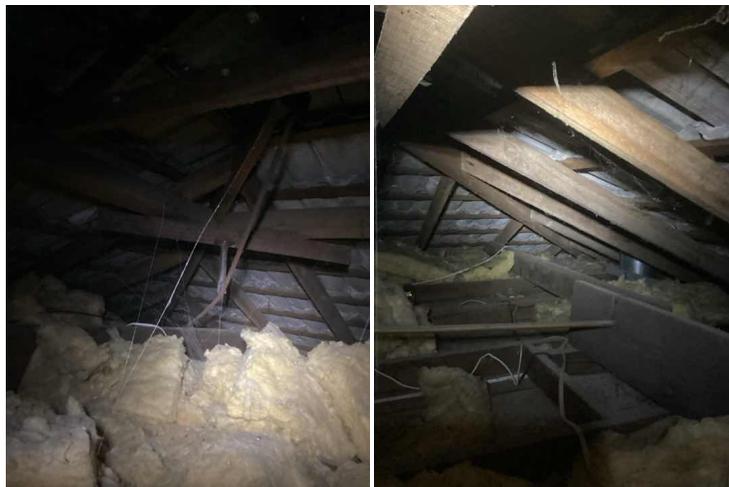
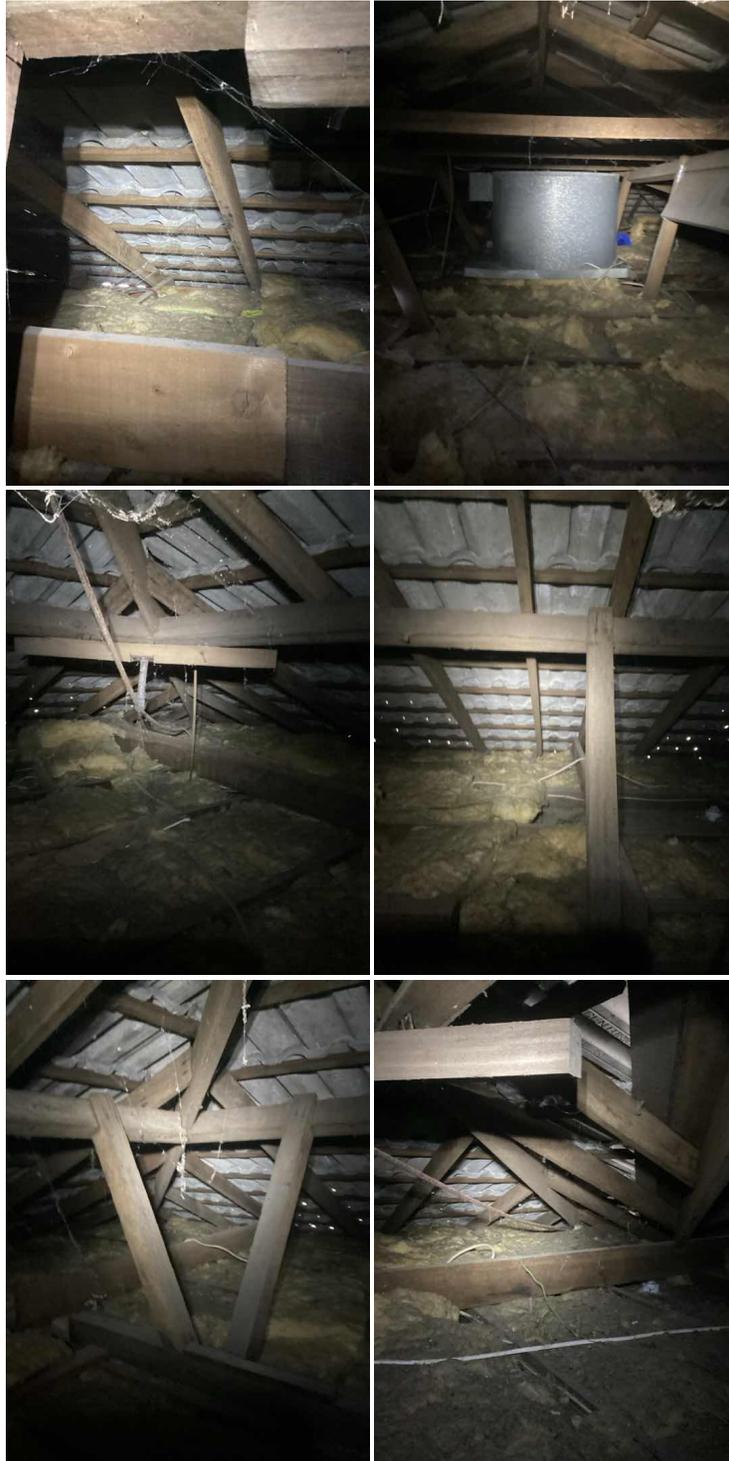
The roof frame is a conventional timber frame.

Visible sections of the roof void is in a serviceable condition for age of this dwelling.

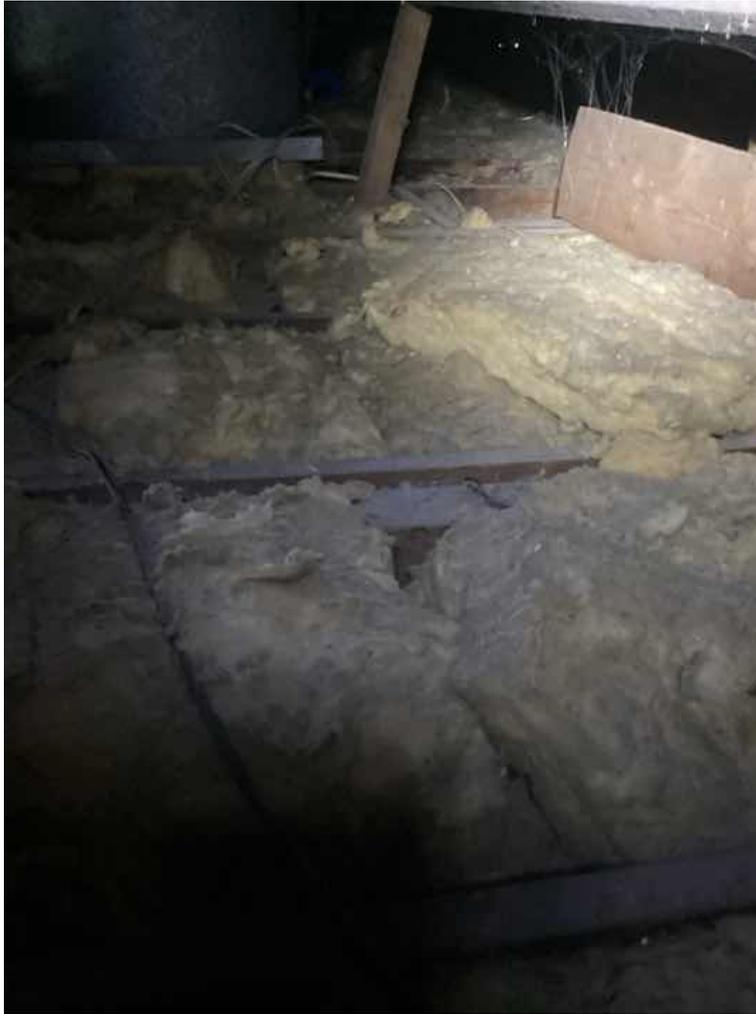
The roof space is insulated with fibreglass batts.

Where visible and accessible, the insulation appears to be in a serviceable condition.

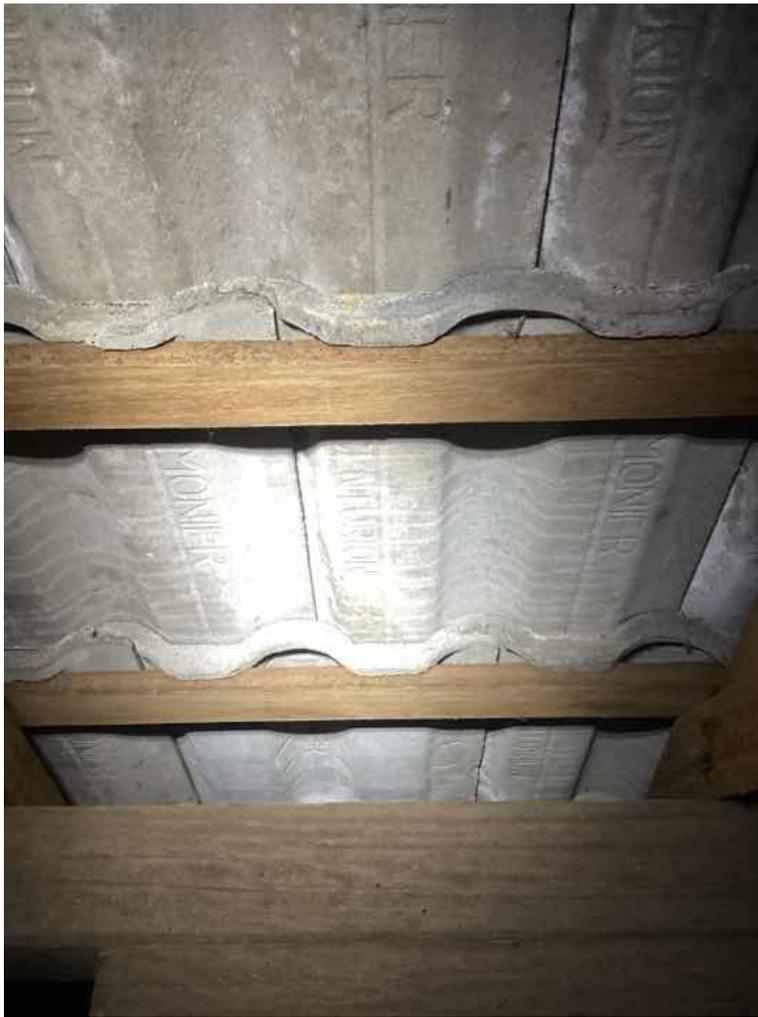
sarking is not installed.

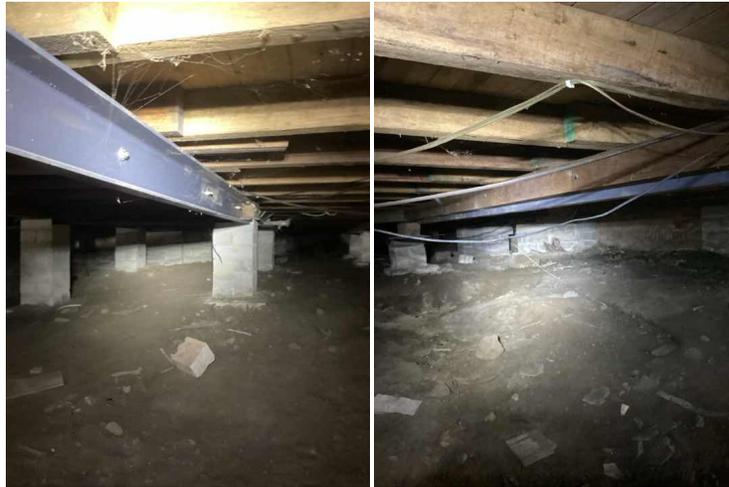
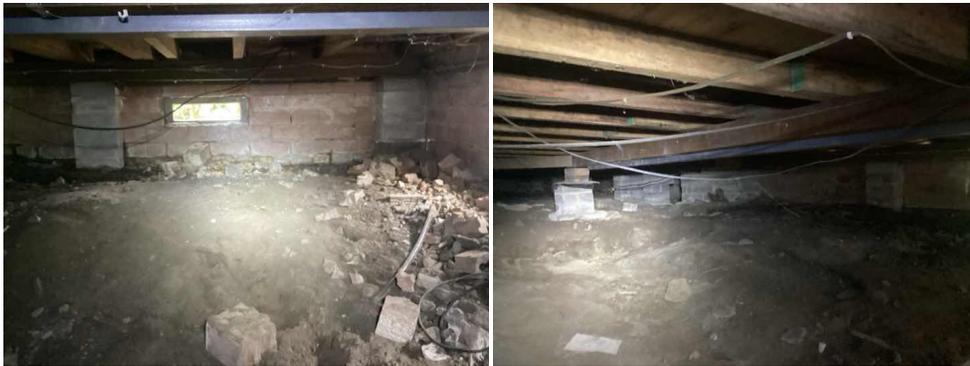
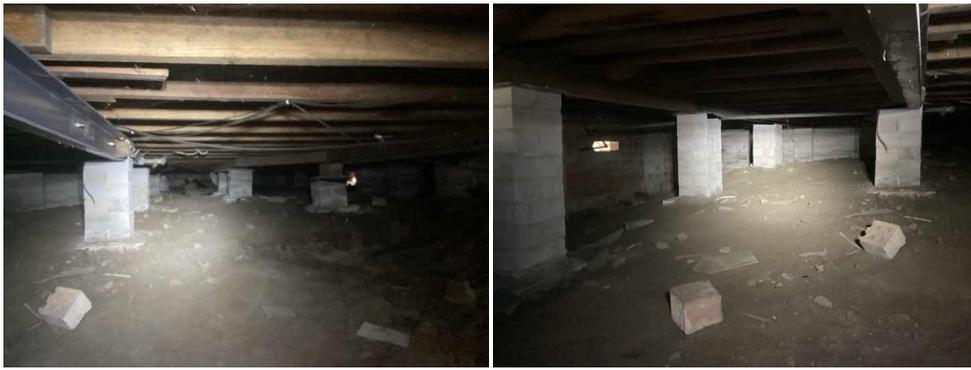
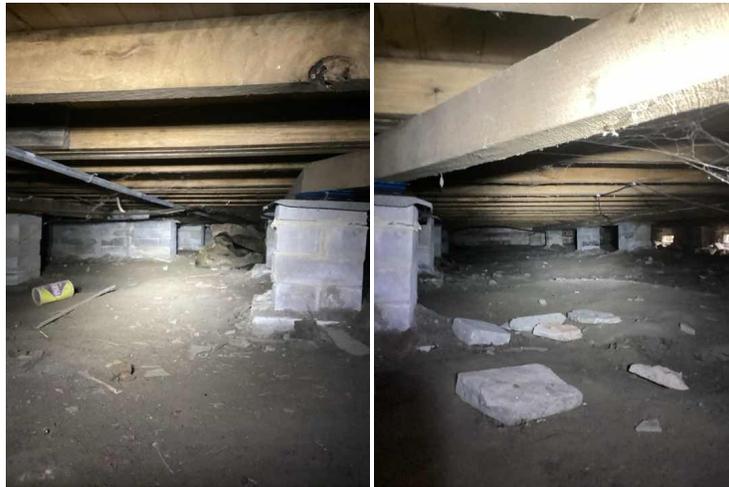
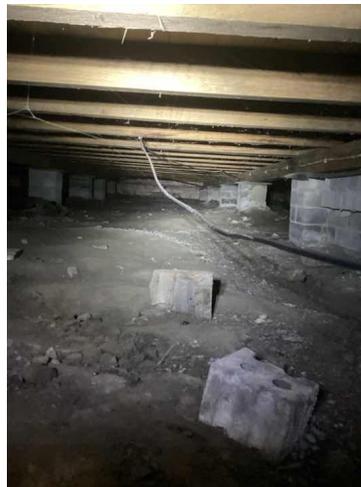
On inspection, defects were present that will require further assessing and recommendations by licensed and qualified trades persons, for example, a structural engineer, plumber, carpenter, electrician, plasterer may need to assess. Please read below for details.

Missing brick piers. Recommend bricklayer to assess and repair accordingly.
