# Inspection Report

## Thorough Check Building Inspections

**83 Wagstaffe Avenue, Wagstaffe, NSW, 2257**

### Pest And Building Inspection

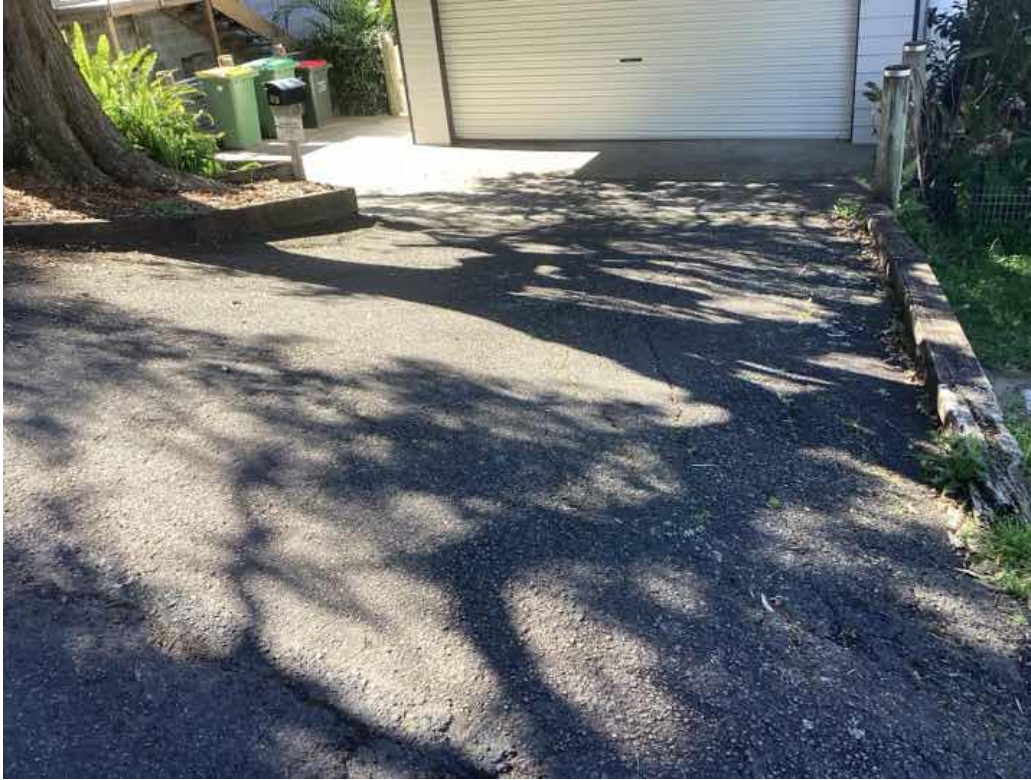
#### Driveway Condition

Common cracks were observed on the driveway. Whilst these cracks appeared to be typical at the time of inspection, we strongly recommend you monitor these cracks and if worsening occurs contact a concreter for further advice.

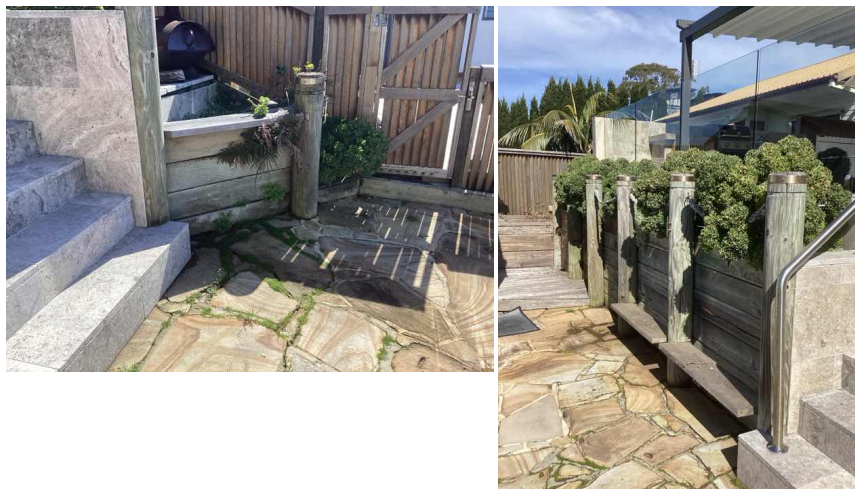
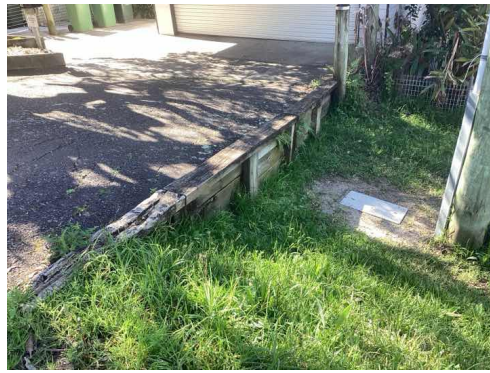
### Overall Condition

Timber fungal decay evident. Recommendations: A qualified landscaping contractor should be engaged for repairs and recommendations.

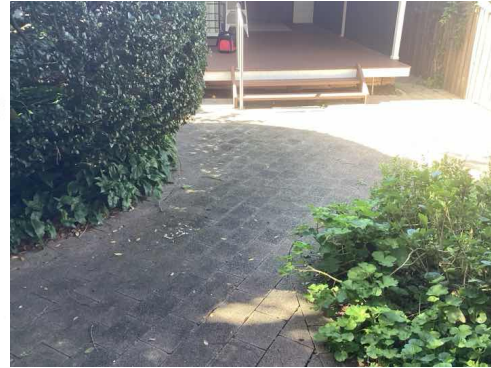
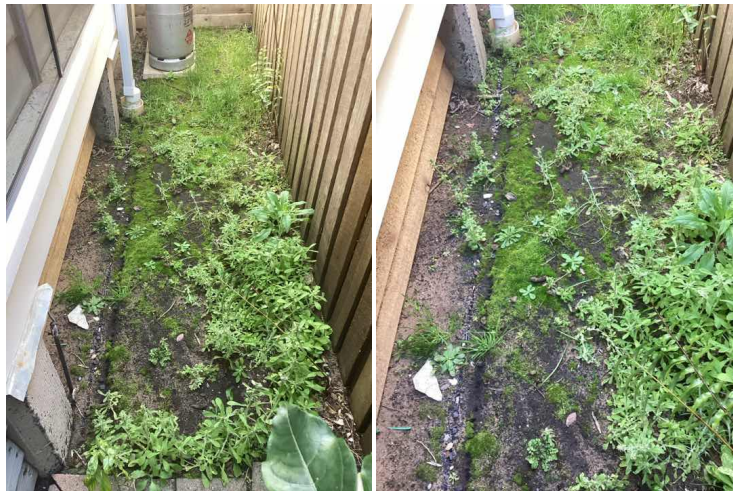
### Drains

Recommend installing a drainage point under the tap to assist with drainage.

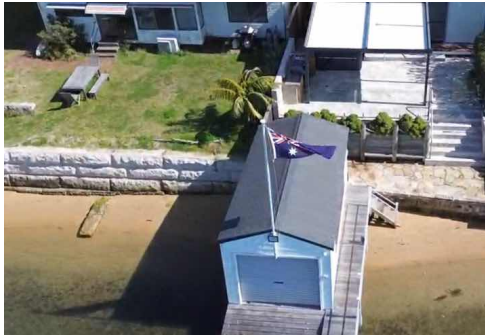
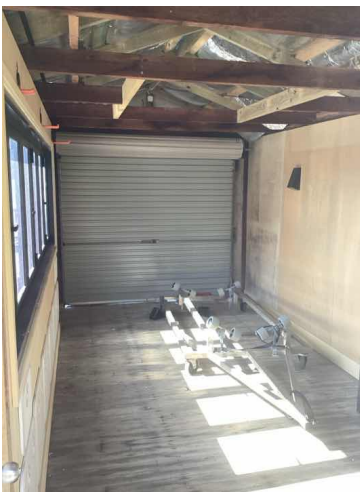
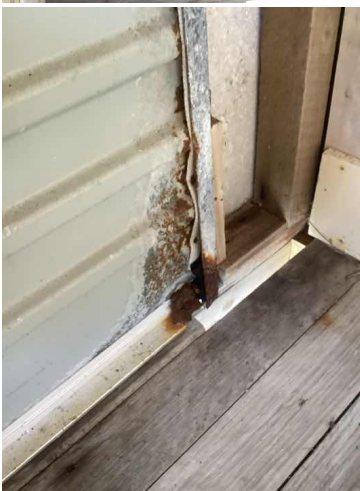
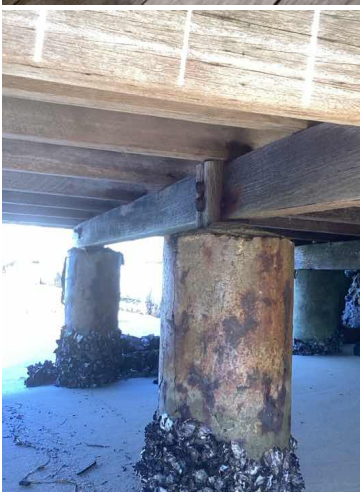
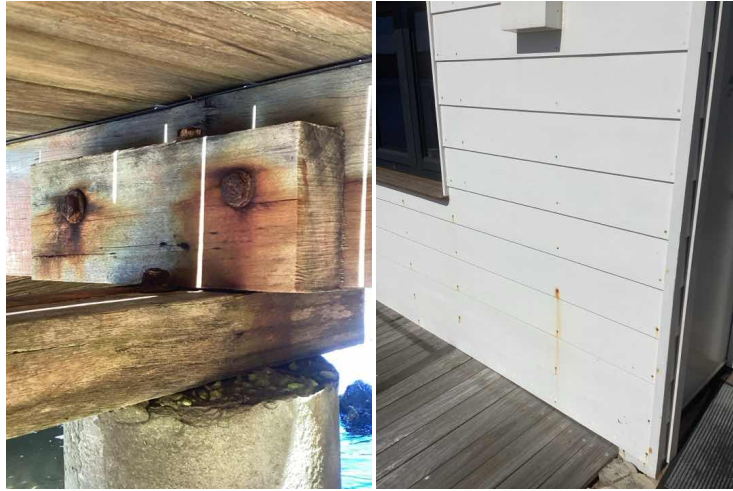
### **Shed Condition**

Rust developing on roller door. Repairs to restrict rust required.

Corrosion to subfloor bolts. Recommend carpenter to assess and repair accordingly.

Corrosion to boat shed cladding fixings. Recommend carpenter to assess and repair accordingly.

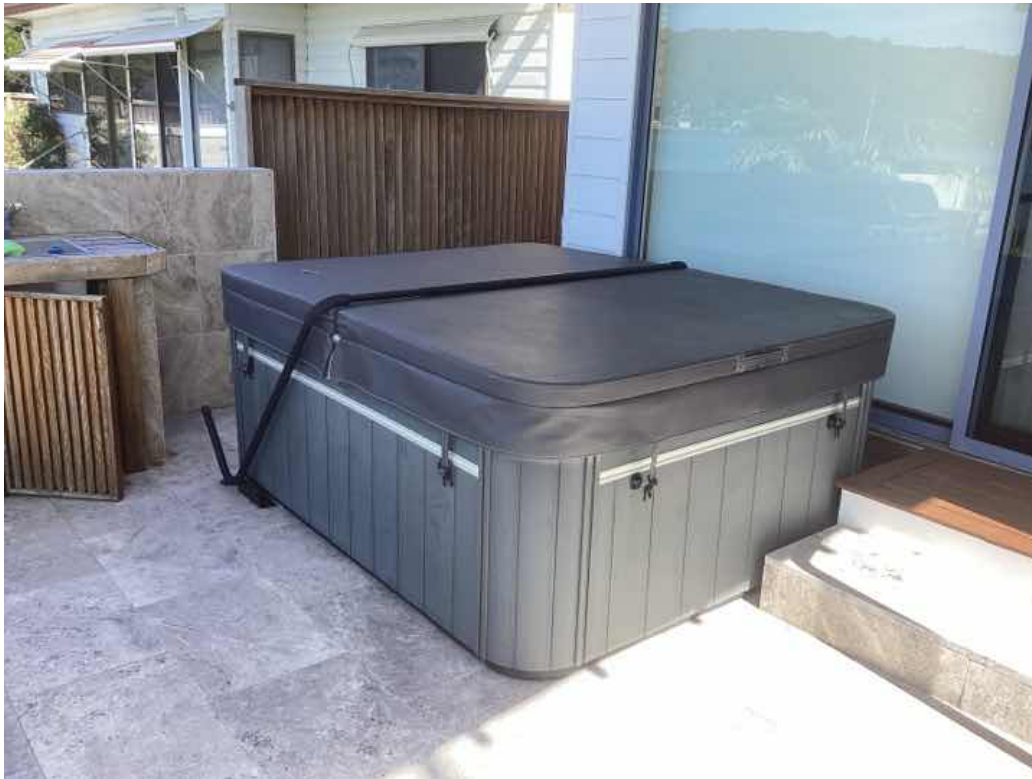
### **Spa Barrier**

The appropriate warning signs do not appear to be present. You should check with your local council regarding the required signs.

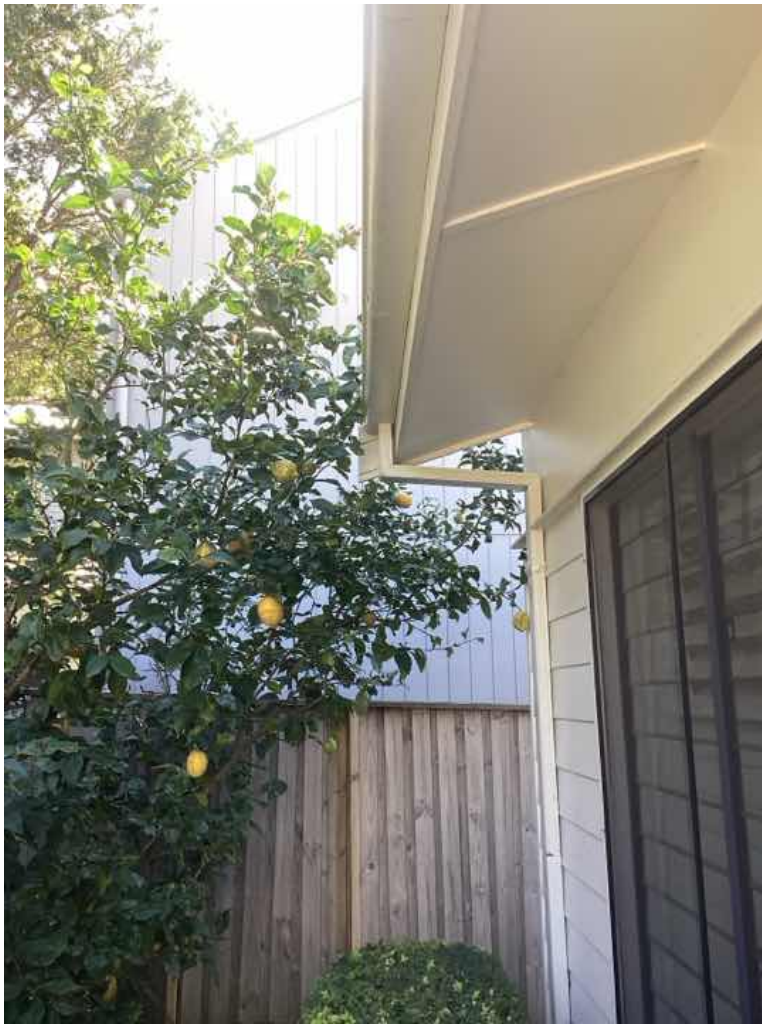
### **Tree Findings**

Trees are overhanging roof areas. These should be cut back away from the roof line and gutters.

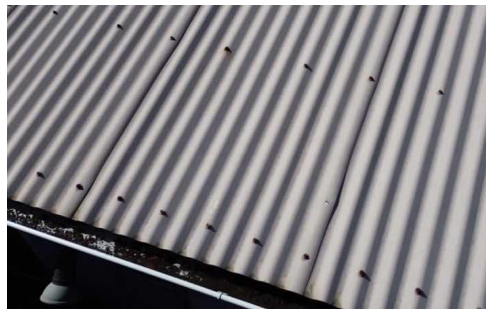
## Roof Clad Condition

Corrosion noted to the screw fixings of the metal roof. Have these checked and replaced by qualified roofing contractor.

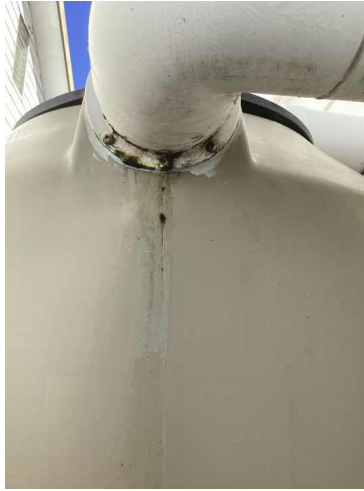
### **Water Tank Condition**

Leaking section. Recommendations: Assessment conducted by a licensed plumber advised.

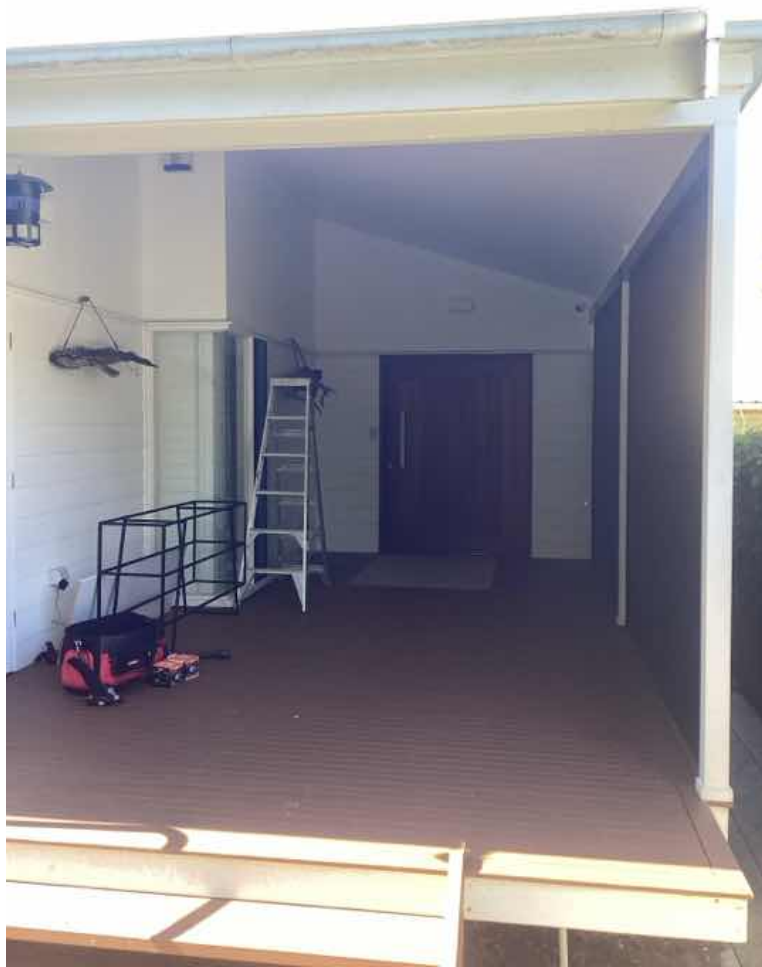
### **Ceiling Lining Condition**

Ceiling lining join cracks. Contact a licensed plasterer fo repairs.

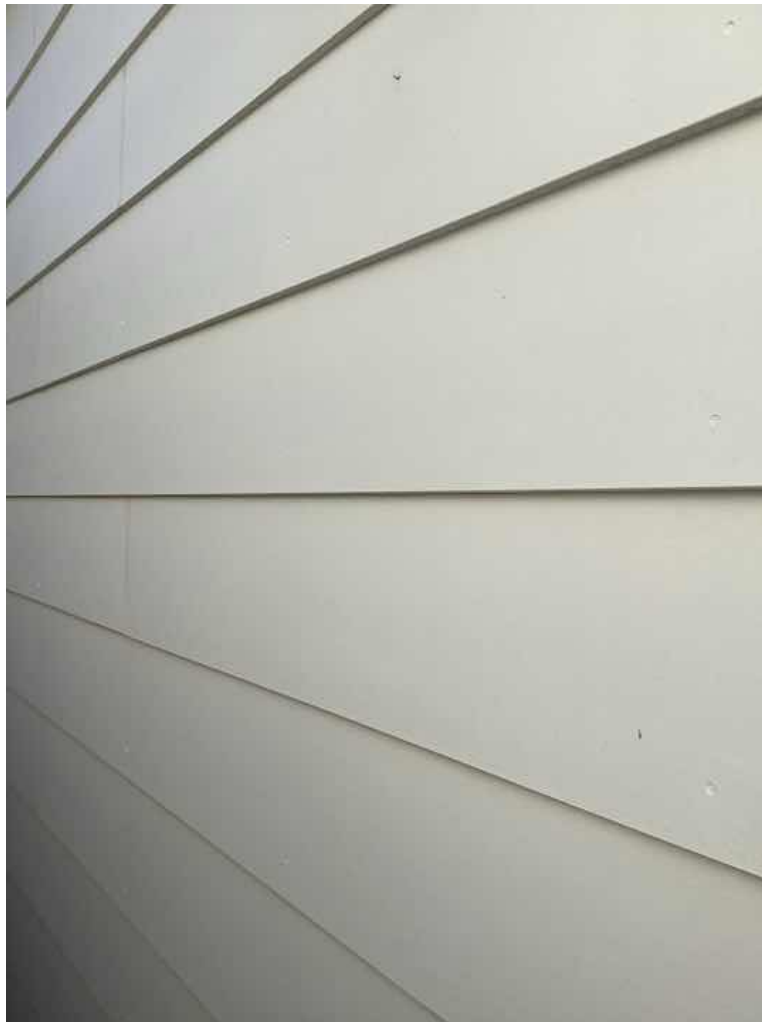
**Condition**

Penetration openings observed. I recommend sealing these off so as to avoid vermin and other pest infestation.

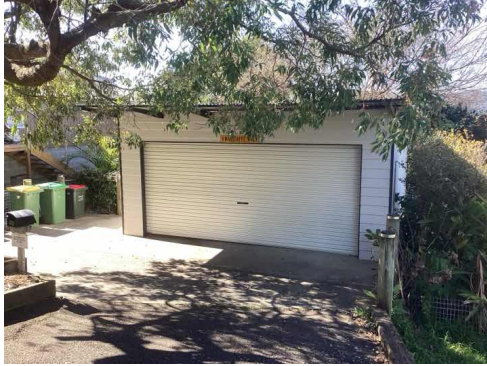
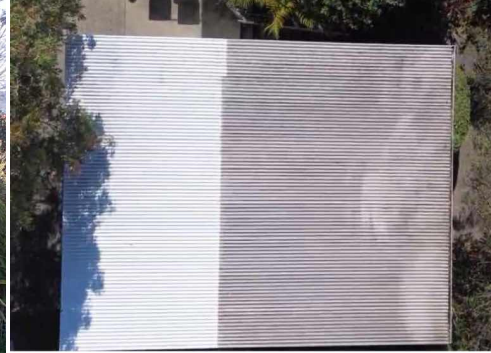
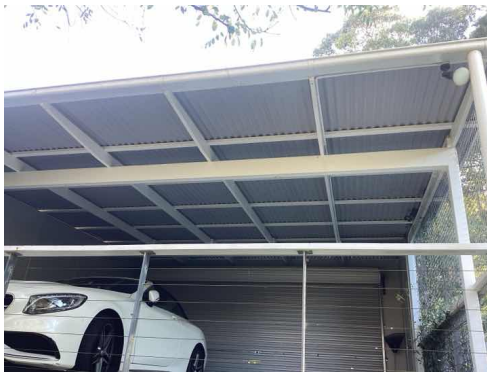
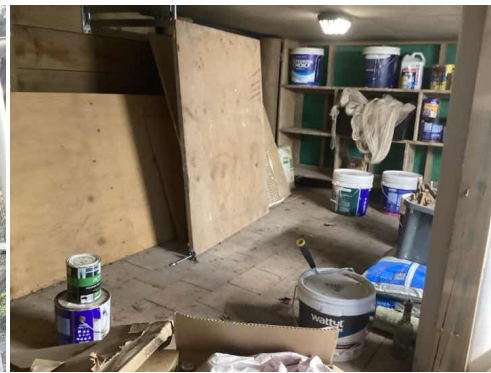
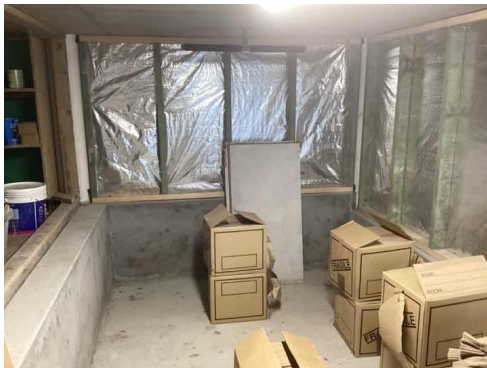
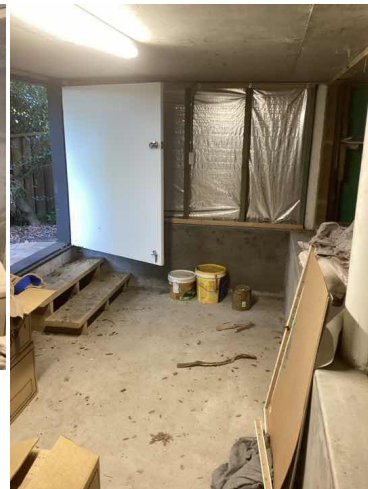
Defects exist to this area or component/s requiring assessment by a specialised field. Please read below for details.

Corrosion noted to the screw fixings of the metal roof. Have these checked and replaced by qualified roofing contractor.

Debris in guttering areas- this requires cleaning out to prevent blocking of downpipes and leaking into eaves and fascia. Have gutters cleaned and assessed by a plumber for adequate fall. Regularly clean to prevent ponding. Ponding water will contribute to rust.

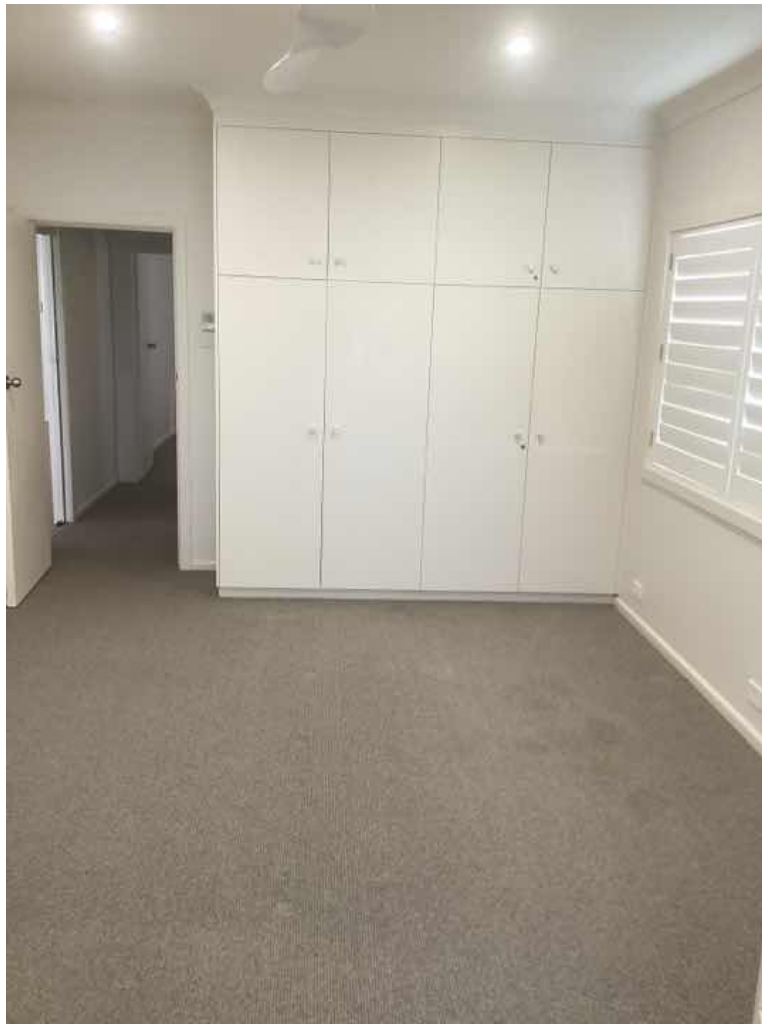
On inspection, defects were present that will require further assessing and recommendations by a qualified trades persons, please read below for details.

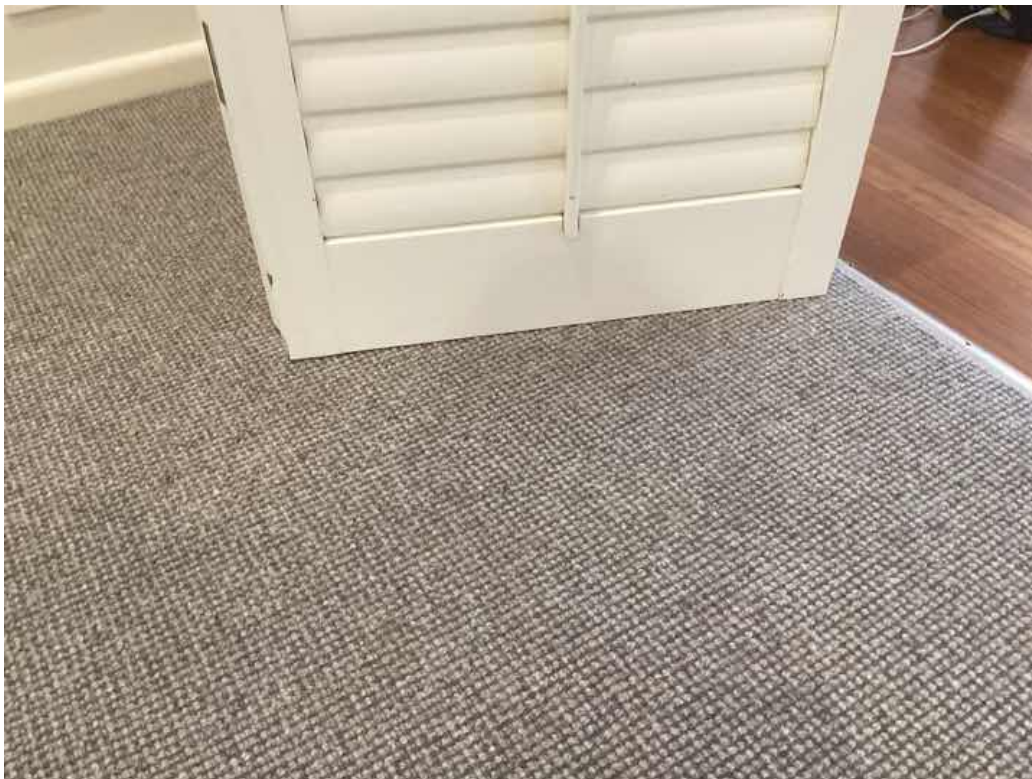
**Door**

Uneven / out of square door causing binding. A qualified carpenter should be engaged to refit.

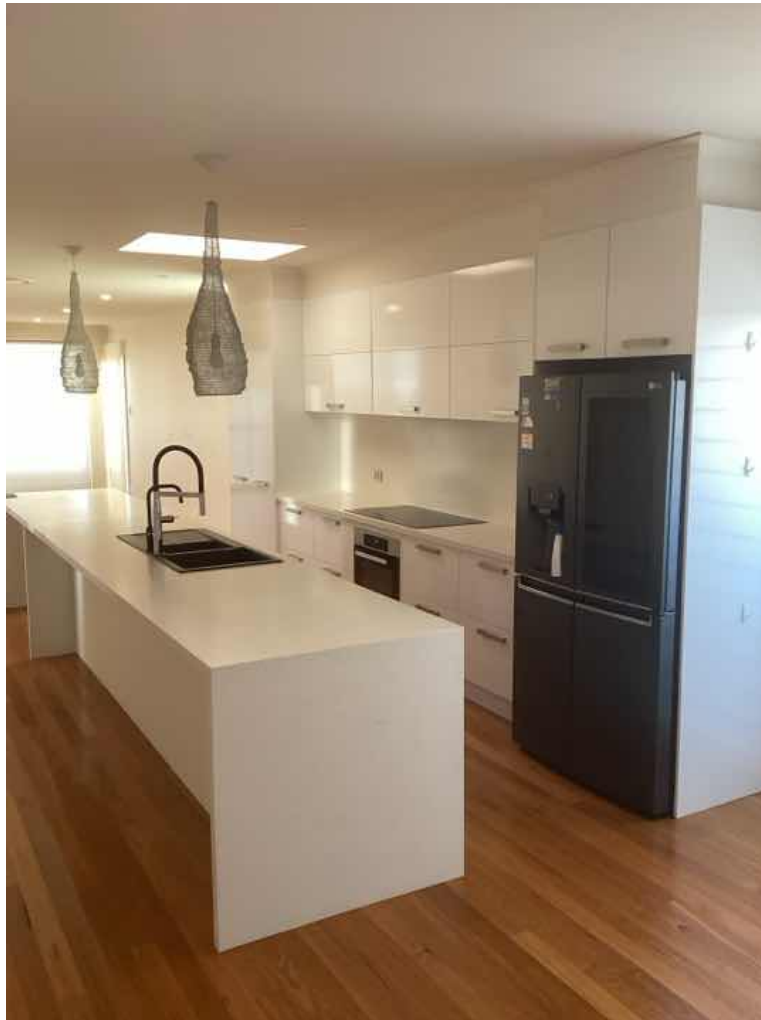
On inspection, defects were present that will require further assessing and recommendations by licensed and qualified trades persons, please read below for details.

Settlement Cracks Noted. These are typical and generally patch and paint will suffice, however monitoring these cracks advised for 12 months and if they become wider or longer, you will need to contact a structural engineer to assess.

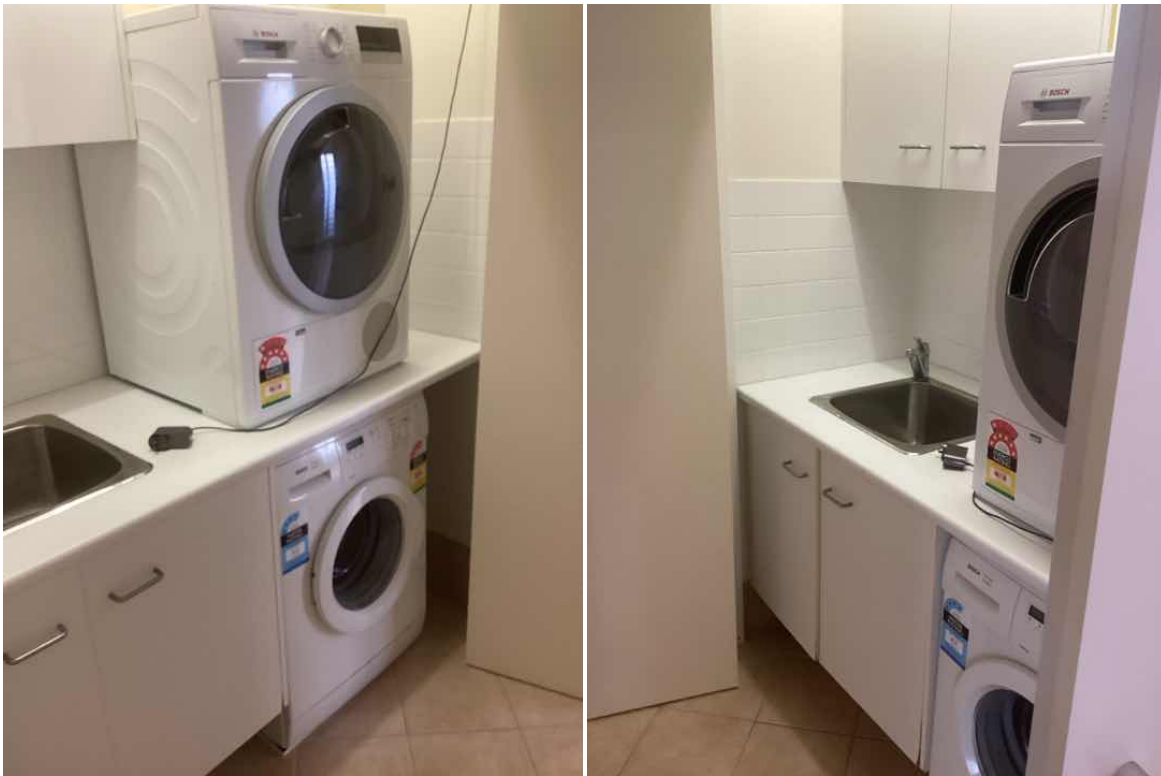
On inspection, defects were present that will require further assessing and recommendations by licensed and qualified trades persons, please read below for details.

The tap / tap head is loose. Might be as simple as tightening or a replacement maybe required. A qualified plumber should be engaged for assessment and recommendations.

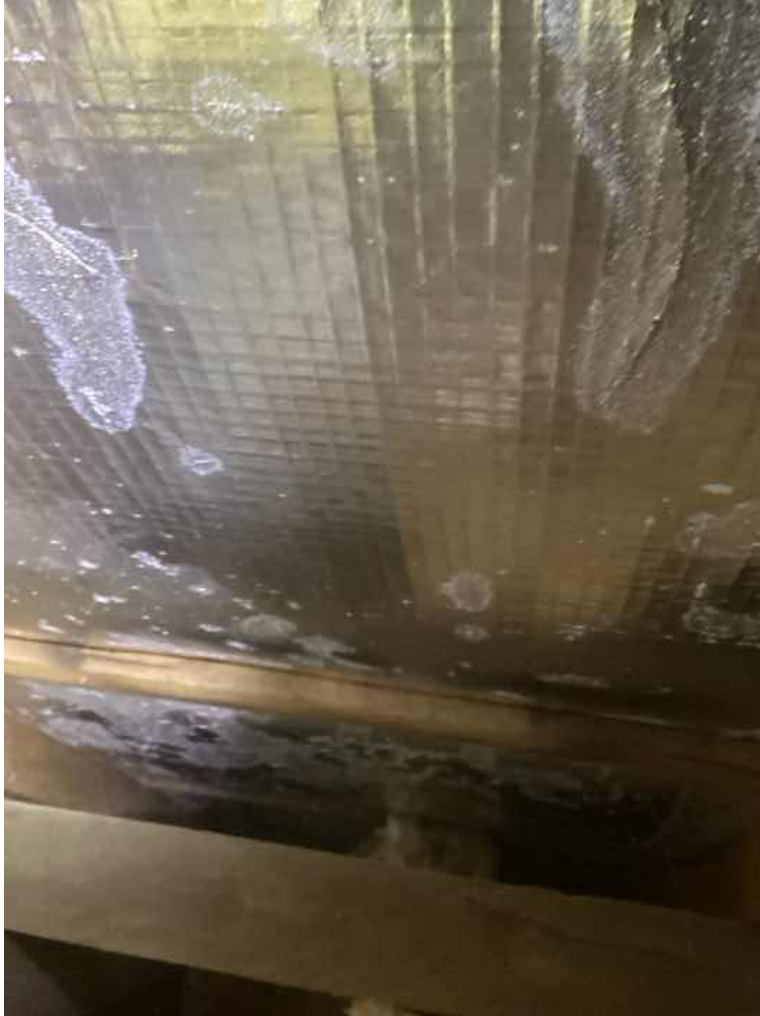
Sarking deteriorated/ damaged / aged in some sections. A qualified roofing contractor should be engaged for advice and recommendations.
