# Inspection Report

## Coastal Building Inspections

**534 the entrance road , erina heights, NSW, 2260**

### Pest And Building Inspection

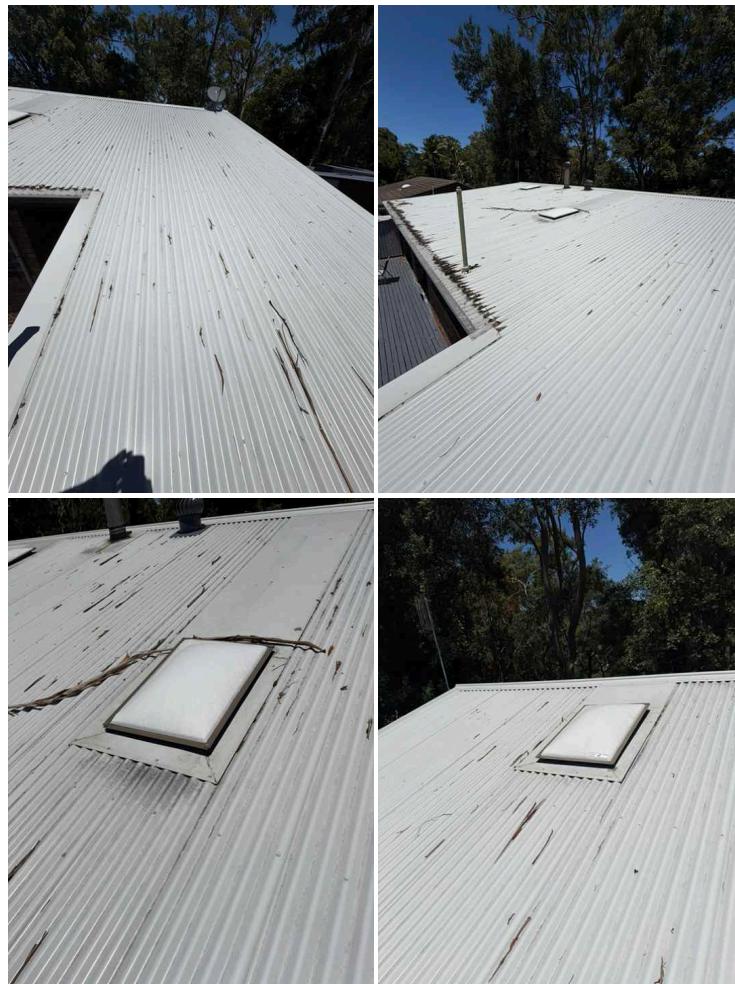
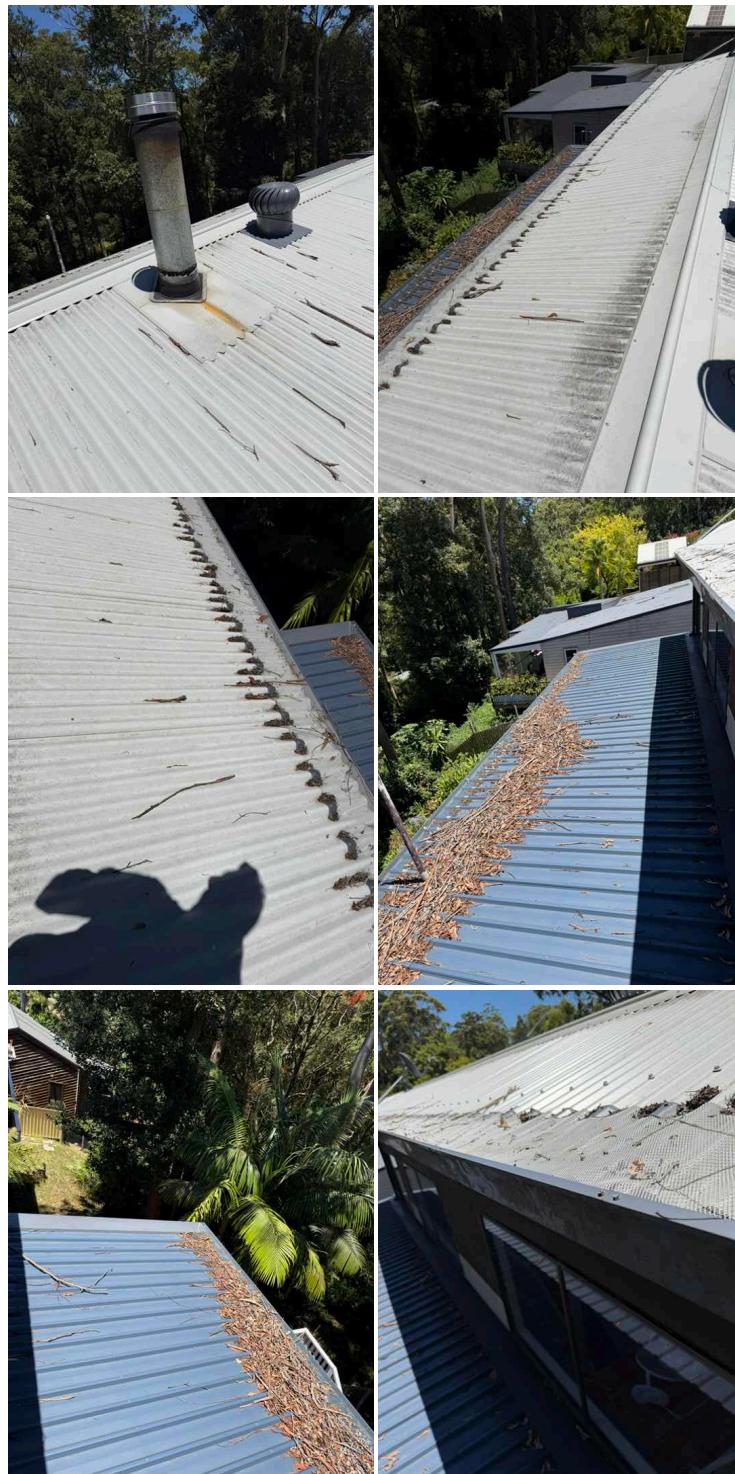
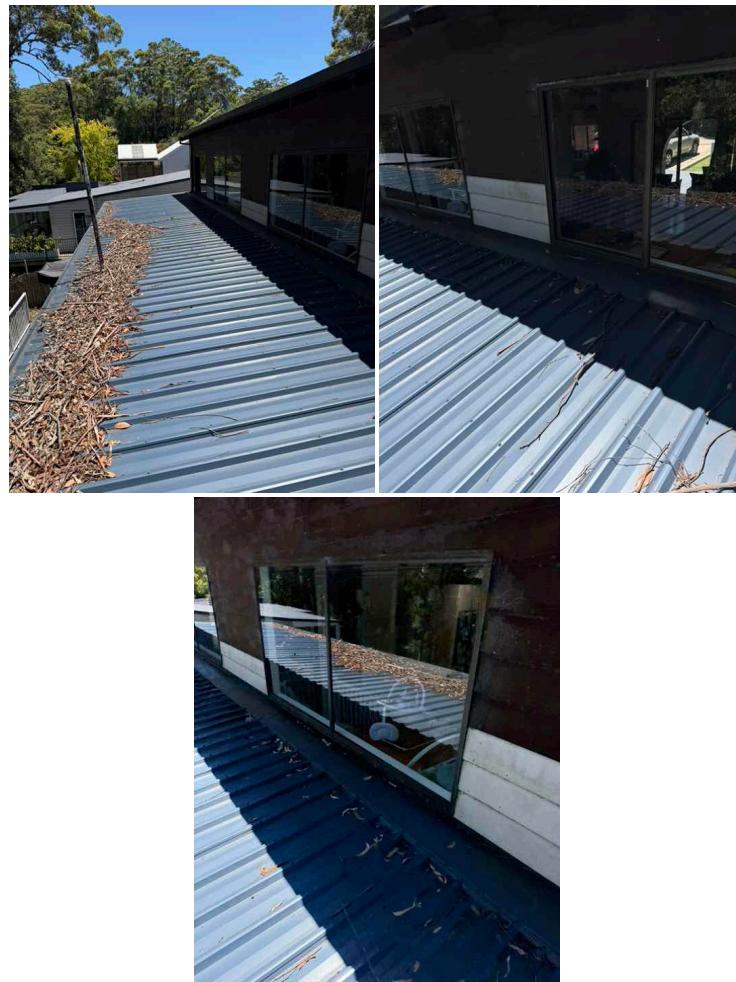
Visible section of The roof cladding appeared in a serviceable condition for the age of this dwelling. Annual maintenance inspection recommended.

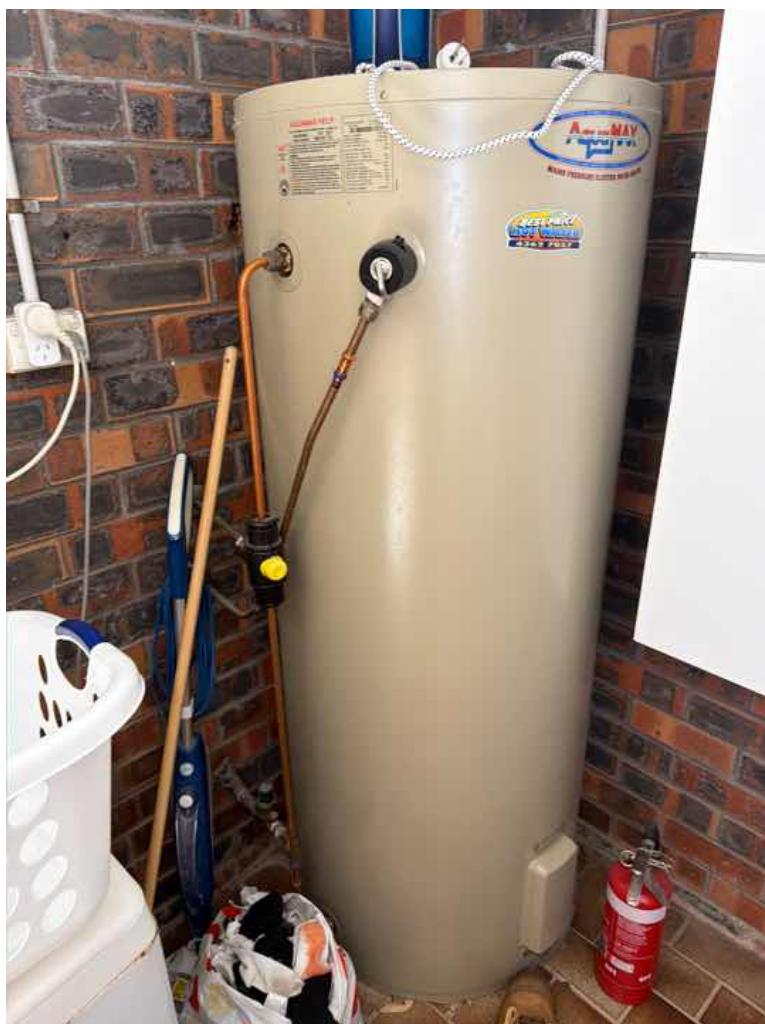
The hot water system appears to be in a serviceable condition. No specific tests other than running the hot water from a tap was carried out. No determination has been made as to the suitability or adequacy of the hot water system in relation to capacity or otherwise.

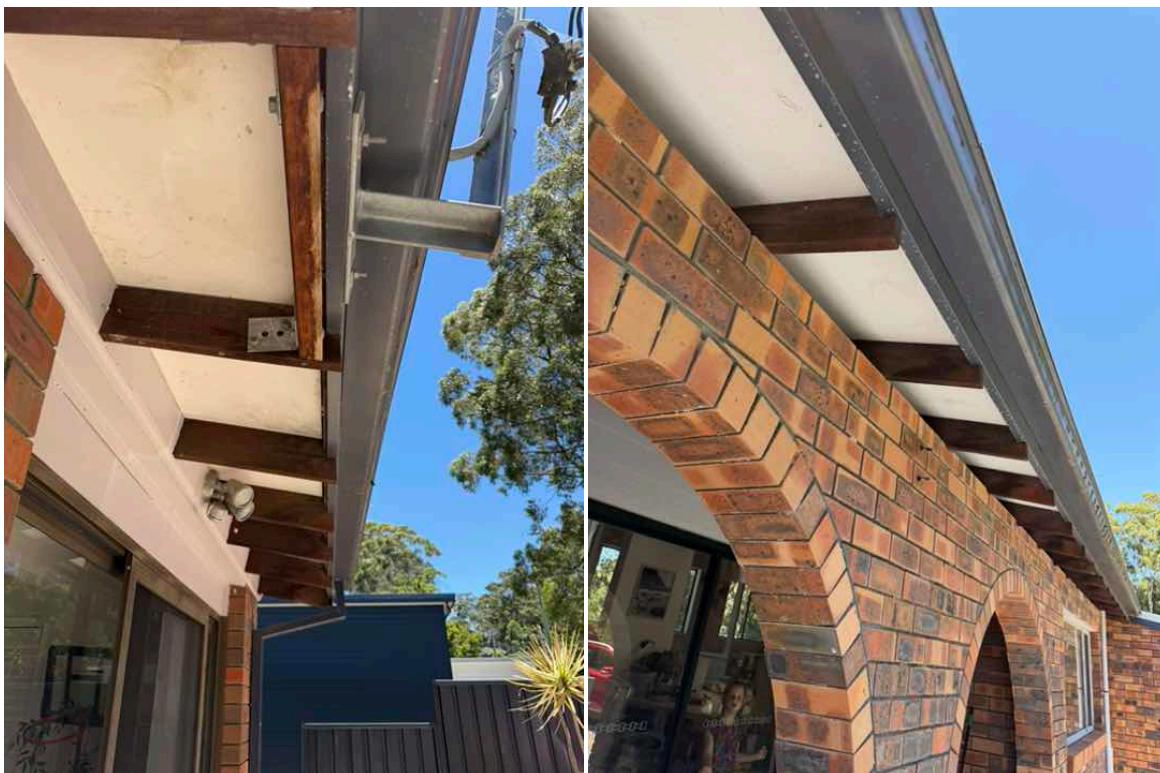
The soffit lining (eaves) are in a serviceable condition with no notable defects.

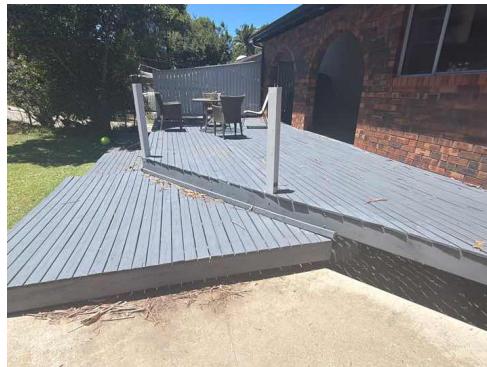
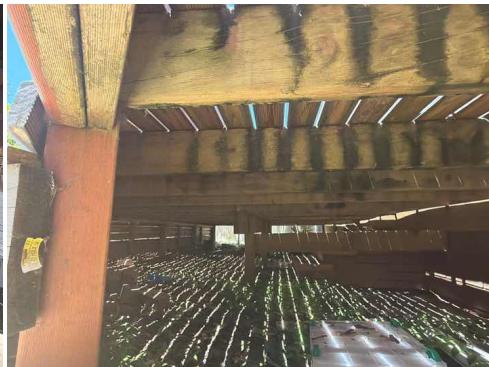
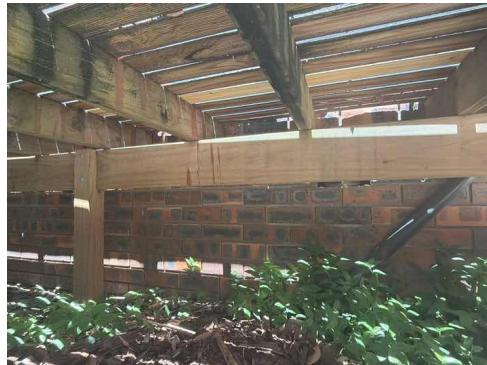
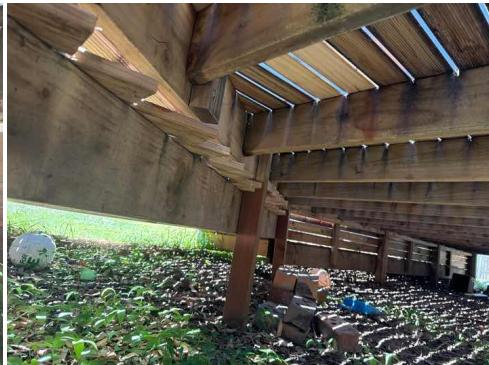
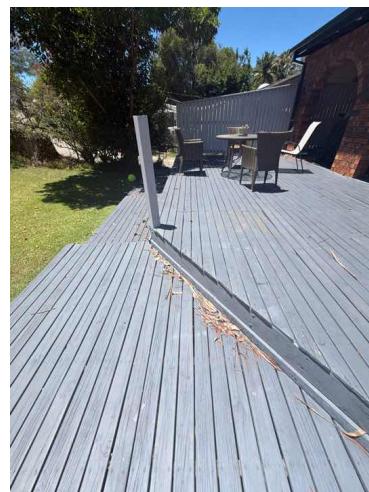
#2. Decking board surfaces are weathered - Recommendations: We recommend cleaning and maintenance as needed.

decking timbers are found to be loose, posing a safety risk. A suitably licensed carpenter or decking specialist should be engaged to secure the loose boards with appropriate screws or fasteners, ensuring all decking is stable.

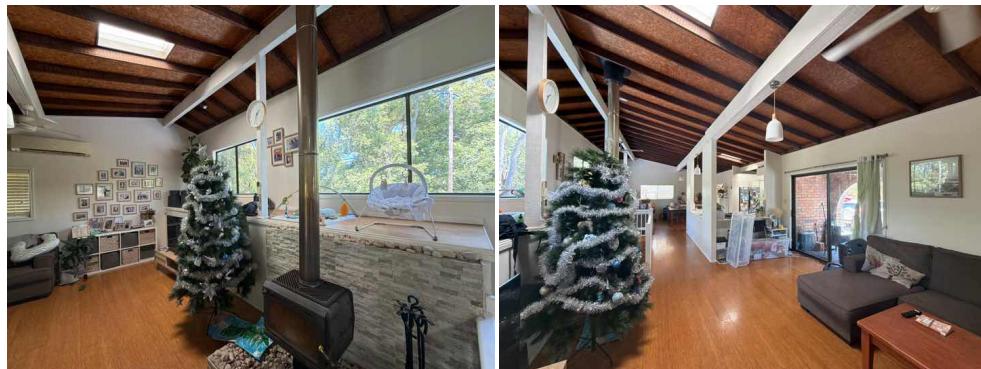
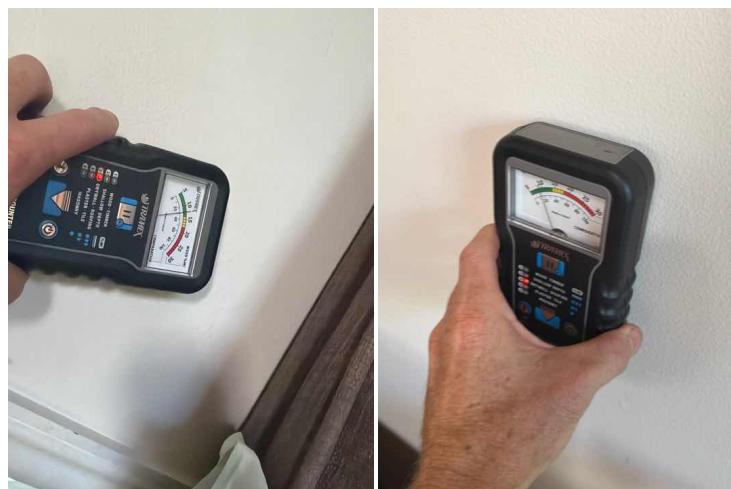
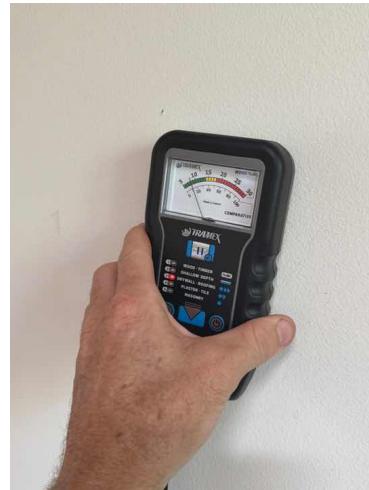
From the visible and accessible areas, the lounge room appears to be in a serviceable condition for the age of the property with no notable structural defects sighted.

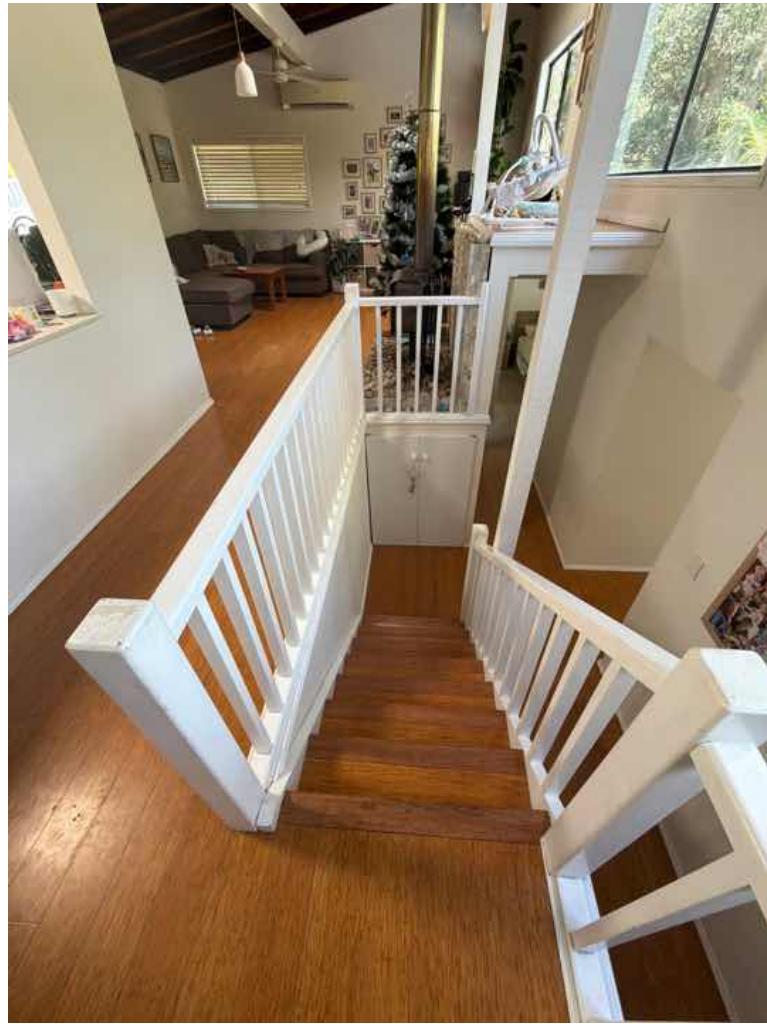
The internal stair case is in a serviceable condition for the age with no notable defects sighted.

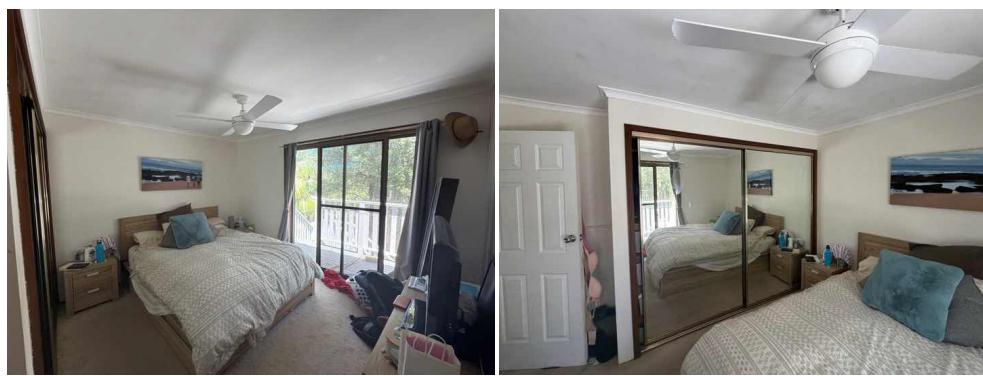
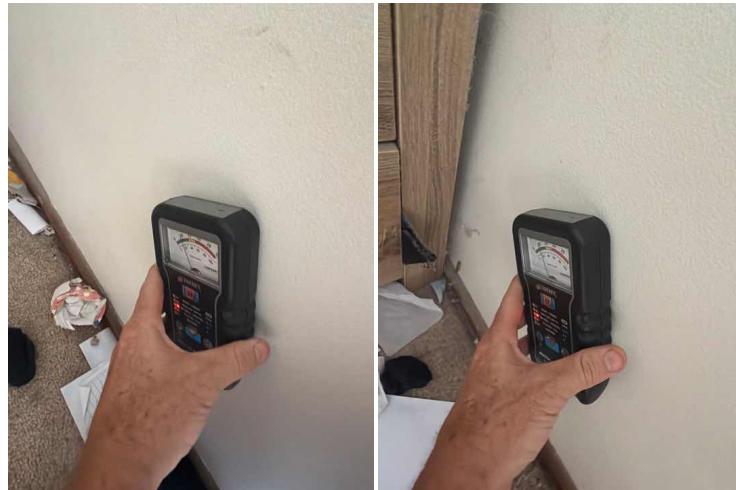
This bedroom is in serviceable condition for the age with no notable structural defects sighted.

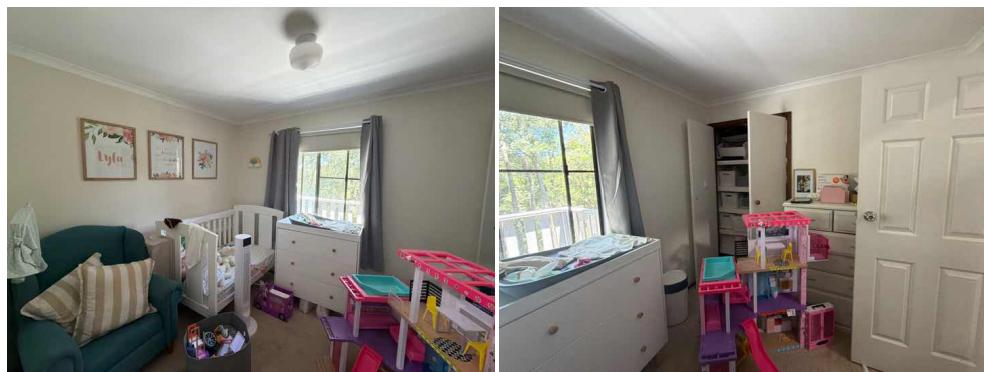
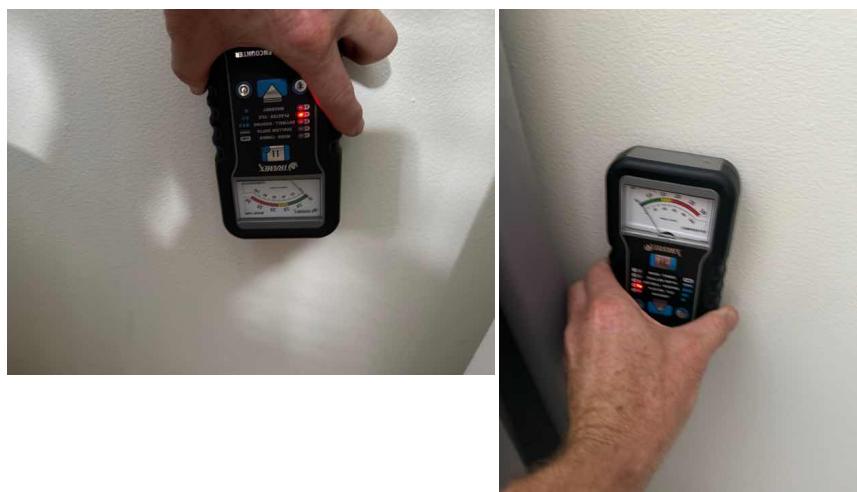
This bedroom is in serviceable condition for the age with no notable structural defects sighted.

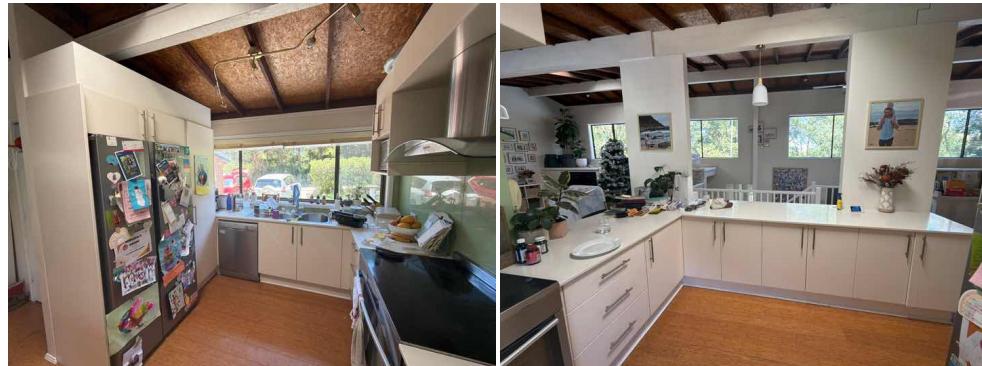
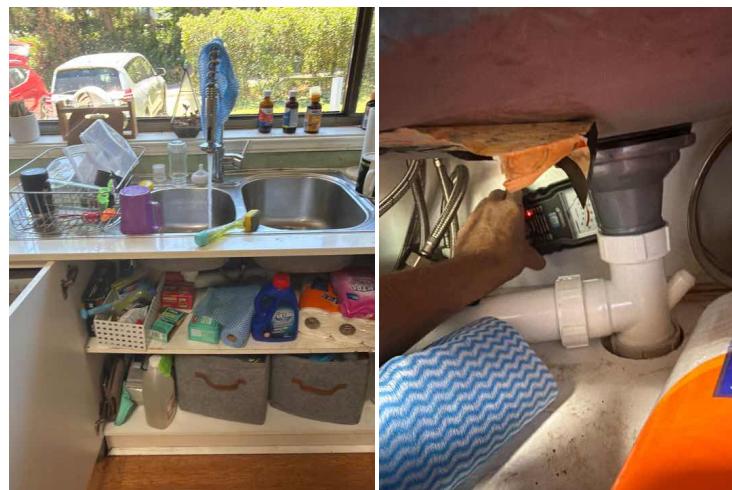
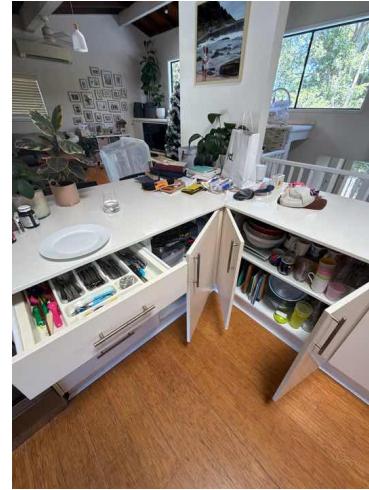
Of the visible areas, the general condition of the kitchen is serviceable or in reasonable condition for age of dwelling.

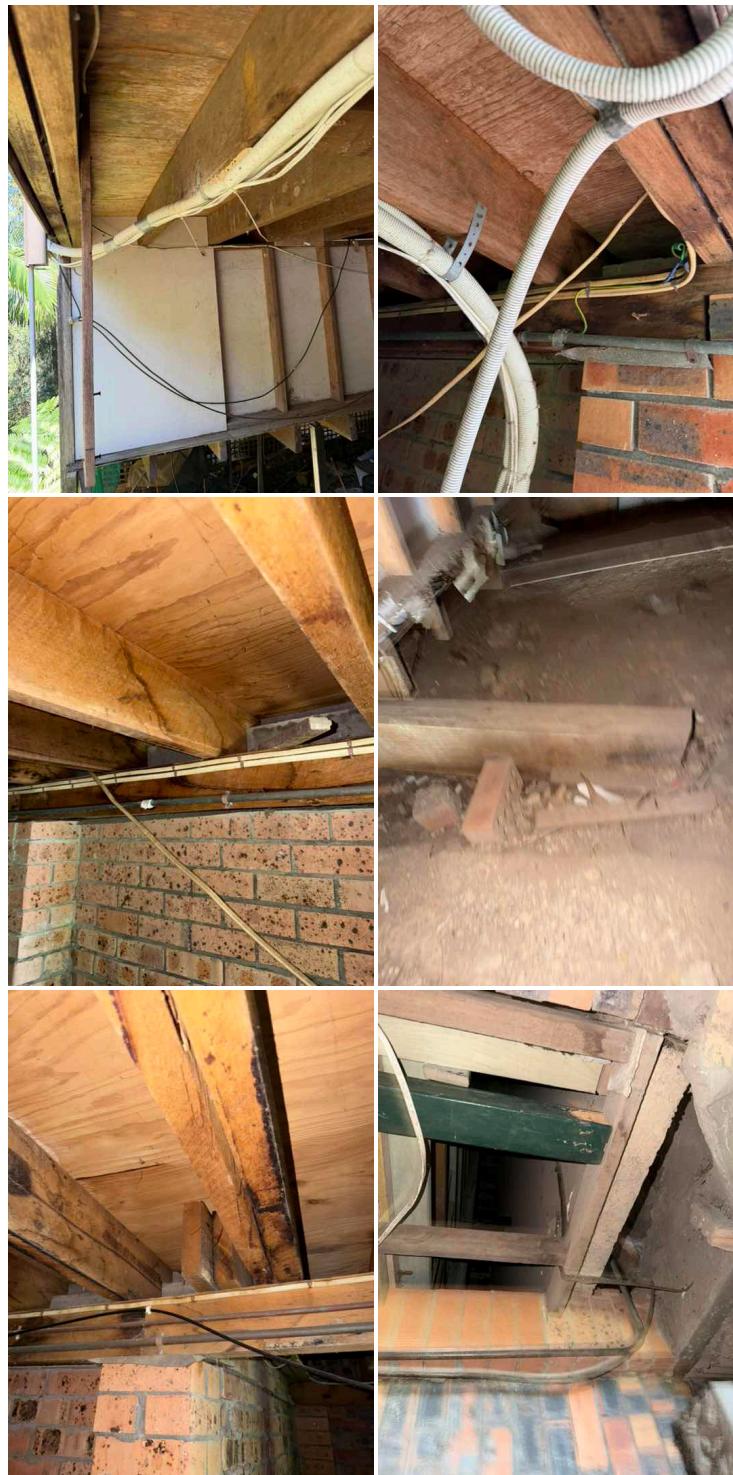
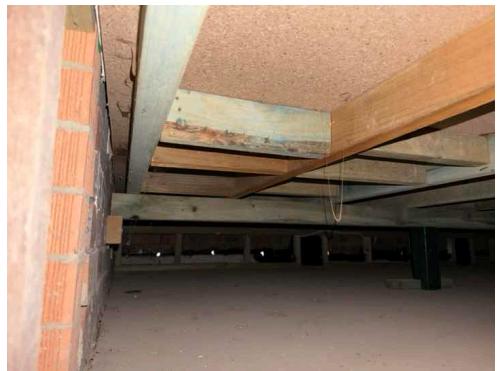
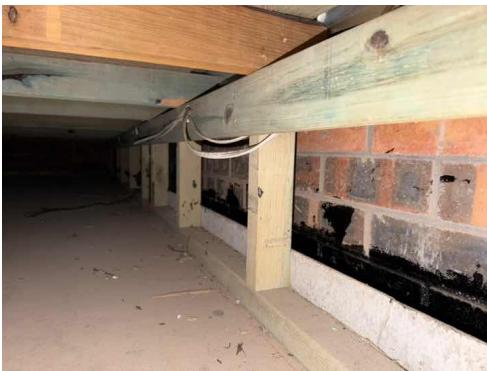
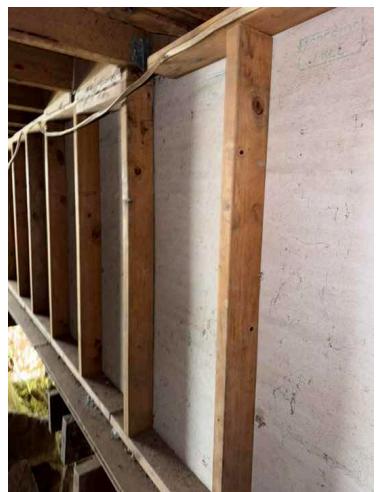
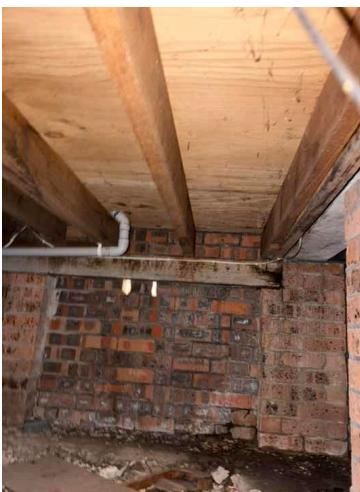
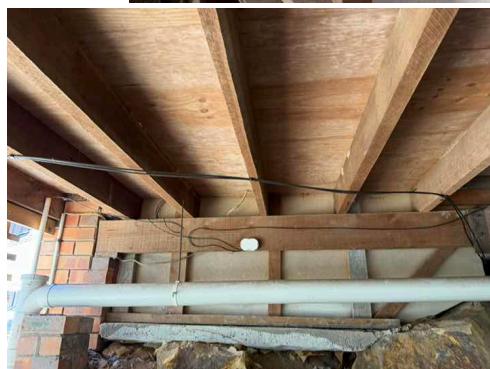
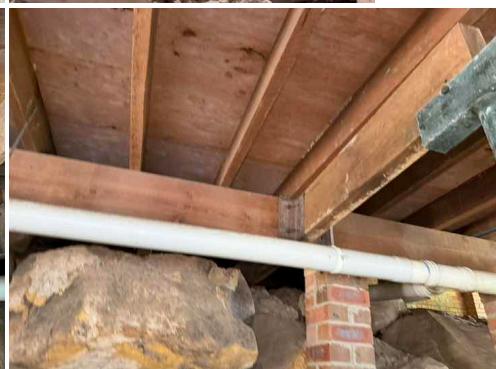
Of areas accessible and visible, the subfloor and components appeared to be in a serviceable condition.
