# Inspection Report

## Thorough Check Building Inspections

**7 Eucalyptus Place, Green Point, NSW, 2251**

### Pest And Building Inspection

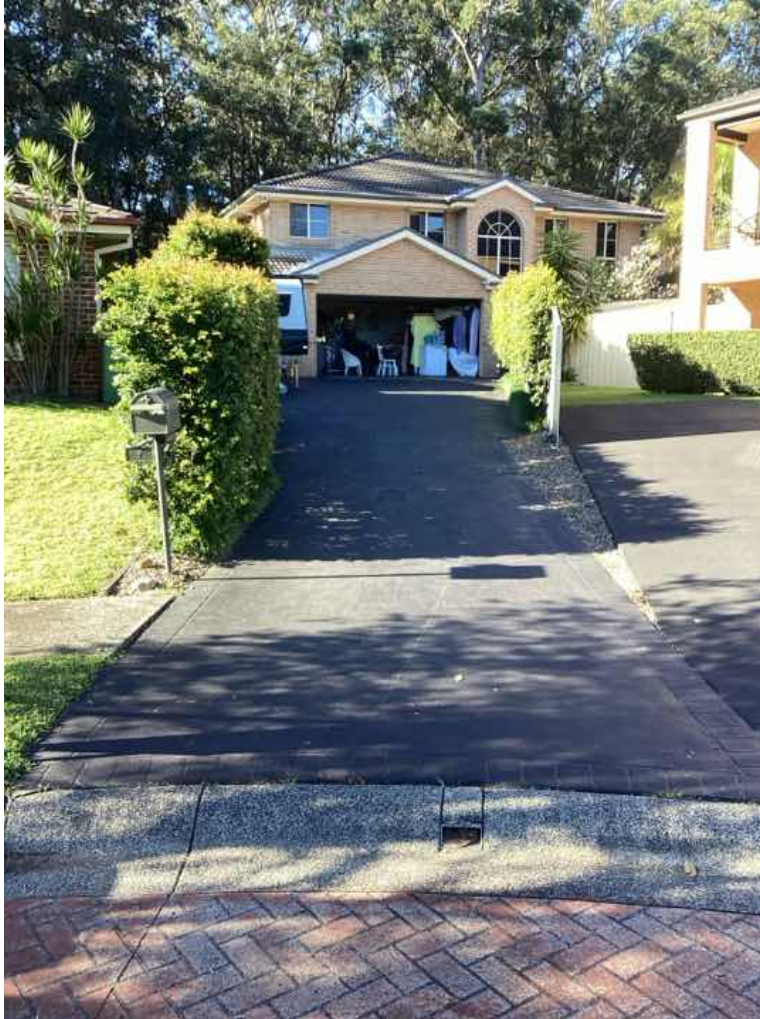
Common cracks were observed on the driveway. Whilst these cracks appeared to be typical at the time of inspection, we strongly recommend you monitor these cracks and if worsening occurs contact a concreter for further advice.

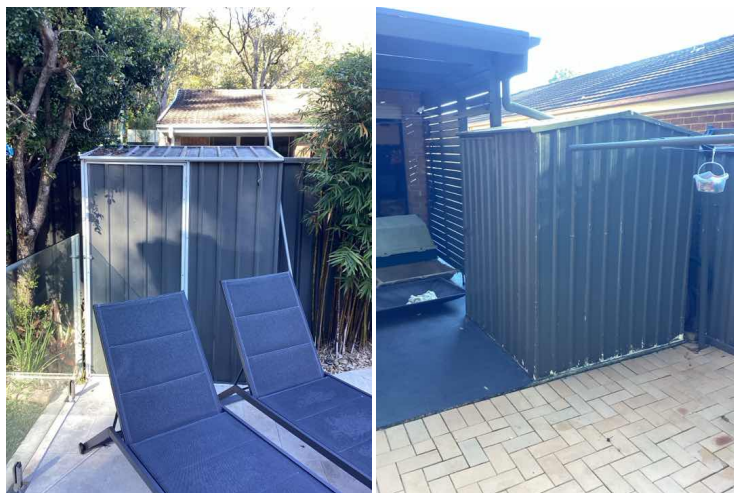
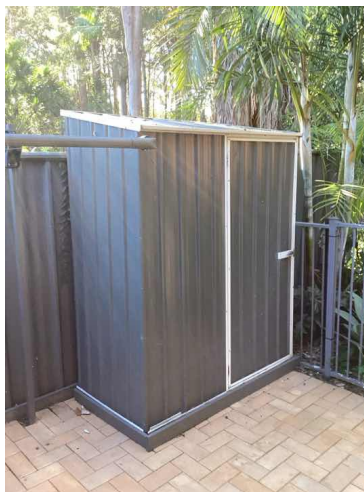
The shed is in fair usable condition.

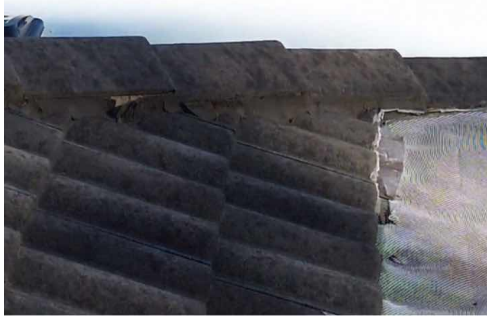
Mortar cracks visible. We recommend having these repaired by a qualified roofer as they may contribute to water ingress.

Cracked tile ends visible. A qualified roof tiling contractor should be engaged for advice and recommendations. Considered a minor defect but has the potential to become a Major defect if repairs aren't carried out immediately due to water ingress into the roof cavity.

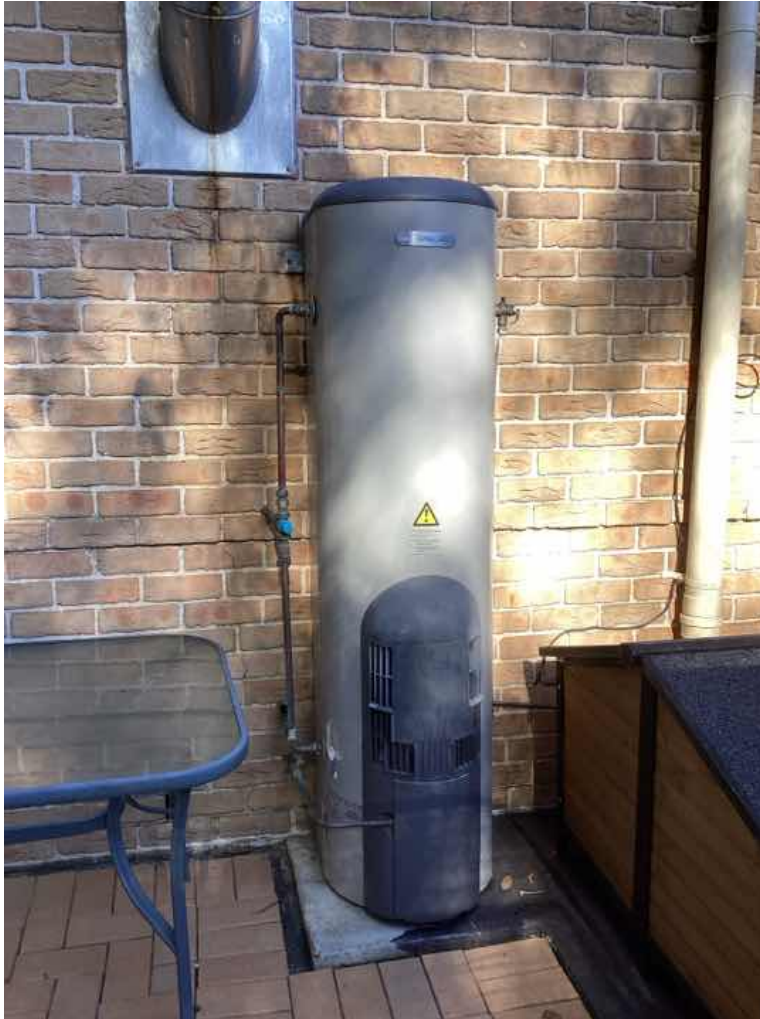
The hot water system appears to be in a serviceable condition. No specific tests other than running the hot water from a tap was carried out. No determination has been made as to the suitability or adequacy of the hot water system in relation to capacity or otherwise.

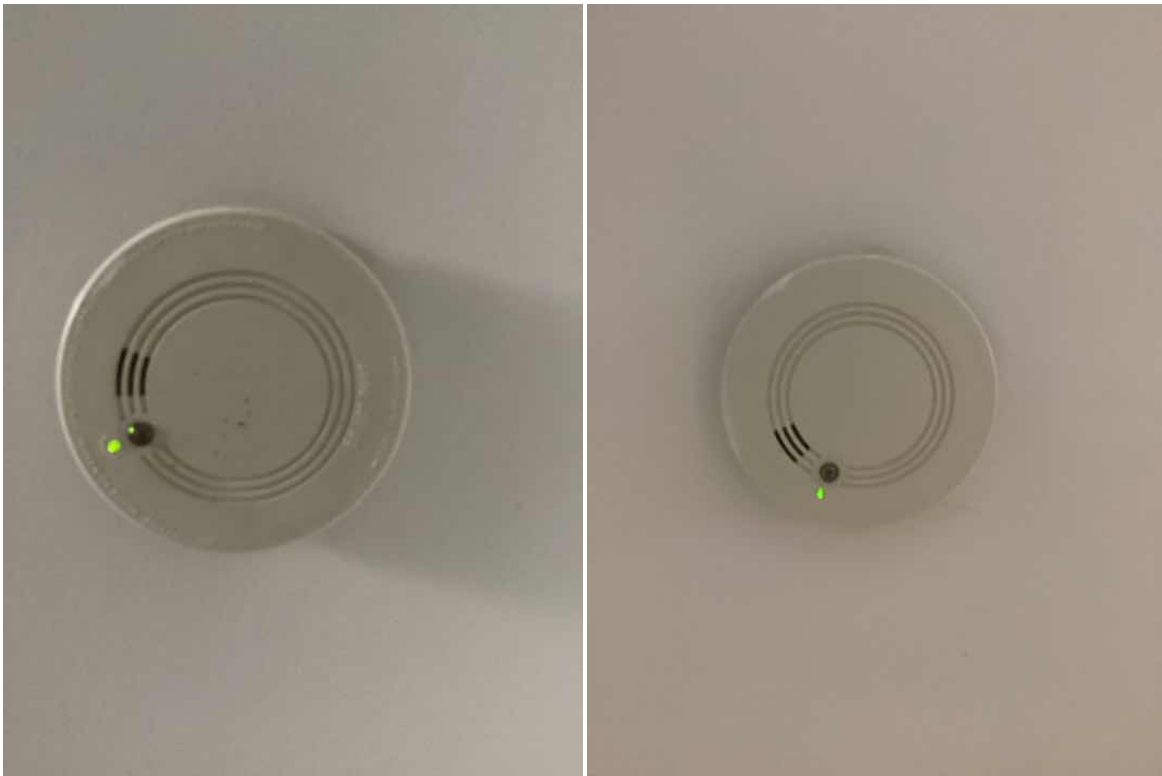
## Smoke Alarm

Yes 2 smoke alarms were sighted but not tested.

Legislation requires smoke Alarms to be installed. Check with your local council regarding type, locations and other related requirements.

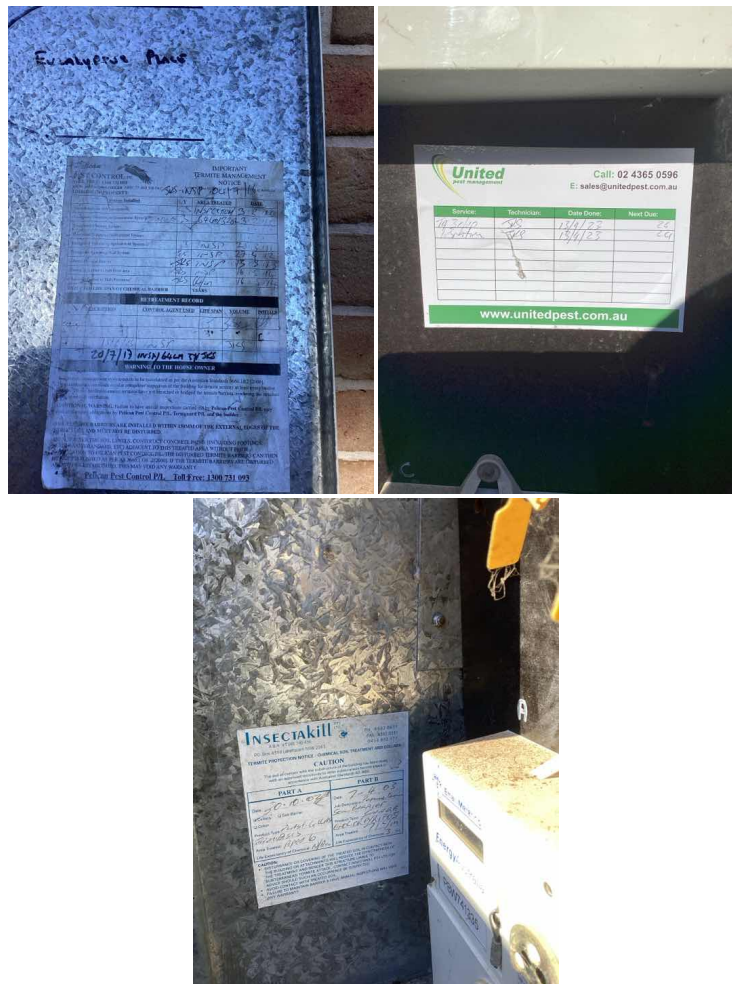
#### **Was a Treatment Notice Found**

Yes, a durable notice was found in the meter-box during the inspection.

This firm can give no assurances with regard to work that may have been previously performed by other firms. You should obtain copies of all paperwork and make your own inquiries as to the quality of the treatment, when it was carried out and warranty information. In most cases you should arrange for a treatment in accord with Australian Standard 3660 be carried out to reduce the risk of further attack.

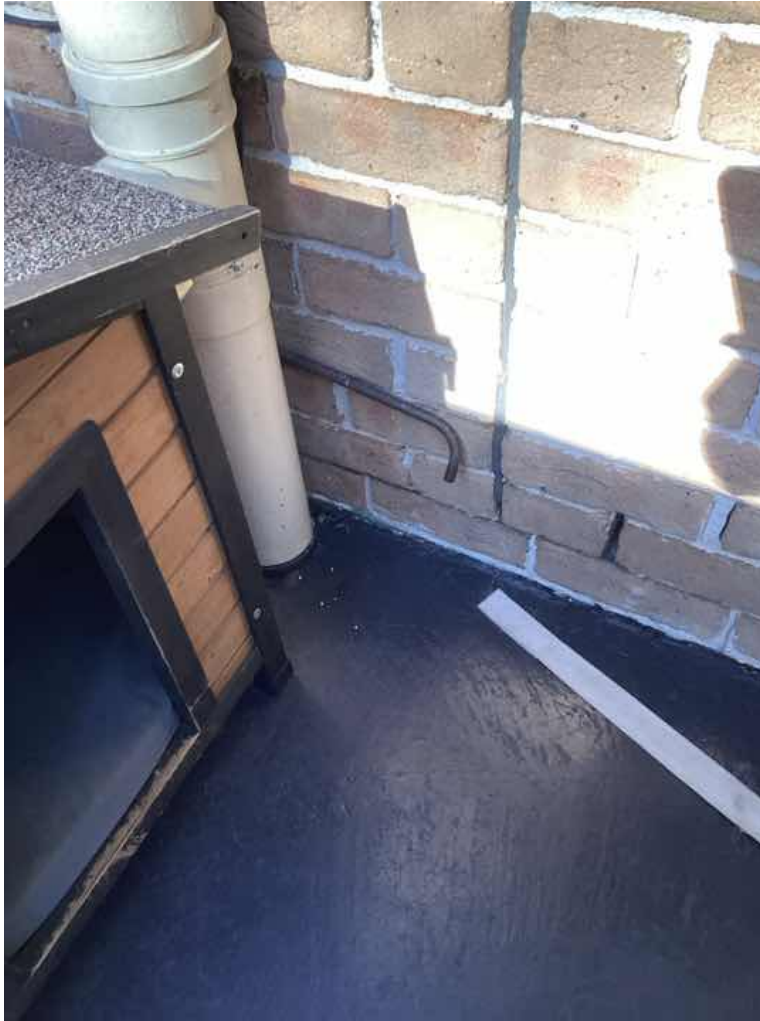
No. Divert hot water overflow away from the building perimeter.
