SDB Inspecta Homes T/A

Pre Purchase Visual Inspection Report

47 Tall Timbers Rd Wamberal

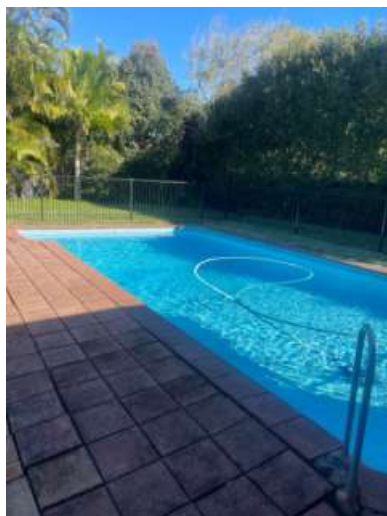
A swimming pool is present. This inspection specifically excludes any inspection of the pool or surrounds. An inspection should be made by a specialist pool inspector to determine the condition of the pool and surrounds.

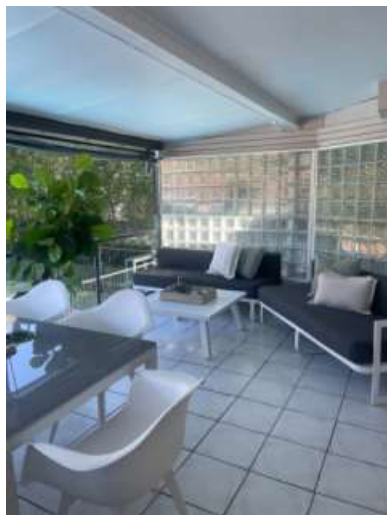
Rear elevation.

Constructed from timber. The condition of the structure is generally acceptable.

The overall condition of the roof coverings is acceptable.

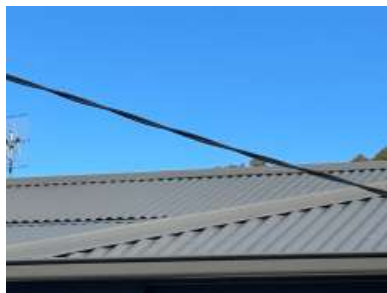
The overall condition of the roof coverings is acceptable.

Flashings appear to be in serviceable condition.

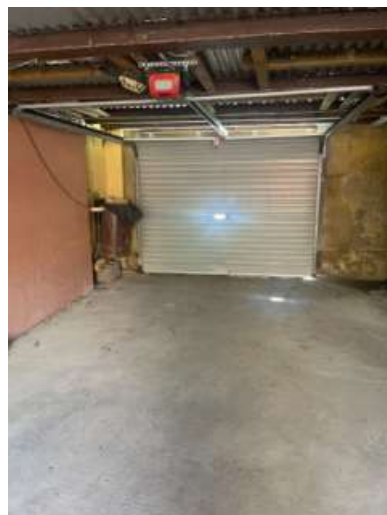
The condition of the walls is generally fair.

The main garage door is a roller shutter style door and is in acceptable condition.

The concrete floor is generally in acceptable condition.

Recommend that an upgrade of this structure be considered.

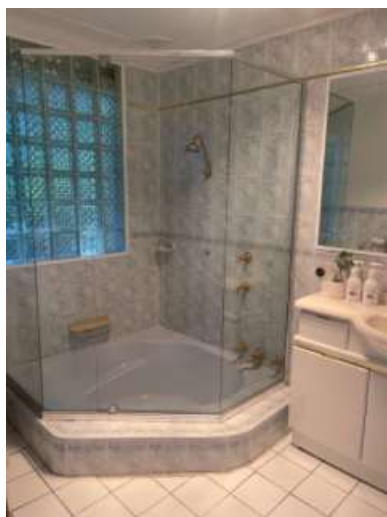
The shower recess was tested and there was no visible water penetration to surrounding areas. **IMPORTANT NOTE:** This test may not reveal water leaks until the shower is put into constant use and surrounding areas monitored over a period of time.

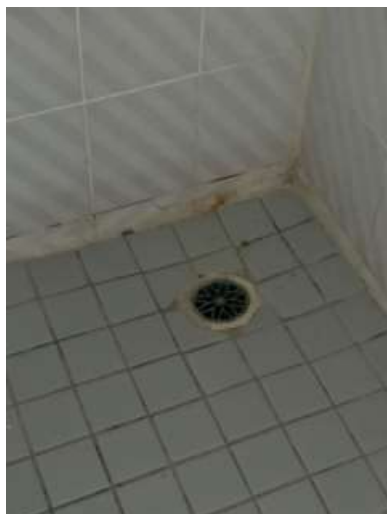
The shower recess was not tested due to stored goods or access limitations. Comments are not provided on this area. Defects may be present and not detected. Silicone sealant has been applied to the interface of the floor and walls in the shower recess in an apparent attempt to prevent water penetration to surrounding areas. This method of repair can only be considered to be temporary. Further waterproofing may be necessary.
