# Inspection Report

## ThoroughCheck Building Inspections

**18 Michaela Road, Terrigal, NSW, 2260**

### Pest And Building Inspection

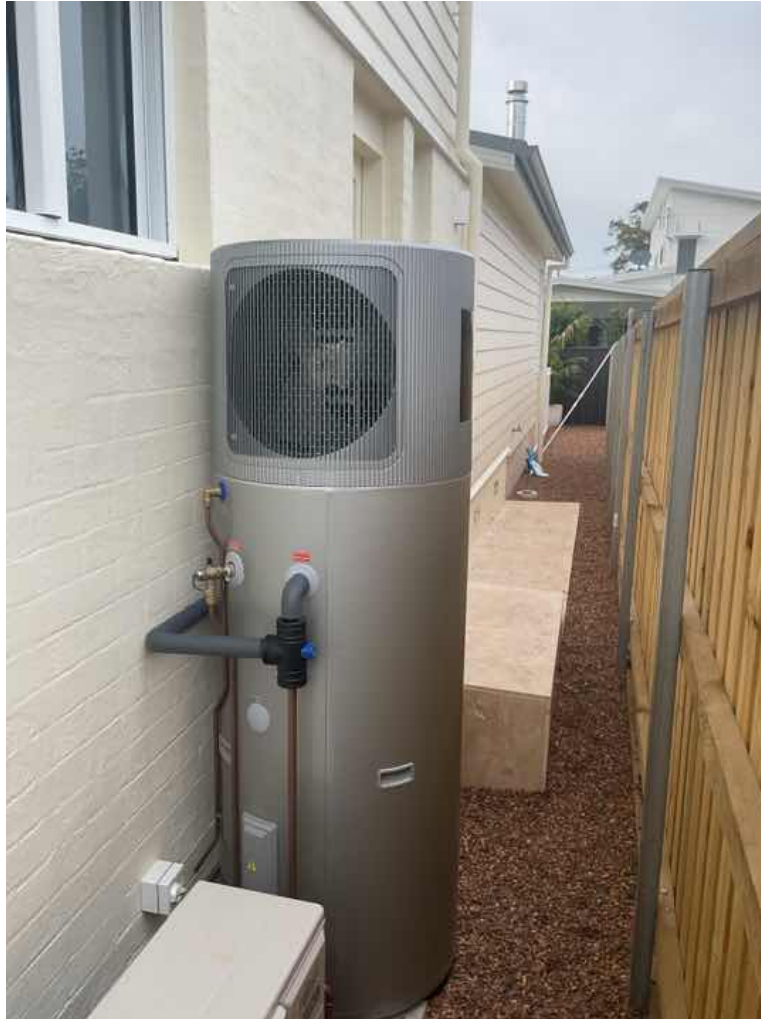
The hot water system appears to be in a serviceable condition. No specific tests other than running the hot water from a tap was carried out. No determination has been made as to the suitability or adequacy of the hot water system in relation to capacity or otherwise.

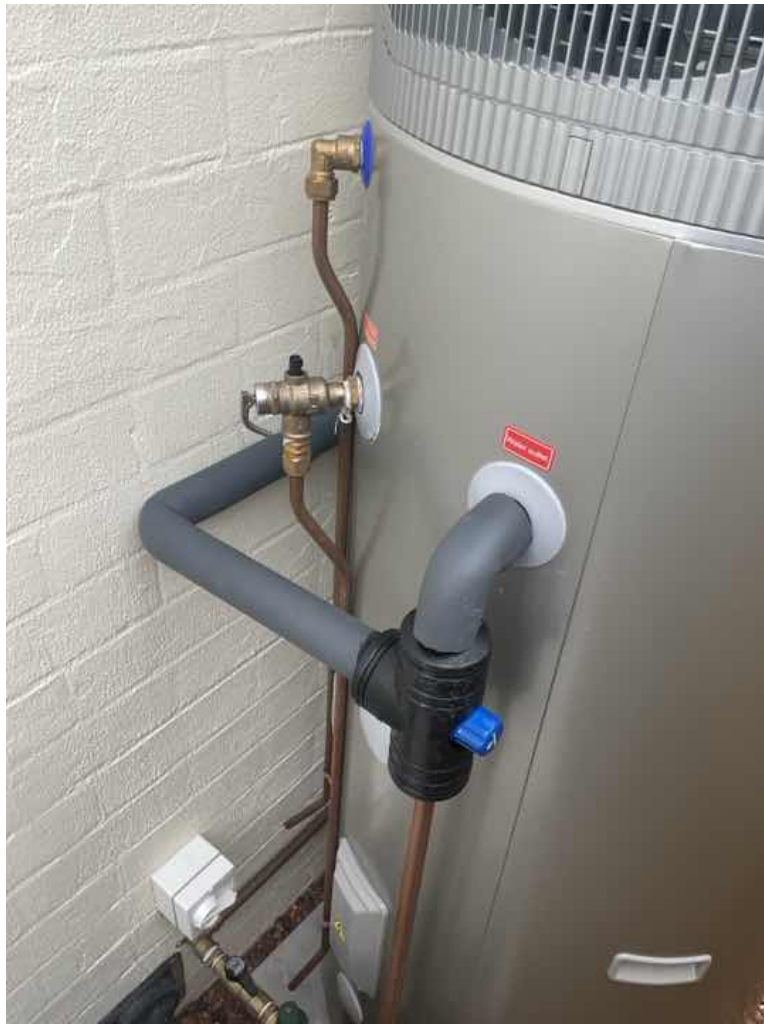
On visual inspection the external plumbing pipes appear serviceable, but should be checked by a qualified plumber.

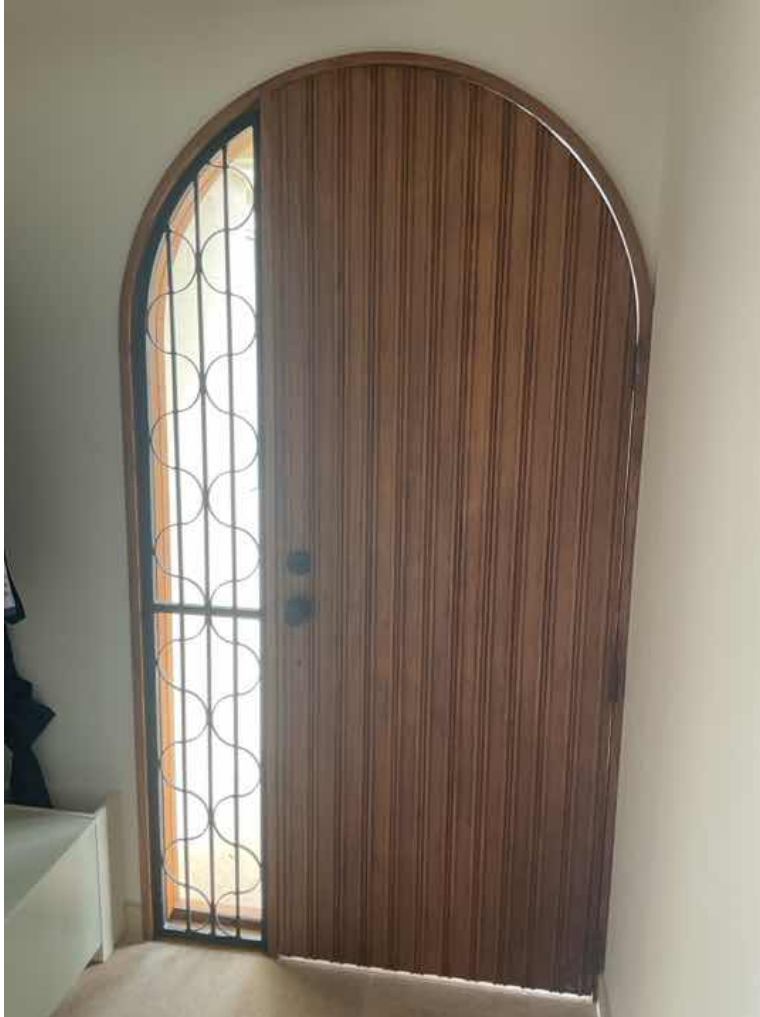
#### **Front Entry Doors**

The doors are in serviceable condition with no notable defects observed.

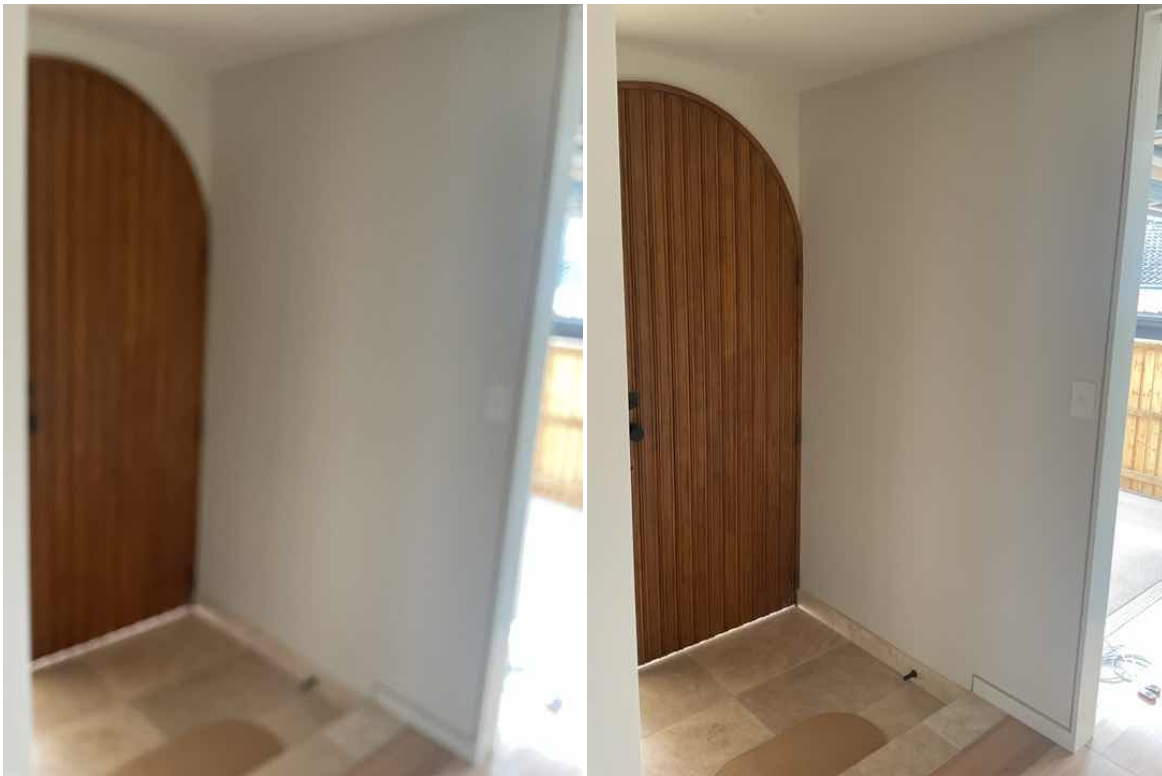
From the visible and accessible areas, this area appears to be in a serviceable condition for the age of the property with no notable structural defects sighted.

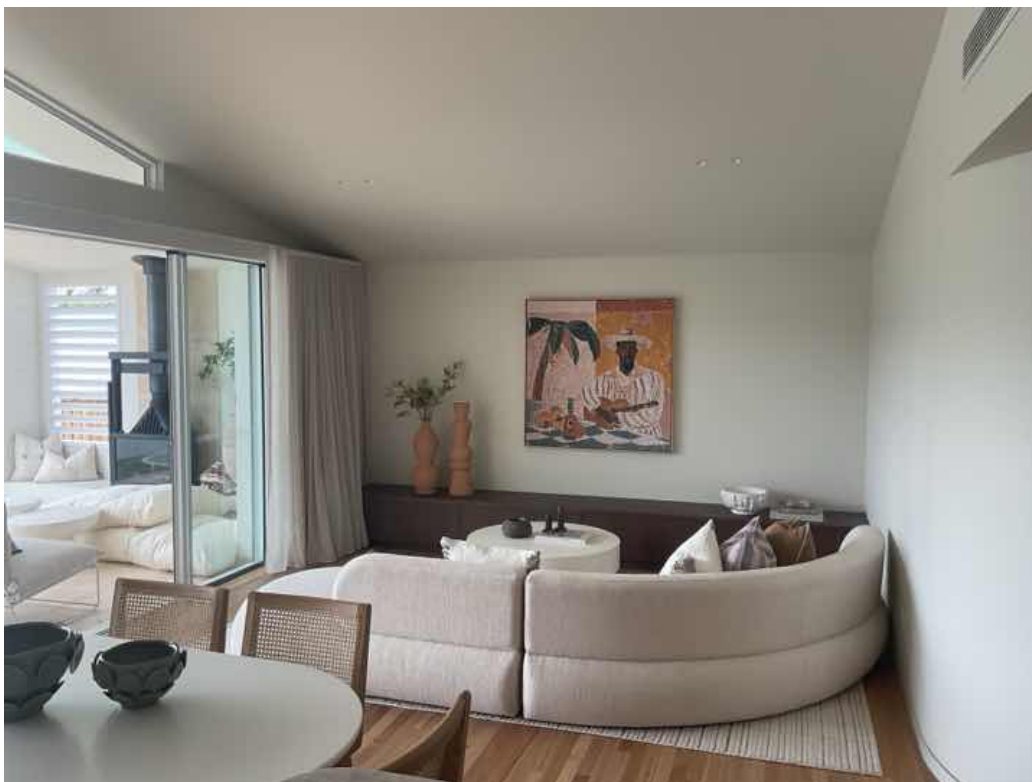
## Living/Dining Room

From the visible and accessible areas, this room appears to be in a serviceable condition for the age of the property with no notable structural defects sighted.

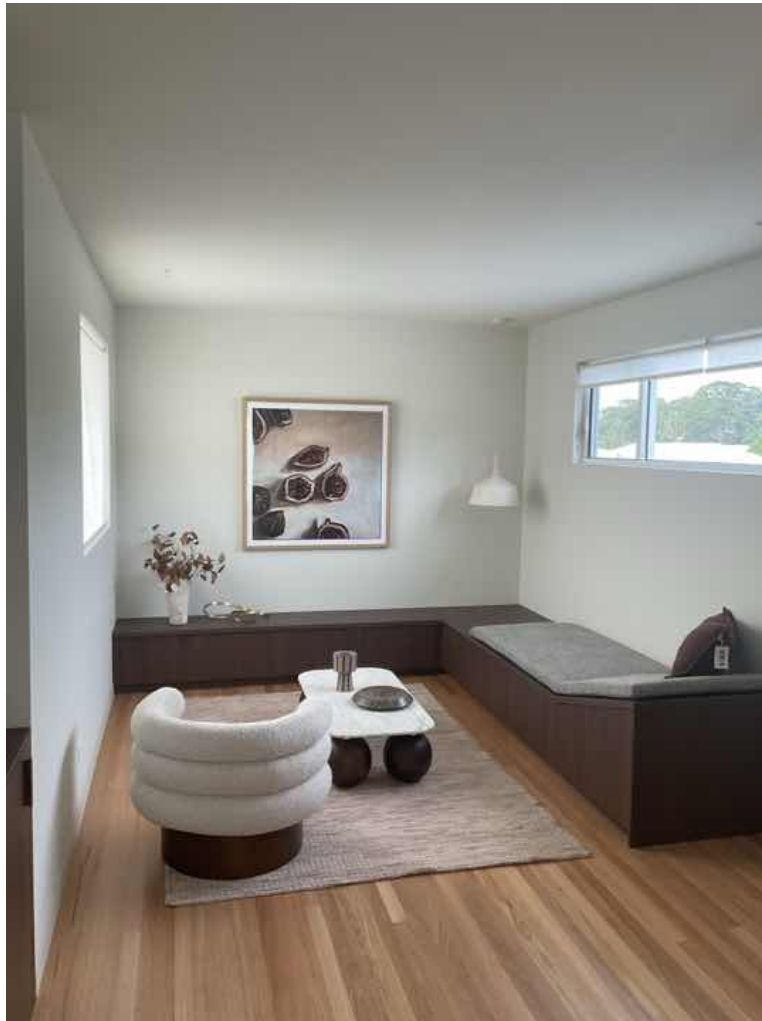
## Upstairs Living Room

From the visible and accessible areas, this room appears to be in a serviceable condition for the age of the property with no notable structural defects sighted.

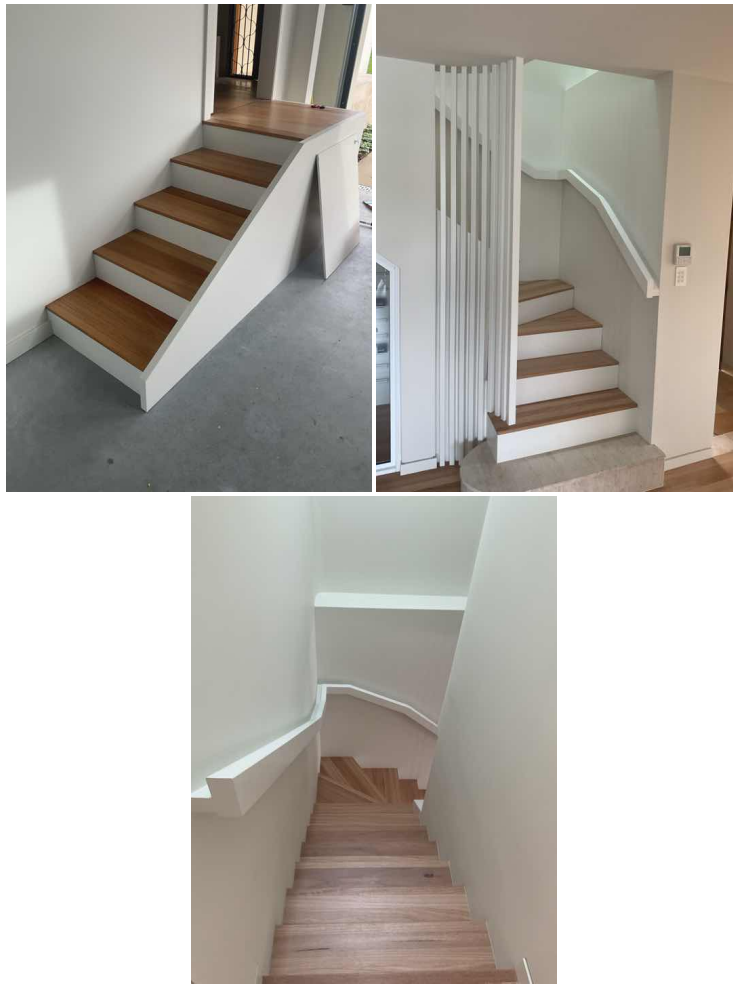
## Internal Stairs

From the visible and accessible areas, the internal stairs appears to be in a serviceable condition for the age of the property with no notable structural defects sighted.

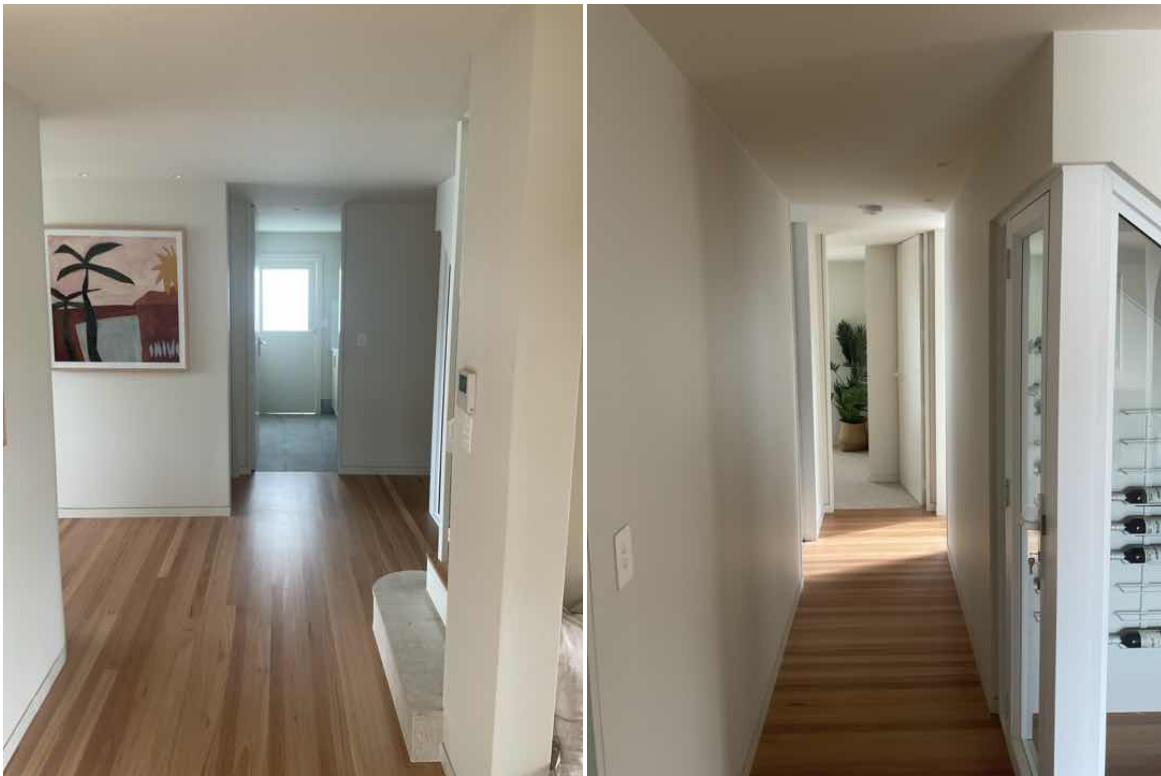
### Hallway/s

From the visible and accessible areas, the hallway/s/ appears to be in a serviceable condition for the age of the property with no notable structural defects sighted.

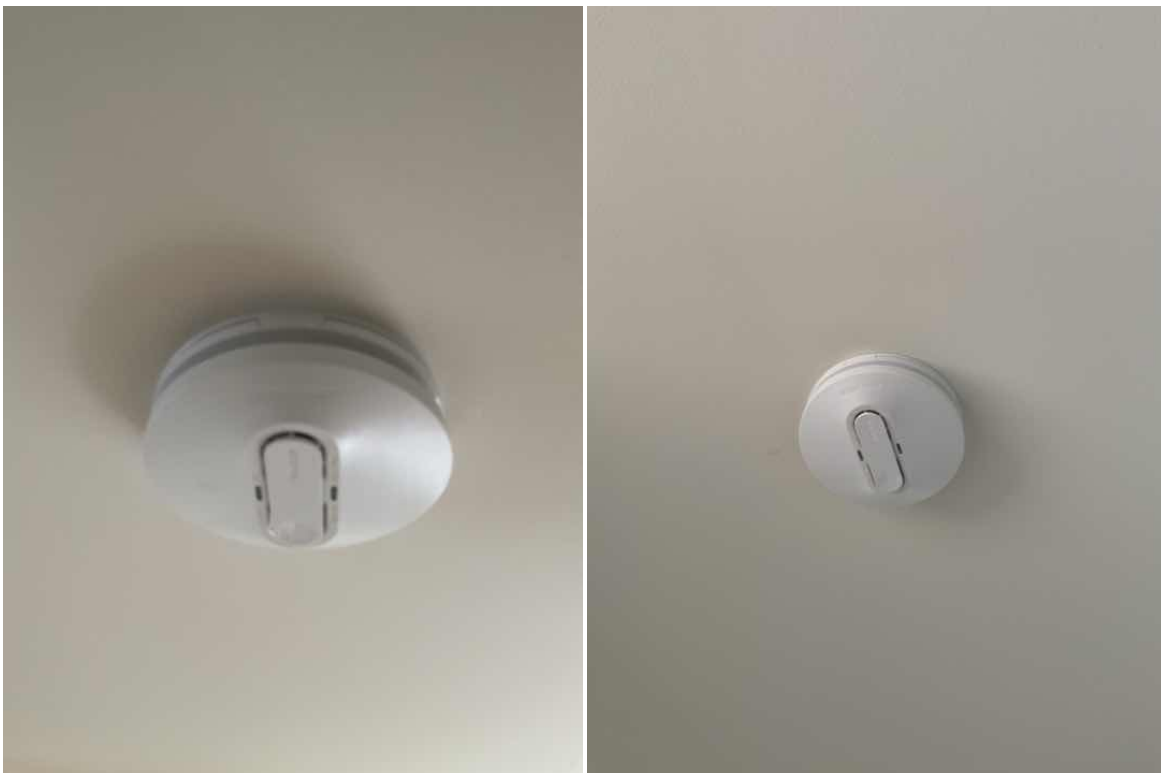
## **Smoke Alarm**

Yes 2 smoke alarms were sighted but not tested.

Legislation requires smoke Alarms to be installed. Check with your local council regarding type, locations and other related requirements.

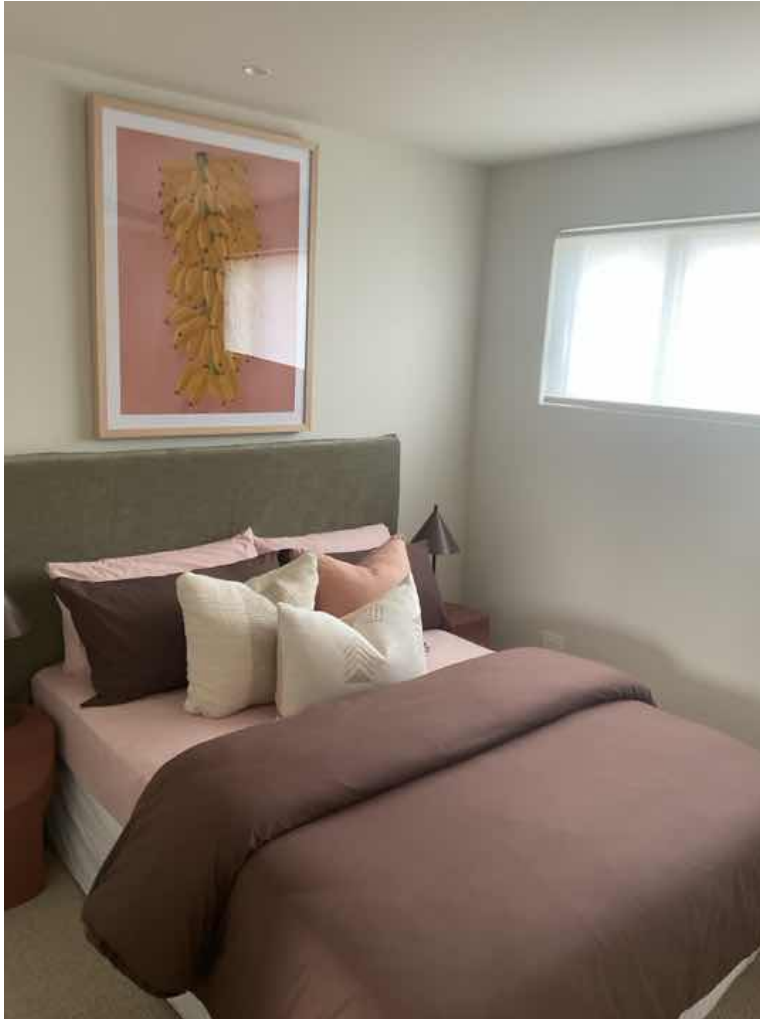
## **Bedroom 1**

From the visible and accessible areas, this bedroom appears to be in a serviceable condition for the age of the property with no notable structural defects sighted.

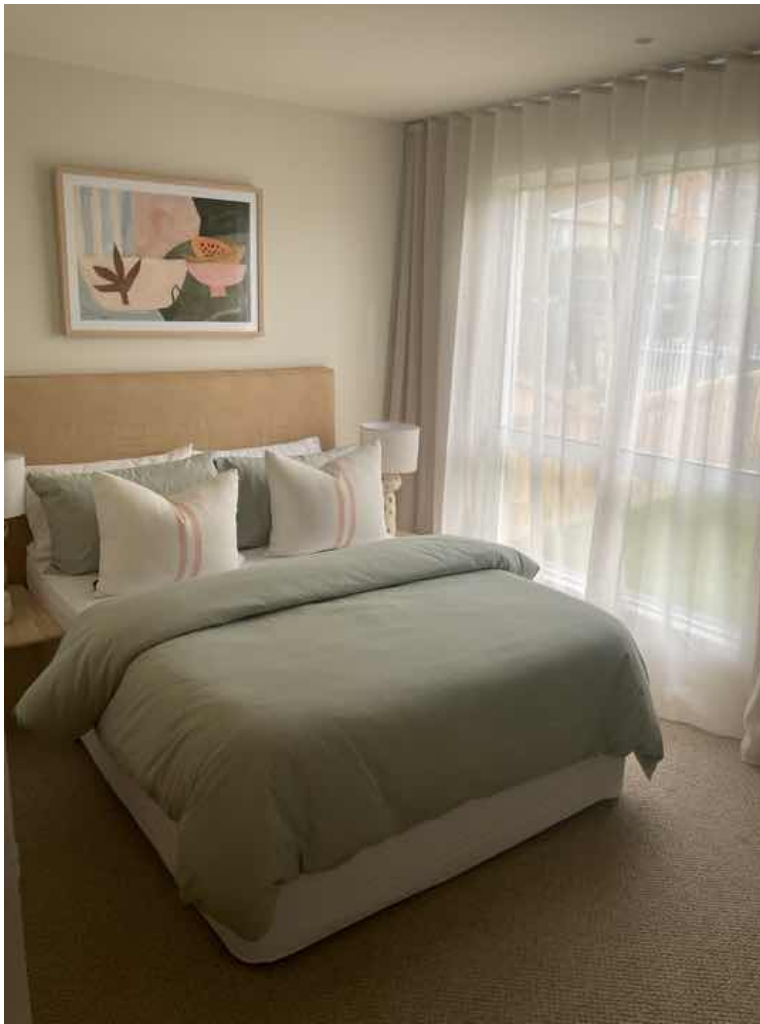
## **Bedroom 2**

From the visible and accessible areas, this bedroom appears to be in a serviceable condition for the age of the property with no notable structural defects sighted.

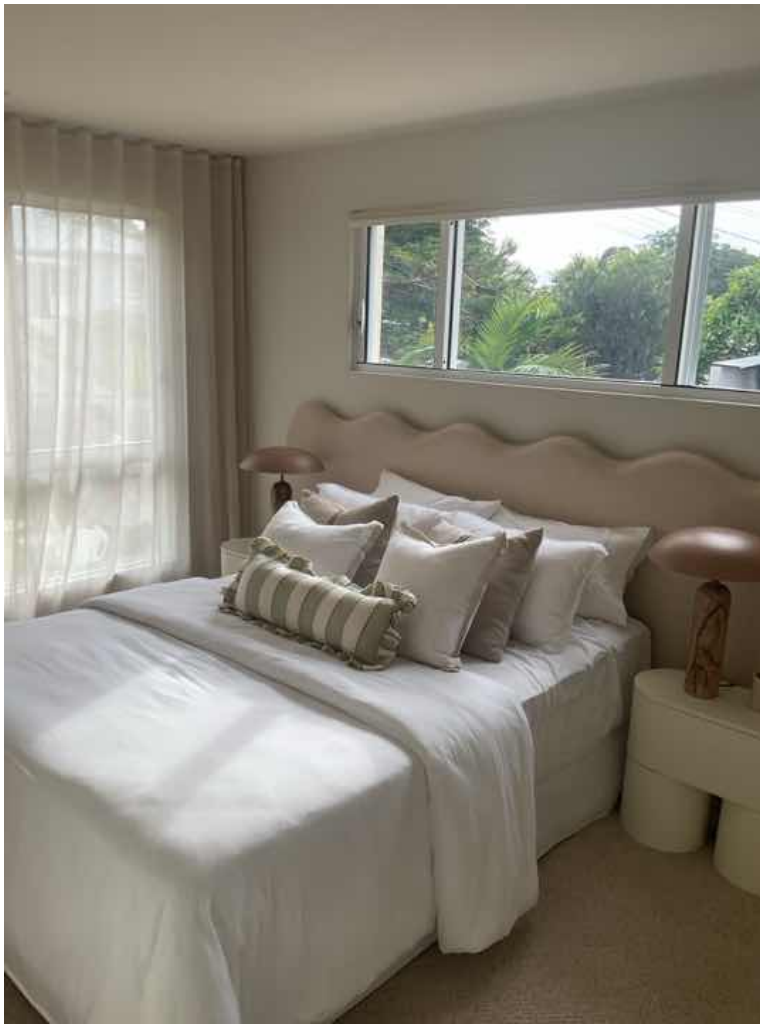
### **Bedroom 3**

From the visible and accessible areas, this bedroom appears to be in a serviceable condition for the age of the property with no notable structural defects sighted.

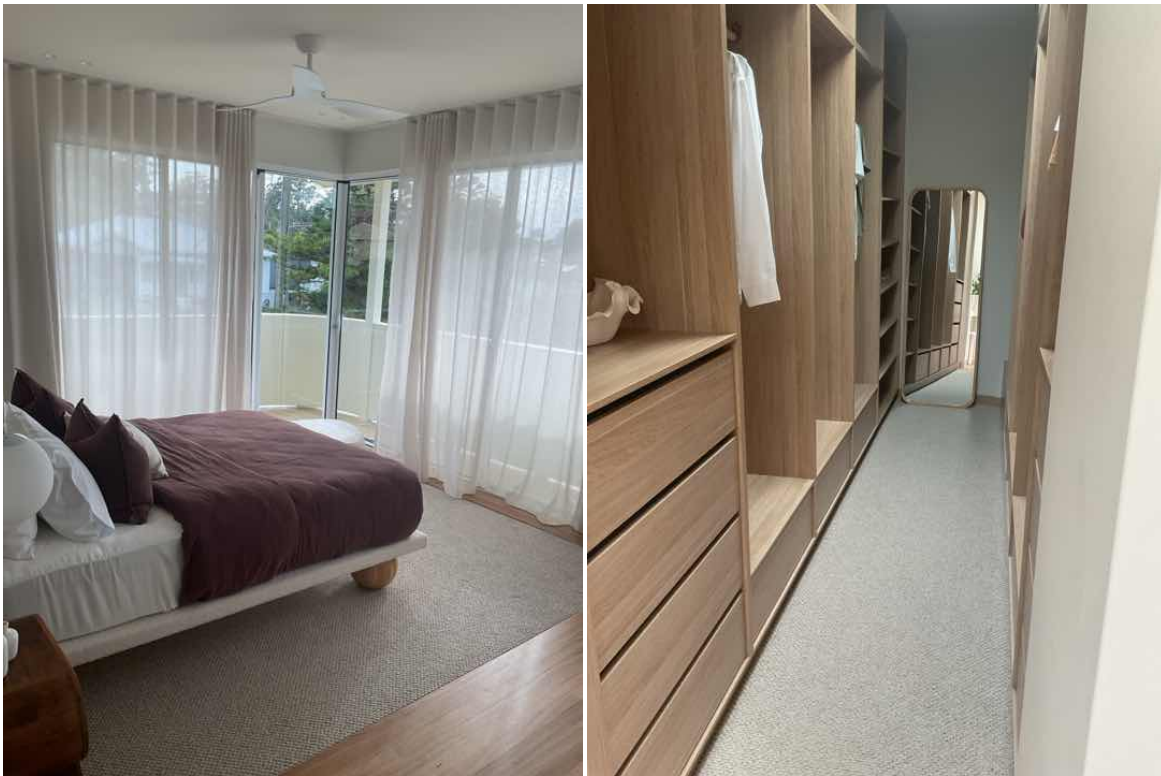
## **Bedroom 4**

From the visible and accessible areas, this bedroom appears to be in a serviceable condition for the age of the property with no notable structural defects sighted.

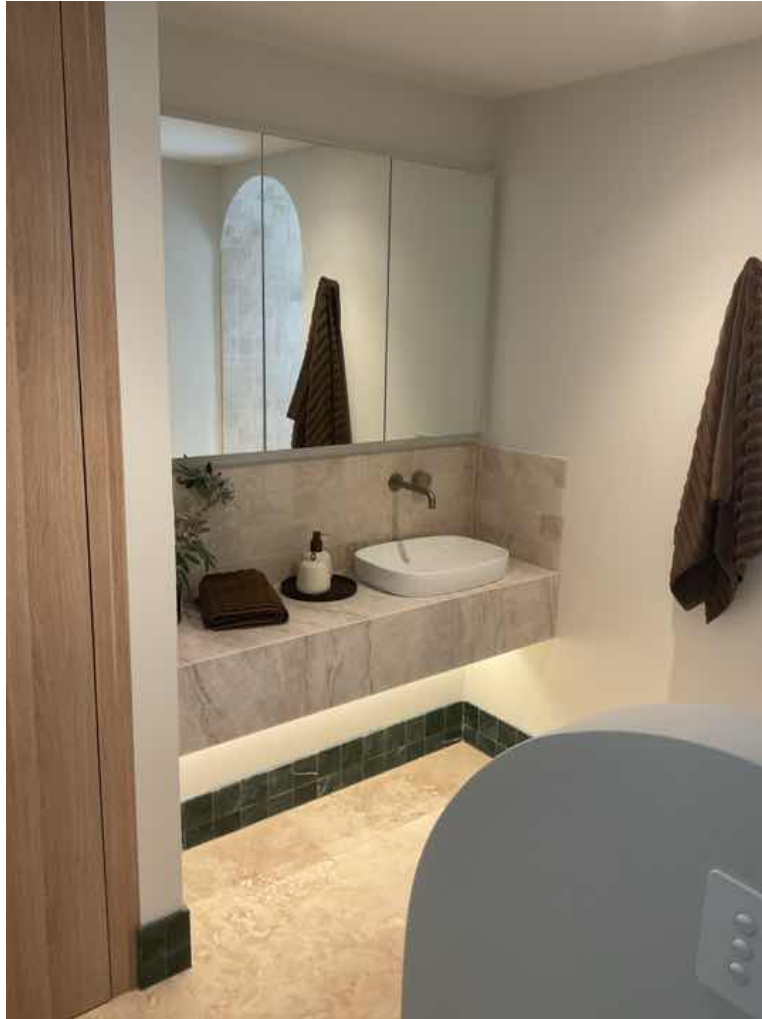
This bathroom is located in the lower level.

Of the visible areas, the general condition of this bathroom is serviceable or in reasonable condition for age of dwelling.

As this Bathroom appears to have been recently renovated, I strongly recommended you obtain the waterproofing certificates prior to settlement.

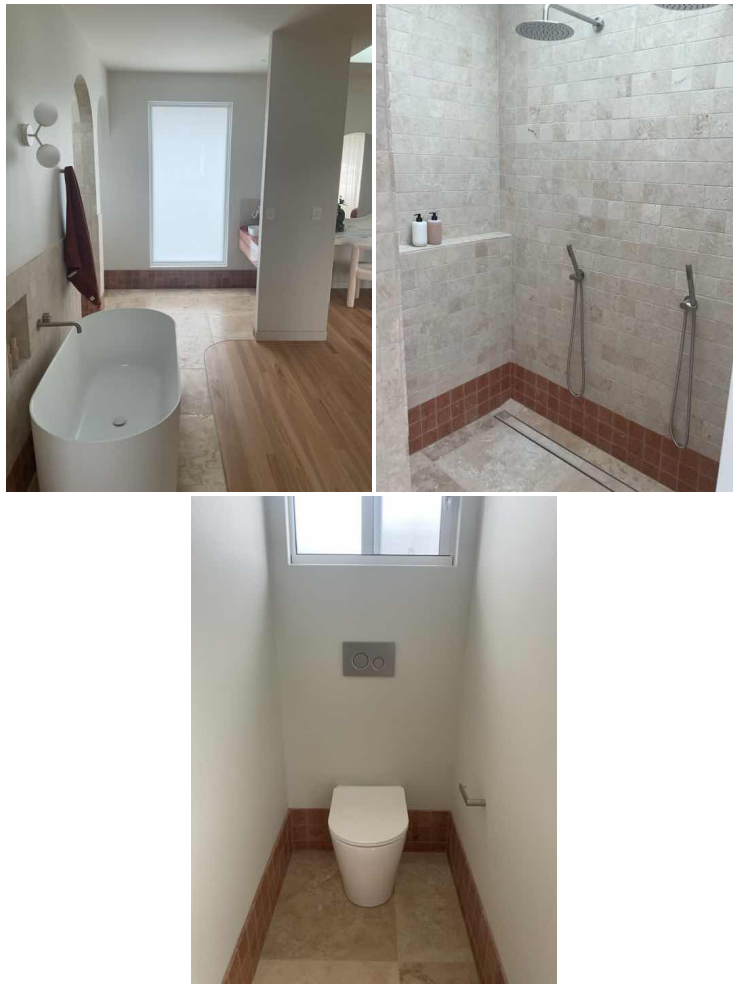
This bathroom is located in the upper level.

Of the visible areas, the general condition of this bathroom is serviceable or in reasonable condition for age of dwelling.

As this Bathroom appears to have been recently renovated, I strongly recommended you obtain the waterproofing certificates prior to settlement.

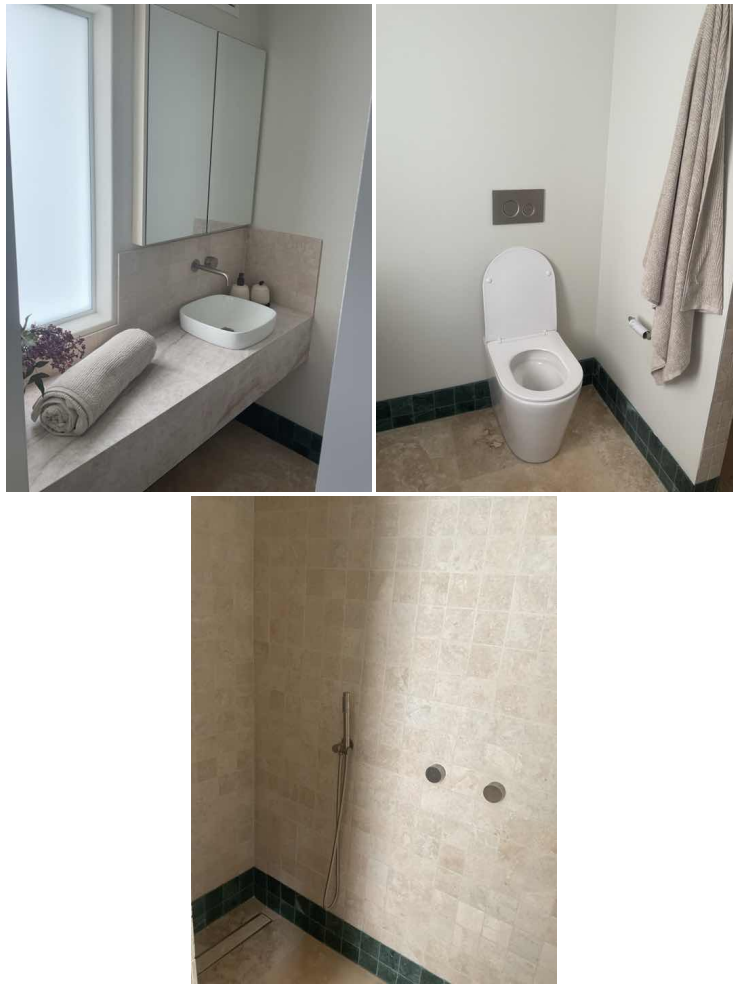
This bathroom is located in the lower level.

Of the visible areas, the general condition of this bathroom is serviceable or in reasonable condition for age of dwelling.

As this Bathroom appears to have been recently renovated, I strongly recommended you obtain the waterproofing certificates prior to settlement.

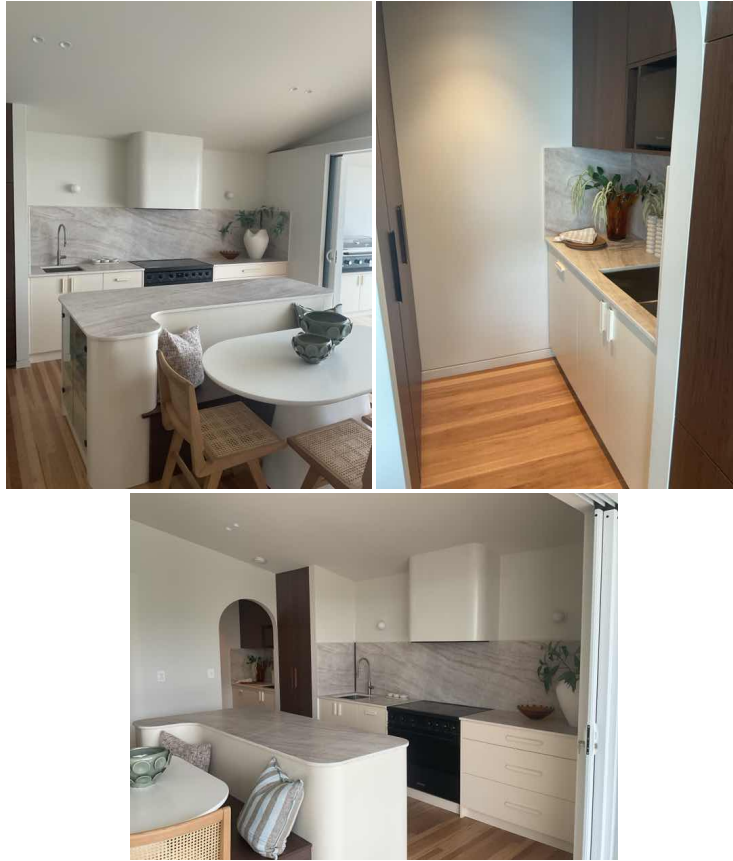
Of the visible areas, the general condition of the kitchen is serviceable or in reasonable condition for age of dwelling.

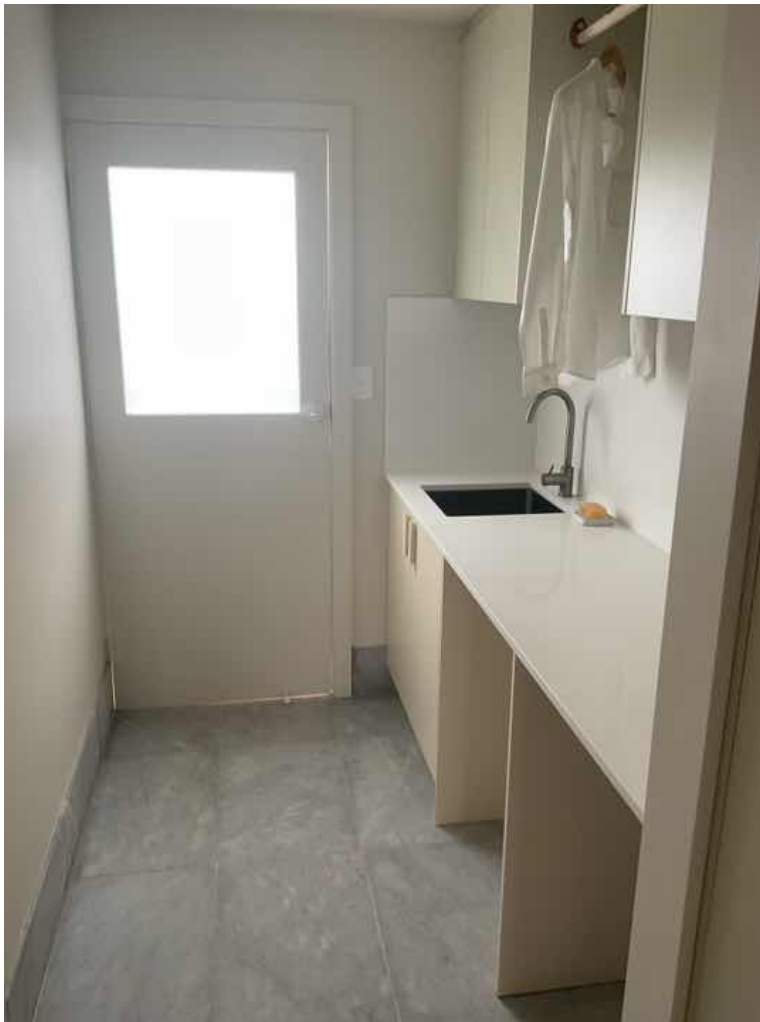
### Laundry

All areas in the laundry were able to be visually inspected.

Of the visible areas, the general condition of the laundry is serviceable or in reasonable condition for age of dwelling.

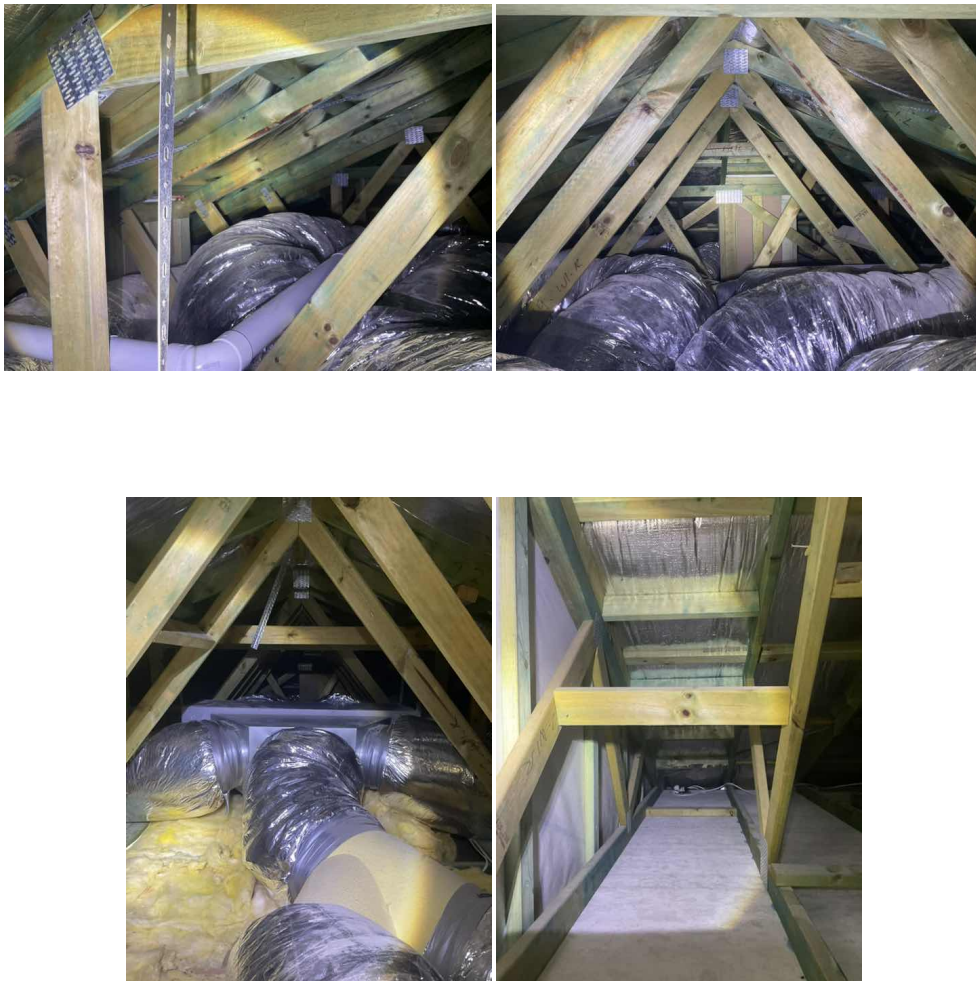
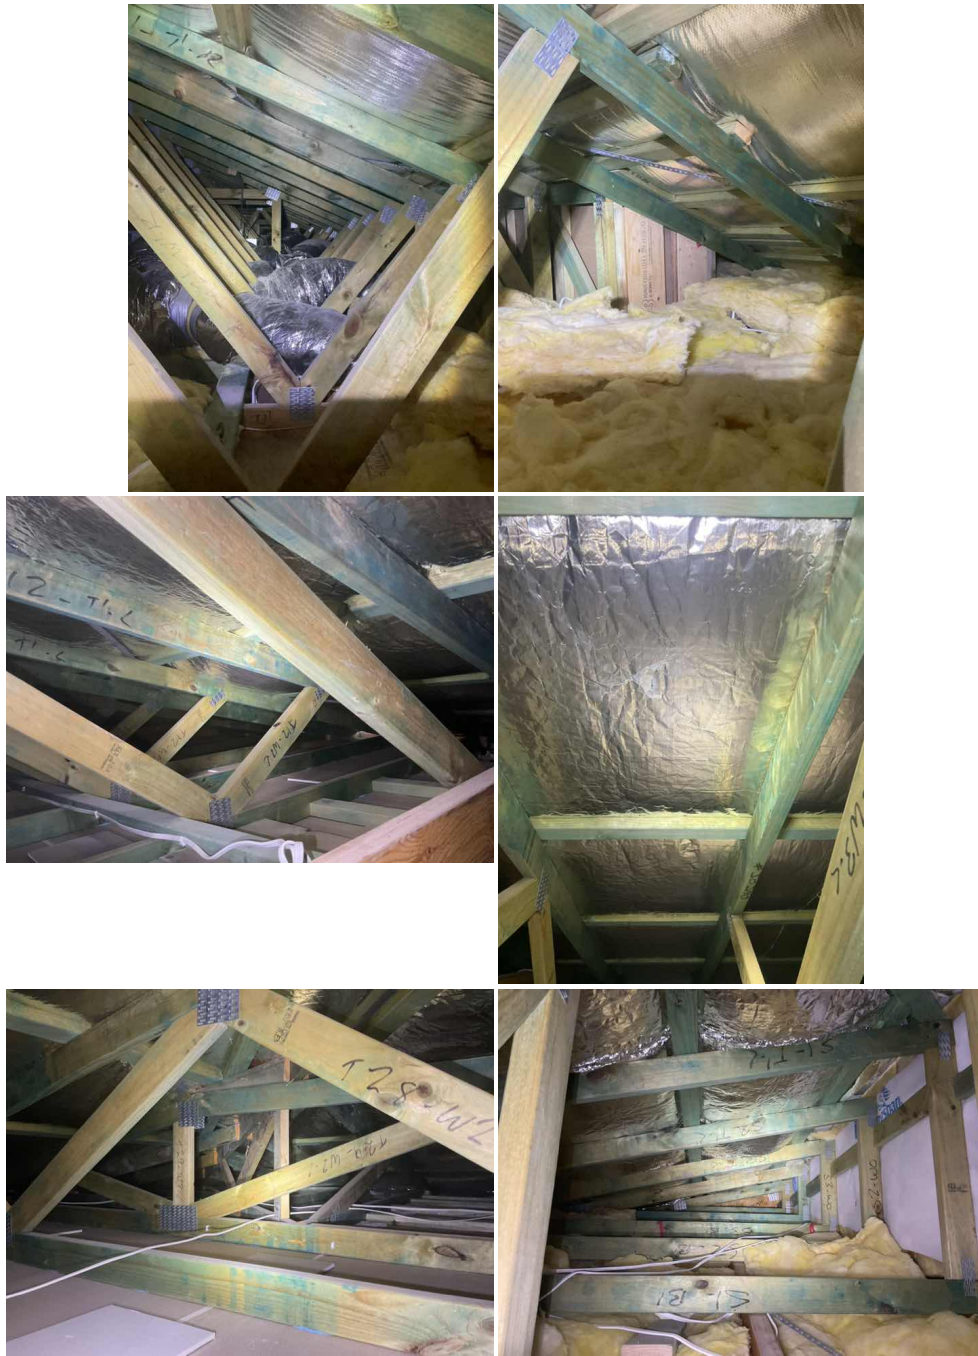
#### Roof Frame Type

The roof frame is a truss timber frame.

Visible sections of the roof void is in a serviceable condition for age of this dwelling.

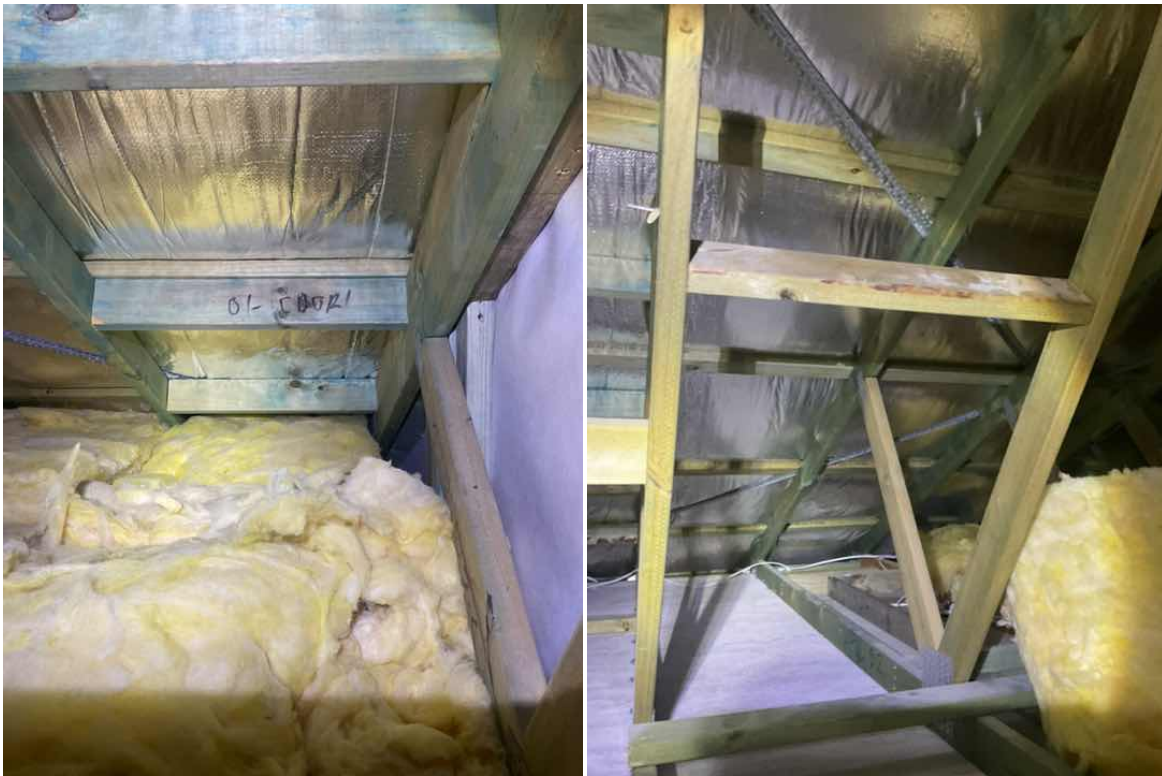
The roof space is insulated with reflective fibreglass batts under the roof cladding.

Where visible and accessible, the insulation appears to be in a serviceable condition.

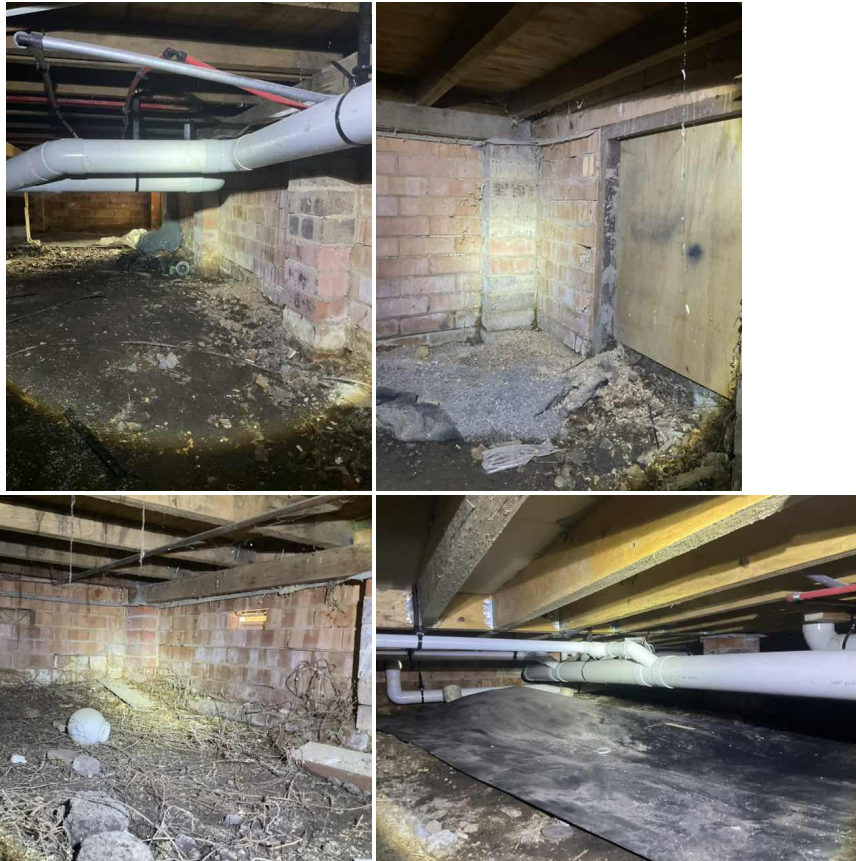
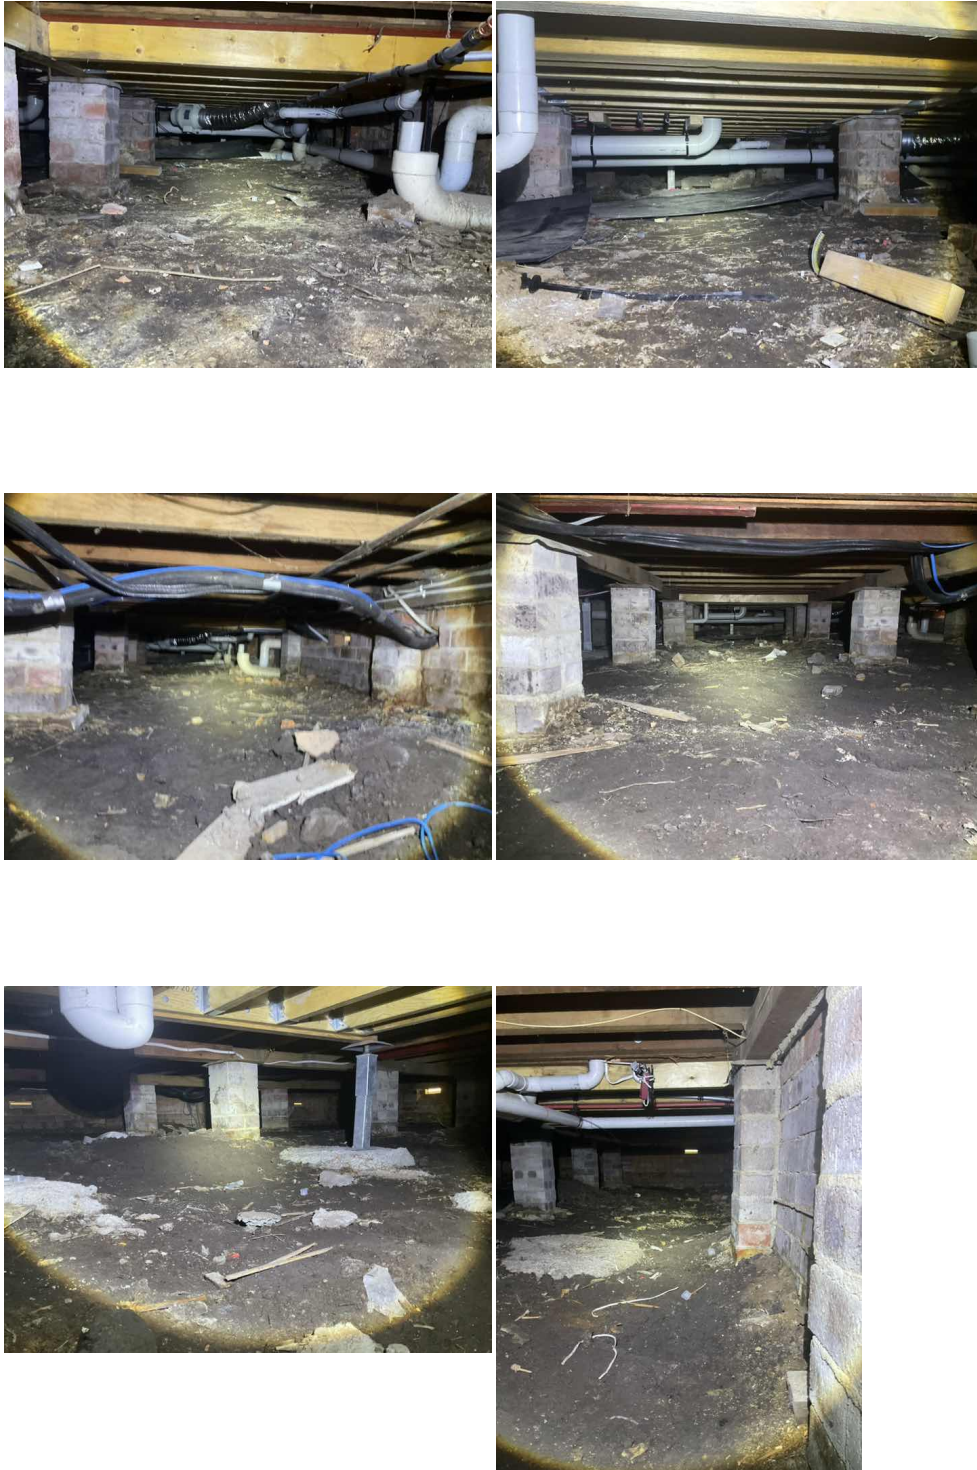
## Bearers

On inspection, defects were present that will require further assessing and recommendations by licensed and qualified trades persons, for example, a structural engineer, plumber, carpenter, electrician, plasterer may need to assess. Please read below for details.

Borer damage was observed on one bearer. It appeared to be minor in nature. Engage a qualified carpenter to assess and make recommendations

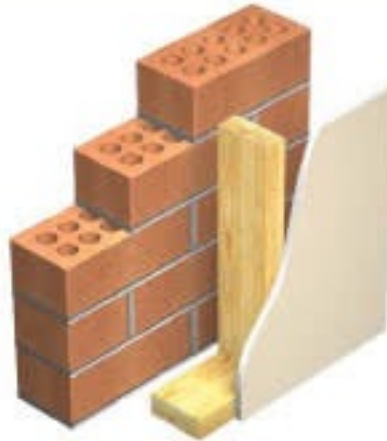
### BRICK VENEER WALL

The structure is of brick veneer construction.
