# BUILDING & PEST INSPECTION

12 Gloster Close, East Gosford NSW 2250

18th November, 2025

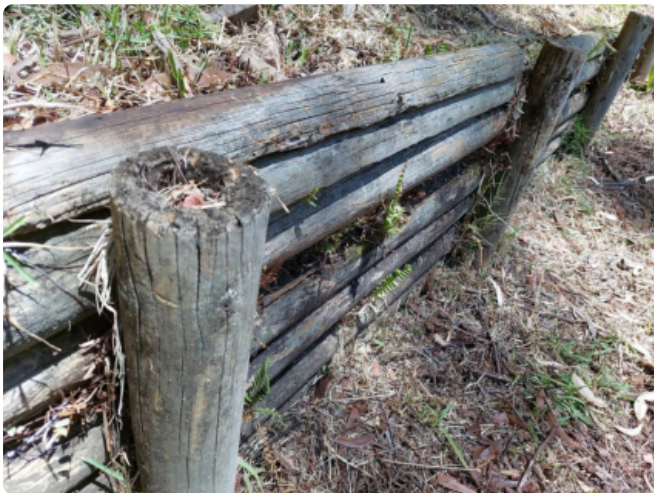
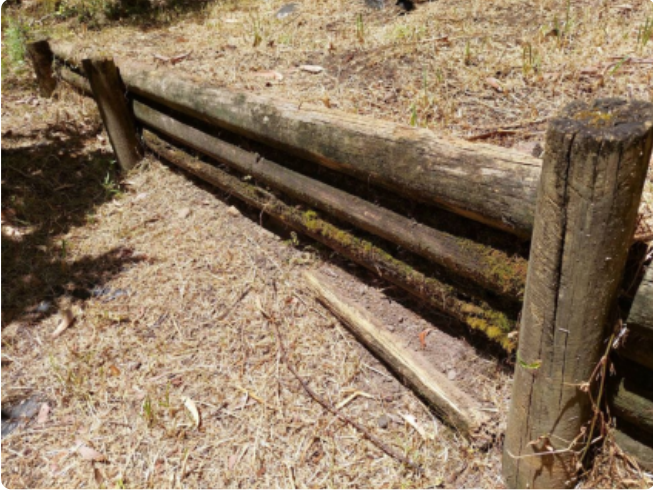
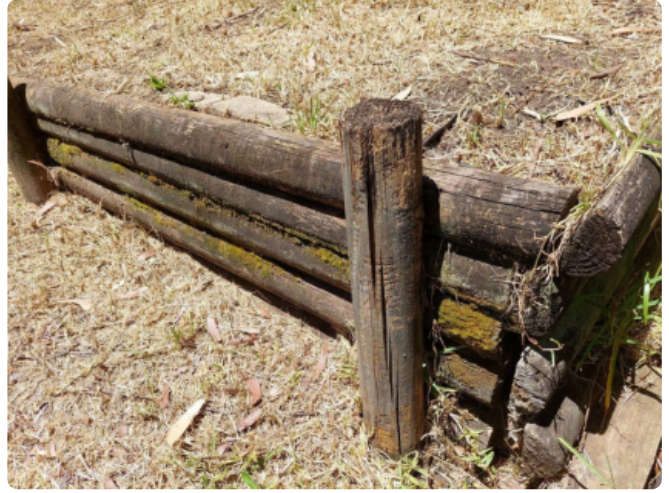
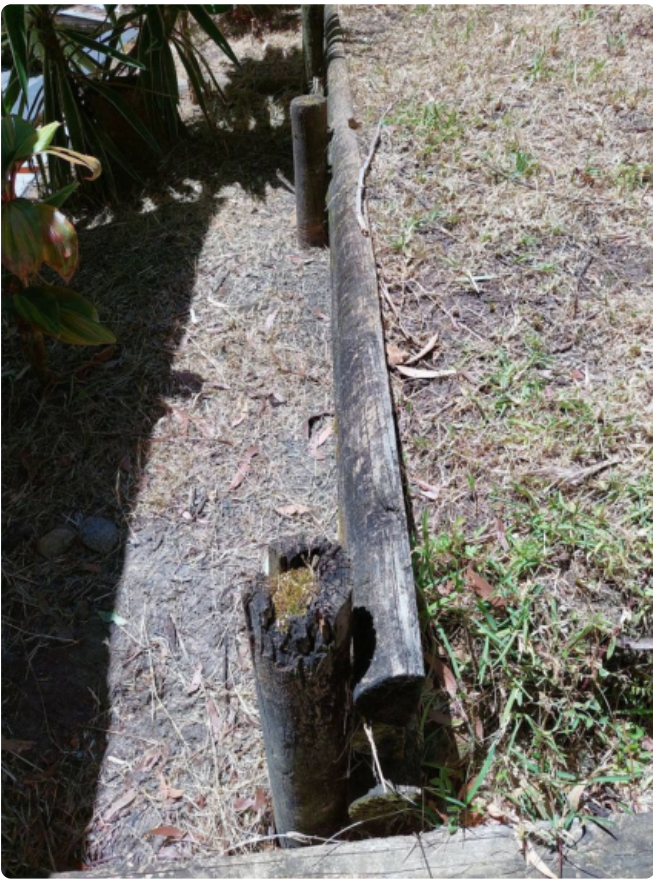
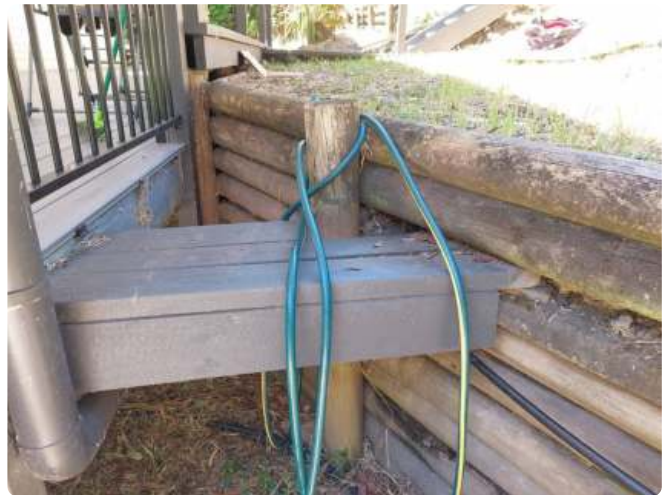
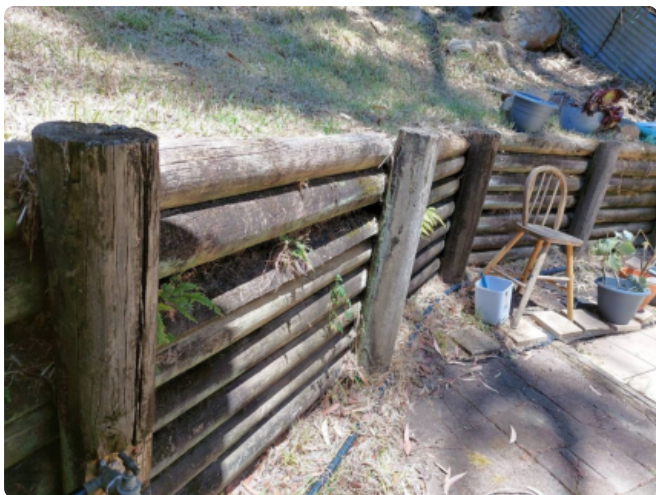
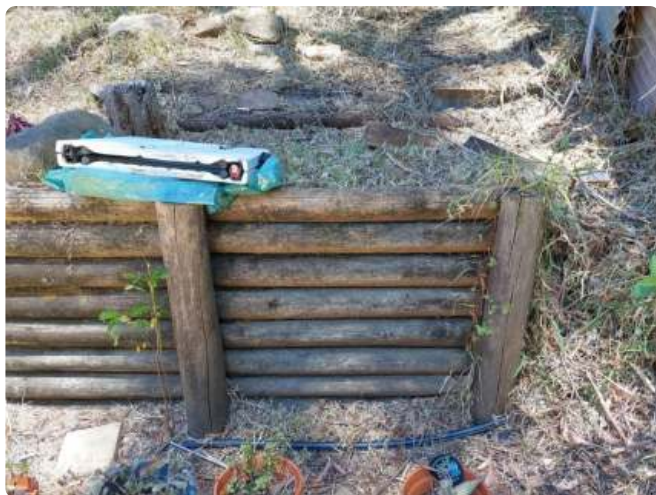
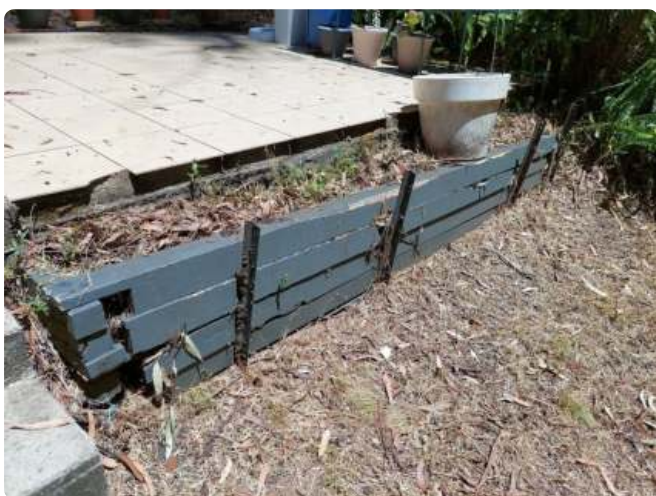
Timber retaining walls exhibit signs of weathering, moisture exposure, and localised deterioration, which may compromise structural integrity and increase susceptibility to movement, decay, or termite activity over time.

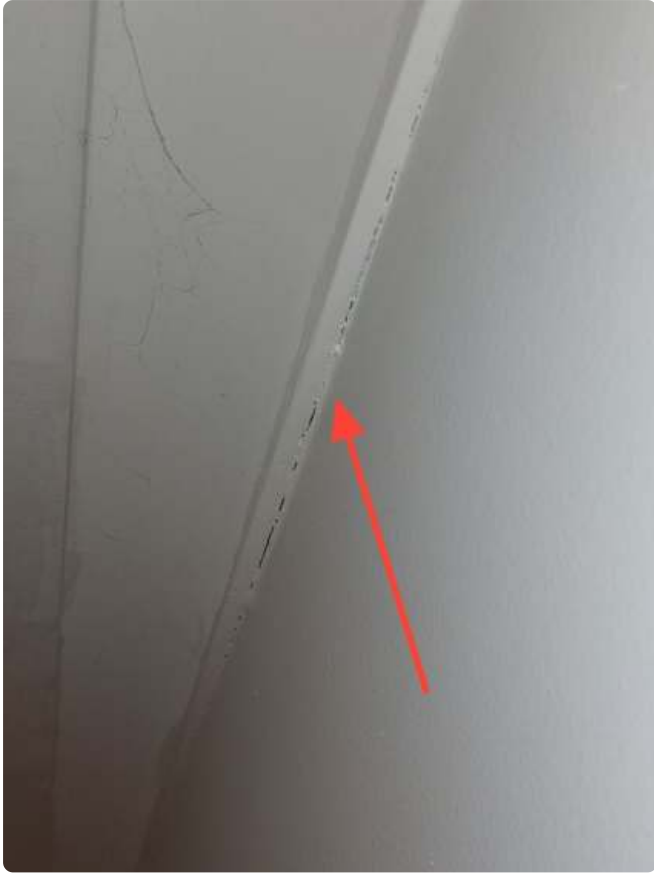
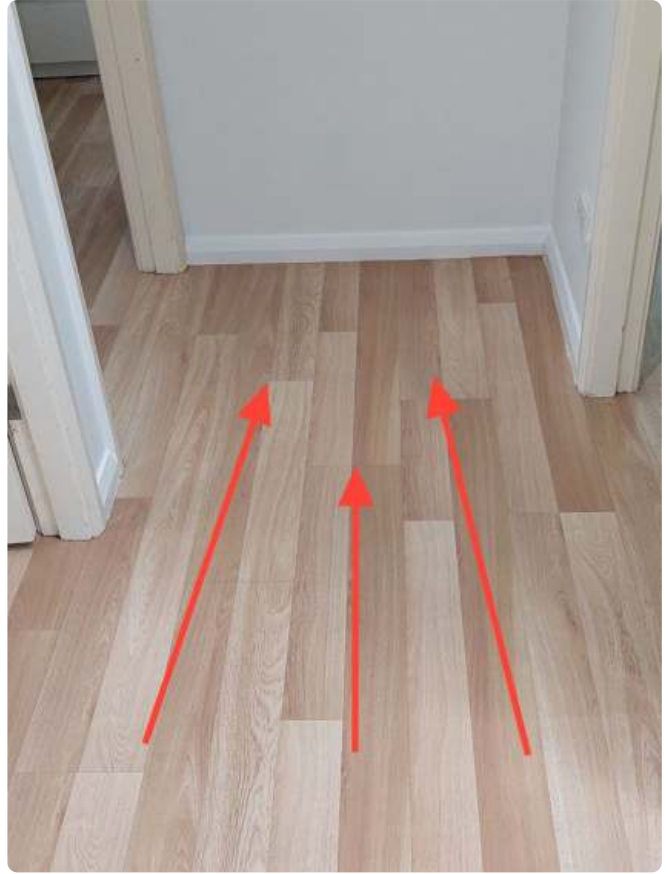
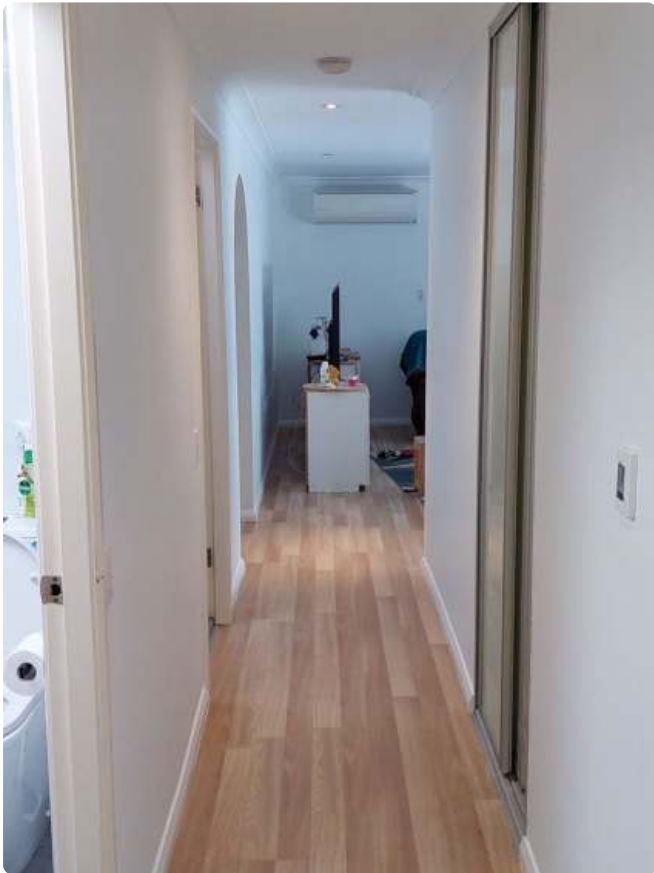
Cracking observed in the hallway cornice and sloping of the hallway floor towards Bedroom 1 indicate possible movement or differential settlement.

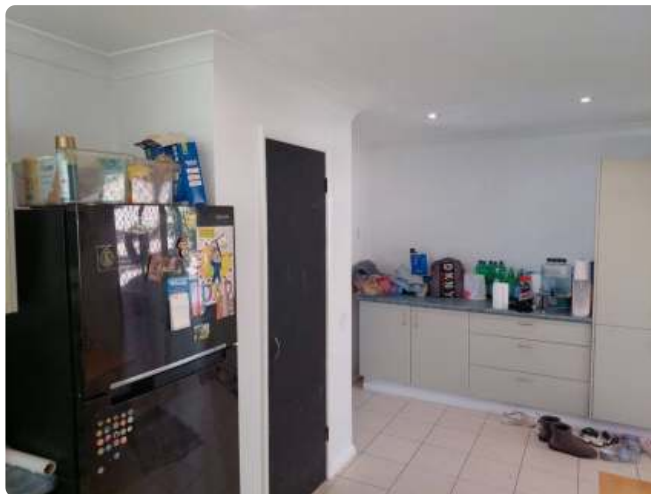
Multiple kitchen floor tiles are cracked, which may present a trip hazard, allow moisture ingress into the subfloor, and indicate possible movement or inadequate substrate preparation.

Sealant cracking at the bench and wall tiles will likely cause water ingress within benchtop.

Damage evident below the window frame.

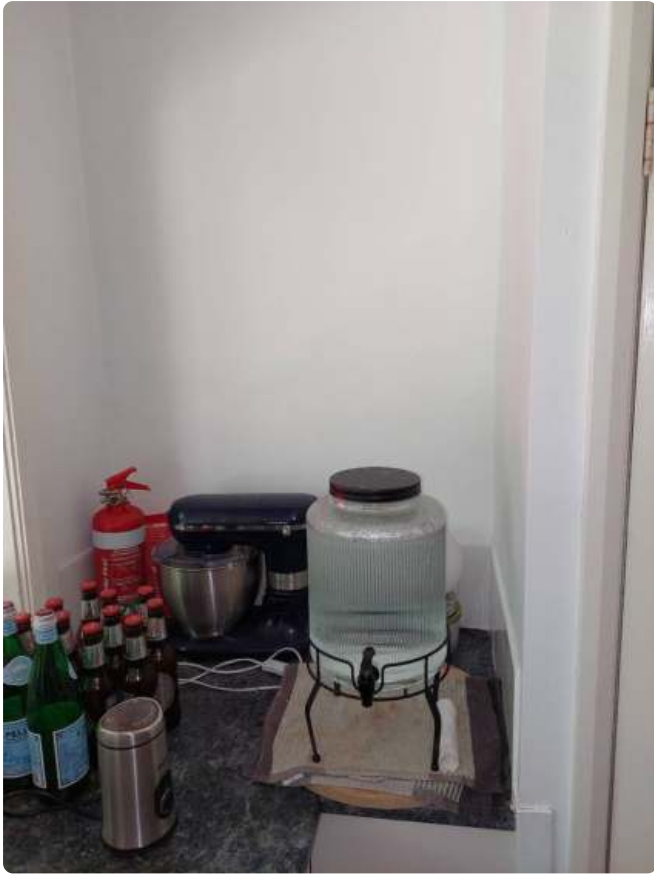
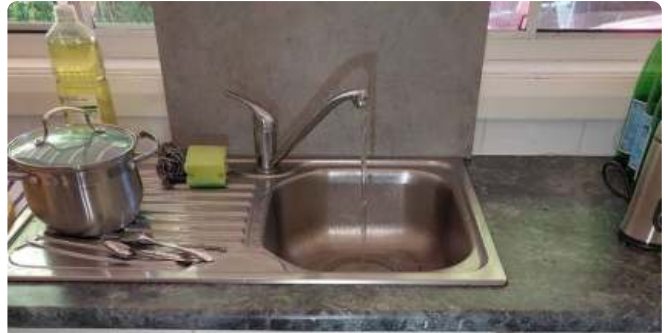
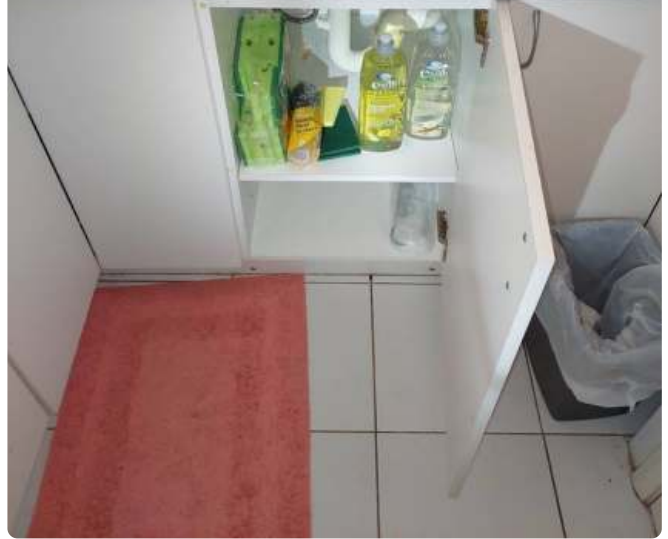
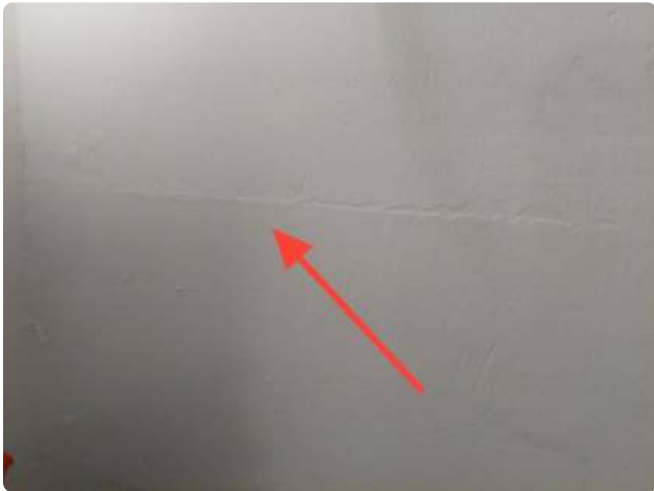
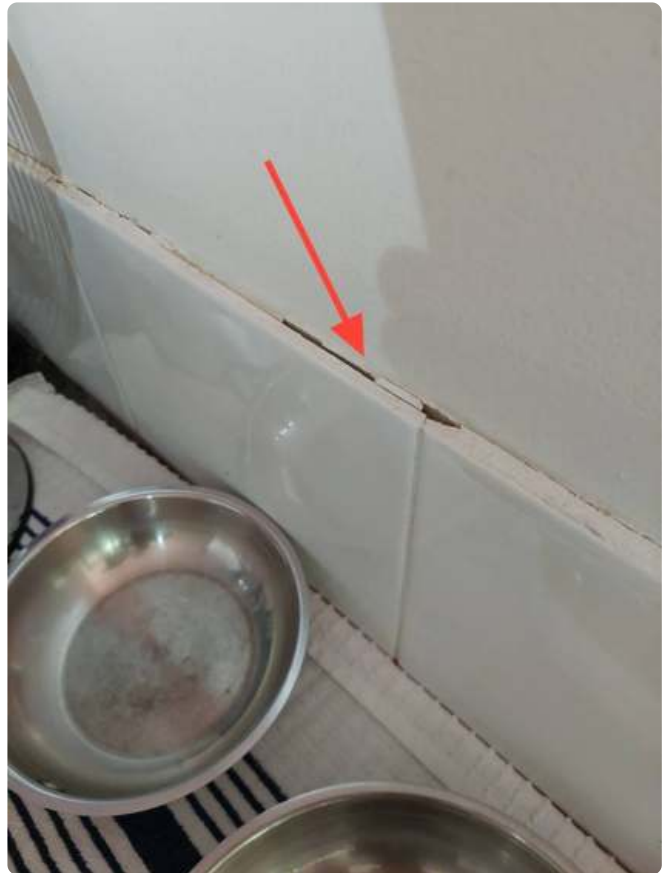
Multiple cracks and areas of minor water staining are present on the walls and ceiling in Kitchen 2, which may indicate movement or previous moisture ingress, raising concerns about possible structural movement and the potential for concealed water damage or conditions conducive to timber pest activity.

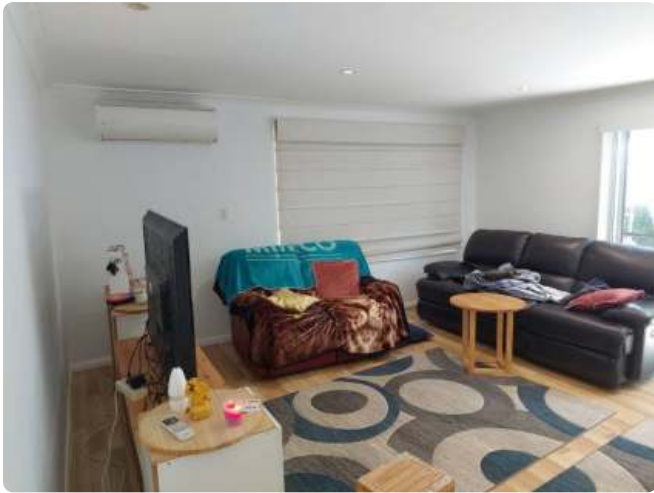
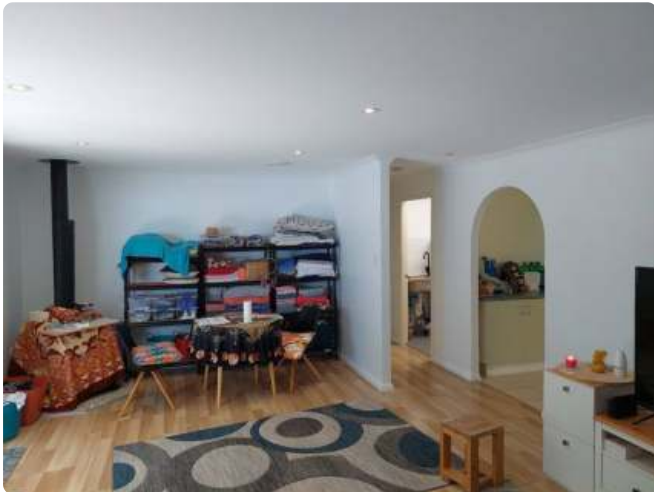
## Lounge

Moisture staining and discolouration are present on the lounge ceiling, and bubbling paint in the corner of the wall are indicating a history of water ingress. Damage noted to fireplace.

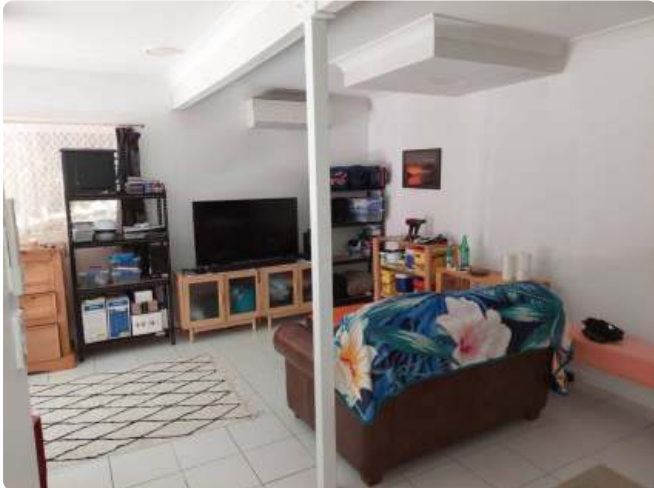
## Family

Multiple structural and movement-related cracks are present in the ceiling, cornices, and wall junctions of the Family area, indicating possible building movement or settling.

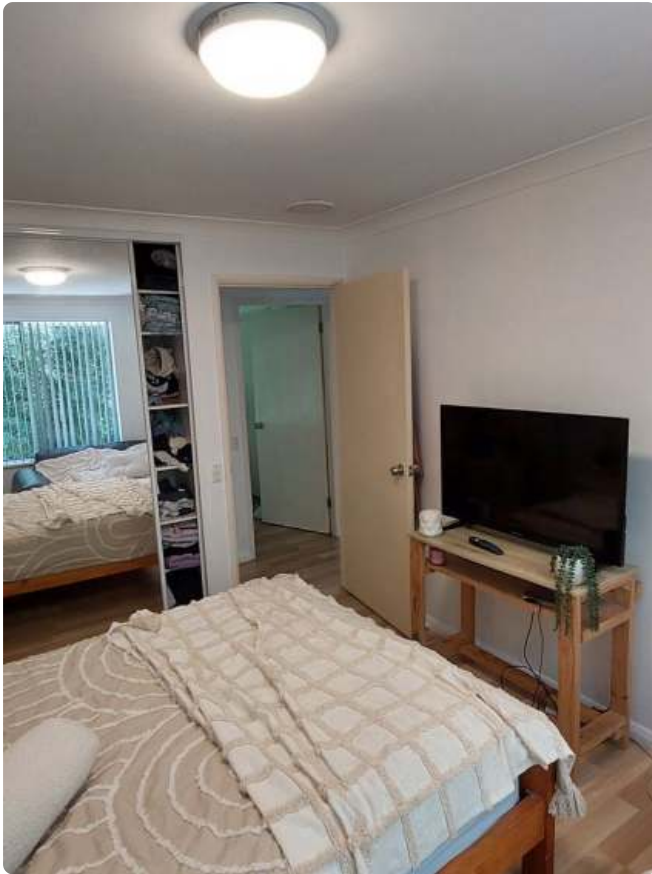
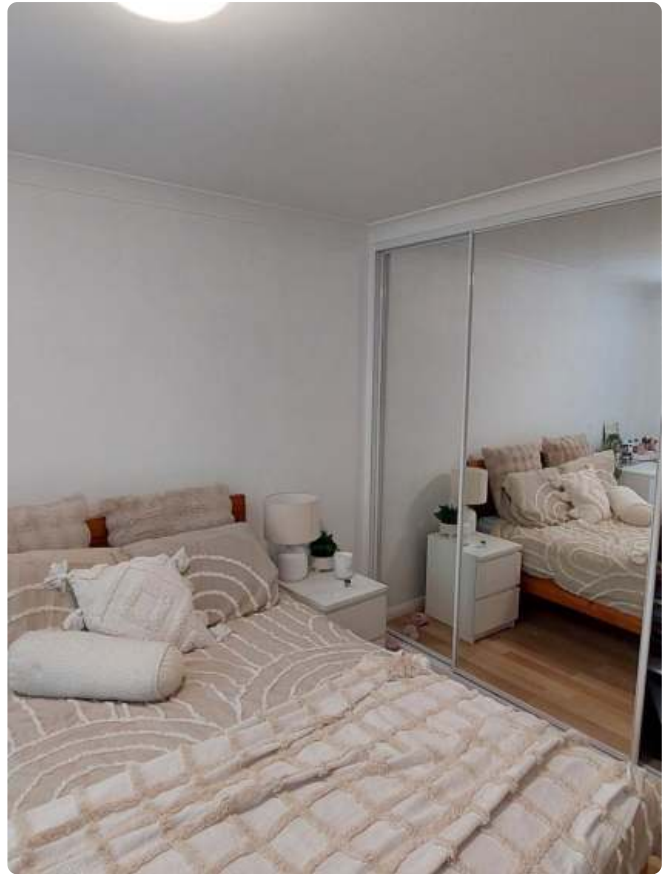
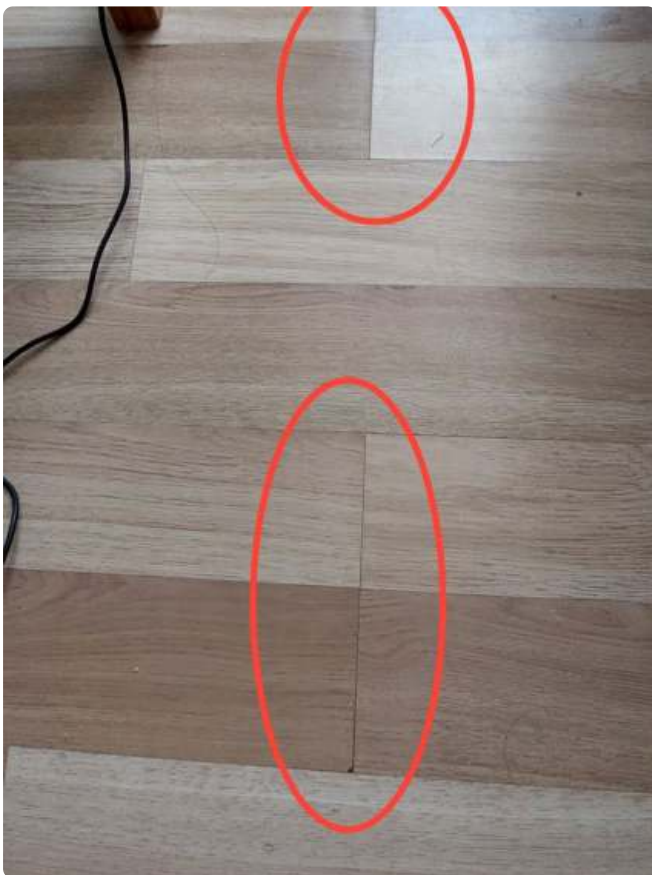
**Bedroom 1 - Continued**

Lifting or delaminating vinyl flooring is present in Bedroom 1, which allows moisture ingress that may lead to subfloor deterioration.

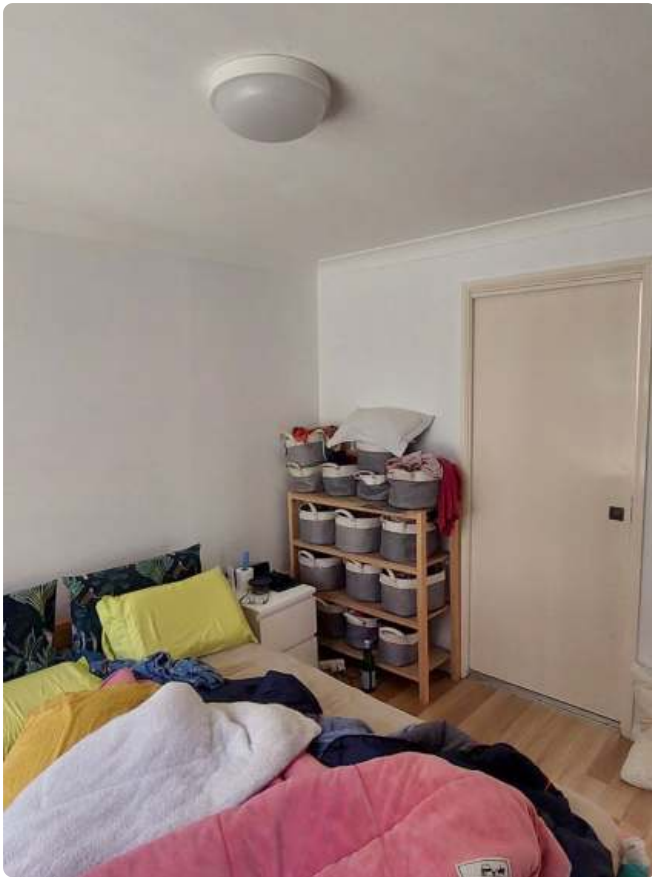
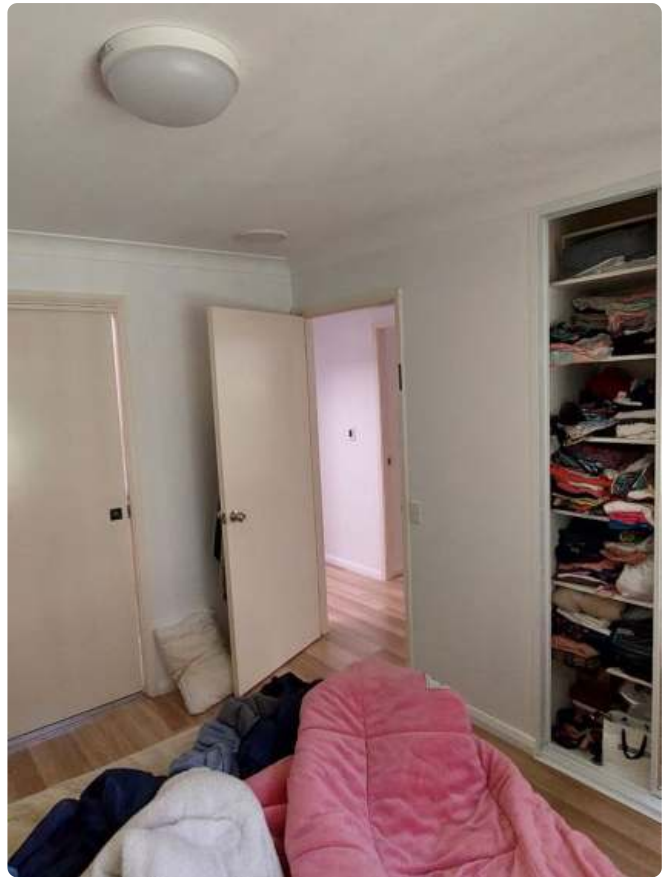
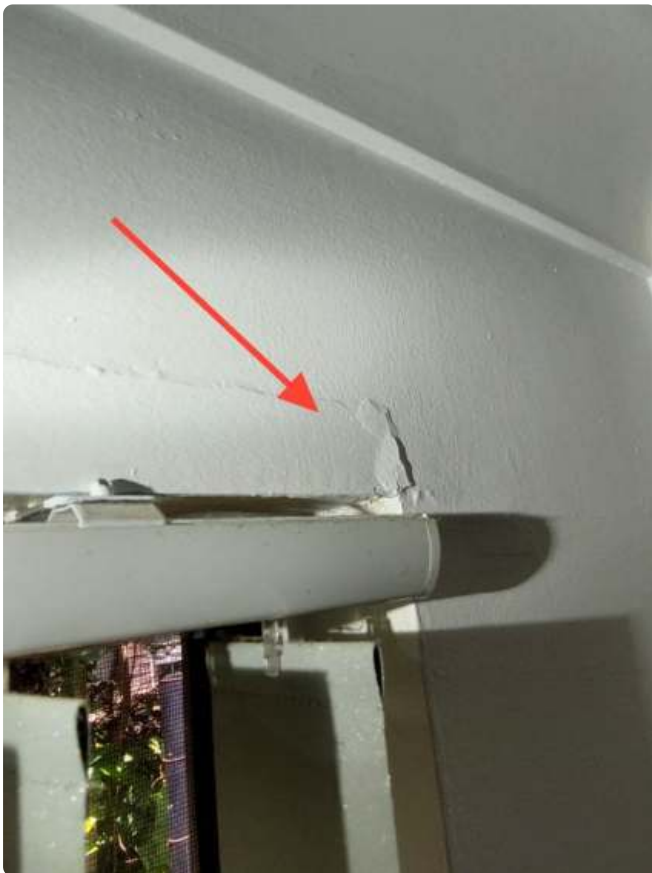
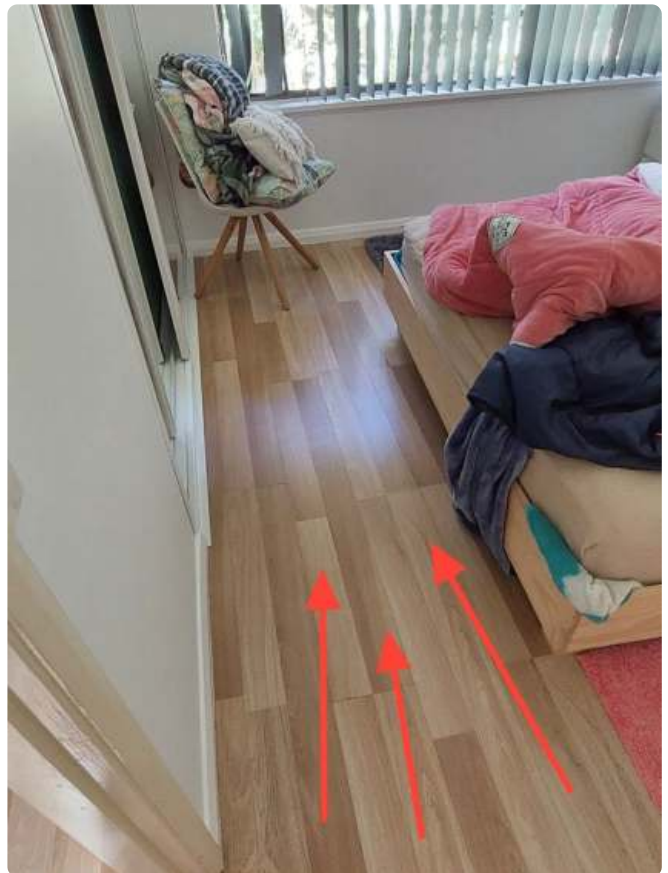
### Bedroom 3 - Continued

Flooring in Bedroom 3 slopes toward the window and cracking is present above the window, indicating possible differential settlement or structural movement.

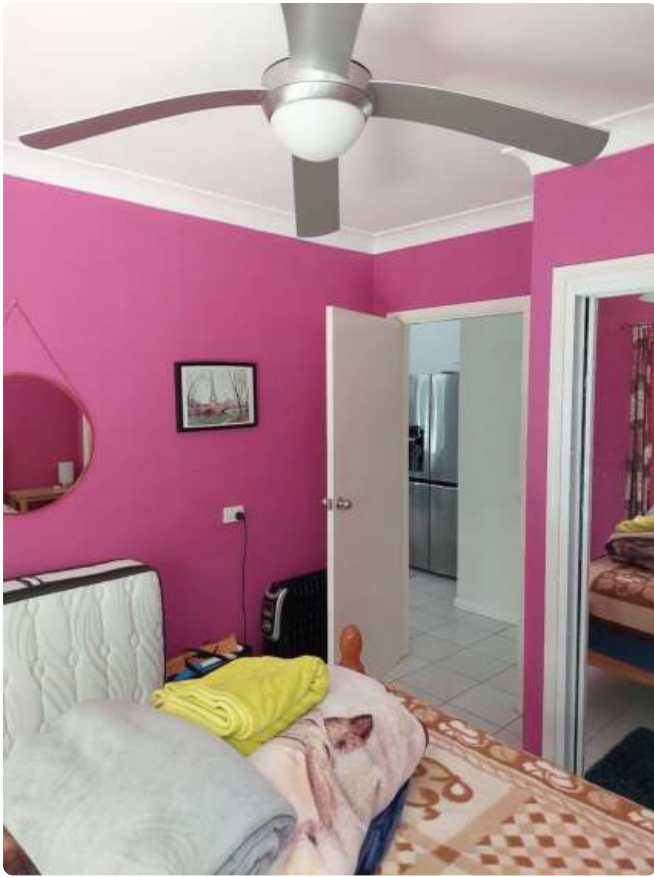
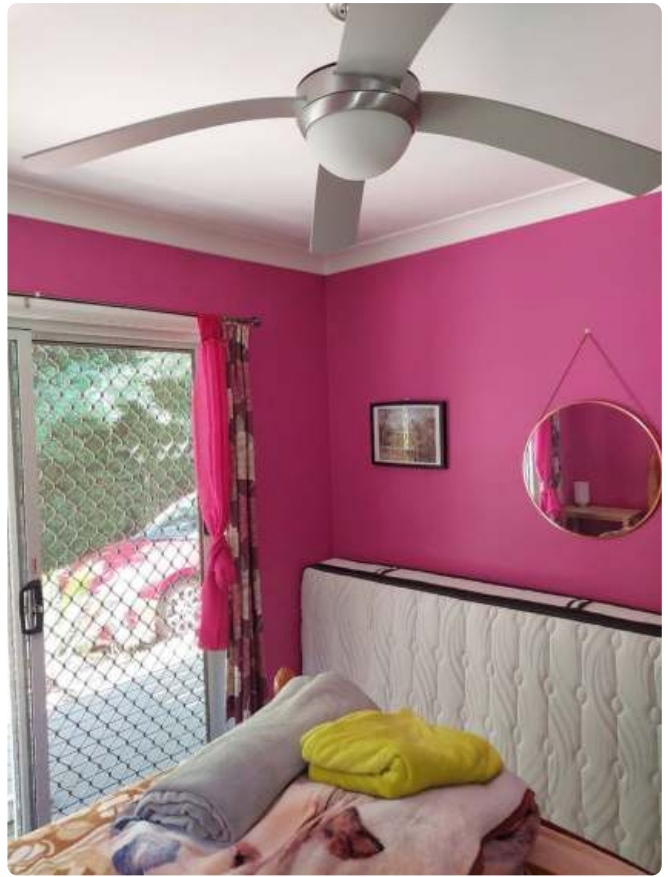
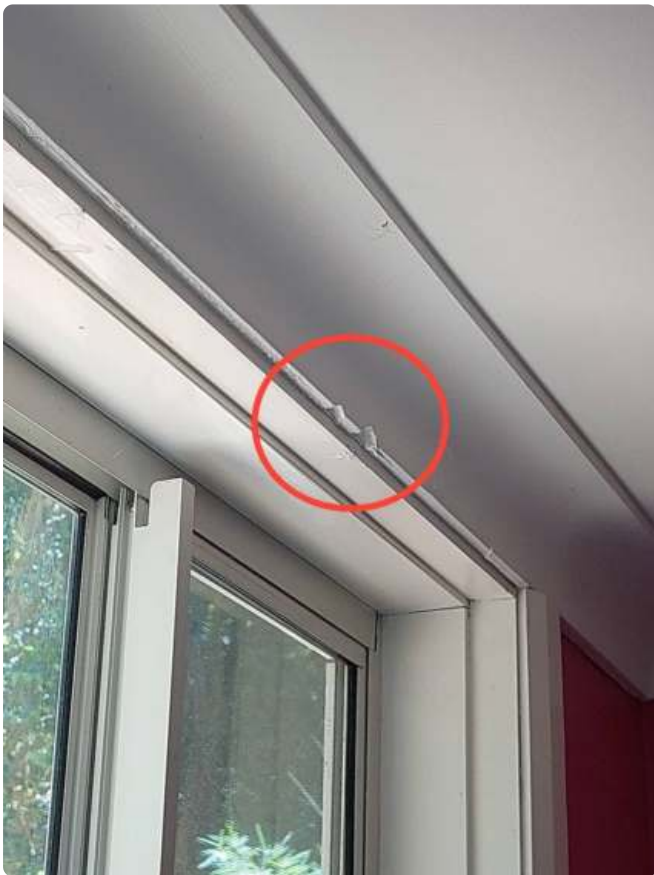
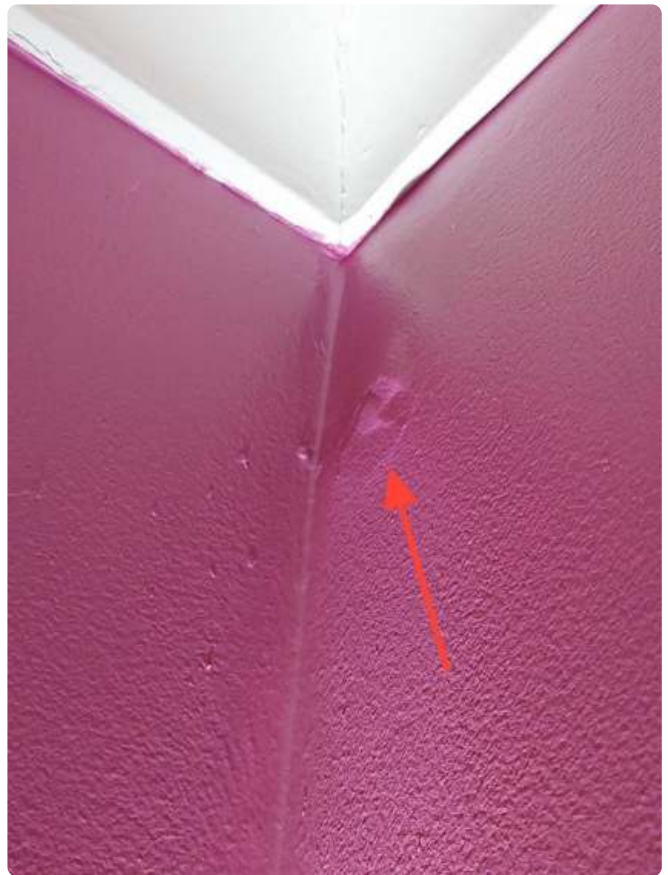
Localised areas of paint bubbling and uneven finish are present on the wall and window reveal in Bedroom 4, which may indicate previous moisture ingress or substandard surface preparation.

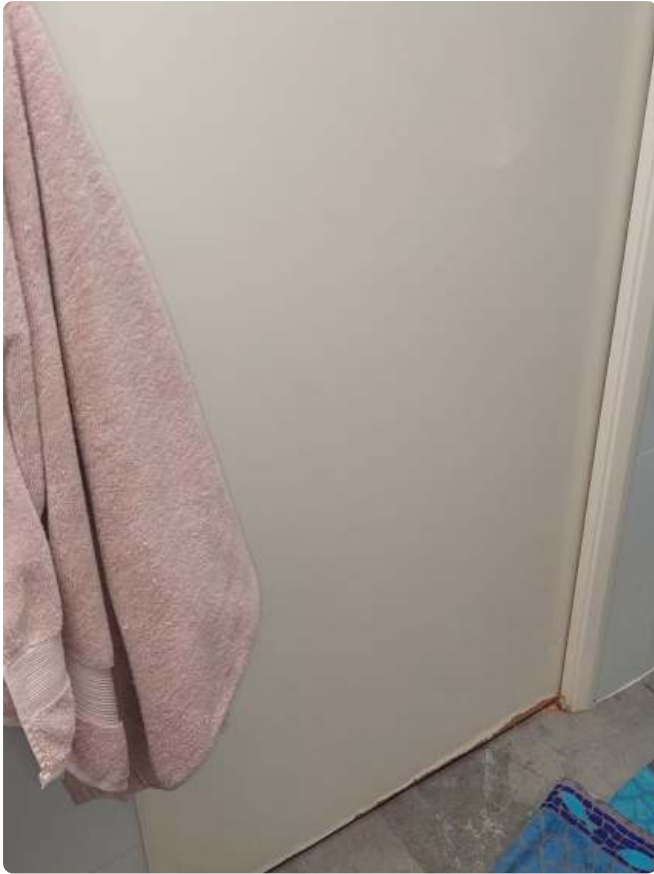
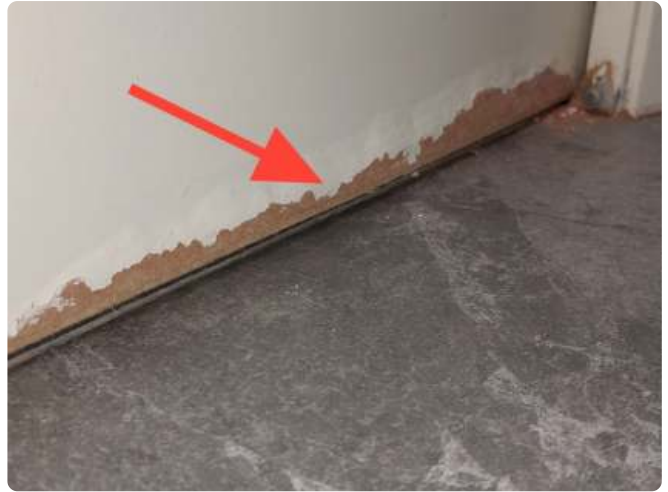
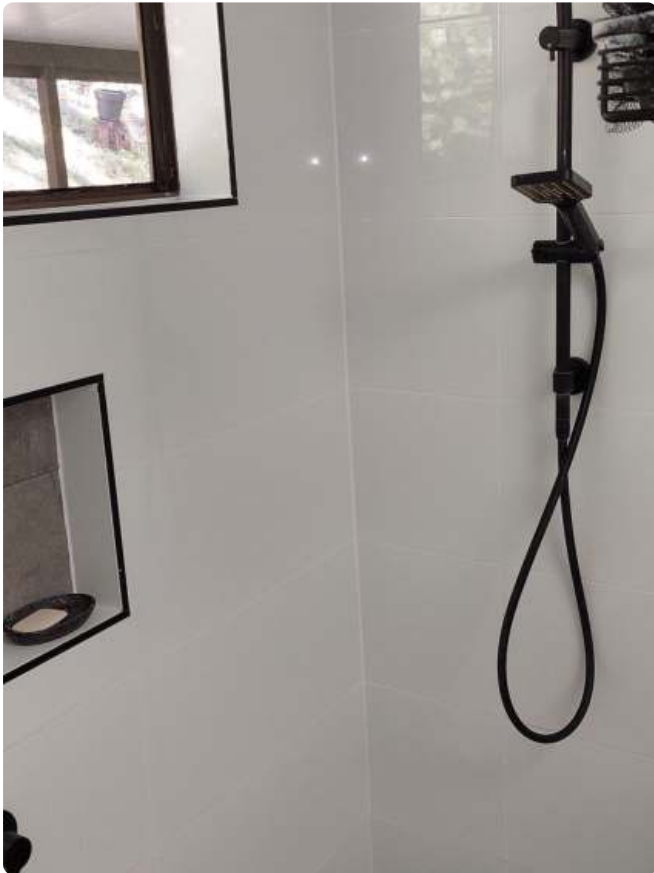
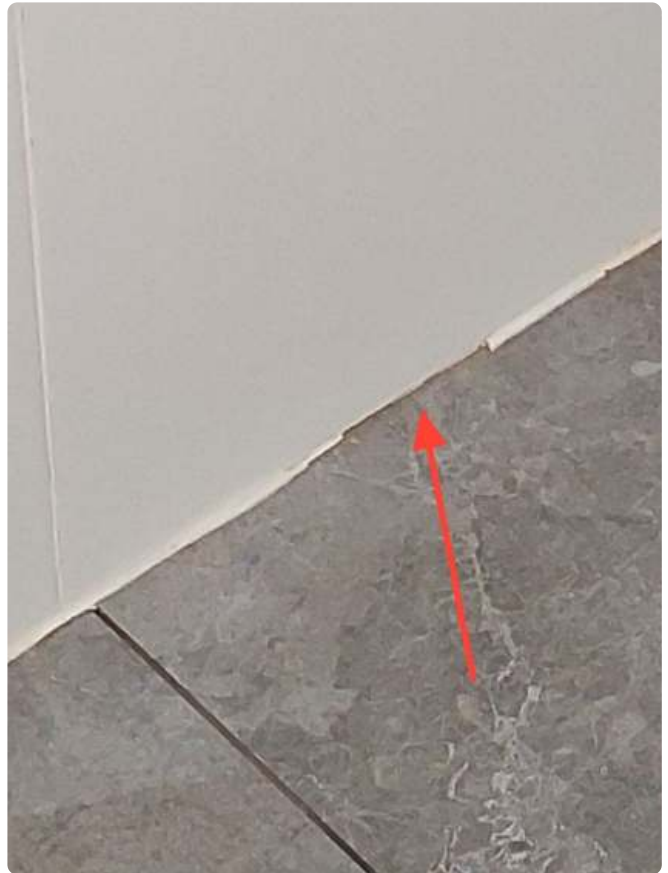
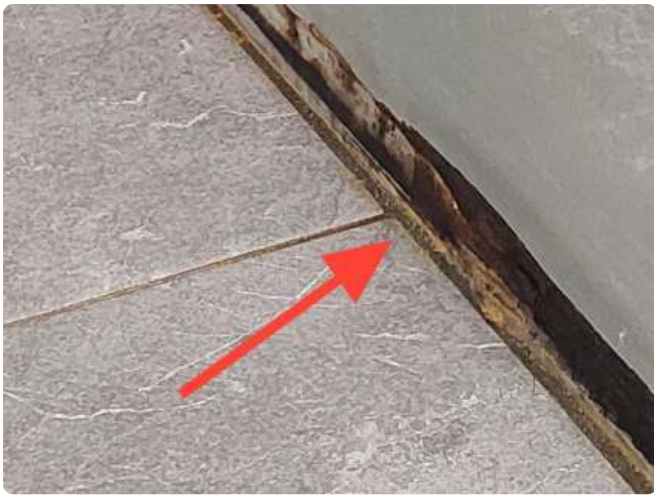
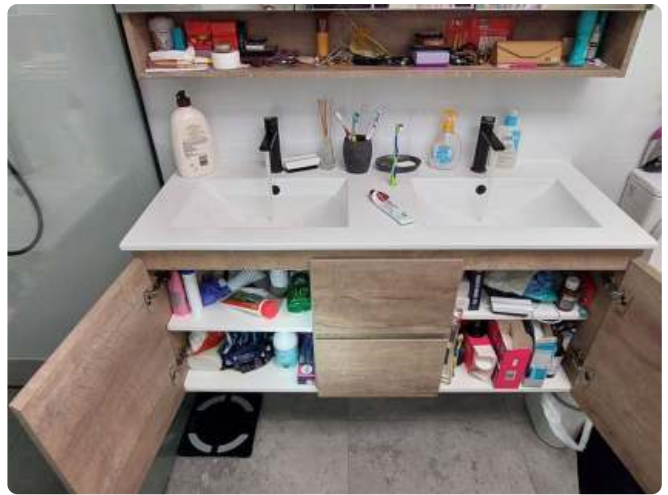
The bathroom exhibits water damage and swelling to the base of the door and visible deterioration to the shower screen base, indicating ineffective waterproofing and ongoing moisture ingress.

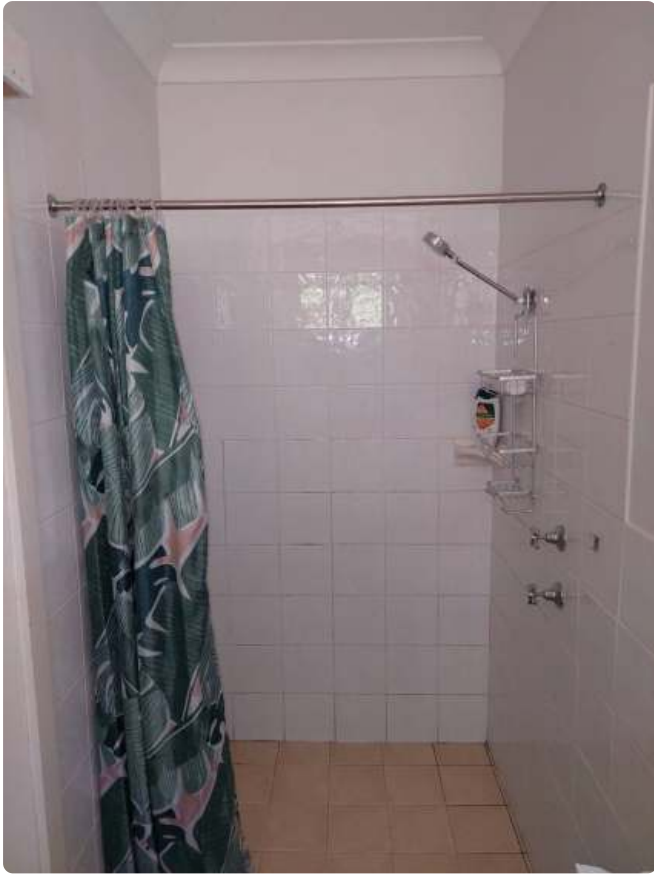
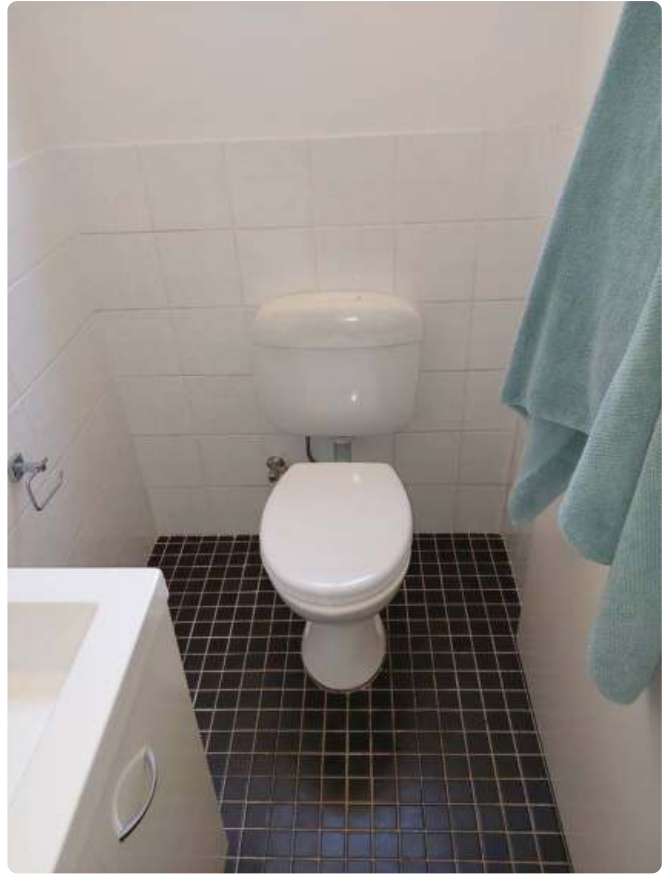
Cracked wall and floor tiles, along with missing grout in the shower area of Bathroom 2, present a risk of water ingress to underlying building elements, which can lead to concealed moisture damage, potential structural deterioration, and conditions conducive to timber pest activity.

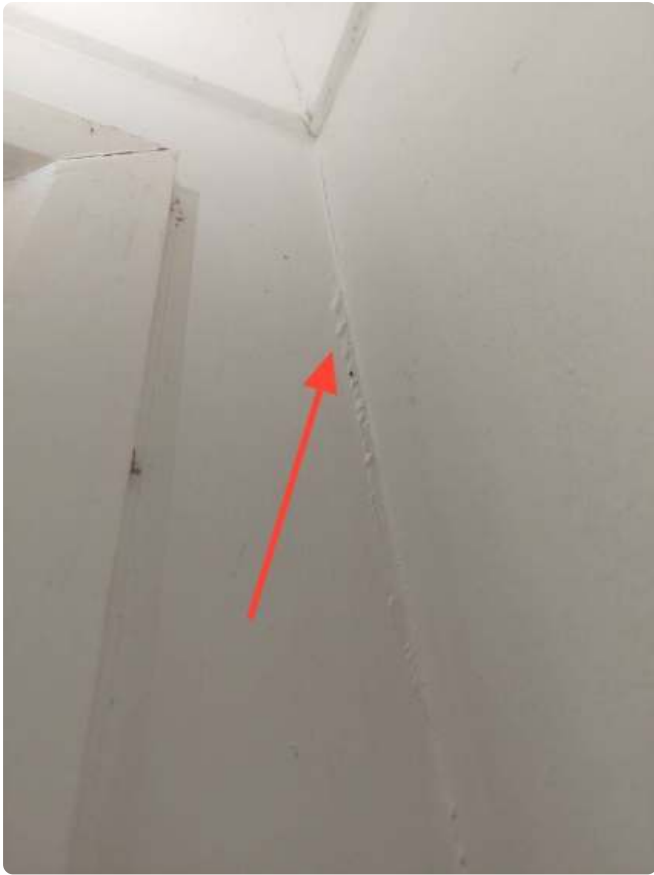
paint bubble

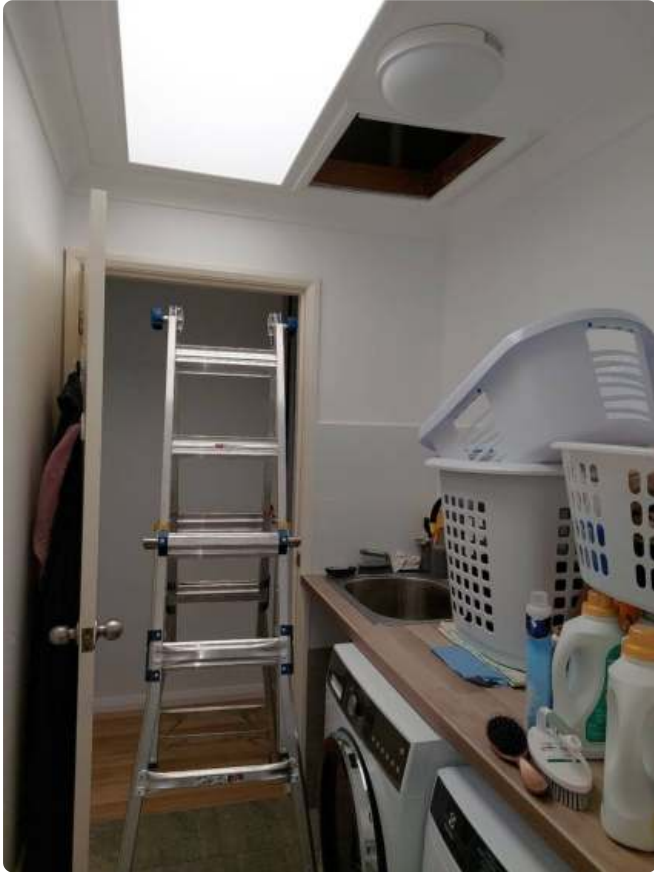
Unable to access roof space fully due to laundry fit out.

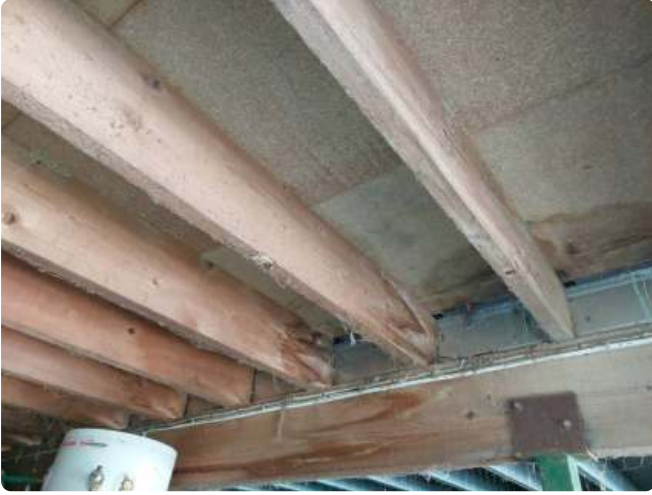
## Floor Framing - Continued

Floor Structure	
Status of floor structure	Minor Defect
Flooring slopes near Bedroom 1 & 2.

All timber floors will have movement, it comes with the age of the building and can cause squeaking and movement in the timber floor and the frame work. This can be addressed at some stage by screwing the existing timber flooring down to the timber floor joists.
