## VISUAL BUILDING & PEST INSPECTION REPORT

Complies with Australian Standard 4349.1 & 4349.6

**43 Abingdon Road, Roseville**

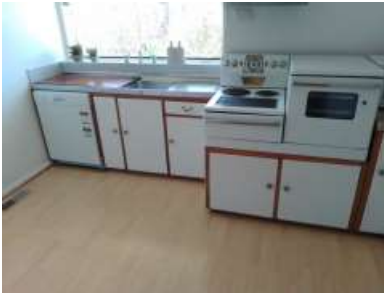
The condition of the fixtures is generally fair.

Sink and taps appear in serviceable condition. Drain appears serviceable.

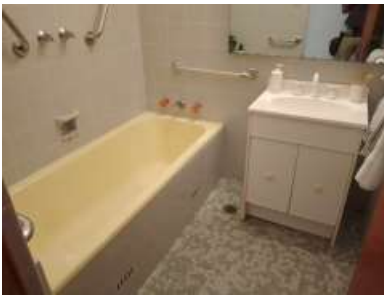
Adjacent to hall.

The shower is located over the bathtub. The area will need to be kept well sealed to prevent water penetration to surrounding areas.

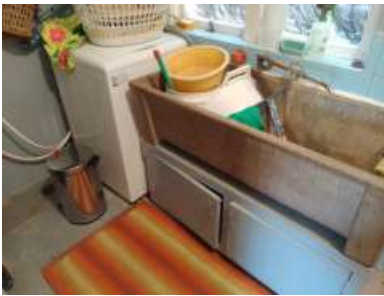
Rear.

The tub and taps appear serviceable. Drain appears serviceable.

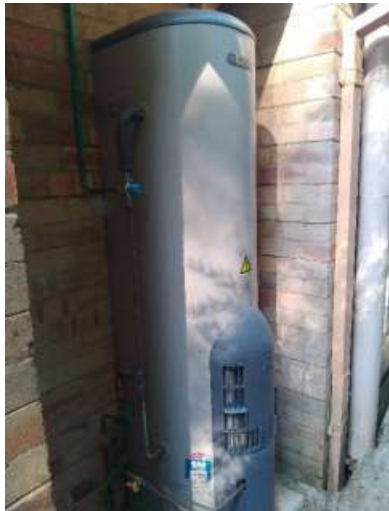
Gas hot water system: Mains pressure: Located externally:

The unit was manufactured in 2023.
