Building and Pest Report

26 Mosman Chase Lennox Head

Pest And Building Inspection

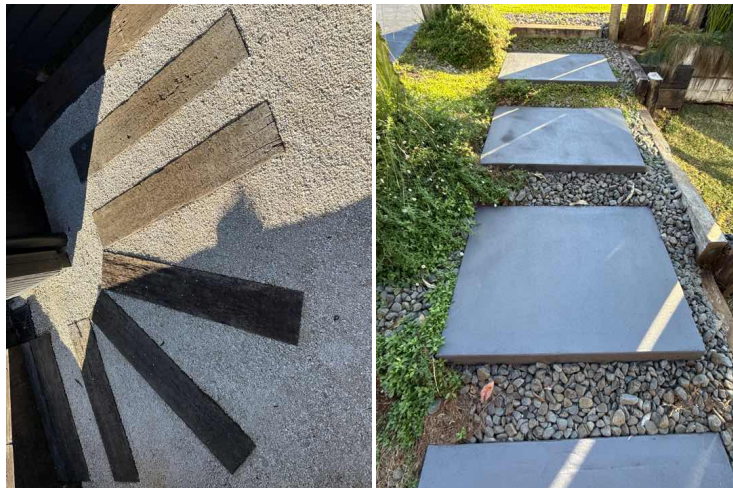
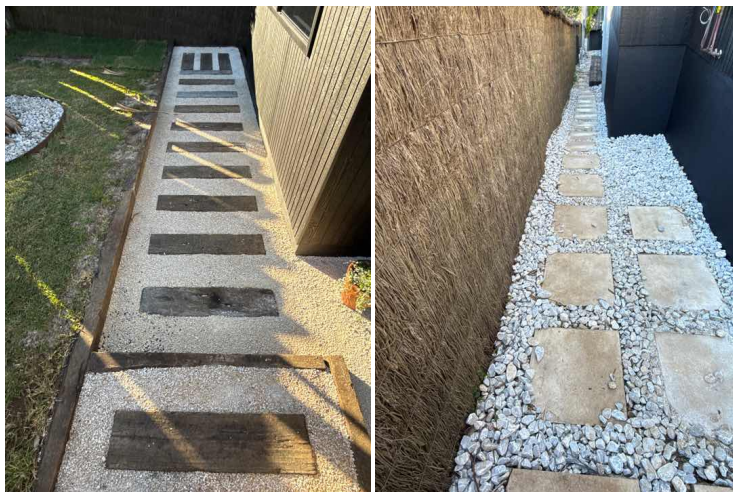
Pathways Condition

The paths around the home are in a serviceable condition for the age of this dwelling with no major defects visible.

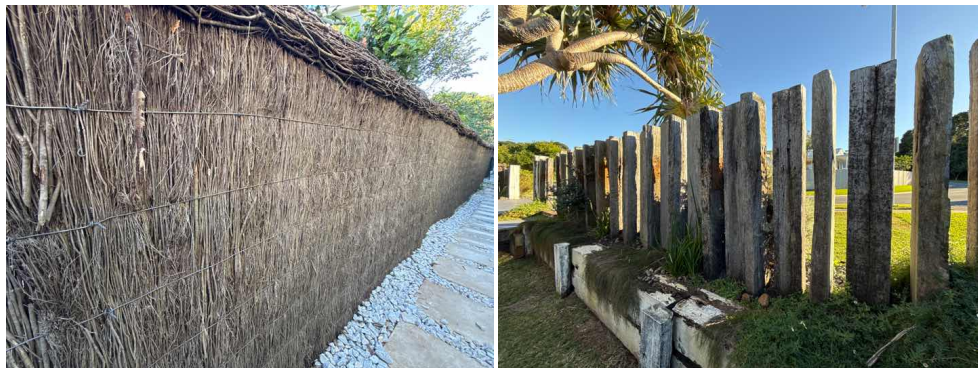
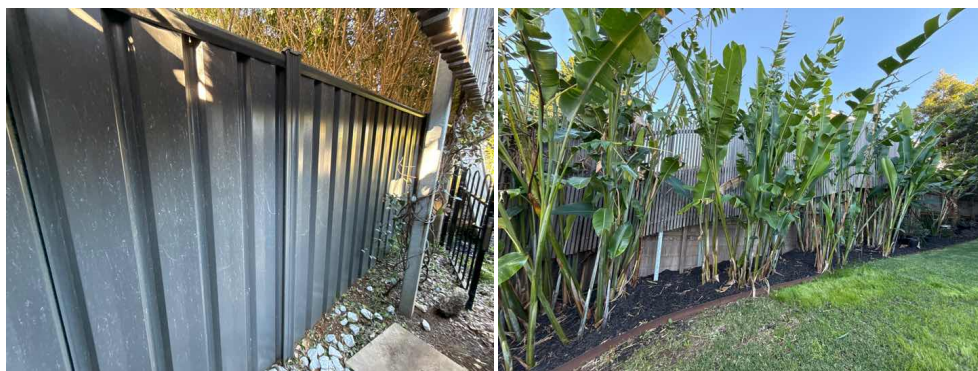
Fences & Gates

Of the visible areas, the general condition of the fences and gates is serviceable for the age of dwelling.

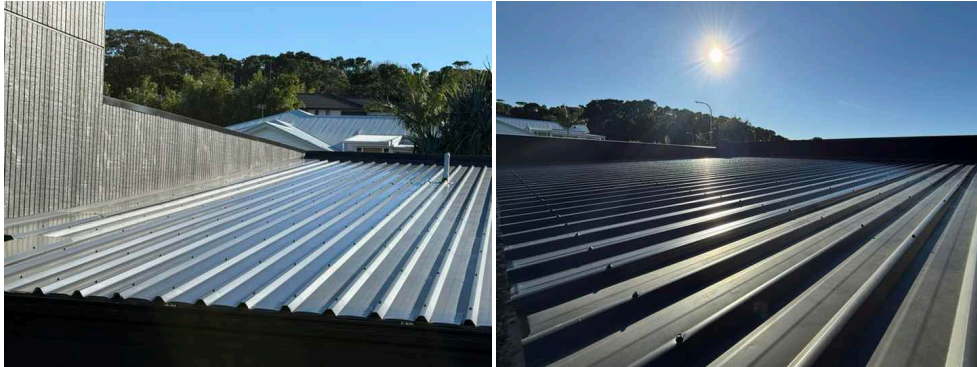
Of the visible areas, the general condition of the roof is in serviceable condition for the age.
Note: In the absence of rainfall there is no guarantee that the roof won't leak.

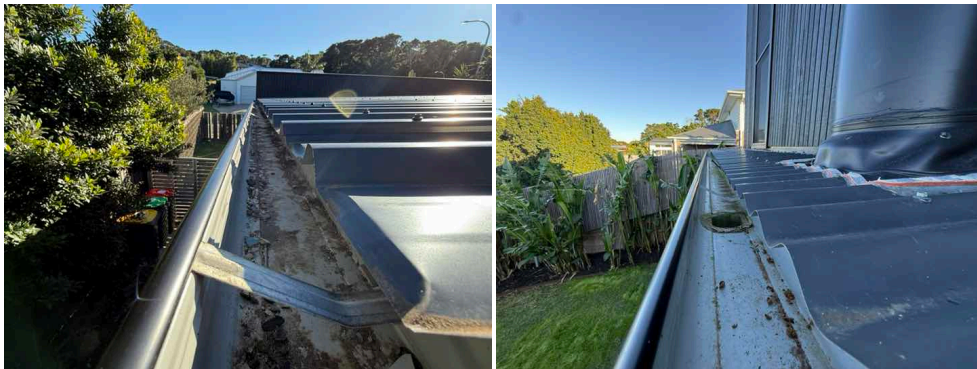
Guttering

All visible and accessible of the physical nature of the guttering system appears to be in a serviceable condition with no apparent defects at the time of inspection. In the absence of prolonged rain fall efficiency of the guttering can not be assessed and you may find that further investigation or repairs maybe required. Note: Periodic maintenance checks should be carried out for rust penetrations and leaks.

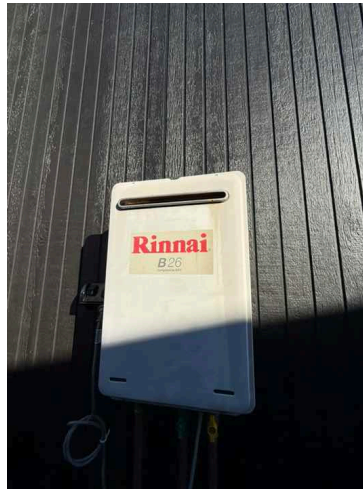
The make of the hot water unit is rinnai.

Unable to determine , no label

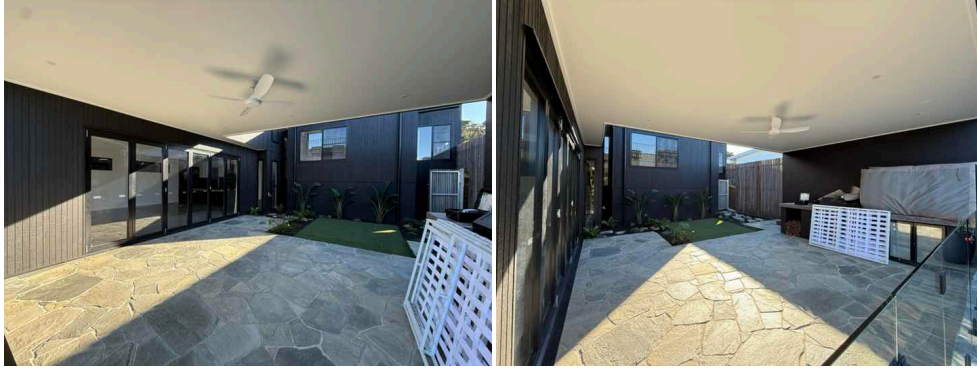
Visible sections of the Alfresco area are serviceable or in reasonable or condition for the age of this dwelling.

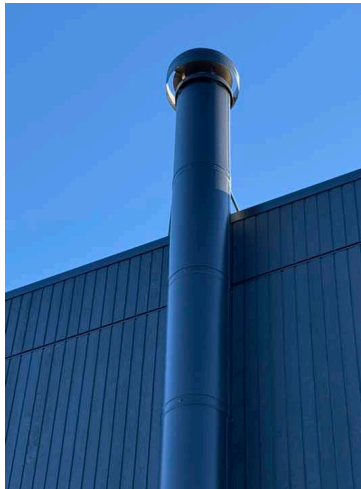
Chimney

On visual inspection, the general condition of the chimney walls is serviceable for the age.

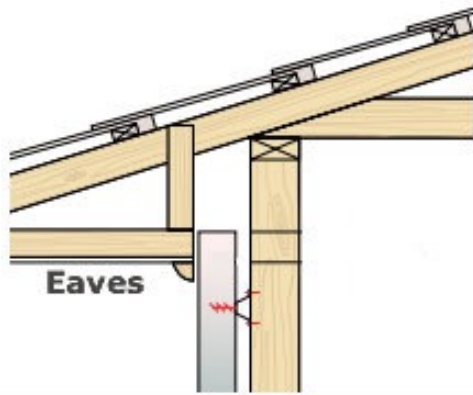
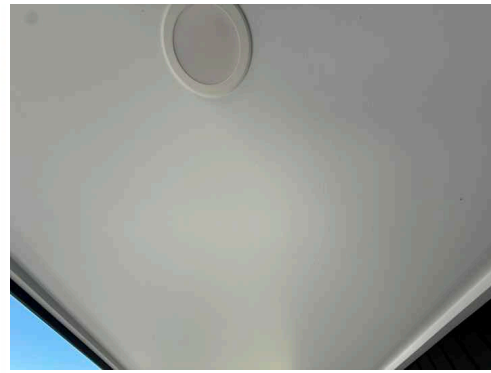
Eaves

The soffit lining (eaves) are in a serviceable condition with no notable defects.

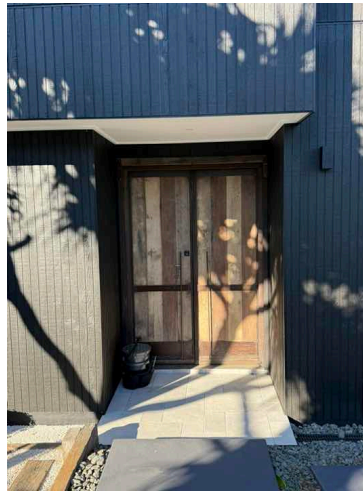
Entry Porch Area

The entry porch serviceable or in reasonable or condition for the age of this dwelling.

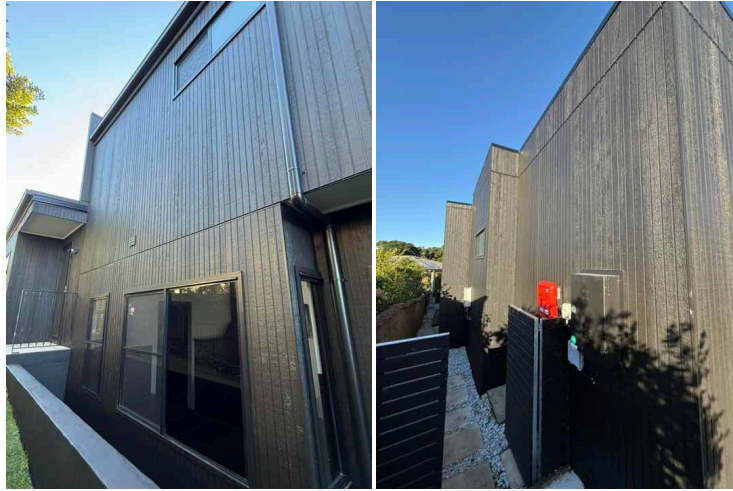
Fibrous cement sheeting. Some fibro may contain asbestos, we recommend that you organise a asbestos inspection to this dwelling prior to a decision to purchase.

On visual inspection, the general condition of the exterior walls is serviceable for the age.

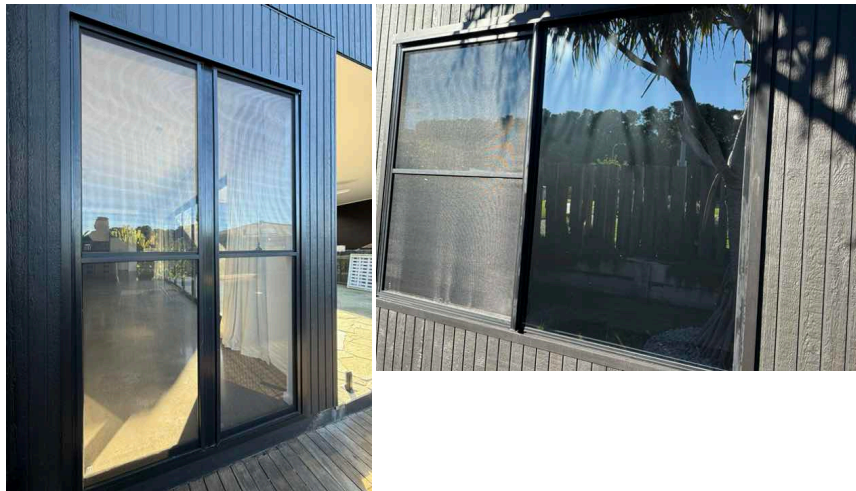
Windows

On visual inspection, the general condition of the windows is serviceable for the age.

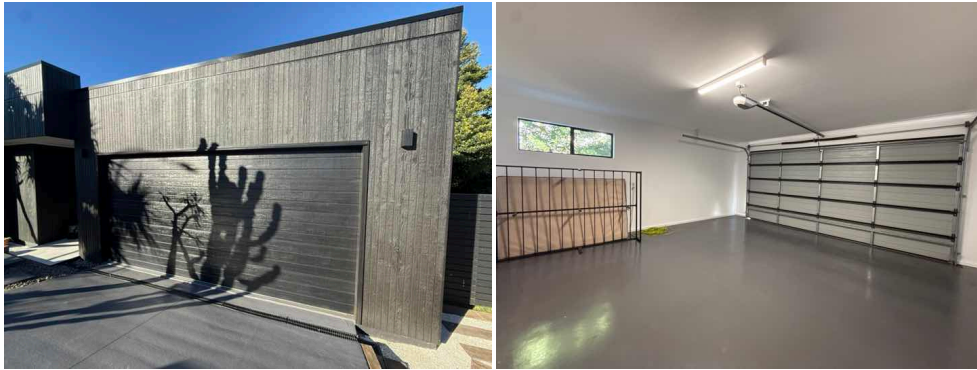
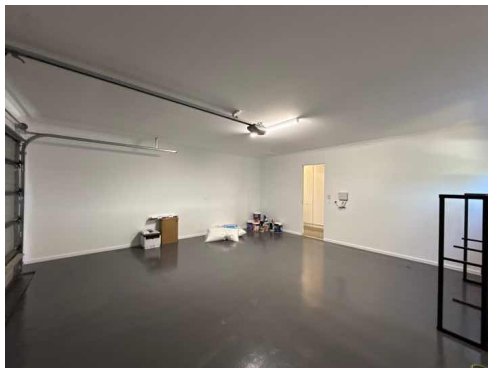
GARAGE - CARPORT

From the visible and accessible areas, the garage appears to be in a serviceable condition for the age of the property with no notable structural defects sighted.

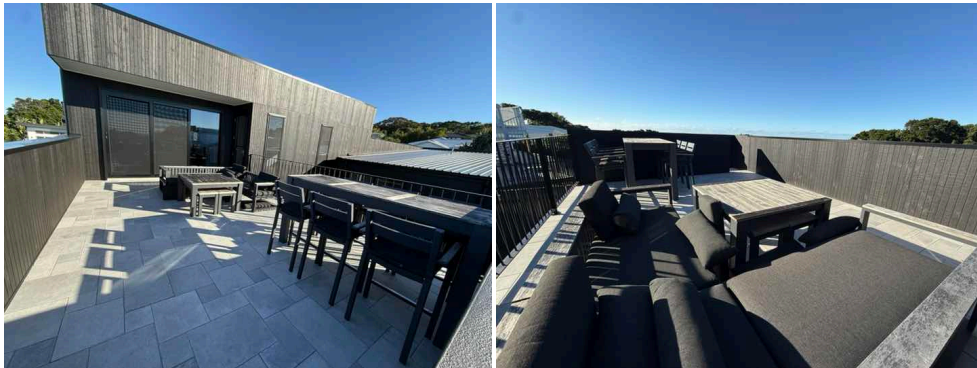
Though we are not structural engineers the balcony/s appear to be in a serviceable condition.

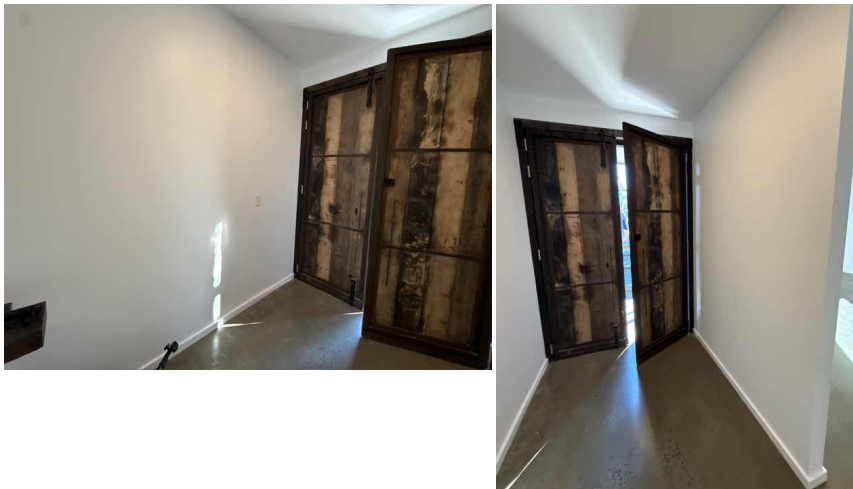
From the visible and accessible areas, this area appears to be in a serviceable condition for the age of the property with no notable structural defects sighted.

Impact damage to wall from door handle. Repairs and installation of a door stop recommended

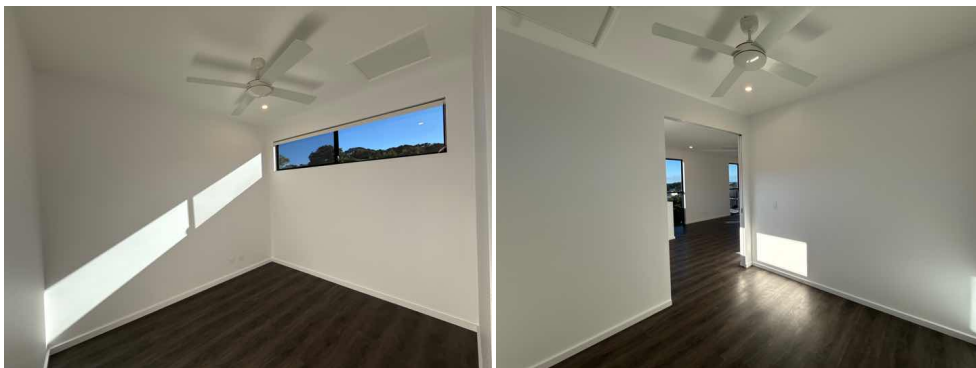
From the visible and accessible areas, this room appears to be in a serviceable condition for the age of the property with no notable structural defects sighted.

Settlement Cracks Noted. These are typical and generally patch and paint will suffice, however monitoring these cracks is advised for 12 months and if they become worse, further investigation by a suitably qualified professional is advised.

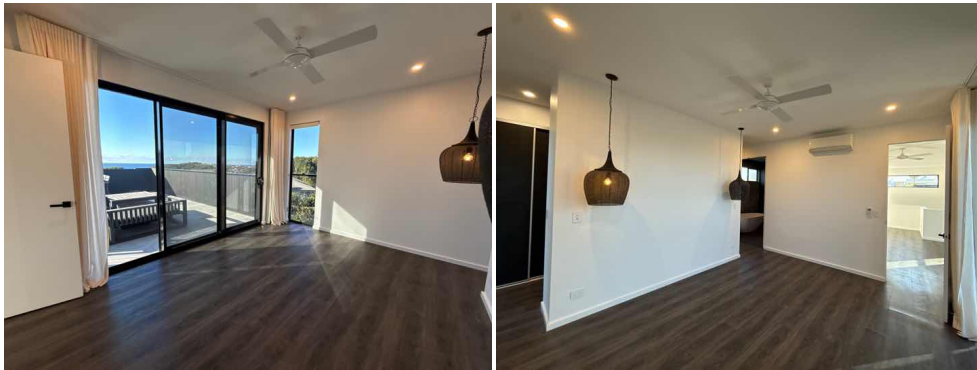
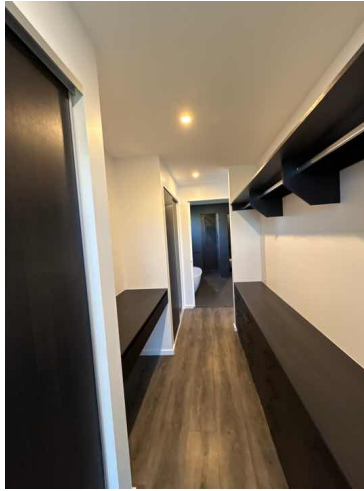
From the visible and accessible areas, this bedroom appears to be in a serviceable condition for the age of the property with no notable structural defects sighted.

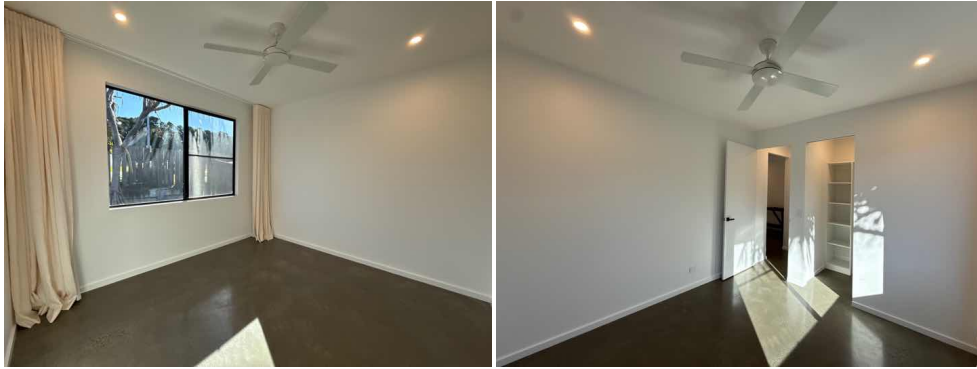
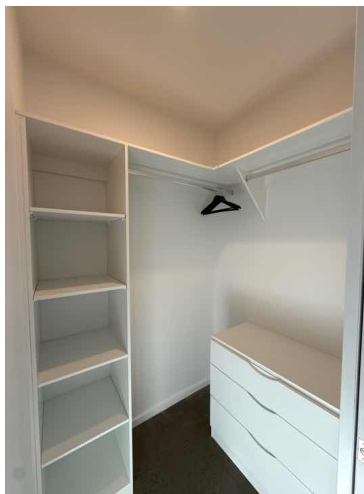
Bedroom 2

From the visible and accessible areas, this bedroom appears to be in a serviceable condition for the age of the property with no notable structural defects sighted.

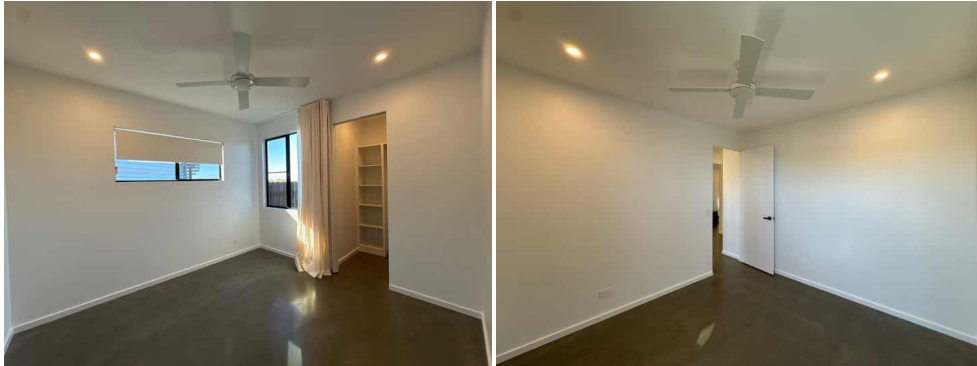
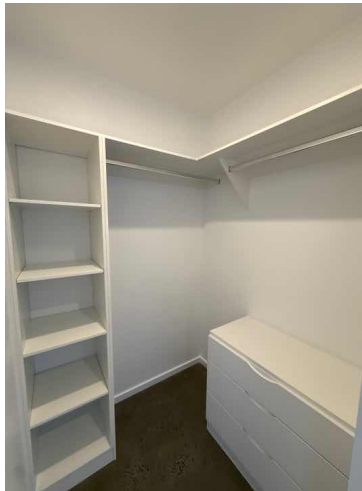
Bedroom 3

From the visible and accessible areas, this bedroom appears to be in a serviceable condition for the age of the property with no notable structural defects sighted.

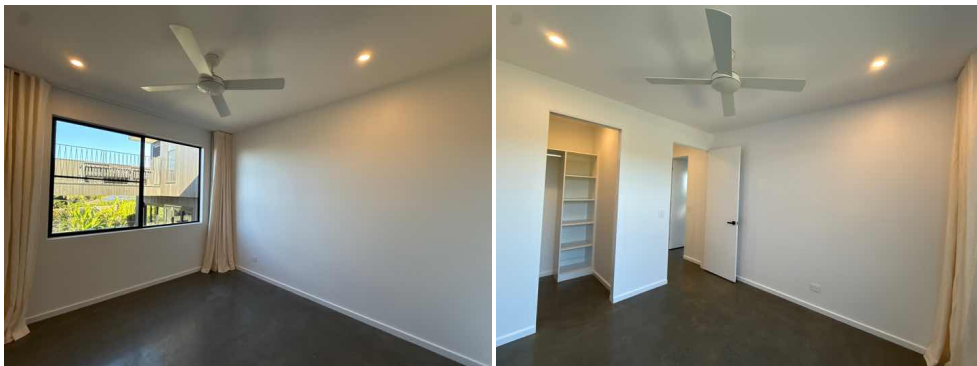
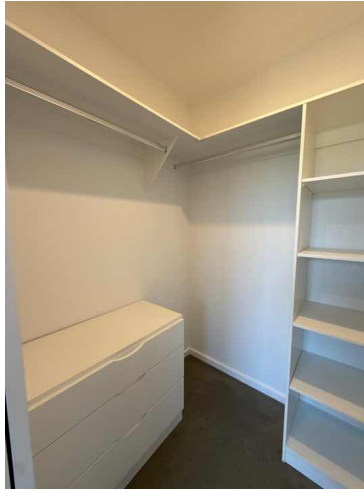
Bedroom 4

From the visible and accessible areas, this bedroom appears to be in a serviceable condition for the age of the property with no notable structural defects sighted.

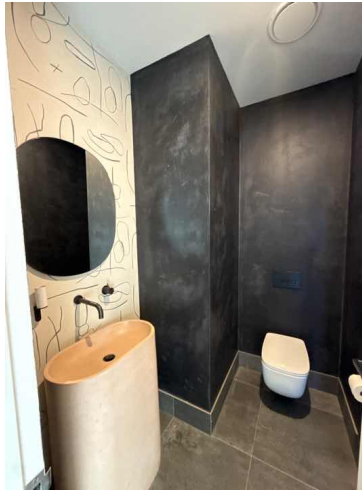
Of the visible areas, the general condition of this bathroom is serviceable or in reasonable condition for age of dwelling.

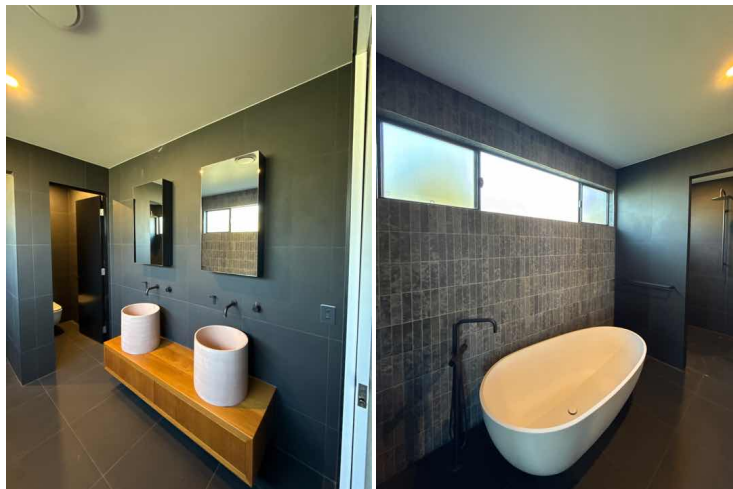
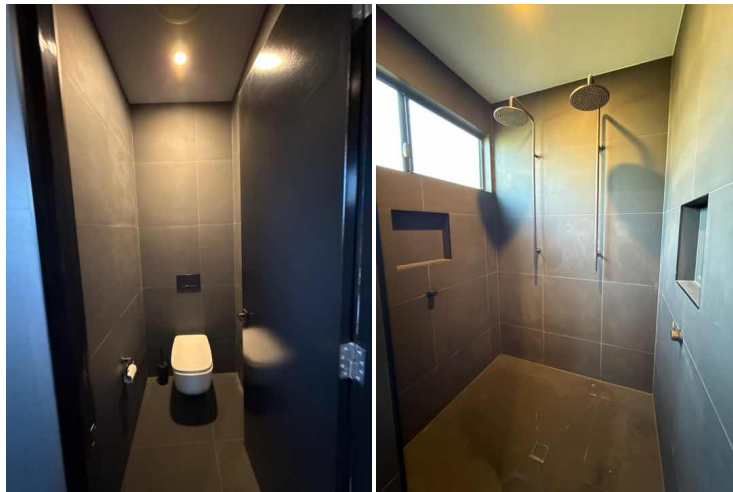
Bathroom 1

Of the visible areas, the general condition of this bathroom is serviceable or in reasonable condition for age of dwelling.

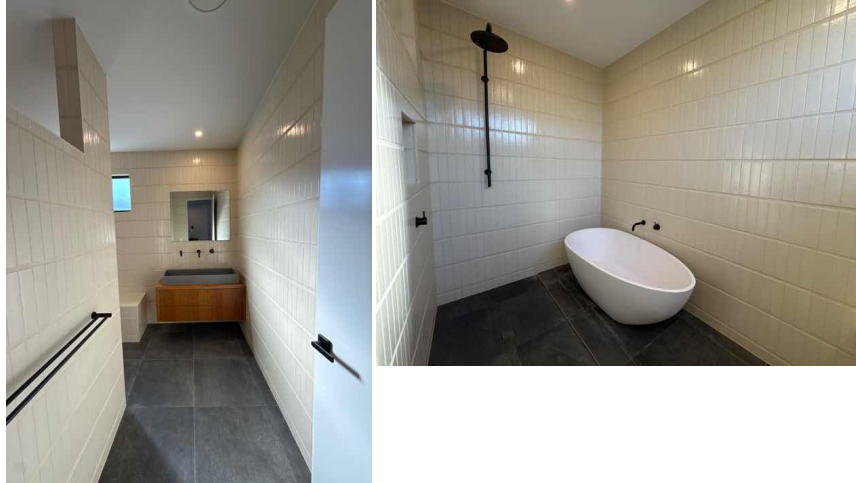
Of the visible areas, the general condition of this bathroom is serviceable or in reasonable condition for age of dwelling.

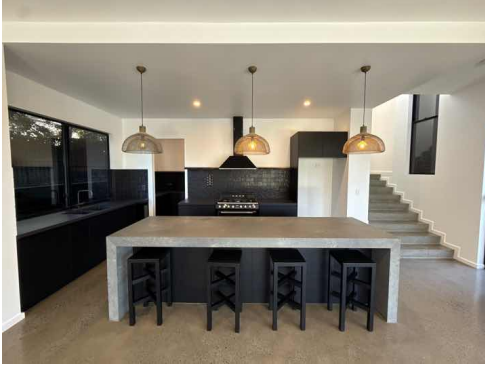
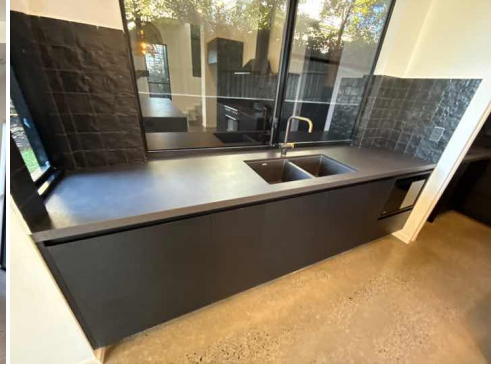
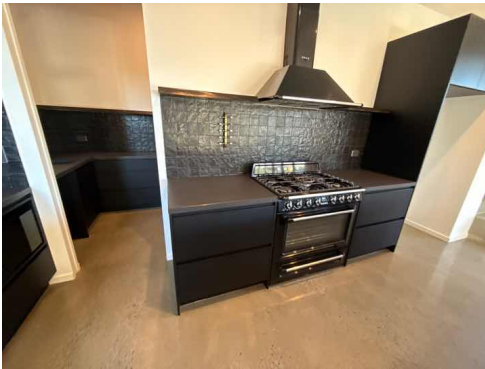
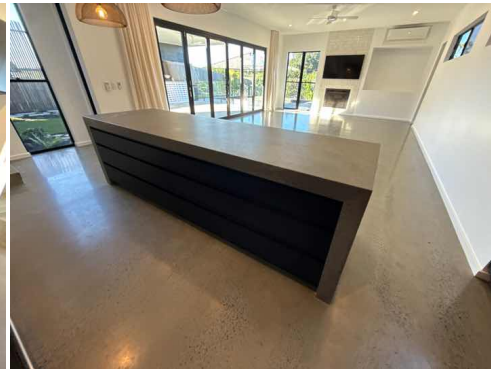
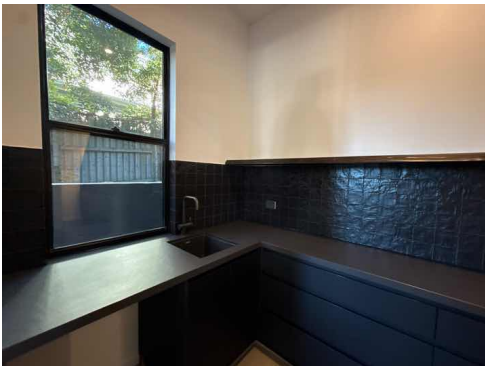
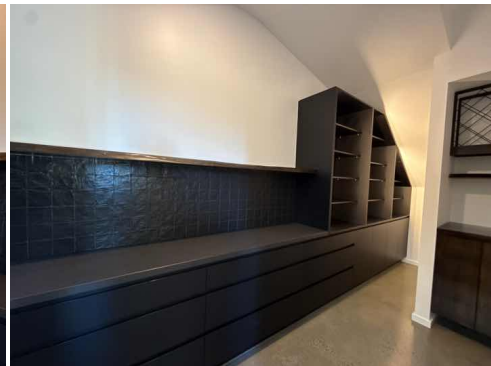
Overall Condition

Of the visible areas, the general condition of the kitchen and pantry is serviceable or in reasonable condition for age of dwelling.

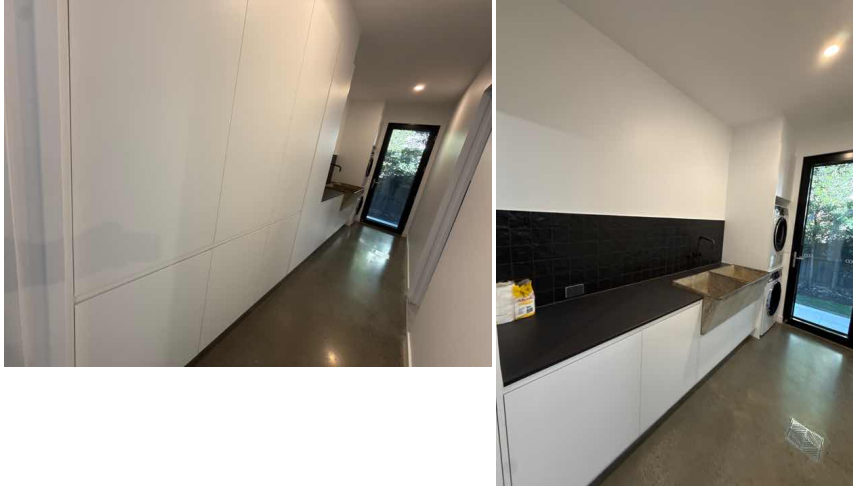
Overall Condition

Of the visible areas, the general condition of the laundry is serviceable or in reasonable condition for age of dwelling.
