Building and Pest Report

1/22 Barrett Drive, Lennox Head

Pest And Building Inspection

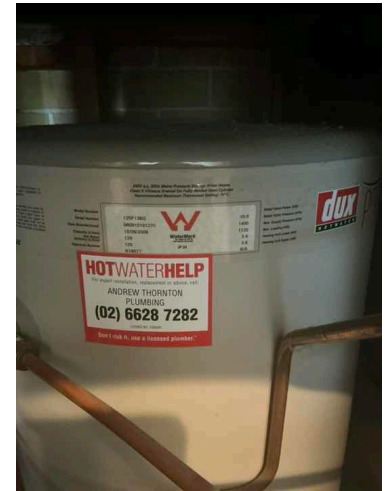
The hot water system appears to be in a serviceable condition. No specific tests other than running the hot water from a tap was carried out. No determination has been made as to the suitability or adequacy of the hot water system in relation to capacity or otherwise.

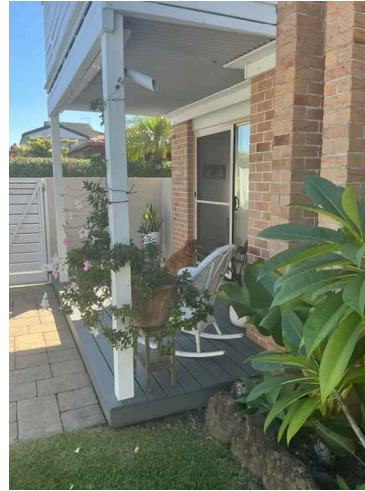
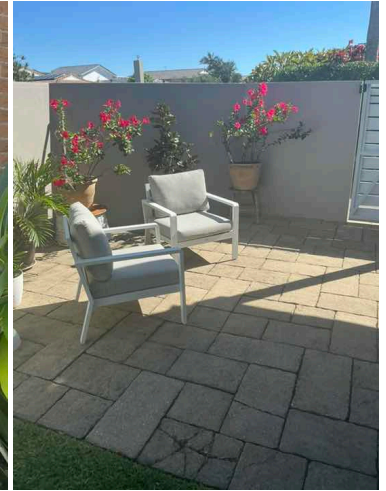
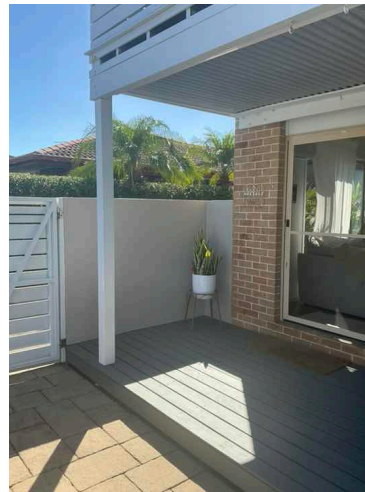
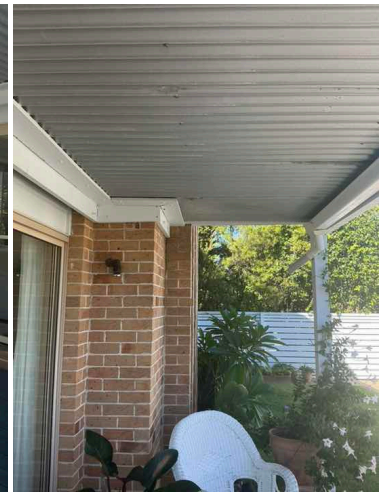
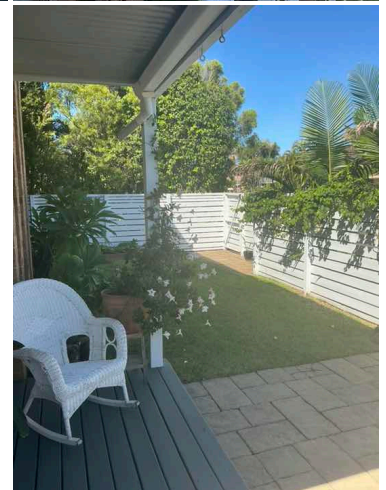
Visible sections of the Alfresco area are serviceable or in reasonable or condition for the age of this dwelling.

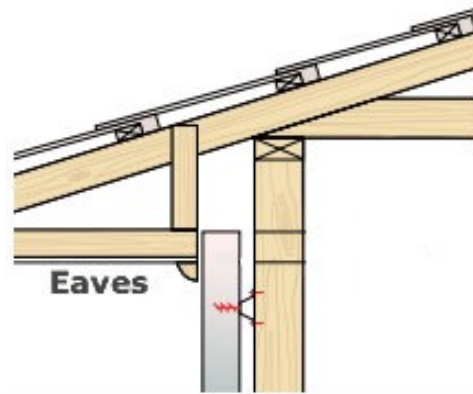
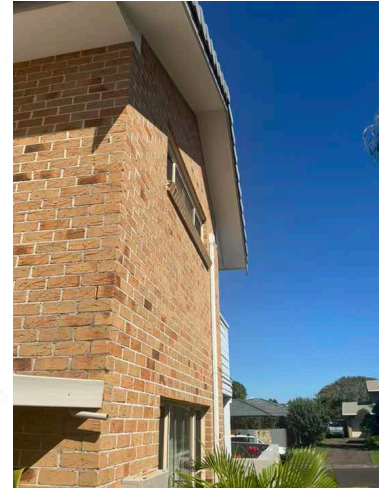
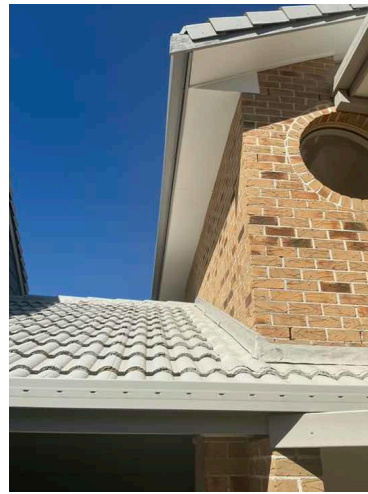
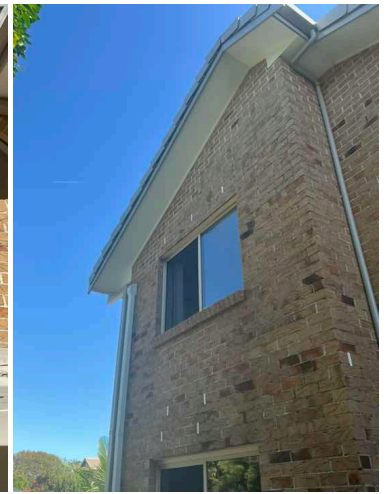
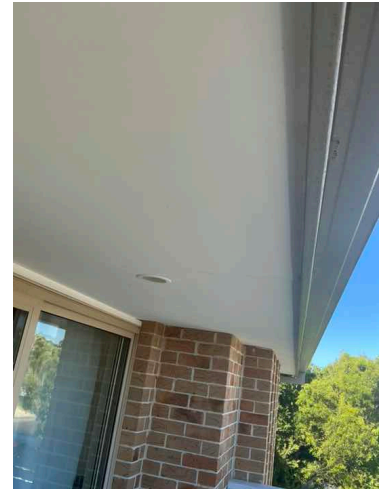
The soffit lining (eaves) are in a serviceable condition with no notable defects.

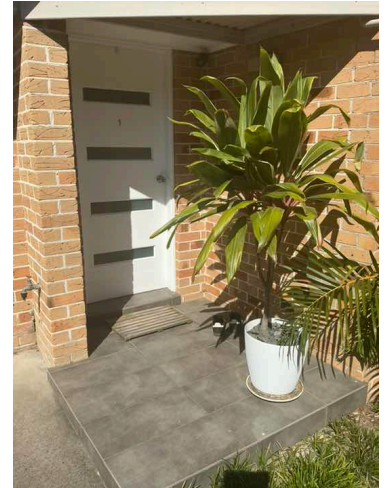
The entry porch serviceable or in reasonable or condition for the age of this dwelling.

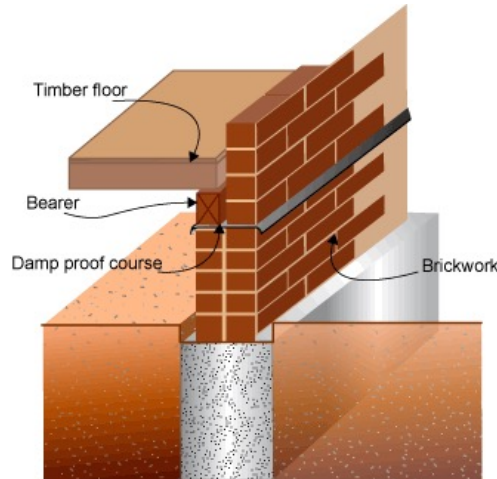
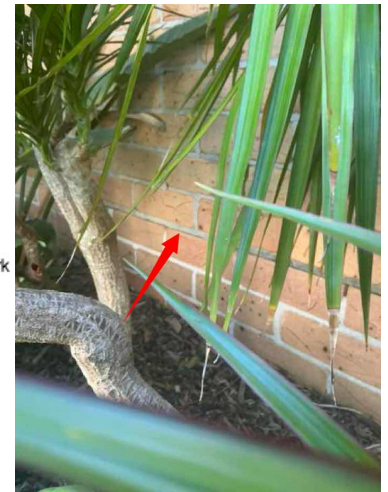
A damp proof course (DPC) was noted.

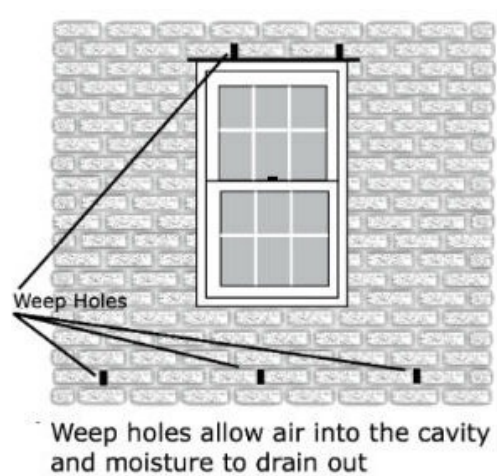
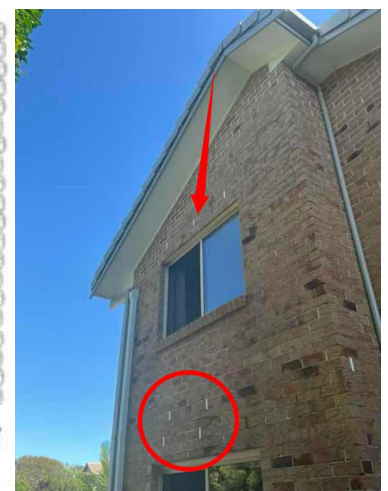
The weep holes are unobstructed .

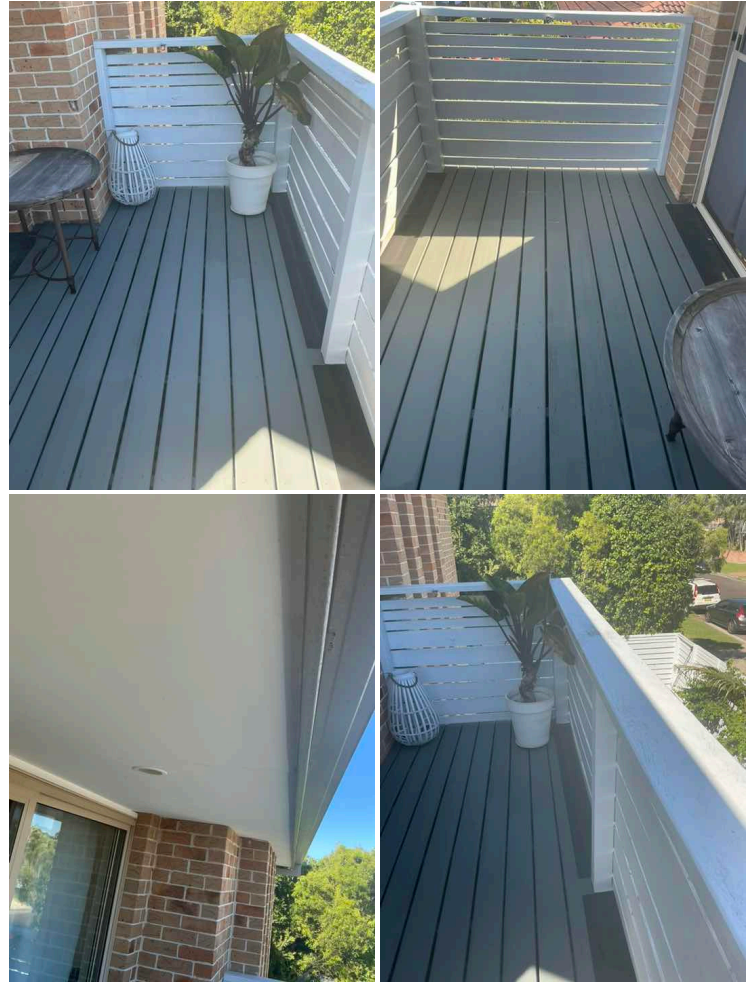
Though we are not structural engineers the balcony/s appear to be in a serviceable condition.

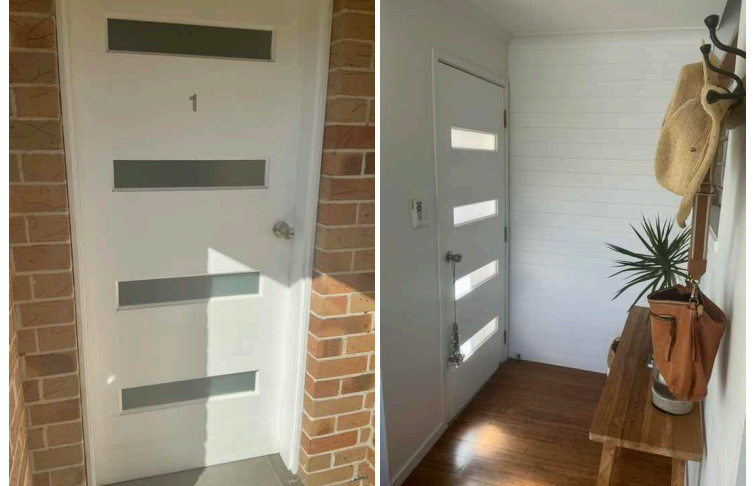
The doors are in serviceable condition with no notable defects observed.

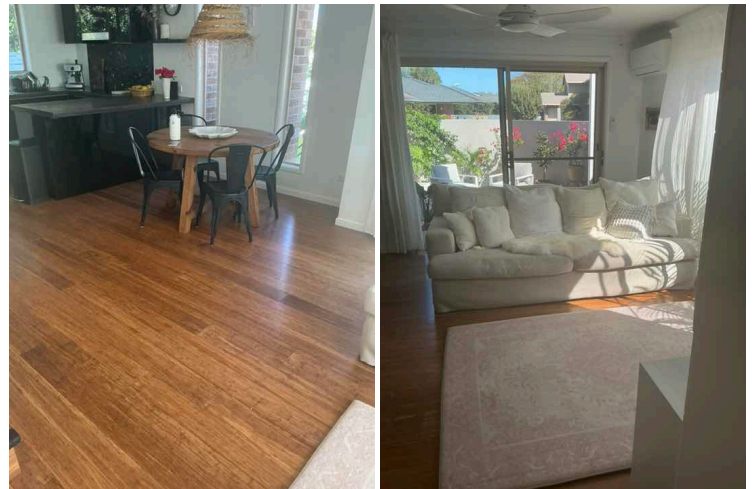
From the visible and accessible areas, this room appears to be in a serviceable condition for the age of the property with no notable structural defects sighted.

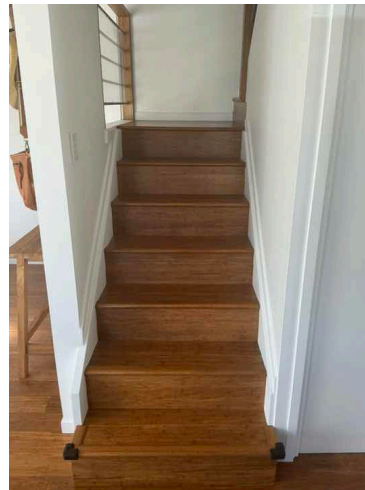
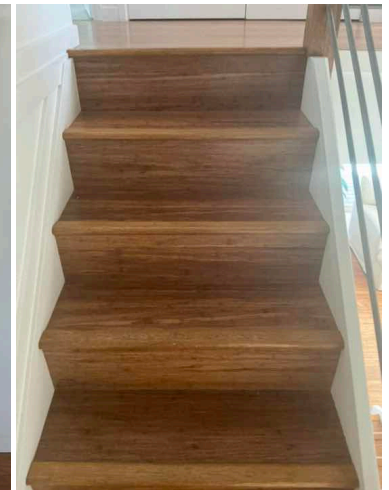
The internal staircase and components appear to be in a serviceable condition for the age with no notable defects sighted.

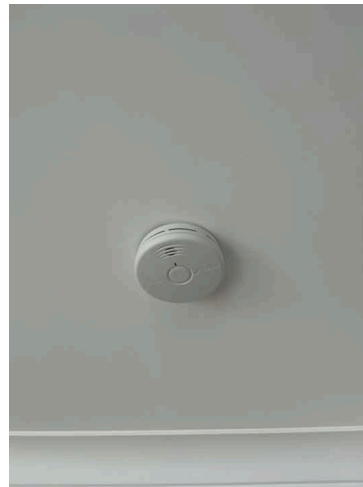
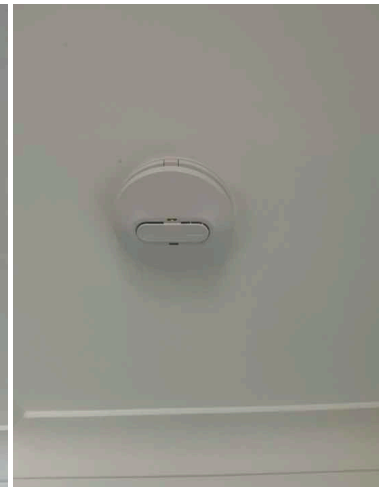
Yes 2 smoke alarms were sighted but not tested.

Legislation requires smoke Alarms to be installed.
Check with your local council regarding type, locations
and other related requirements.

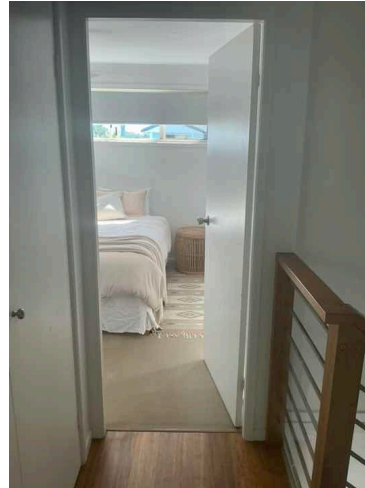
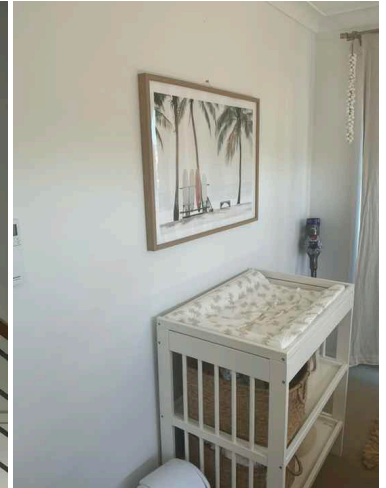
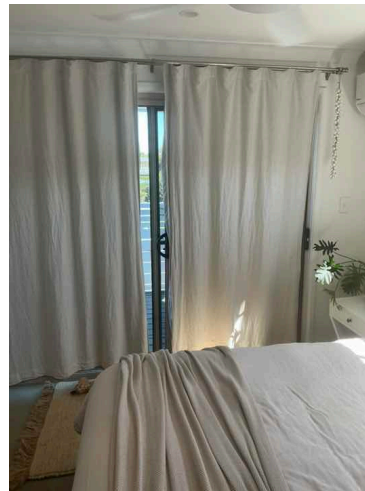
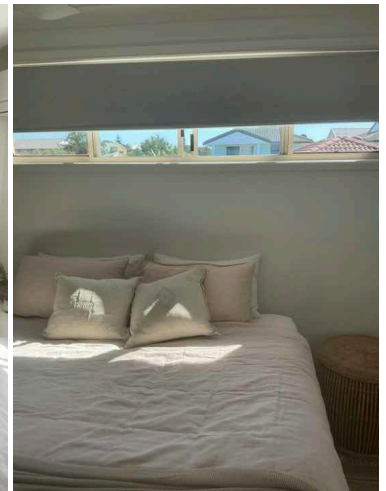
Bedroom 1

From the visible and accessible areas, this bedroom appears to be in a serviceable condition for the age of the property with no notable structural defects sighted.

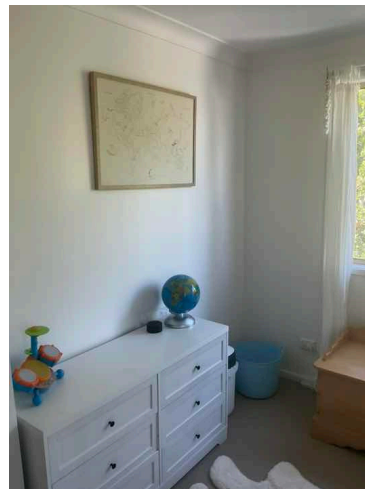
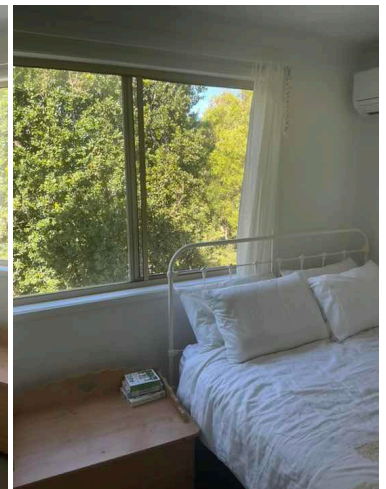
Bedroom 2

From the visible and accessible areas, this bedroom appears to be in a serviceable condition for the age of the property with no notable structural defects sighted.

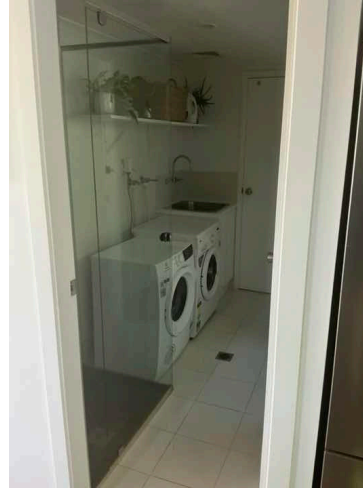
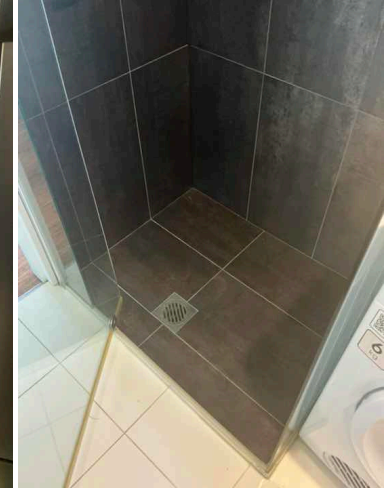
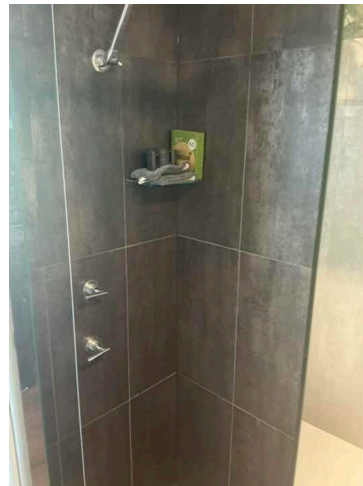
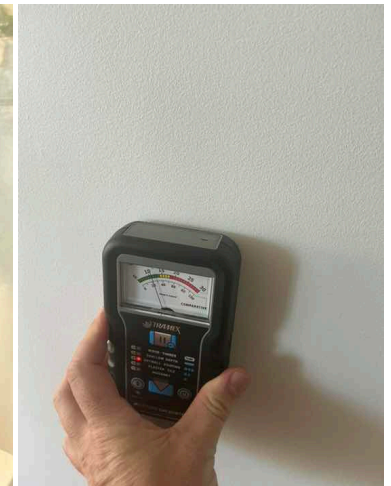
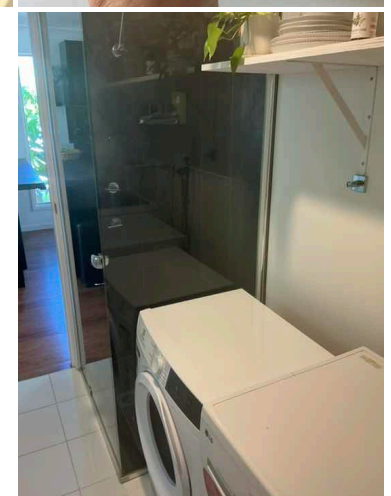
Of the visible areas, the general condition of this bathroom is serviceable or in reasonable condition for age of dwelling.

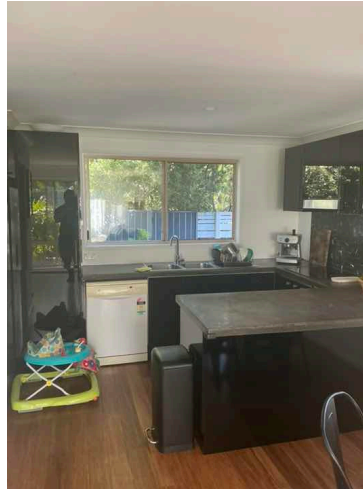
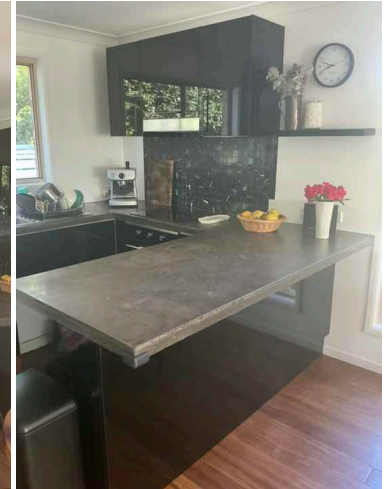
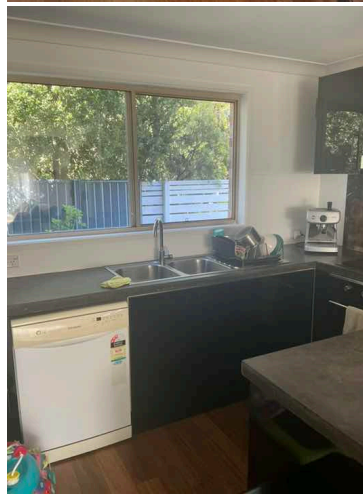
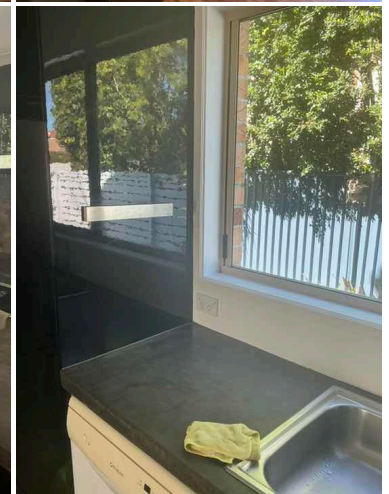
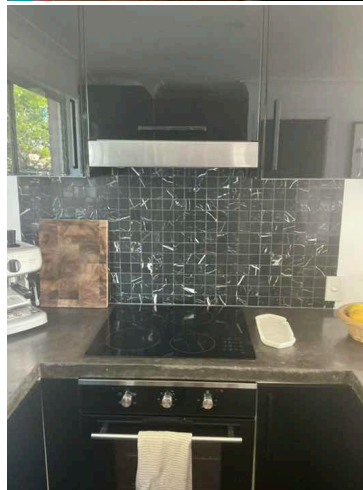
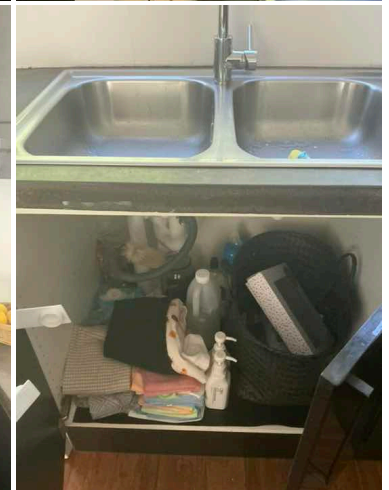
Of the visible areas, the general condition of the kitchen and pantry is serviceable or in reasonable condition for age of dwelling.

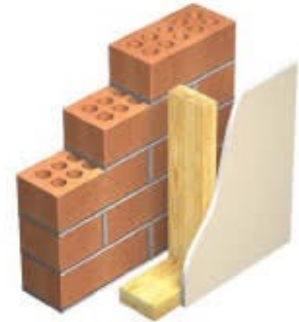
BRICK VENEER WALL

The structure is of brick veneer construction.
