Building and Pest Report

2/17 Sandbreak Crescent Lennox Head

Pest And Building Inspection

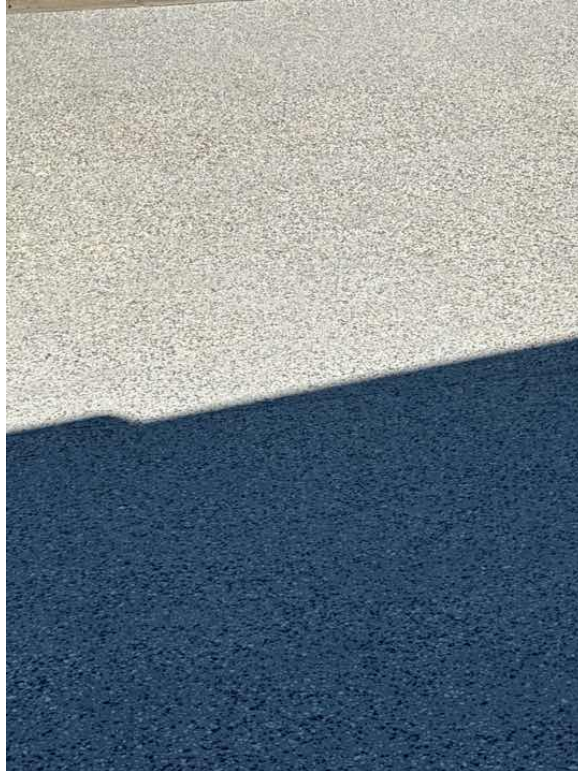
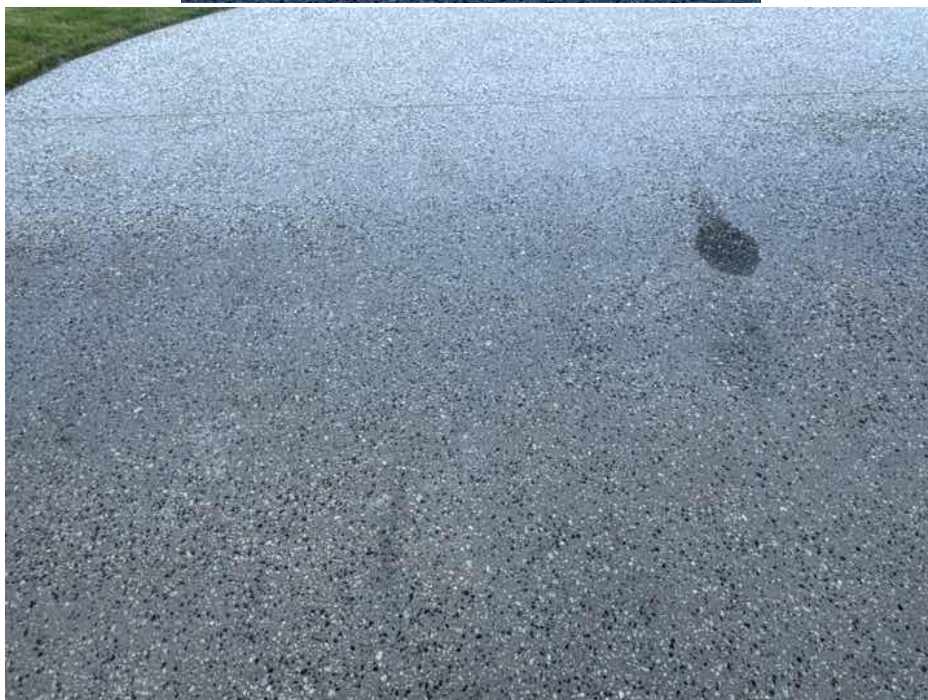
Driveway Condition

On visual inspection, the general condition of the driveway is serviceable.

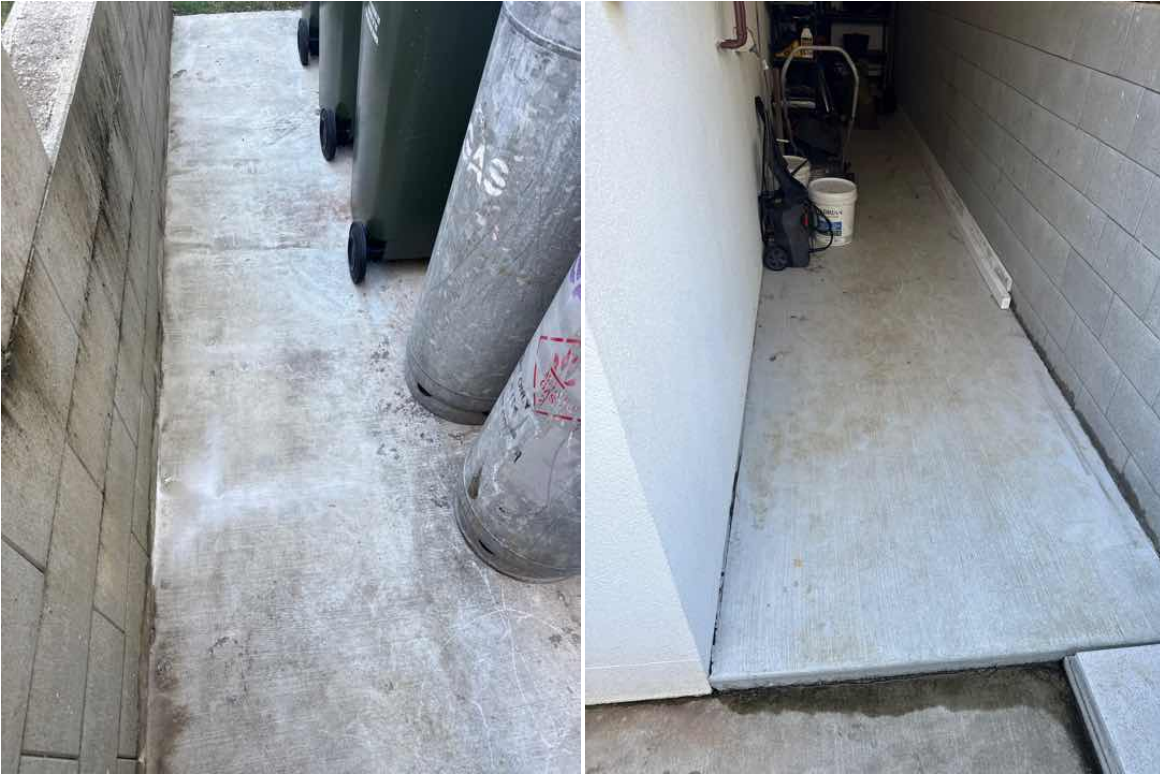
Pathways Condition

The paths around the home are in a serviceable condition for the age of this dwelling with no major defects visible.

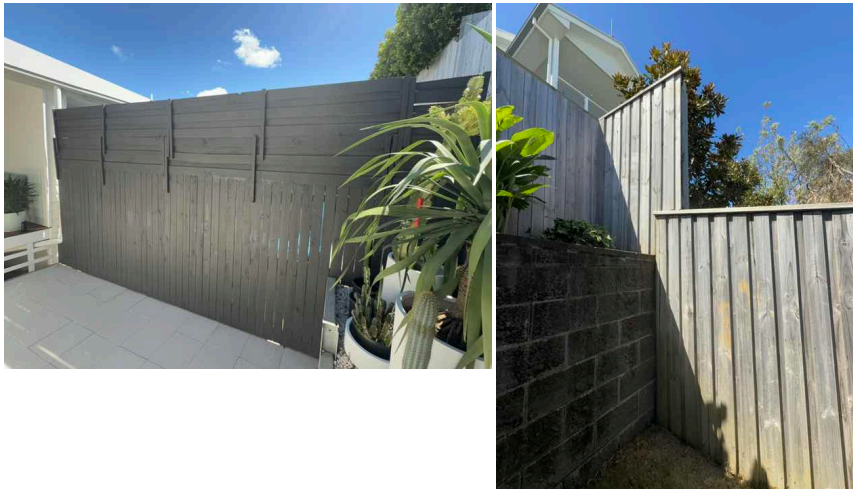
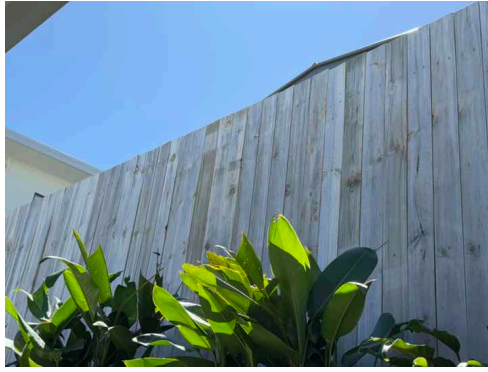
Fences & Gates

Of the visible areas, the general condition of the fences and gates is serviceable for the age of dwelling.

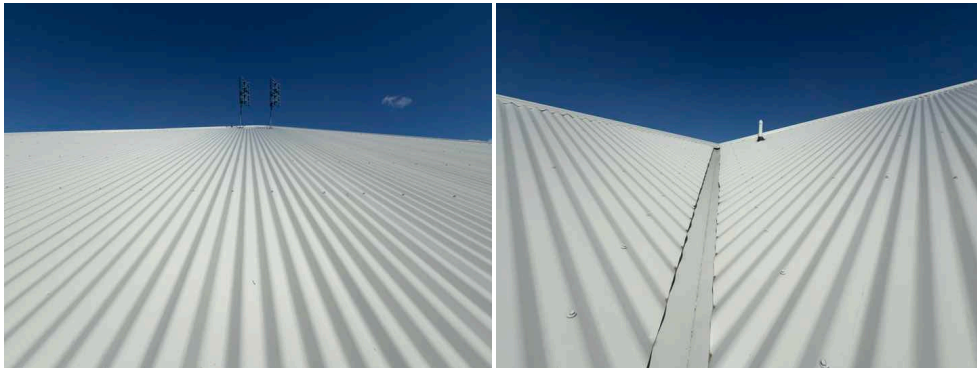
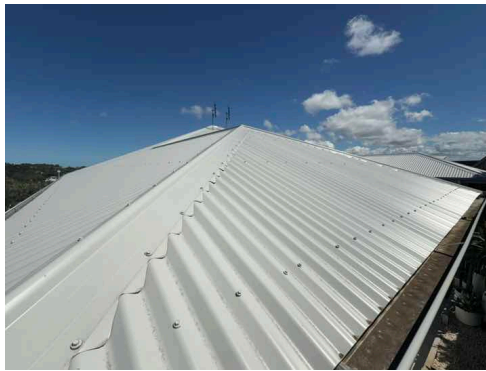
Of the visible areas, the general condition of the roof is in serviceable condition for the age.

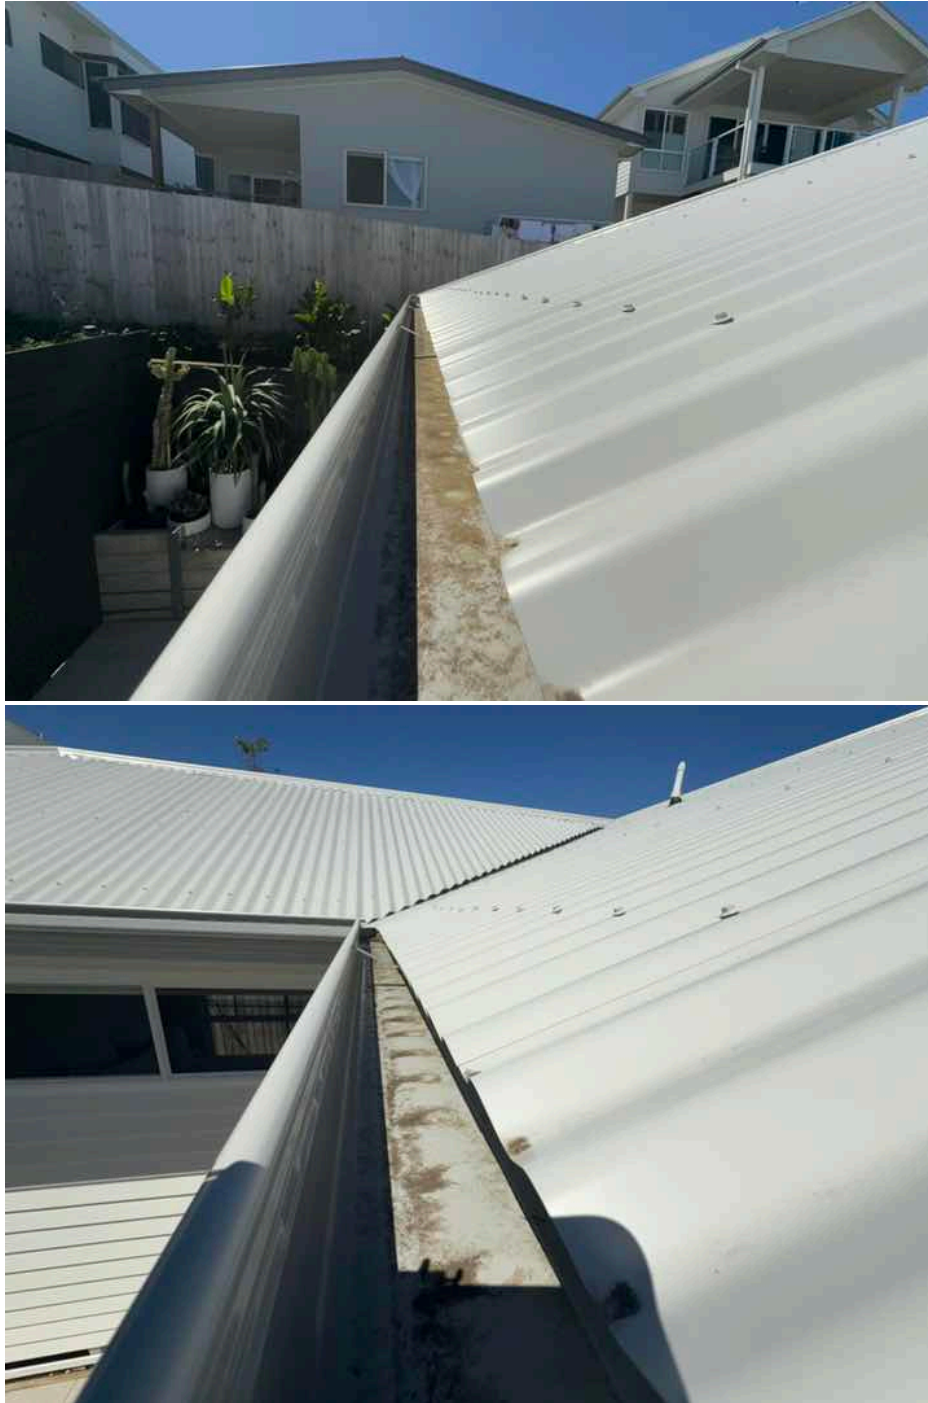
Gutter Findings

All visible and accessible of the physical nature of the guttering system appears to be in a serviceable condition with no apparent defects at the time of inspection. In the absence of prolonged rain fall efficiency of the guttering can not be assessed and you may find that further investigation or repairs maybe required. Note: Periodic maintenance checks should be carried out for rust penetrations and leaks.

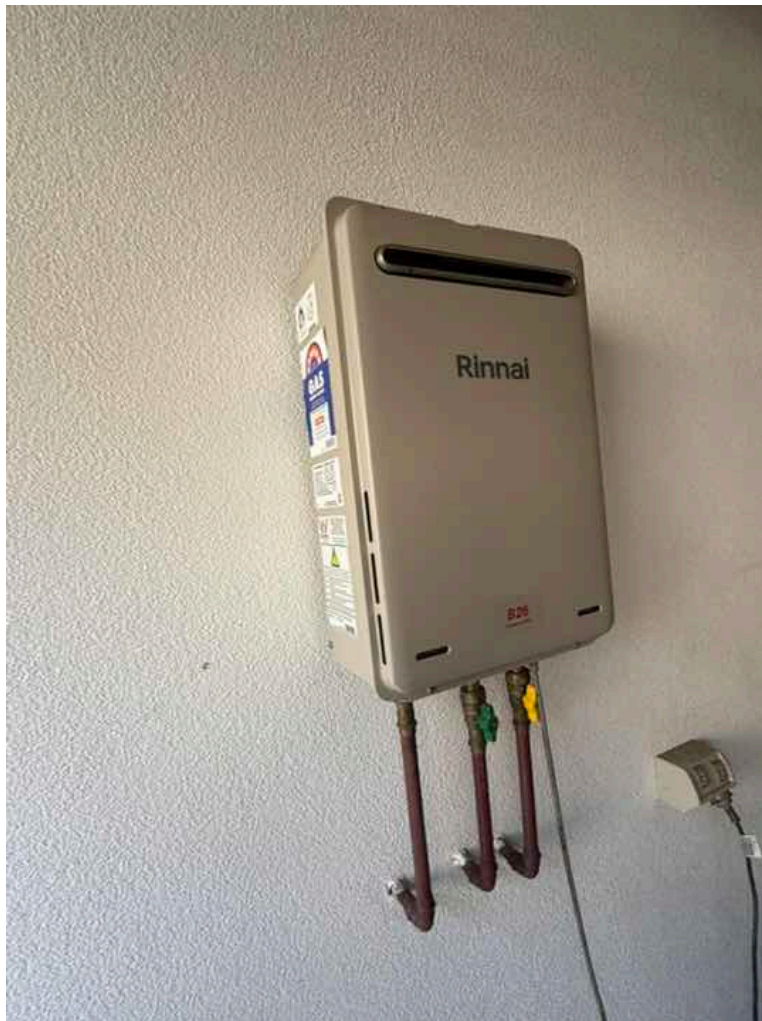
System Make

The make of the hot water unit is rinnai.

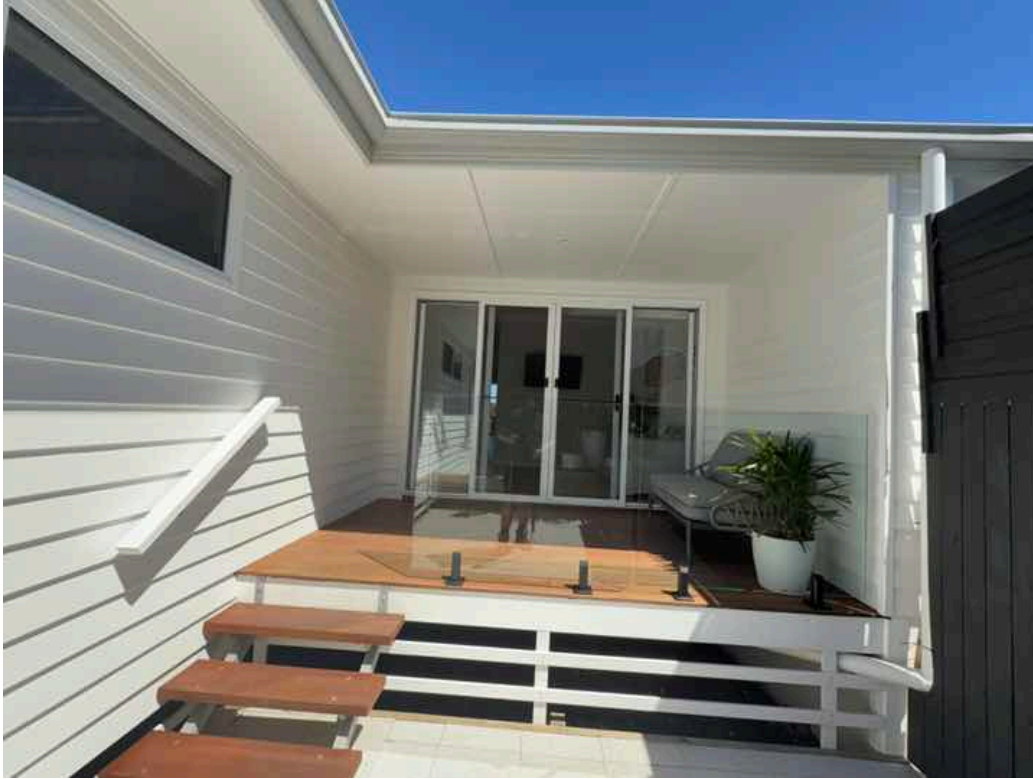
Visible sections of the Alfresco area are serviceable or in reasonable or condition for the age of this dwelling.

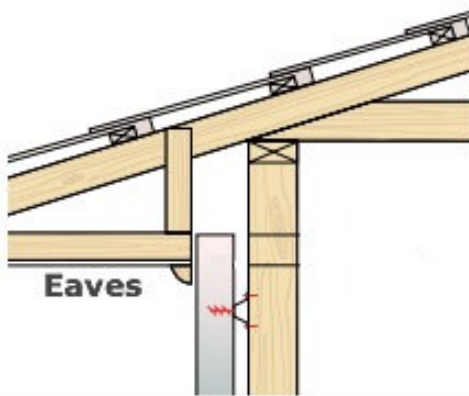
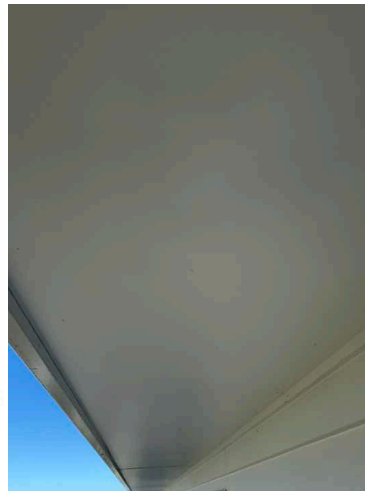
Eave Condition

The soffit lining (eaves) are in a serviceable condition with no notable defects.

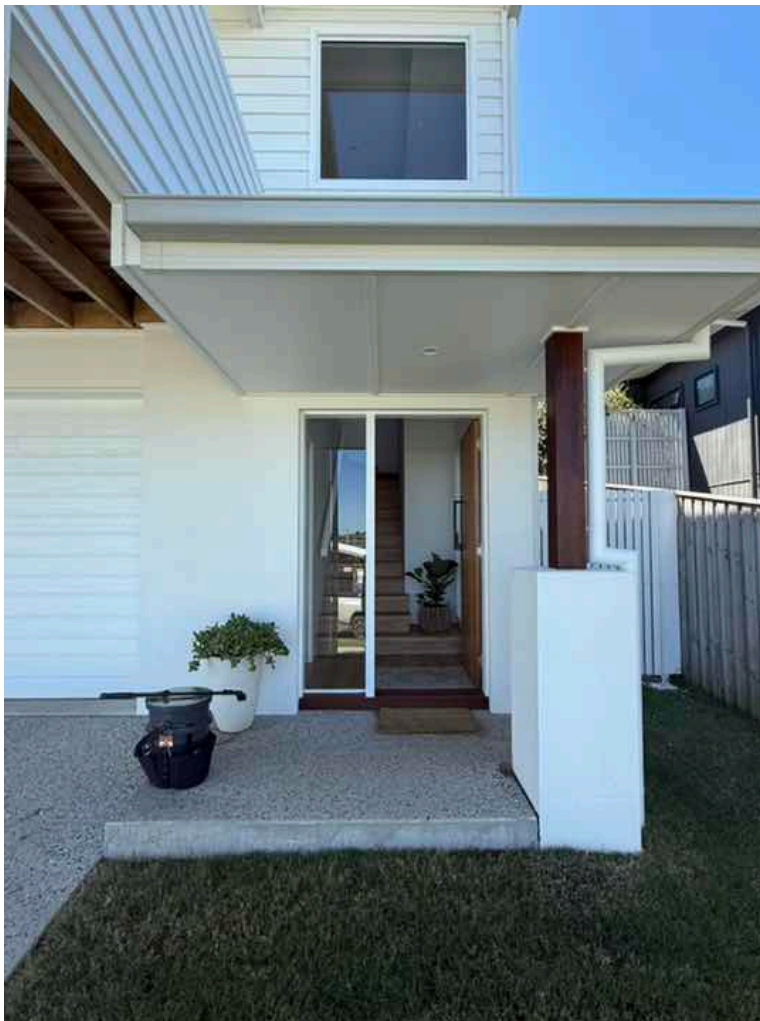
Entry Porch Area

The entry porch serviceable or in reasonable or condition for the age of this dwelling.

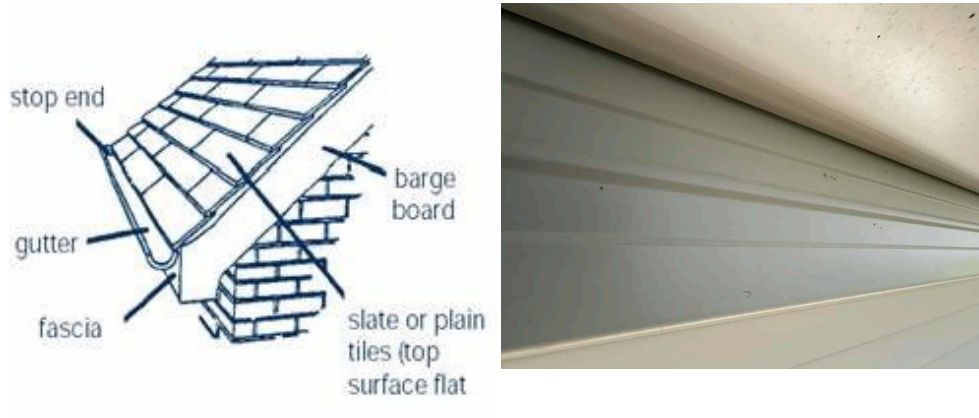
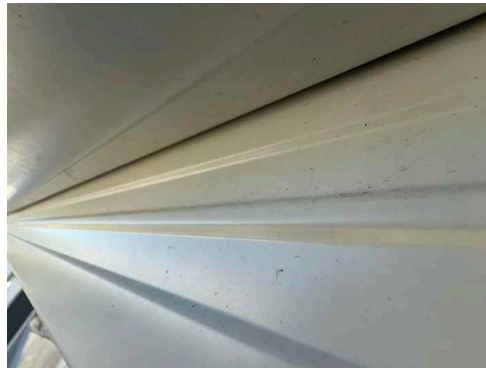
On visual inspection, the general condition of the fascia/barge boards is serviceable.

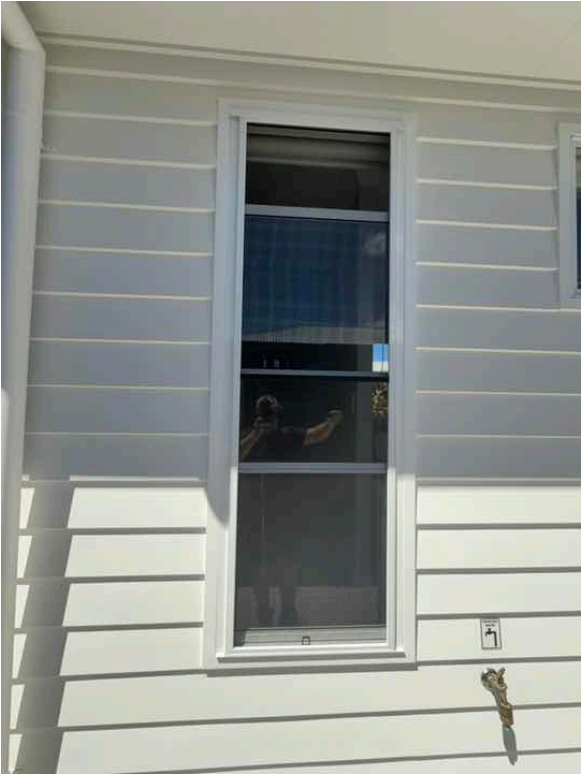
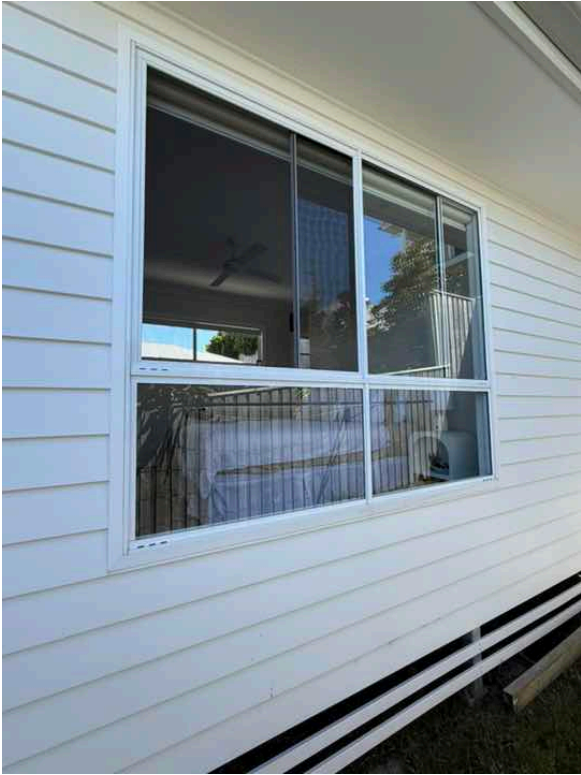
On visual inspection, the general condition of the windows is serviceable for the age.

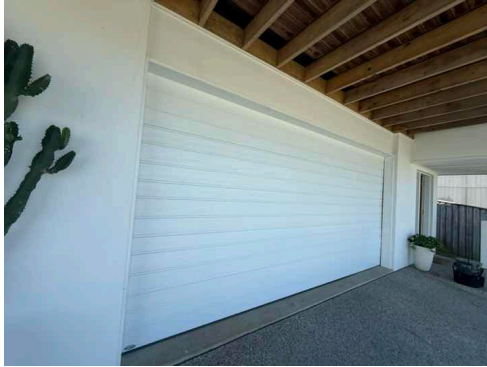
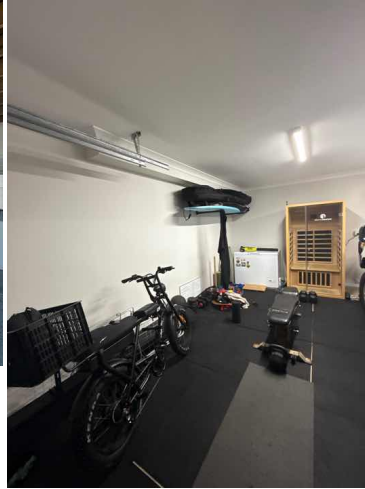
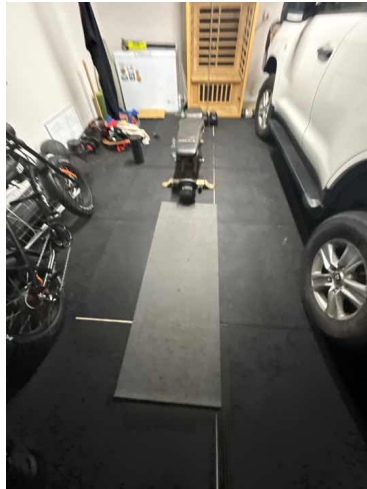
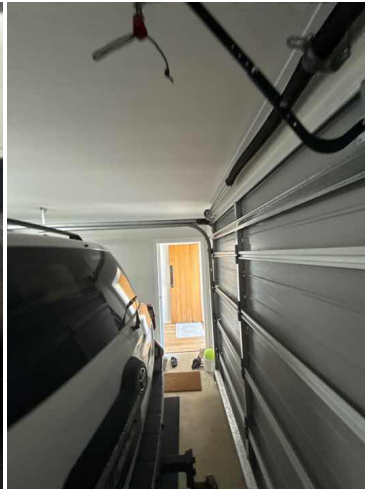
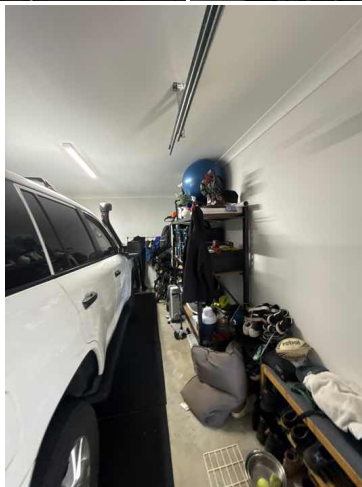
From the visible and accessible areas, the garage appears to be in a serviceable condition for the age of the property with no notable structural defects sighted.

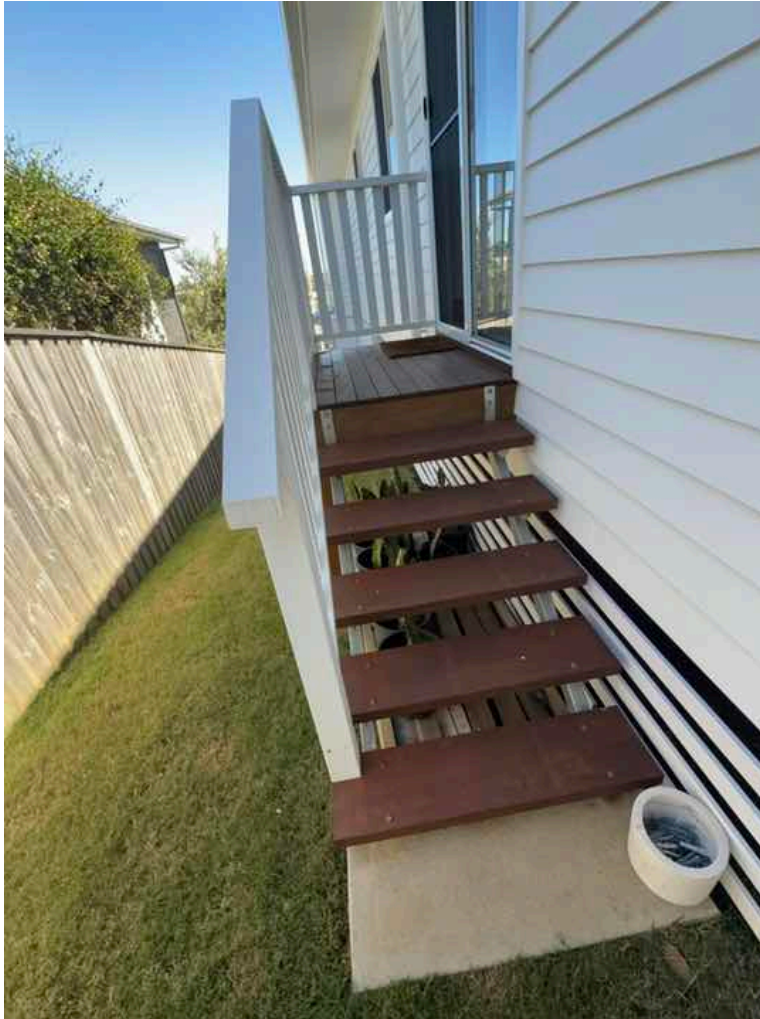
The stairs/steps appear to be serviceable with no notable defects.

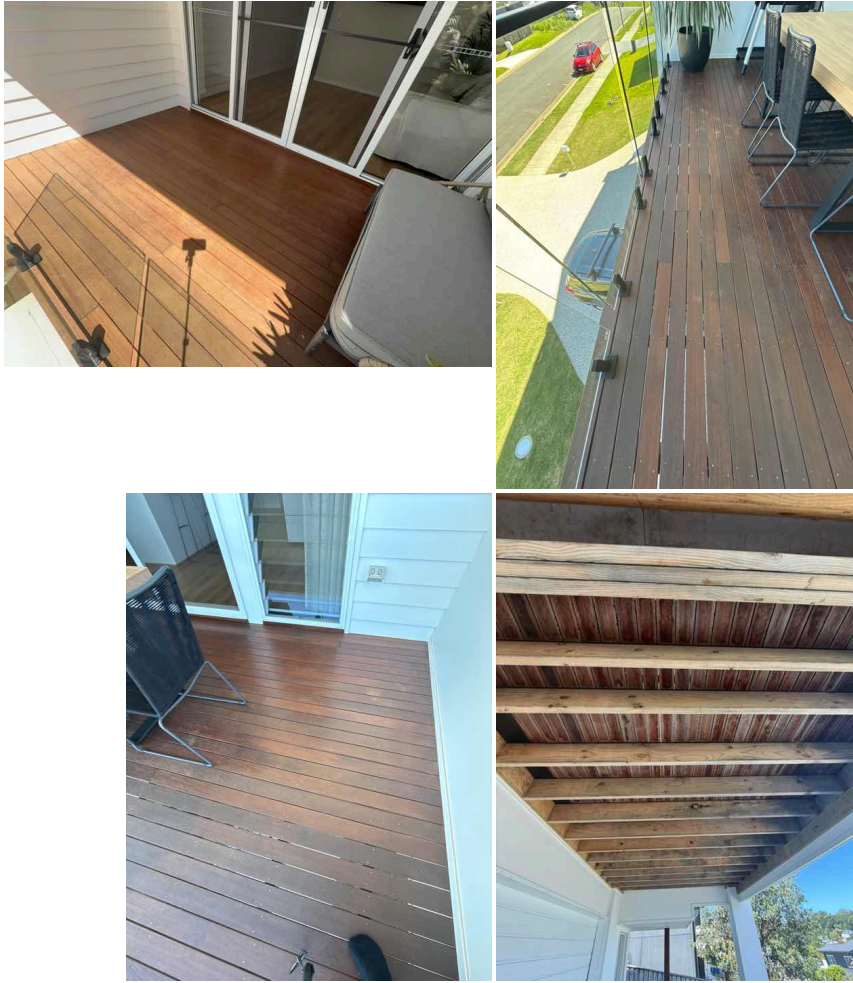
Decking Findings

Of areas visible, the decking appears to be in a serviceable condition.

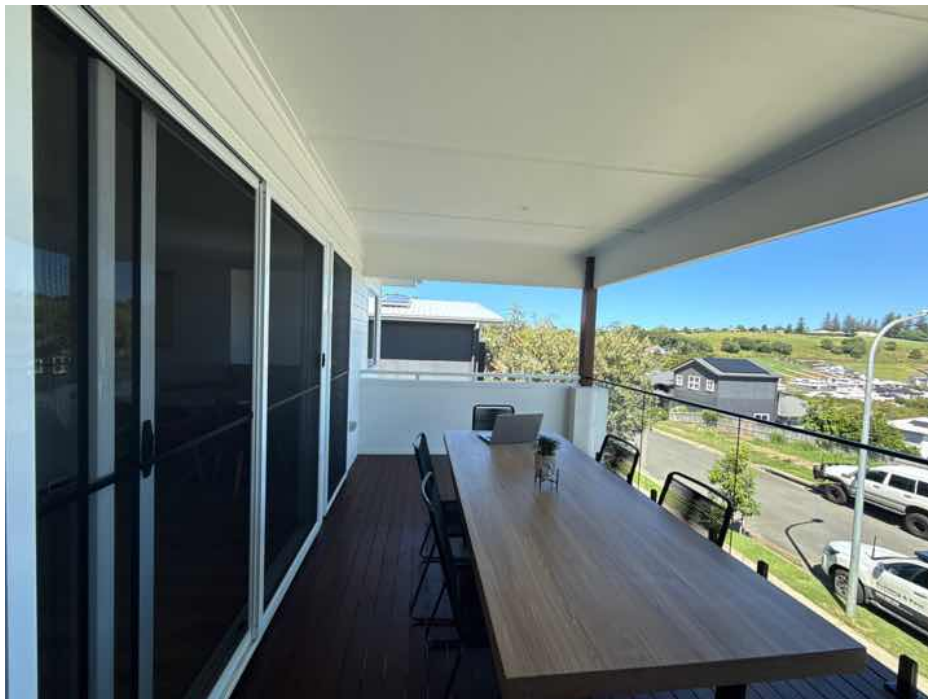
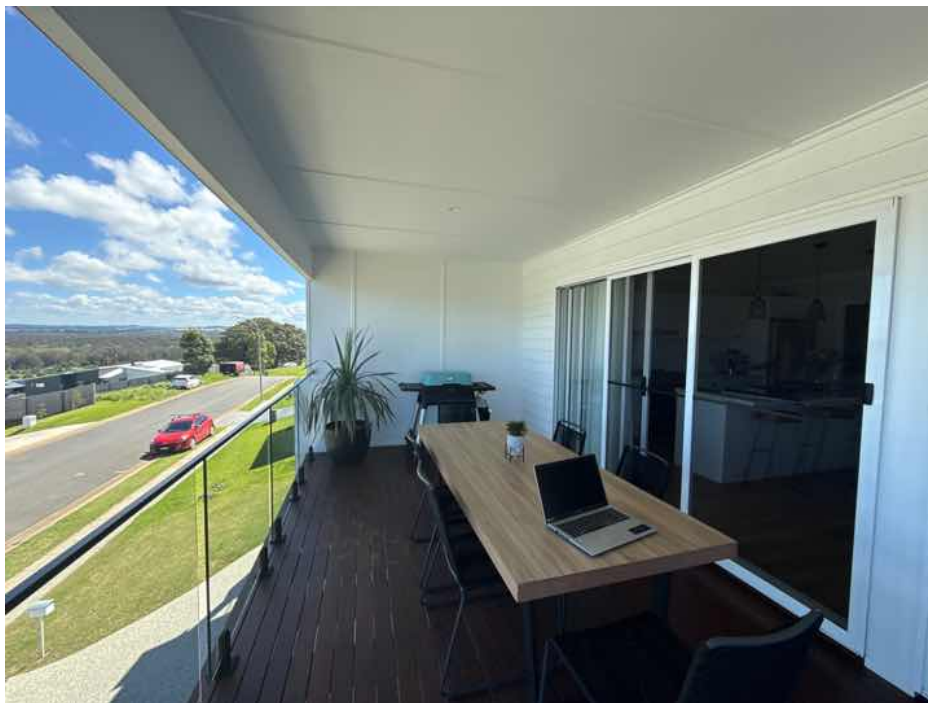
Balcony Findings

Though we are not structural engineers the balcony/s appear to be in a serviceable condition.

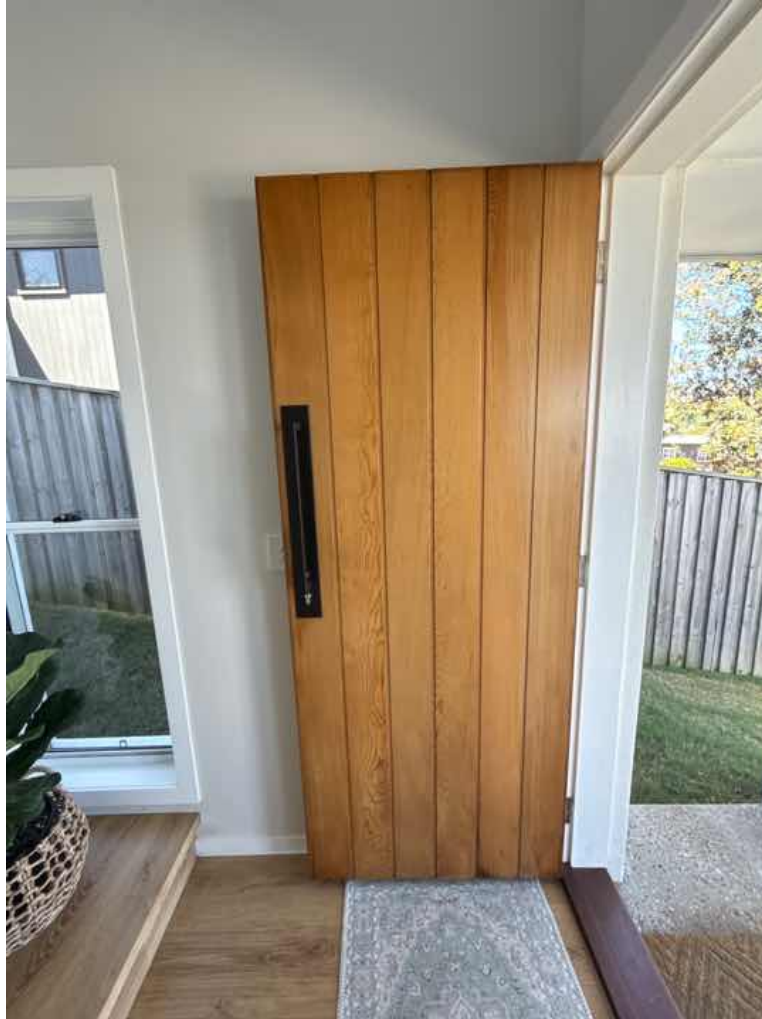
Front Entry Doors

The doors are in serviceable condition with no notable defects observed.

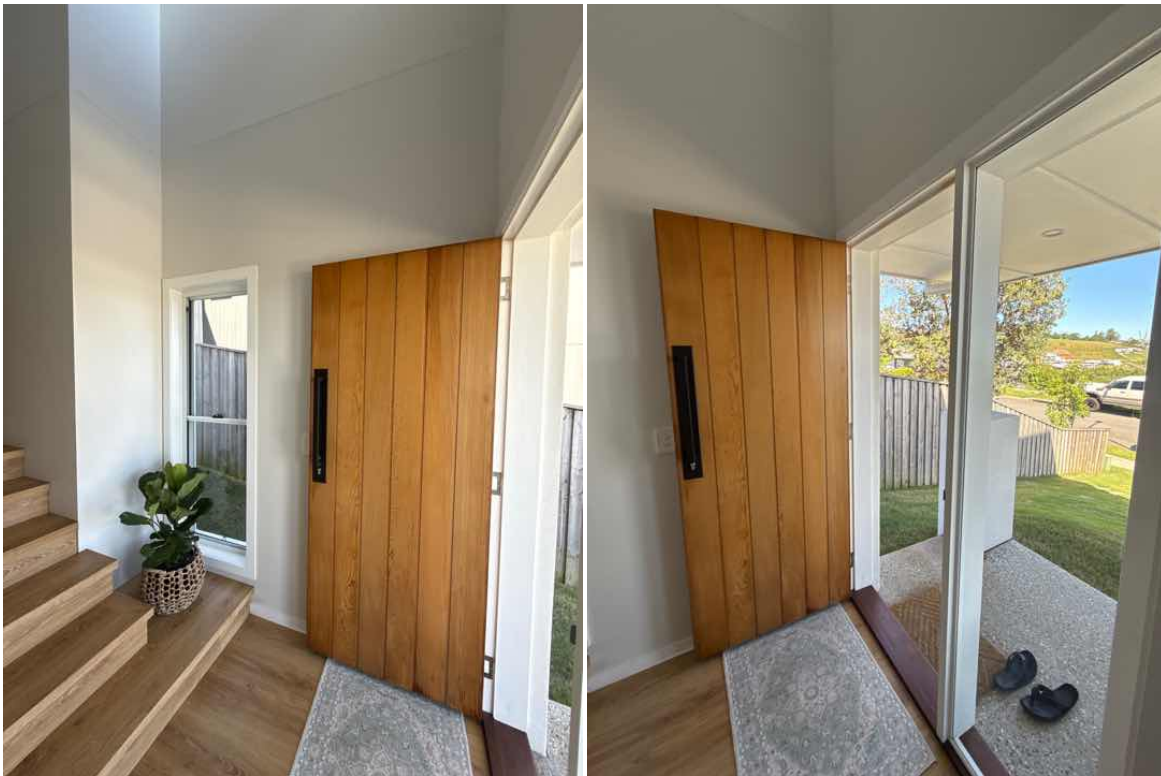
From the visible and accessible areas, this area appears to be in a serviceable condition for the age of the property with no notable structural defects sighted.

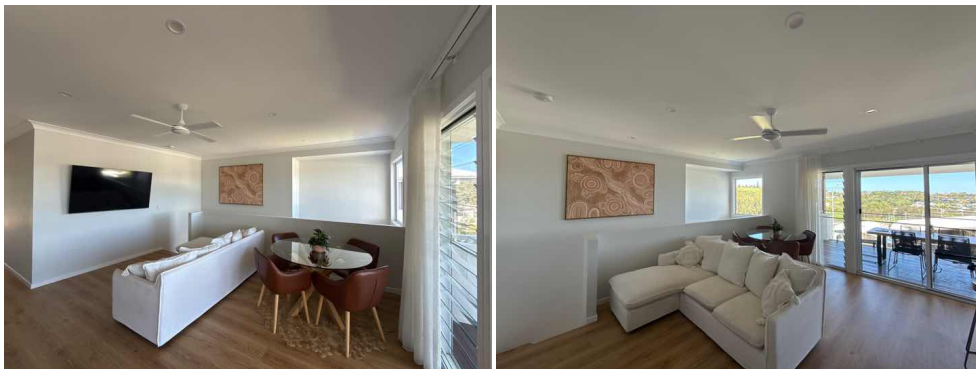
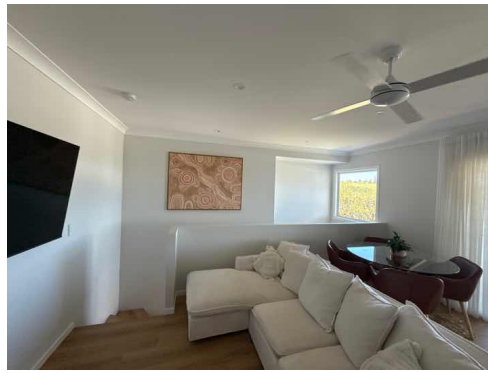
Combined Living & Dining

From the visible and accessible areas, this room appears to be in a serviceable condition for the age of the property with no notable structural defects sighted.

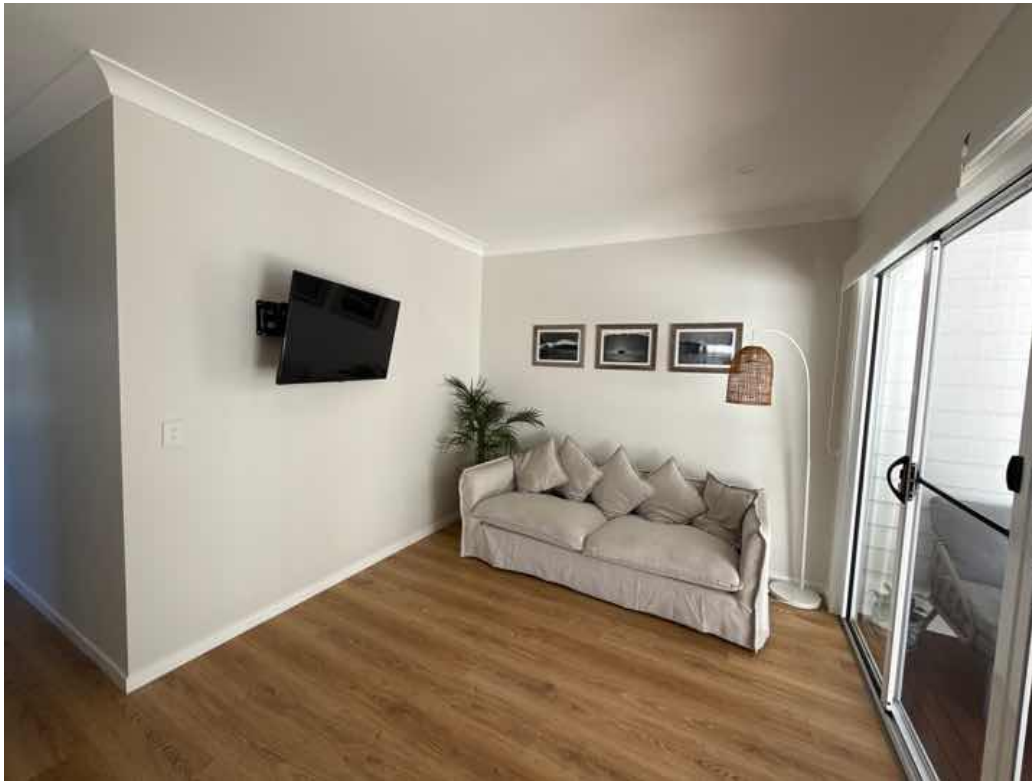
Family Room

From the visible and accessible areas, this room appears to be in a serviceable condition for the age of the property with no notable structural defects sighted.

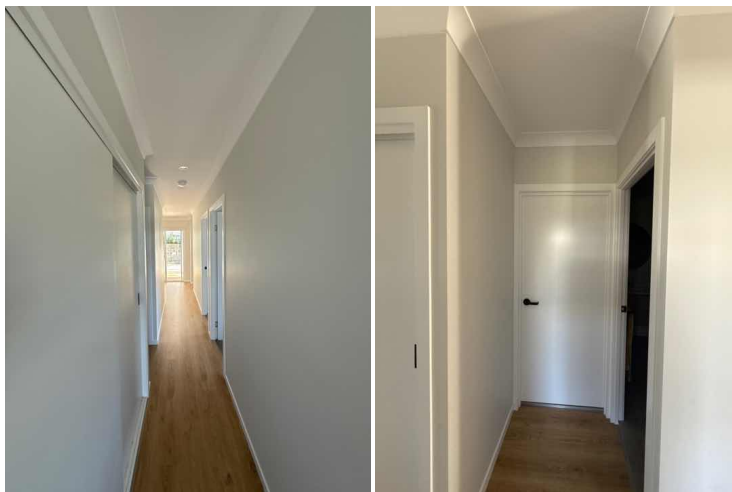
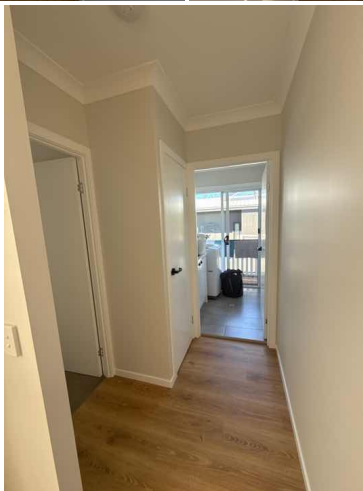
Hallway/s

From the visible and accessible areas, the hallway/s/ appears to be in a serviceable condition for the age of the property with no notable structural defects sighted.

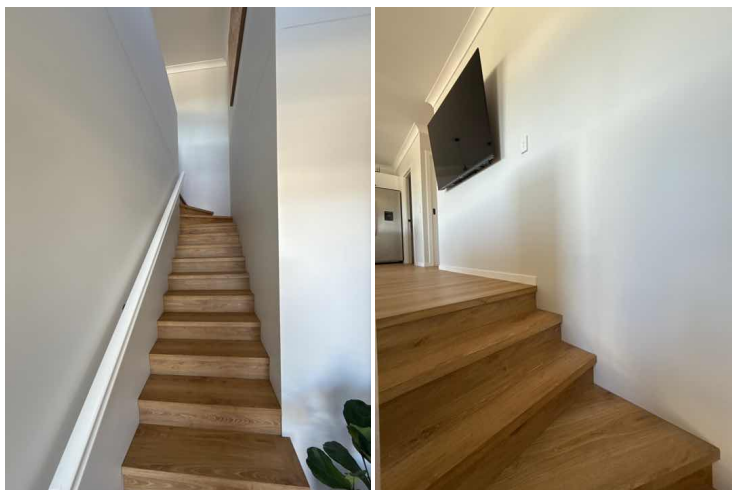
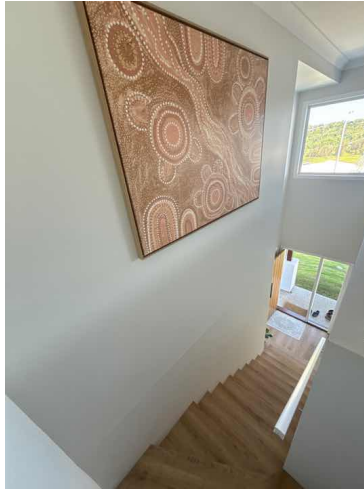
Internal Stair Case

The internal staircase and components appear to be in a serviceable condition for the age with no notable defects sighted.

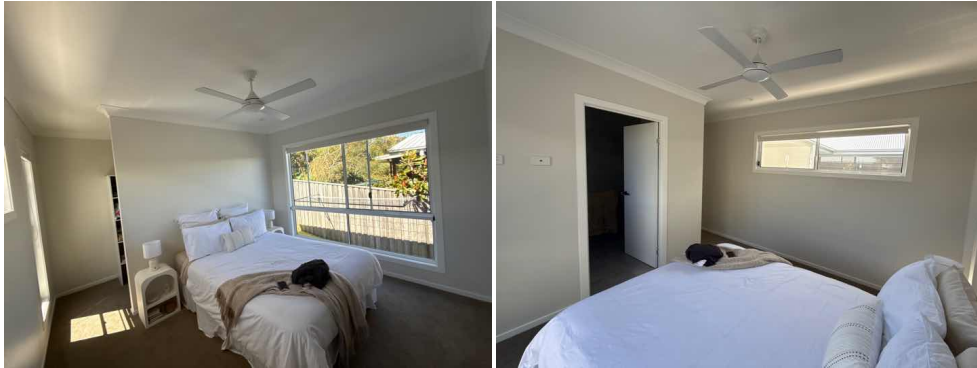
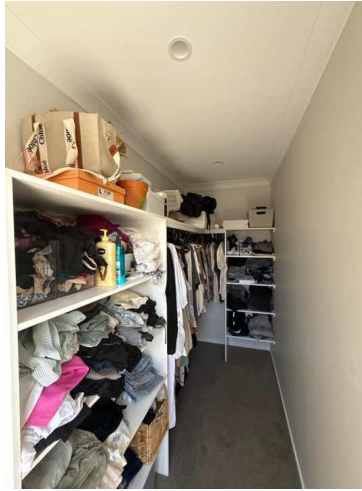
From the visible and accessible areas, this bedroom appears to be in a serviceable condition for the age of the property with no notable structural defects sighted.

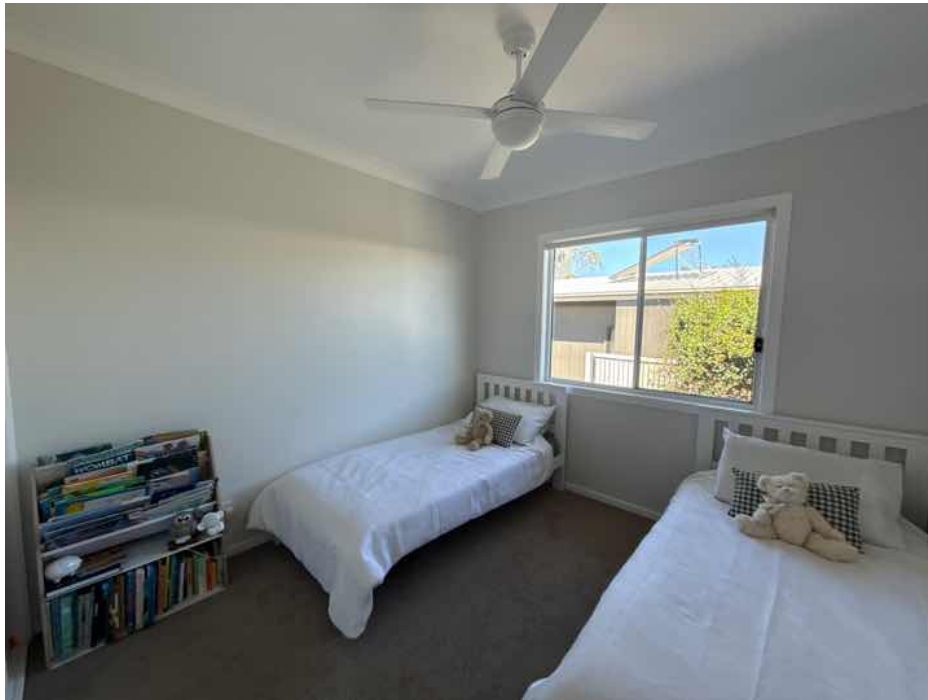
Bedroom 2

From the visible and accessible areas, this bedroom appears to be in a serviceable condition for the age of the property with no notable structural defects sighted.

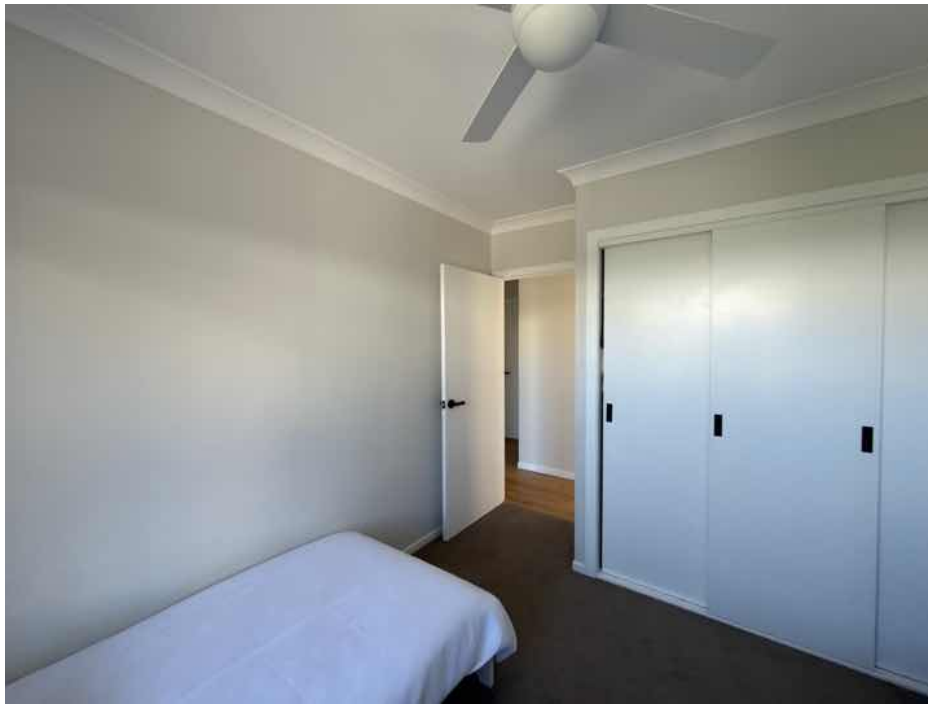
Bedroom 3

From the visible and accessible areas, this bedroom appears to be in a serviceable condition for the age of the property with no notable structural defects sighted.

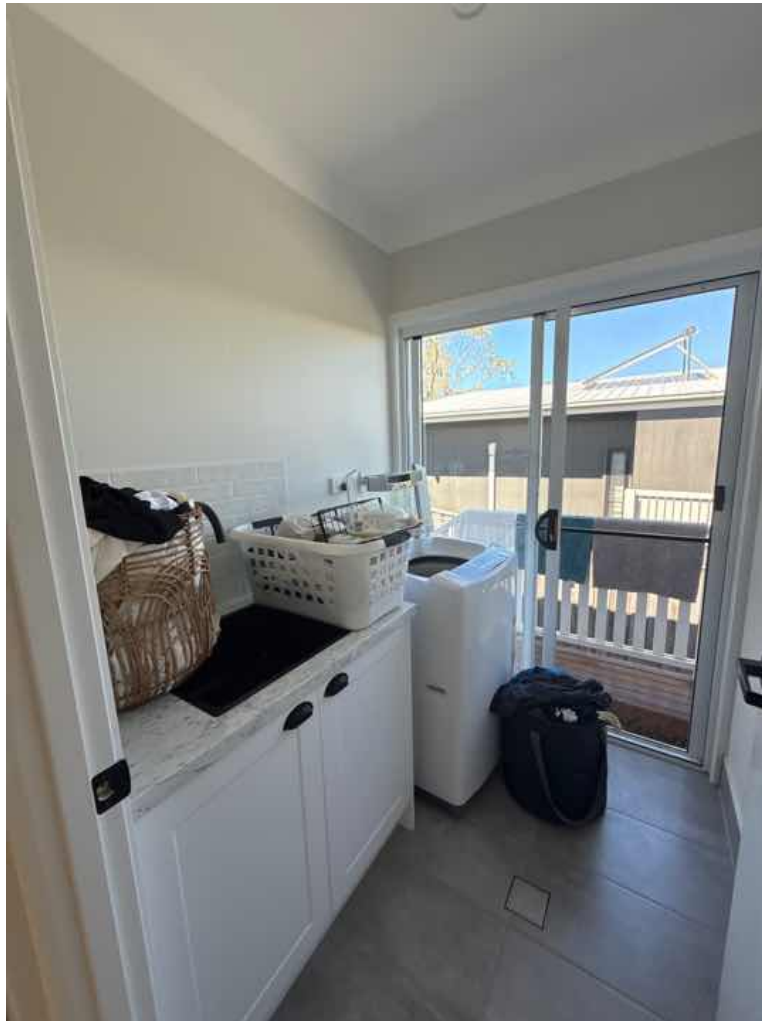
Of the visible areas, the general condition of the laundry is serviceable or in reasonable condition for age of dwelling.

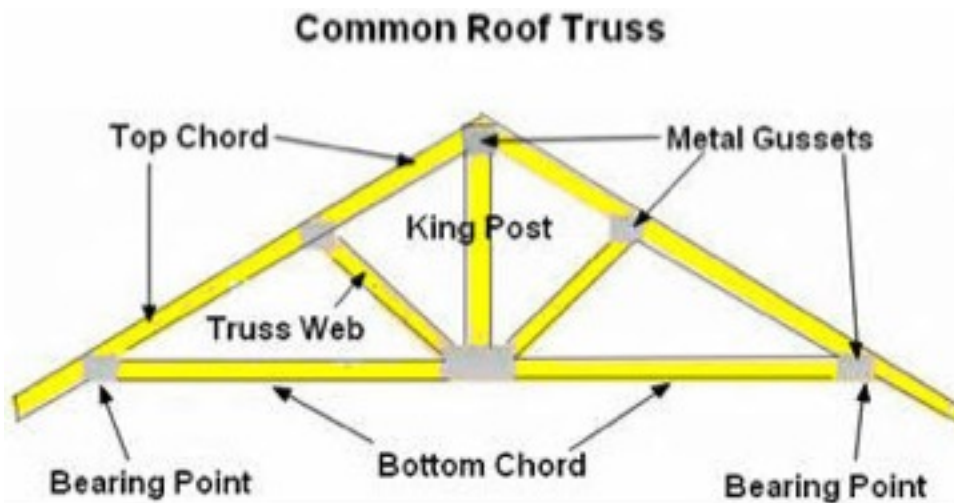
The roof frame is a truss timber frame.

Visible sections of the roof void is in a serviceable condition for age of this dwelling.

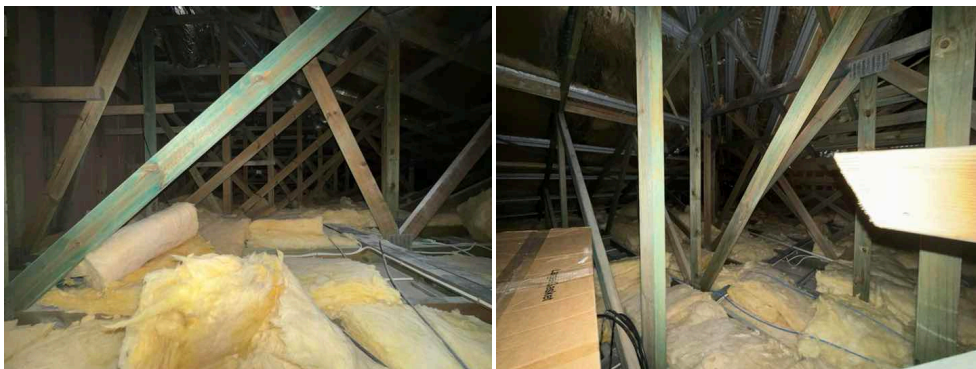
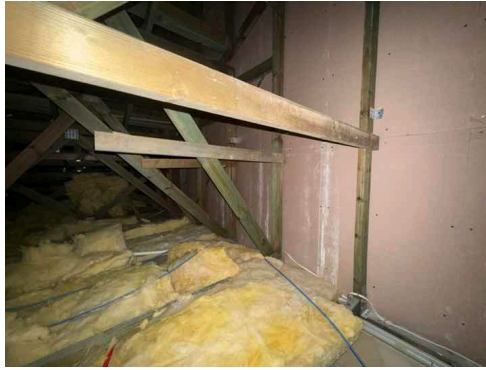
Where visible and accessible, the insulation appears to be in a serviceable condition.

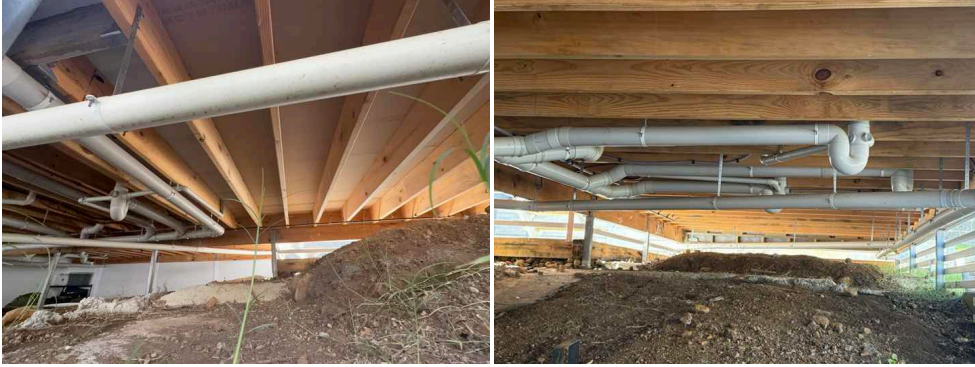
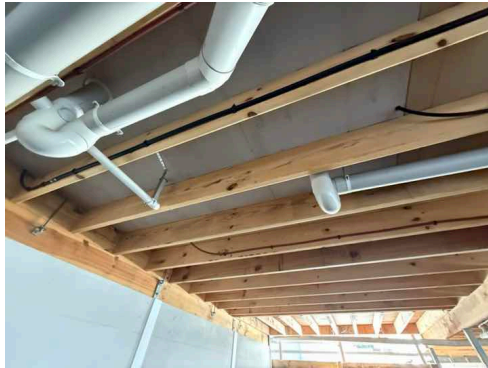
Of areas accessible and visible, the subfloor and components appeared to be in a serviceable condition.

Of the visible areas, no excess damp was visible.
