PEST AND BUILDING PRE-PURCHASE REPORTS

BUILDING & PEST INSPECTIONS

7 Sand Street
Skennars Head

BPI - INSPECTION REPORT

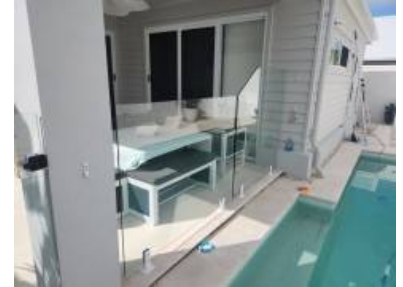
Swimming Pool Fence:

The Pool Gate does not self-close and requires repair / adjustment. This is a safety Hazard and requires Immediate Rectification.

A swimming pool is present to the property. I recommend that a qualified pool safety inspector be engaged to check all pool fencing & gates are to government standards. If a pool safety inspection has already been carried out, ensure you obtain all relevant documentation.

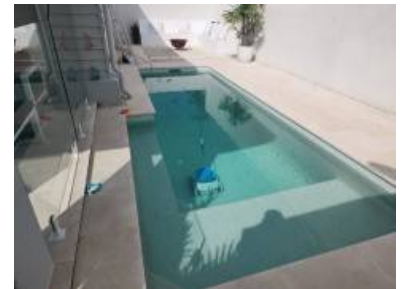
Swimming Pool:
Satisfactory.
