# Building and Pest Report

## 5 Blackwood Cres Bangalow

| Inspection Date: | 25 Sep 2025 |

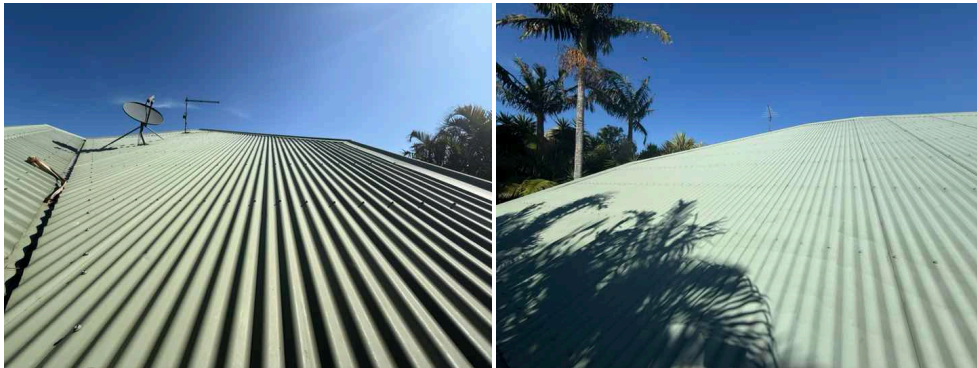
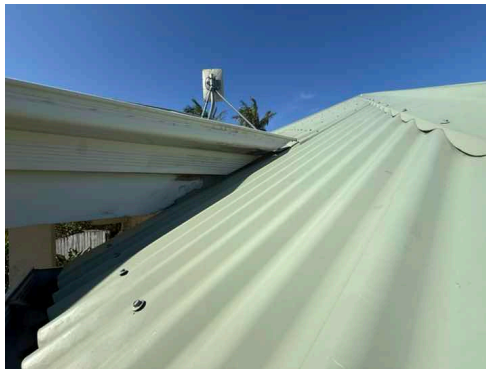
Visible section of The roof cladding appeared in a serviceable condition for the age of this dwelling. Annual maintenance inspection recommended.

Corrosion noted to the screw fixings of the metal roof. Have these checked and replaced by qualified roofing contractor.

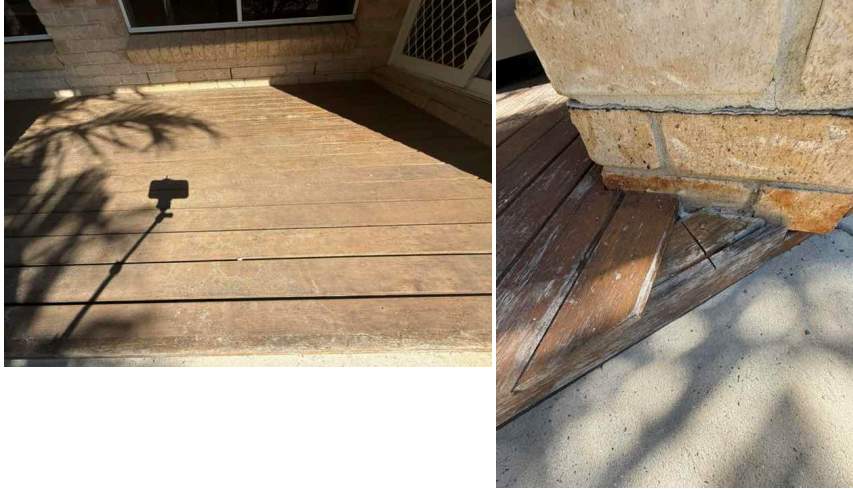
Decking board surfaces are weathered. We recommend cleaning and maintenance as needed.

Missing deck timber. Safety issue as may cause personal injury. Consult with a qualified carpenter for repair prior to settlement.

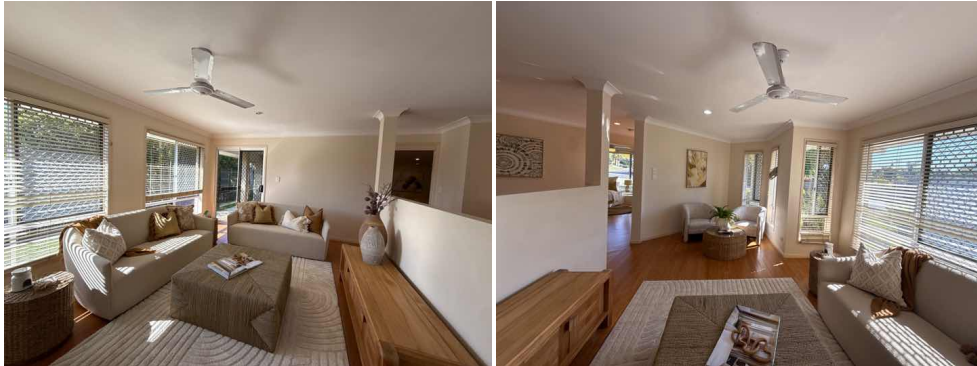
Incomplete patch/paint repairs noted. I recommend you contact a qualified painter for repairs.

Ceiling stains - No moisture readings obtained. These may have been repaired however you will need to monitor after a prolonged period of rainfall. If leaking persists, a qualified plumber should be engaged for advice and recommendations. All water damaged plaster should be replaced.

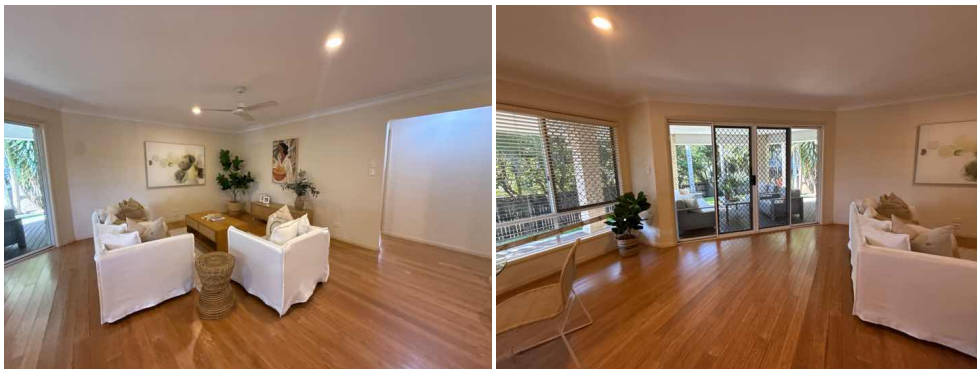
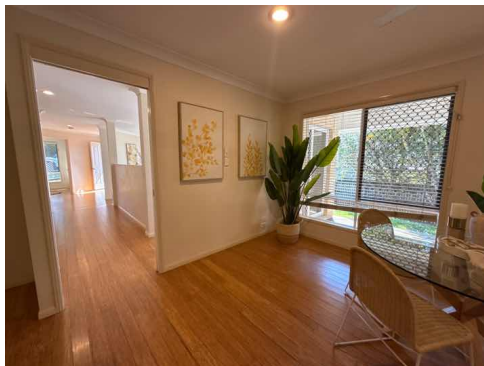
Stained timber flooring - This is normally due some water penetration. This will not be able to be removed and options include replacement, staining all the boards dark or lining same to cover. A qualified carpenter should be engaged for advice and recommendations.

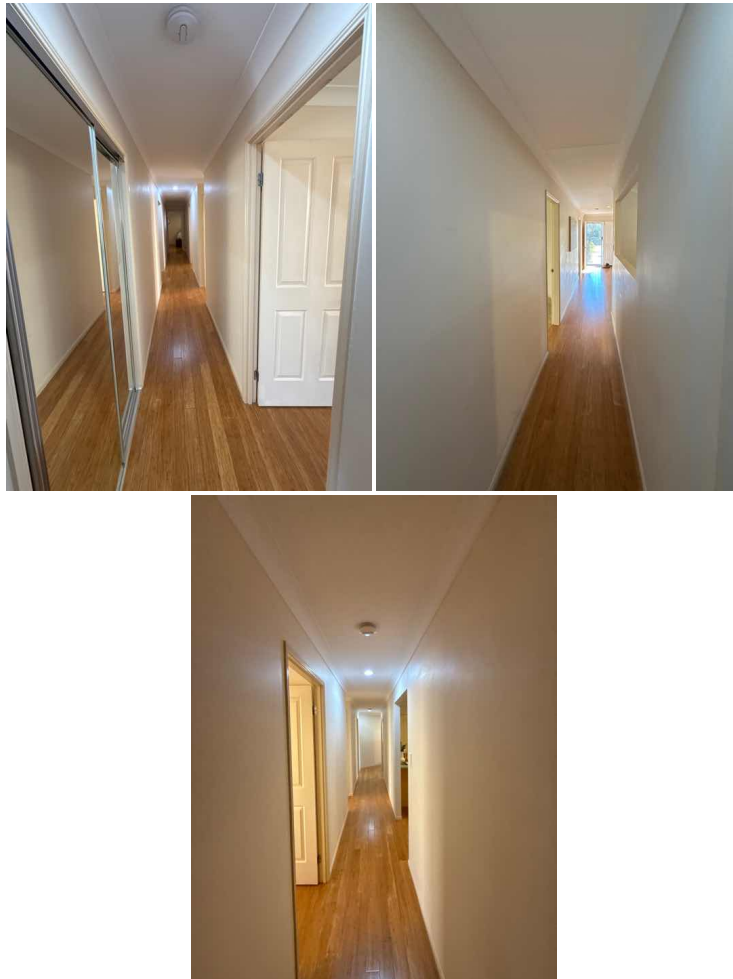
Incomplete Patch/Paint repairs noted. I recommend you contact a qualified painter for repairs.

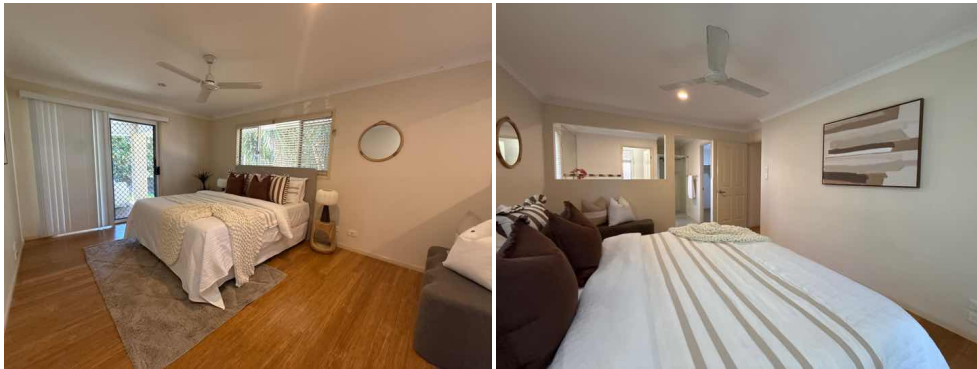
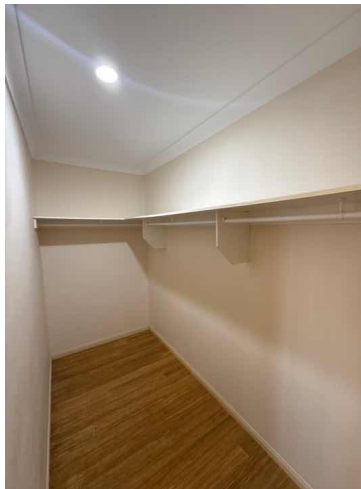
Impact damage noted. Contact a qualified painter for repairs.

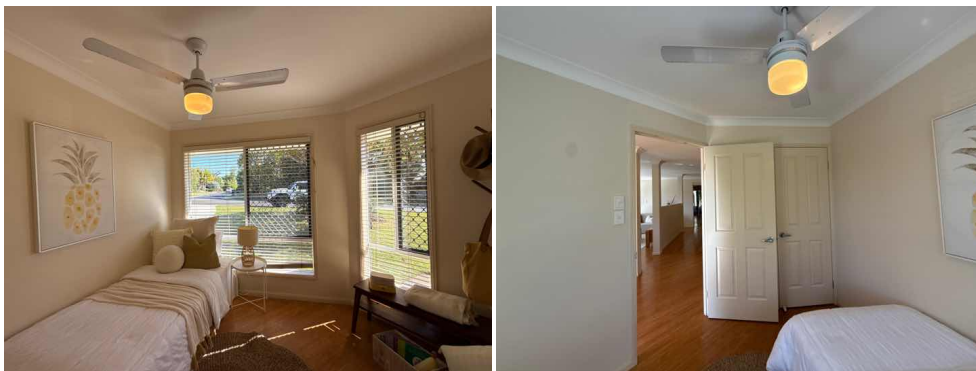
Impact damage noted. Contact a qualified painter for repairs.

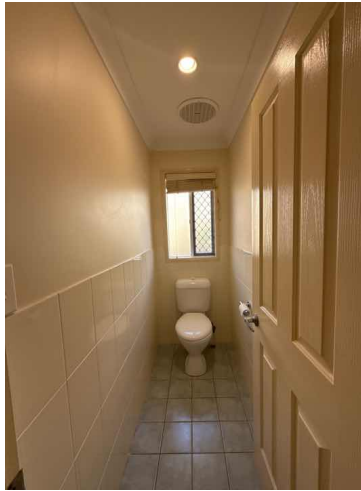
Binding/out of square door frame - This can relate to some differential settlement in the footings, frame movement, age, expansion, shrinkage and the like. A qualified carpenter should be engaged for advice and recommendations.

Loose hinge

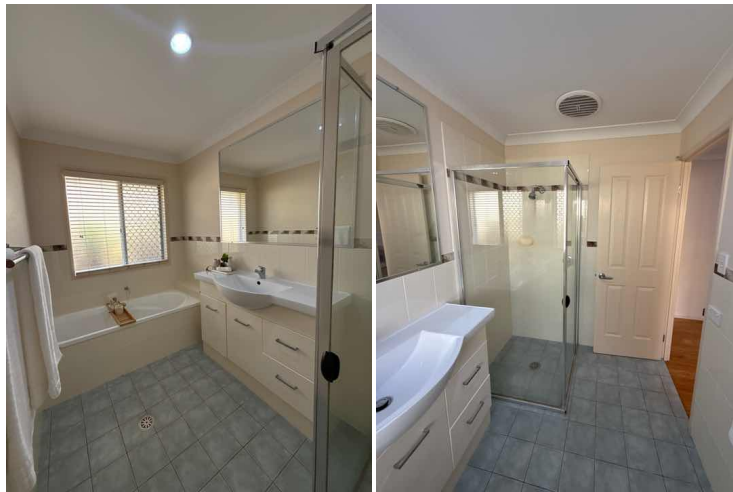
Water damaged door. Possible due to leak in bathroom. Replacement recommended.

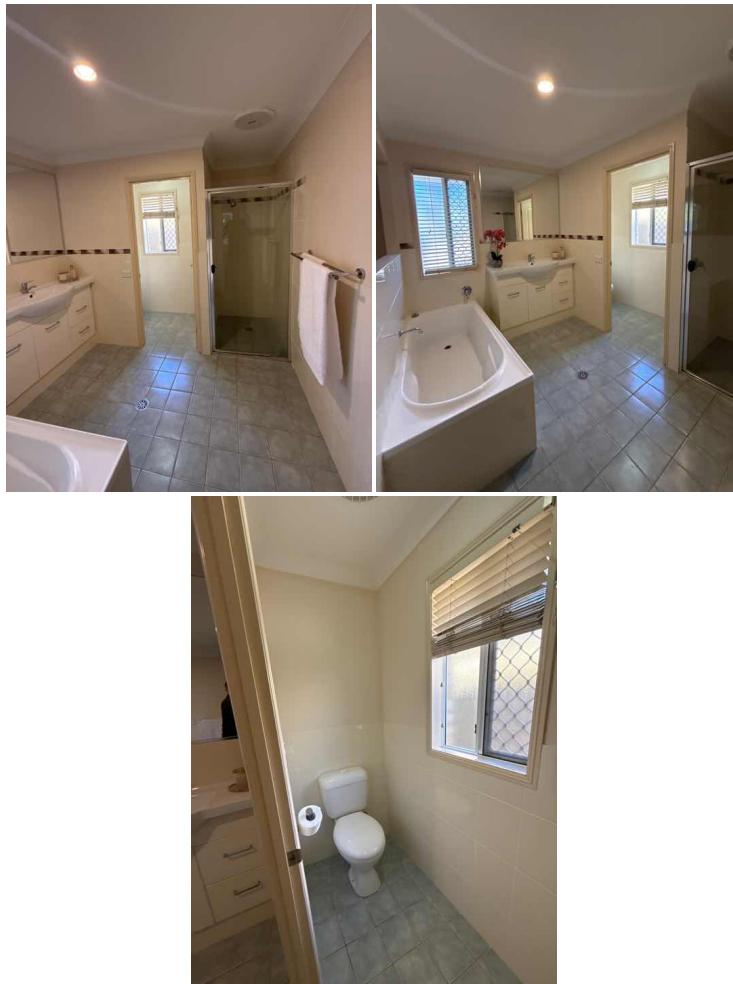
The exhaust fan is noisy - Have assessed by a qualified electrician.

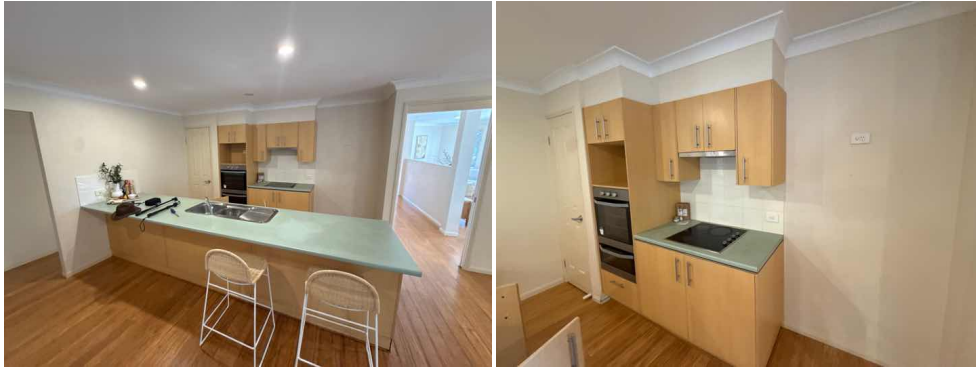
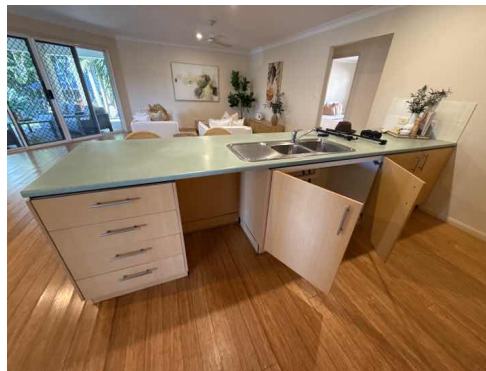
Adjustment to cabinet doors required, in some instance hinges may need to be replaced.

Damage was noted to the cabinets, contact a joinery company for repairs

Water damage to cabinet observed. Replacement required. Contact a cabinet maker for repairs.
