# Building and Pest Report

## 50 Heath Street Evans Head

| Report/Agreement # | 18112501200782 |
| Inspection Date: | 18 Nov 2025 |

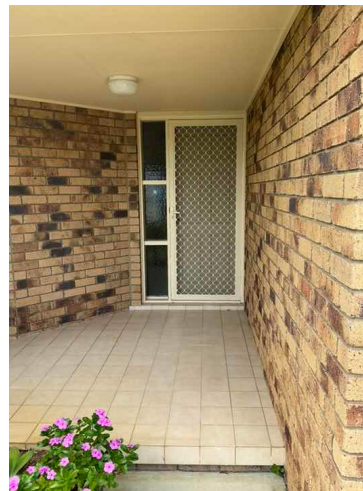
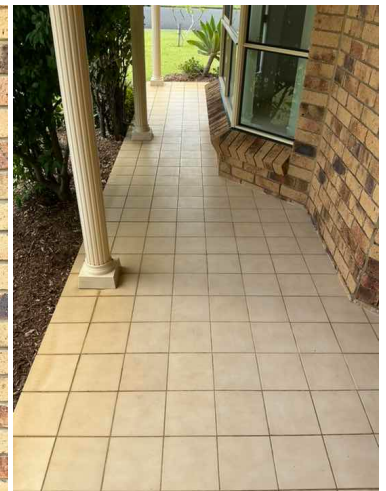
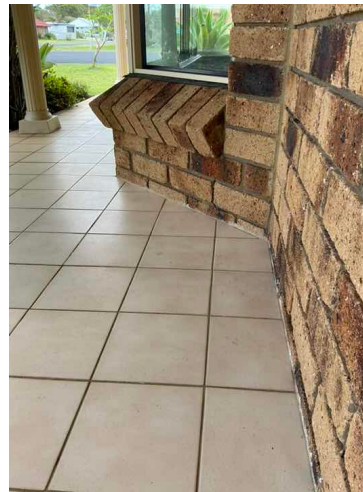
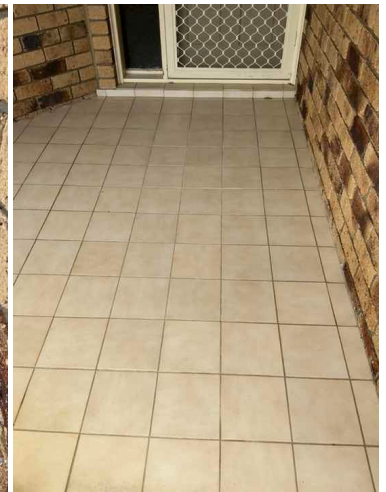
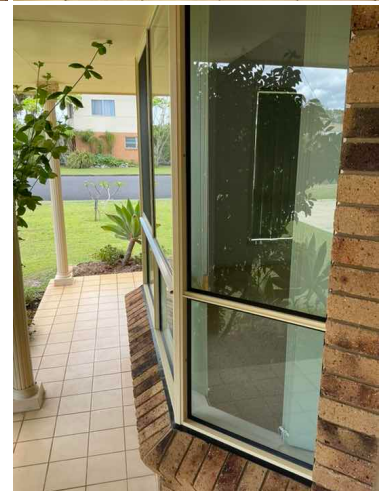
The entry porch serviceable or in reasonable or condition for the age of this dwelling.

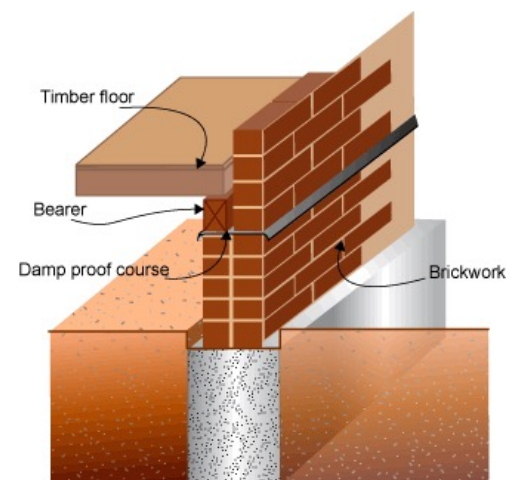
A damp proof course (DPC) was noted.

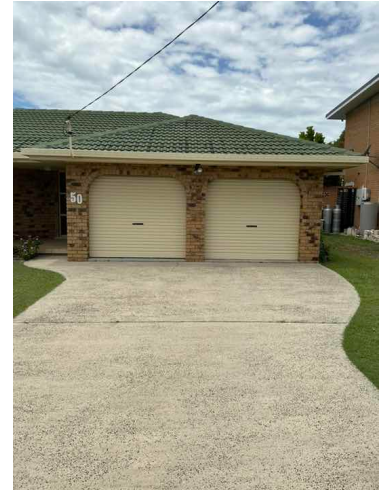
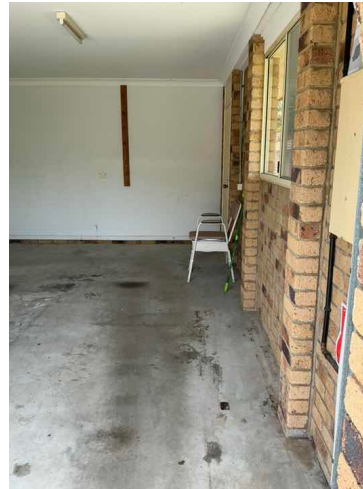
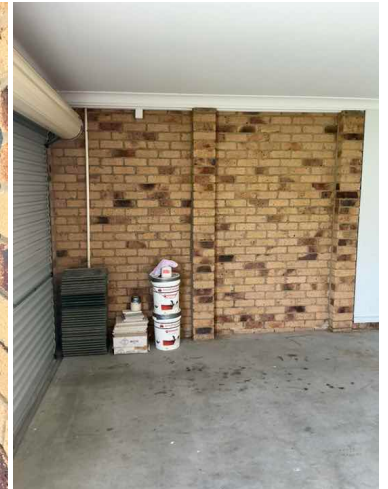
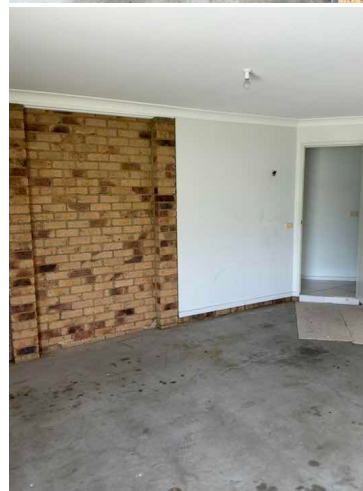
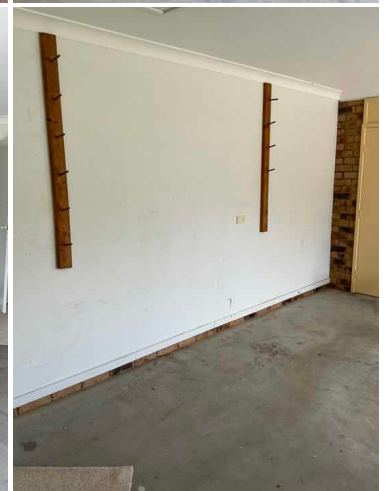
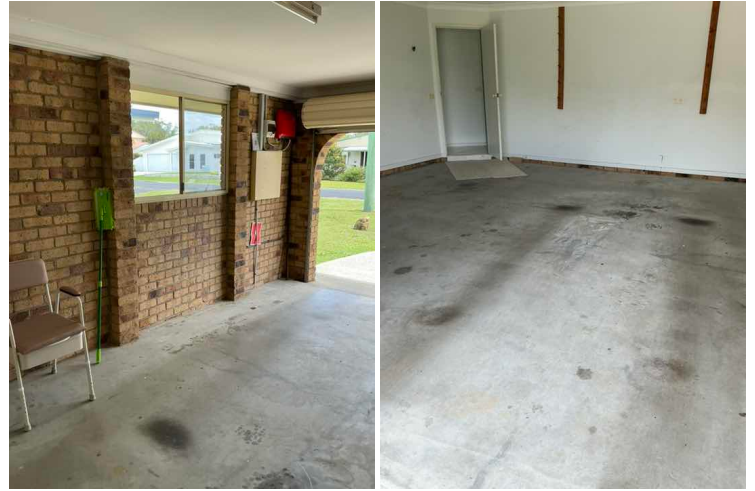
From the visible and accessible areas, the garage appears to be in a serviceable condition for the age of the property with no notable structural defects sighted.

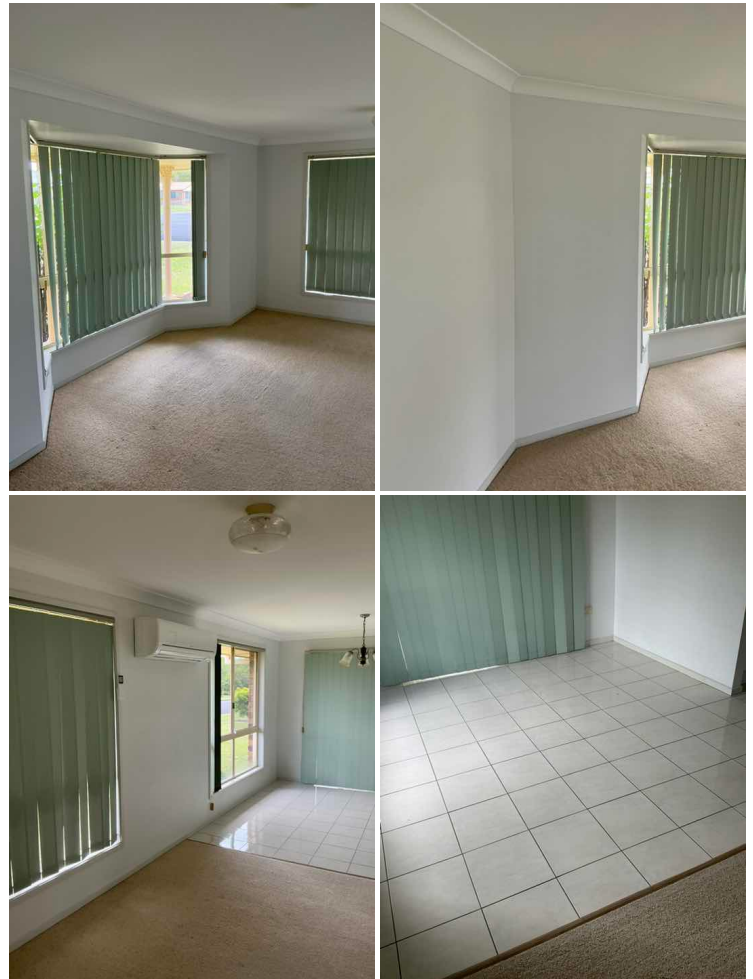
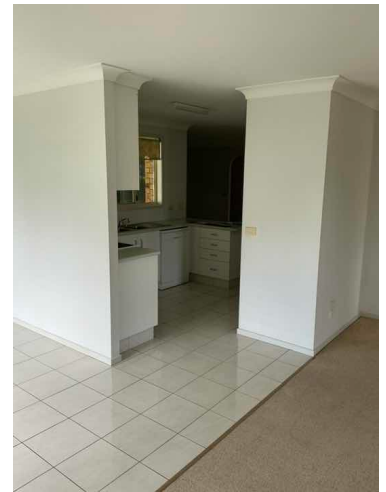
From the visible and accessible areas, this room appears to be in a serviceable condition for the age of the property with no notable structural defects sighted.

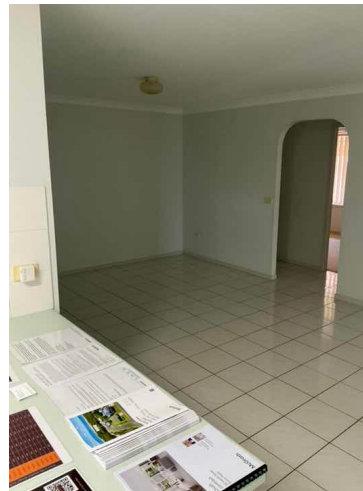
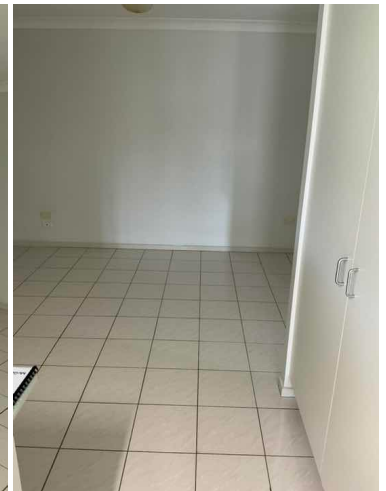
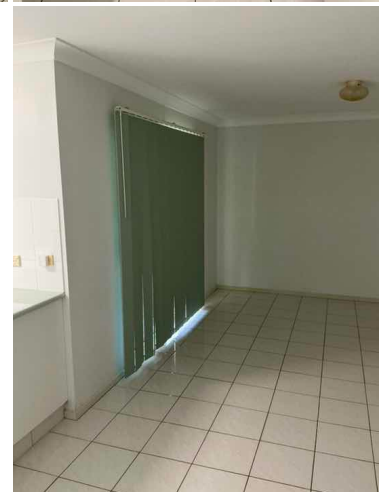
From the visible and accessible areas, this room appears to be in a serviceable condition for the age of the property with no notable structural defects sighted.

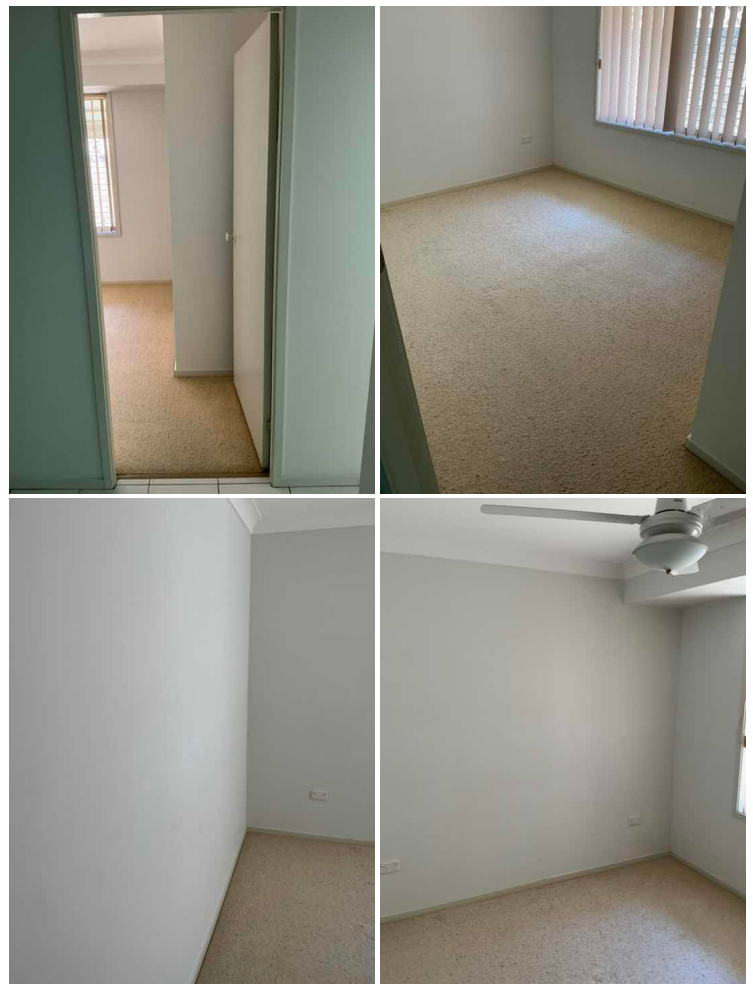
From the visible and accessible areas, this bedroom appears to be in a serviceable condition for the age of the property with no notable structural defects sighted.

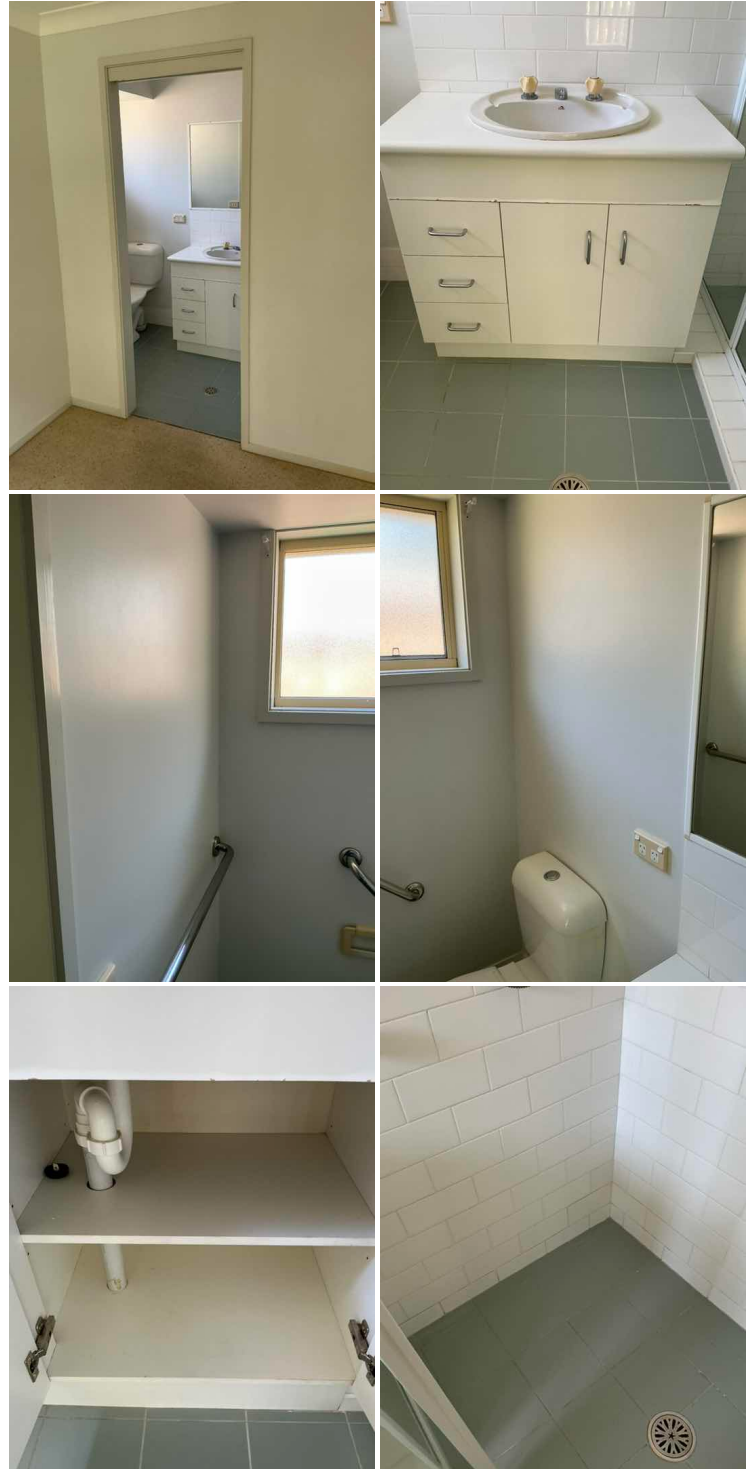
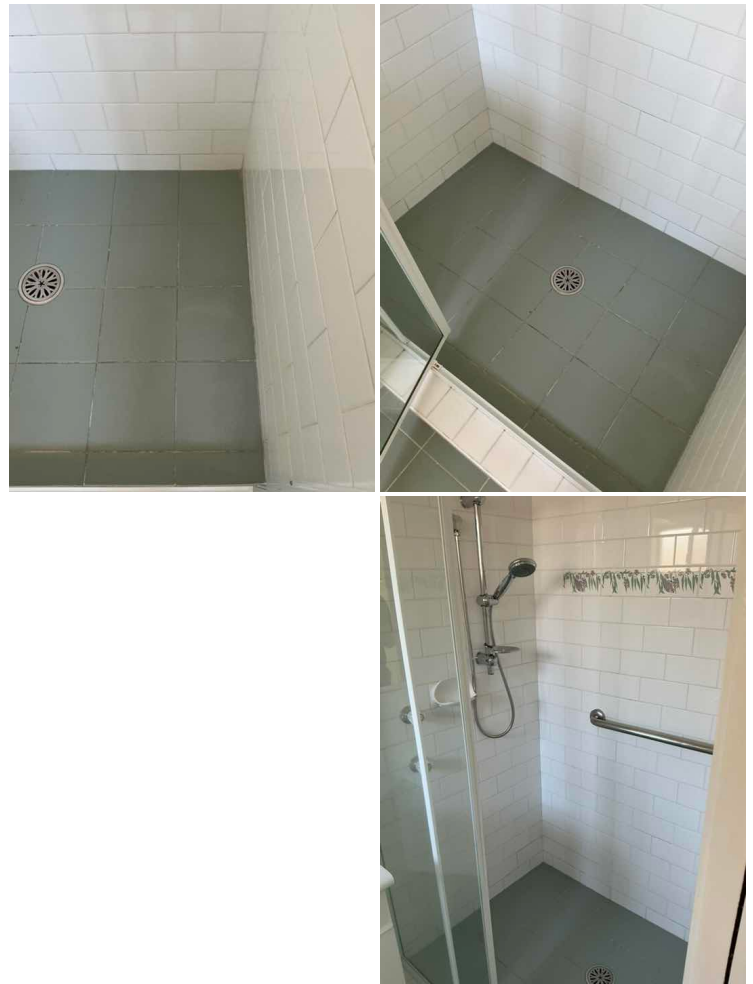
Of the visible areas, the general condition of this bathroom is serviceable or in reasonable condition for age of dwelling.

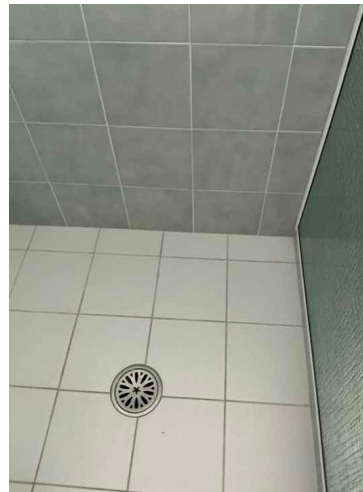
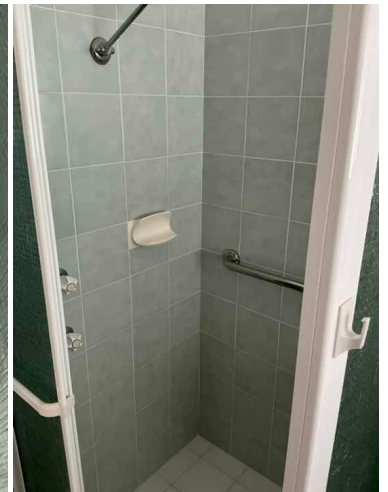
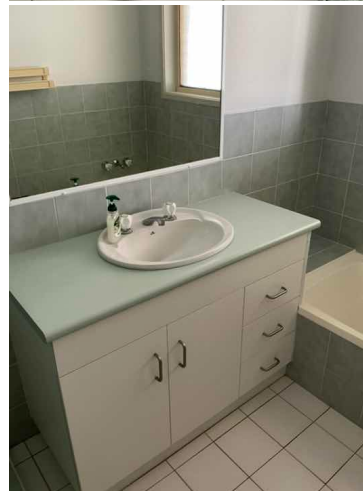
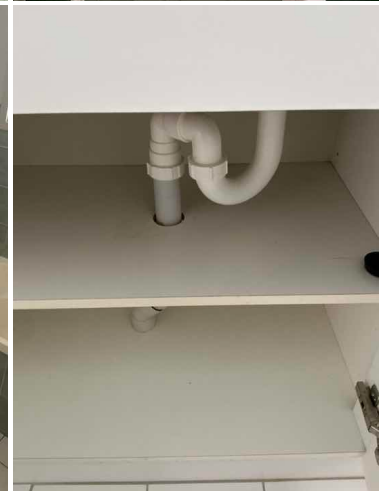
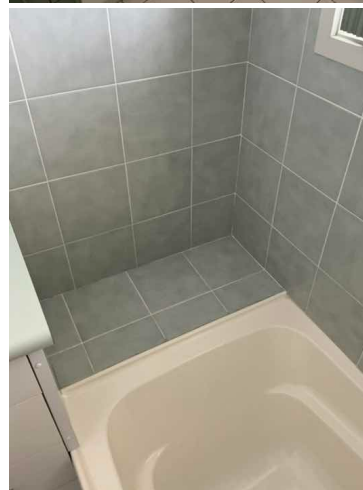
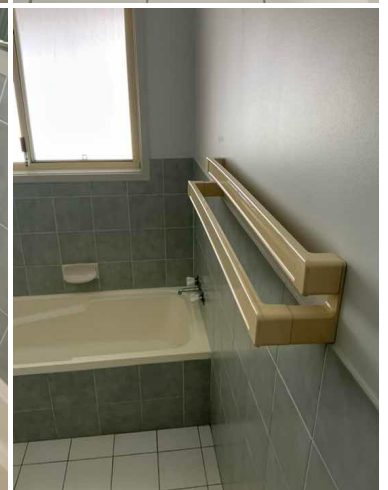
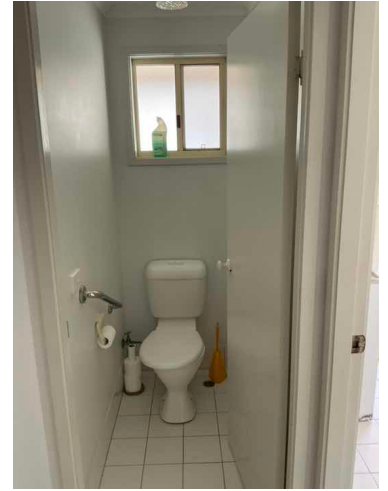
This bathroom is located in the hallway.

Of the visible areas, the general condition of this bathroom is serviceable or in reasonable condition for age of dwelling.

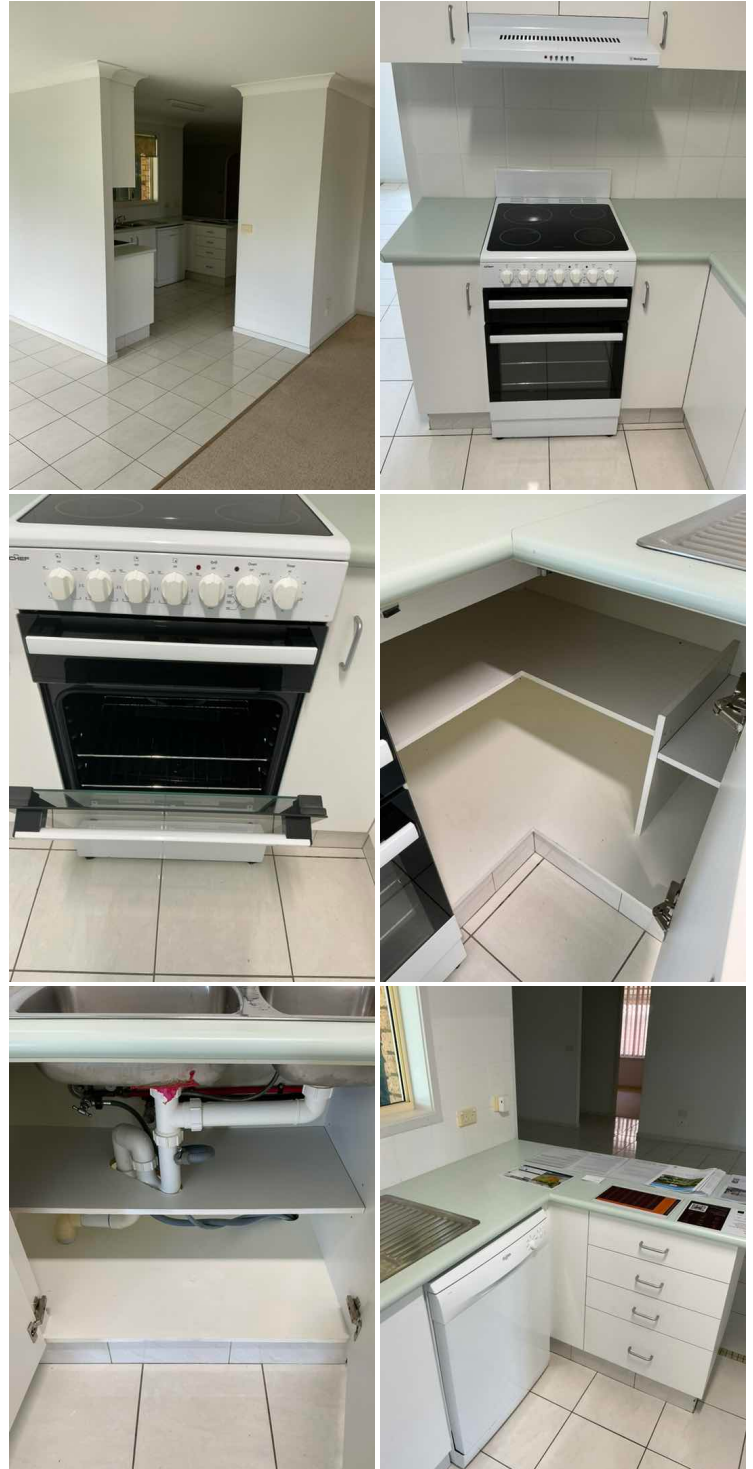
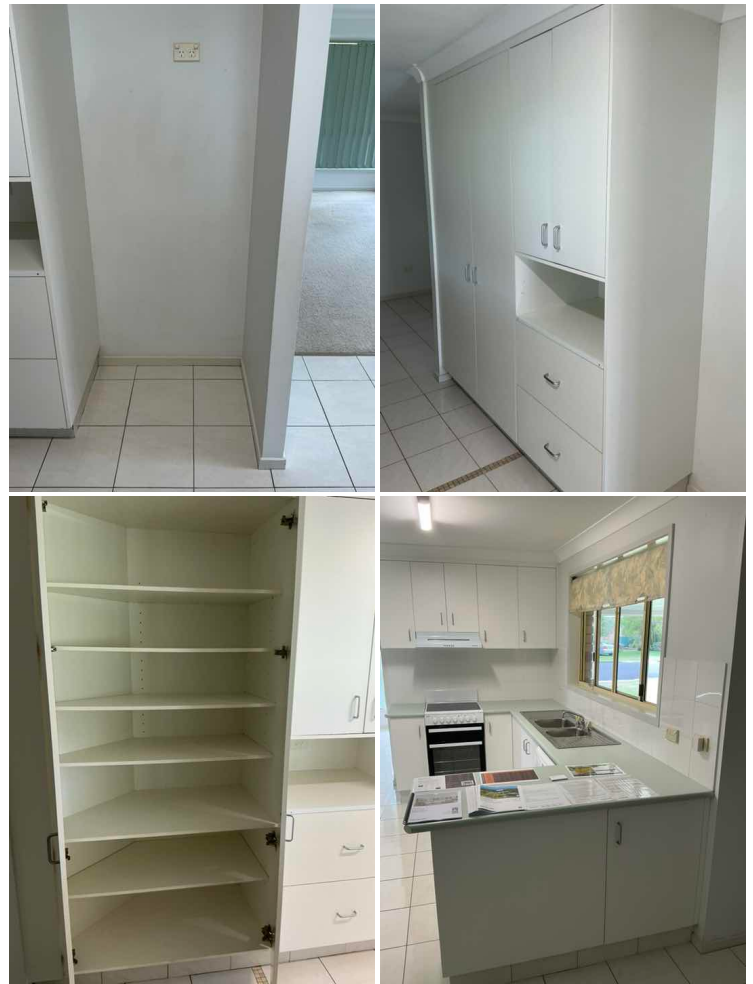
Of the visible areas, the general condition of the kitchen and pantry is serviceable or in reasonable condition for age of dwelling.

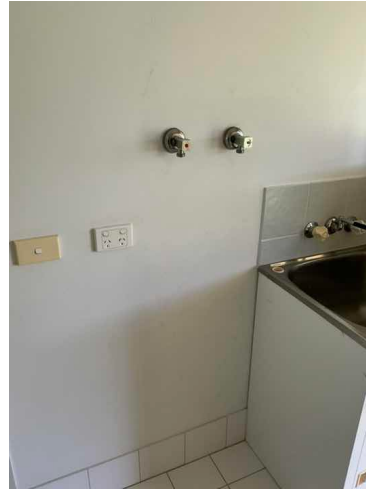
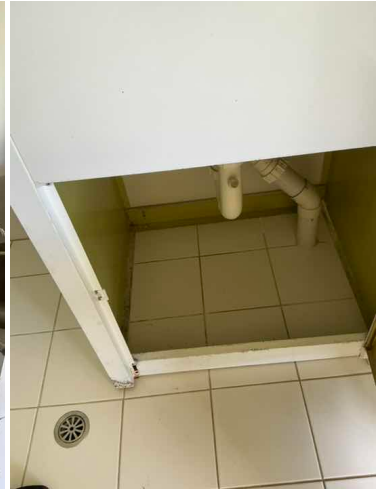
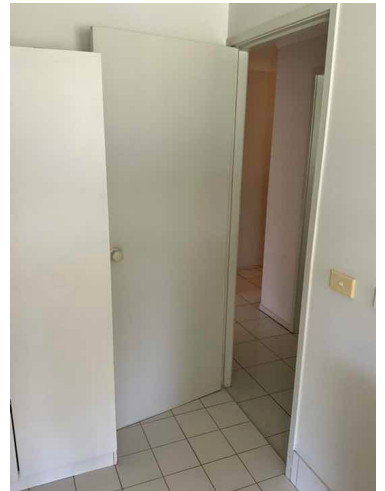
Of the visible areas, the general condition of the laundry is serviceable or in reasonable condition for age of dwelling.

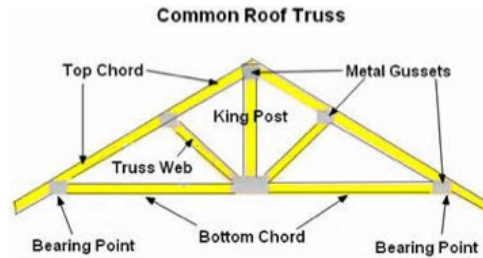
There is insulation present in the roof space/void. This is preventing a full inspection of ceiling joists from being undertaken. It is strongly recommended that full access be gained as it could be harbouring timber pest activity, damage or defects.

Viewed from out side due to restricted entry. No comment can be made regarding condition

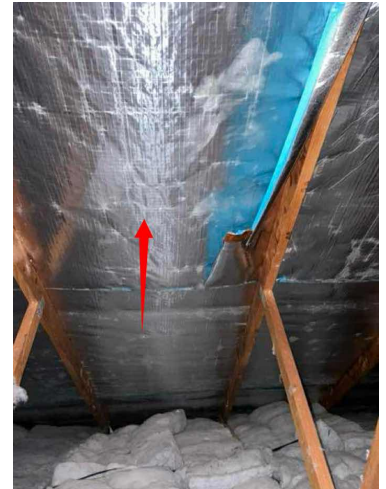
Sarking is installed.

The sarking generally is in a serviceable condition.

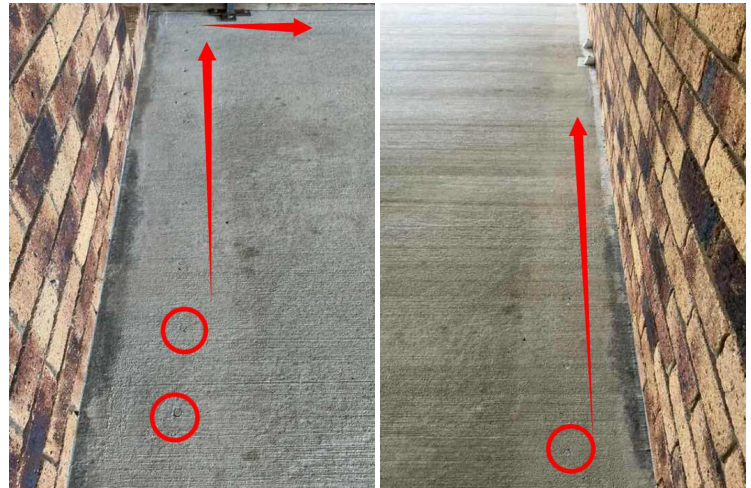
Yes, a reticulated pipe system was located at the dwelling.

Yes, Drill Holes (Chemical Treatment) were located at the property.
