Building and Pest Report

1/4 Pinnacle Row Lennox Head

Report/Agreement #	170625114555506
Inspection Date:	17 Jun 2025
Inspection Time:	11:45 am

Pest And Building Inspection

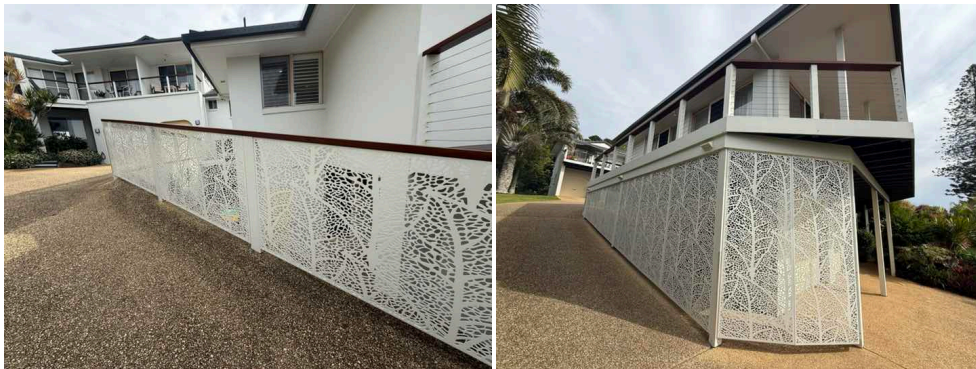
Overall Condition

Of the visible areas, the general condition of the fences and gates is serviceable for the age of dwelling.

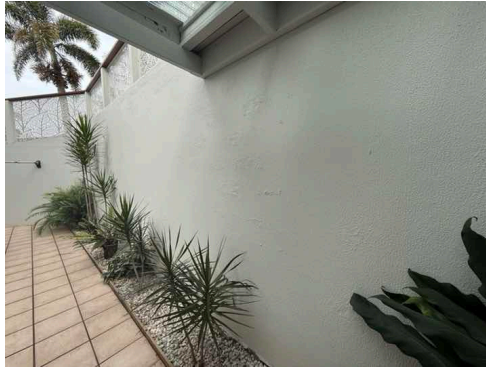
Overall Condition

Of the visible areas, the general condition is serviceable or in reasonable condition for age of dwelling.

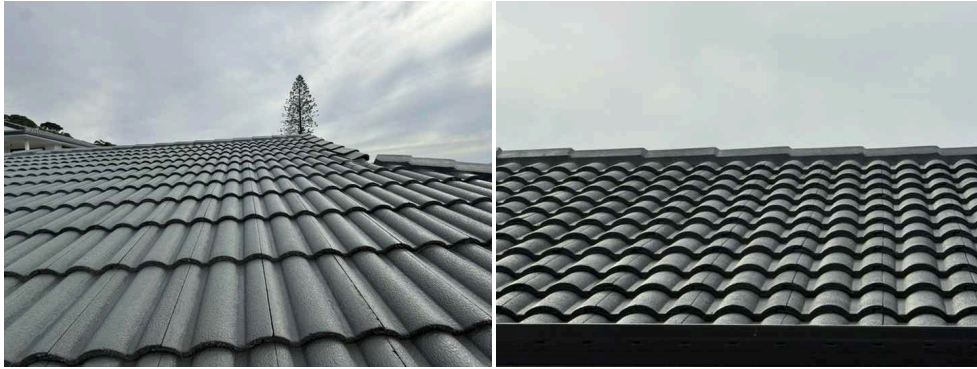
Overall Condition

Of the visible areas, the general condition of the roof is in serviceable condition for the age.

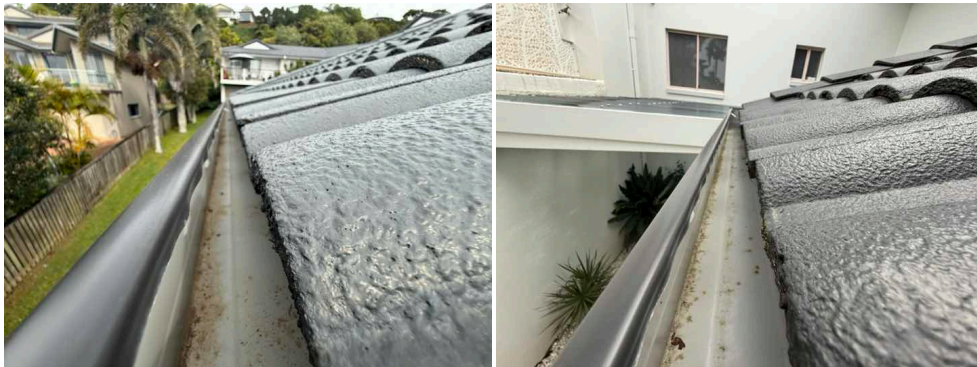
Guttering

All visible and accessible of the physical nature of the guttering system appears to be in a serviceable condition with no apparent defects at the time of inspection. In the absence of prolonged rain fall efficiency of the guttering can not be assessed and you may find that further investigation or repairs maybe required. Note: Periodic maintenance checks should be carried out for rust penetrations and leaks.

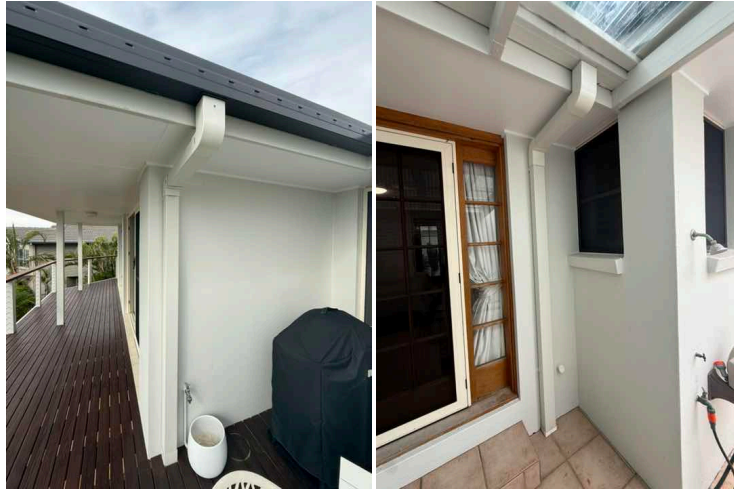
Downpipes

On visual inspection no apparent defects were noted to the down pipes and are considered serviceable, however no comment can be made with regard to blockages or connections to stormwater or functionality in the absence of rain. Note: Periodic maintenance checks should be carried out for rust penetrations and leaks.

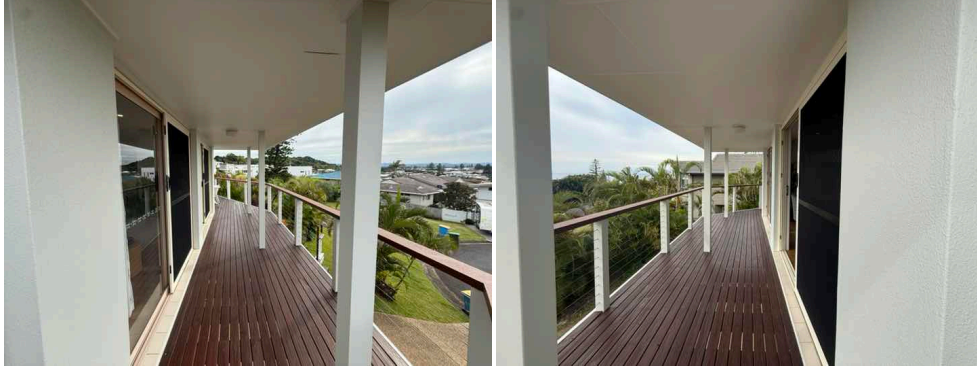
Overall Condition

Visible sections of the Alfresco area are serviceable or in reasonable or condition for the age of this dwelling.

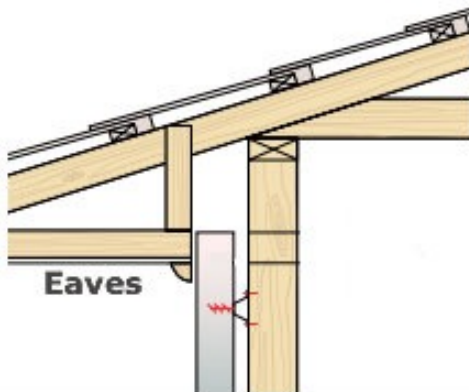
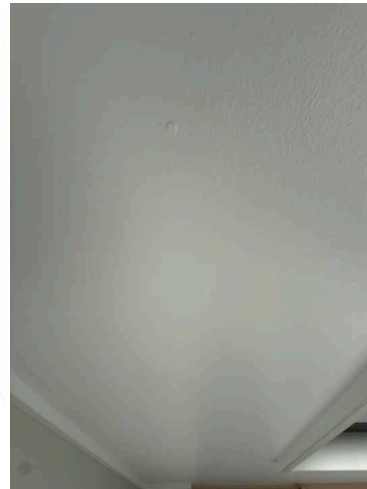
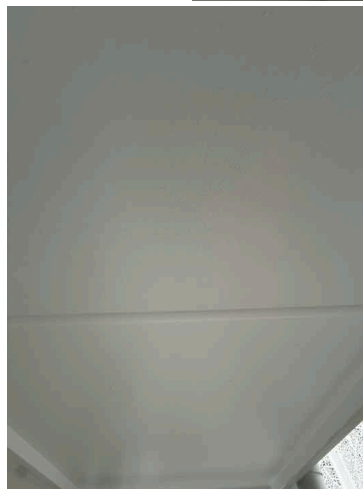
Eaves

The soffit lining (eaves) are in a serviceable condition with no notable defects.

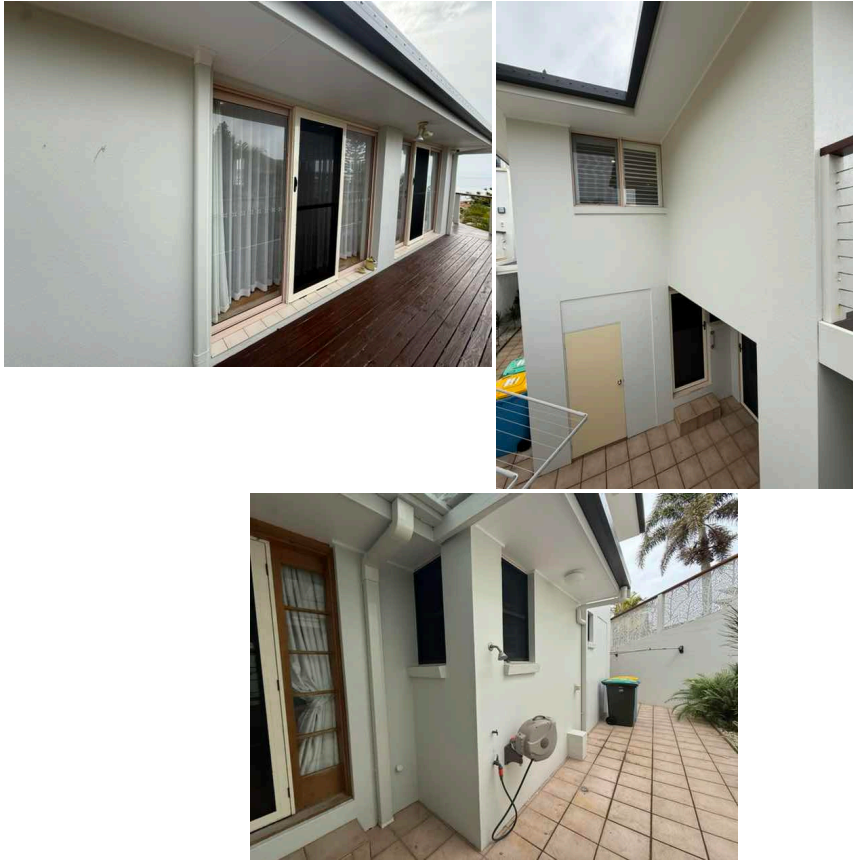
Condition

On visual inspection, the general condition of the exterior walls is serviceable for the age.

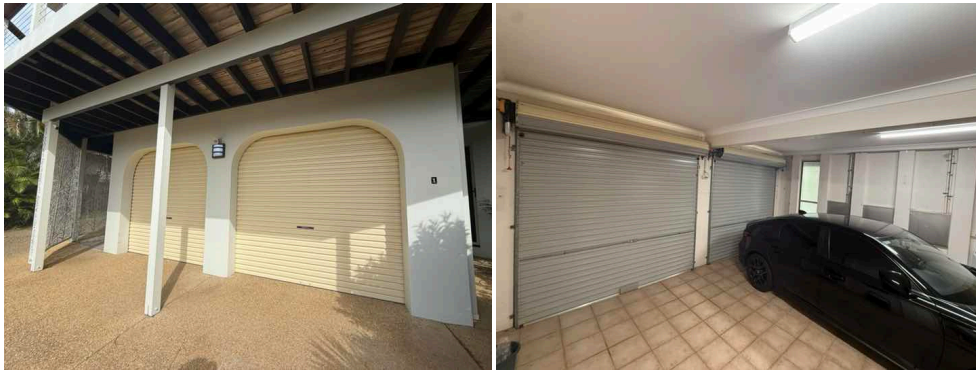
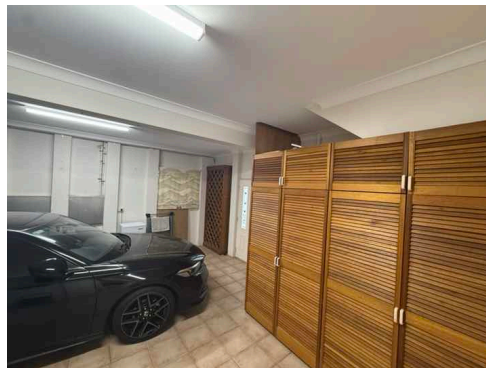
Overall Condition

From the visible and accessible areas, the garage appears to be in a serviceable condition for the age of the property with no notable structural defects sighted.

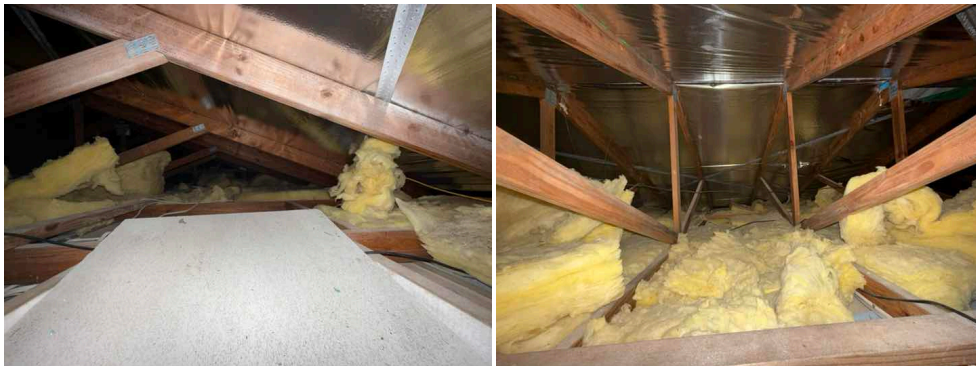
Overall Condition

Visible sections of the roof void is in a serviceable condition for age of this dwelling.
