# Building and Pest Report

## 1/17 Stewart Street Lennox Head

Report/Agreement #	080725101832555
Inspection Date:	08 Jul 2025
Inspection Time:	10:18 am

### Pest And Building Inspection

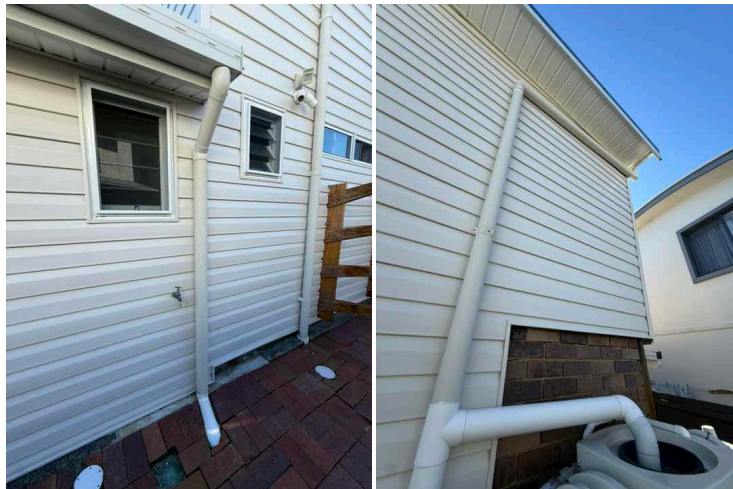
### **Downpipe Findings**

On visual inspection no apparent defects were noted to the down pipes and are considered serviceable, however no comment can be made with regard to blockages or connections to stormwater or functionality in the absence of rain. Note: Periodic maintenance checks should be carried out for rust penetrations and leaks.

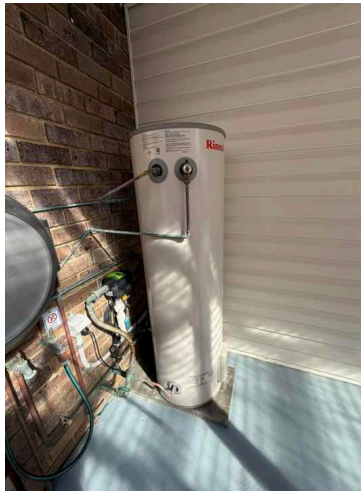
### System Make

The make of the hot water unit is rinnai.

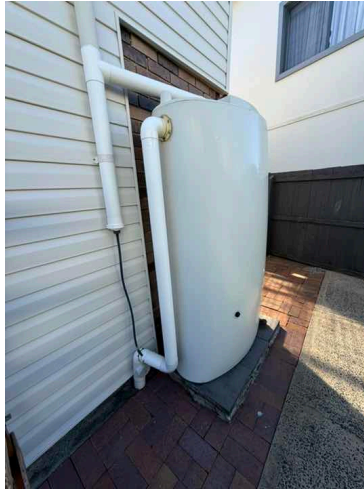
### Water Tank Condition

On Visual Inspection the water tank appears serviceable, but should be checked by a qualified plumber.

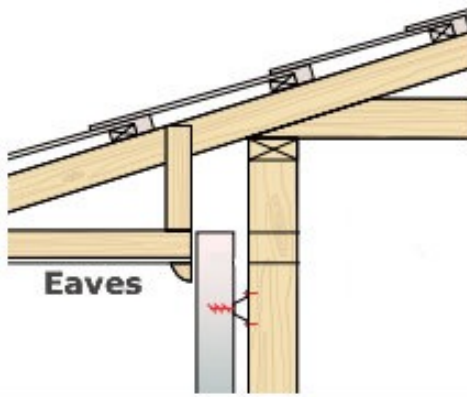
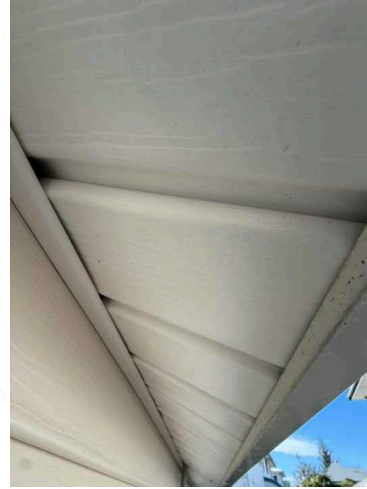
#### **Eave Condition**

The soffit lining (eaves) are in a serviceable condition with no notable defects.

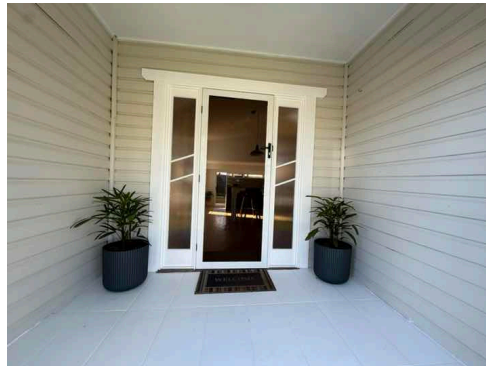
The entry porch serviceable or in reasonable or condition for the age of this dwelling.

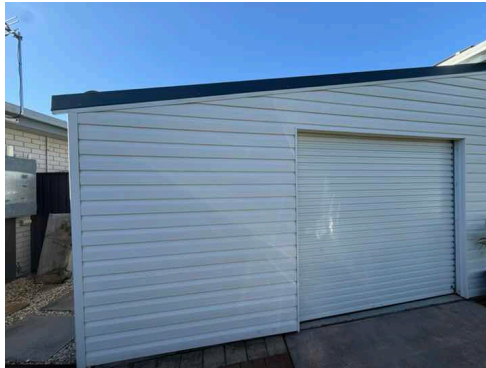
Access restricted. Unable to inspect.

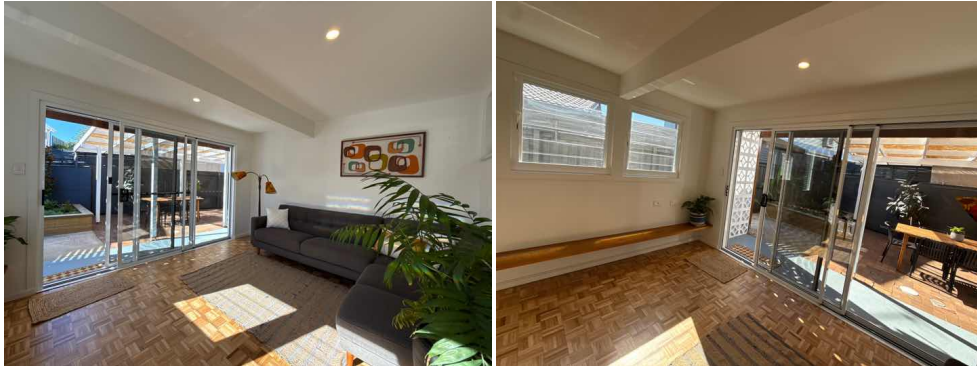
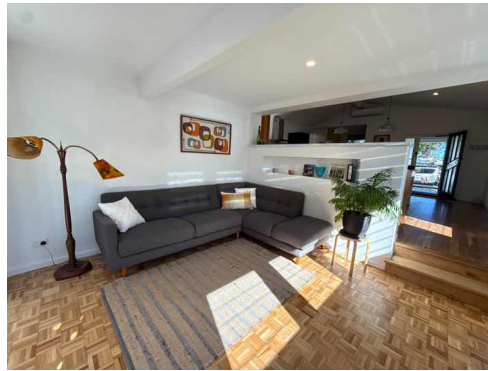
Upon visual inspection, the timber flooring was found to be loose, posing potential safety hazards. It is recommended to engage a licensed tradesperson to assess and secure the flooring. Repairs may involve re-nailing or replacing affected boards to ensure stability. Regular maintenance checks should be scheduled to prevent future issues and maintain the integrity of the flooring.

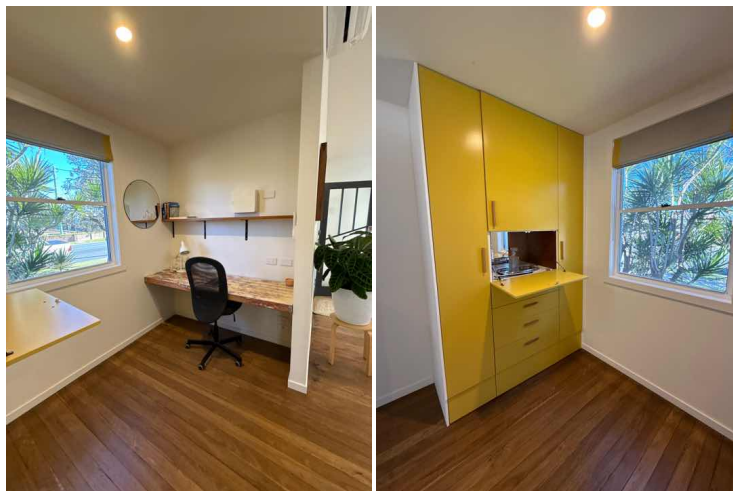
From the visible and accessible areas, this room appears to be in a serviceable condition for the age of the property with no notable structural defects sighted.

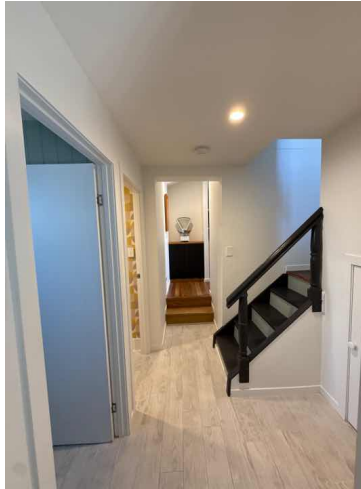
From the visible and accessible areas, the hallway/ appears to be in a serviceable condition for the age of the property with no notable structural defects sighted.

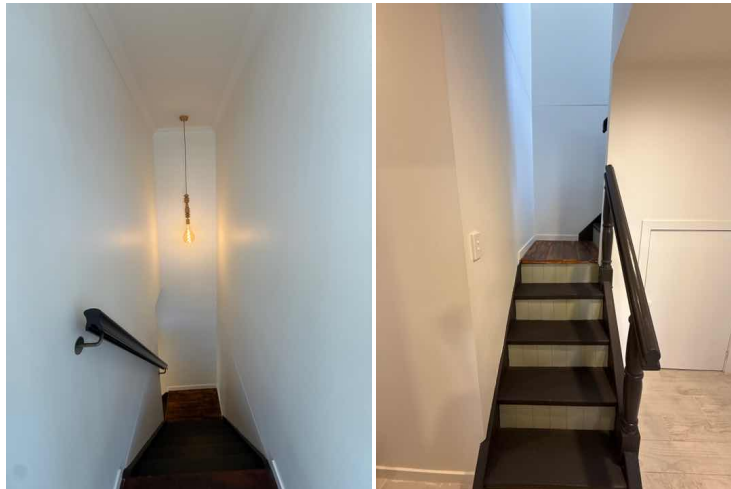
The internal staircase and components appear to be in a serviceable condition for the age with no notable defects sighted.

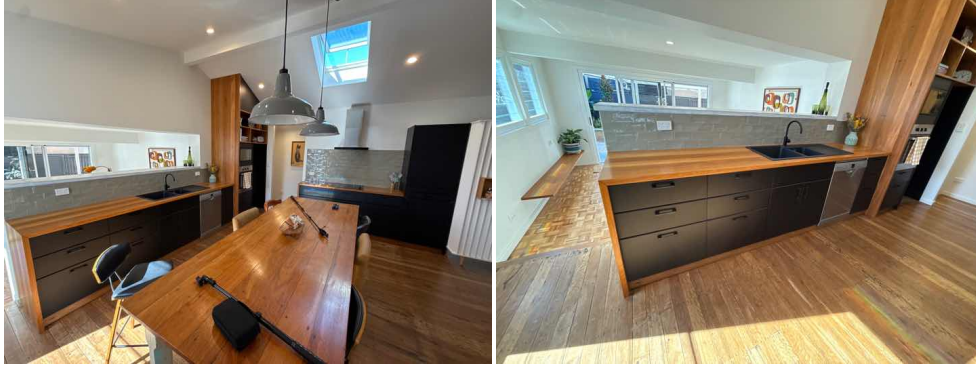
Minor cornice cracks - Minor cornice cracks visible. Recommendations: I recommend you contact a licensed plasterer for further advice and recommendations.

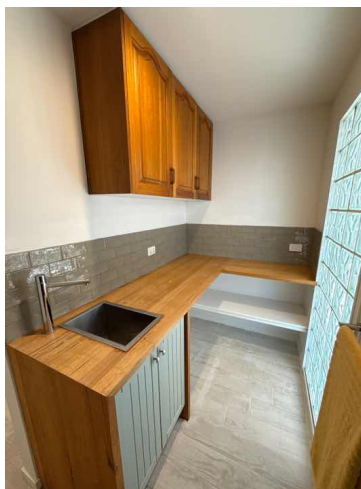
Of the visible areas, the general condition of the laundry is serviceable or in reasonable condition for age of dwelling.
