# PEST AND BUILDING PRE-PURCHASE REPORTS

# BPI BUILDING & PEST INSPECTIONS

1/8 Stewart Street  
Lennox Head

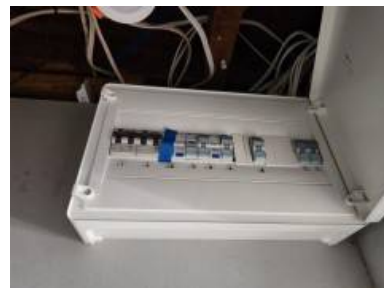
Whilst not an electrician, it appears that an electrical safety switch is present.

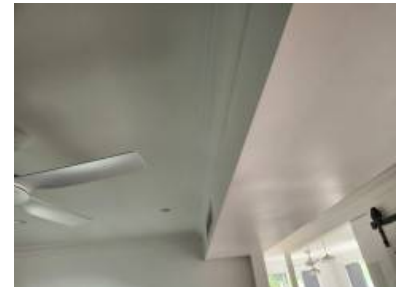
**Damp Damage**

There is evidence of water penetration to ceiling sheeting to Master bedroom.

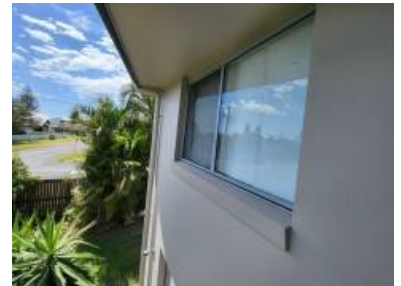
**Condition:**  
The external paintwork / finish to the external surfaces and timberwork is generally in good condition. There may be sections / areas that require touching up / repainting.

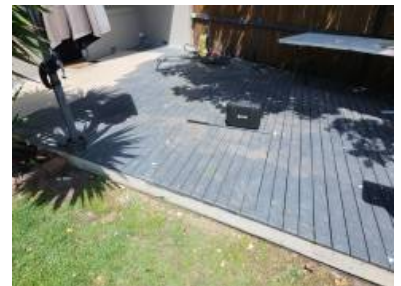
**Restrictions:**  
There is insufficient crawl space below the decking timbers due to the method of construction. There may be concealed defects where access cannot be achieved.

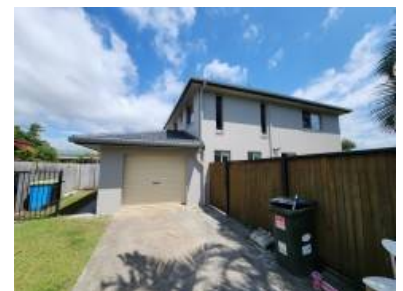
No Safe Access could be gained to the Top Level roof exterior from a 4.6m ladder. No inspection of the Top Level roof exterior could be carried out. See Terms & Conditions: Reasonable Access.

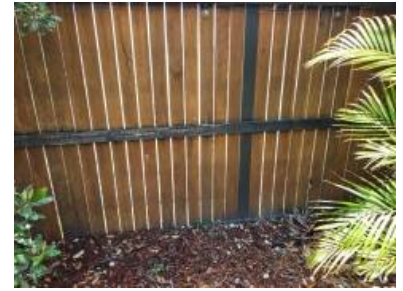
**Condition:**

Satisfactory.
