# Inspection Report

## East Coast Building Solutions

**2 Karalauren Crt , Lennox Head, NSW, 2478**

### Pest And Building Inspection

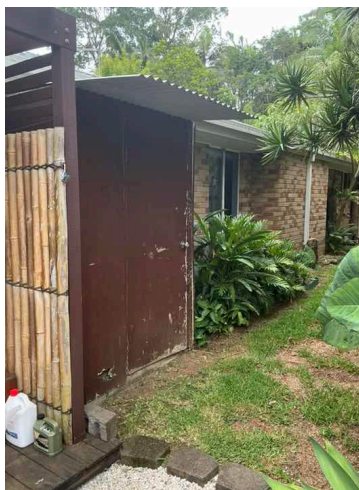
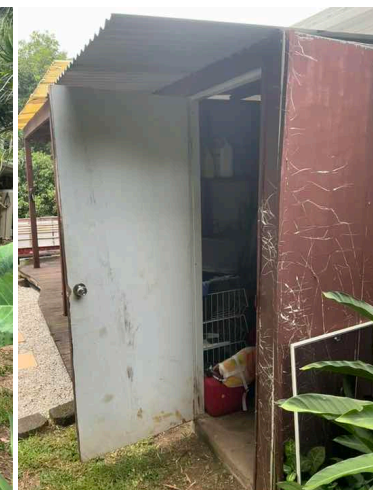
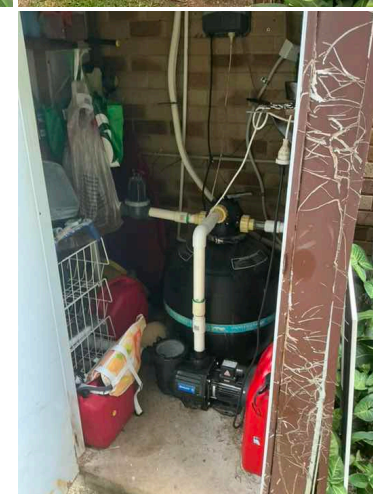
The shed is in fair usable condition.

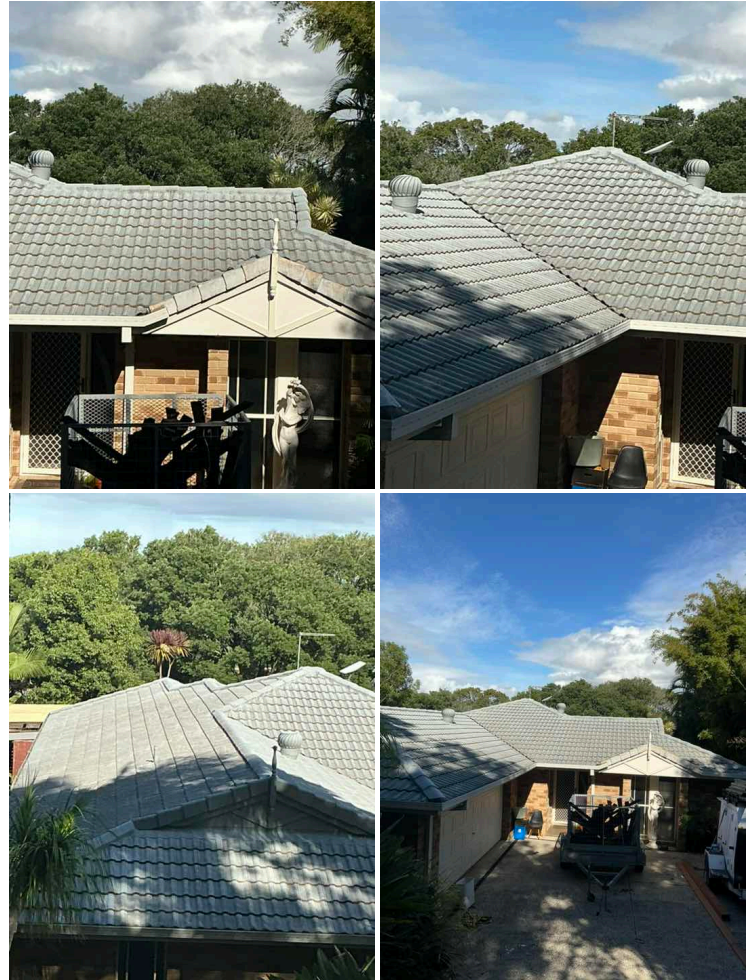
Of the visible areas, the general condition of the roof is in serviceable condition for the age.

Note: In the absence of rainfall there is no guarantee that the roof won't leak.

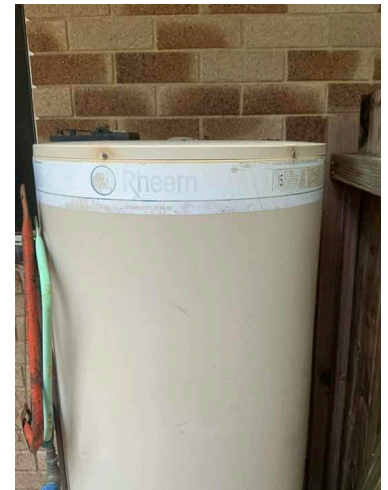
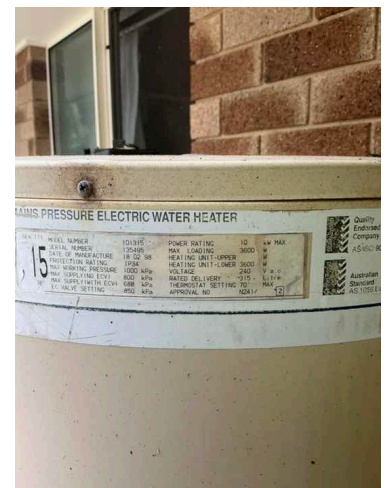
Hot water unit system capacity is 315 litre.

1998

Traditional storage tank water heaters have a life span of **around 10 years**.

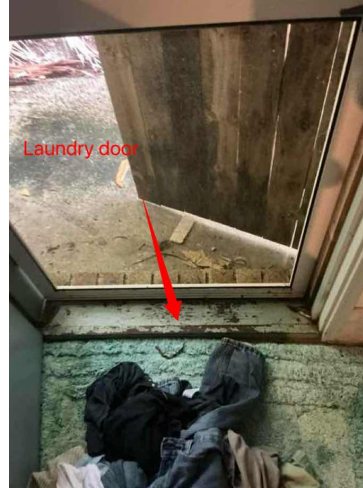
#1. The laundry door is weathered and deteriorated. Replacement recommended  
 Upon visual inspection, the door frame exhibits signs of wood rot and paint deterioration. Recommend engaging a licensed carpenter to replace or repair the damaged wood and repaint to prevent further decay. Ensure proper sealing to protect against moisture ingress.

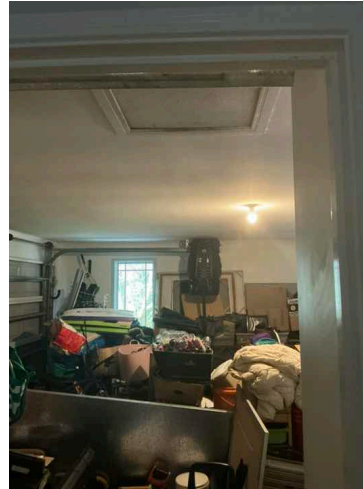
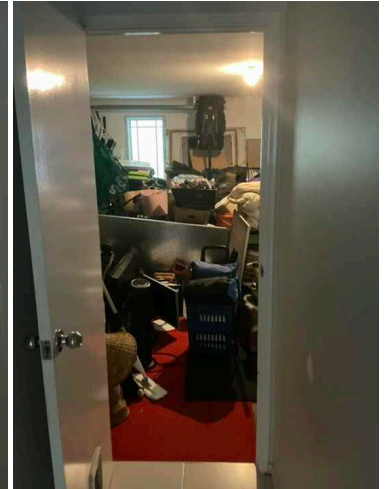
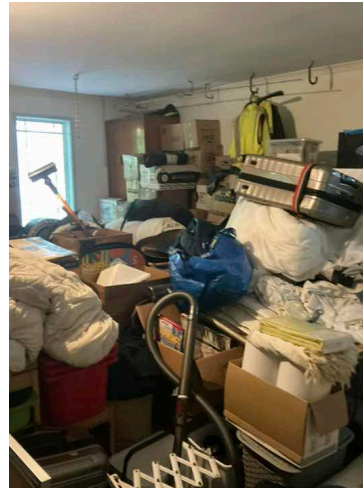
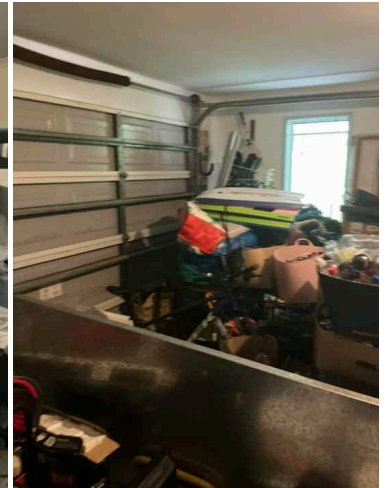
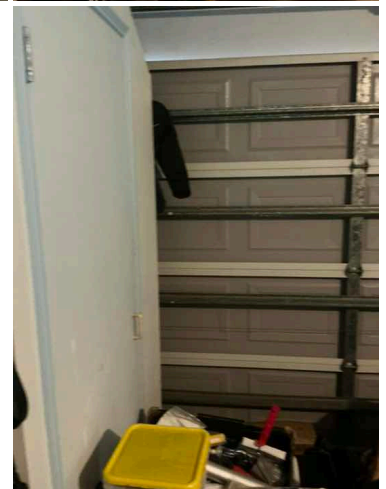
Stored items restricted a full and thorough inspection of this area. Defects may exist in the obstructed and inaccessible areas. It is strongly recommended that full access be granted to enable a thorough inspection as there may be timber pest activity, damage or defects. Note: Where vehicles and storage has restricted a full inspection it is advised that this area be cleared so a full and unobstructed inspection can be carried out.

Access restricted. Unable to inspect.

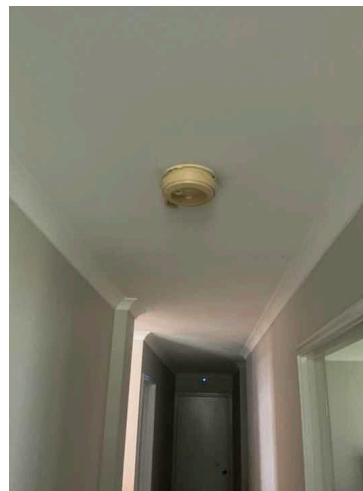
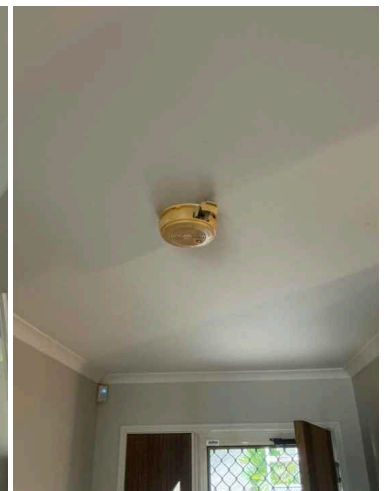
Yes 2 smoke alarms were sighted but not tested.

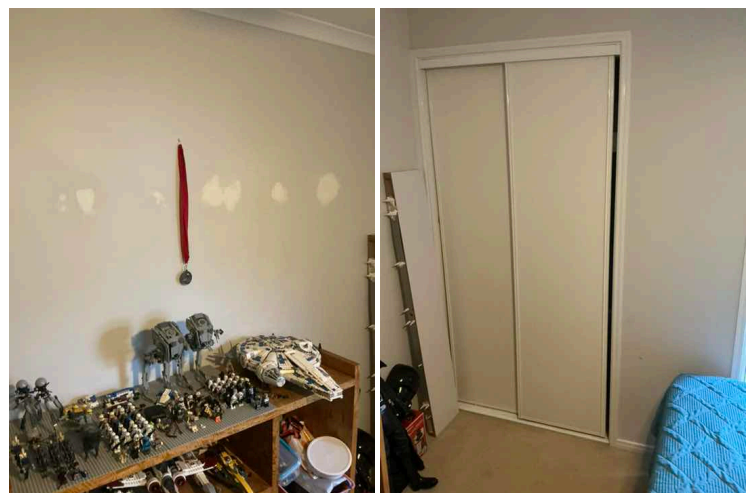
On inspection, defects were present that will require further assessing and recommendations by a qualified trades persons, please read below for details.

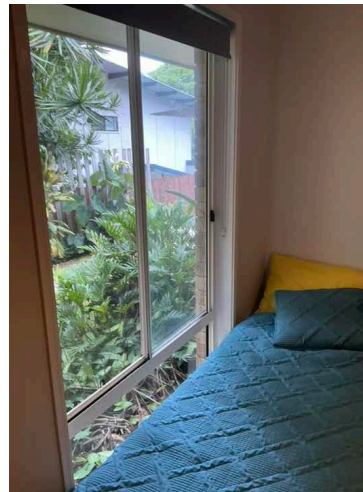
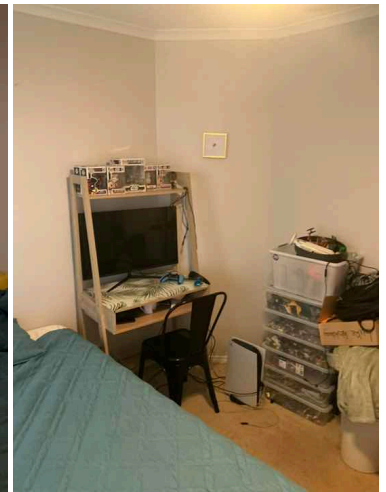
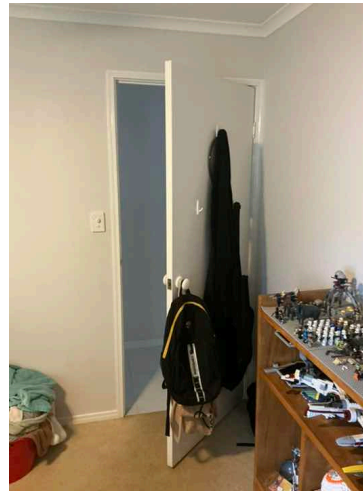
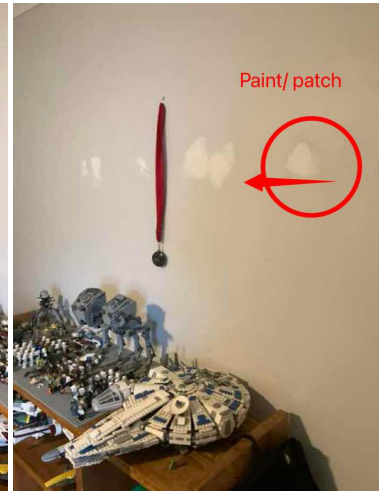
Ceiling paint flake/deterioration is evident. Recommendations: General maintenance/painting as required.

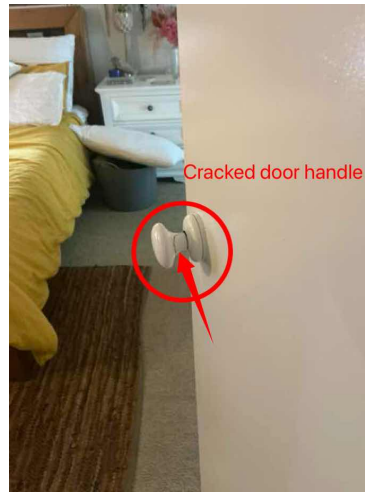
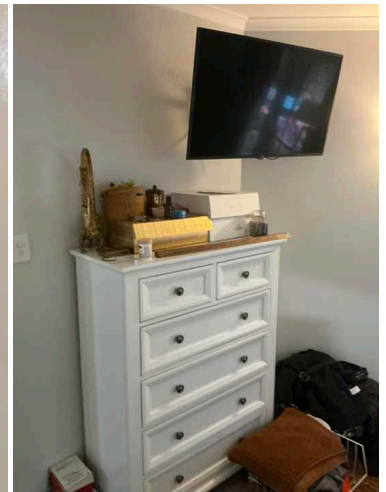
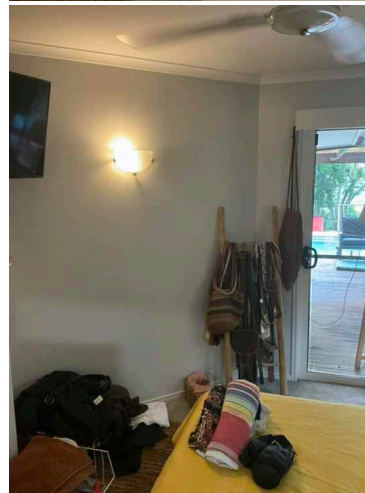
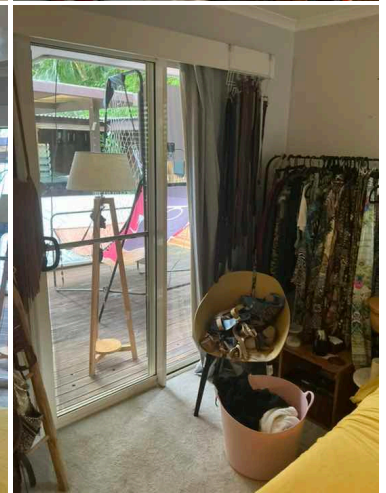
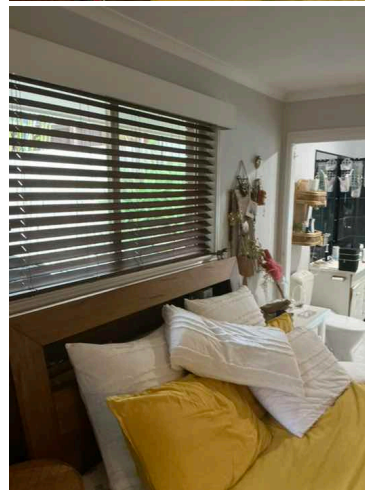
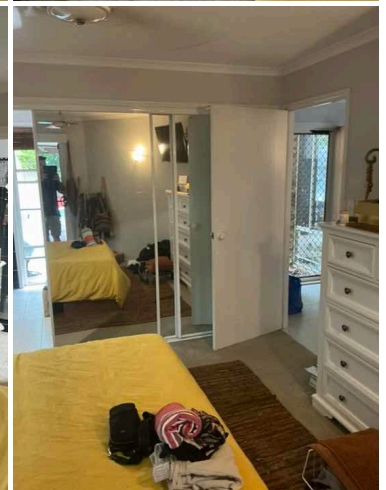
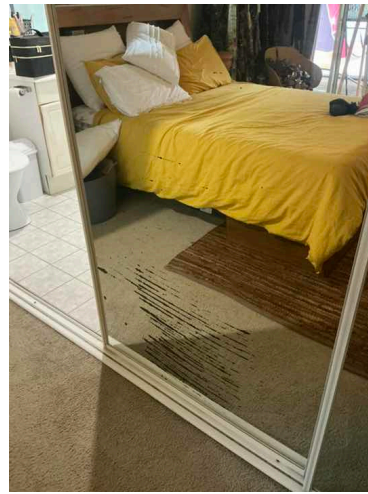
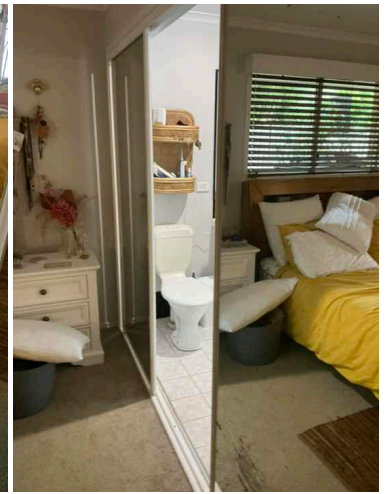
On inspection, defects were present that will require further assessing and recommendations by a qualified trades persons, please read below for details.

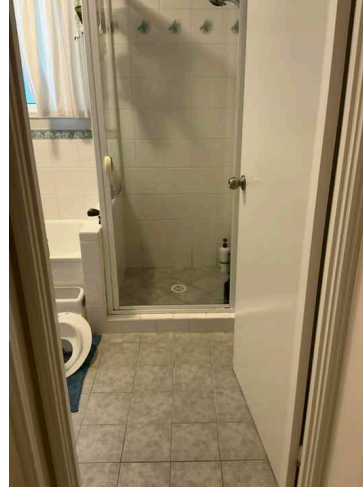
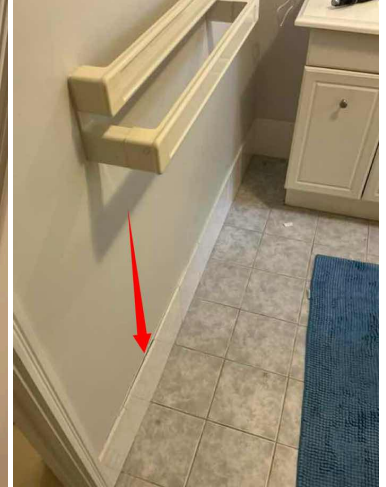
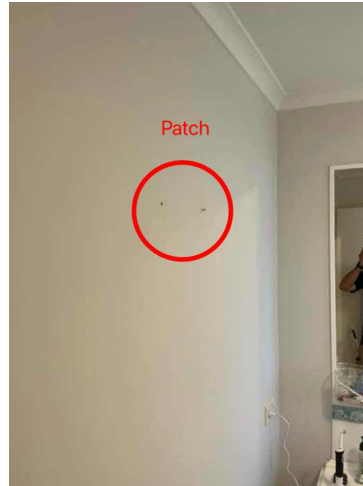
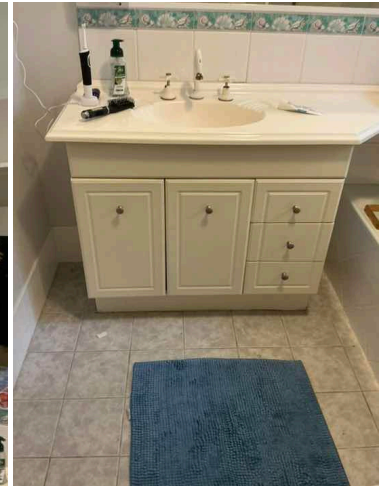
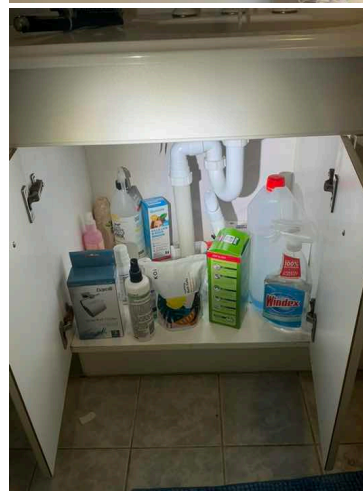
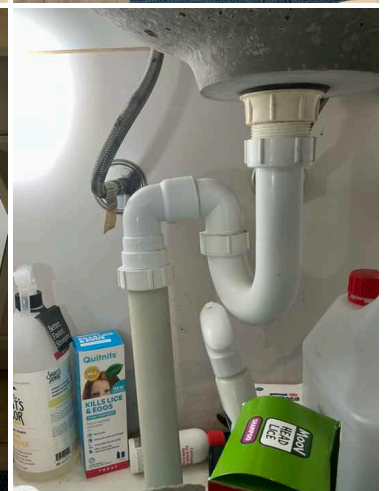
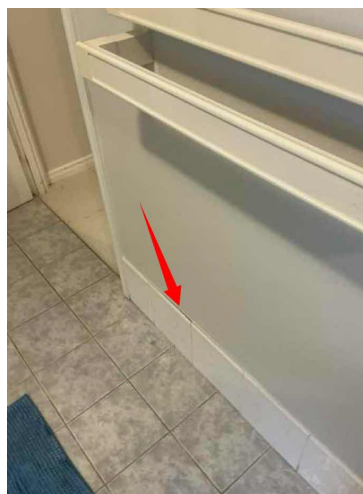
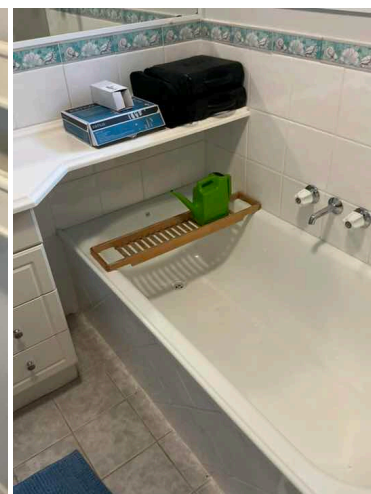
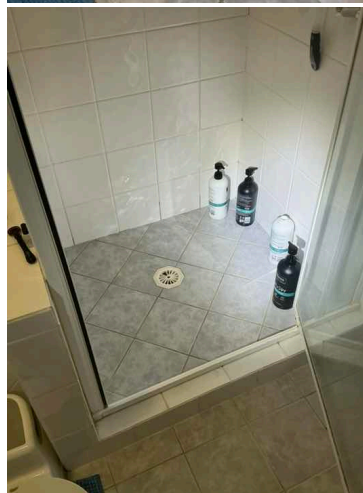
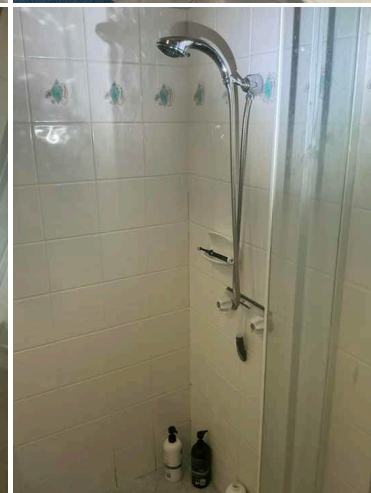
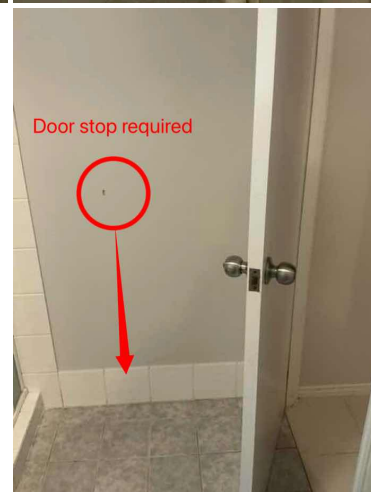
On inspection, defects were present that will require further assessing and recommendations by licensed and qualified trades persons, please read below for details.

Upon visual inspection, there appears to be water damage at the base of the door, indicated by discoloration. Recommend engaging a licensed tradesperson to assess and repair potential leaks. Ensure proper sealing and waterproofing to prevent future issues.

#4. General ageing and/or denting and/or wear and/or previous patching and the like is evident on ceiling linings - Recommendations: A qualified painter should be engaged to assess and repair as required.

#5. General ageing and/or denting and/or wear and/or previous wall patching and the like is evident on wall linings - Recommendations: A qualified painter should be engaged to assess and repair as required.

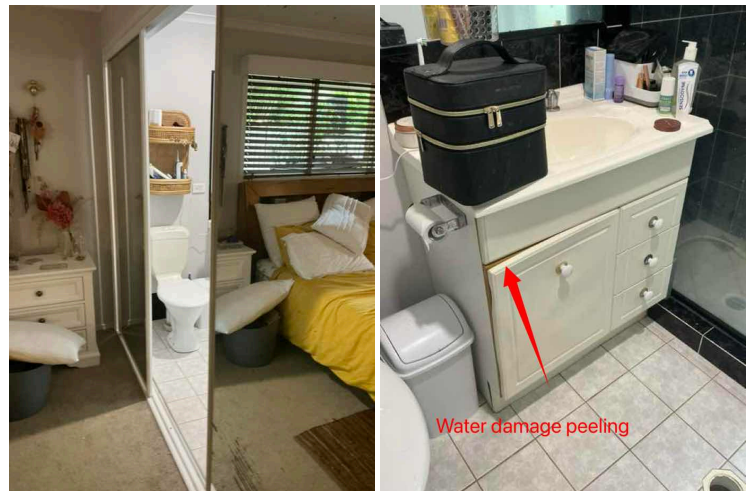
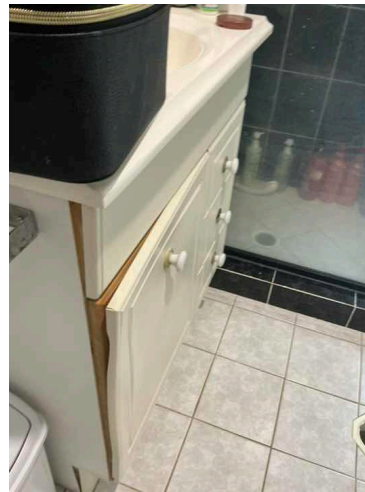
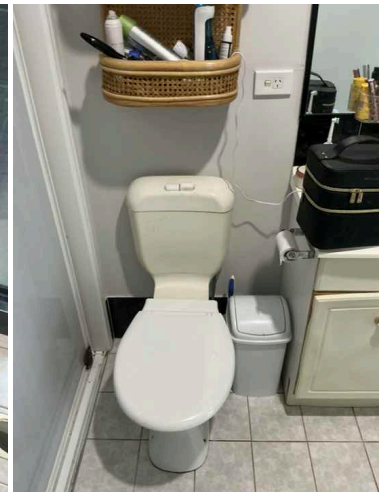
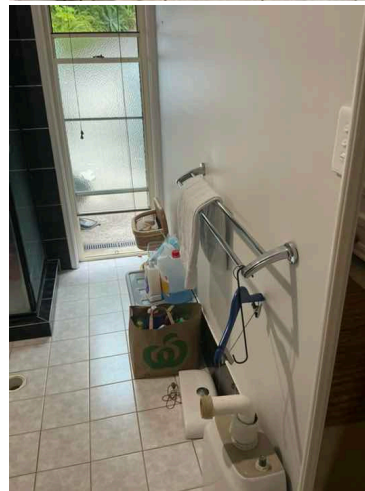
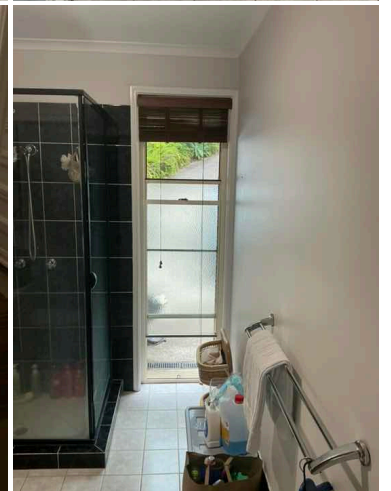
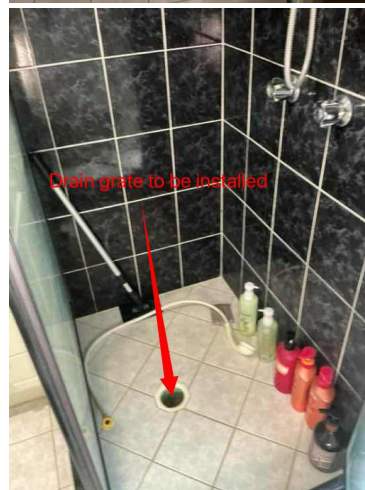
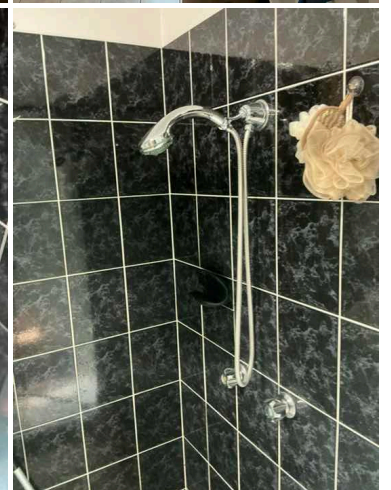
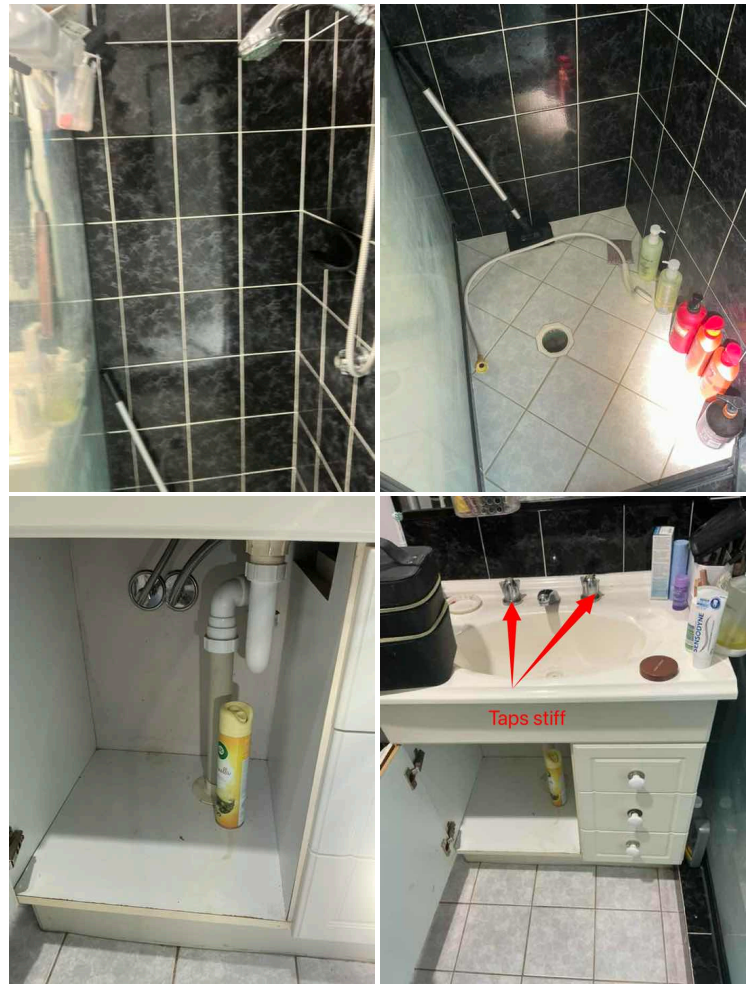
On inspection, defects were present that will require further assessing and recommendations by licensed and qualified trades persons, please read below for details.

Door / frame deterioration - General age/damage has occurred to door frame, face or components. Recommendations: A qualified carpenter should be engaged for advice and recommendations.

#6. General ageing and/or denting and/or wear and/or previous patching and the like is evident on ceiling linings - Recommendations: A qualified painter should be engaged to assess and repair as required.

#7. General ageing and/or denting and/or wear and/or previous wall patching and the like is evident on wall linings - Recommendations: A qualified painter should be engaged to assess and repair as required.

#8. General age wear deterioration - The window frame/components showed evidence of ageing and wear. General maintenance works required.

#9. Deteriorated grout noted. This should be repaired as this will lead to water ingress under the tiles causing uplifting and possible water penetration.

#10. The taps are stiff to open. A qualified plumber should be engaged for advice and recommendations. Normally replacing spindles will rectify.

#11. The cistern is leaking and should be repaired. Contact a qualified plumber for repairs.

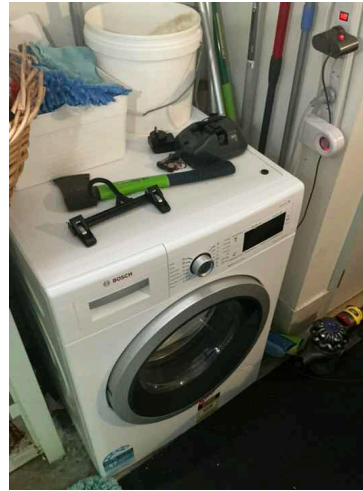
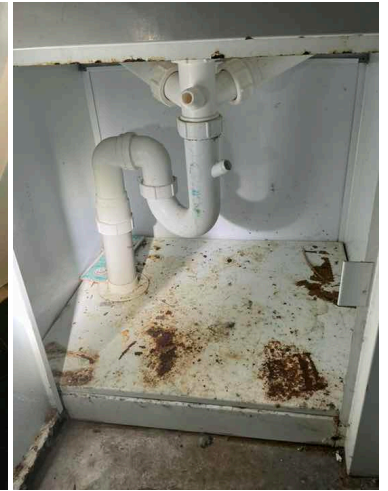
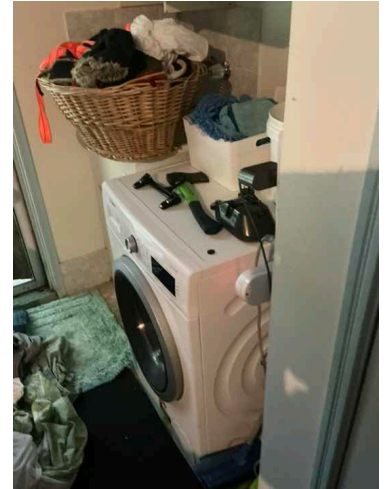
Appliances and the like restricted a full visual inspection.

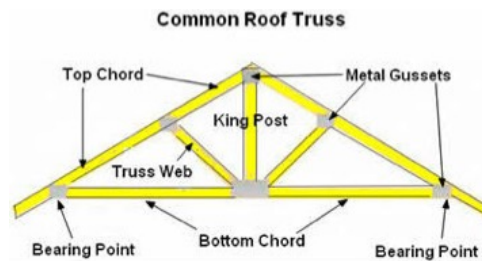
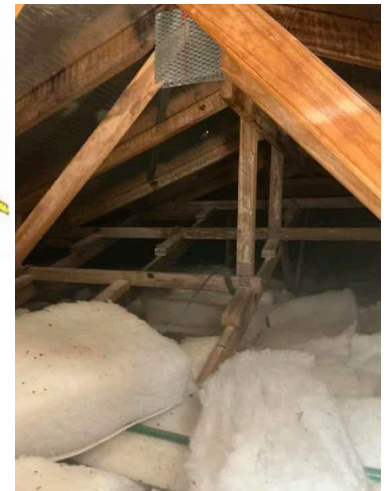
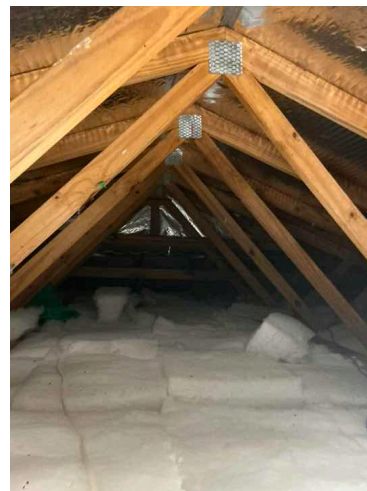
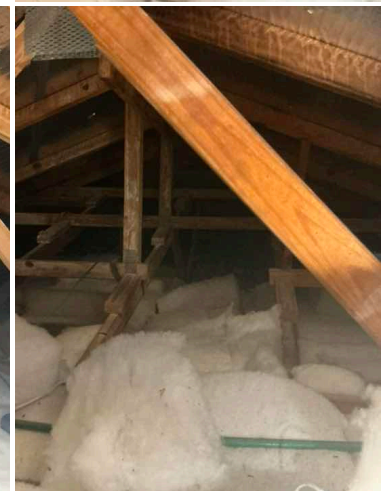
### Roof Frame Type

The roof frame is a truss timber frame.

Viewed from out side due to restricted entry. No comment can be made regarding condition

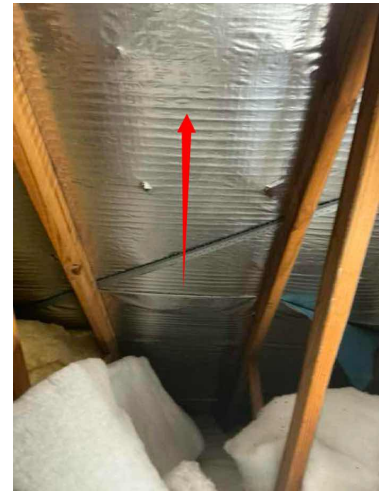
Sarking is installed.

The sarking generally is in a serviceable condition.

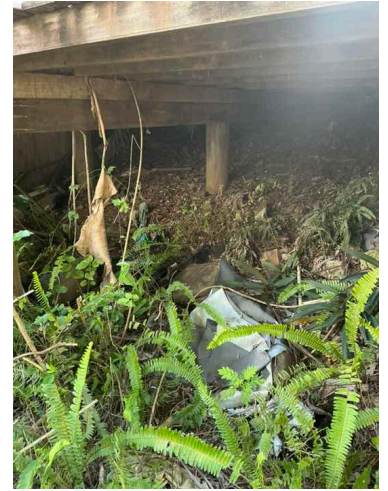
Of areas accessible and visible, the subfloor and components appeared to be in a serviceable condition.

Please note this dwelling is a slab construction. Areas under deck appear serviceable

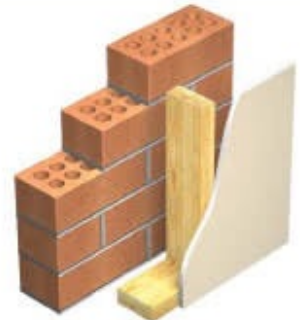
#### BRICK VENEER WALL

The structure is of brick veneer construction.

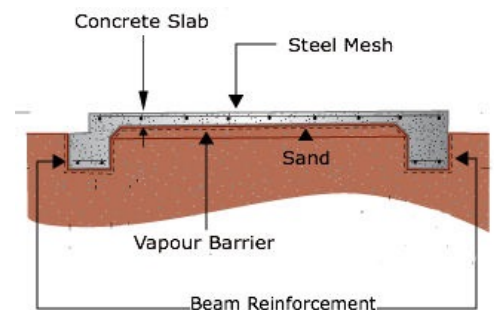
#### Footings Type

Slab on ground construction.

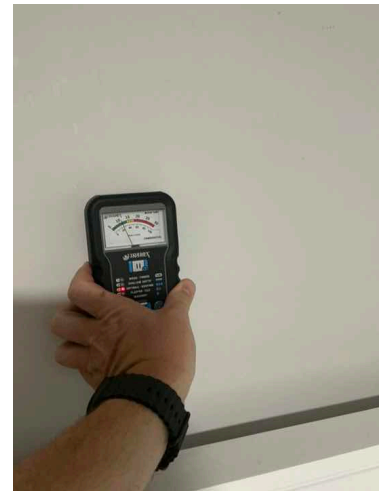
At the time of the inspection, our electronic moisture meter readings were normal.

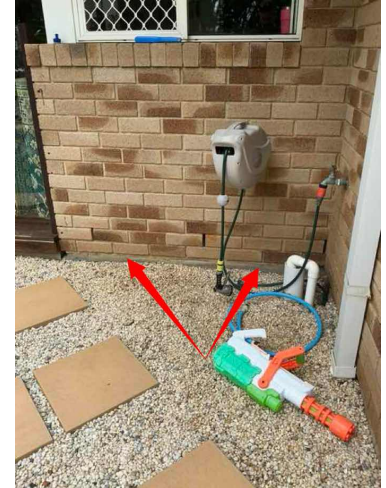
### **Is the Slab Edge adequately Exposed**

Yes in some areas.

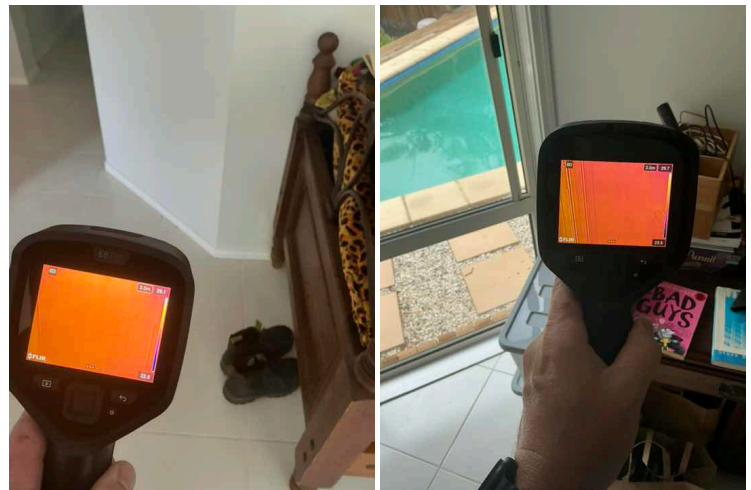
An infrared thermal imager was utilised during the inspection. No thermal anomalies were detected during this inspection, however various factors must be taken into effect which may hamper or impede the reading obtainable by the imager. These factors include obstructions, ambient temperature, wall material and thickness etc. If any surface is restricted visually or otherwise, a proper thermal reading is not possible and is not within the scope of this inspection. Any findings or otherwise is reported on at the time of the inspection only.
