Building and Pest Report

2/33 Allens Pde Lennox Head

Report/Agreement #	170625011853507
Inspection Date:	17 Jun 2025
Inspection Time:	01:18 pm

Pest And Building Inspection

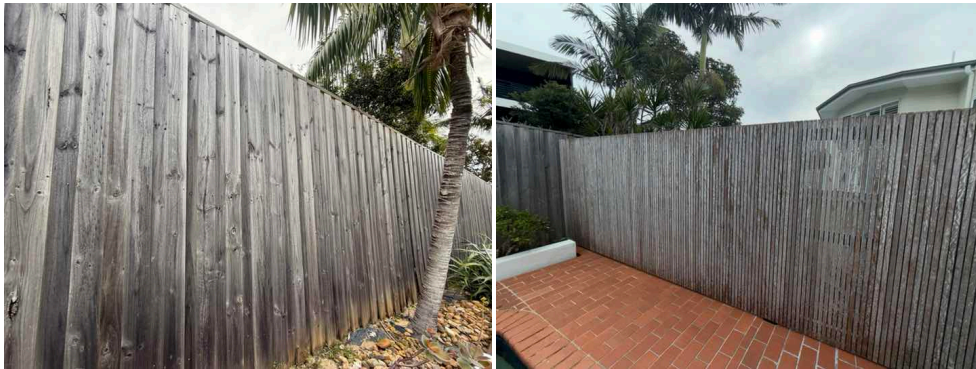
Overall Condition

Of the visible areas, the general condition of the fences and gates is serviceable for the age of dwelling.

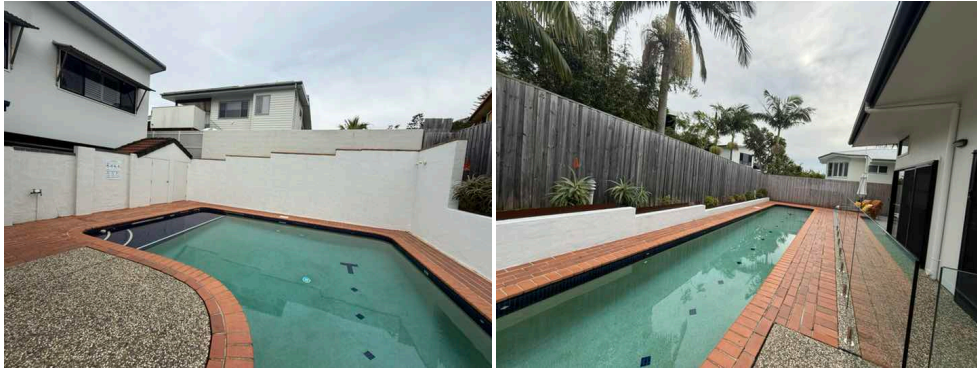
Pool fence and signage were sighted.

A swimming pool is present but the pool fence appears inadequate. The gate is not closing and latching as it should. This should be repaired. The pool fence should be checked for compliance with safety regulations. Considered safety Hazard

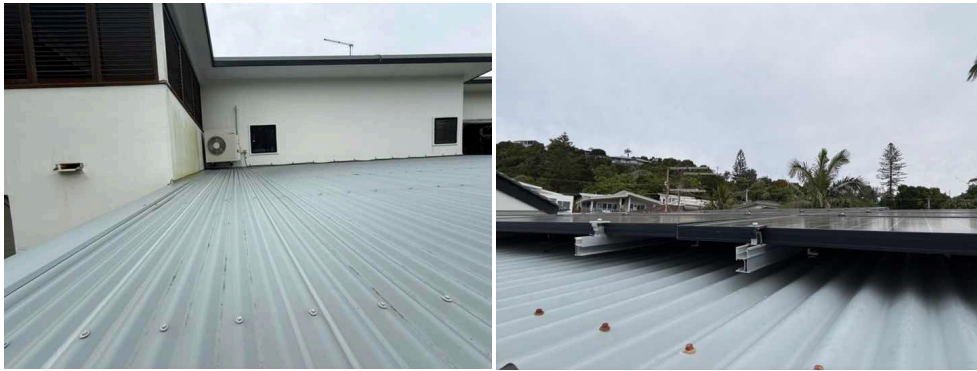
Guttering

Of the visible areas, the general condition of the roof is in serviceable condition for the age.

Note: In the absence of rainfall there is no guarantee that the roof won't leak.

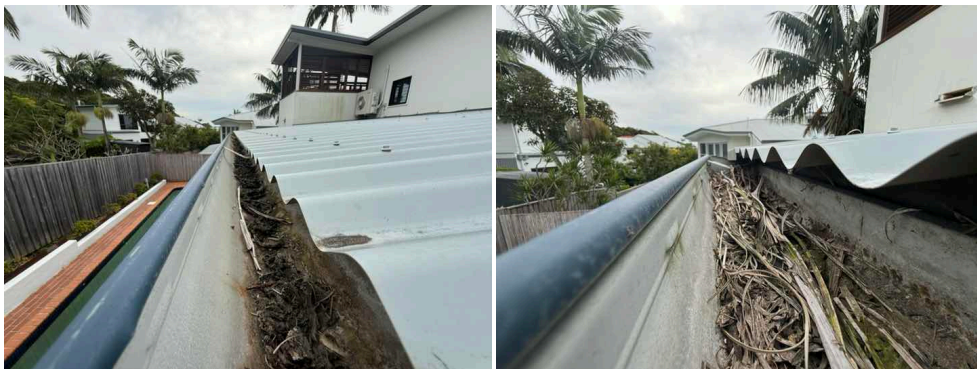
Downpipes

All visible and accessible of the physical nature of the guttering system appears to be in a serviceable condition with no apparent defects at the time of inspection. In the absence of prolonged rain fall efficiency of the guttering can not be assessed and you may find that further investigation or repairs maybe required. Note: Periodic maintenance checks should be carried out for rust penetrations and leaks.

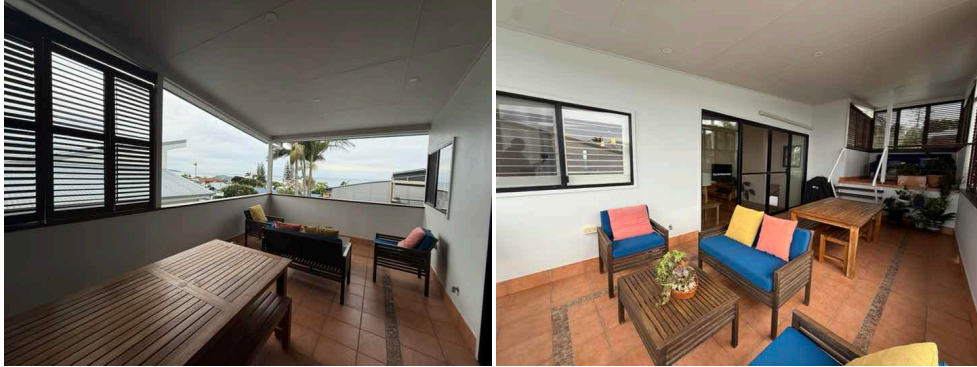
Eaves

Visible sections of the Alfresco area are serviceable or in reasonable or condition for the age of this dwelling.

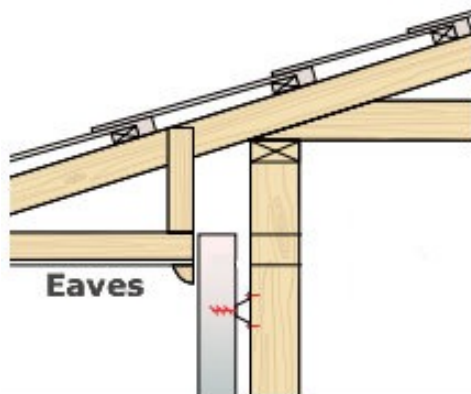
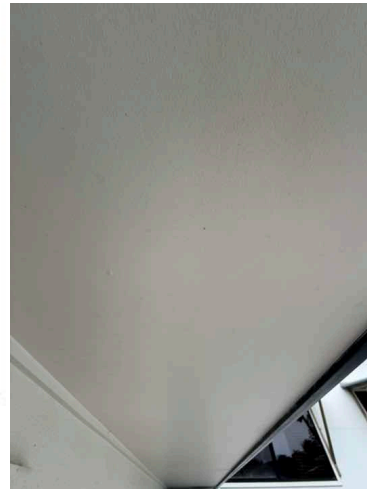
Entry Porch Area

The soffit lining (eaves) are in a serviceable condition with no notable defects.

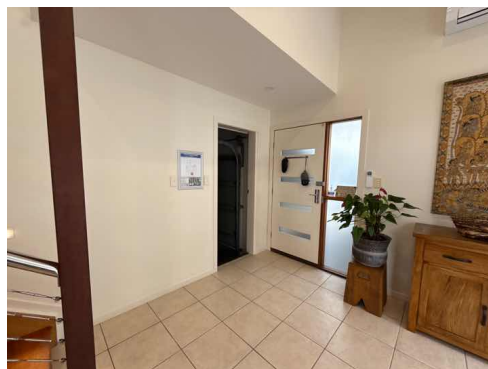
Flooring

From the visible and accessible areas, this area appears to be in a serviceable condition for the age of the property with no notable structural defects sighted.

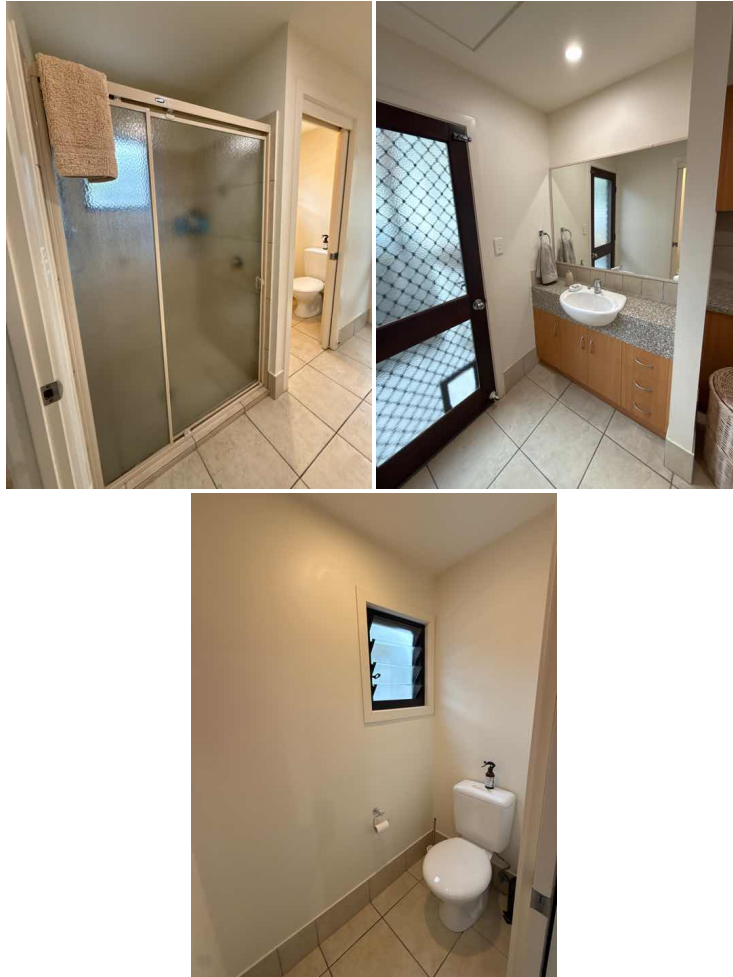
Ventilation

Of the visible areas, the general condition of this bathroom is serviceable or in reasonable condition for age of dwelling.
