Building and Pest Report

273 Hutley Drive Skennars Head

BUILDING & PEST INSPECTIONS

273 Hutley Drive
Lennox Head

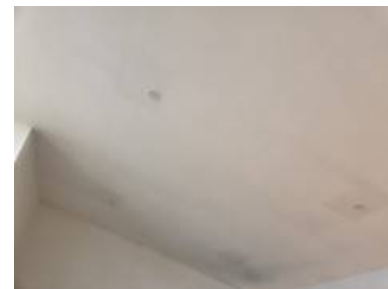
Cracking / Sagging / Defective Lining

Satisfactory.

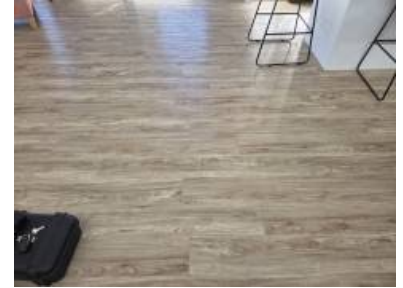
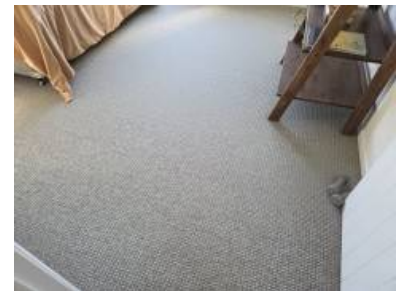
The Timber floors were covered by flooring coverings and no inspection of the timber floor surfaces could be carried out.

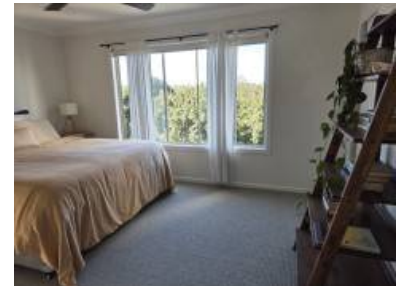
We recommend that all openable Bedroom windows over 2m above the external ground level have safety devices fitted that limit the window opening to a maximum of 125mm or have security grills installed. This is a safety hazard.

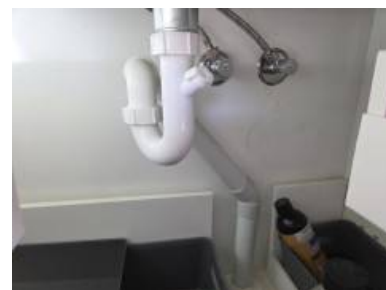
Leakage

No leaks / moisture was detected at the time of the inspection.

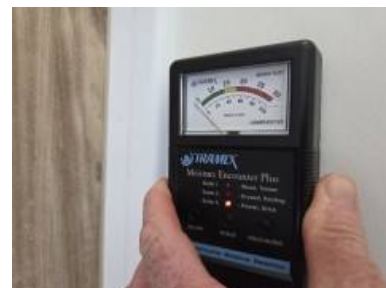
Leakage

At the time of inspection no moisture was detected to the wall/s to the rear or side of the shower(s).

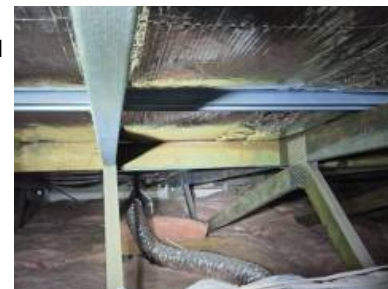
Inspection over the eaves was restricted due to the low pitch and construction allowing only a limited visual inspection from a distance of some areas to be carried out.

Clearance within sections of the roof was too low to allow body access. Outer top wall plates and framing timbers were not inspected due to the area being too low to allow body access. This allows only a limited visual inspection from a distance of some areas to be carried out.

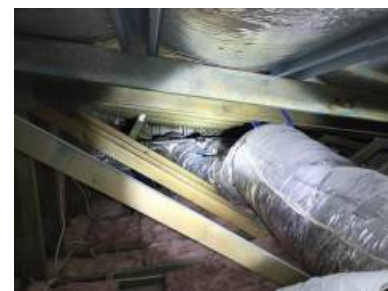
Insulation is present in the roof cavity. This restricted inspection to some roofing & ceiling members and wall top plates. Removal of insulation is not within the scope of a standard building inspection report. Foil Blanket Insulation (fibreglass batts covered in foil) is present in the roof cavity. This restricted inspection to some roofing members. Removal of the Foil Blanket is not within the scope of a standard building inspection. Ducting associated with air-conditioning or heating restricted the inspection. Removal of ducting is not within the scope of a standard building inspection report.

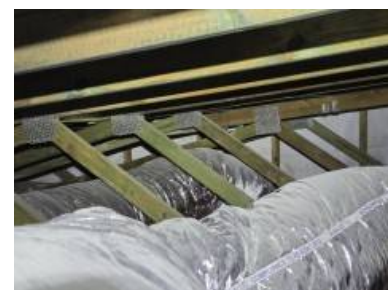
Roof Void & Framing - Condition

The roof framing is in satisfactory / typical condition for the age / construction date.

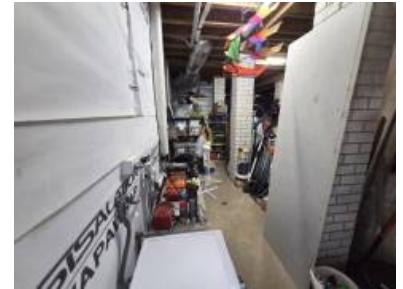
Stored goods are present in this area and restricted inspection.

Further inspection of these areas is strongly recommended once access has been obtained.

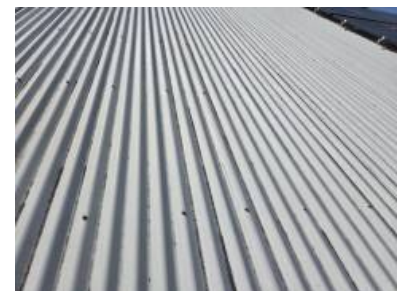
Satisfactory.

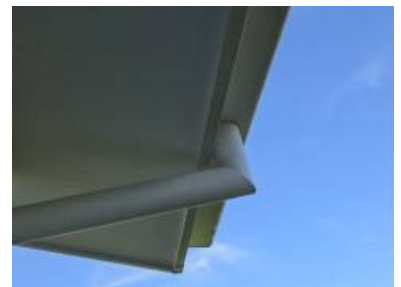
GUTTERS / DOWNPIPES

Condition:
Satisfactory.

Restrictions:
No inspection can be made of the concealed stormwater pipes. I recommend the gutters, downpipes & stormwater be further inspected by a qualified plumber to ensure that they are functional, clear of blockages / damage / cracks and are adequate for the situation.

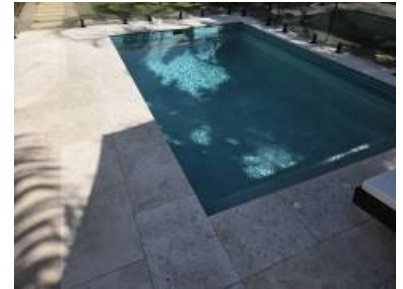
Swimming Pool:

I recommend a qualified swimming pool builder / specialist be engaged for further inspection of the swimming pool.
Satisfactory.

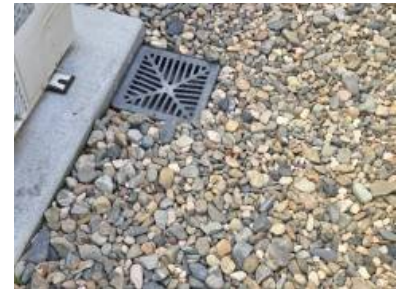
SURFACE WATER DRAINAGE

Whilst not a plumber it appears that at the time of the inspection, drainage seems generally adequate.

No inspection & comment can be made of concealed stormwater pipes and their functionality. I recommend the drainage systems / stormwater be further inspected by a qualified plumber to ensure that they are functional, clear of blockages / damage / cracks and are adequate for the situation.
