# Building and Pest Report

## 239 Hutley Drive, Skennars Head

| Report/Agreement # | 260326115130350 |
| Inspection Date: | 26 Mar 2026 |

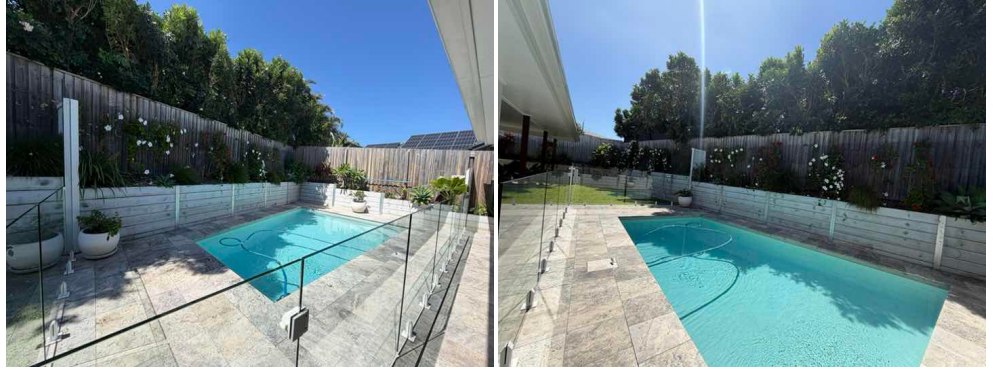
### **Pool Fence**

Pool fence and signage were sighted.

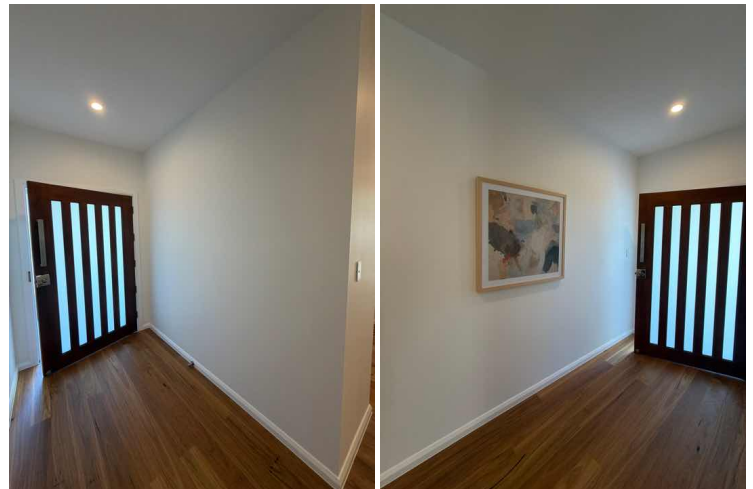
From the visible and accessible areas, this area appears to be in a serviceable condition for the age of the property with no notable structural defects sighted.
