# Building and Pest Report

## 42 Phoenix Drive Tintenbar

| Inspection Date: | 23 Sep 2025 |

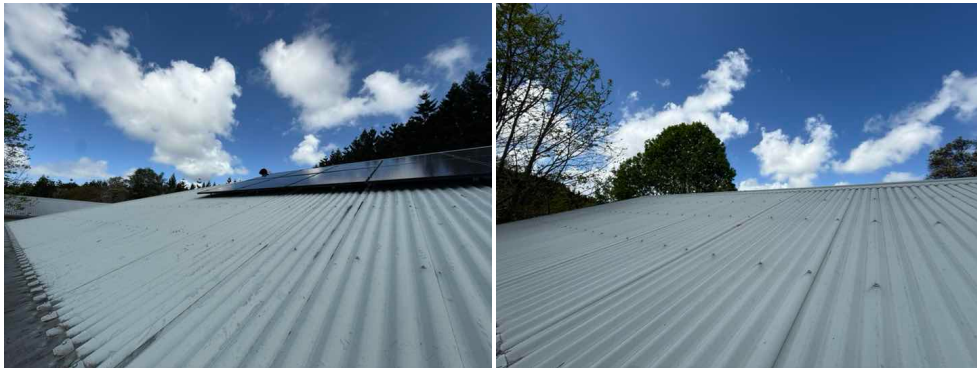
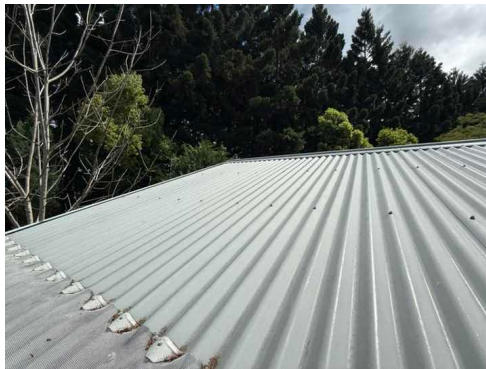
Of the visible areas, the general condition of the roof is in serviceable condition for the age.

Impact/Denting damage observed. Replace as required.

Gutter surface rust in sections- the rust is yet to penetrate and repairs/sealing may be an option. A qualified roof plumber should be engaged for advice and recommendations.

Gutter rust/penetrations- The guttering has excessive rust where leaking will occur. The gutters require replacement by a roof plumber.

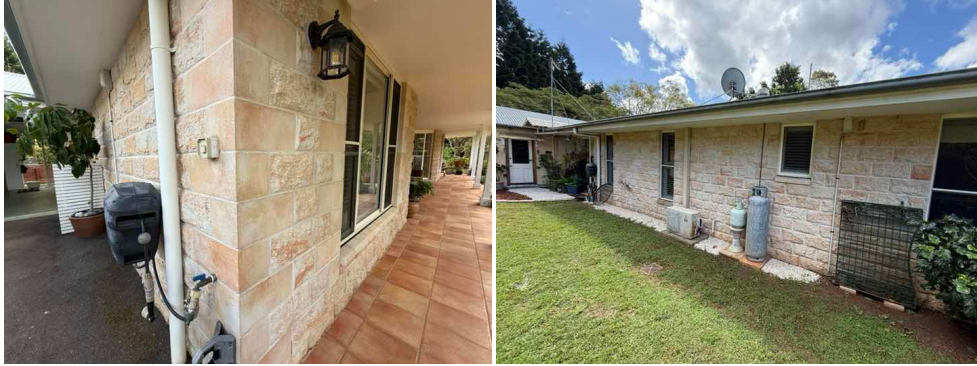
On visual inspection, the general condition of the windows is serviceable for the age.

Cracked window pane. A qualified glazier should be engaged to repair.

Damaged fly screen/s replace as required.

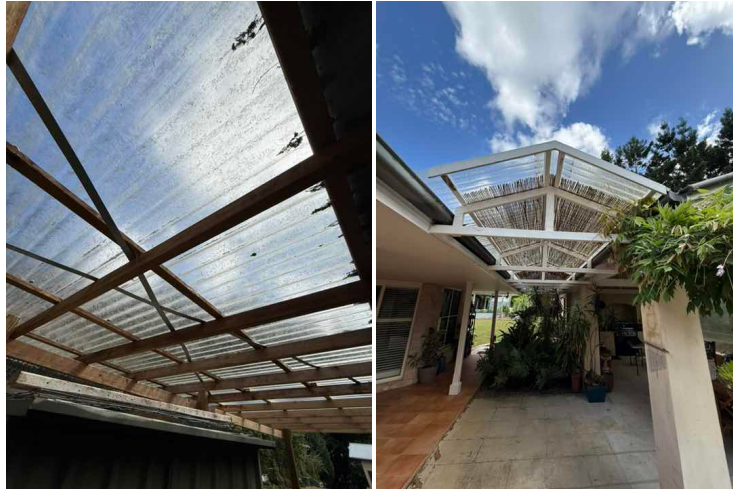
Though we are not structural engineers the balcony/s appear to be in a serviceable condition.

Tiles are drummy and loose. This needs to be fixed by a qualified tiler to eliminate any water penetration issues.

Tile cracking observed. A qualified tiler should be engaged for advice and recommendations. This may cause leaking and water penetration.

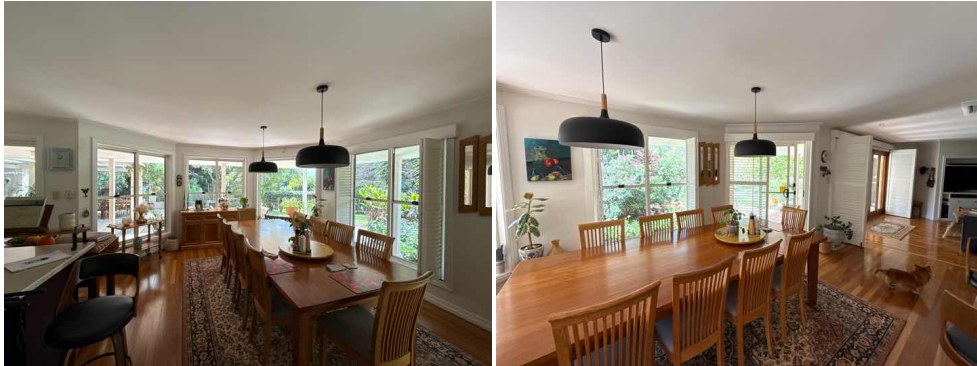
Typical cornice separation/detachment observed. I recommend you contact a qualified painter for repairs.

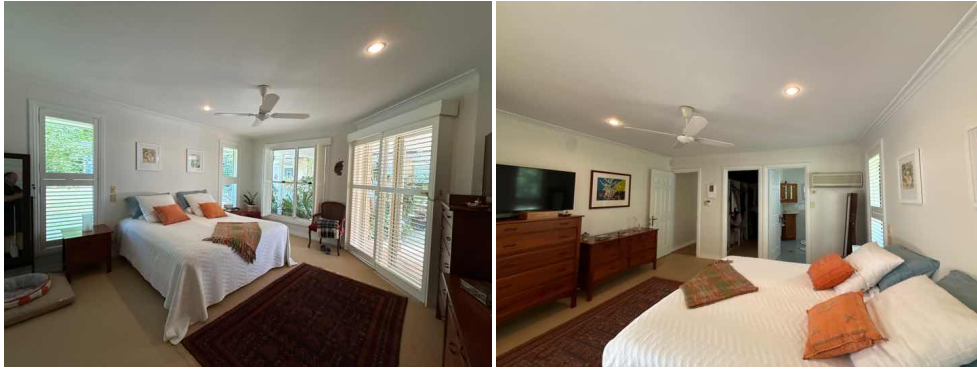
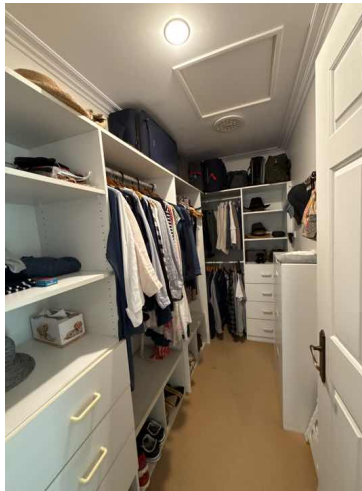
Stains observed - Steam cleaning may rectify stained areas but they appear entrenched.

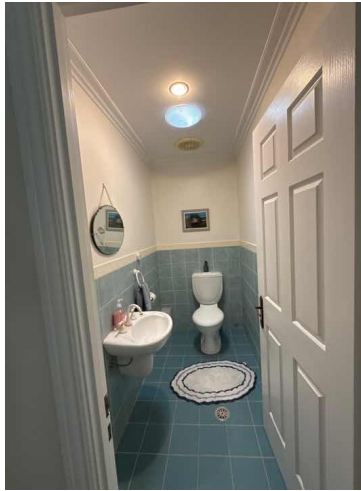
Drummy tiles noted. This needs to be repaired at the earliest as this has the potential to lead to many related issues such as damp, water ingress to other areas and cracked tiles. Contact a qualified tiler for repairs and recommendation

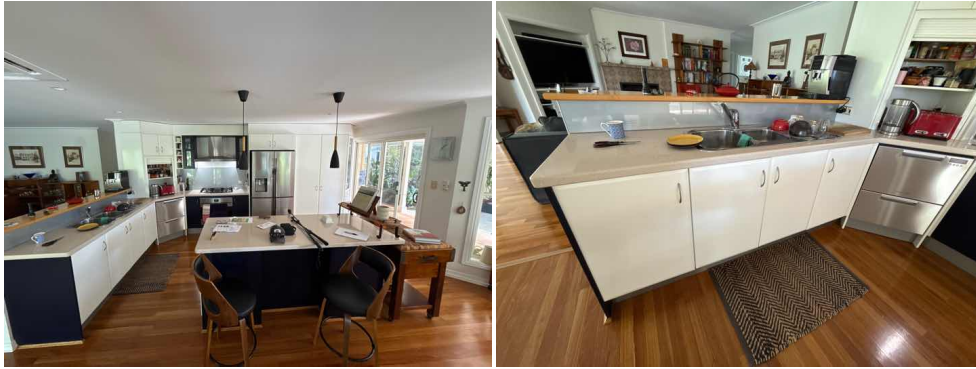
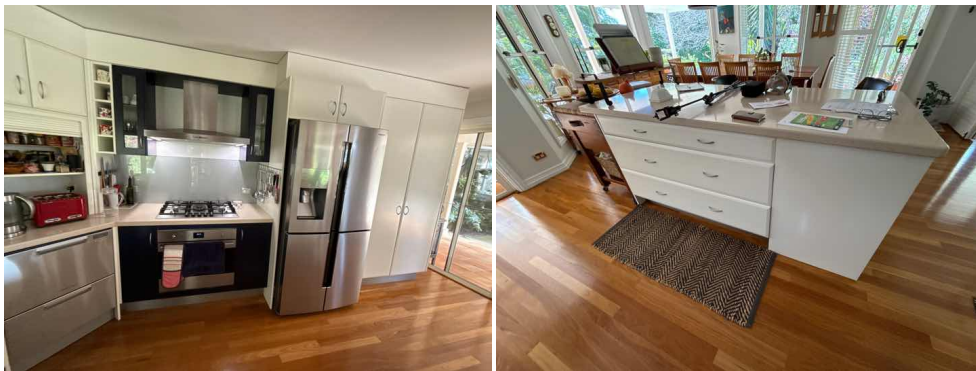
Adjustment to cabinet doors required, in some instance hinges may need to be replaced.

Damage was noted to the bench top, contact a joinery company for repairs

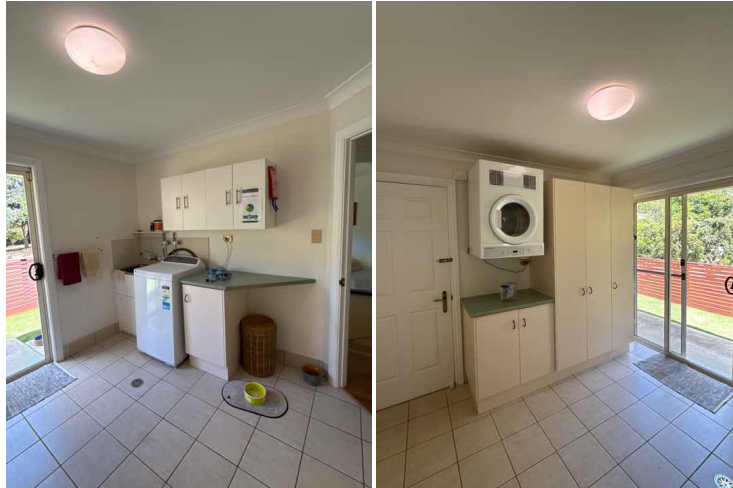
Drummy tiles noted. This needs to be repaired at the earliest as this has the potential to lead to many related issues such as damp, water ingress to other areas and cracked tiles. Contact a qualified tiler for repairs and recommendation.

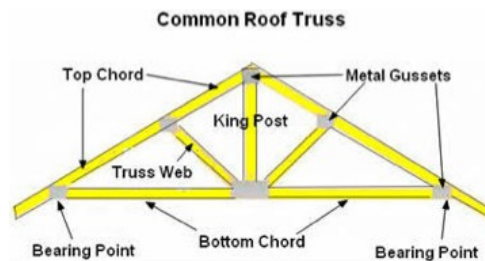
#### Roof Frame Type

The roof frame is a truss timber frame.

Visible sections of the roof void is in a serviceable condition for age of this dwelling.

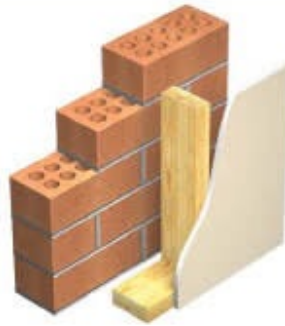
#### BRICK VENEER WALL

The structure is of brick veneer construction.

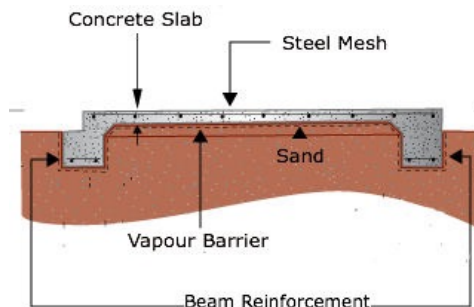
#### Footings Type

Slab on ground construction.
