Building and Pest Report

1/33 Sunrise Cres, Lennox Head

Inspection Report

1/33 Sunrise Crescent , Lennox Head , NSW , 2478

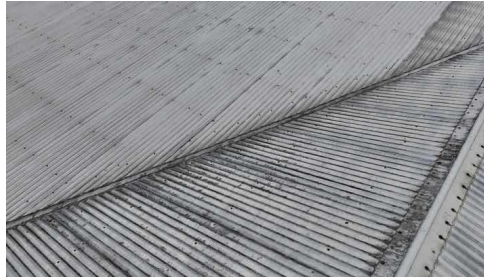
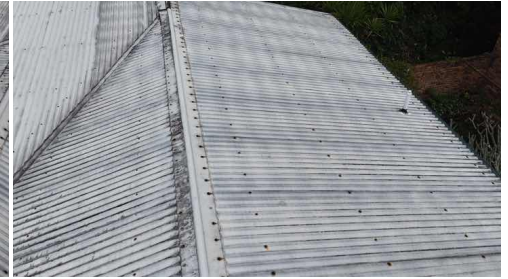
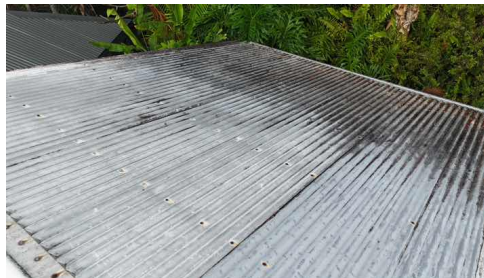
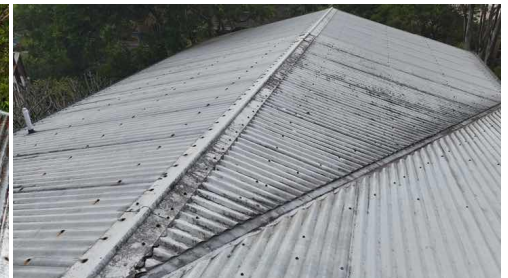
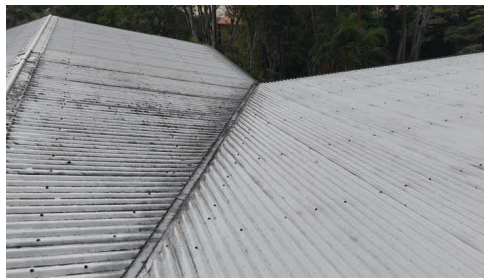
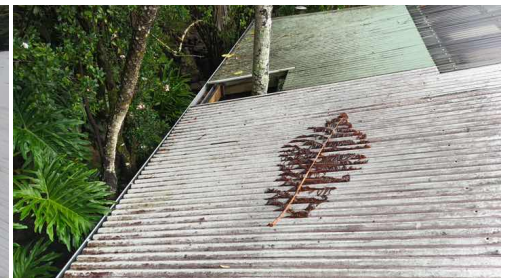
Upon visual inspection, the roof appears to have accumulated debris and possible minor surface wear. It is recommended to clean the roof thoroughly and inspect for any underlying damage. Engage a licensed roofing professional to assess and perform necessary maintenance to ensure longevity and prevent potential leaks. Rust is evident on most screws. Recommend contacting a roofer for possible rescrew of roof.

#1. Corrosion noted to the screw fixings of the metal roof. Have these checked and replaced by qualified roofing contractor.

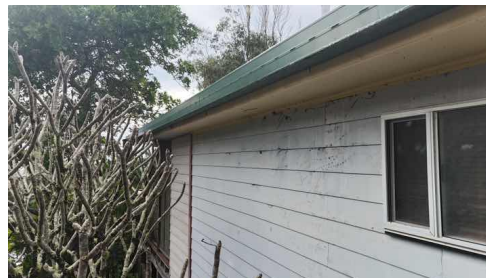
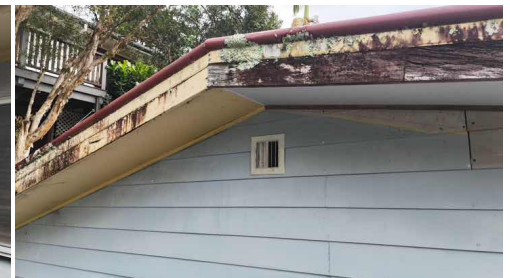
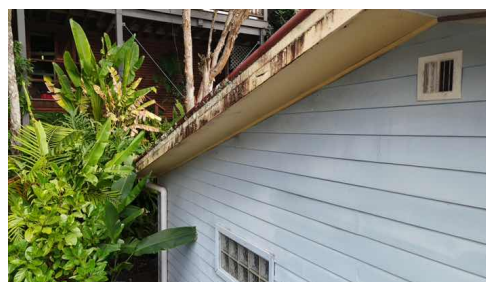
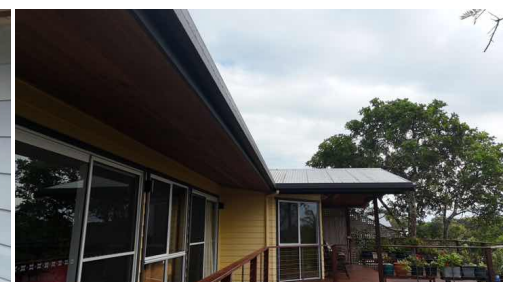
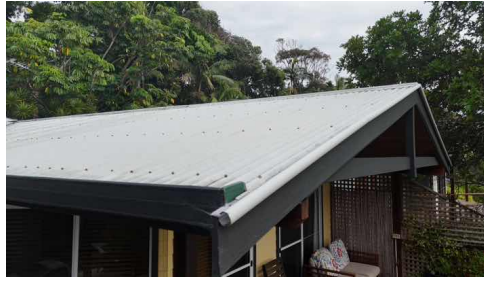
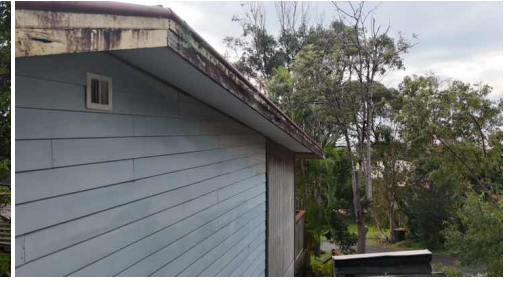
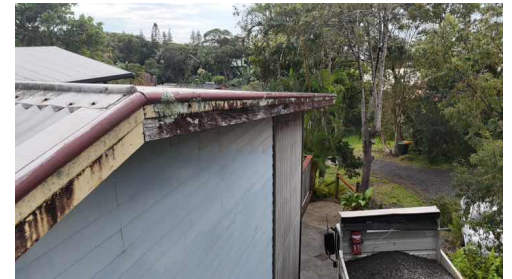
Upon visual inspection, there is evident wood rot and peeling paint on the fascia board. Recommend replacing damaged wood and repainting to prevent further deterioration. Engage a licensed carpenter to assess and repair the affected areas, ensuring proper sealing and protection against moisture. Regular maintenance checks are advised to prevent recurrence.

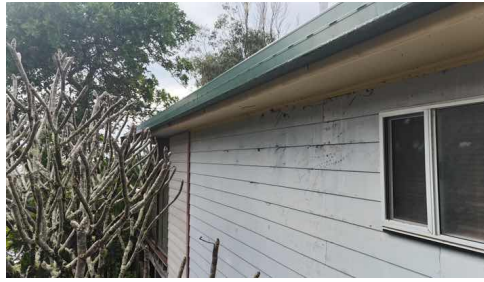
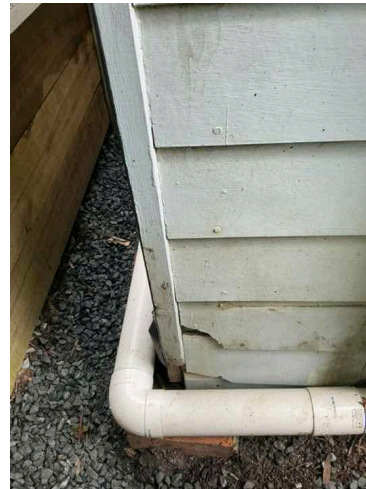
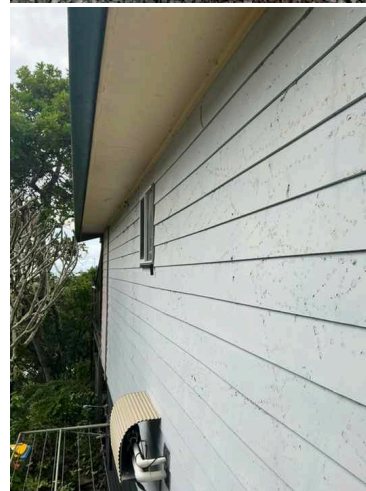
#3. Paneling/cladding damaged. Have a suitably qualified tradesman assess and repair.

#4. End trim missing / not installed

#5. The external paint has deteriorated . External wall paint preserves and protects the building elements. Contact a qualified painter for repairs.

Upon visual inspection, the siding shows signs of weathering and potential gaps between panels. Recommend sealing gaps to prevent moisture ingress and repainting to protect against further weather damage. Engage a licensed tradesperson to assess and repair any structural issues. Regular maintenance checks are advised to ensure long-term integrity.

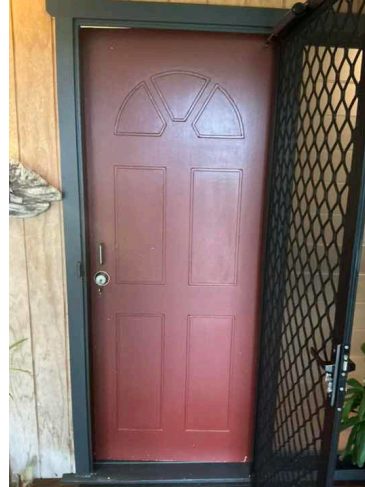
Front Entry Doors

Upon visual inspection, the door appears to have minor scuff marks and potential weathering at the bottom edge. Recommend sanding and repainting to protect against further wear. Ensure the door frame is properly sealed to prevent drafts. Consult a licensed tradesperson for any necessary adjustments or repairs to the door hardware for optimal functionality.

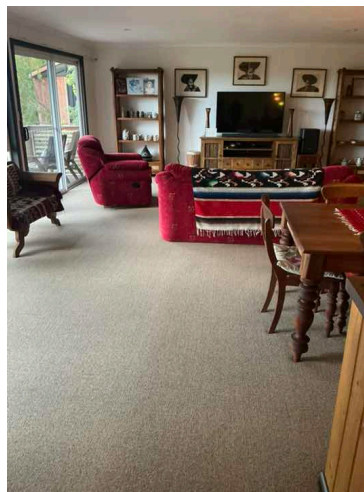
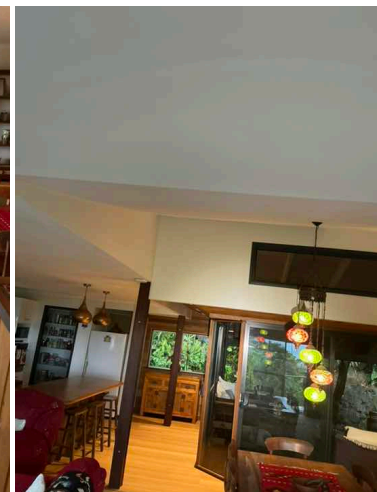
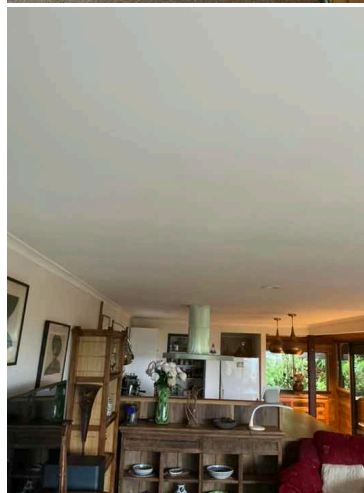
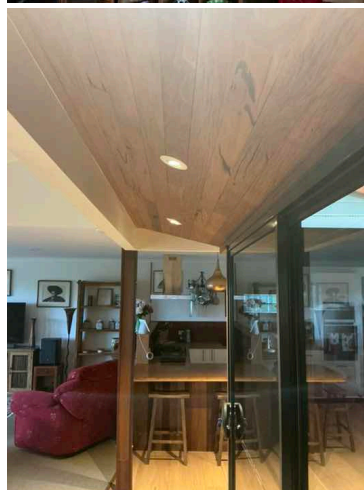
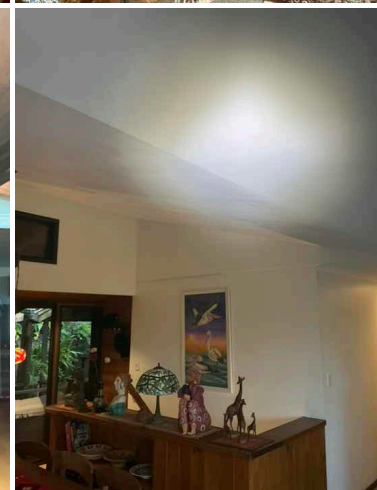
Combined Living & Dining

Upon visual inspection, there is a noticeable ceiling sag, possibly due to water damage or structural issues. It is recommended to engage a licensed tradesperson to assess and repair the ceiling. Ensure any leaks are addressed to prevent further damage.

#7. Ceiling sagging - Requires immediate repairs to prevent further collapse. Contact a qualified plasterer for repairs.

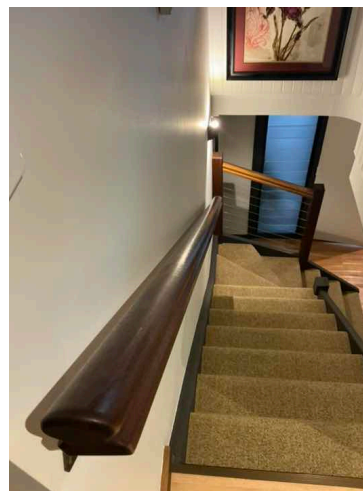
Internal Stair Case

The stair treads squeak and require maintenance.

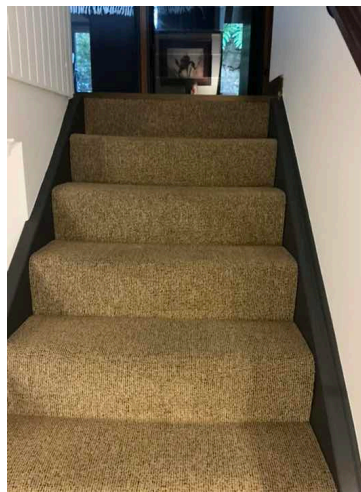
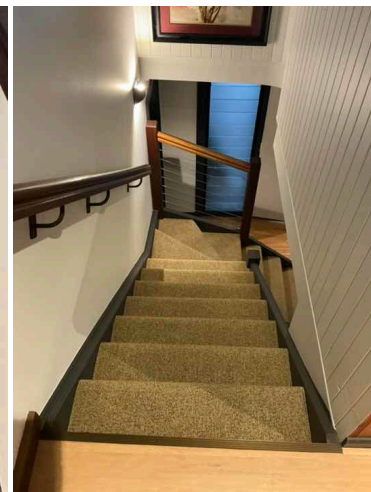
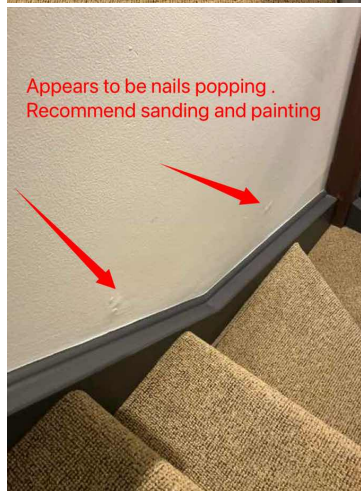
Appears to be nails popping .
Recommend sanding and painting

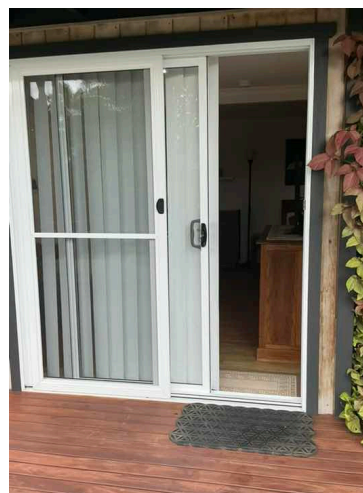
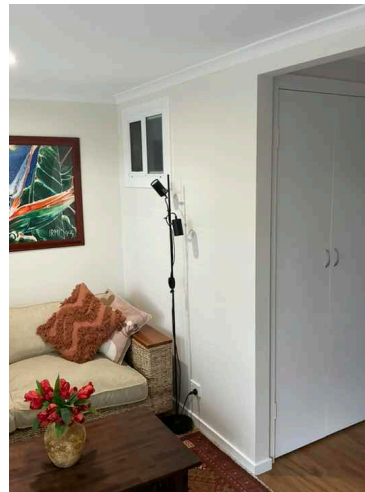
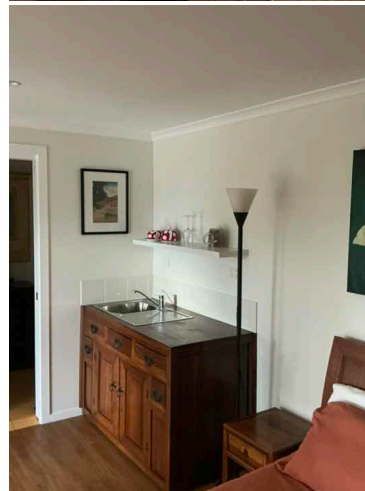
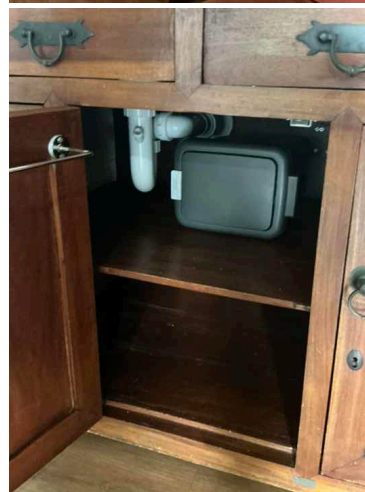
Bedroom 4

On inspection, defects were present that will require further assessing and recommendations by a qualified trades persons, please read below for details. Upon visual inspection, the moisture meter indicates elevated levels. Recommend engaging a licensed tradesperson to investigate potential water intrusion sources. Ensure proper sealing around windows and inspect for leaks. Address any water damage promptly to prevent further issues.

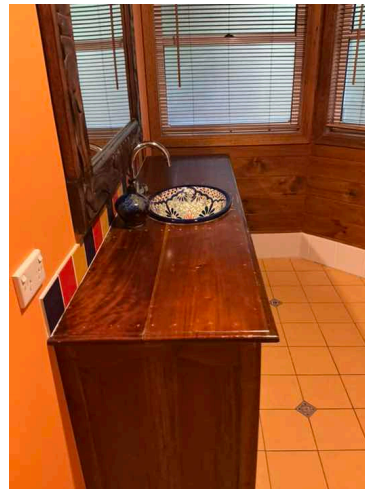
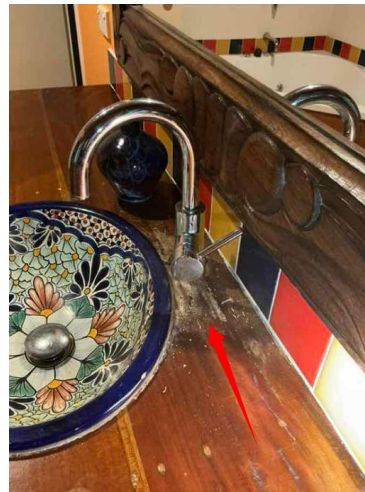
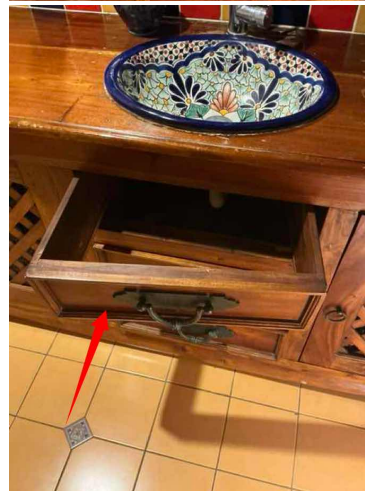
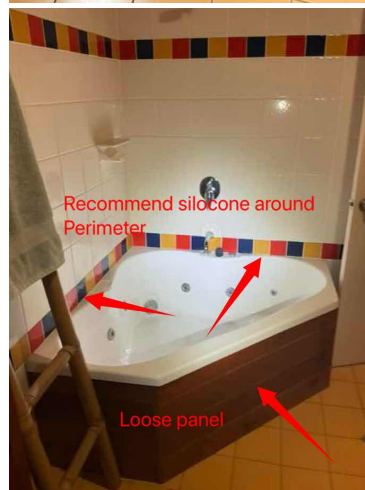
Bathroom 1

Upon visual inspection, water damage is evident around the sink area, likely due to leakage. Recommend sealing the faucet base and countertop edges with waterproof sealant. A licensed plumber should inspect and repair any leaks to prevent further deterioration. Additionally, consider refinishing or replacing the affected wood to restore integrity and appearance.

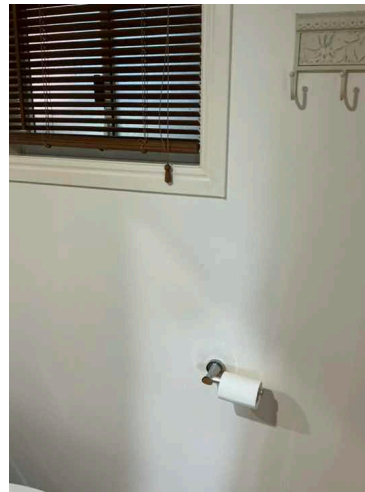
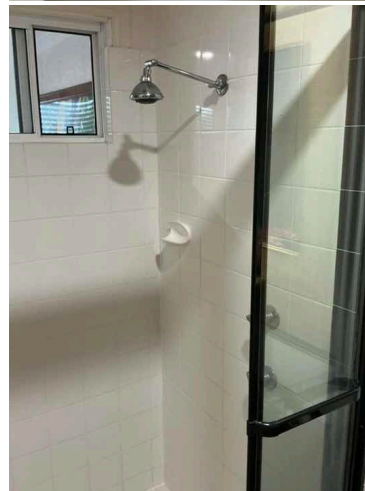
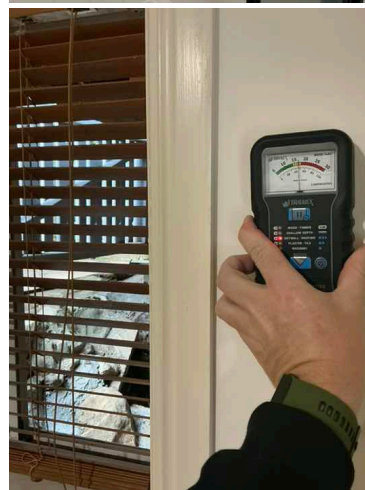
Upon visual inspection, the moisture meter indicates elevated moisture levels in the wall. It is recommended to engage a licensed plumber to investigate potential leaks or water ingress. Additionally, a licensed builder should assess any structural implications and ensure proper repairs to prevent further moisture-related issues.

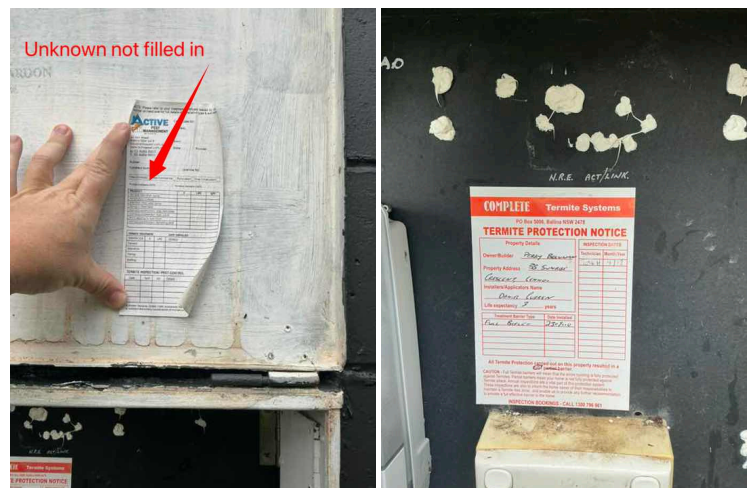
Yes, a durable notice was found in the meter-box during the inspection.
