Building and Pest Report

12 Tidepool Street Lennox Head

Report/Agreement #	190325084503308
Inspection Date:	19 Mar 2025
Inspection Time:	08:45 am

Pest And Building Inspection

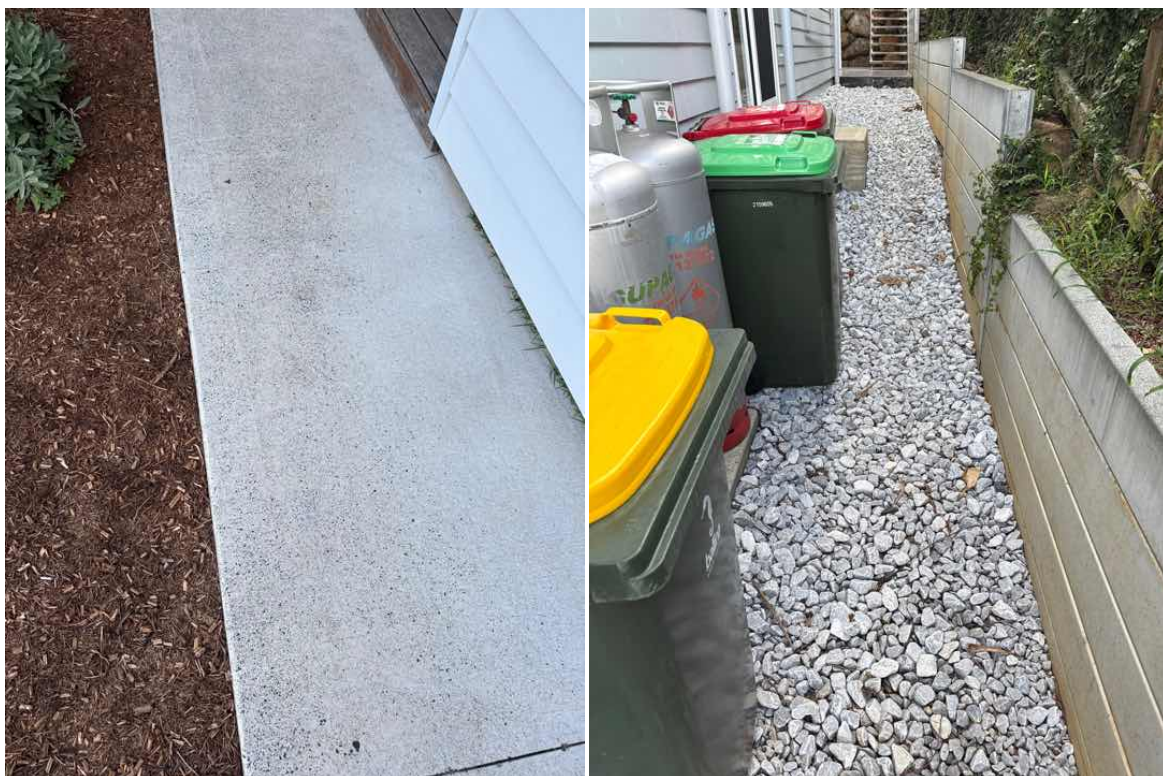
Pathways Condition

The paths around the home are in a serviceable condition for the age of this dwelling with no major defects visible.

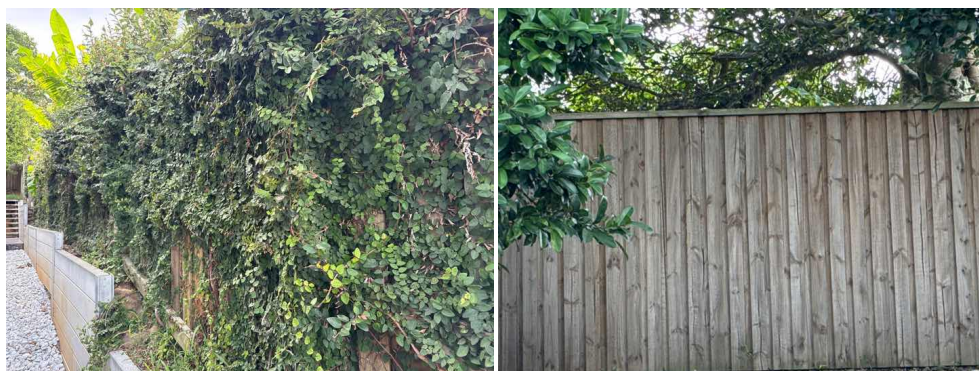
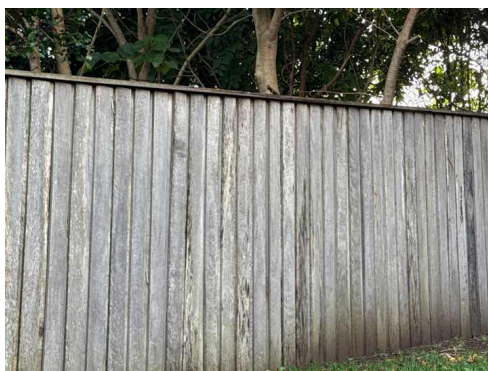
Fences & Gates

Of the visible areas, the general condition of the fences and gates is serviceable for the age of dwelling.

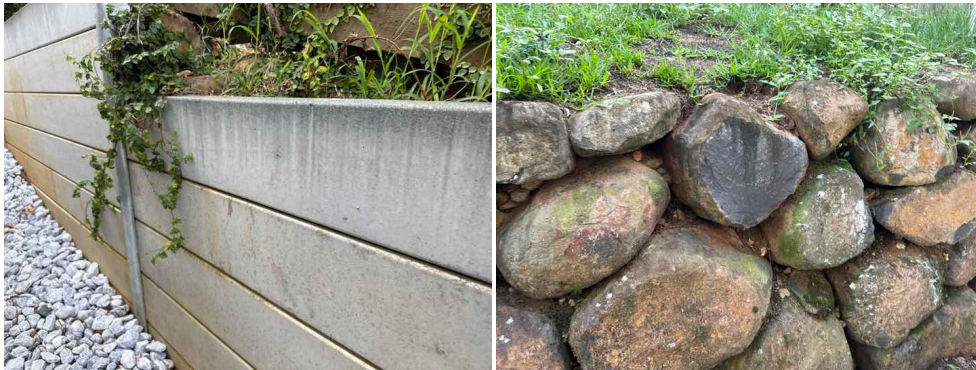
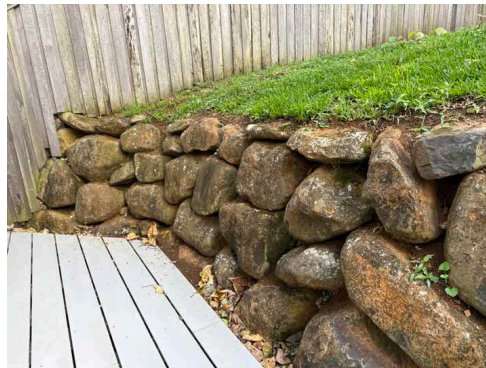
Retaining Walls

Of the visible areas, the general condition is serviceable or in reasonable condition for age of dwelling.

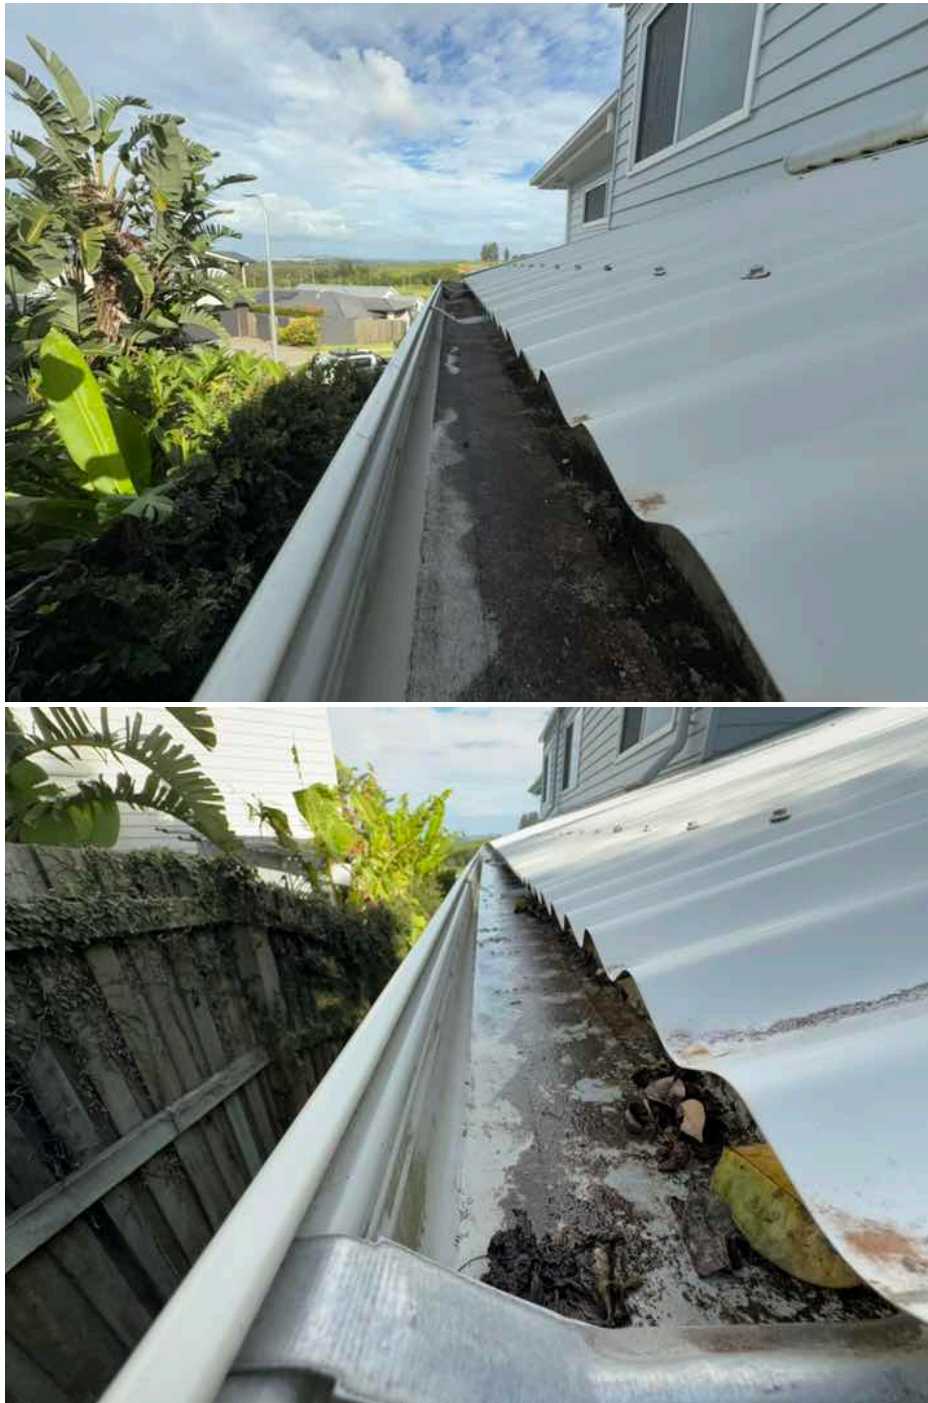
Gutter Findings

All visible and accessible of the physical nature of the guttering system appears to be in a serviceable condition with no apparent defects at the time of inspection. In the absence of prolonged rain fall efficiency of the guttering can not be assessed and you may find that further investigation or repairs maybe required. Note: Periodic maintenance checks should be carried out for rust penetrations and leaks.

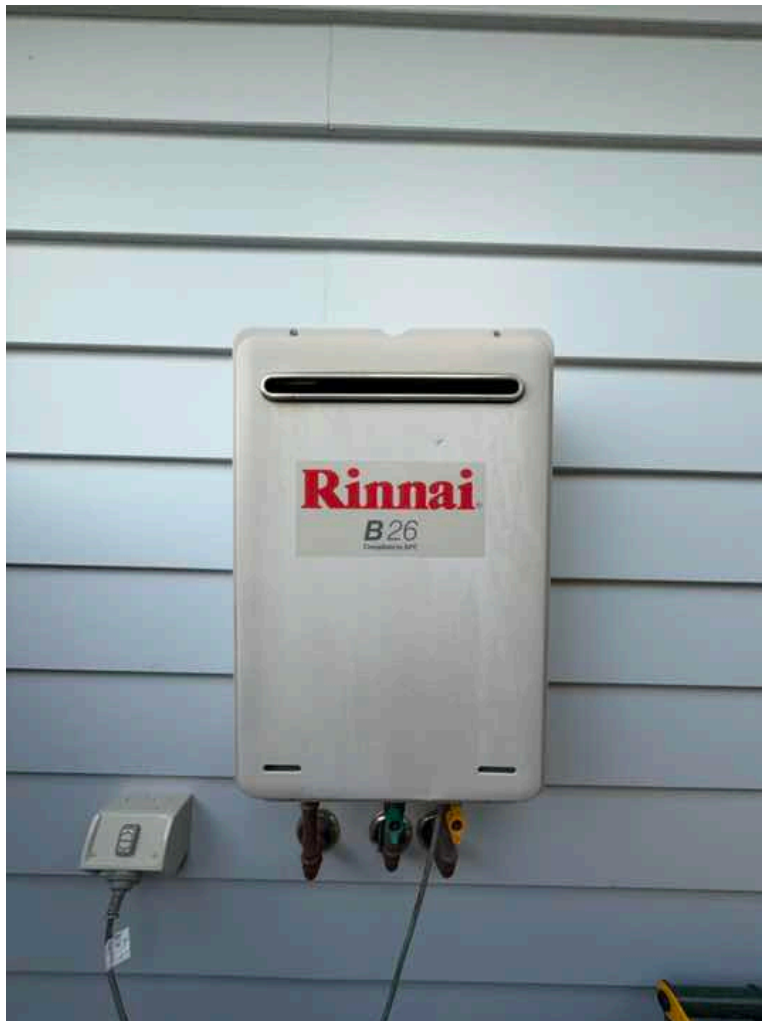
The hot water system appears to be in a serviceable condition. No specific tests other than running the hot water from a tap was carried out. No determination has been made as to the suitability or adequacy of the hot water system in relation to capacity or otherwise.

The make of the hot water unit is rinnai.

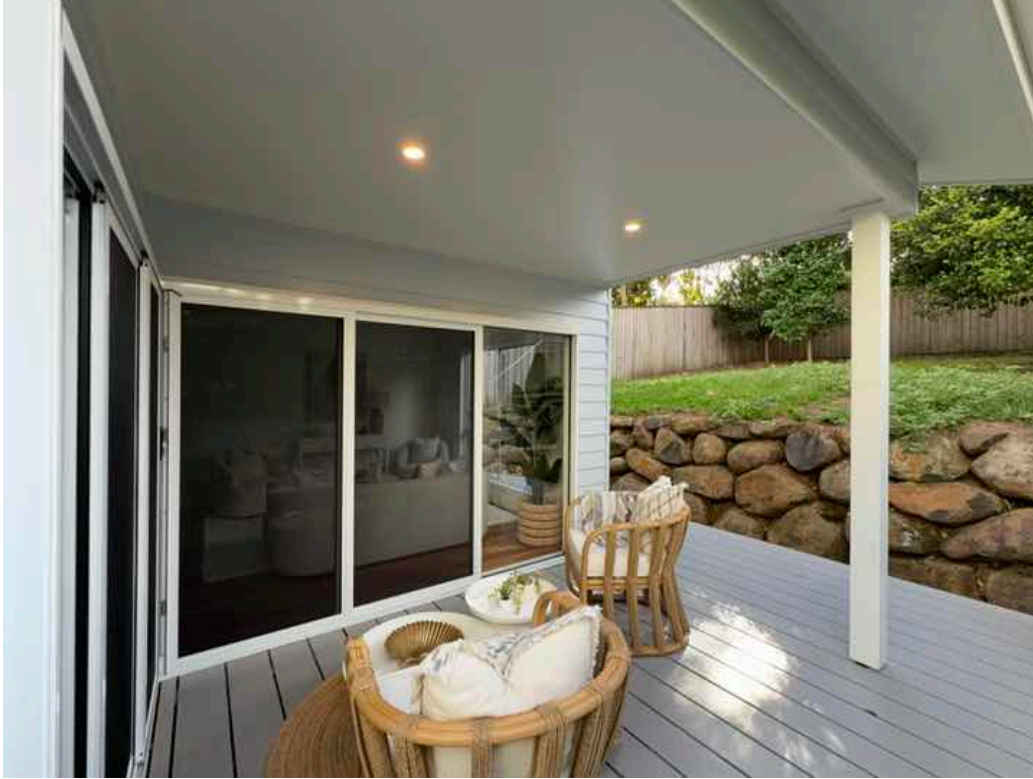
Visible sections of the Alfresco area are serviceable or in reasonable or condition for the age of this dwelling.

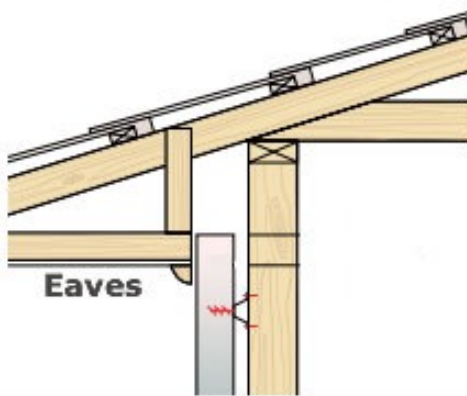
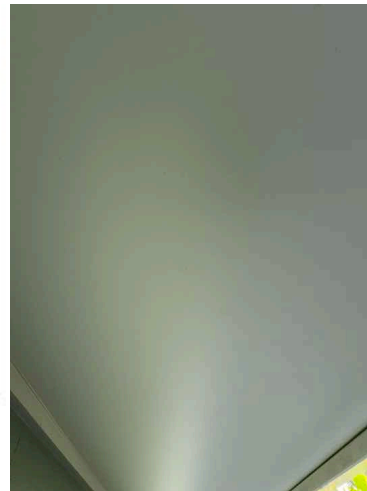
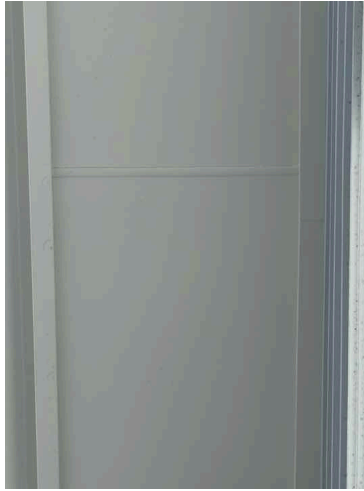
Eaves

The soffit lining (eaves) are in a serviceable condition with no notable defects.

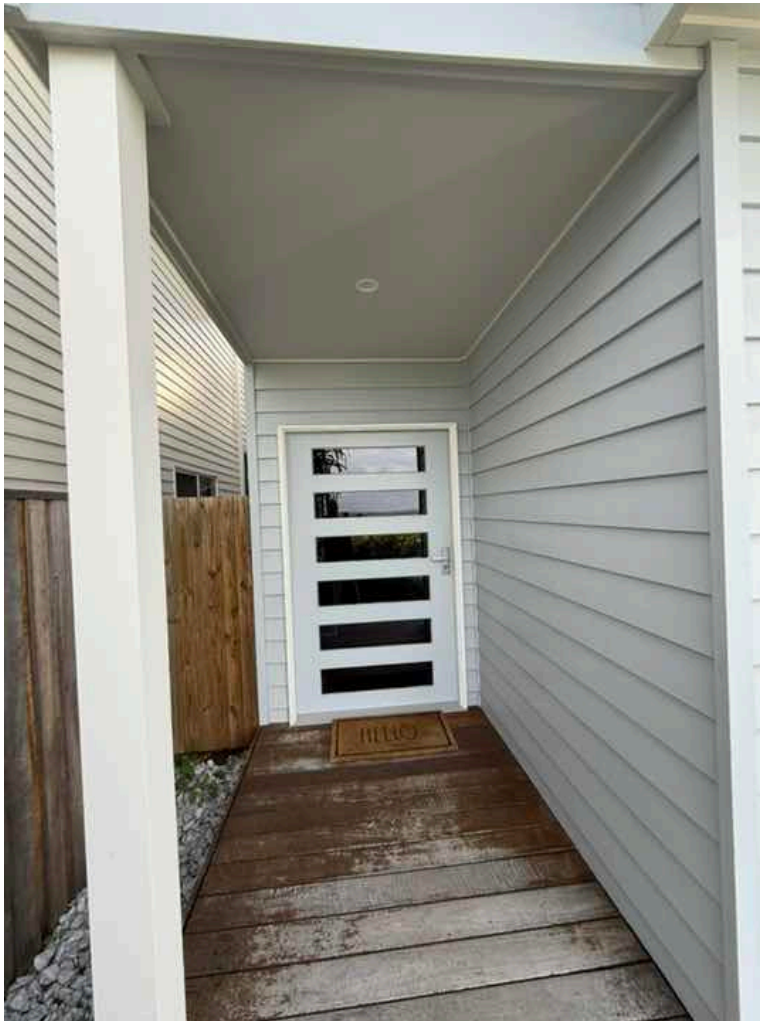
Entry Porch Area

The entry porch serviceable or in reasonable or condition for the age of this dwelling.

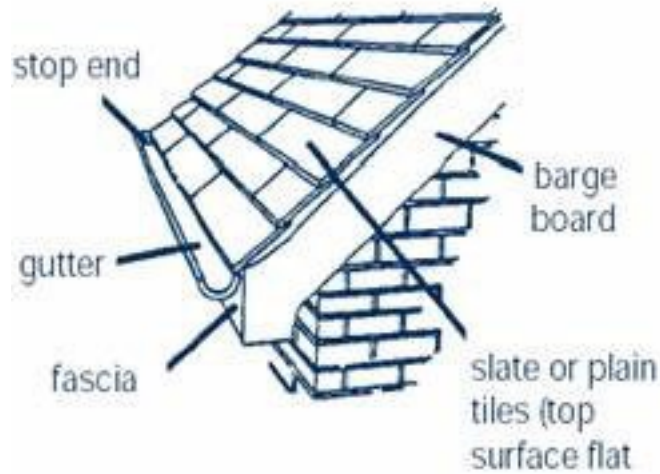
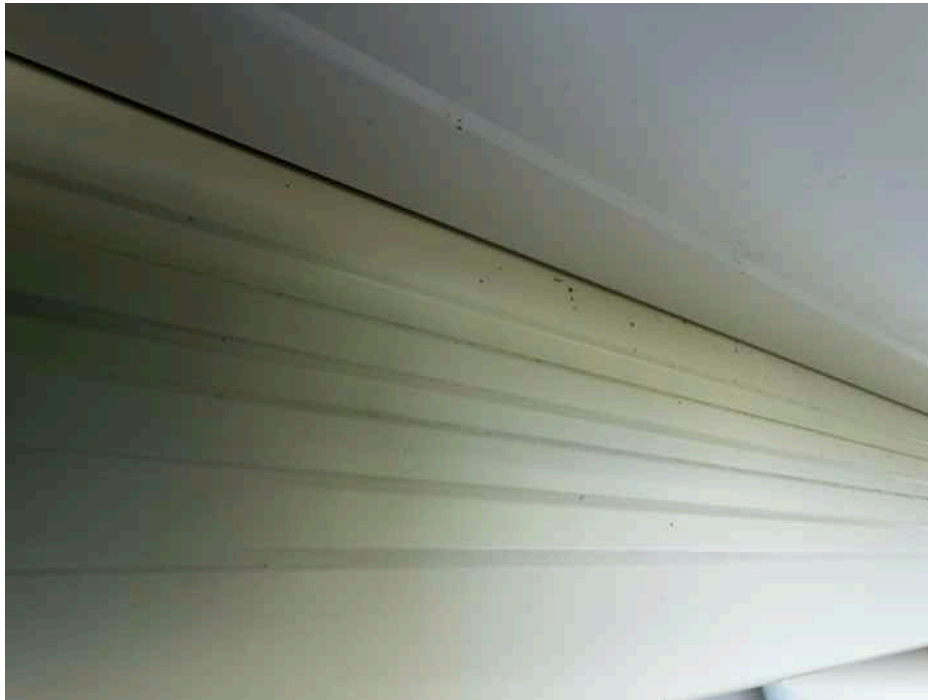
On visual inspection, the general condition of the fascia/barge boards is serviceable.

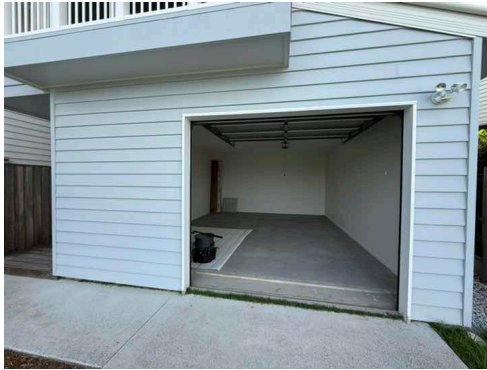
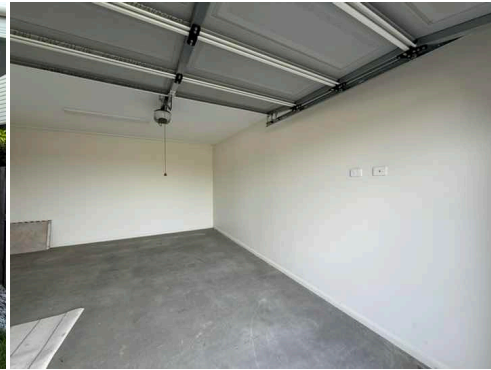
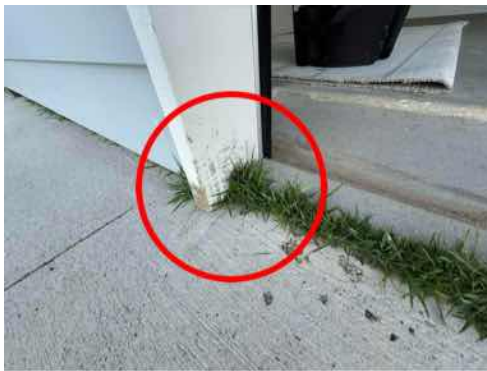
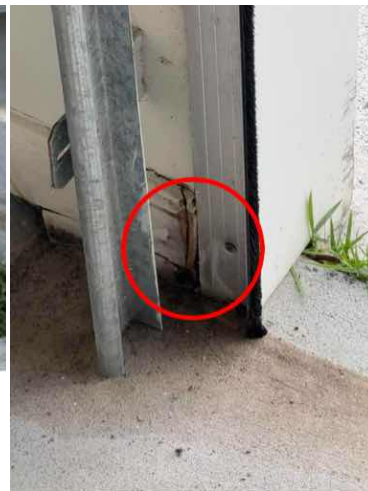
From the visible and accessible areas, the garage appears to be in a serviceable condition for the age of the property with no notable structural defects sighted.

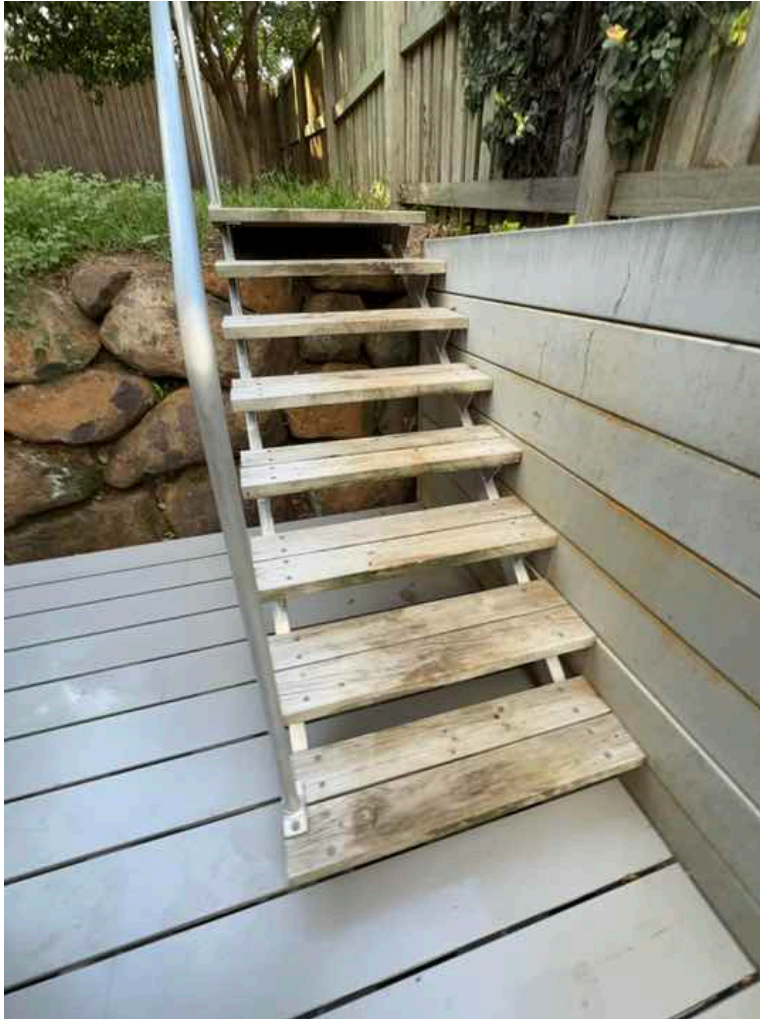
The stairs/steps appear to be serviceable with no notable defects.

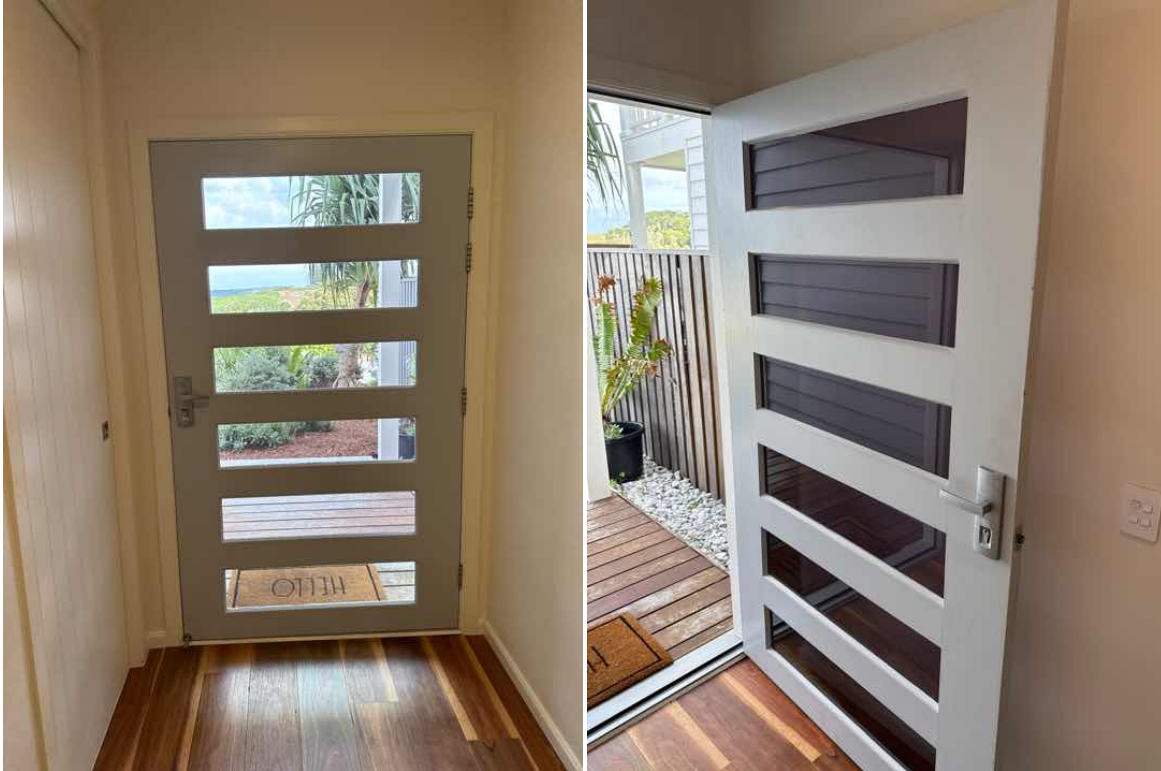
Front Entry Doors

The doors are in serviceable condition with no notable defects observed.

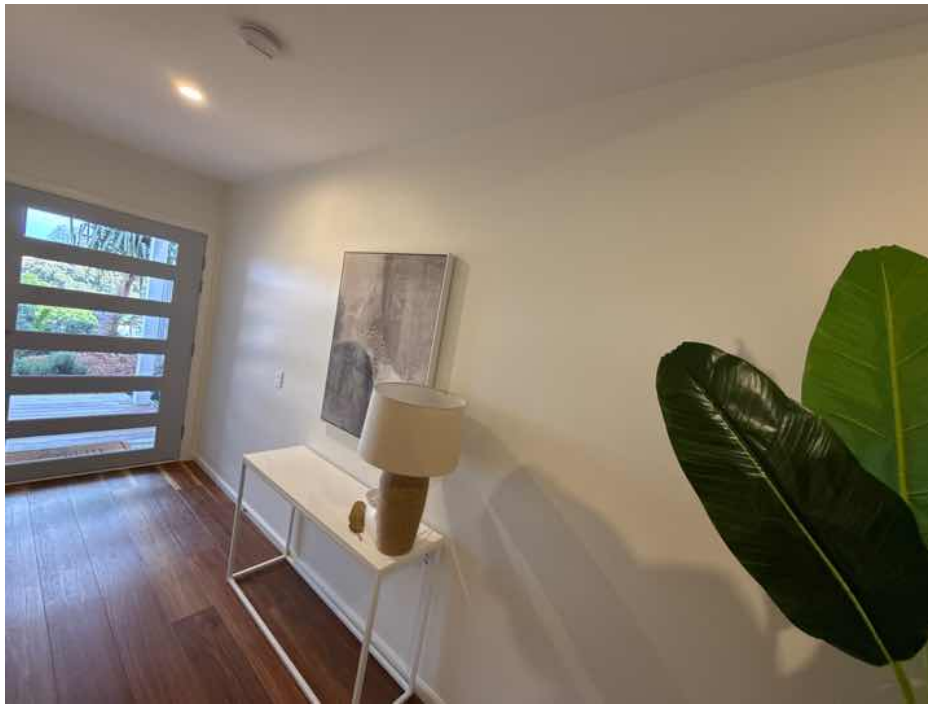
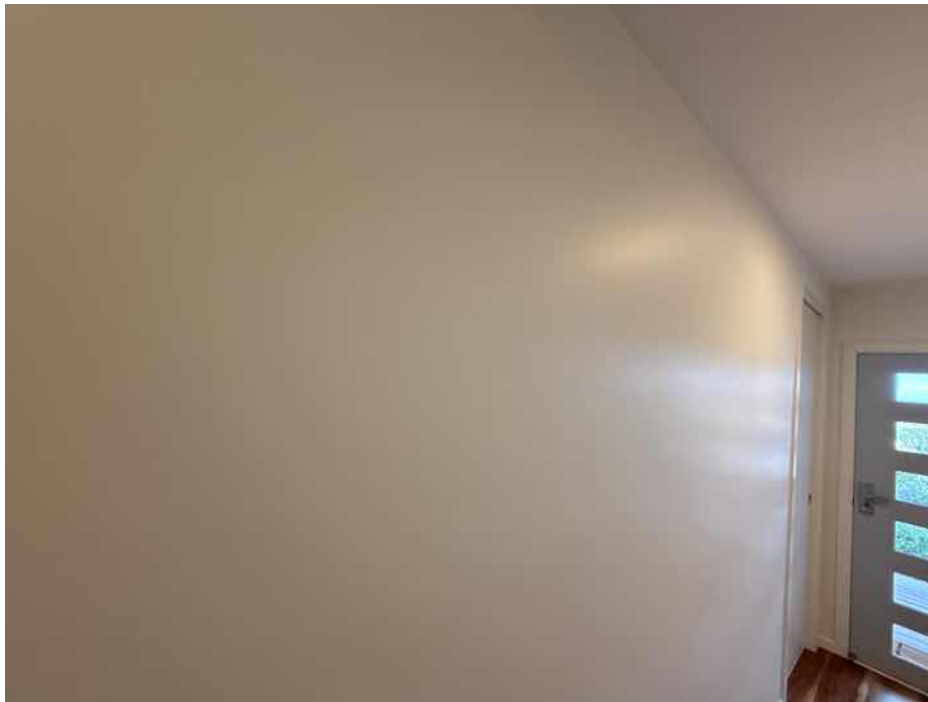
From the visible and accessible areas, this area appears to be in a serviceable condition for the age of the property with no notable structural defects sighted.

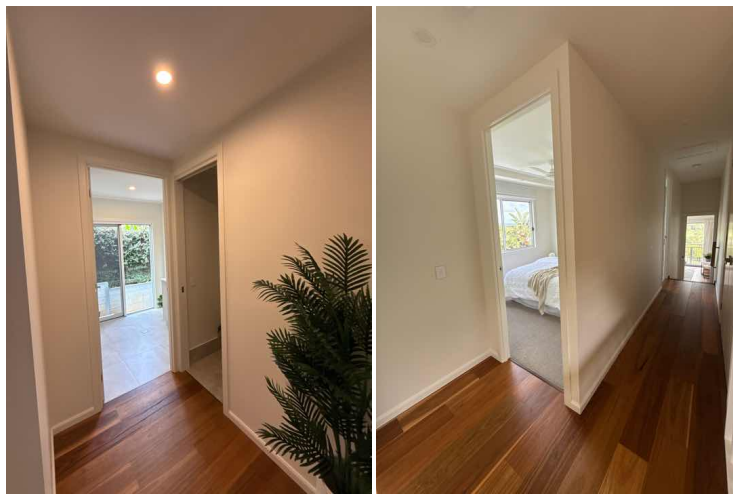
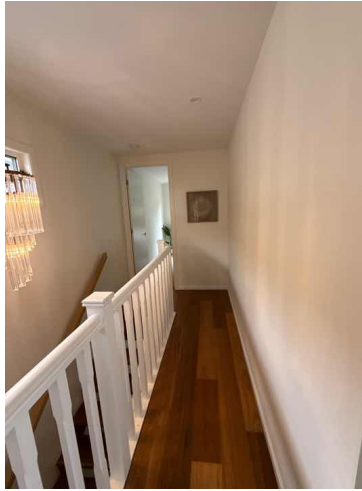
From the visible and accessible areas, the hallway/s/ appears to be in a serviceable condition for the age of the property with no notable structural defects sighted.

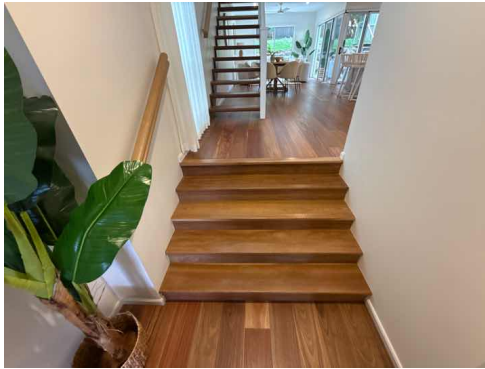
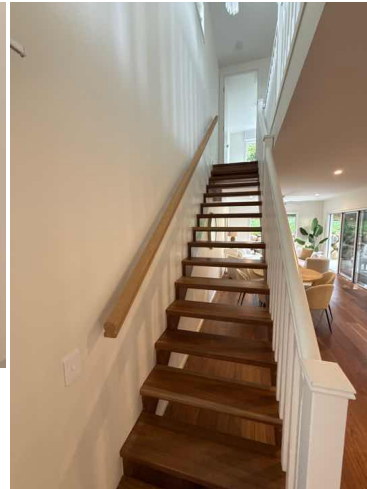
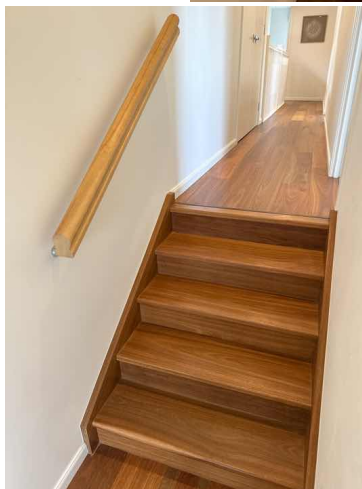
The internal staircase and components appear to be in a serviceable condition for the age with no notable defects sighted.

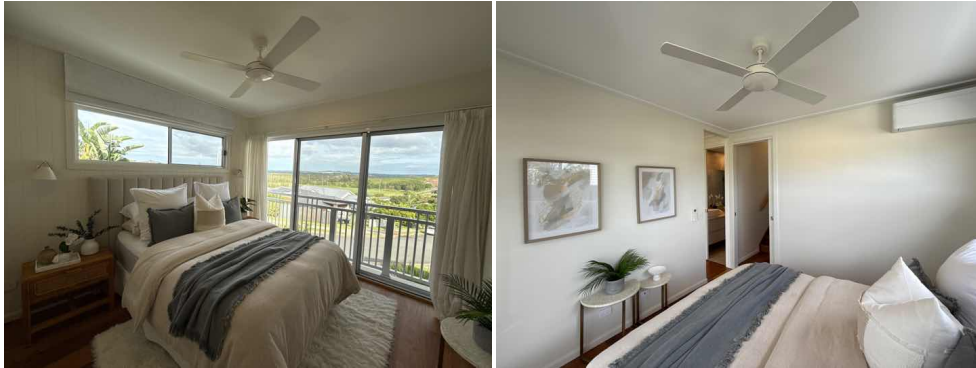
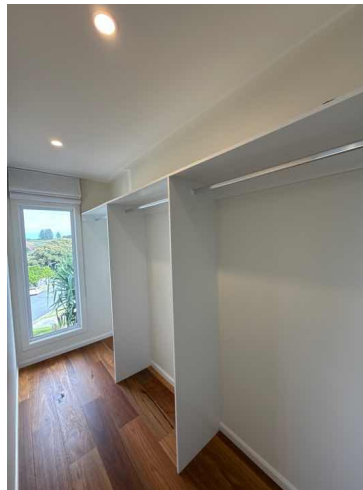
From the visible and accessible areas, this bedroom appears to be in a serviceable condition for the age of the property with no notable structural defects sighted.

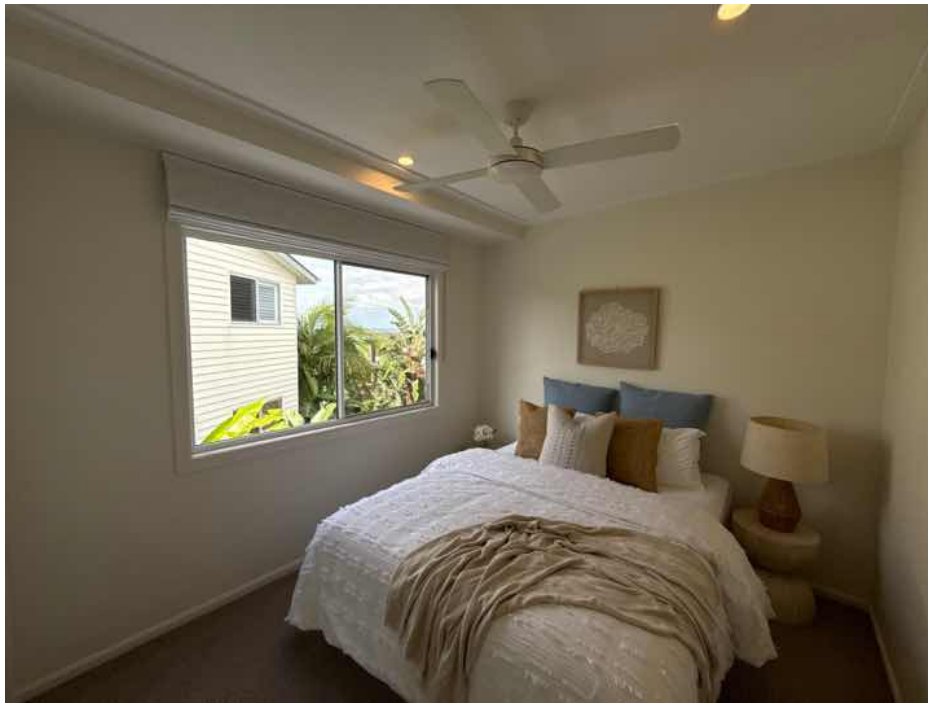
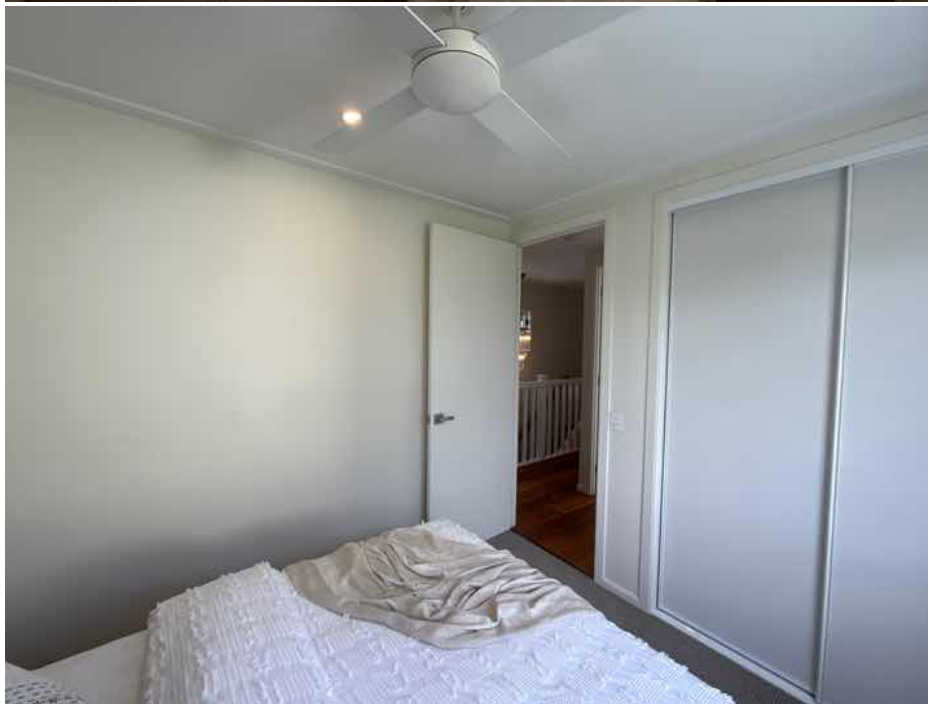
Bedroom 2

From the visible and accessible areas, this bedroom appears to be in a serviceable condition for the age of the property with no notable structural defects sighted.

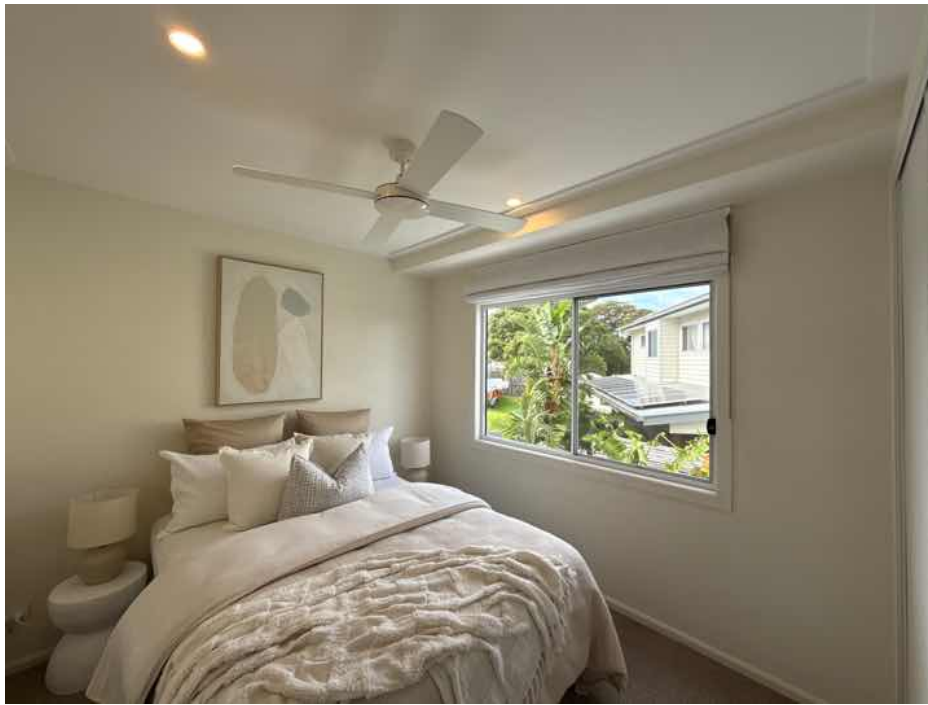
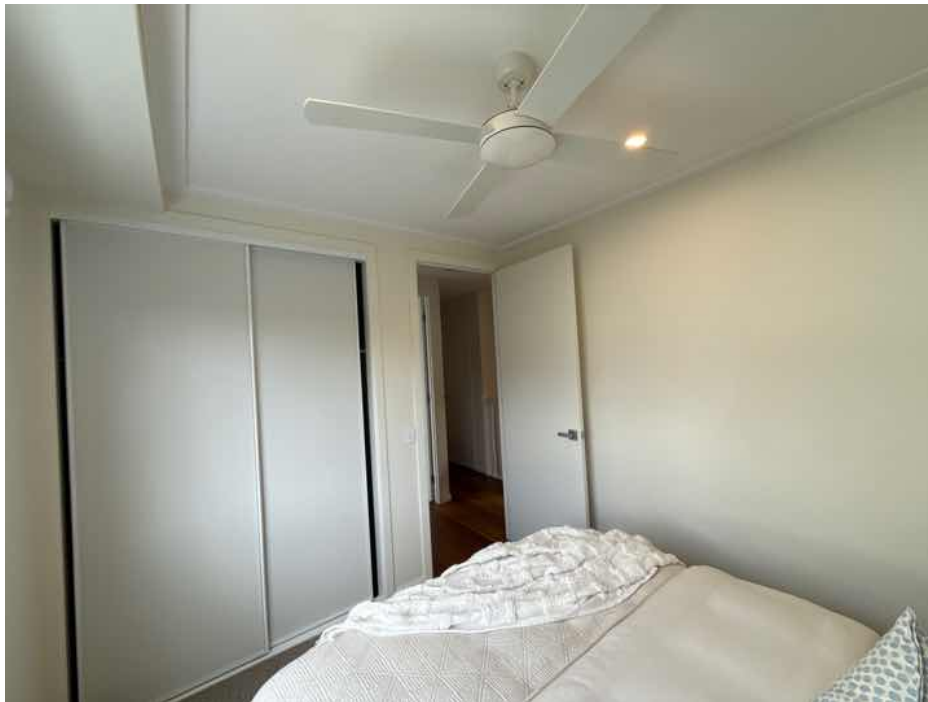
Bedroom 3

From the visible and accessible areas, this bedroom appears to be in a serviceable condition for the age of the property with no notable structural defects sighted.

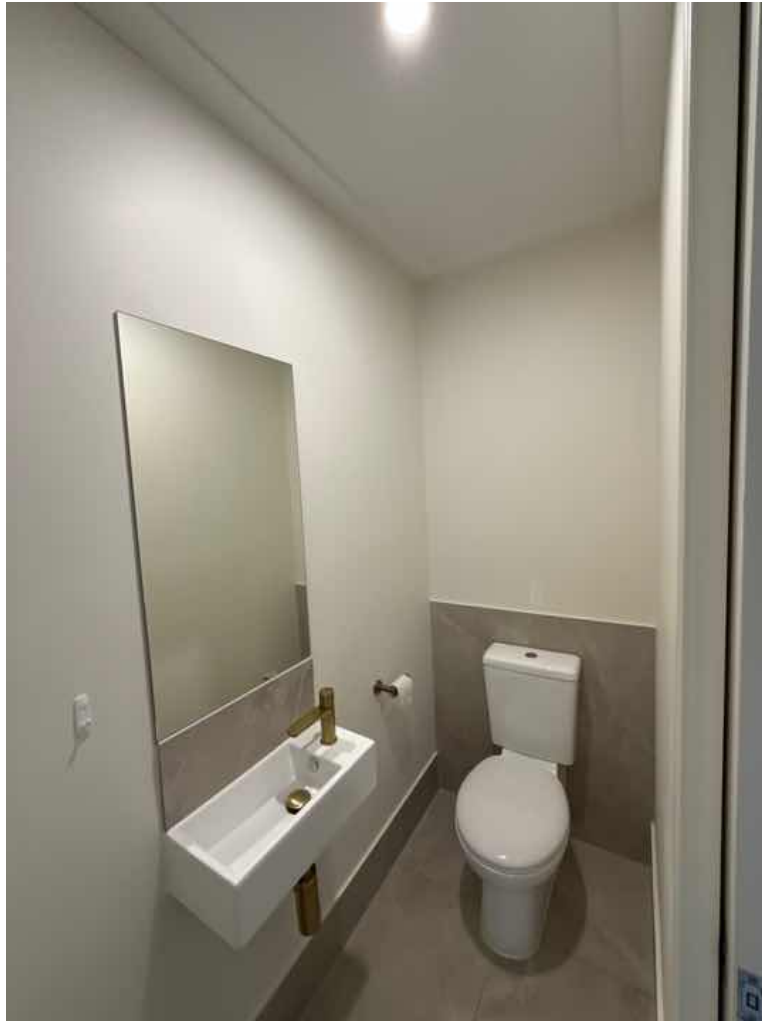
Of the visible areas, the general condition of this bathroom is serviceable or in reasonable condition for age of dwelling.

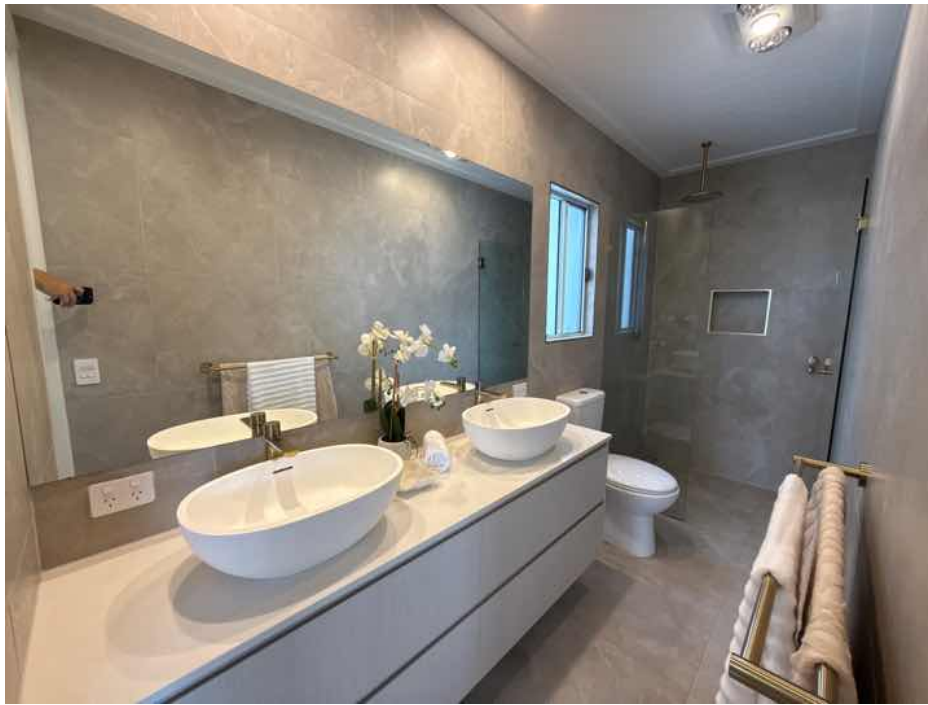
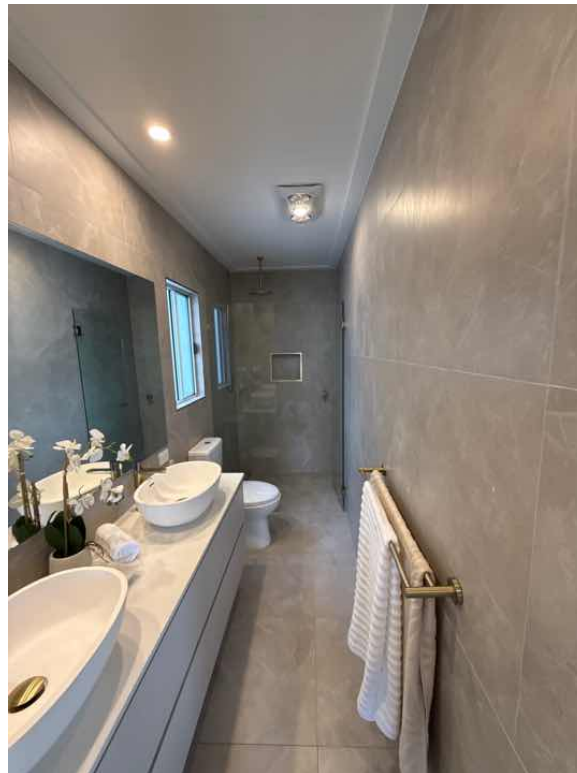
Bathroom 1

Of the visible areas, the general condition of this bathroom is serviceable or in reasonable condition for age of dwelling.

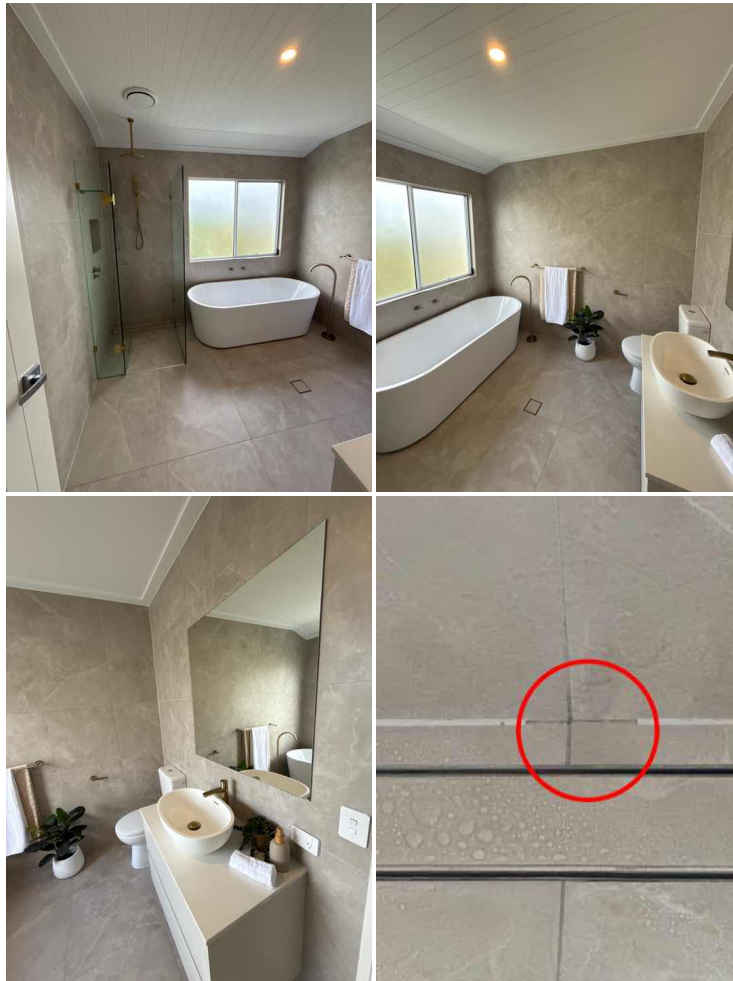
Of the visible areas, the general condition of this bathroom is serviceable or in reasonable condition for age of dwelling.

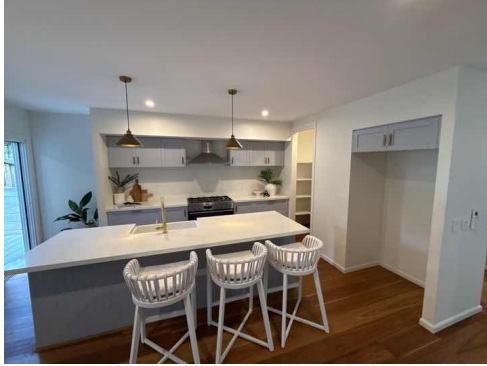
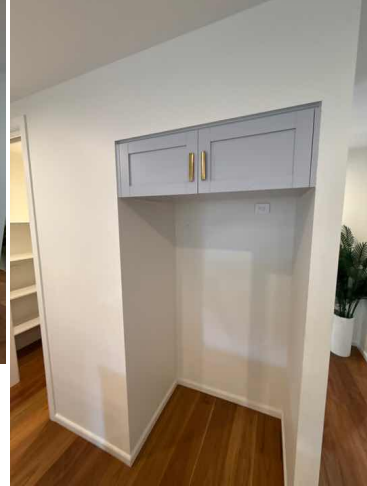
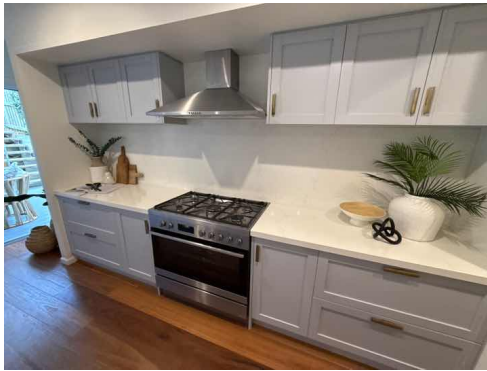
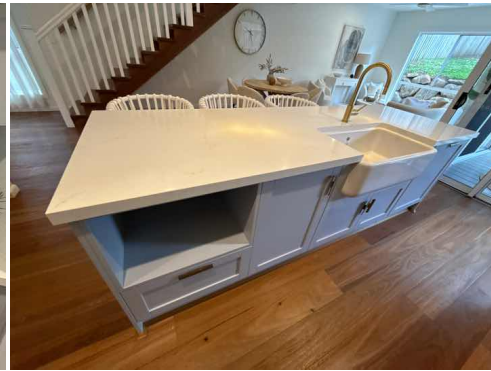
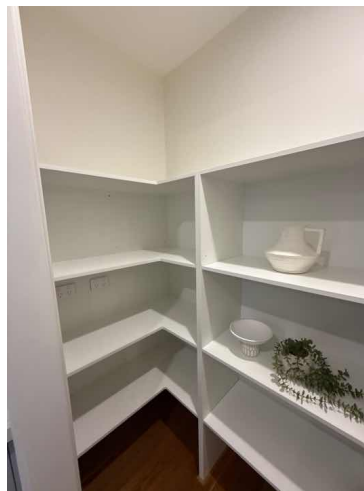
Of the visible areas, the general condition of the kitchen and pantry is serviceable or in reasonable condition for age of dwelling.

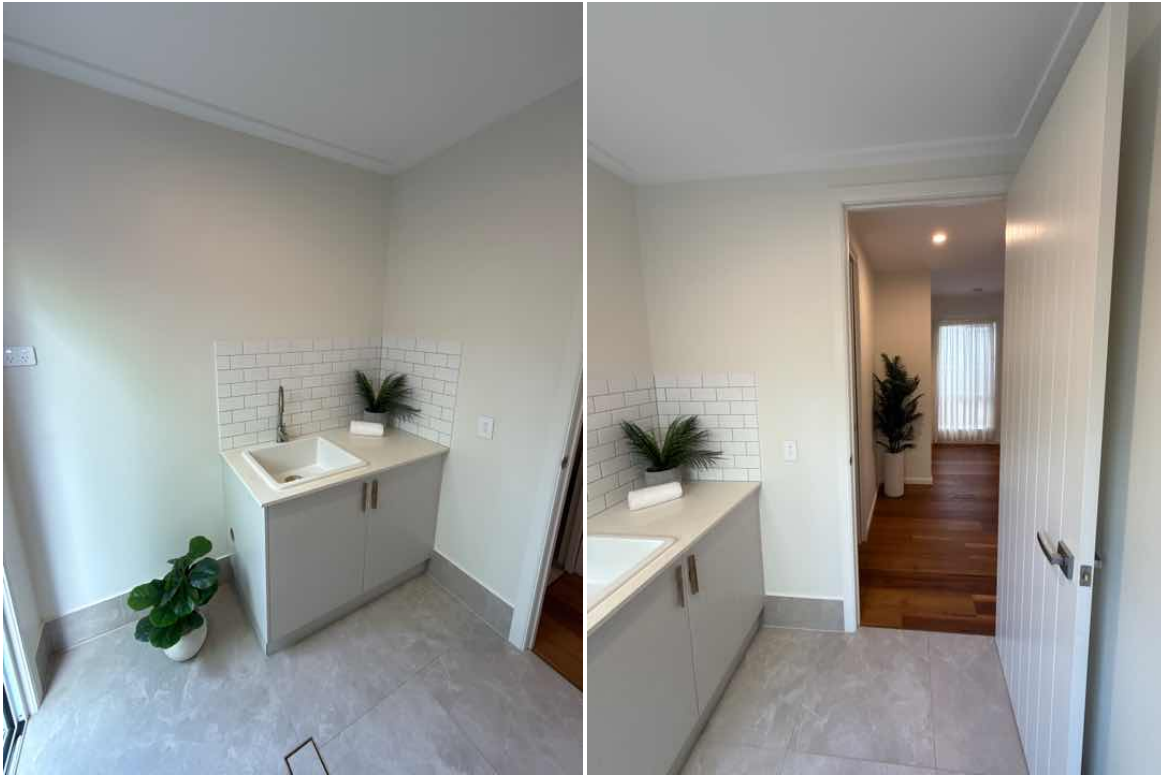
Of the visible areas, the general condition of the laundry is serviceable or in reasonable condition for age of dwelling.

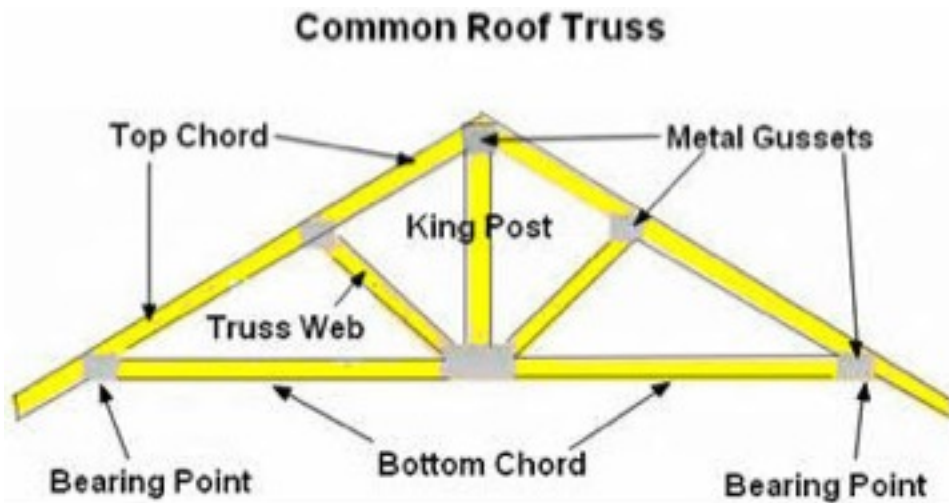
The roof frame is a truss timber frame.

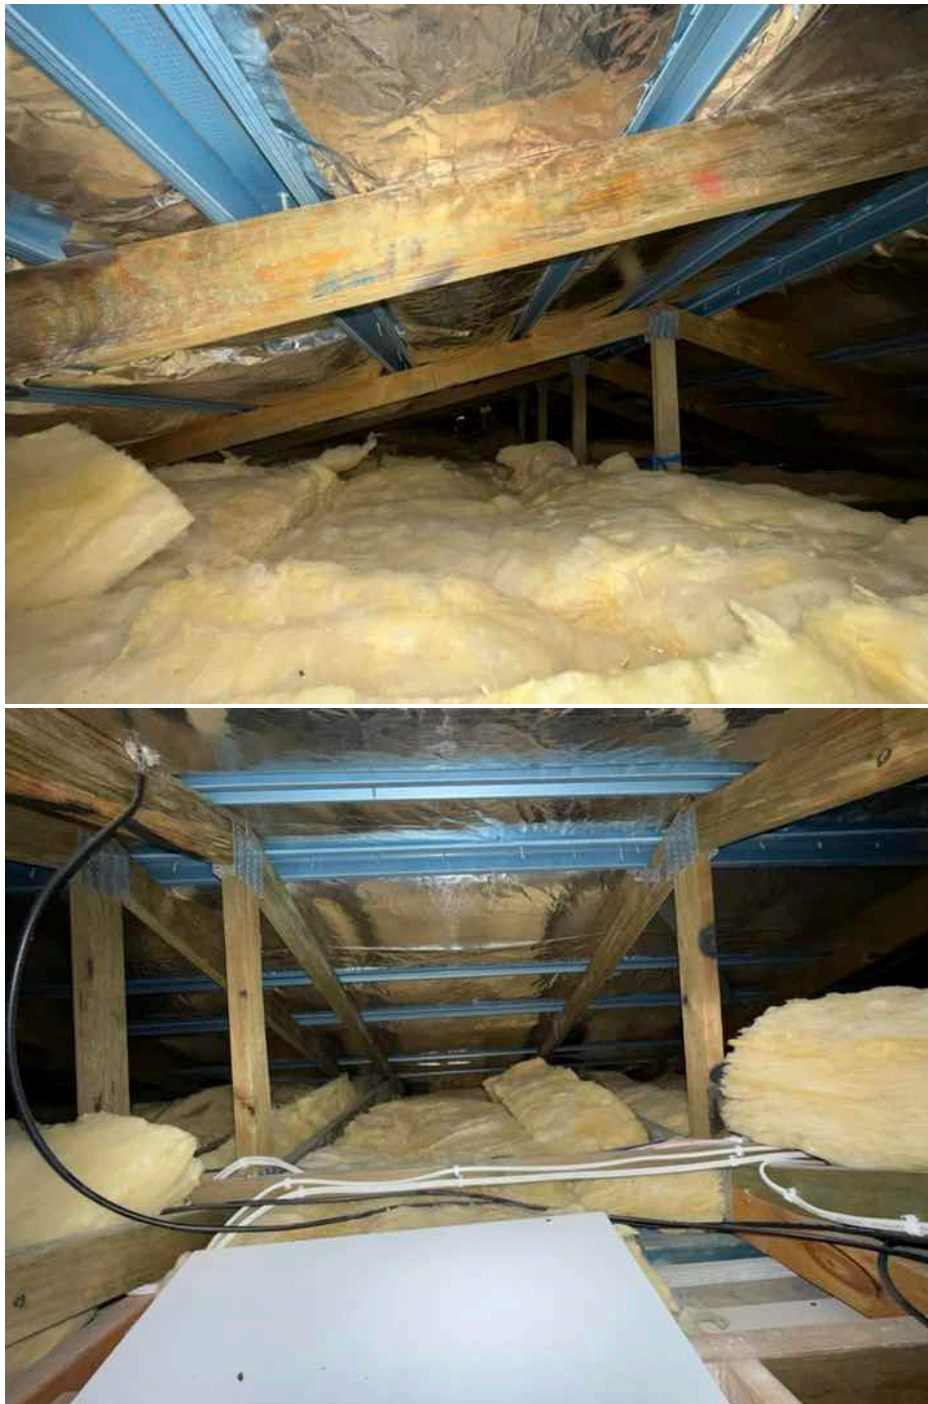
Visible sections of the roof void is in a serviceable condition for age of this dwelling.
