Building and Pest Report

107 Stoneyhurst Dr, Lennox Head

Pest And Building Inspection

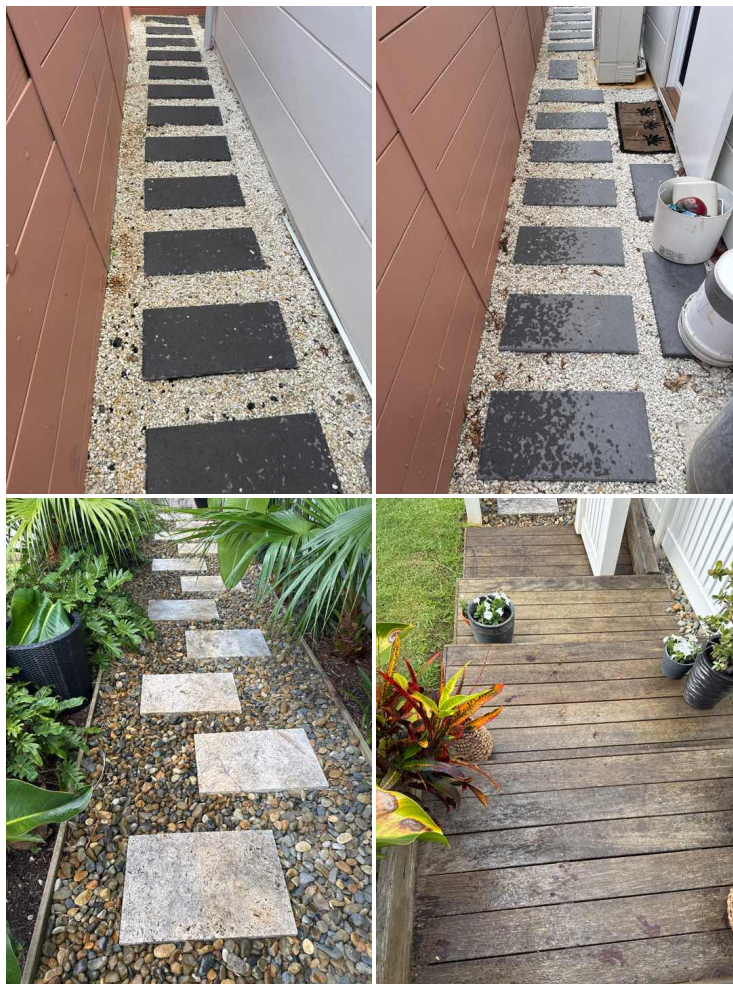
Pathways Condition

The paths around the home are in a serviceable condition for the age of this dwelling with no major defects visible.

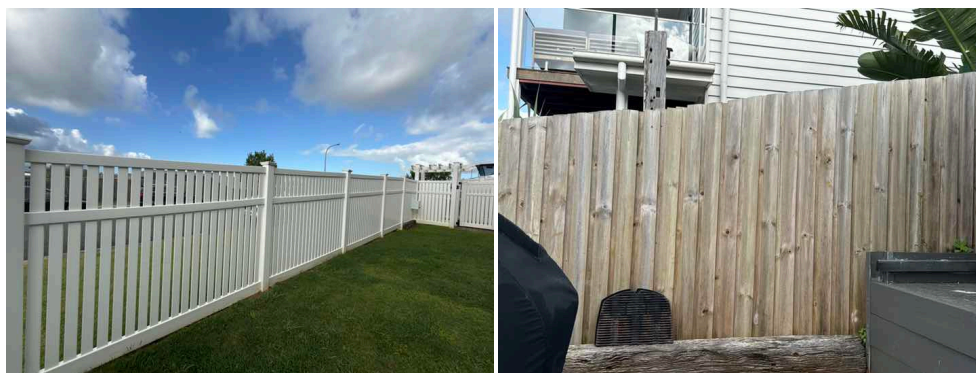
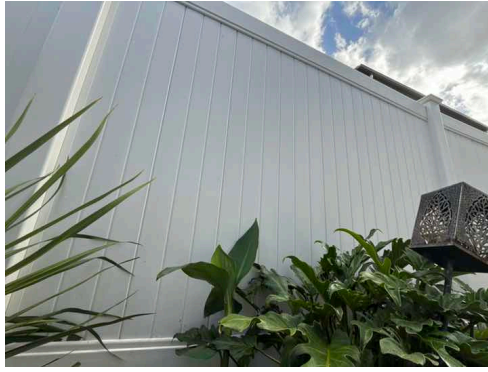
Fences & Gates

Of the visible areas, the general condition of the fences and gates is serviceable for the age of dwelling.

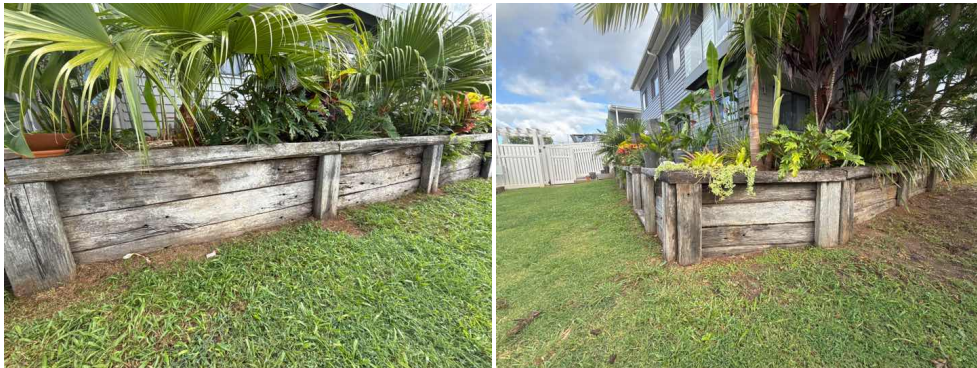
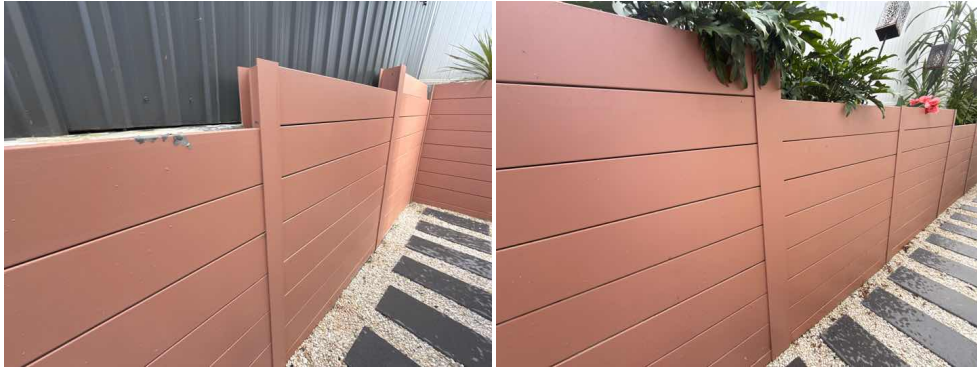
Retaining Walls

Of the visible areas, the general condition is serviceable or in reasonable condition for age of dwelling.

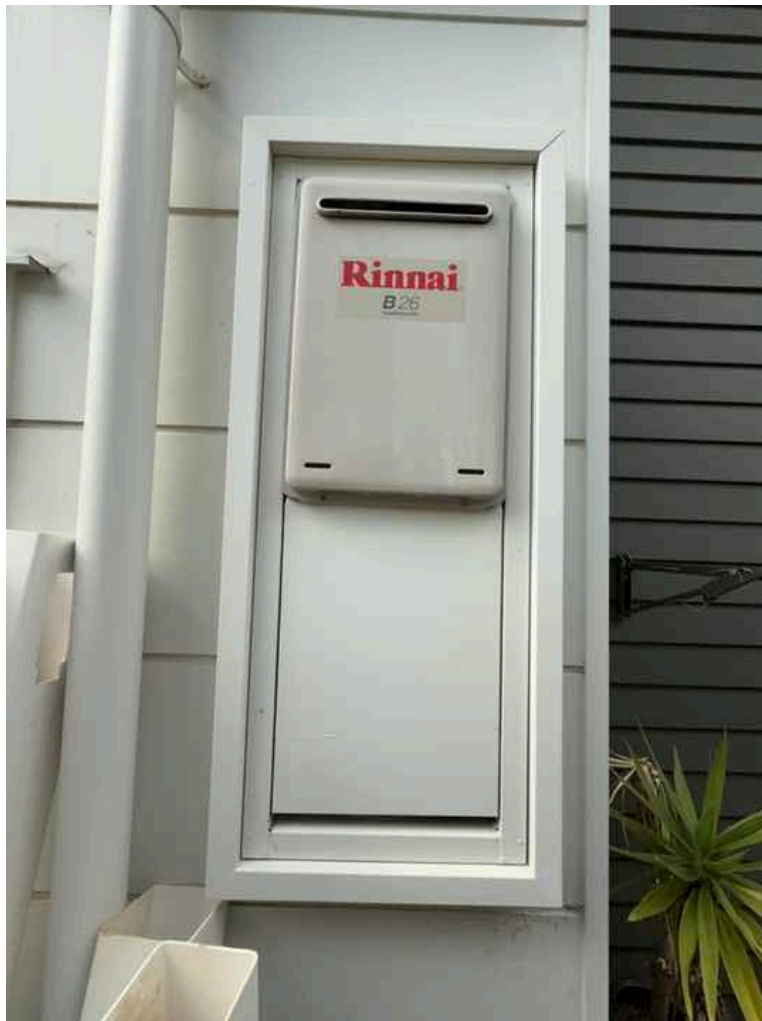
System Make

The make of the hot water unit is rinnai.

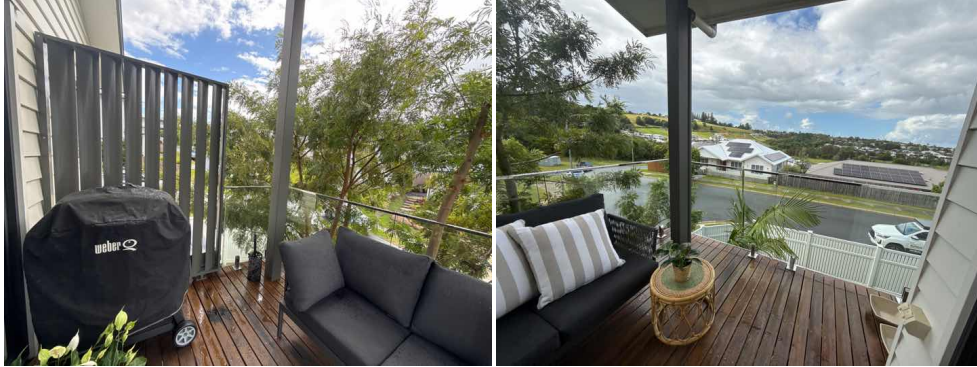
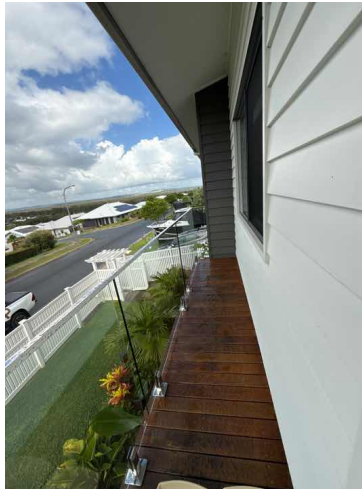
Visible sections of the Alfresco area are serviceable or in reasonable or condition for the age of this dwelling.

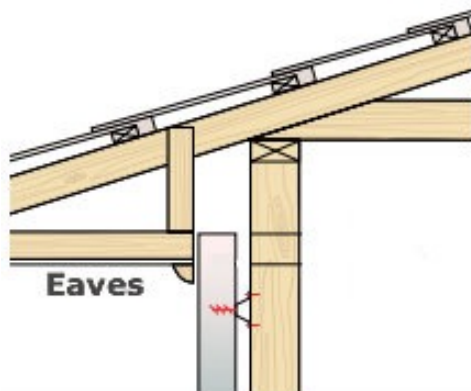
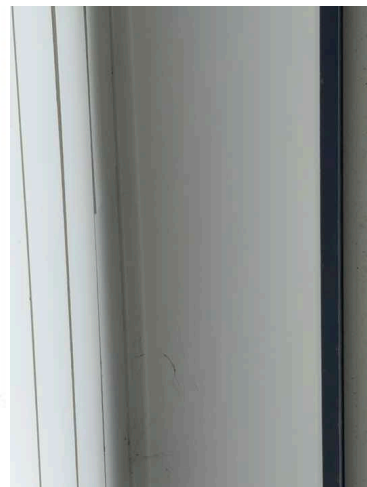
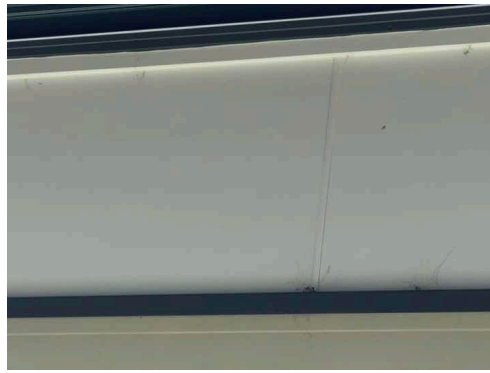
Eaves

The soffit lining (eaves) are in a serviceable condition with no notable defects.

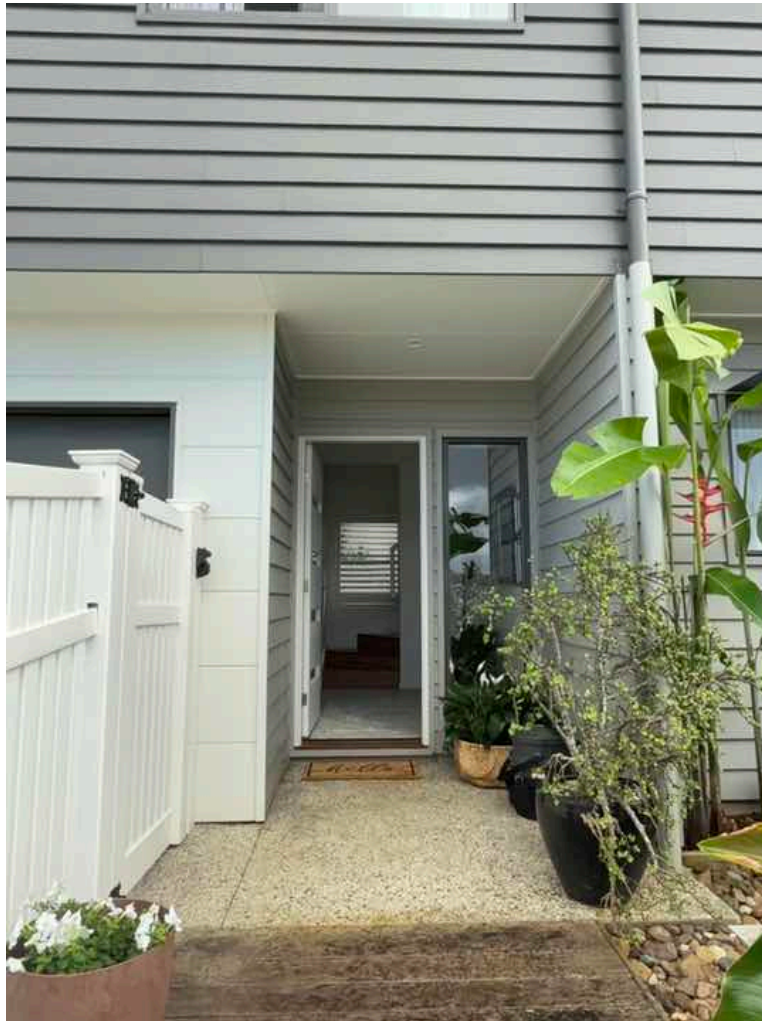
Entry Porch Area

The entry porch serviceable or in reasonable or condition for the age of this dwelling.

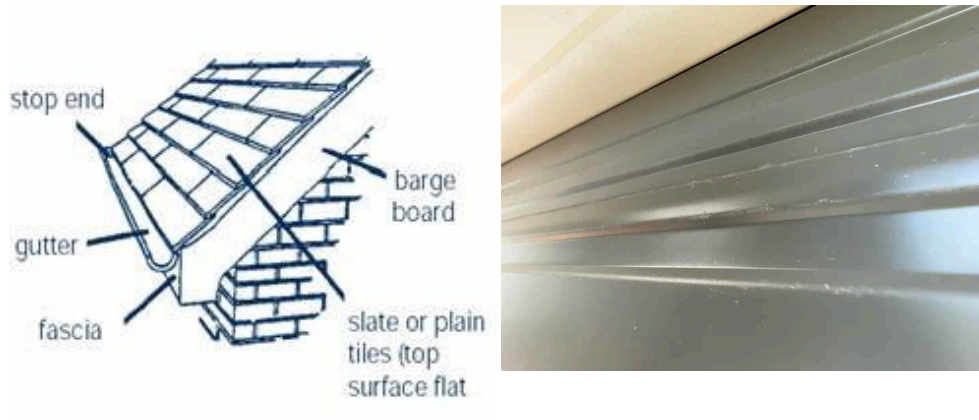
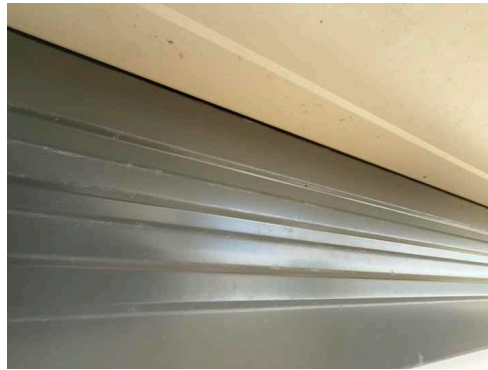
On visual inspection, the general condition of the fascia/barge boards is serviceable.

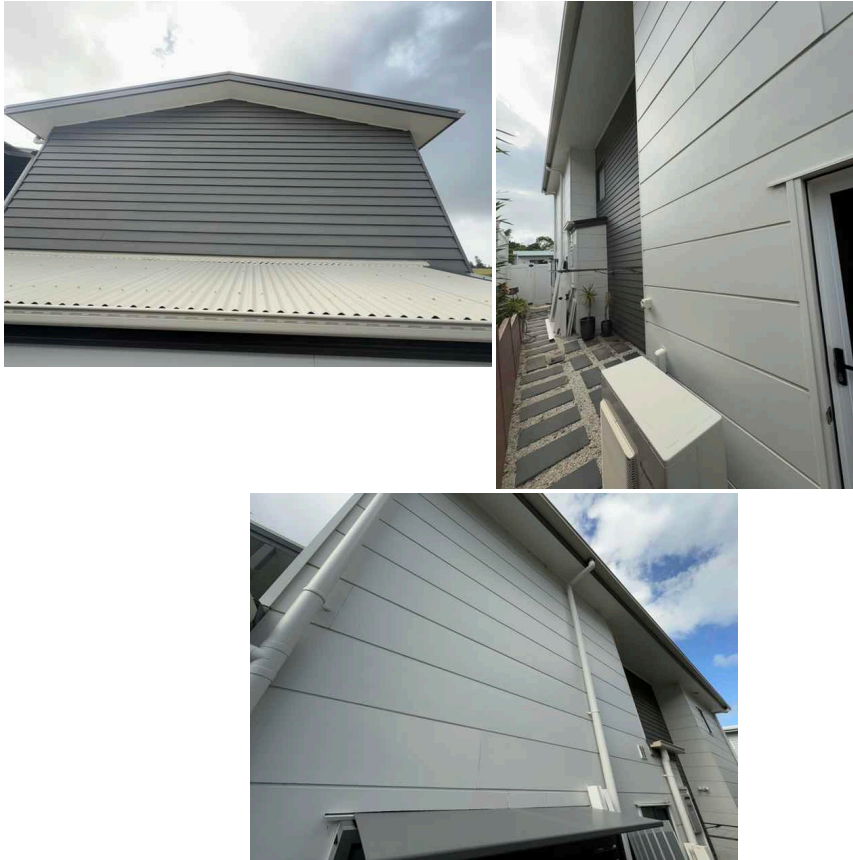
Walls

On visual inspection, the general condition of the exterior walls is serviceable for the age.

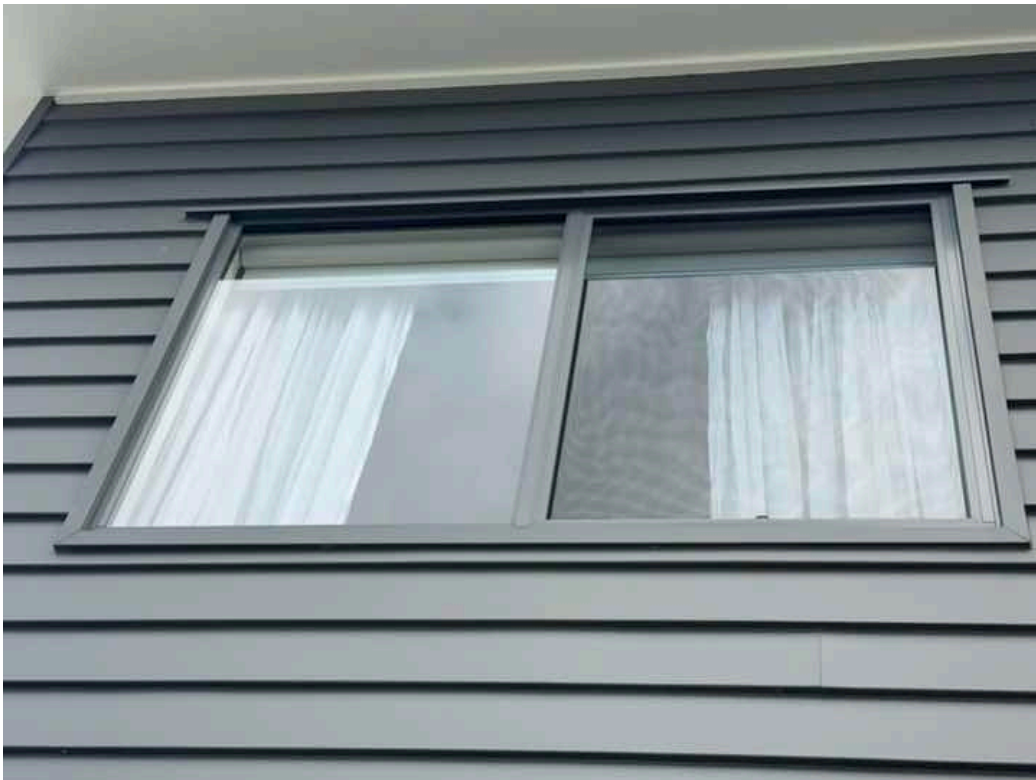
Windows

On visual inspection, the general condition of the windows is serviceable for the age.

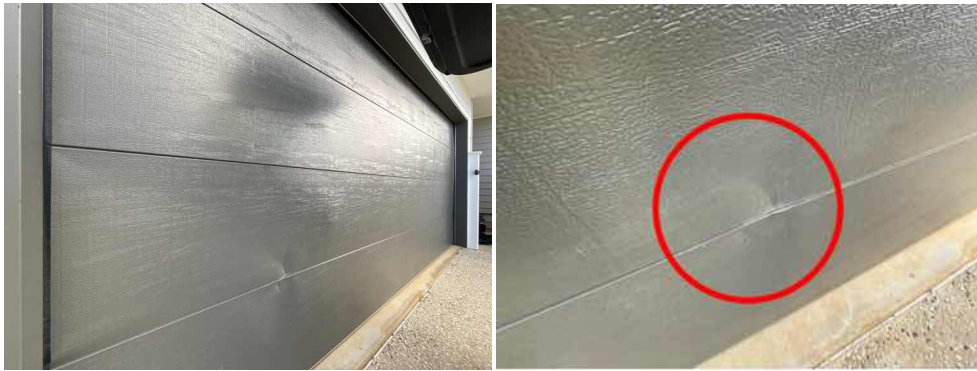
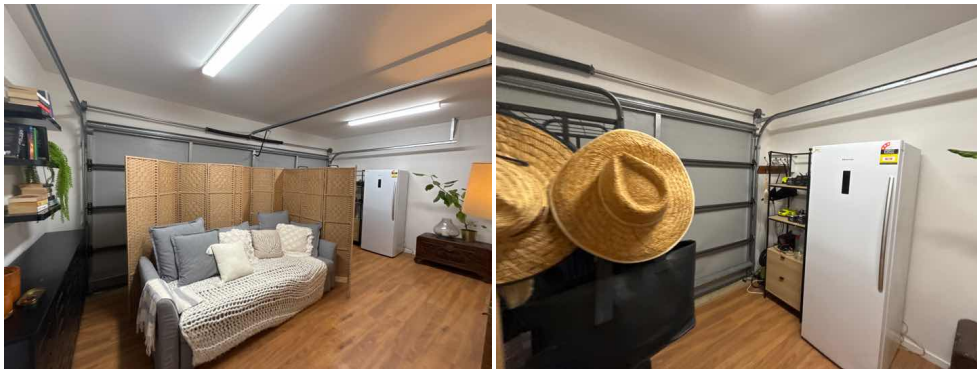
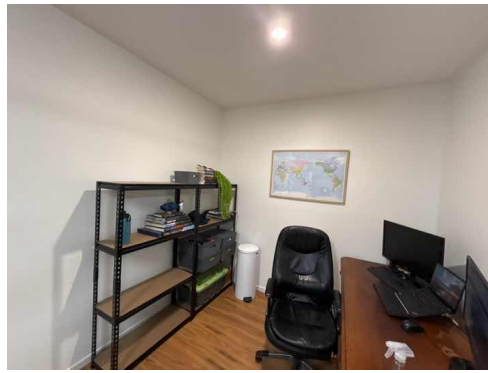
GARAGE - CARPORT

From the visible and accessible areas, the garage appears to be in a serviceable condition for the age of the property with no notable structural defects sighted.

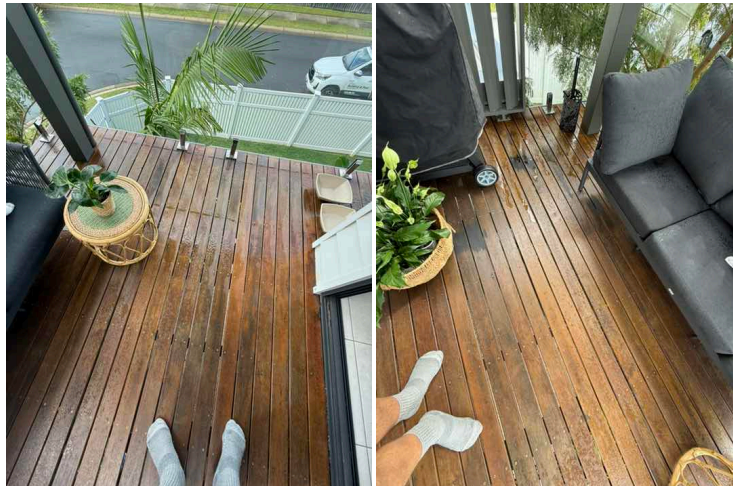
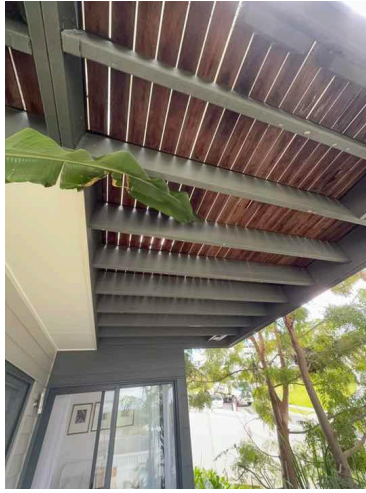
Of areas visible, the decking appears to be in a serviceable condition.

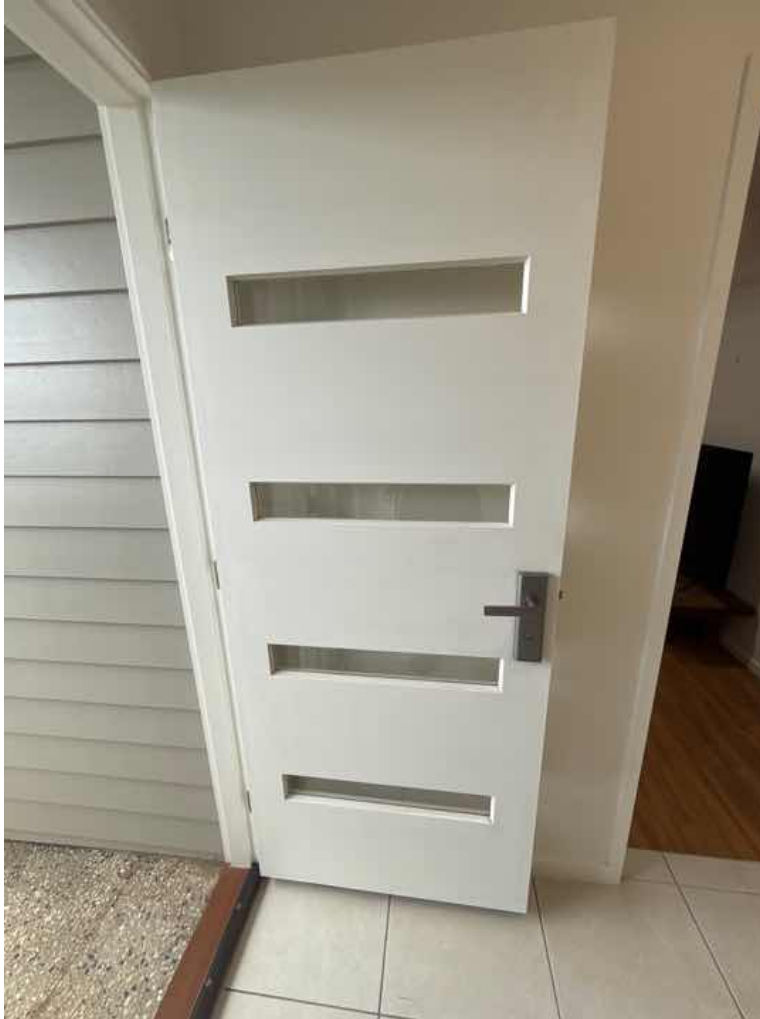
Front Entry Doors

The doors are in serviceable condition with no notable defects observed.

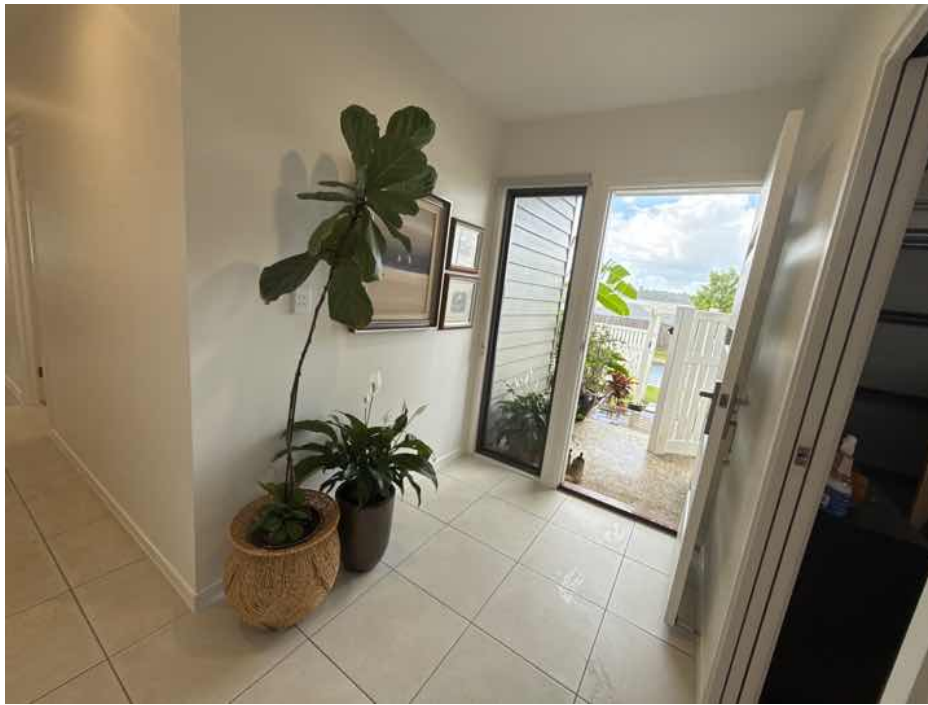
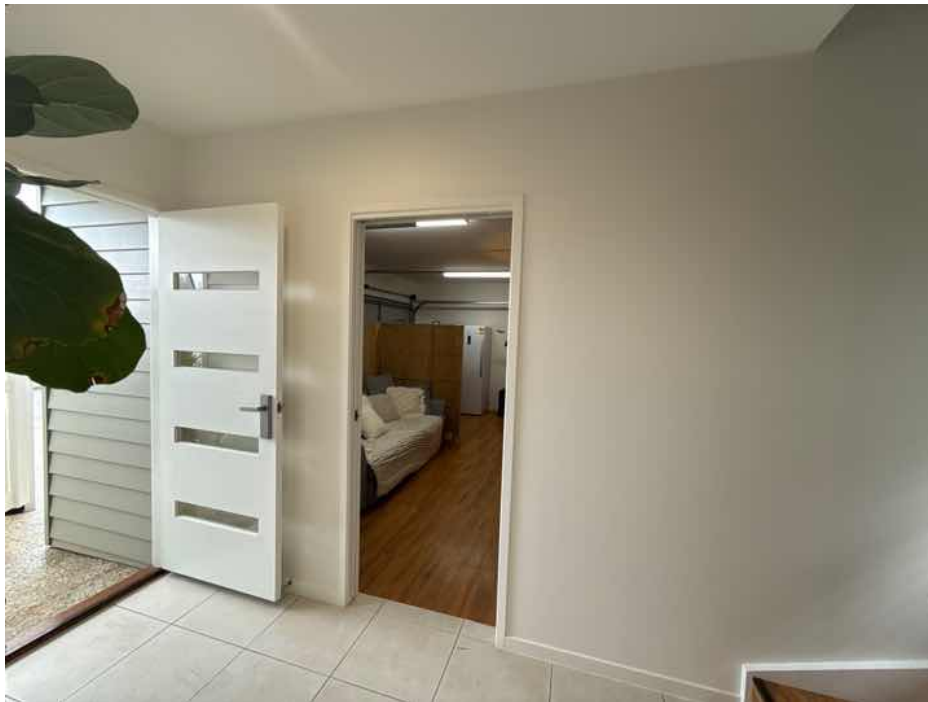
From the visible and accessible areas, this area appears to be in a serviceable condition for the age of the property with no notable structural defects sighted.

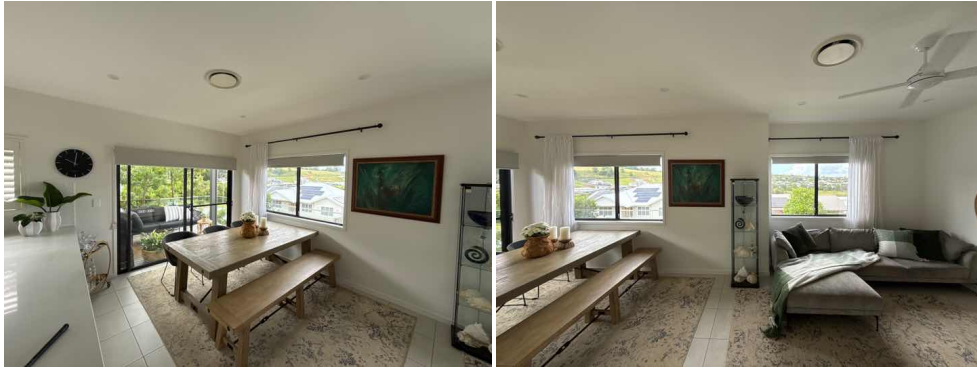
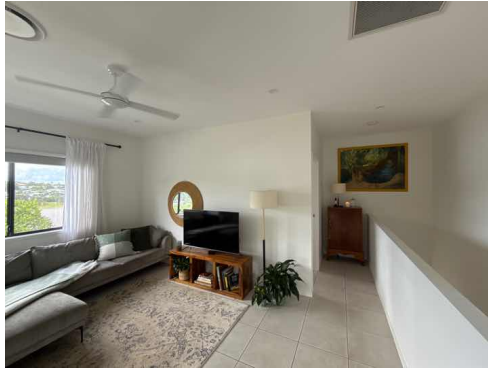
Combined Living & Dining

From the visible and accessible areas, this room appears to be in a serviceable condition for the age of the property with no notable structural defects sighted.

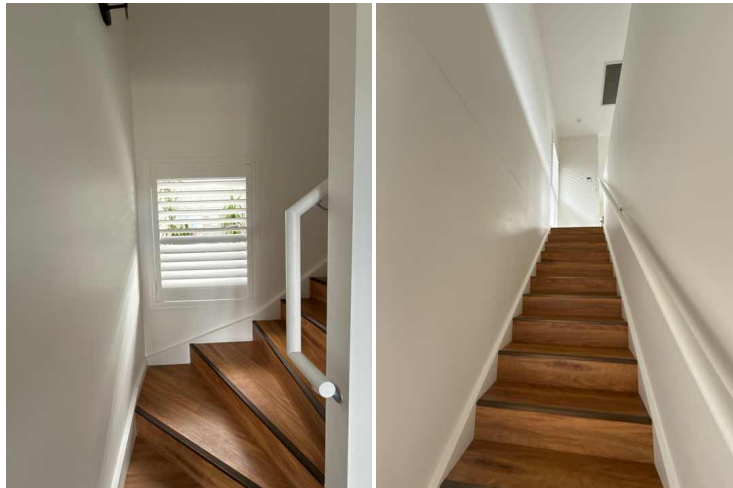
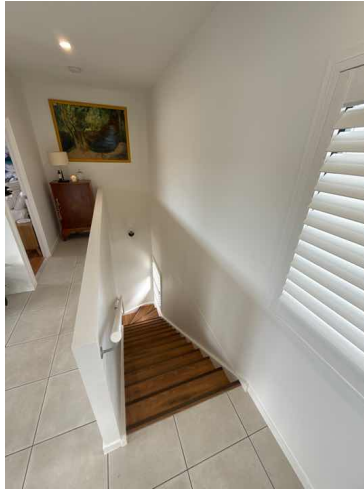
Internal Stair Case

The internal staircase and components appear to be in a serviceable condition for the age with no notable defects sighted.

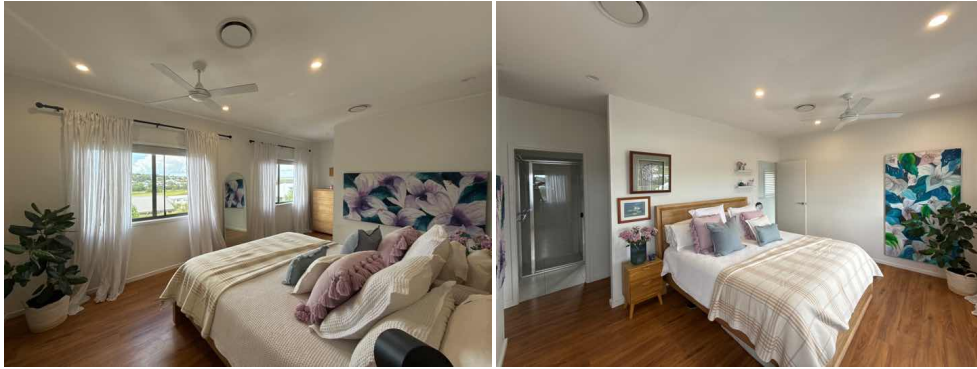
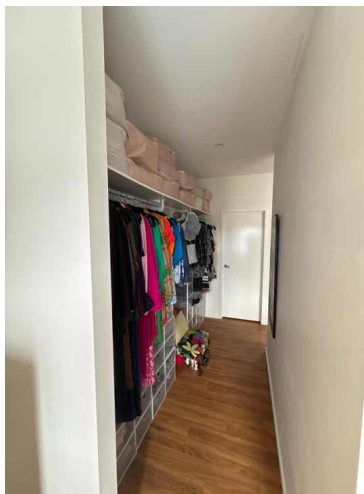
Bedroom 1

From the visible and accessible areas, this bedroom appears to be in a serviceable condition for the age of the property with no notable structural defects sighted.

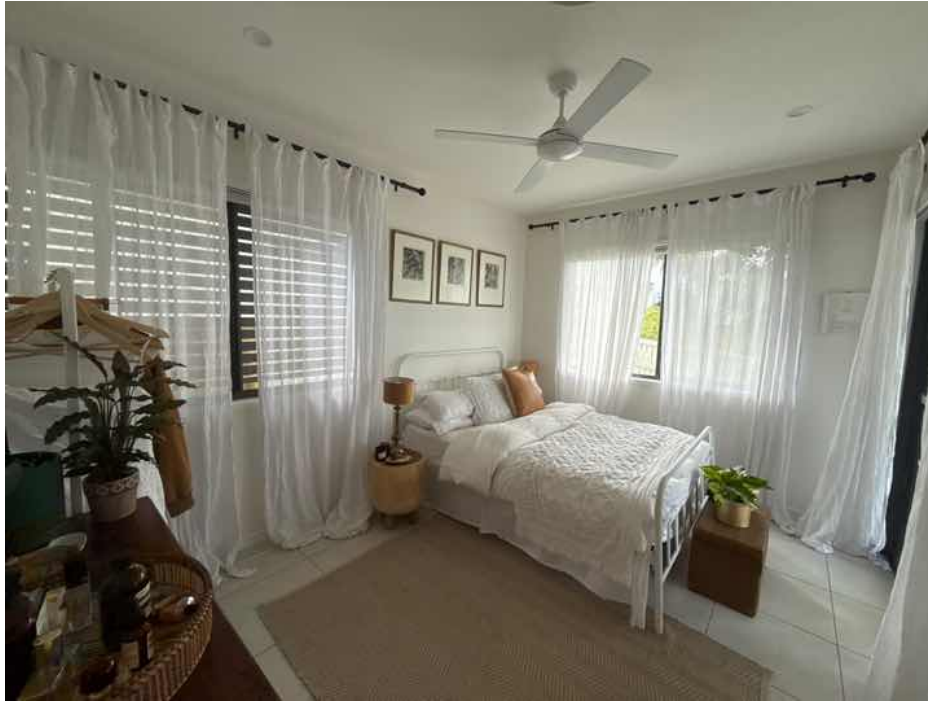
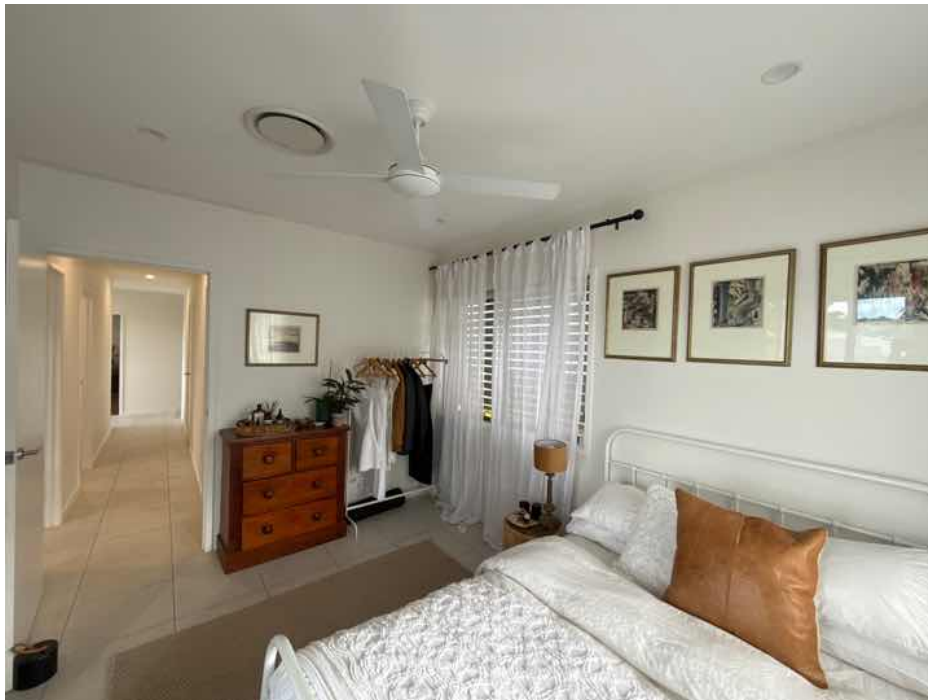
Bedroom 2

From the visible and accessible areas, this bedroom appears to be in a serviceable condition for the age of the property with no notable structural defects sighted.

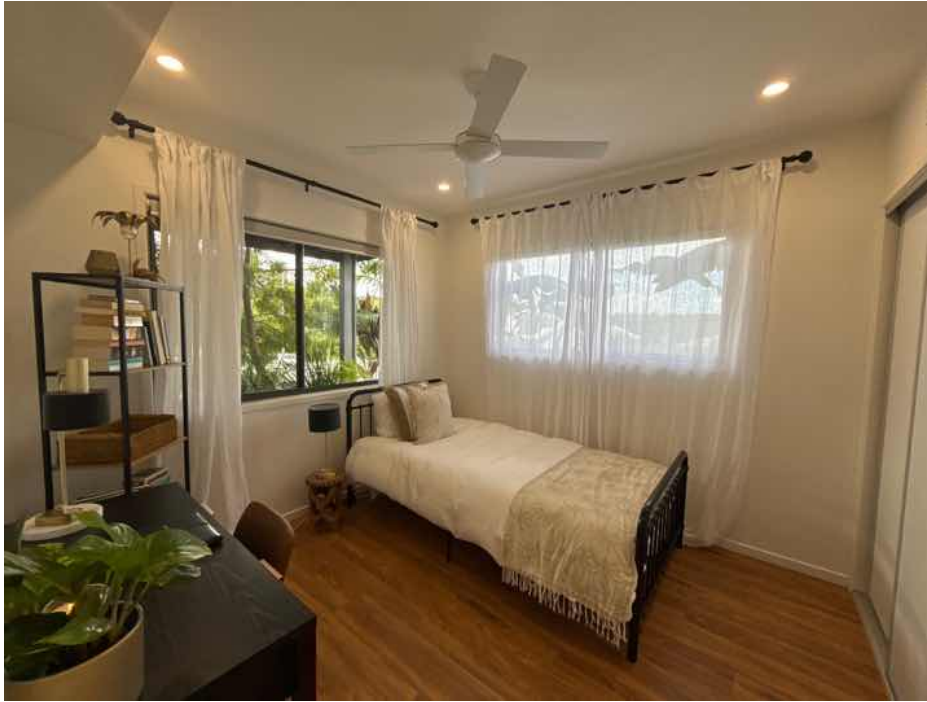
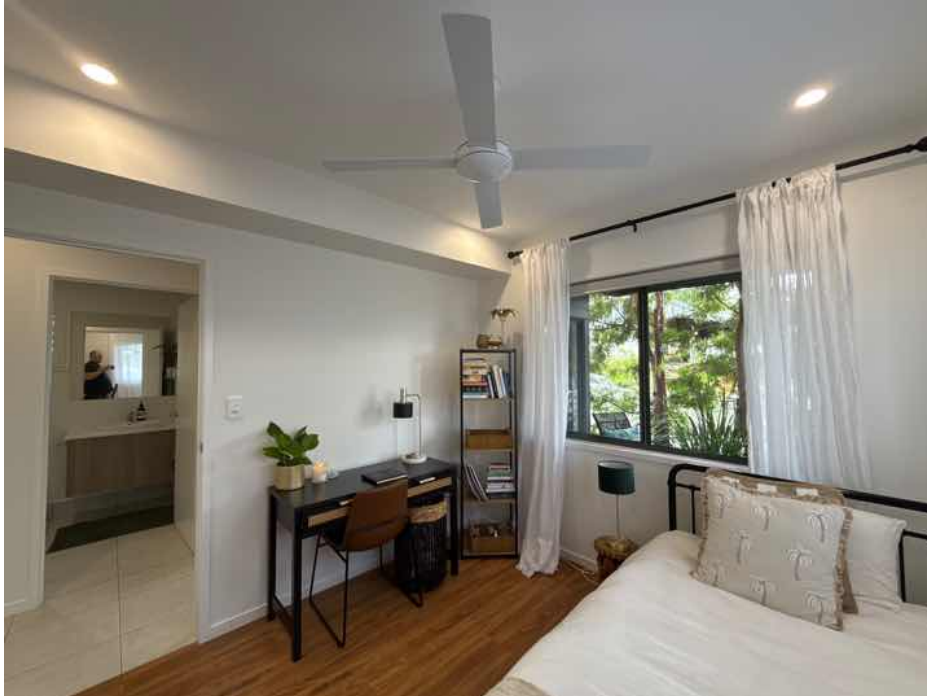
Bedroom 3

From the visible and accessible areas, this bedroom appears to be in a serviceable condition for the age of the property with no notable structural defects sighted.

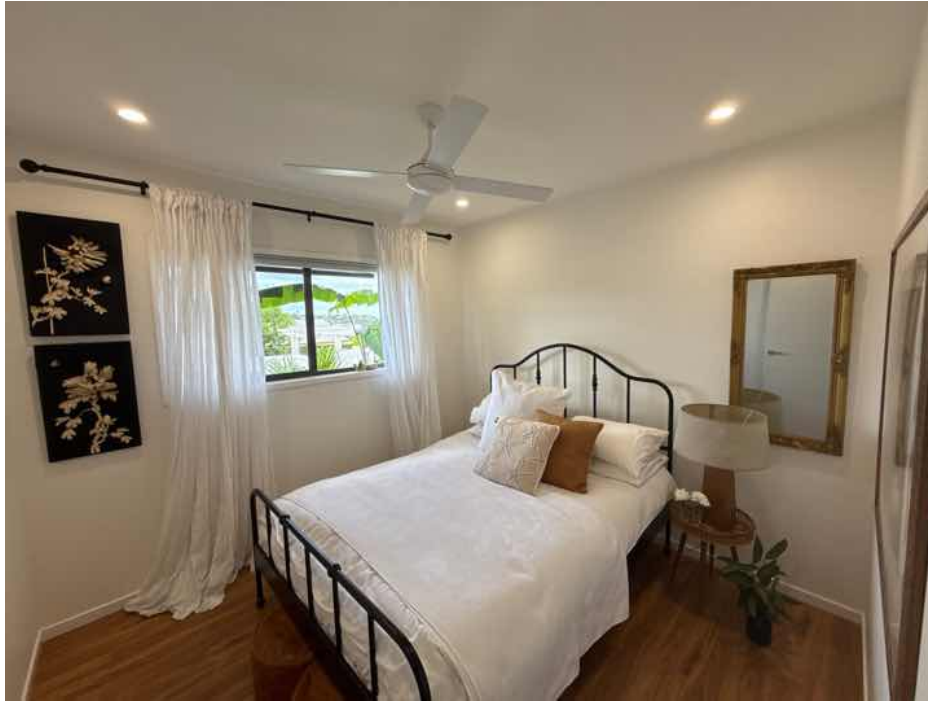
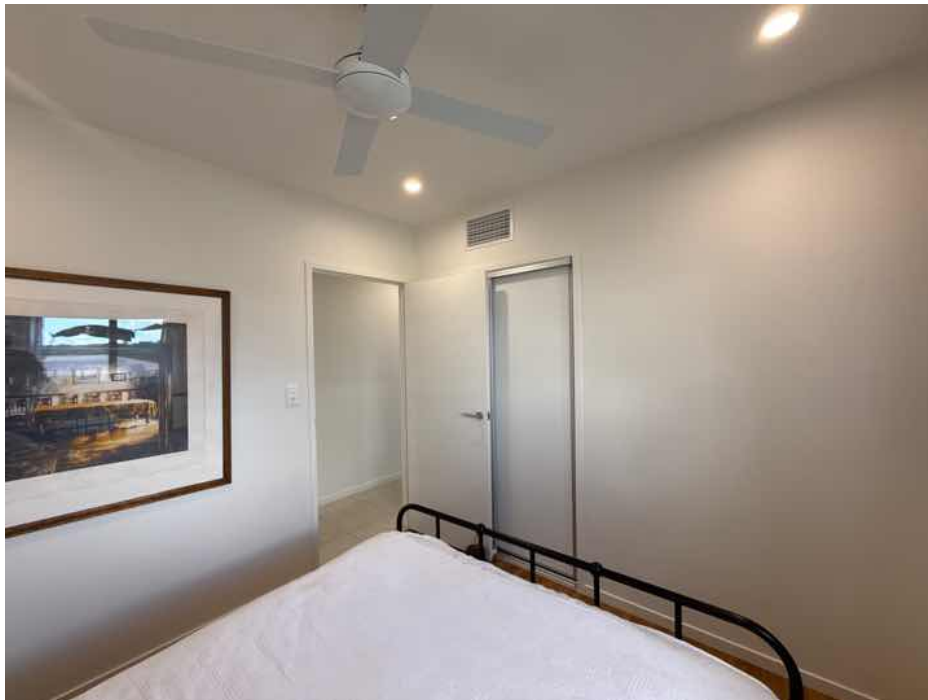
Bedroom 4

From the visible and accessible areas, this bedroom appears to be in a serviceable condition for the age of the property with no notable structural defects sighted.

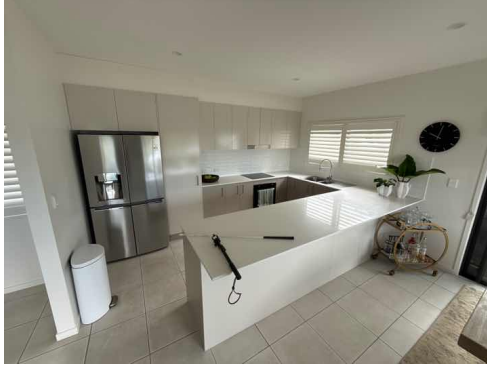
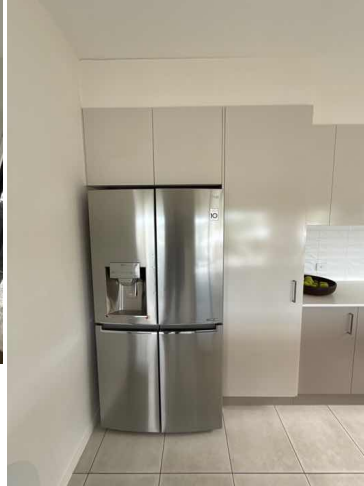
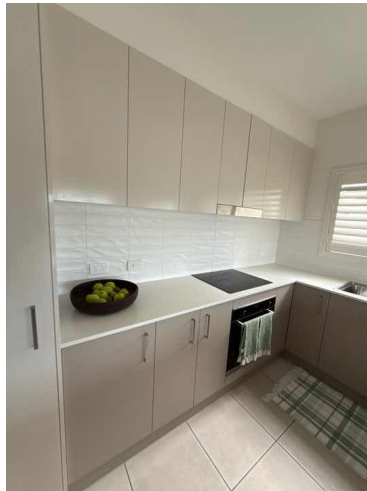
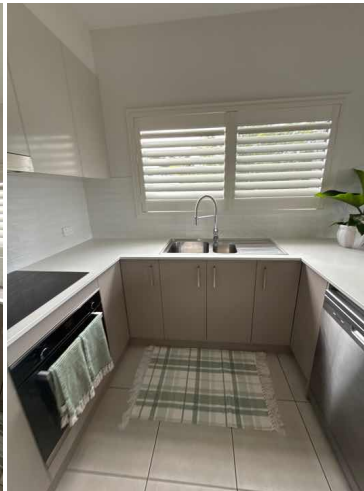
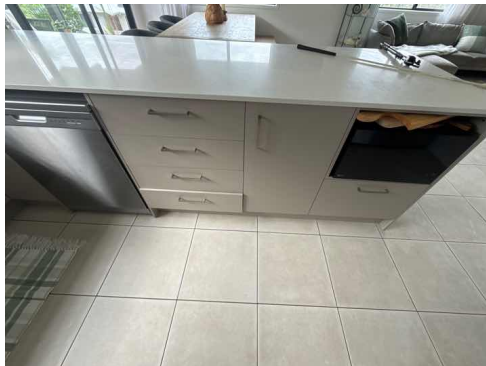
Of the visible areas, the general condition of the kitchen and pantry is serviceable or in reasonable condition for age of dwelling.

Cornice separation. I recommend you contact a licensed painter for repairs.

Adjustment to cabinet doors required, in some instance hinges may need to be replaced.

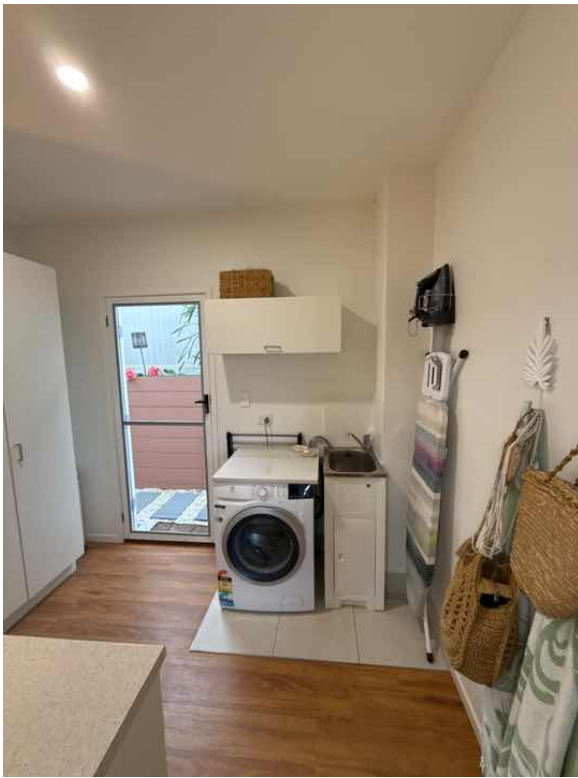
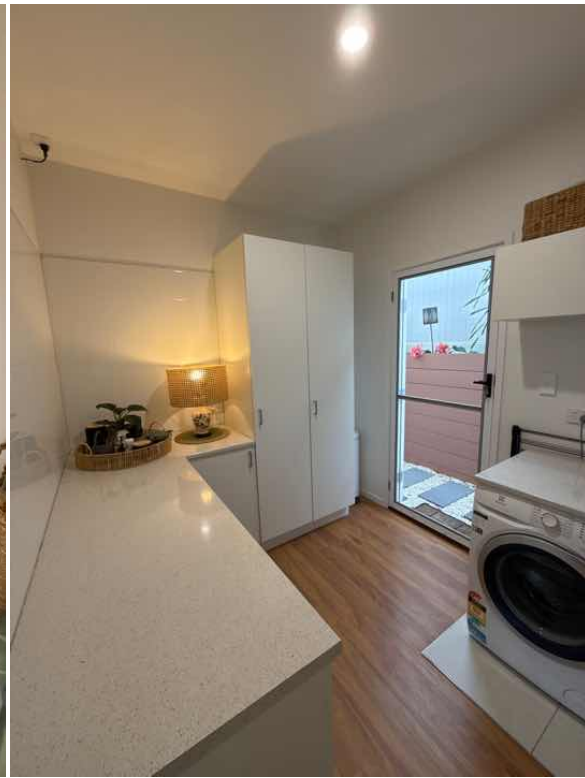
Of the visible areas, the general condition of the laundry is serviceable or in reasonable condition for age of dwelling.

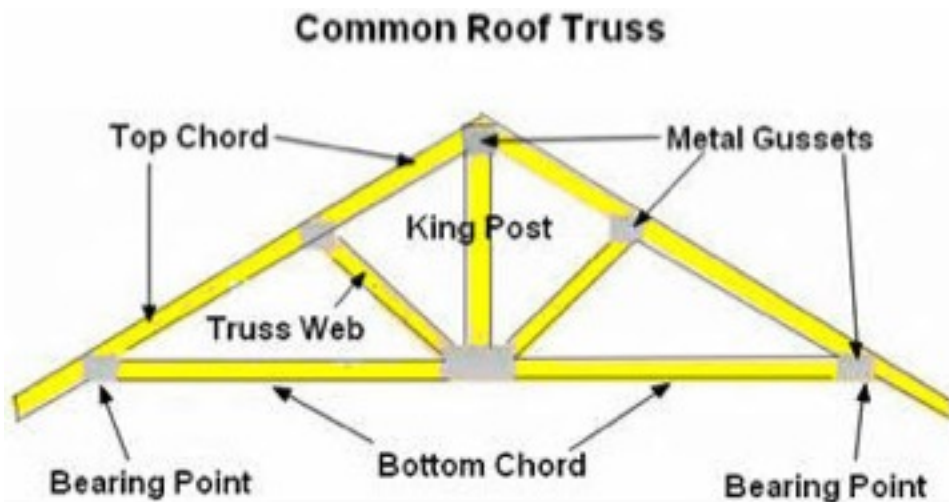
Roof Frame Type

The roof frame is a truss timber frame.

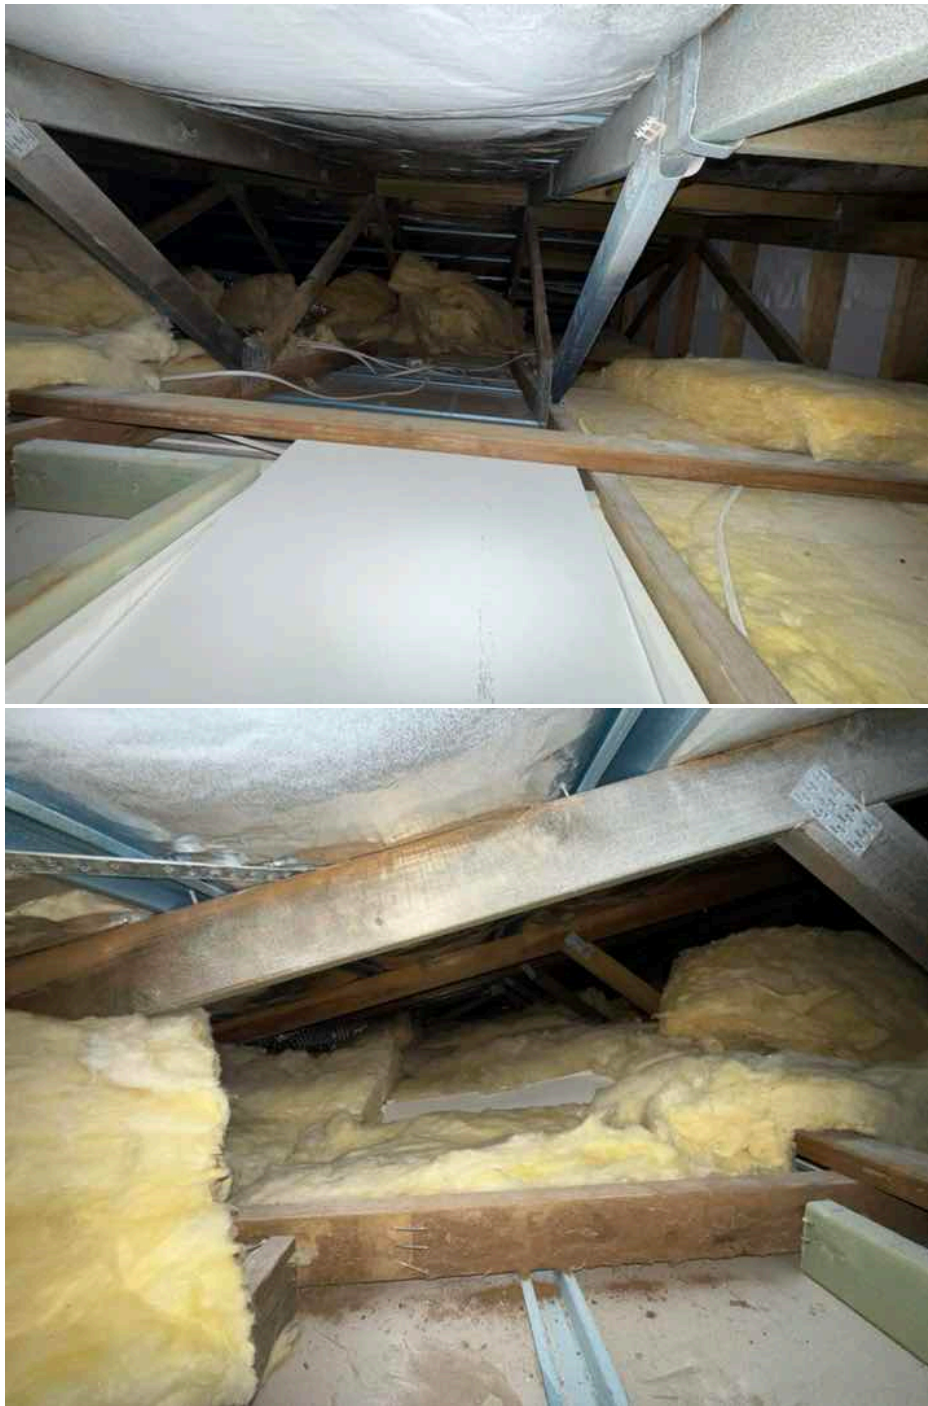
Visible sections of the roof void is in a serviceable condition for age of this dwelling.
