Building and Pest Report

8 Tresise Place Lennox Head

Report/Agreement #	200225033017246
Inspection Date:	20 Feb 2025
Inspection Time:	03:30 pm

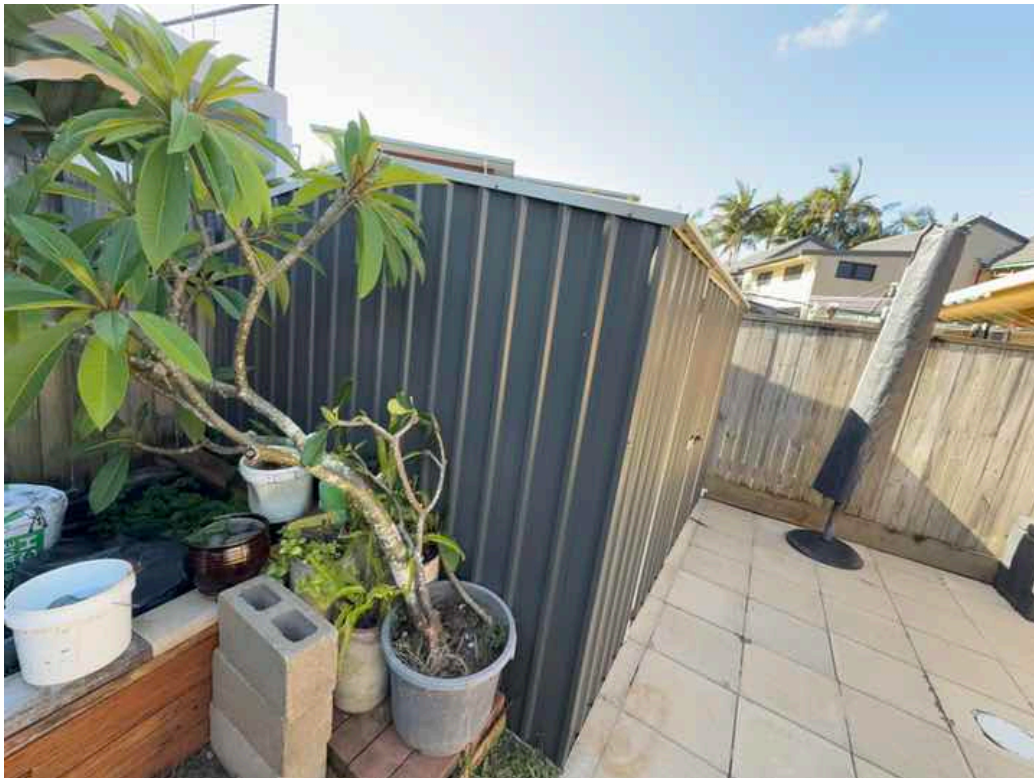
Shed Condition

The shed is in fair usable condition.

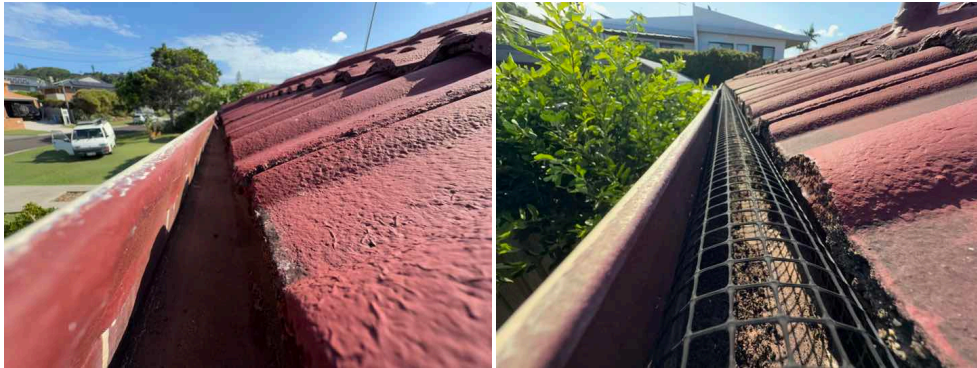
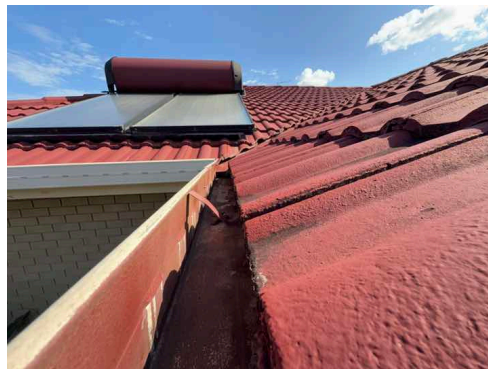
Gutter Findings

All visible and accessible of the physical nature of the guttering system appears to be in a serviceable condition with no apparent defects at the time of inspection. In the absence of prolonged rain fall efficiency of the guttering can not be assessed and you may find that further investigation or repairs maybe required. Note: Periodic maintenance checks should be carried out for rust penetrations and leaks.

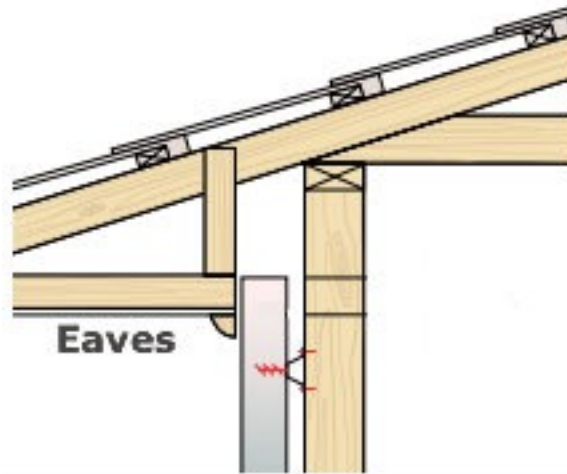
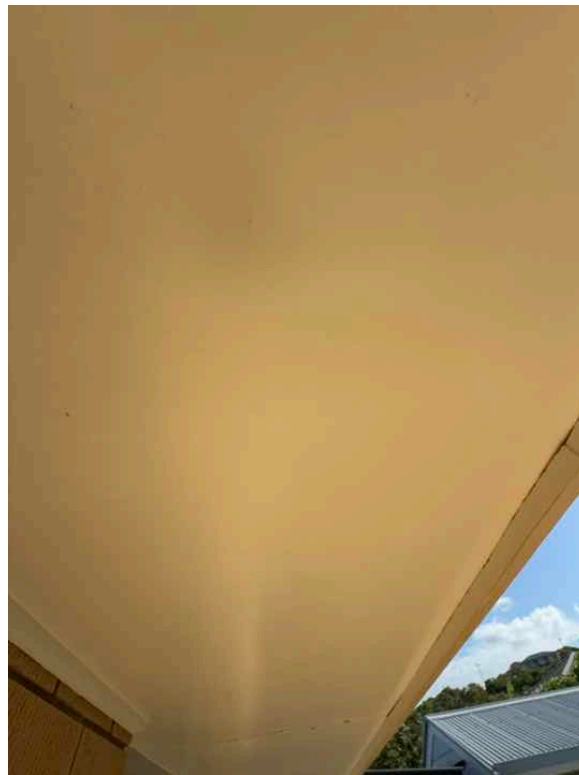
Eave Condition

The soffit lining (eaves) are in a serviceable condition with no notable defects.

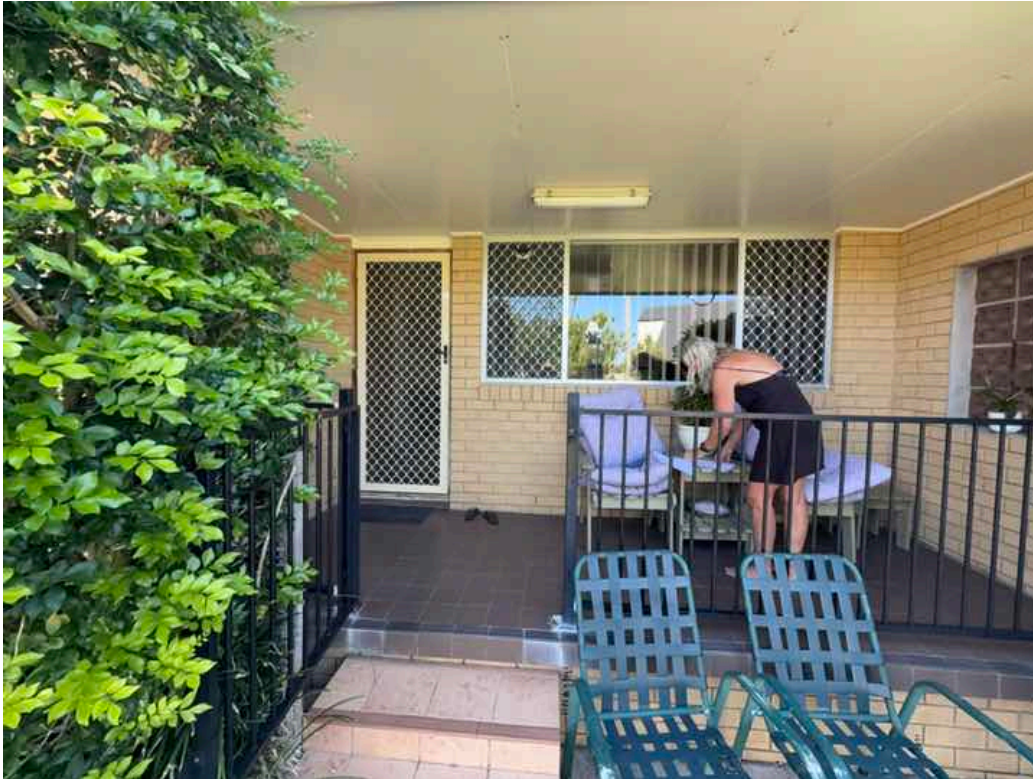
Entry Porch Area

The entry porch serviceable or in reasonable or condition for the age of this dwelling.

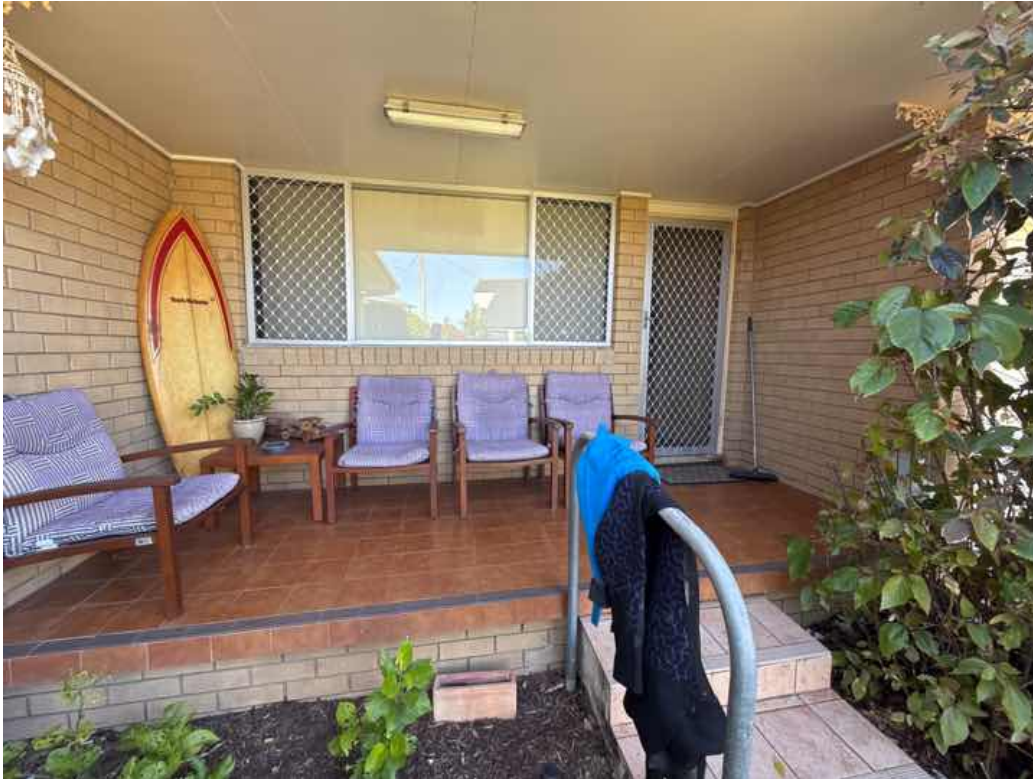
The entry porch serviceable or in reasonable or condition for the age of this dwelling.

Tile cracks evident on entry patio/porch - Recommendations: Engage a qualified tiling contractor to repair.

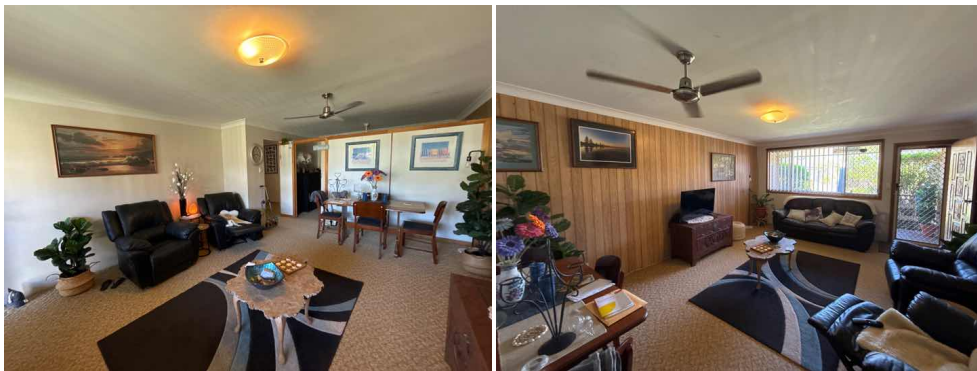
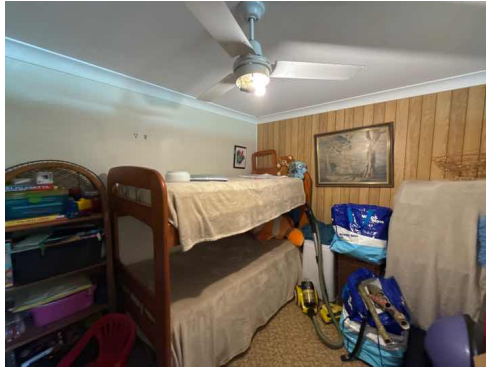
Ceiling

Settlement Cracks Noted. These are typical and generally patch and paint will suffice, however monitoring these cracks is advised for 12 months and if they become worse, further investigation by a suitably qualified professional is advised.

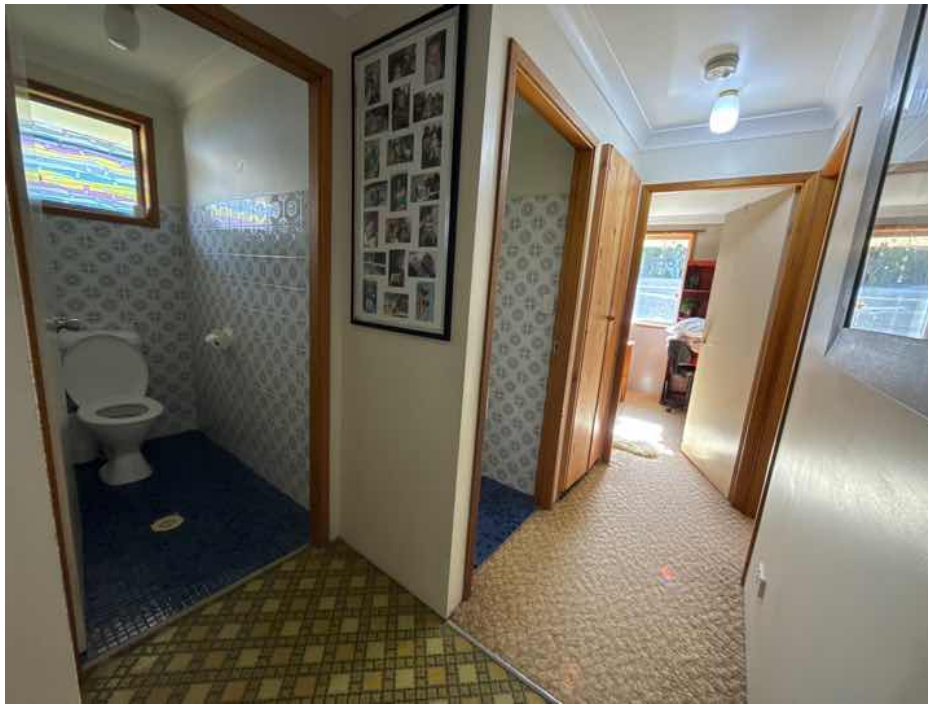
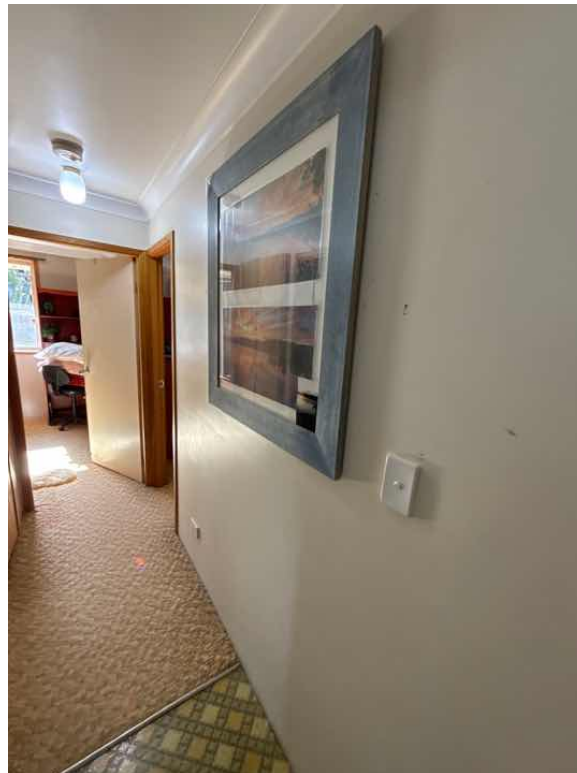
Walls

Settlement Cracks Noted. These are typical and generally patch and paint will suffice, however we recommend you monitor these cracks and if they become wider or longer, you will need to contact a structural engineers to assess.

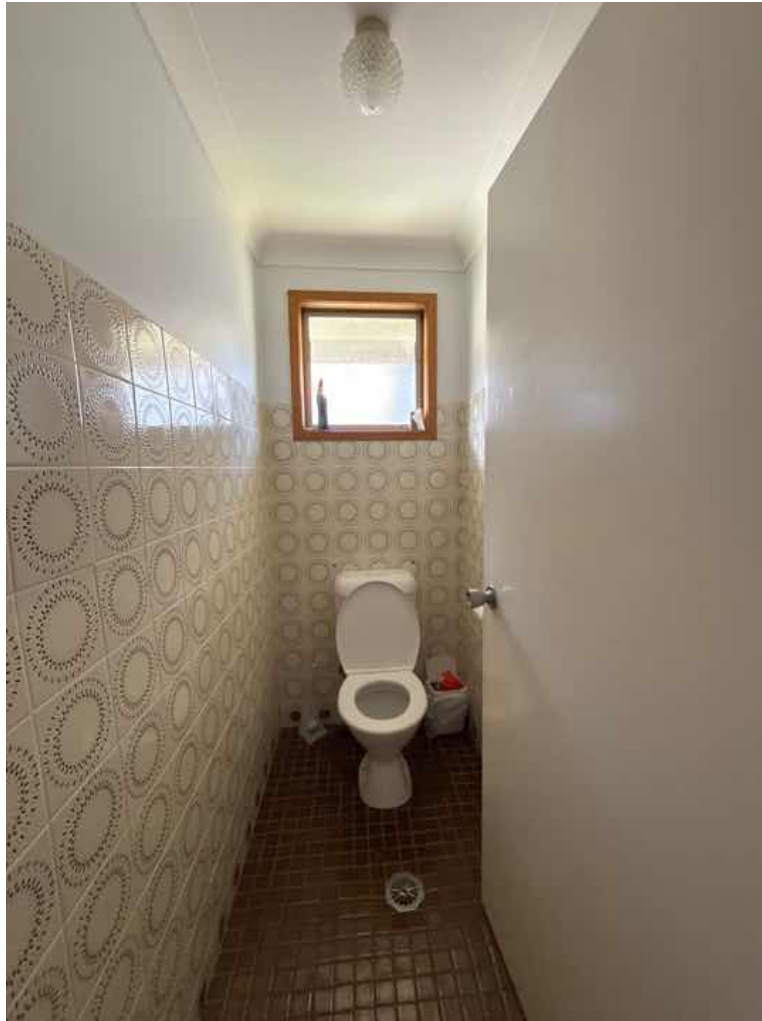
Ventilation

Of the visible areas, the general condition of this bathroom is serviceable or in reasonable condition for age of dwelling.

No exhaust fan is installed - Recommend having one installed.

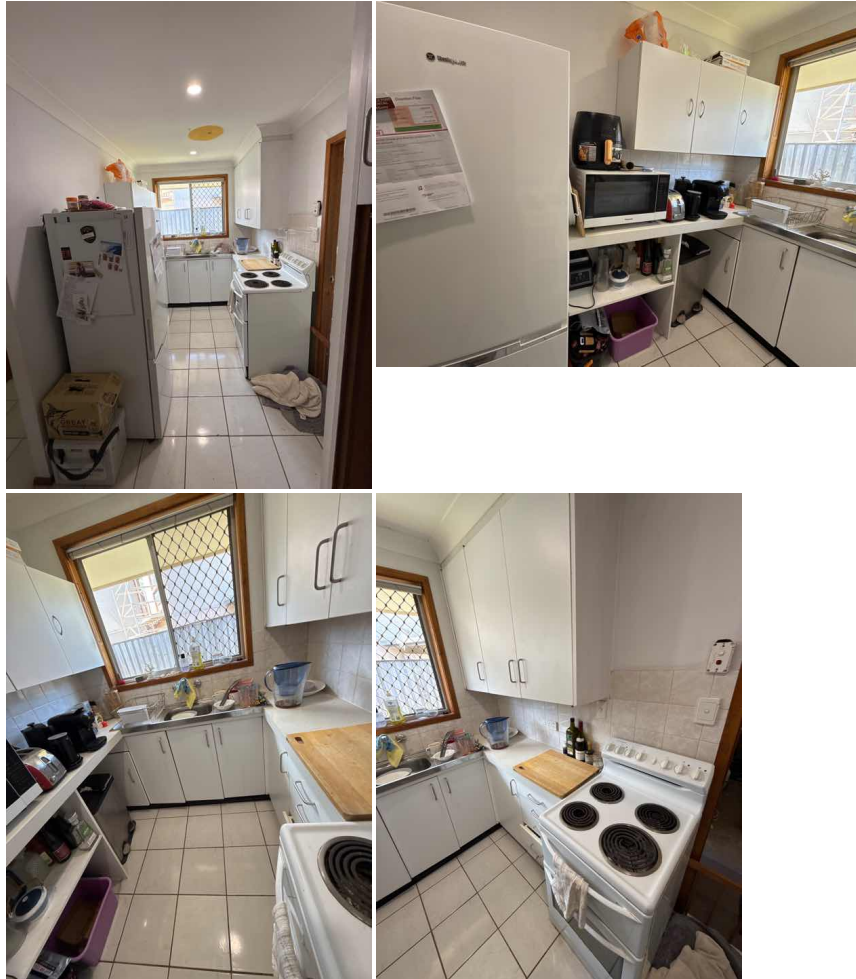
Ceiling

Of the visible areas, the general condition of the kitchen is serviceable or in reasonable condition for age of dwelling.

Minor cornice cracks - Minor cornice cracks visible. Recommendations: I recommend you contact a licensed plasterer for further advice and recommendations.
