# Building and Pest Report

31 Castle Drive  
Lennox Head

### Pest And Building Inspection

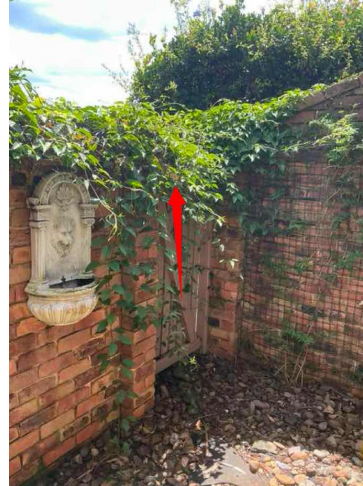
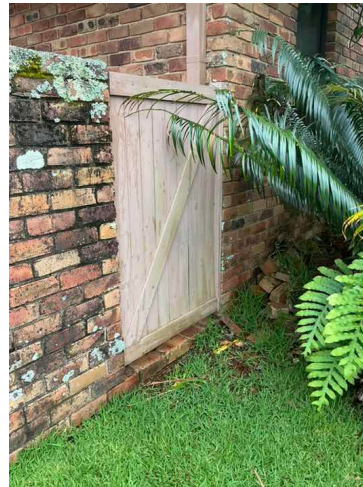
On inspection, defects were present that will require further accessing and recommendations by licensed and qualified trades persons. rear courtyard gate in accessible due to foliage

The gate does not latch. Have repaired by a qualified fencer.

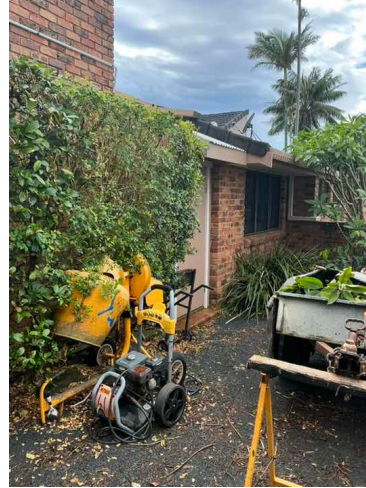
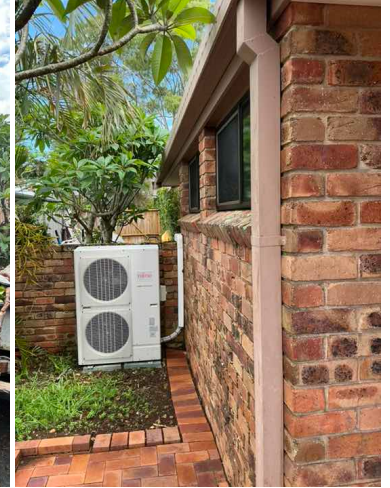
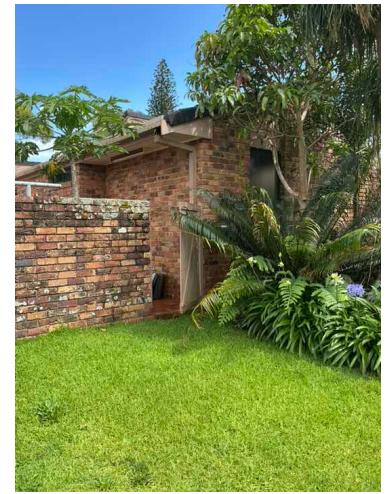
Trees are overhanging roof areas. These should be cut back away from the roof line and gutters.

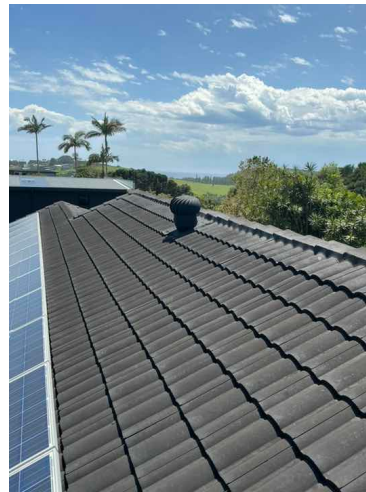
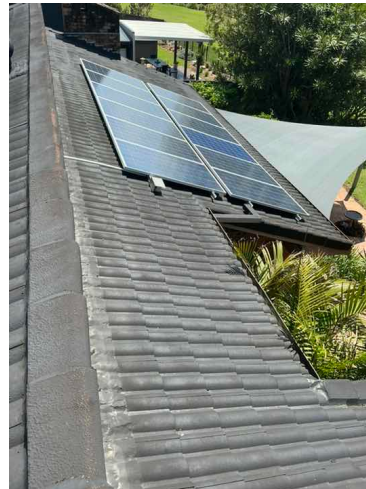
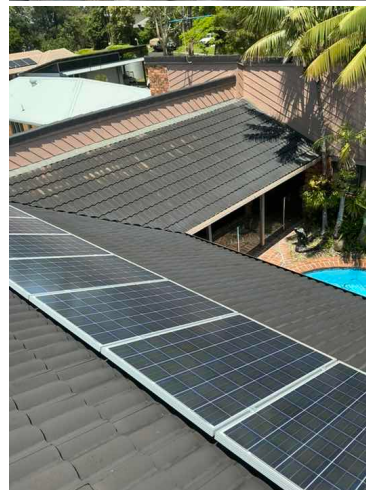
On inspection, defects were noted that may require further assessment and recommendations by licensed roofer.  
Rust located in some stretches of gutter and will require replacing

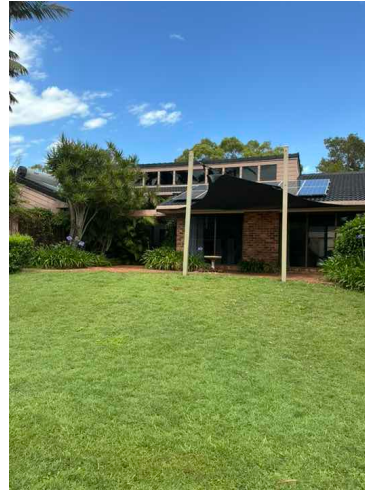
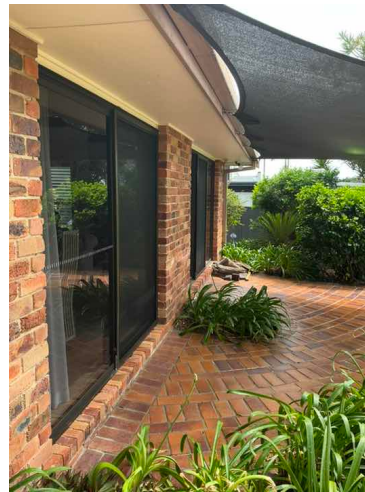
Visible sections of the Alfresco area are serviceable or in reasonable or condition for the age of this dwelling.  
Shade sail torn and requires replacing

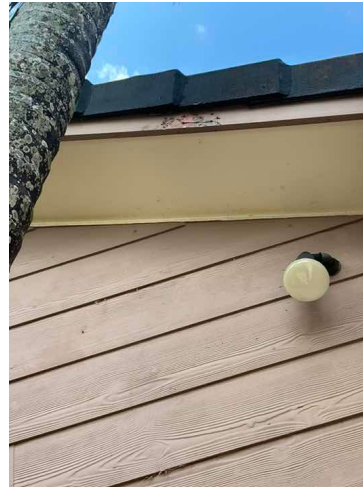
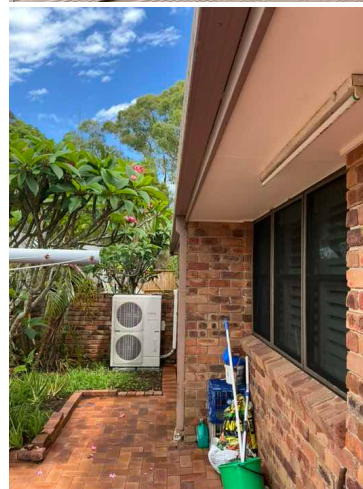
#11. Minor eave deterioration & ageing evident. Recommendations: Maintenance works, general upkeep should be carried out. Upon visual inspection, there is a noticeable gap and misalignment in the fascia and soffit area. Recommend sealing gaps and securing loose components to prevent water ingress. Engage a licensed carpenter to assess and repair structural integrity, ensuring proper alignment and weatherproofing.

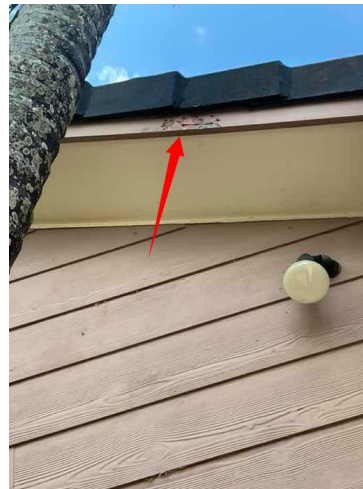
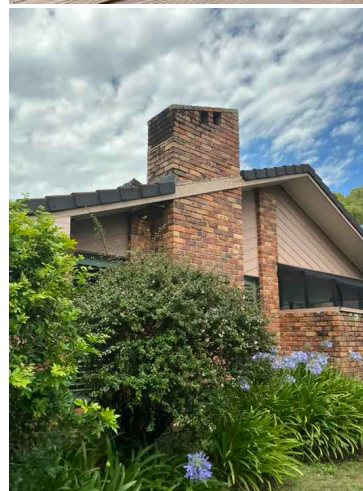
#12. Minor deterioration & ageing evident.  
 Recommendations: Maintenance works, general upkeep should be carried out.  
 Upon visual inspection, there is visible damage to the fascia board, likely due to weather exposure. Recommend a licensed carpenter replace the damaged section and apply a weather-resistant sealant to prevent future deterioration. Additionally, ensure the roof flashing is intact to avoid water ingress.  
 Upon visual inspection, the flashing around the chimney appears to be improperly sealed, which may lead to water ingress. Recommend sealing gaps with appropriate weatherproof sealant. Additionally, the roof tiles show signs of wear and may require replacement to prevent leaks. Consult a licensed roofer for repairs and further assessment.

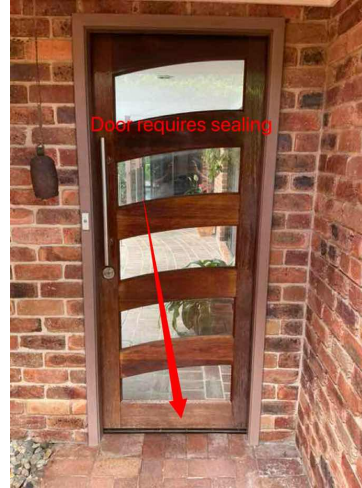
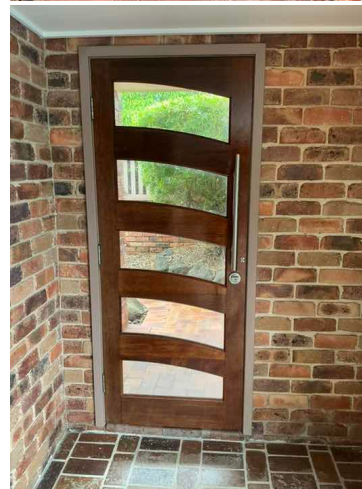
Upon visual inspection, the door appears well-fitted with no visible signs of damage or misalignment. The brickwork surrounding the door is intact, with no noticeable cracks or deterioration. It is recommended to ensure regular maintenance of the door's seal and hardware to prevent future issues. Consult a licensed tradesperson for any adjustments or repairs as needed. Door will require resealing for longevity

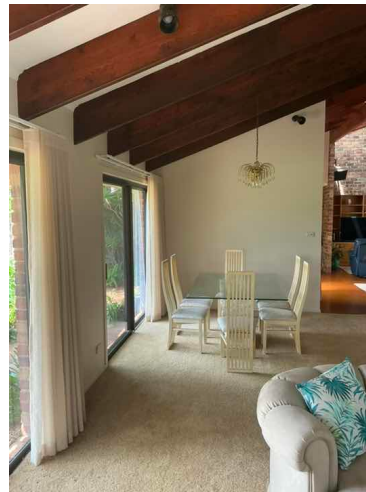
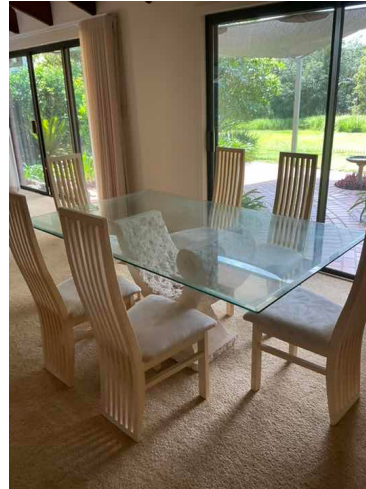
Upon visual inspection, the carpet edges appear frayed, indicating wear. Recommend engaging a licensed carpet installer to trim and secure the edges to prevent further damage. Additionally, ensure the window seals are intact to avoid moisture ingress, which could exacerbate carpet deterioration. Upon visual inspection, there is a visible crack in the ceiling. It is recommended to have a licensed tradesperson assess and repair the crack to prevent further damage. Ensure the structural integrity of the ceiling is maintained by addressing any underlying issues. Mould appears to be present in the ceiling sheets

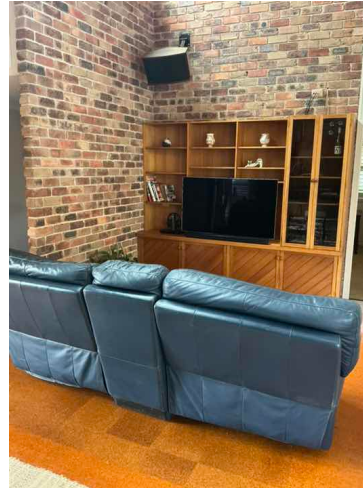
On inspection, defects were present that will require further assessing and recommendations by a qualified trades persons, please read below for details. All windows appear to be leaking during rainfall. Will require attention. Replacement windows are located at the property for installation.

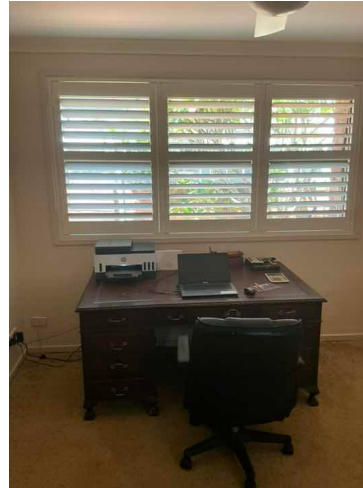
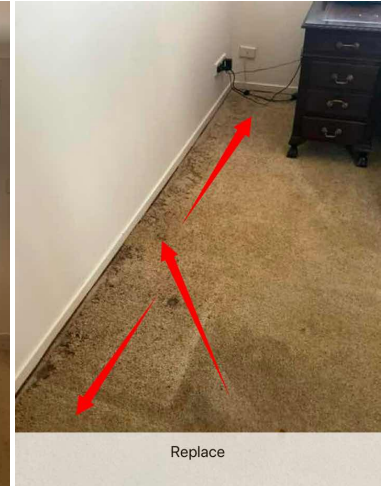
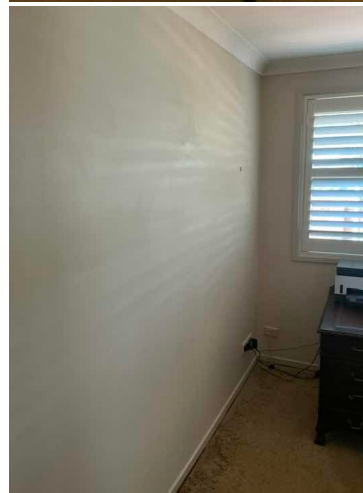
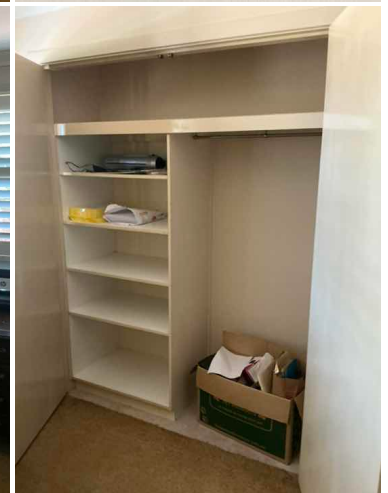
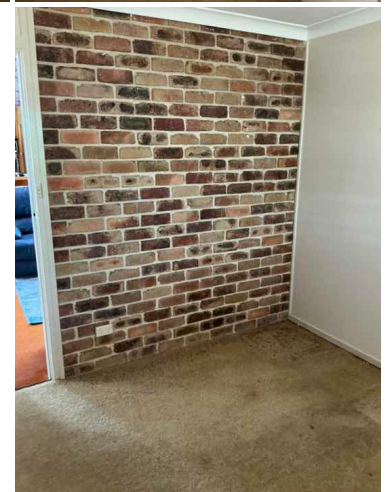
#22. General ageing and/or denting and the like is evident on ceiling linings - Recommendations: A qualified painter should be engaged to assess and repair as required.

#23. General ageing and/or denting and the like is evident on wall linings - Recommendations: A qualified painter should be engaged to assess and repair as required.

General carpet deterioration. Replacement may be required A qualified carpet layer should be engaged.

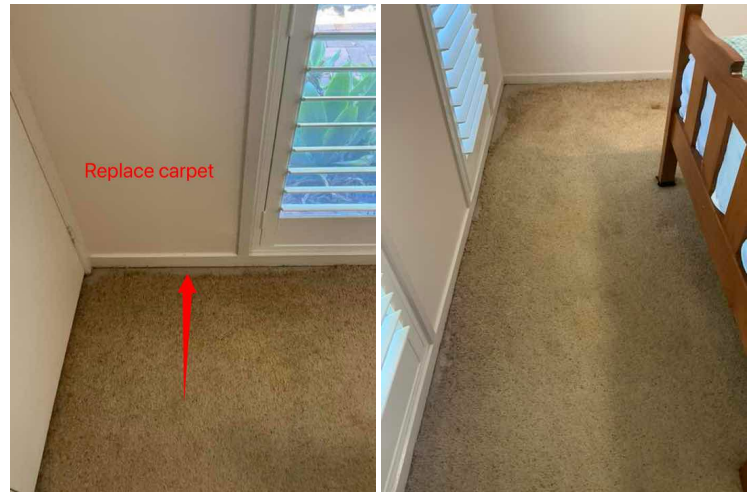
#25. General ageing and/or denting and the like is evident on wall linings - Recommendations: A qualified painter should be engaged to assess and repair as required.

General carpet deterioration. Replacement may be required A qualified carpet layer should be engaged.

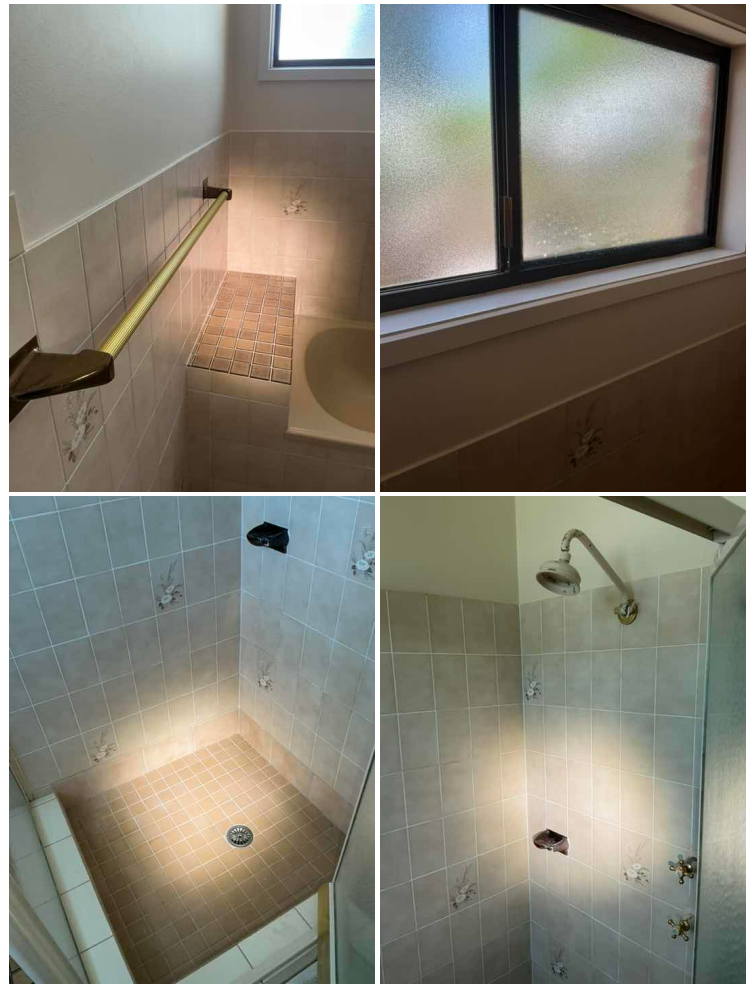
Upon visual inspection, there is evidence of moisture damage on the window sill, indicated by peeling paint. It is recommended to have a licensed painter repair the paintwork and a plumber check for any leaks or condensation issues. Ensure proper sealing around the window to prevent future moisture ingress.

#26. General ageing and/or denting and/or wear and/or previous wall patching and the like is evident on wall linings - Recommendations: A qualified painter should be engaged to assess and repair as required.

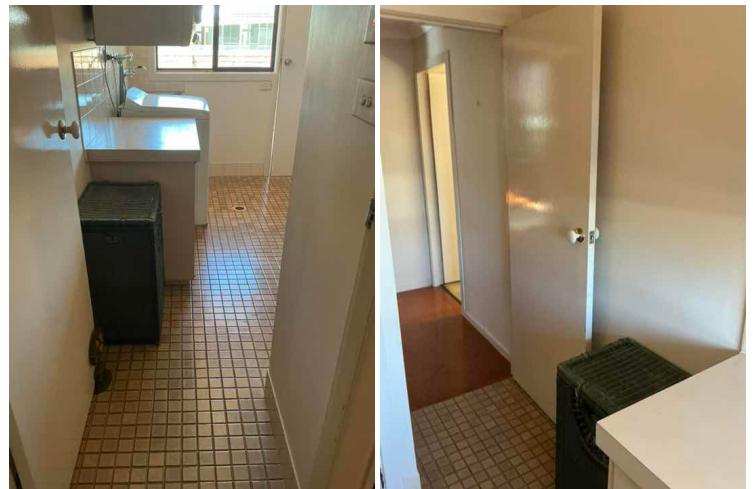
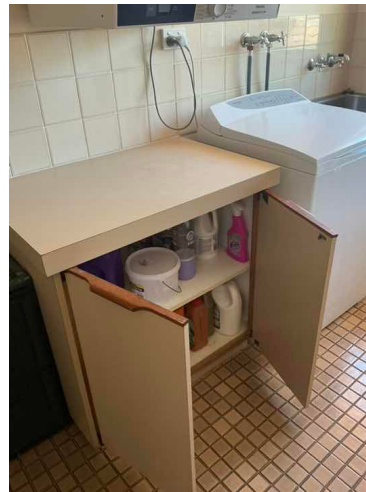
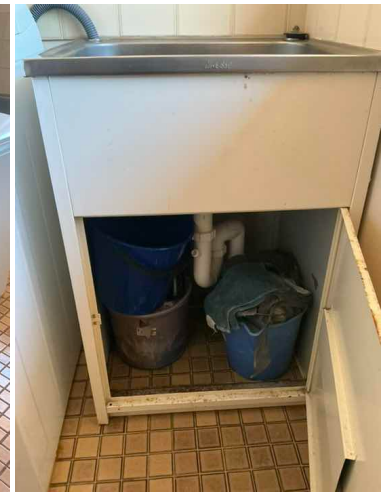
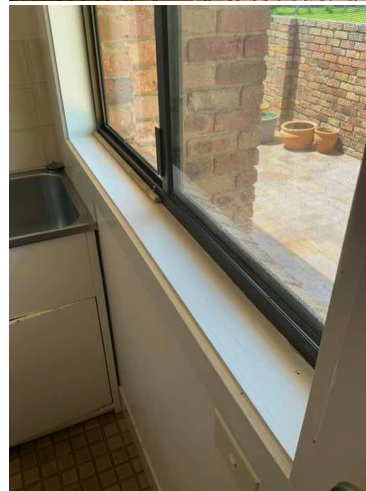
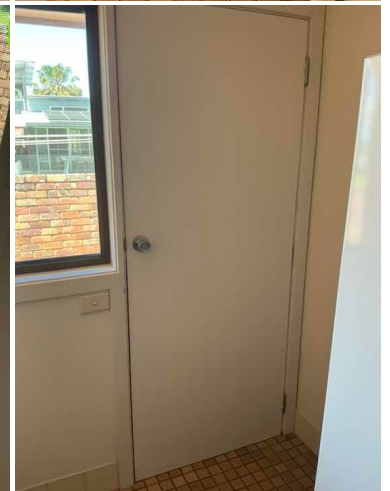
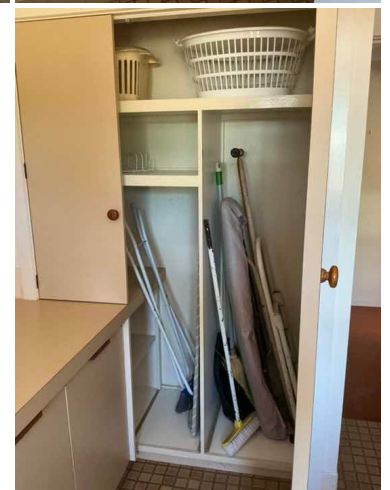
Of the visible areas, the general condition of the laundry is serviceable or in reasonable condition for age of dwelling.

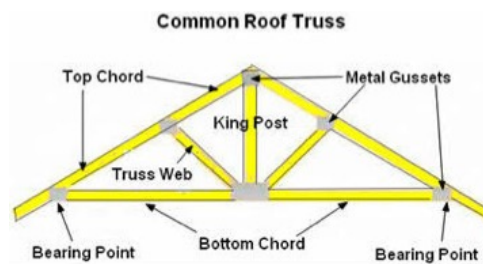
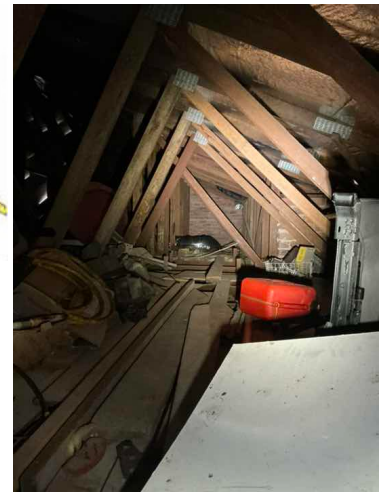
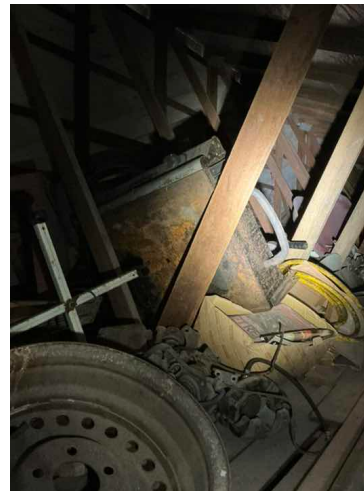
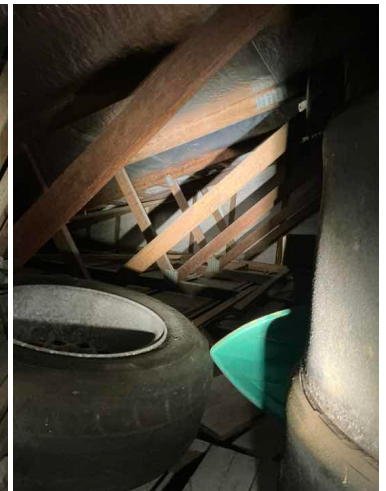
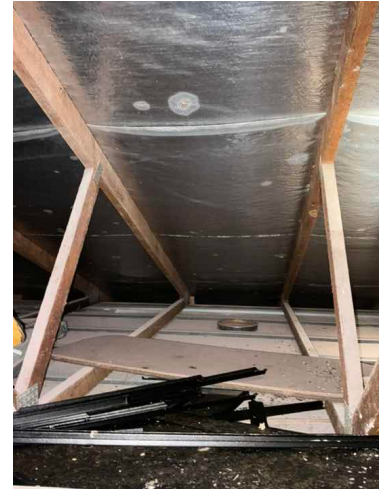
The roof frame is a truss timber frame.

Visible sections of the roof void is in a serviceable condition for age of this dwelling.

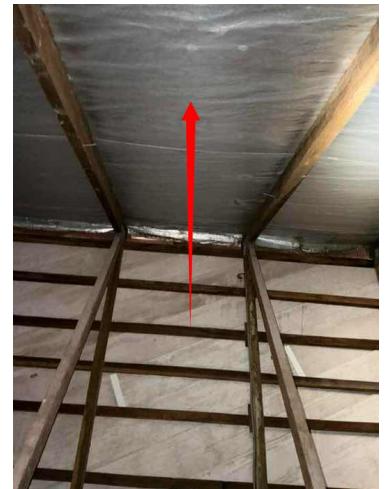
Where visible and accessible, the insulation appears to be in a serviceable condition.

Sarking is installed.
