# Building and Pest Report

## 1 Albatross Street, Ballina

### Pest And Building Inspection

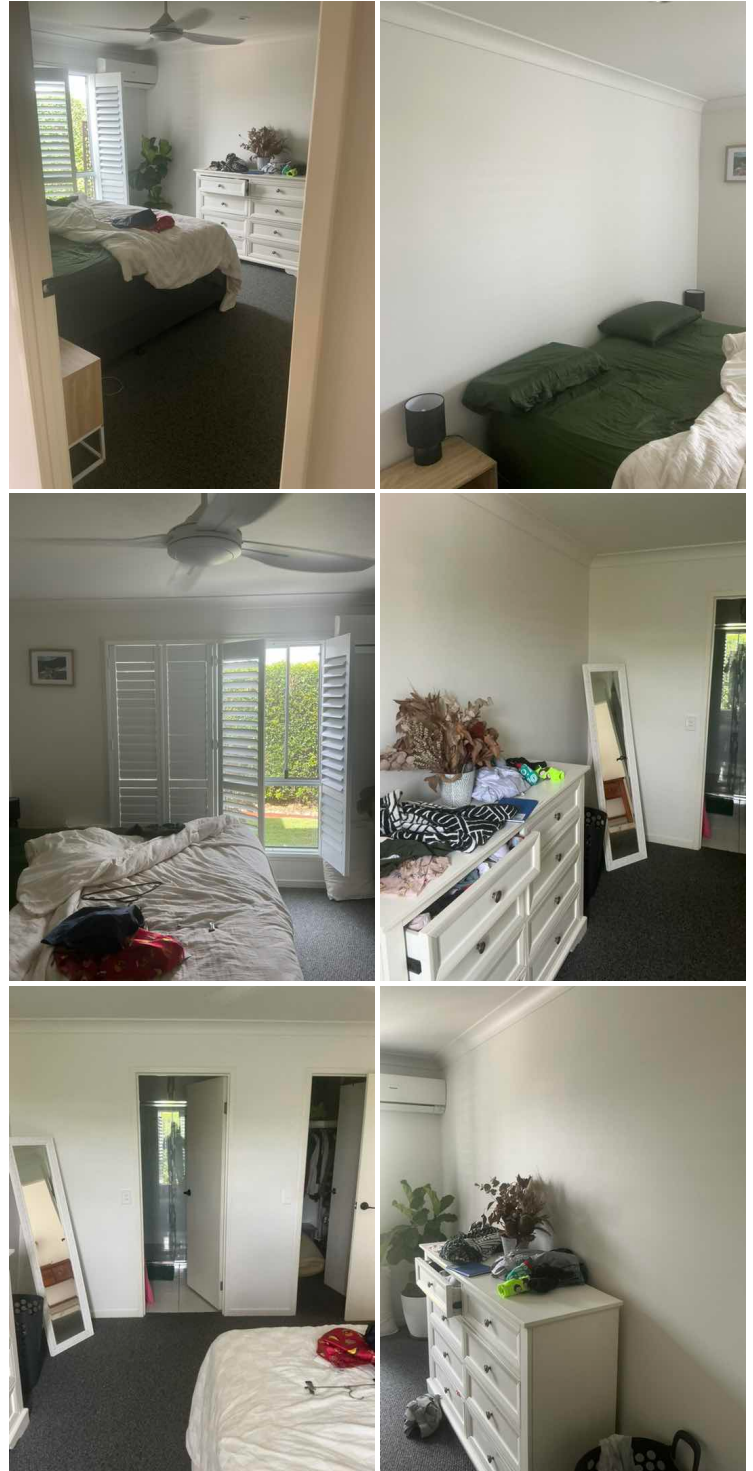
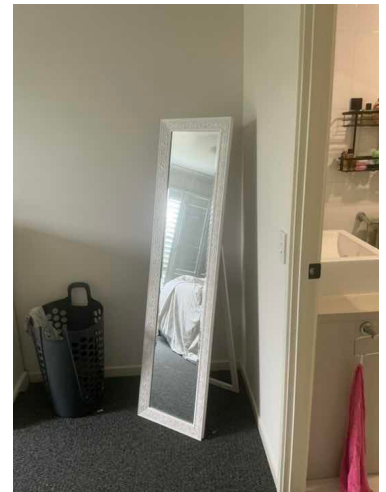
From the visible and accessible areas, this bedroom appears to be in a serviceable condition for the age of the property with no notable structural defects sighted.

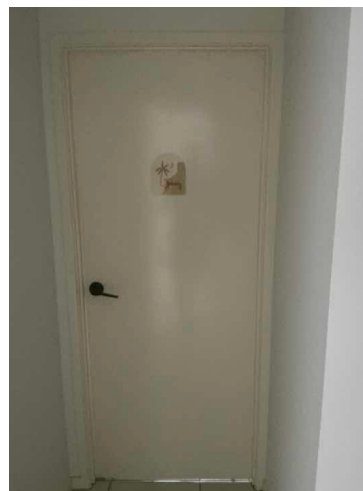
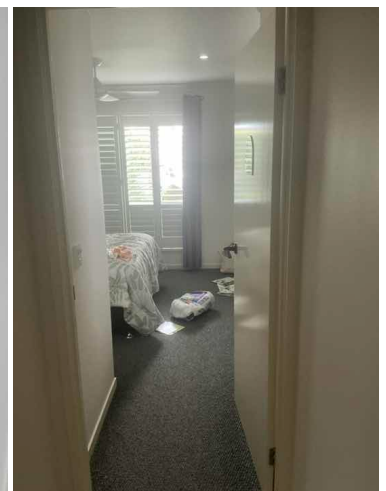
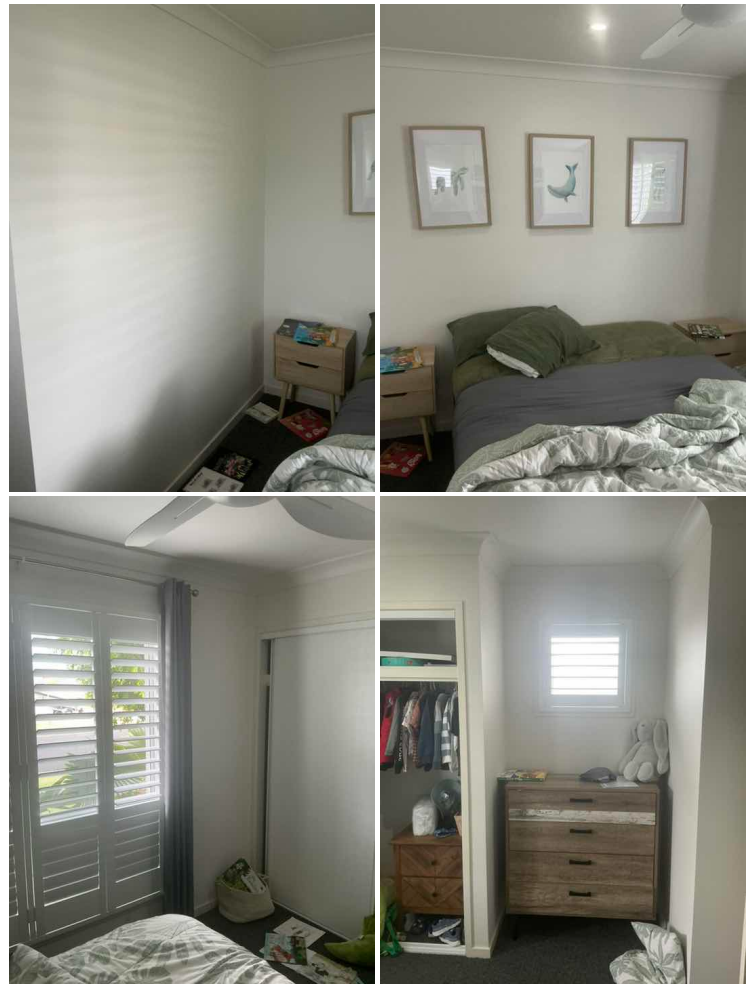
From the visible and accessible areas, this bedroom appears to be in a serviceable condition for the age of the property with no notable structural defects sighted.

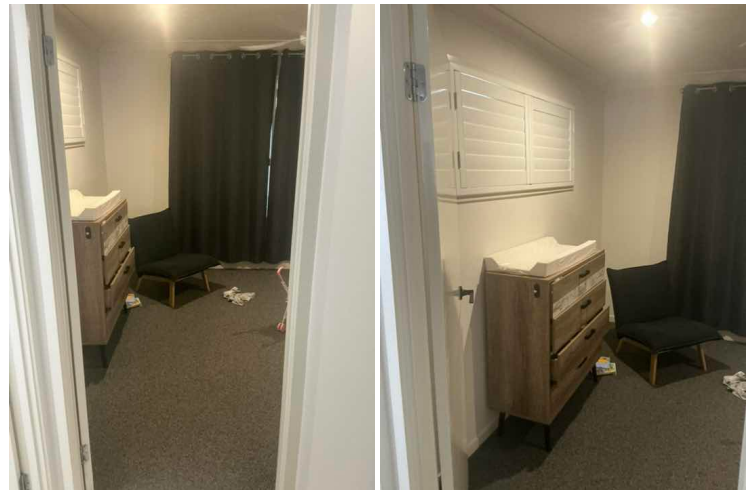
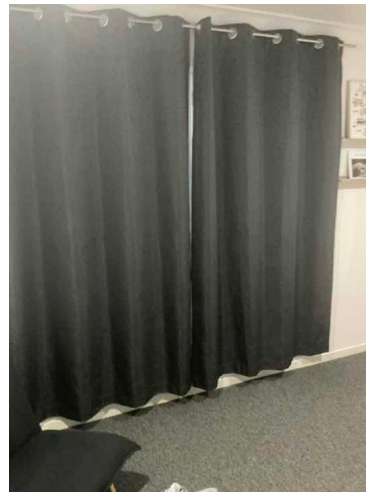
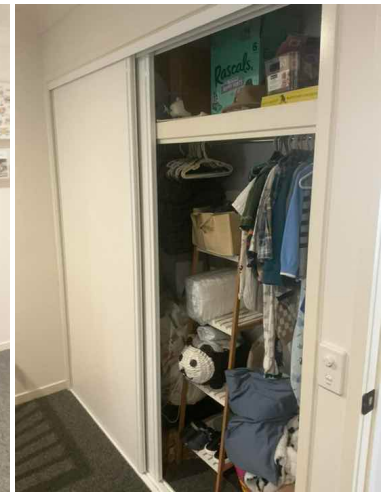
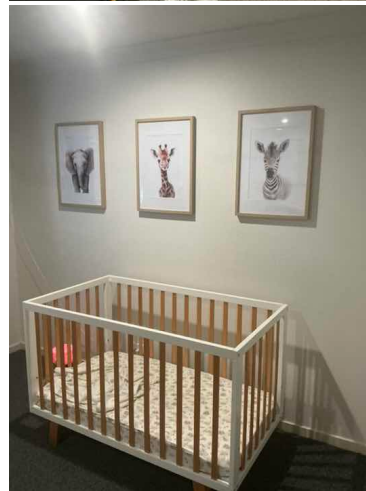
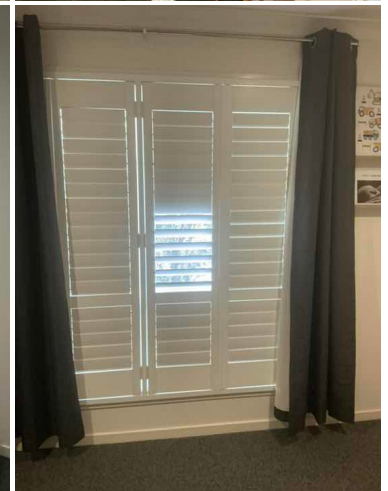
## **Bedroom 4**

From the visible and accessible areas, this bedroom appears to be in a serviceable condition for the age of the property with no notable structural defects sighted.

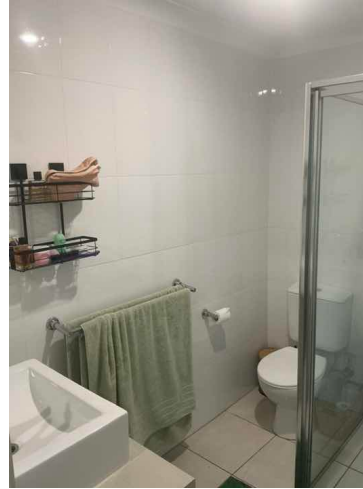
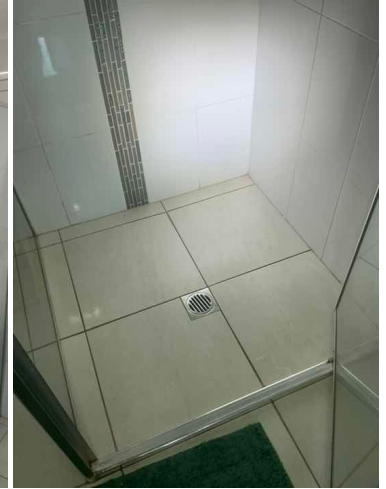
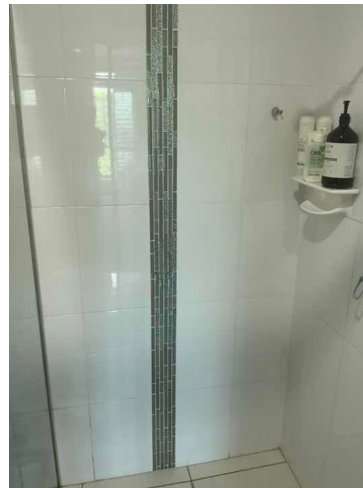
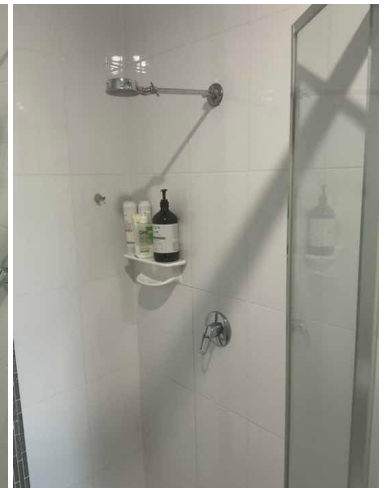
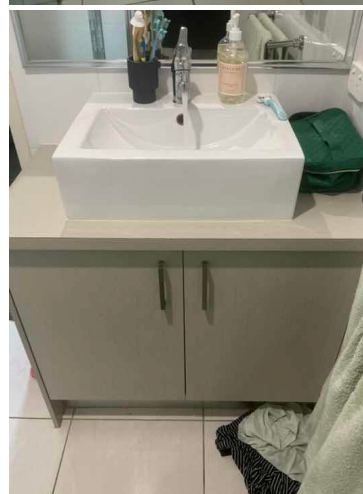
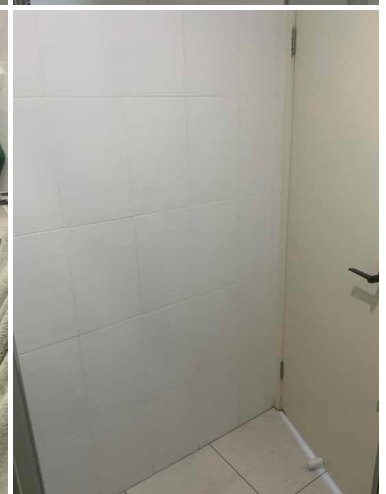
Of the visible areas, the general condition of this bathroom is serviceable or in reasonable condition for age of dwelling.

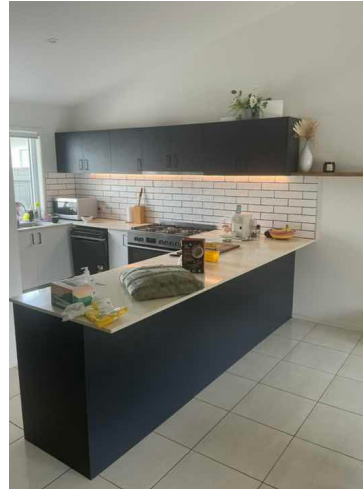
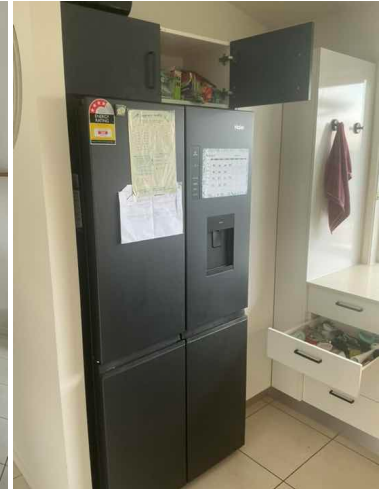
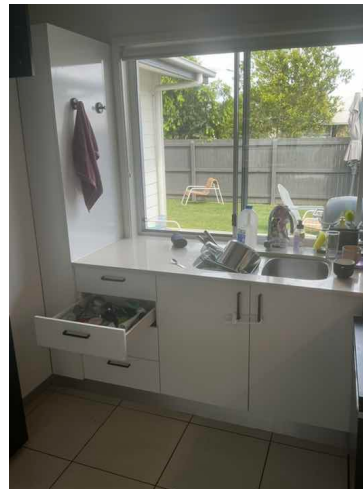
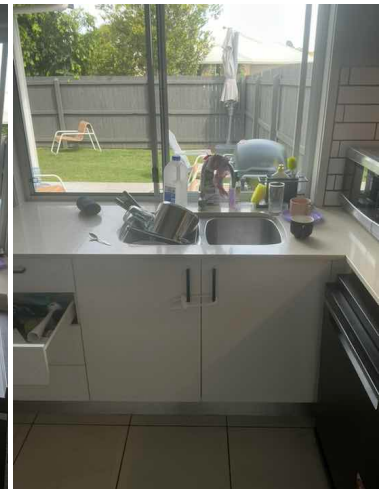
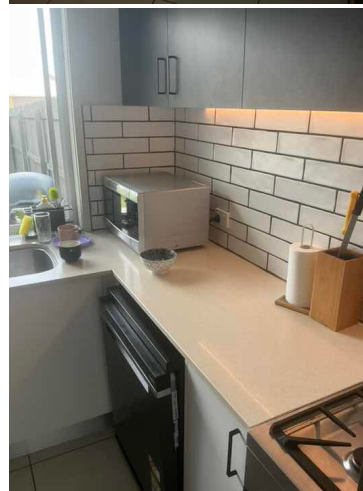
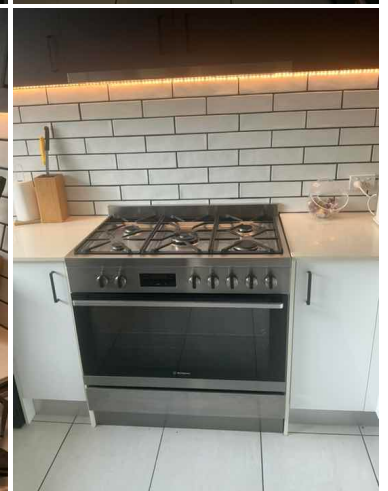
Of the visible areas, the general condition of the kitchen and pantry is serviceable or in reasonable condition for age of dwelling.

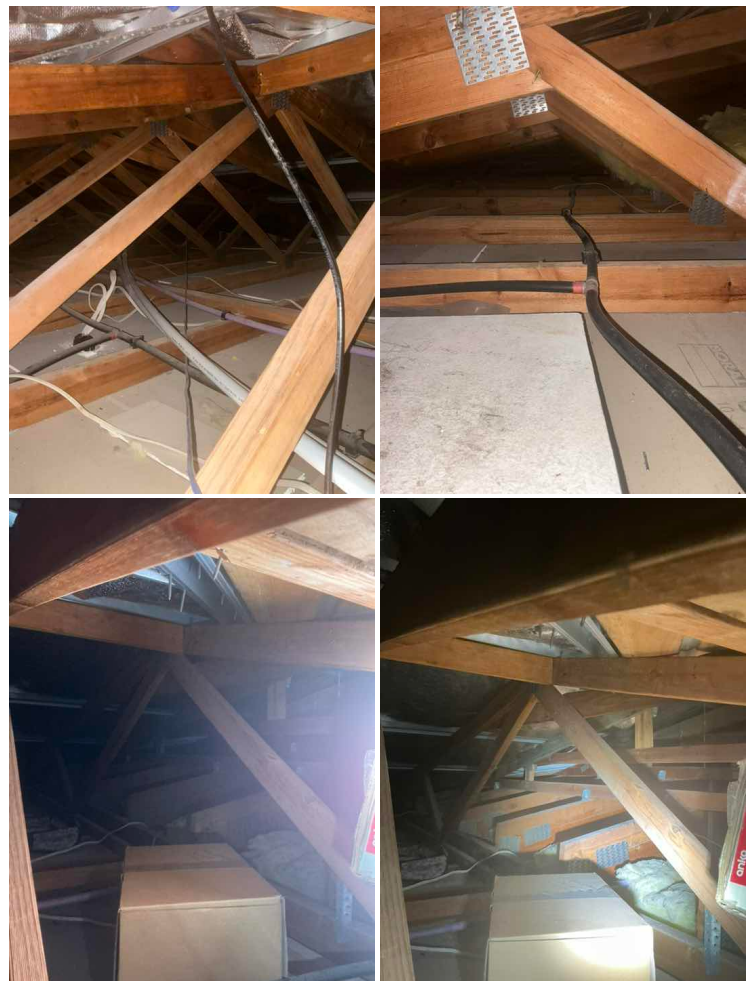
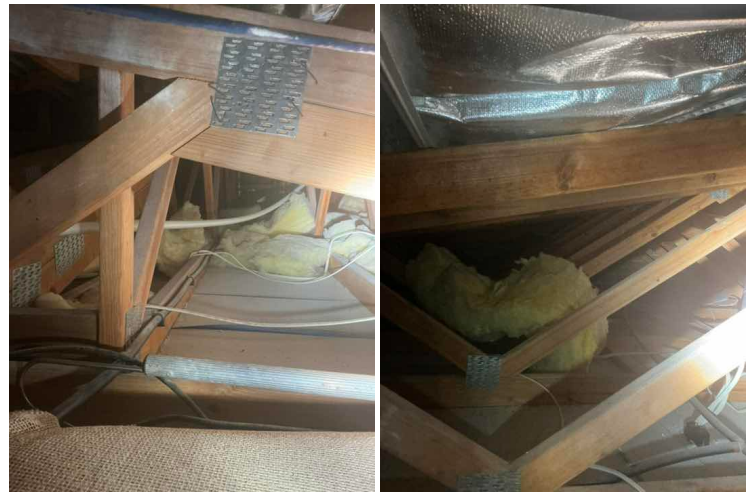
Visible sections of the roof void is in a serviceable condition for age of this dwelling.
