PEST AND BUILDING PRE-PURCHASE REPORTS

2/40 Sunray Cres
Lennox Head

BPI - INSPECTION REPORT	3
PROPERTY DESCRIPTION	4
BPI - INSPECTION AGREEMENT	5
*BPI BUILDING REPORT - EXECUTIVE SUMMARY	6
TERMS AND CONDITIONS (Building Report)	7
INTERIOR (Building Report)	9
ROOF VOID (Building Report)	17
EXTERIOR (Building Report)	18
ROOF EXTERIOR (Building Report)	20
THE SITE (Building Report)	22
CONCLUSION (Building Report)	24
* BPI TIMBER PEST REPORT - EXECUTIVE SUMMARY	25
TERMS & CONDITIONS (Timber Pest Report)	26
INTERIOR (Timber Pest Report)	29
ROOF VOID (Timber Pest Report)	30
GARAGING (Timber Pest Report)	31
EXTERNAL (Timber Pest Report)	31
FENCES (Timber Pest Report)	31
EVIDENCE OF BARRIERS and RECOMMENDATIONS (Timber Pest Report)	32
OVERALL RISK ASSESSMENT (Timber Pest Report)	33
GENERAL REMARKS & TIMBER PEST INFORMATION	33
BUILDING & TIMBER PEST REPORT - Signed for and on behalf of:	33
APPENDICES	34

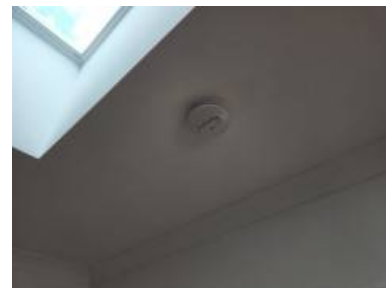
Present - Hall, Rumpus Room.

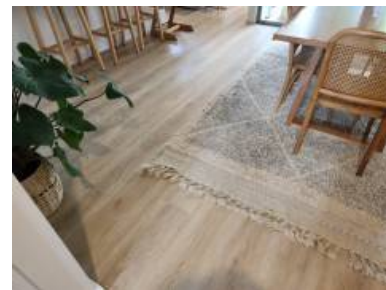
The concrete slabs were covered by flooring coverings and no inspection of the concrete surfaces could be carried out.

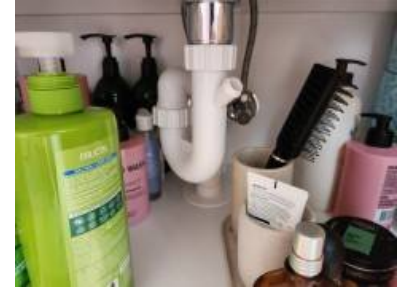
No leaks / moisture was detected at the time of the inspection.

Junctions of Bathroom bath / wall tile & hob tiles require resealing with silicone.

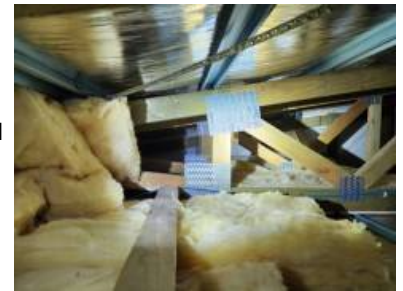
Inspection over the eaves was restricted due to the low pitch and construction allowing only a limited visual inspection from a distance of some areas to be carried out.

Clearance within sections of the roof was too low to allow body access. Outer top wall plates and framing timbers were not inspected due to the area being too low to allow body access. This allows only a limited visual inspection from a distance of some areas to be carried out.

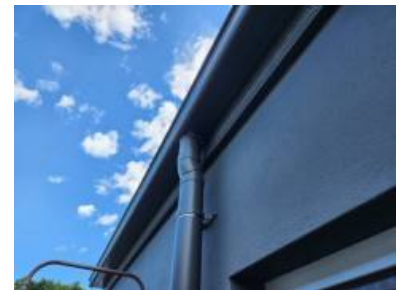
No inspection can be made of the concealed stormwater pipes. I recommend the gutters, downpipes & stormwater be further inspected by a qualified plumber to ensure that they are functional, clear of blockages / damage / cracks and are adequate for the situation.

Condition:
Satisfactory.

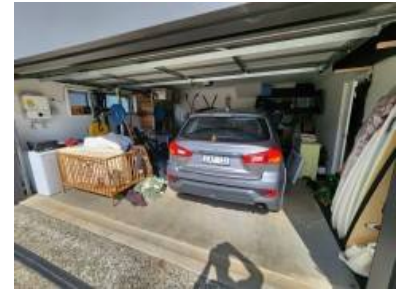
Some surface cracks to the concrete slab. These *types of minor cracks are common and generally occur when the slab surface cures.*

Minor damage to some walls need patching and painting.

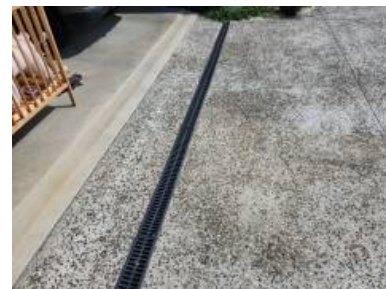
Whilst not a plumber it appears that at the time of the inspection, drainage seems generally adequate.

No inspection & comment can be made of concealed stormwater pipes and their functionality. I recommend the drainage systems / stormwater be further inspected by a qualified plumber to ensure that they are functional, clear of blockages / damage / cracks and are adequate for the situation.
