# Building and Pest Report

## 9 Cove Avenue Skennars Head

### Pest And Building Inspection

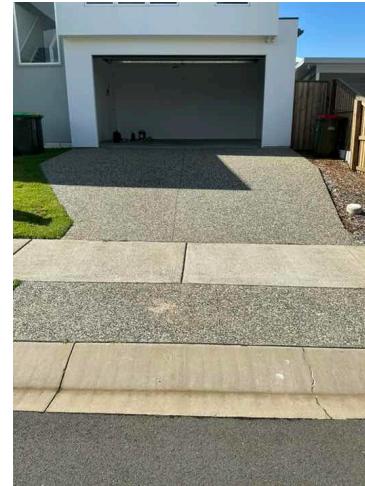
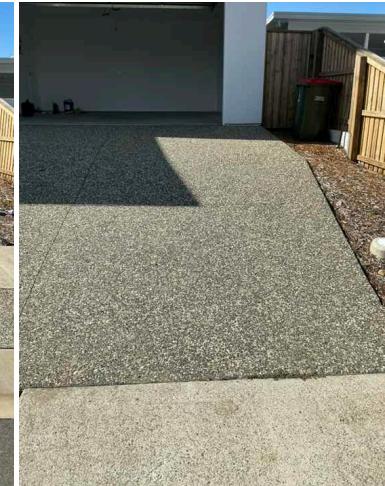
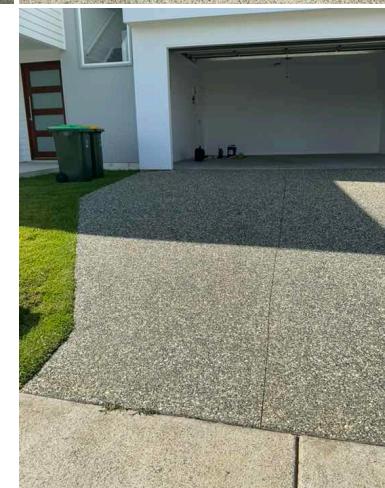
On visual inspection, the general condition of the driveway is serviceable.

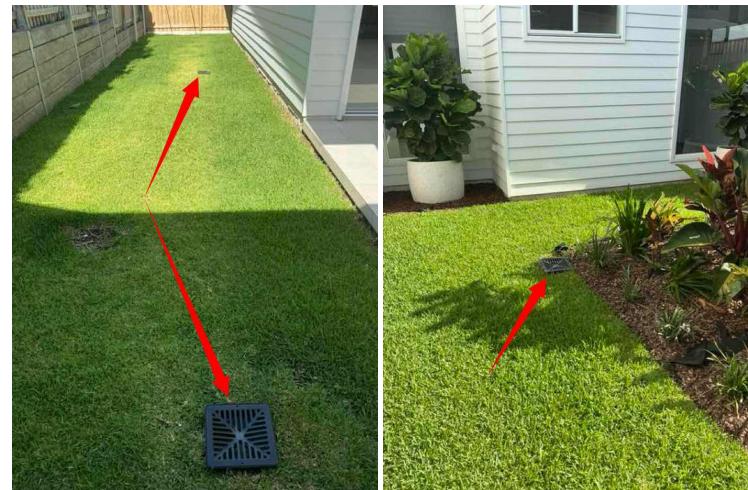
There was no visible evidence of excess ponding or fall towards the property walls at the time of the inspection. Regardless, it is difficult to ascertain in dry conditions and it is therefore recommended that you assess same after a rainfall period to be able to sufficiently ascertain if any problems exist in this regard. If water is ponding around perimeter walls and paths or appears to be flowing into the footings/foundations you must have assessed by a qualified plumber or landscaper.

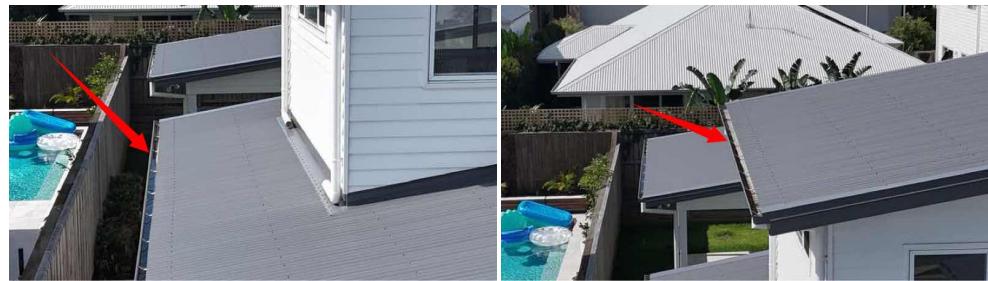
All visible and accessible of the physical nature of the guttering system appears to be in a serviceable condition with no apparent defects at the time of inspection. In the absence of prolonged rain fall efficiency of the guttering can not be assessed and you may find that further investigation or repairs maybe required. Note: Periodic maintenance checks should be carried out for rust penetrations and leaks.

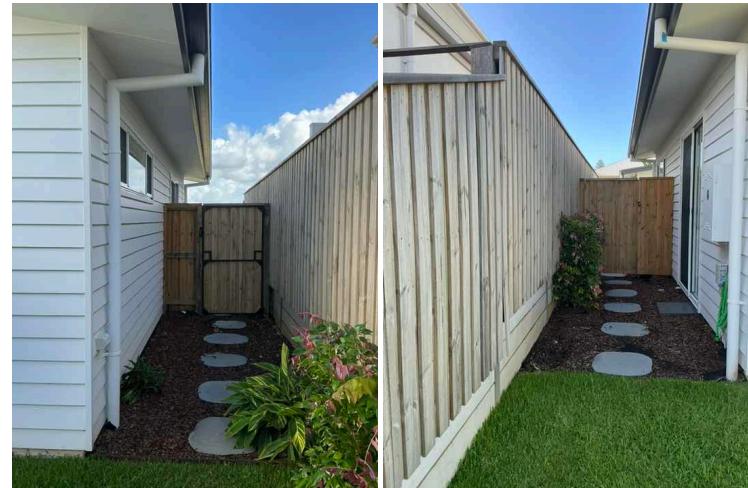
On visual inspection no apparent defects were noted to the down pipes and are considered serviceable, however no comment can be made with regard to blockages or connections to stormwater or functionality in the absence of rain. Note: Periodic maintenance checks should be carried out for rust penetrations and leaks.

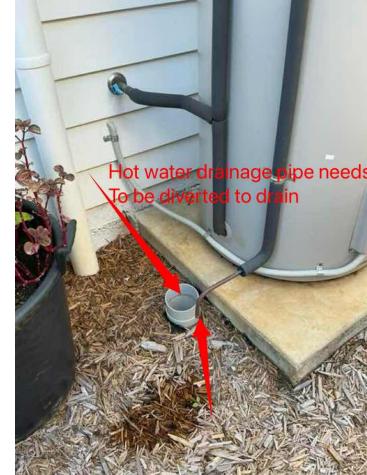
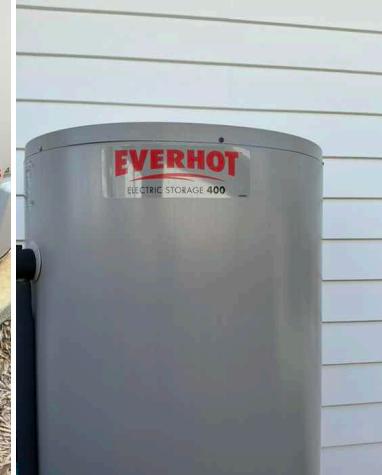
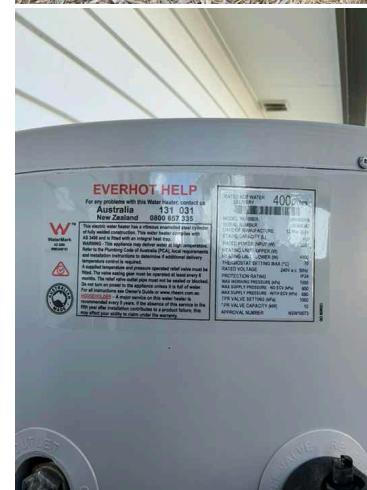
The hot water overflow requires diverting to a drain or further from the dwellings wall or footings. Excess water ponding alongside walls and into perimeter footings has the potential to cause rising damp, differential settlement and wall cracks over time. It is also conducive to termite infestation.

Recommendations: Engage a plumber to rectify.

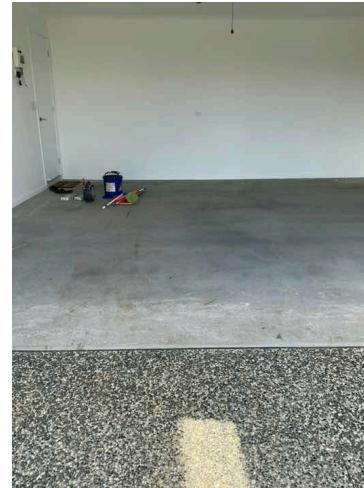
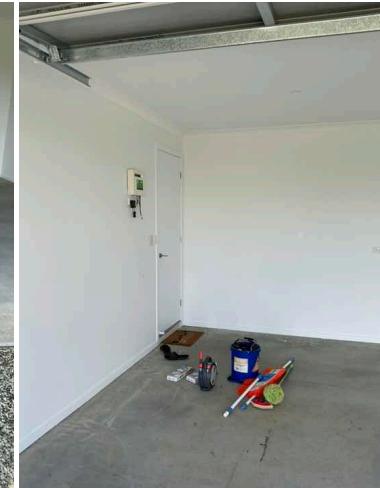
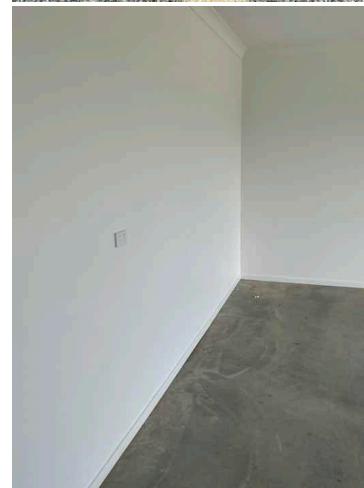
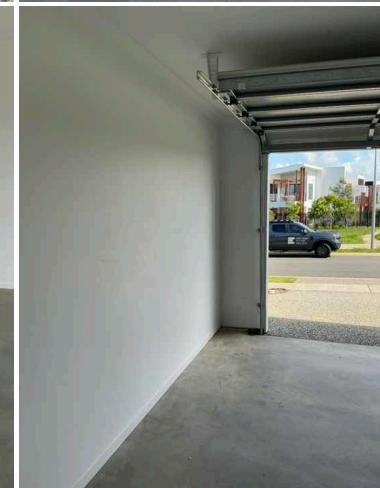
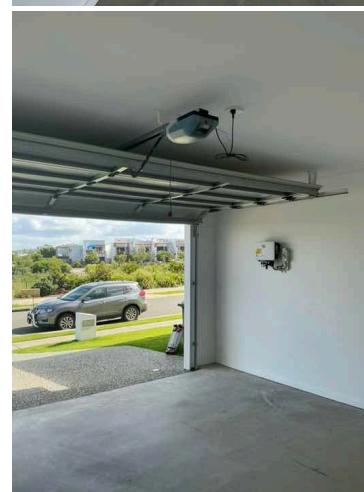
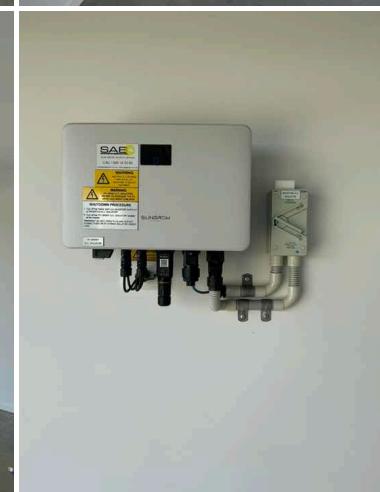
From the visible and accessible areas, the garage appears to be in a serviceable condition for the age of the property with no notable structural defects sighted.

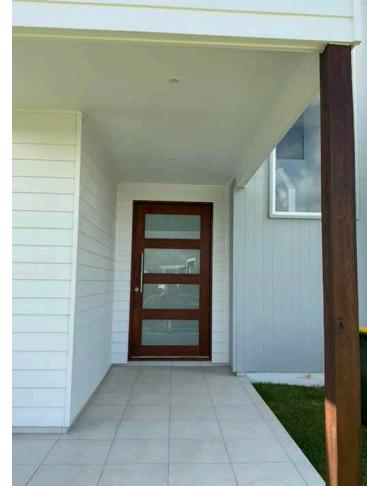
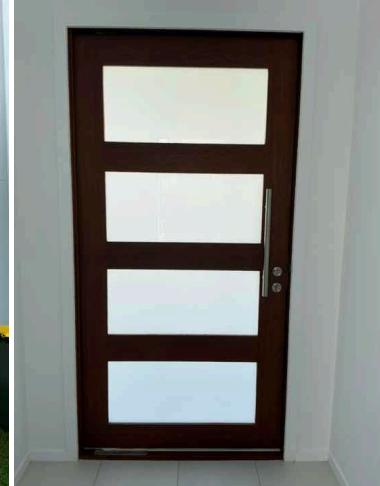
### **Front Entry Doors**

The doors are in serviceable condition with no notable defects observed.

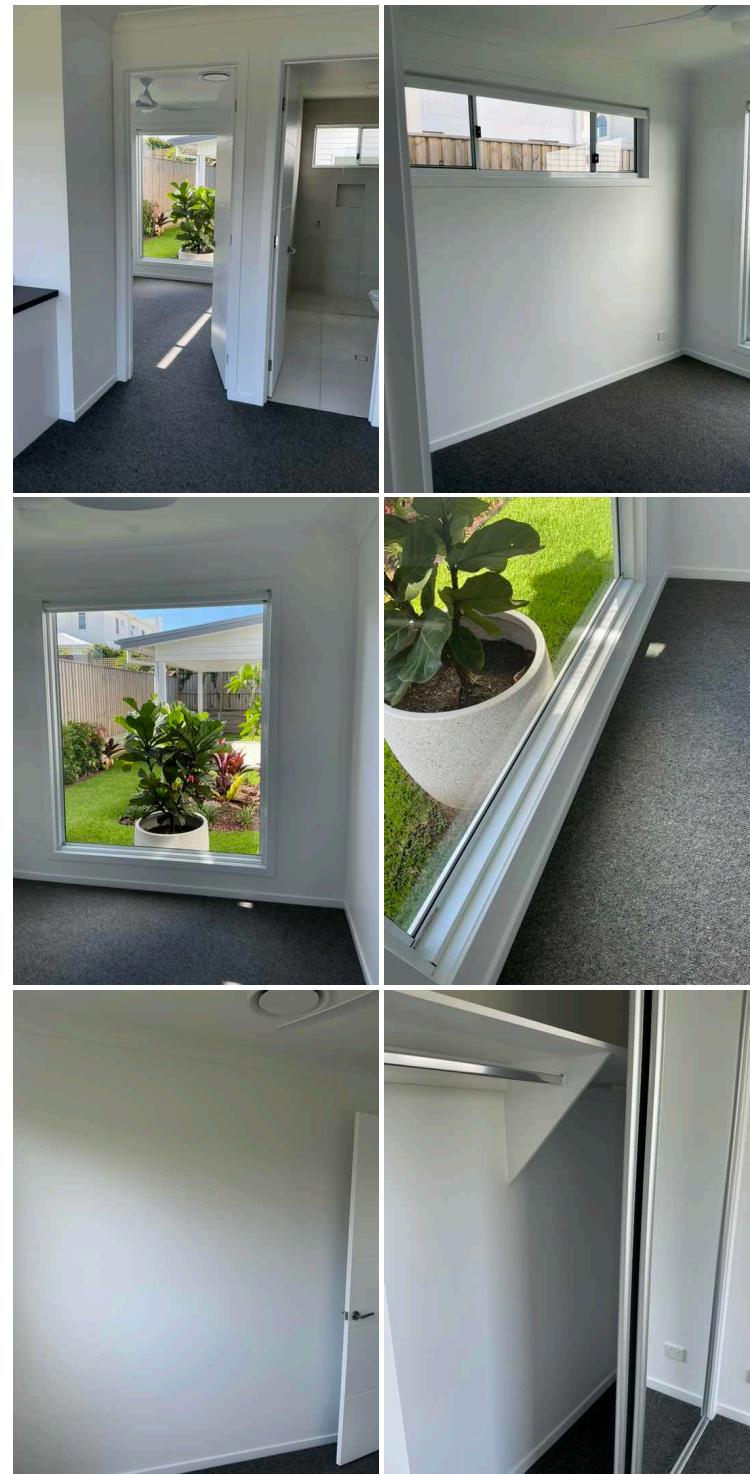
## **Bedroom 1**

From the visible and accessible areas, this bedroom appears to be in a serviceable condition for the age of the property with no notable structural defects sighted.

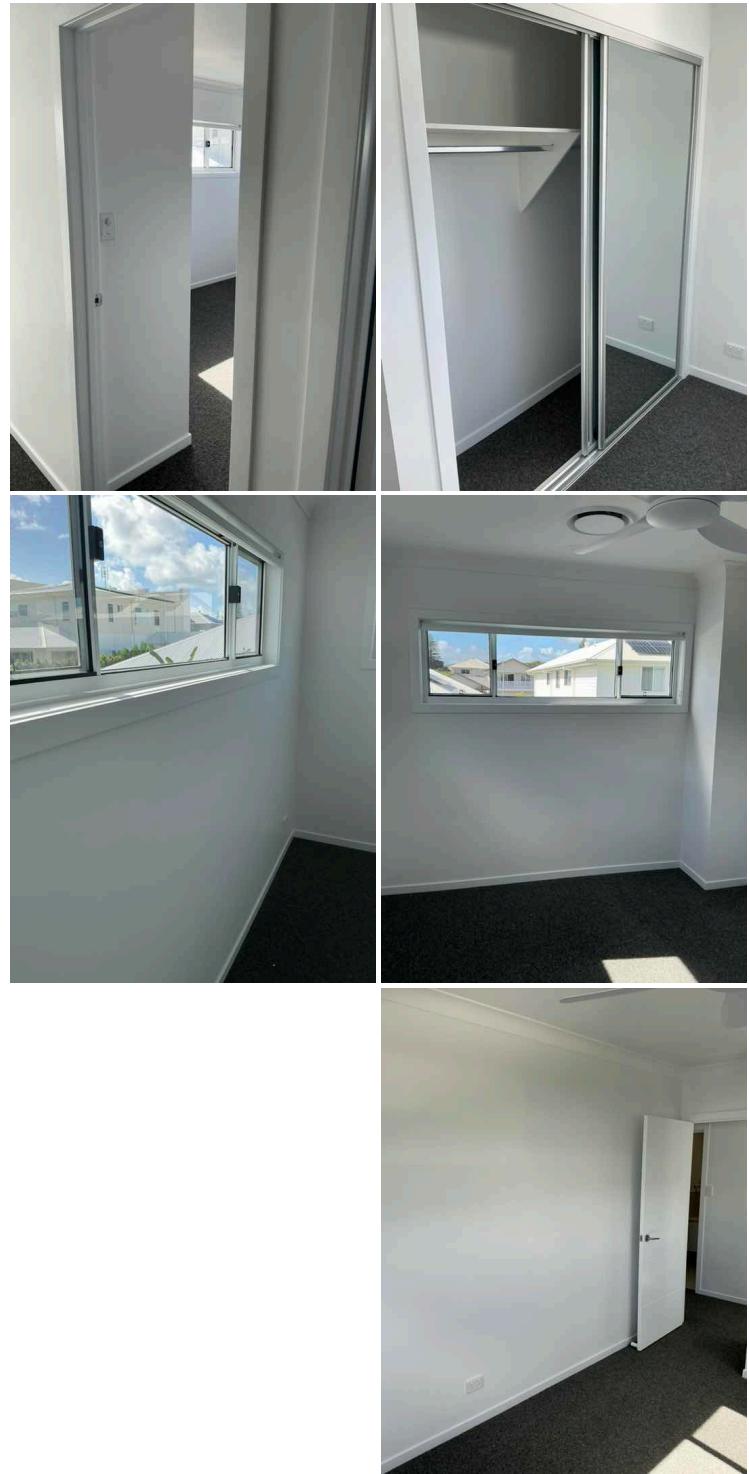
## **Bedroom 2**

From the visible and accessible areas, this bedroom appears to be in a serviceable condition for the age of the property with no notable structural defects sighted.

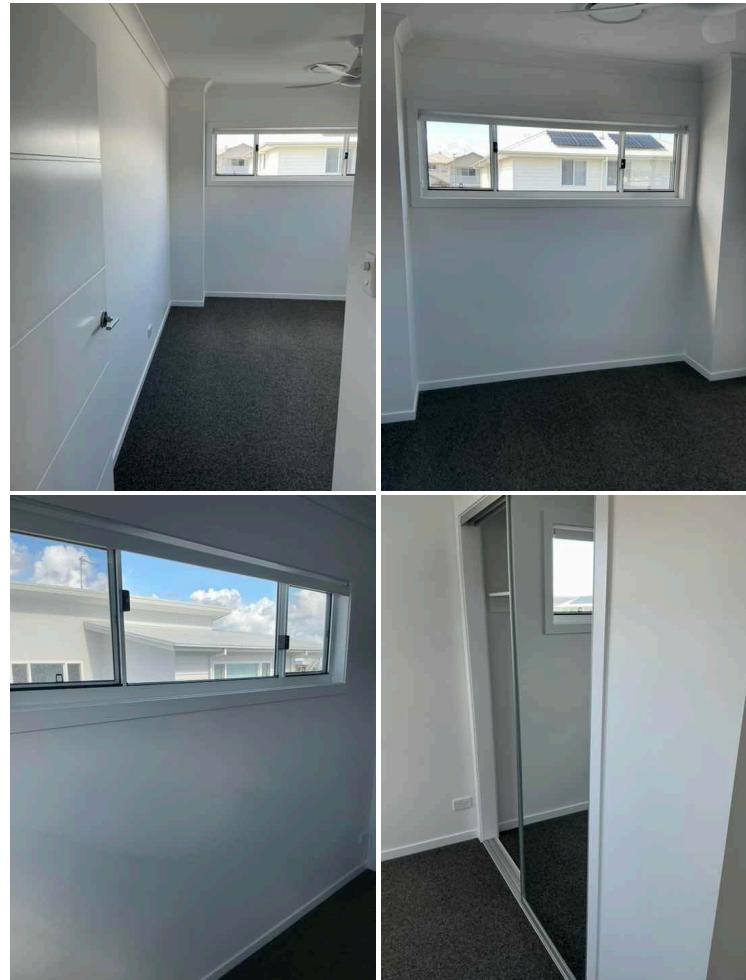
From the visible and accessible areas, this bedroom appears to be in a serviceable condition for the age of the property with no notable structural defects sighted.

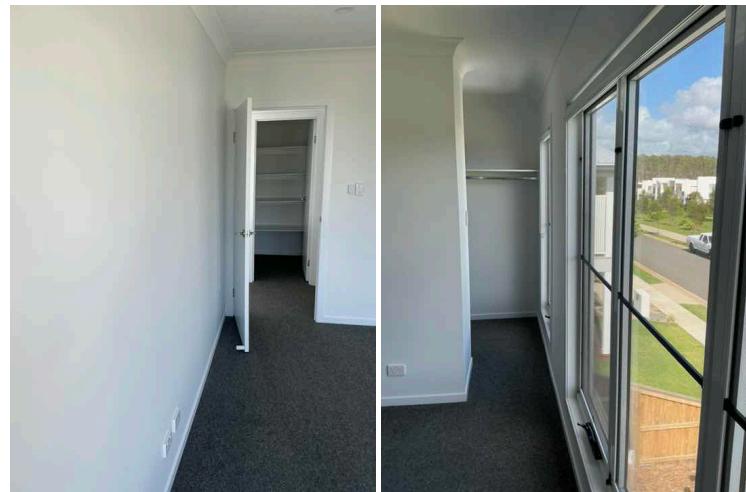
## **Bedroom 4**

From the visible and accessible areas, this bedroom appears to be in a serviceable condition for the age of the property with no notable structural defects sighted.

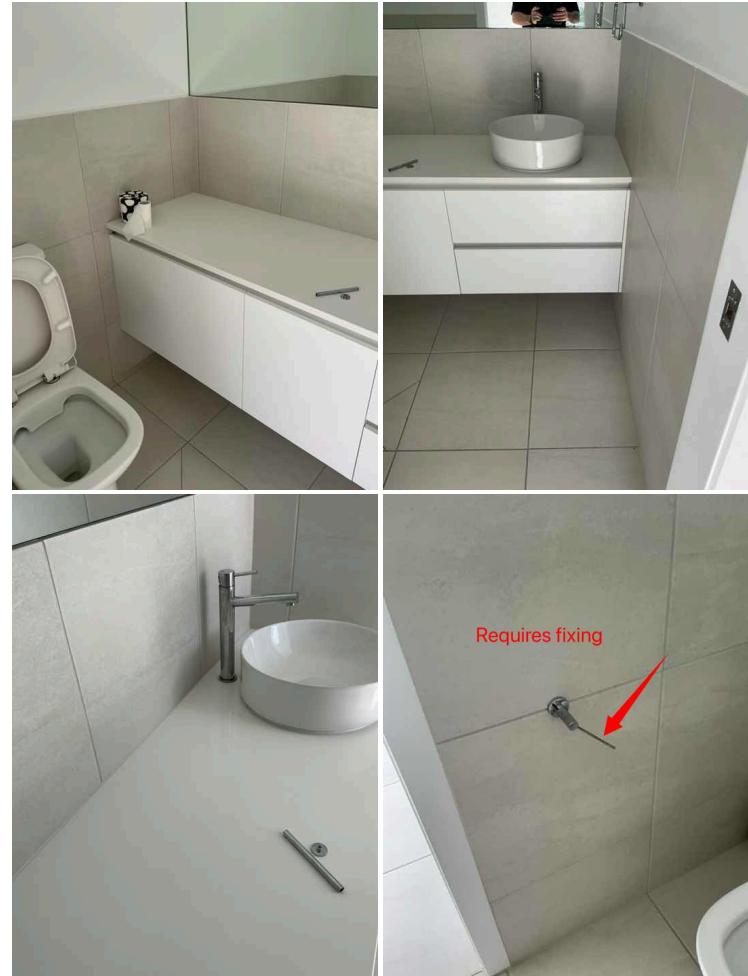
Of the visible areas, the general condition of this bathroom is serviceable or in reasonable condition for age of dwelling.

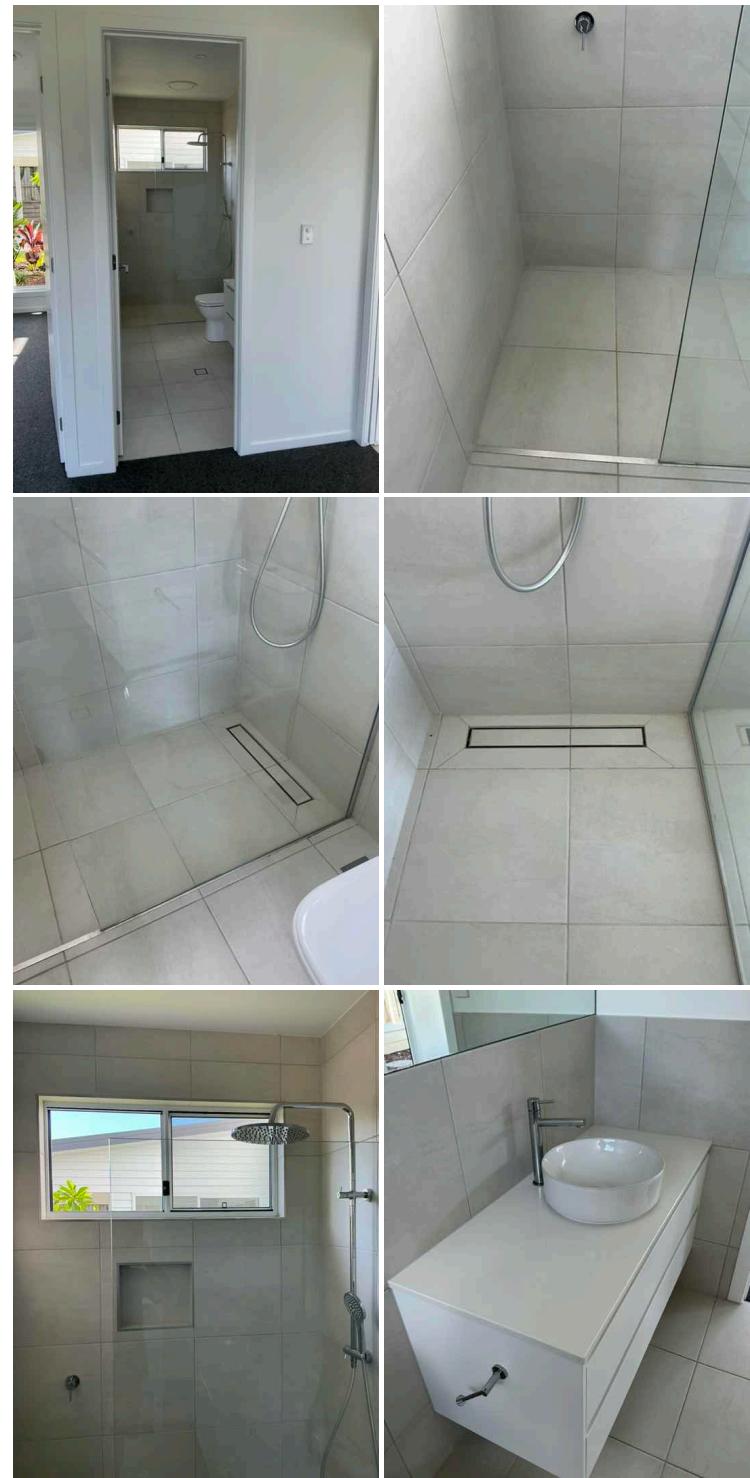
This bathroom is located off the bedroom.

Of the visible areas, the general condition of this bathroom is serviceable or in reasonable condition for age of dwelling.

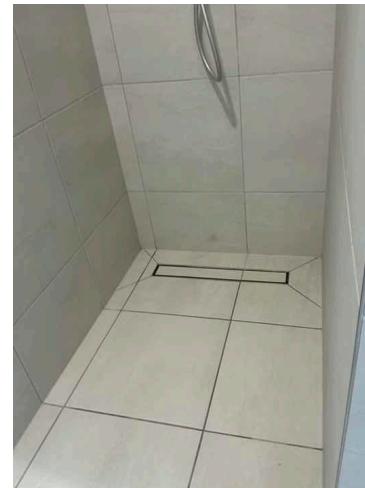
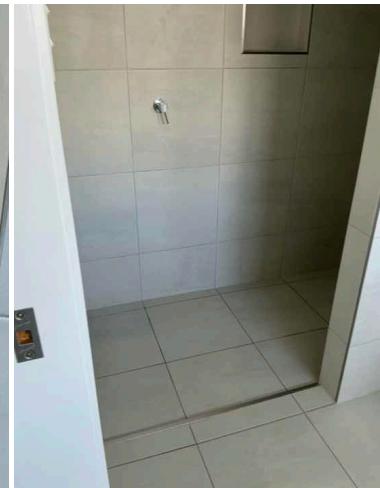
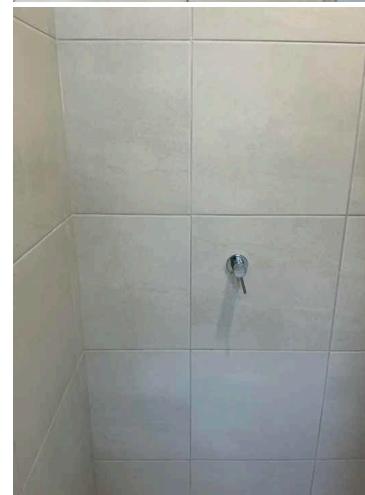
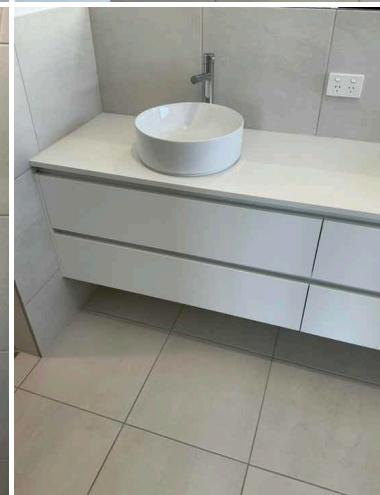
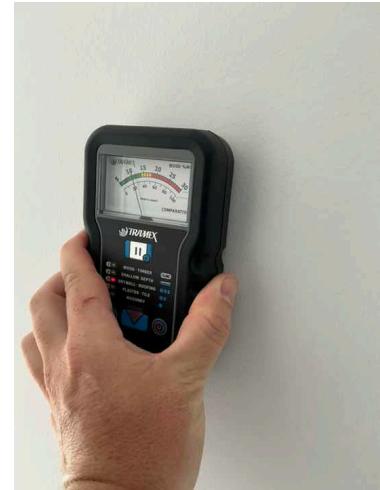
Of the visible areas, the general condition of this bathroom is serviceable or in reasonable condition for age of dwelling.

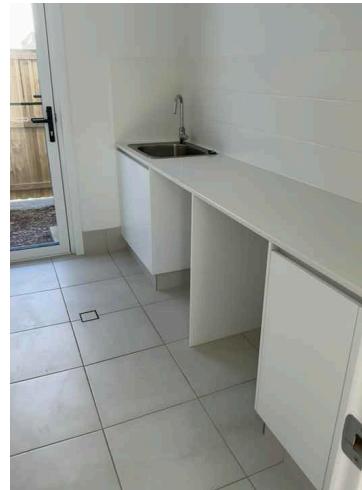
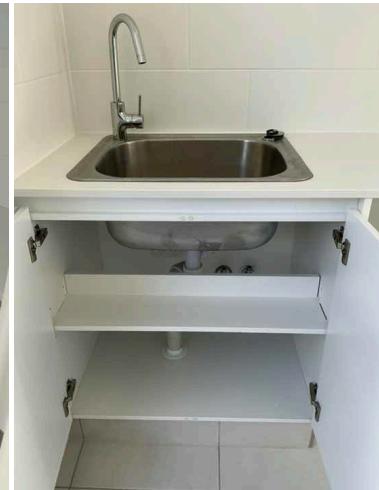
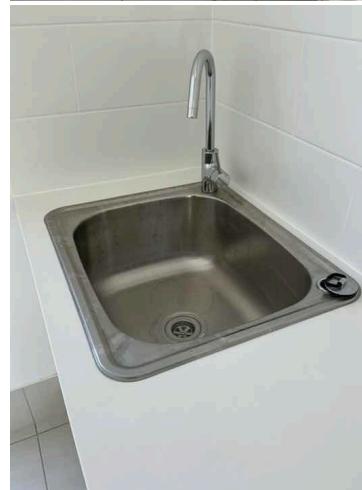
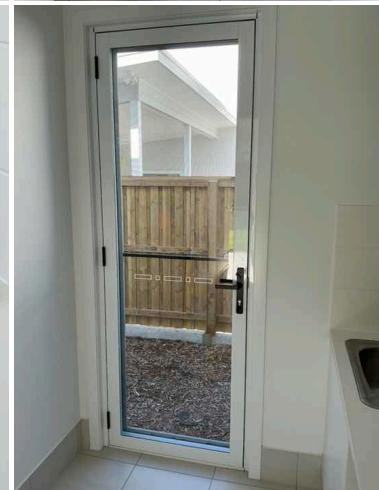
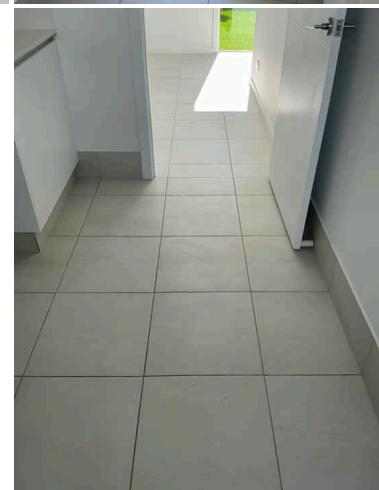
Of the visible areas, the general condition of the laundry is serviceable or in reasonable condition for age of dwelling.

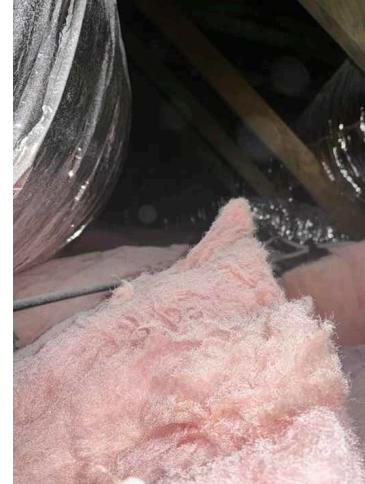
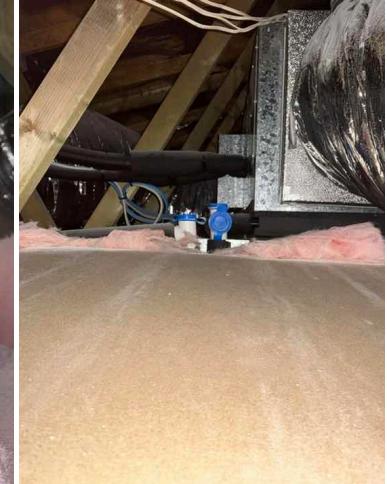
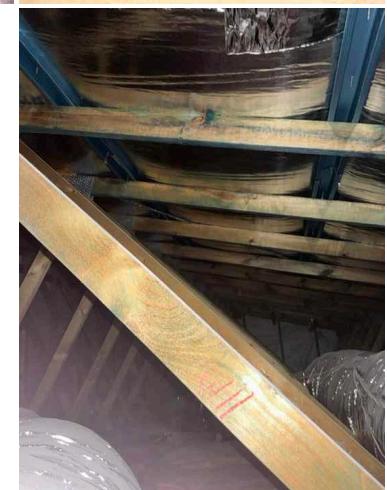
There is heating and/or cooling ducting present in the roof space. This is preventing a full inspection from being undertaken. It is strongly recommended that full access be gained as it could be harbouring timber pest activity, damage or defects.

There is insulation present in the roof space/void. This is preventing a full inspection of ceiling joists from being undertaken. It is strongly recommended that full access be gained as it could be harbouring timber pest activity, damage or defects.

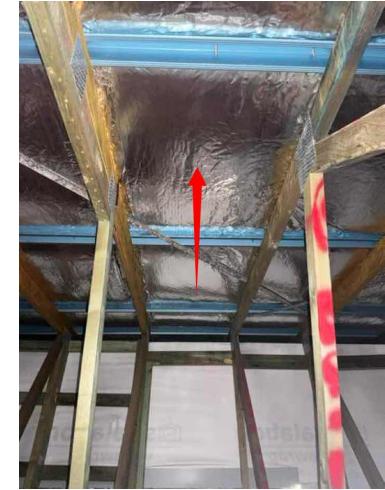
Sarking is installed.

The sarking generally is in a serviceable condition.
