# Building and Pest Report

## 1/53 Gibbon St, Lennox Head

# Inspection Report

**1/53 Gibbon Street, Lennox Head , NSW, 2478**

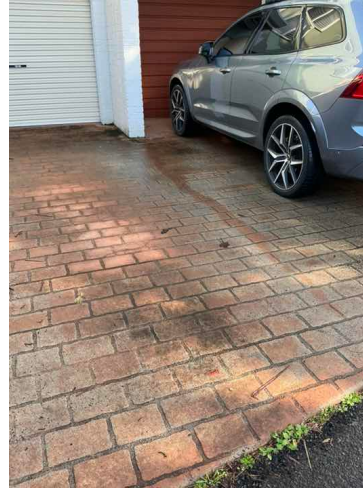
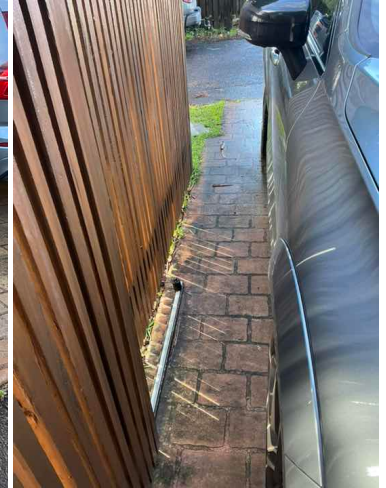
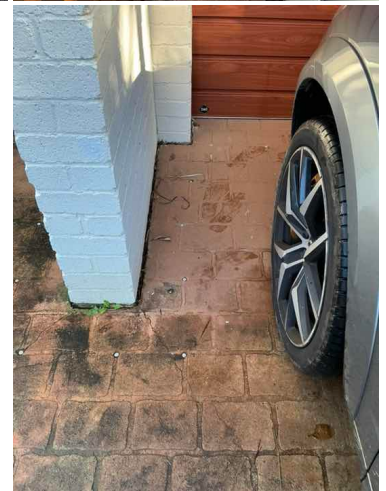
#### Driveway Condition

On visual inspection, the general condition of the driveway is serviceable.

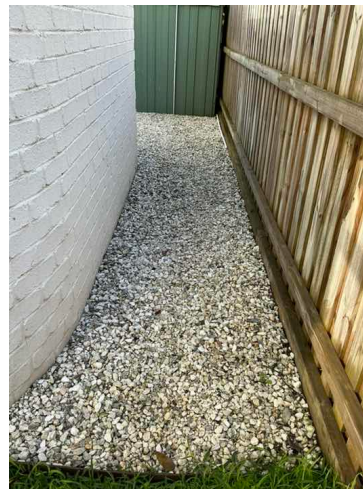
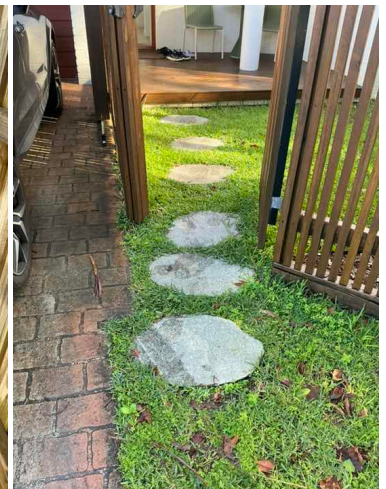
#### Pathways Condition

The paths around the home are in a serviceable condition for the age of this dwelling with no major defects visible.

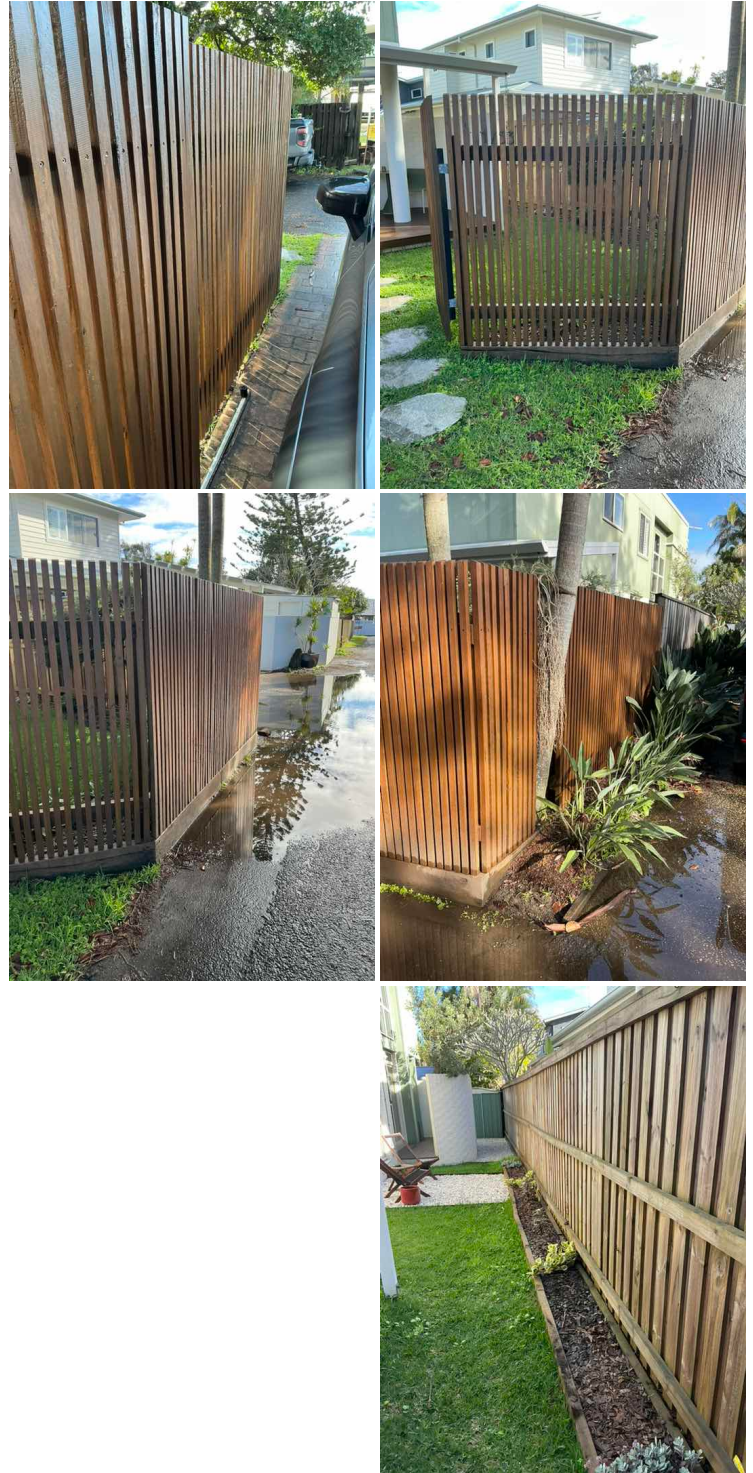
### **Overall Condition**

Of the visible areas, the general condition of the fences and gates is serviceable for the age of dwelling.

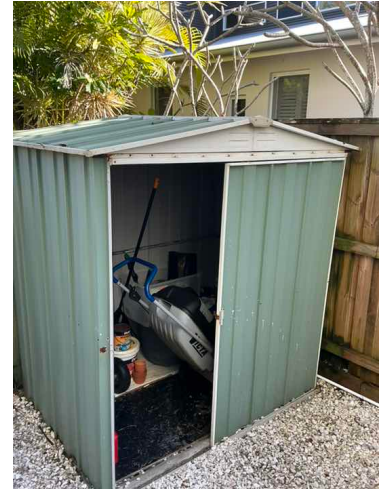
**Shed****Shed Condition**

The shed is in fair usable condition.

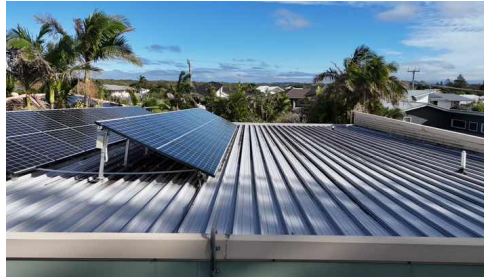
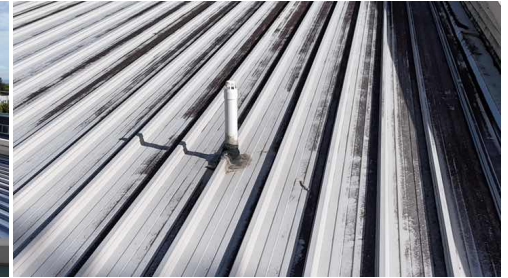
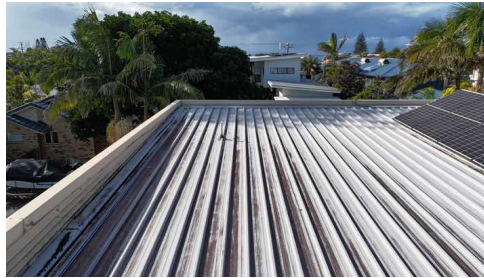
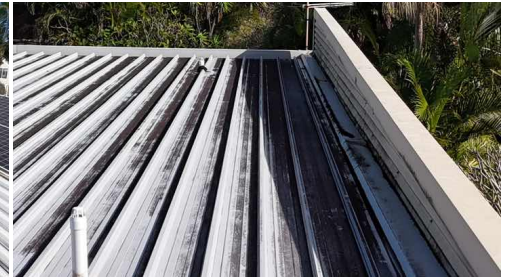
#### Overall Condition

Of the visible areas, the general condition of the roof is in serviceable condition for the age.

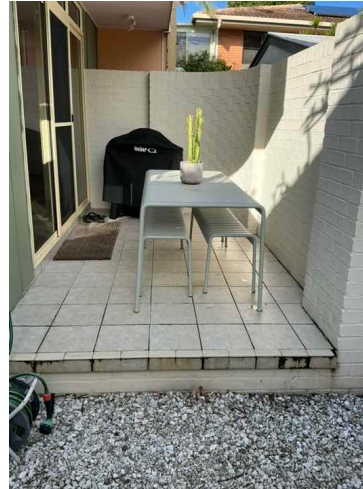
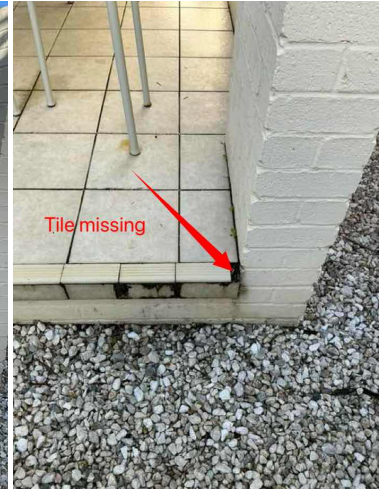
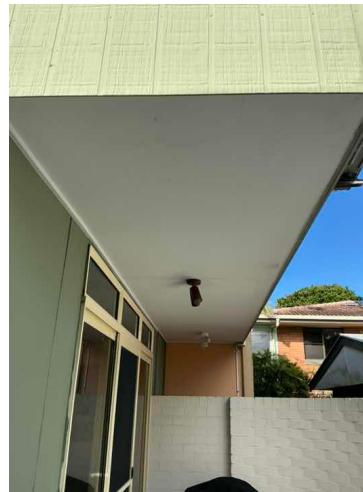
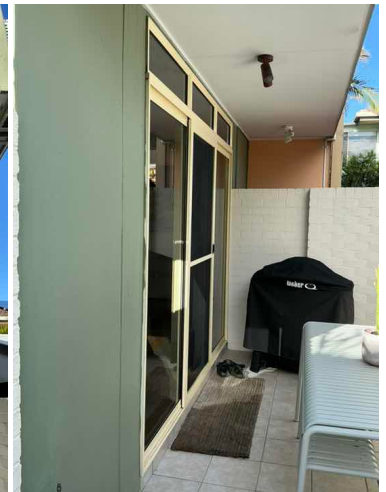
#### Overall Condition

Visible sections of the Alfresco area are serviceable or in reasonable or condition for the age of this dwelling.

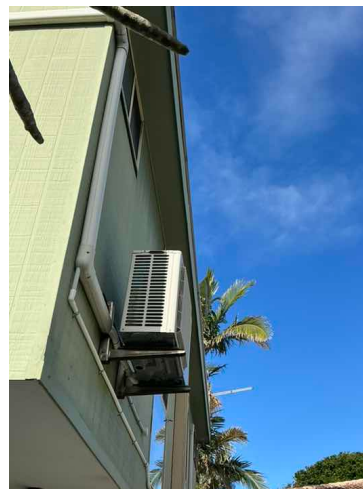
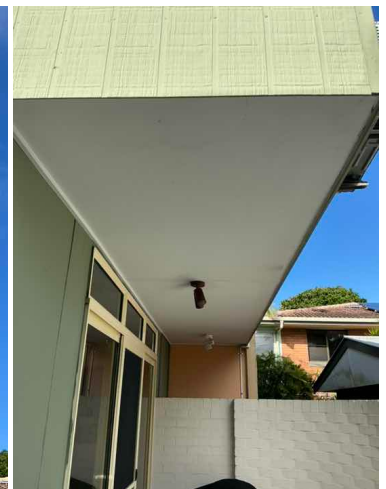
#### Eave Condition

The soffit lining (eaves) are in a serviceable condition with no notable defects.

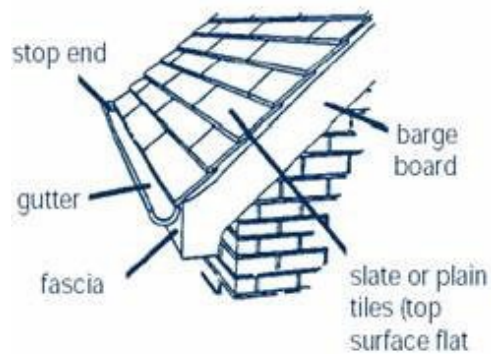
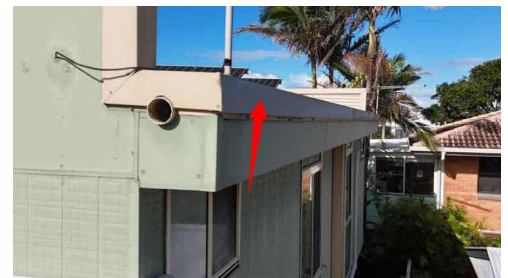
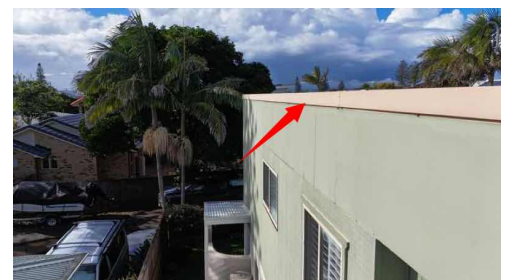
### **Condition**

On visual inspection, the general condition of the fascia/barge boards is serviceable.

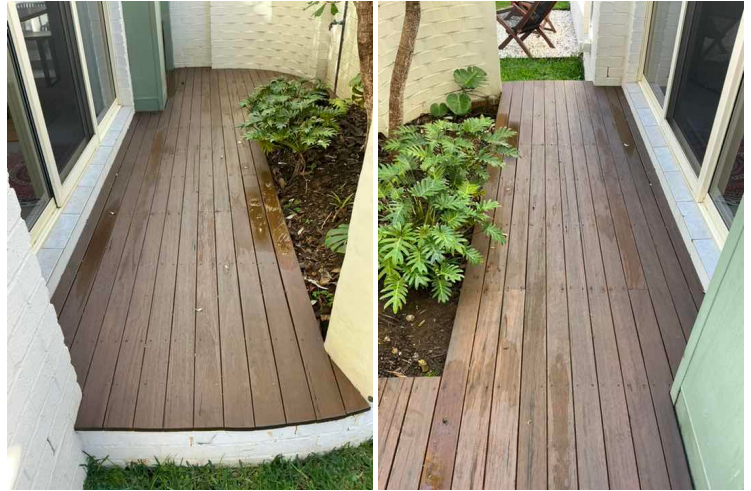
#### **Overall Condition**

Of areas visible, the decking appears to be in a serviceable condition.

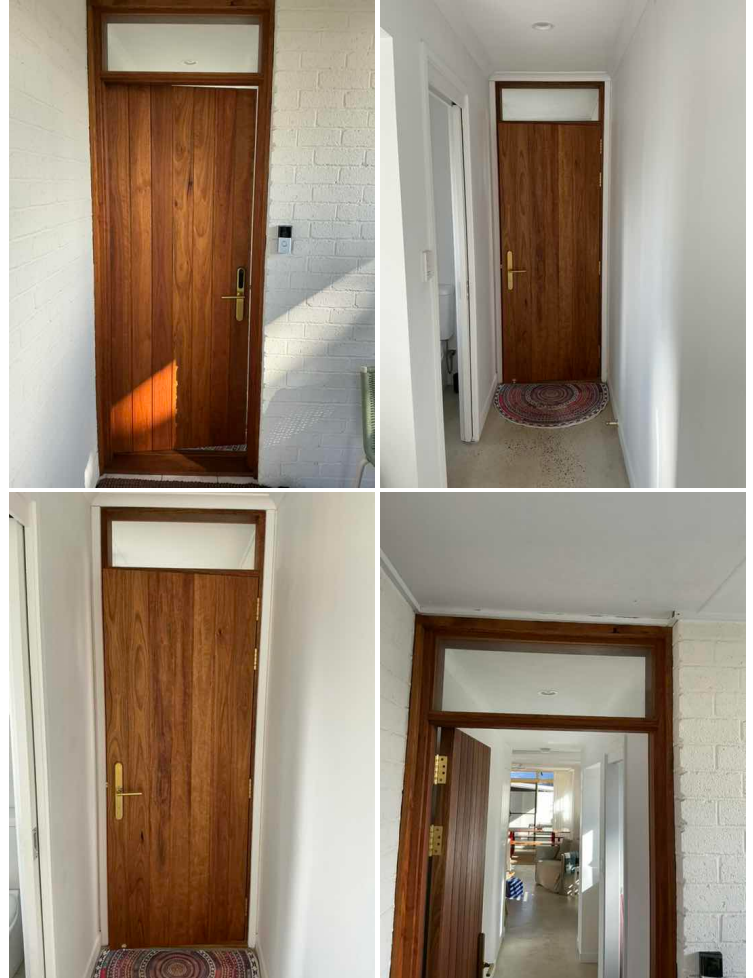
#### **Front Entry Doors**

The doors are in serviceable condition with no notable defects observed.

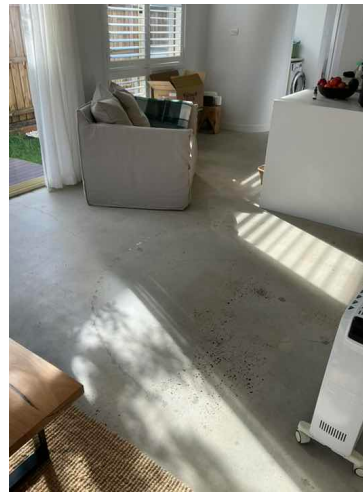
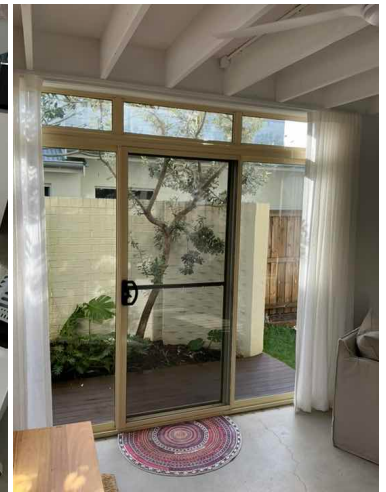
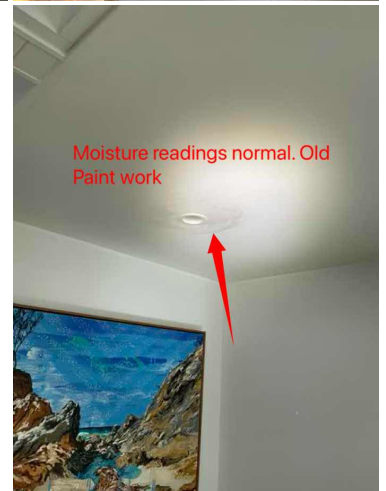
## Flooring

Upon visual inspection, the concrete floor exhibits noticeable cracking. It is recommended to consult a licensed contractor to assess and repair the cracks to prevent further deterioration. Consider using a suitable concrete filler or sealant to address the issue effectively. Regular monitoring is advised to ensure no additional structural concerns arise.

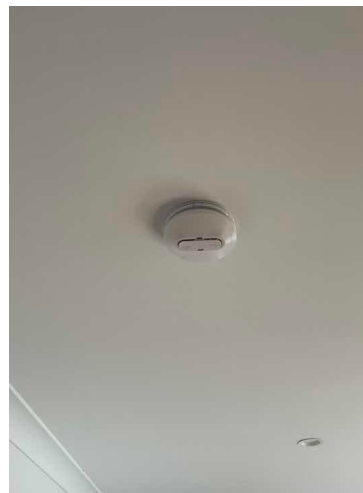
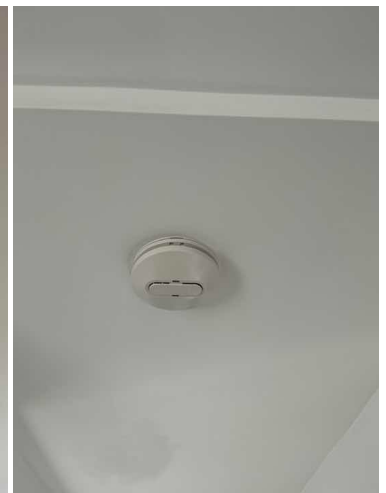
### **Was a Smoke Alarm Fitted**

Yes 2 smoke alarms were sighted but not tested.

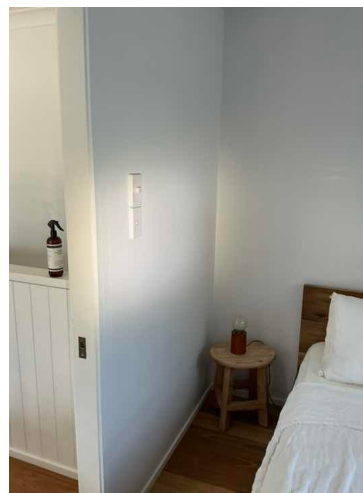
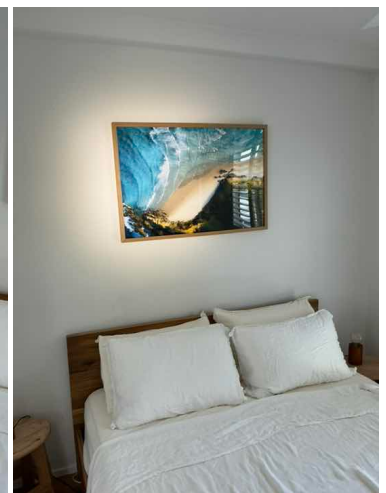
## **Bedroom 1**

From the visible and accessible areas, this bedroom appears to be in a serviceable condition for the age of the property with no notable structural defects sighted.

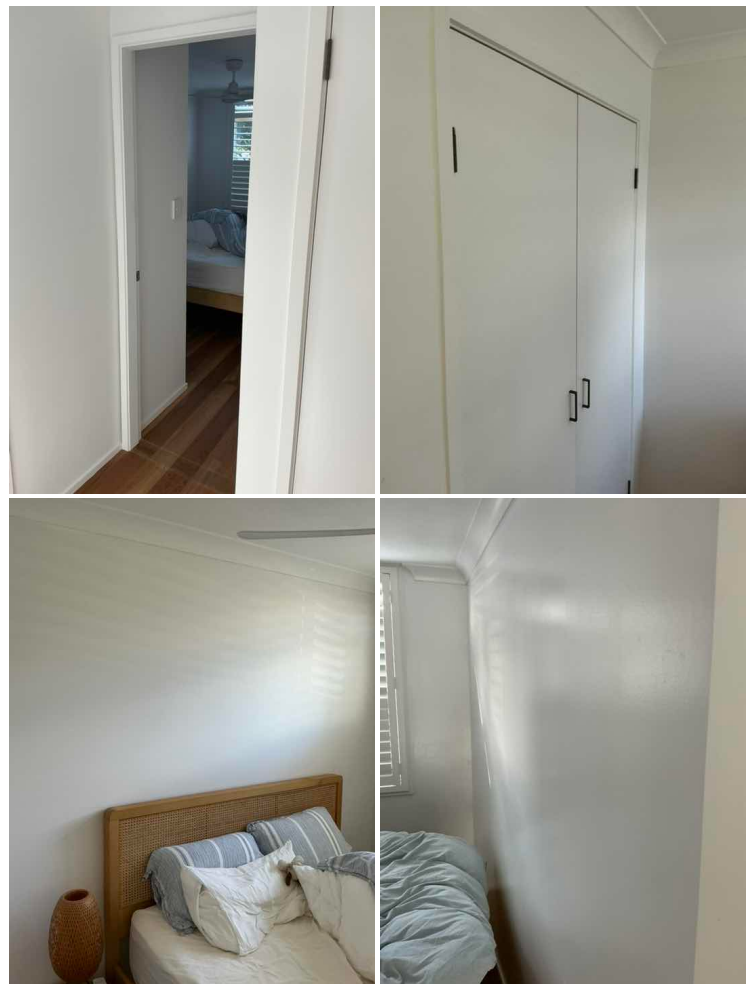
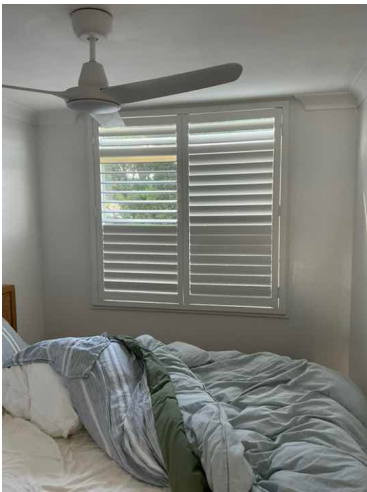
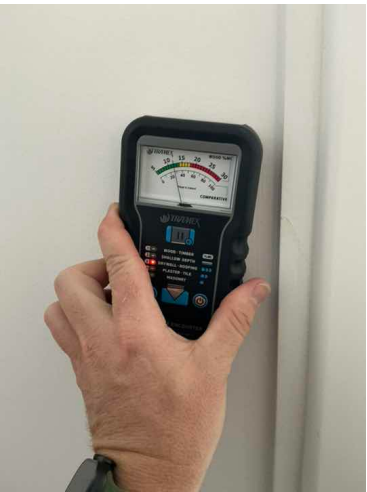
From the visible and accessible areas, this bedroom appears to be in a serviceable condition for the age of the property with no notable structural defects sighted.

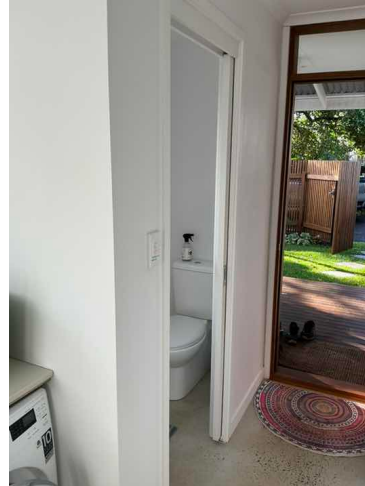
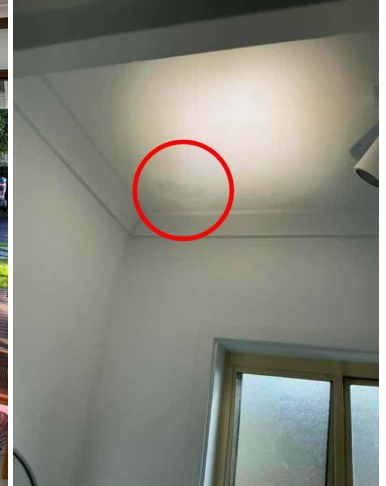
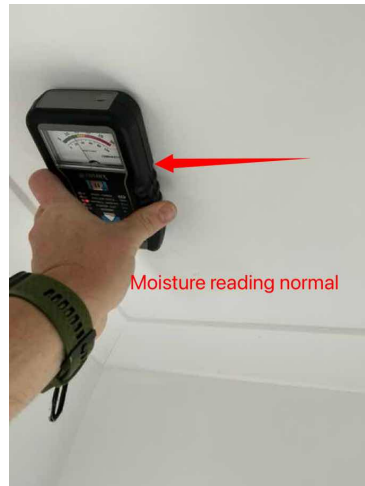
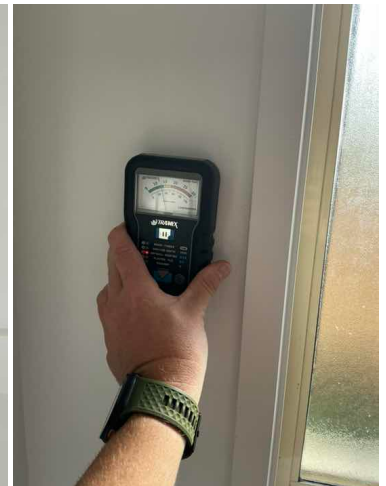
Of the visible areas, the general condition of this bathroom is serviceable or in reasonable condition for age of dwelling.

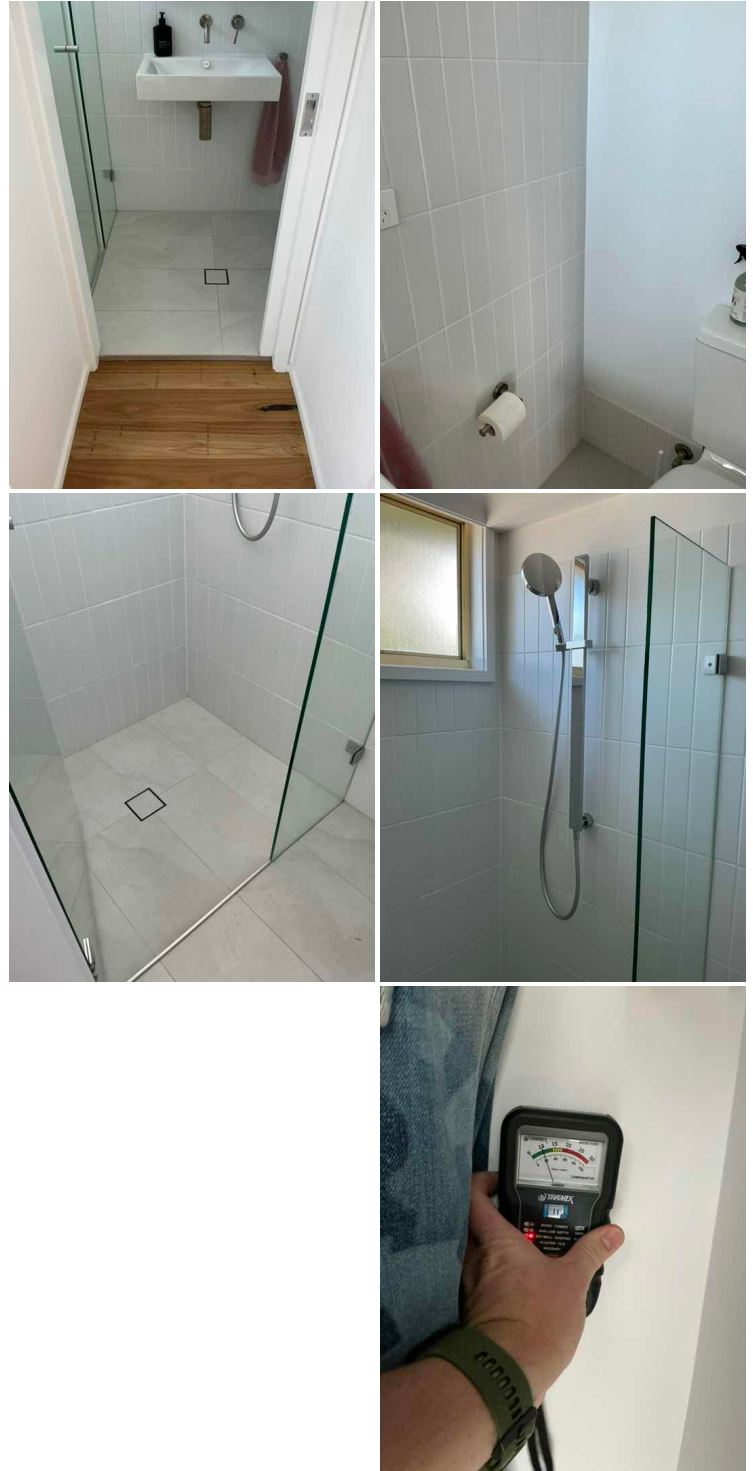
Of the visible areas, the general condition of this bathroom is serviceable or in reasonable condition for age of dwelling.

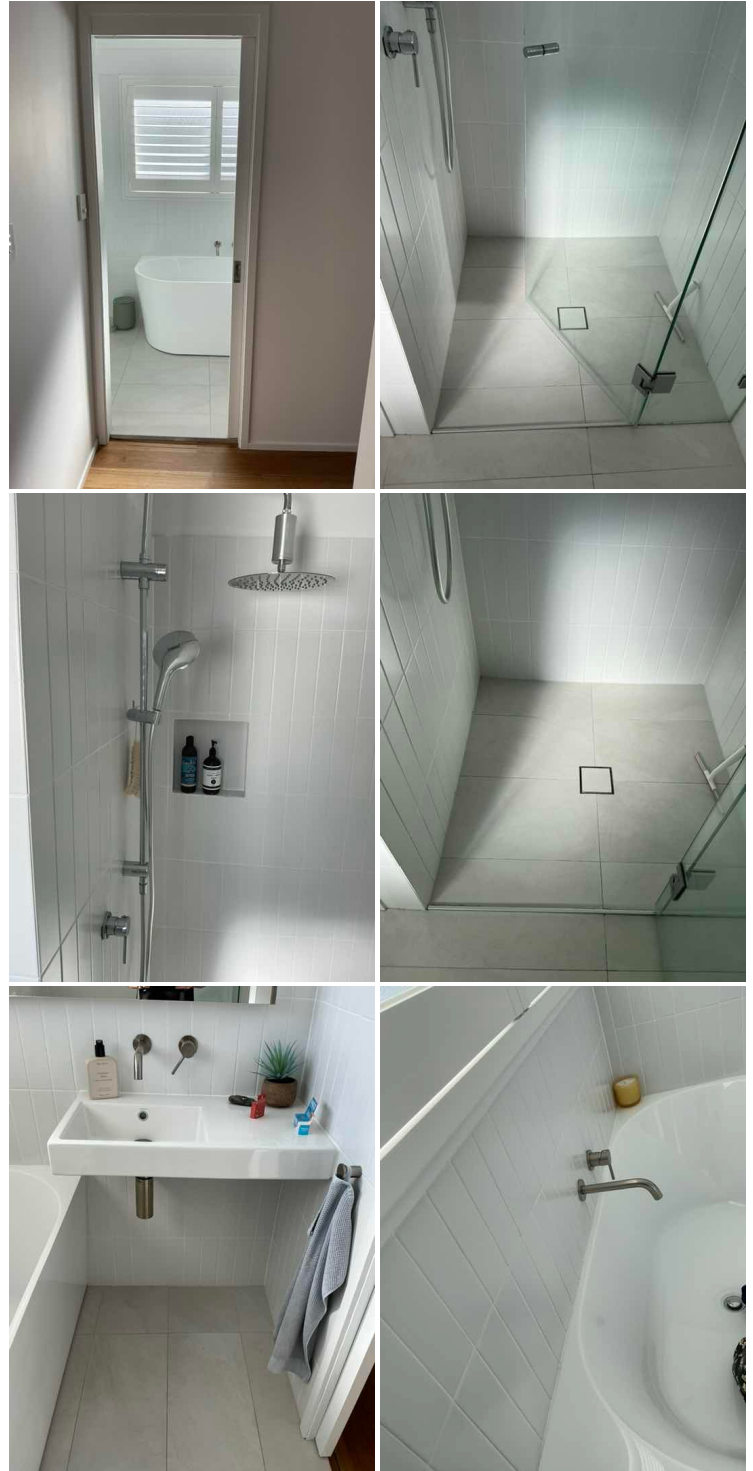
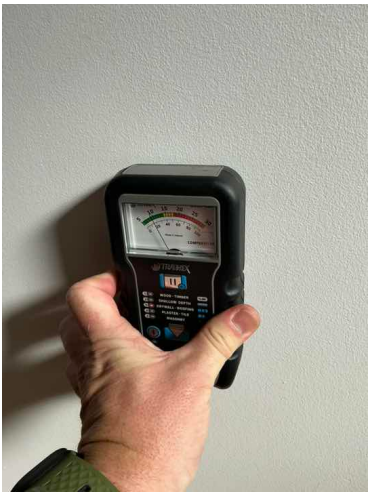
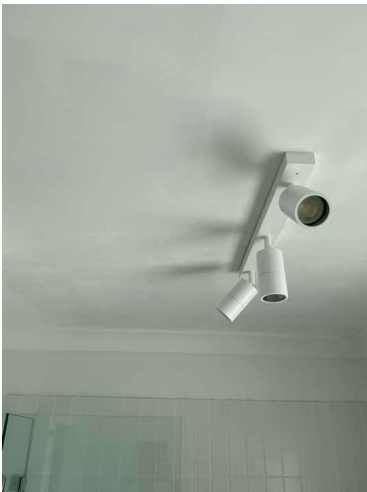
Of the visible areas, the general condition of this bathroom is serviceable or in reasonable condition for age of dwelling.

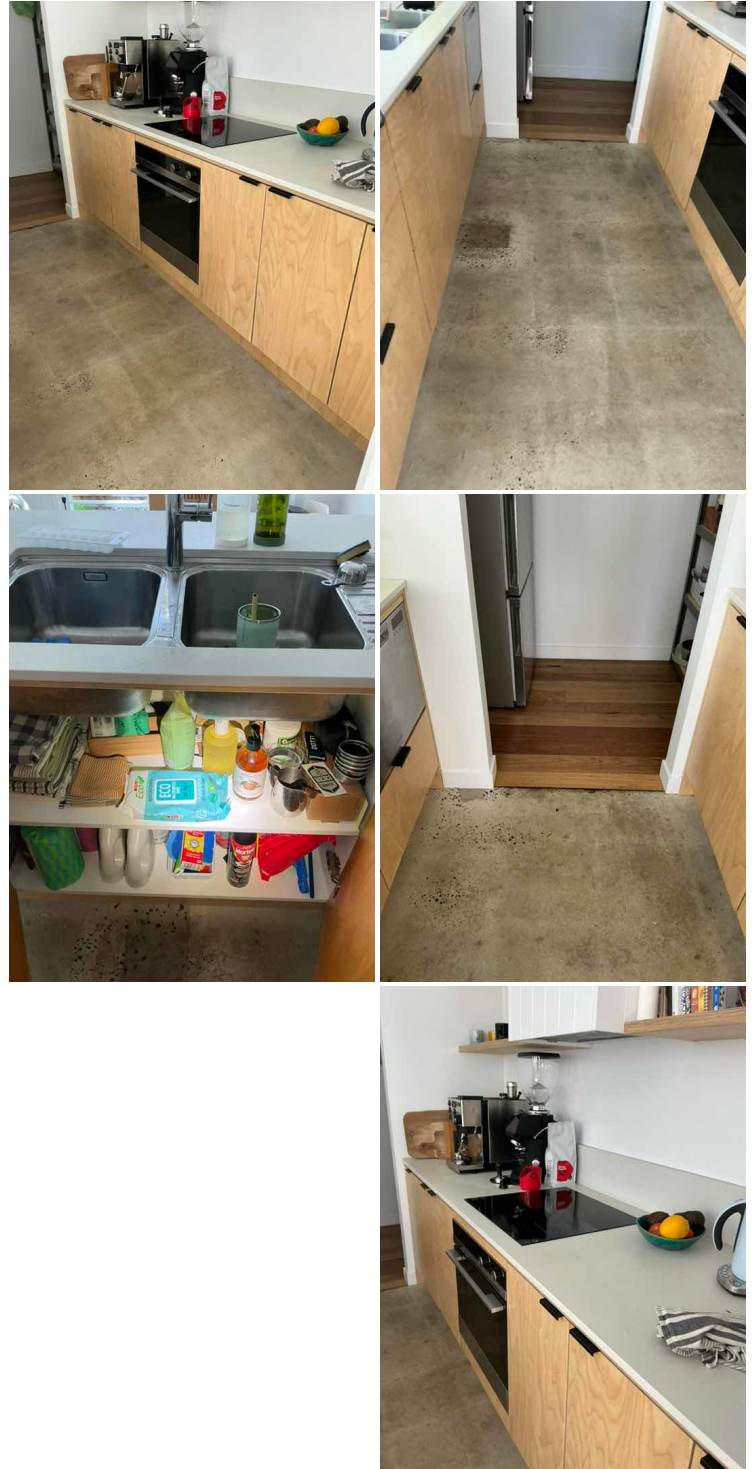
Of the visible areas, the general condition of the kitchen and pantry is serviceable or in reasonable condition for age of dwelling.

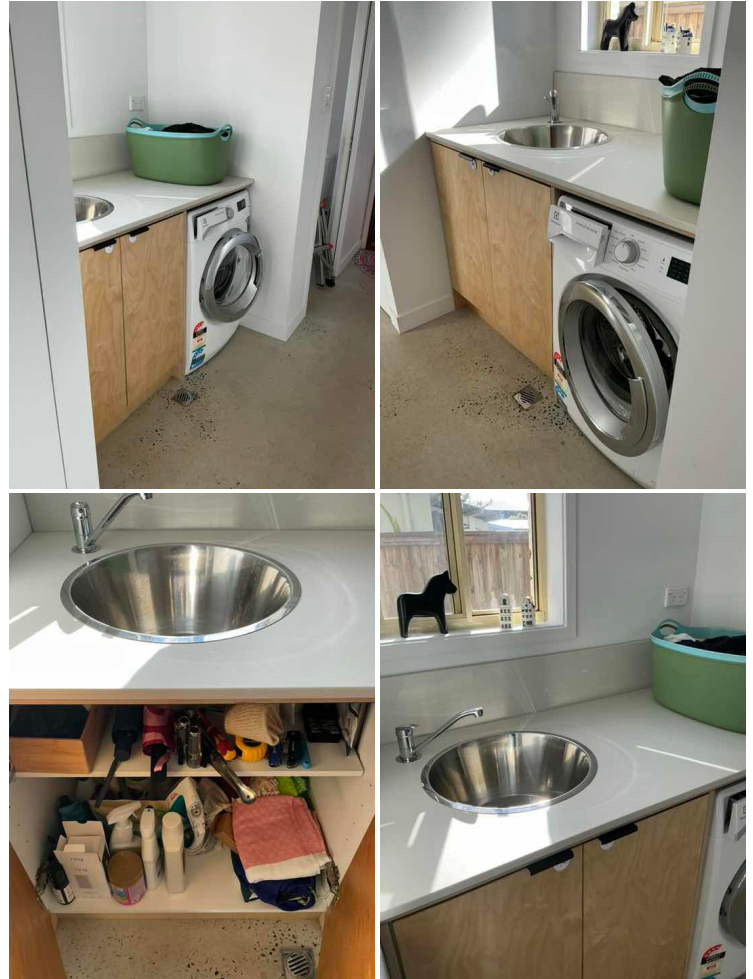
Of the visible areas, the general condition of the laundry is serviceable or in reasonable condition for age of dwelling.

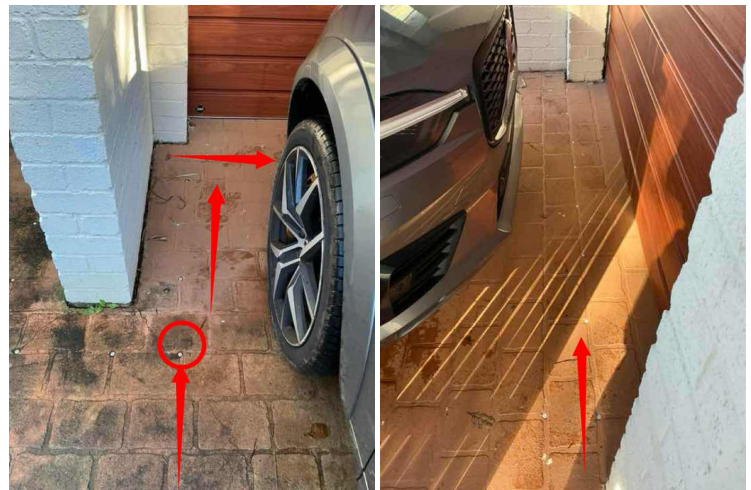
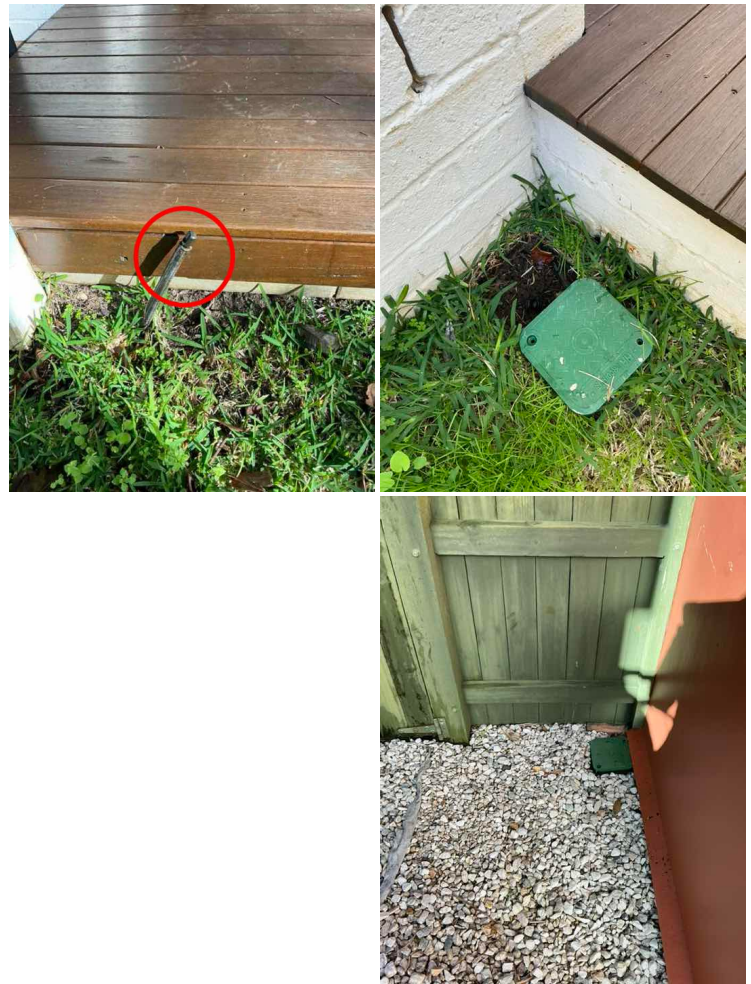
Yes, a reticulated pipe system was located at the dwelling.

Yes, Drill Holes (Chemical Treatment) were located at the property.

Warning: If evidence of drill holes in concrete or brickwork or other signs of a possible previous treatment are reported then the treatment was probably carried out because of an active termite attack. Extensive structural damage may exist in concealed areas. You should have an invasive inspection carried out and have a builder determine the full extent of any damage and the estimated cost of repairs as the damage may only be found when wall linings etc. are removed. Normally if a termite treatment has been carried out then a durable notice should be located in the meter box indicating the type of termite shield system, treated zone or combination has been installed.
