# Building and Pest Report

## 1/53 Seawell Cres, Lennox Head

Report/Agreement #	160226101057122
Inspection Date:	16 Feb 2026
Inspection Time:	09:00 am

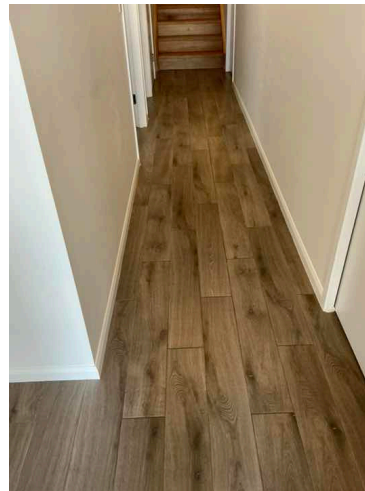
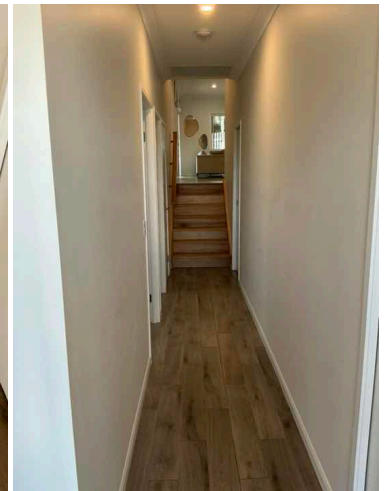
## Hallway/s

From the visible and accessible areas, the hallway/s appears to be in a serviceable condition for the age of the property with no notable structural defects sighted.

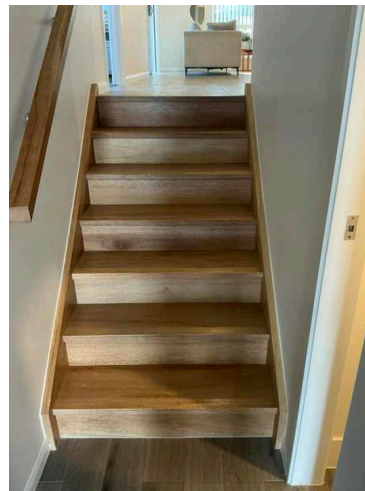
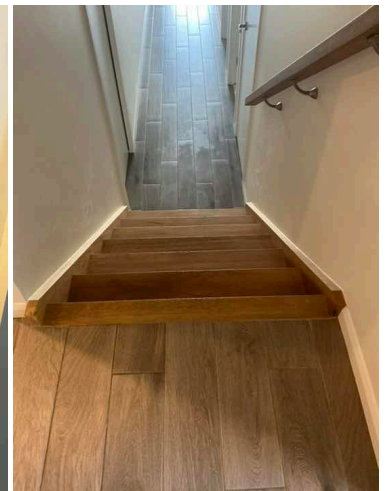
## Internal Stair Case

The internal staircase and components appear to be in a serviceable condition for the age with no notable defects sighted.

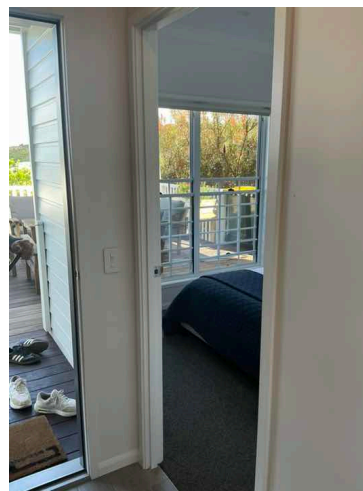
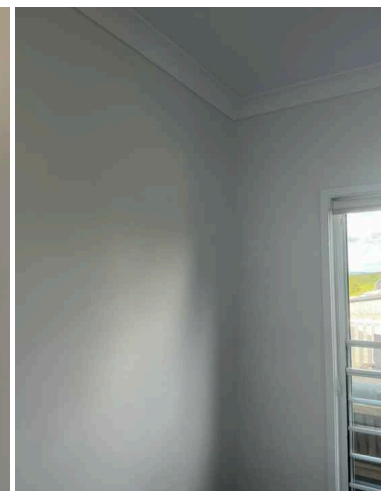
**Bedroom 1**

From the visible and accessible areas, this bedroom appears to be in a serviceable condition for the age of the property with no notable structural defects sighted.

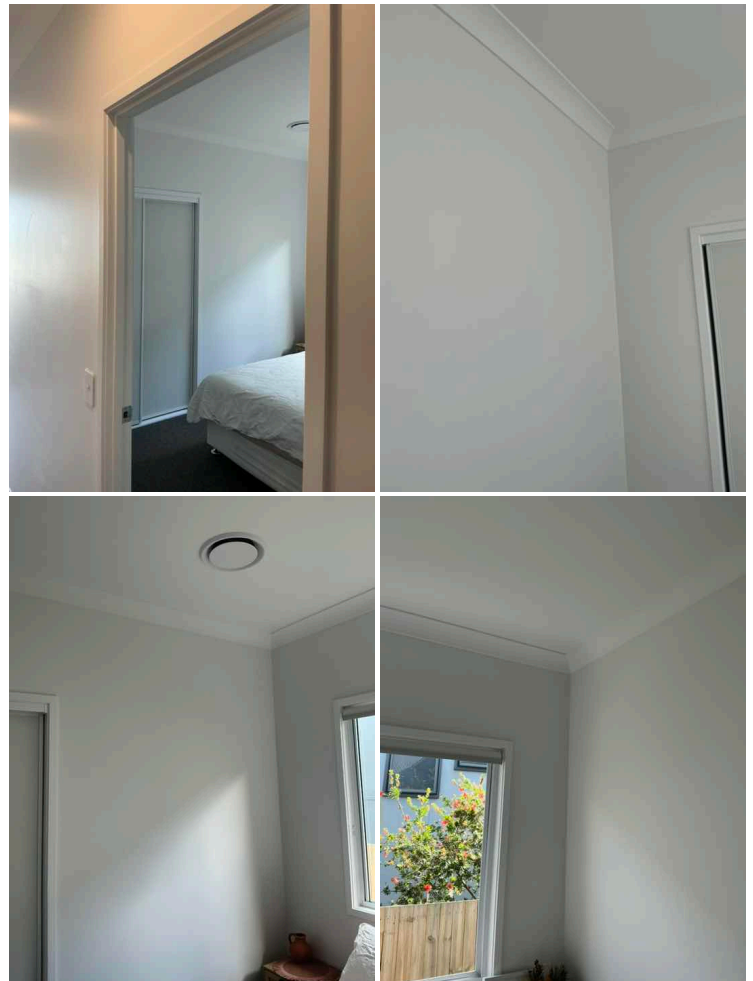
## **Bedroom 2**

From the visible and accessible areas, this bedroom appears to be in a serviceable condition for the age of the property with no notable structural defects sighted.

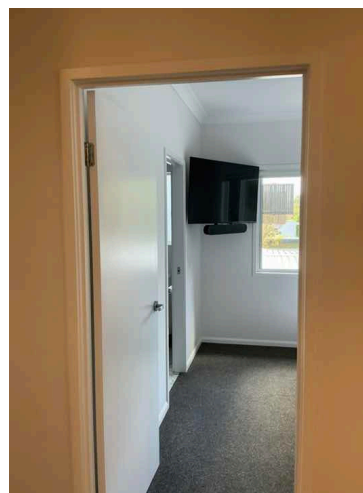
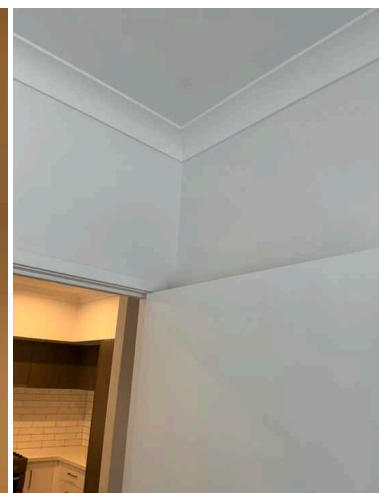
### **Bedroom 3**

From the visible and accessible areas, this bedroom appears to be in a serviceable condition for the age of the property with no notable structural defects sighted.

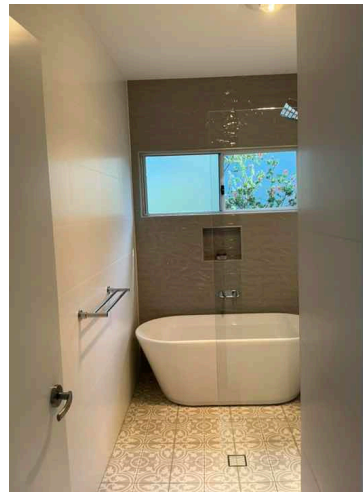
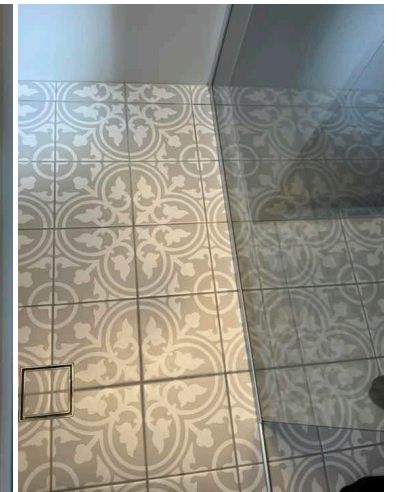
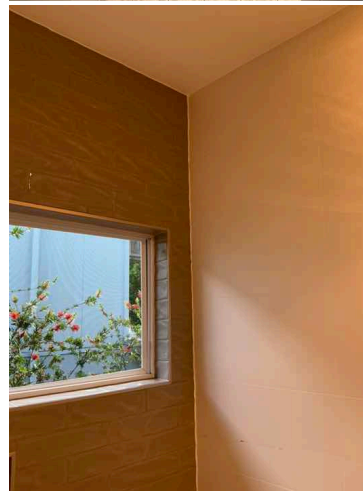
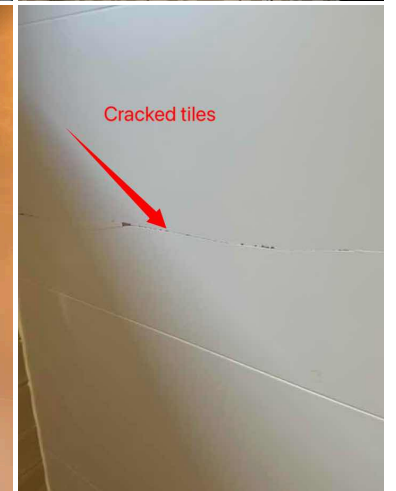
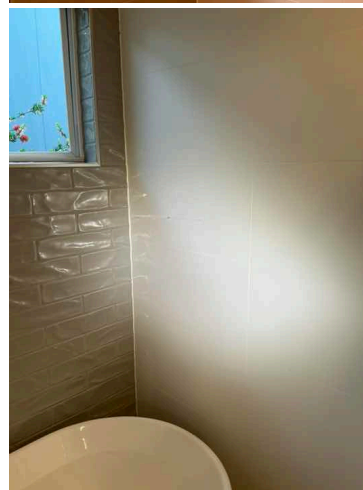
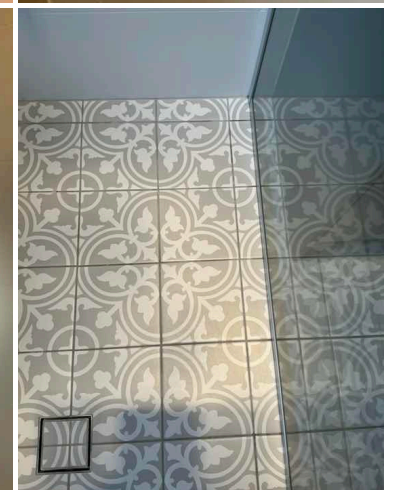
### Bathroom 1

Upon visual inspection, a crack is visible on the wall surface. It is recommended to have a licensed tiler assess and repair the crack to prevent further damage. Ensure proper sealing and to maintain the wall's integrity and appearance.
