# Property Inspection Report

**31 Pearces Creek Hall Road,  
Pearces Creek , 2477, NSW**

**Date of Inspection: 14/8/2025 | Time: 9:30AM**

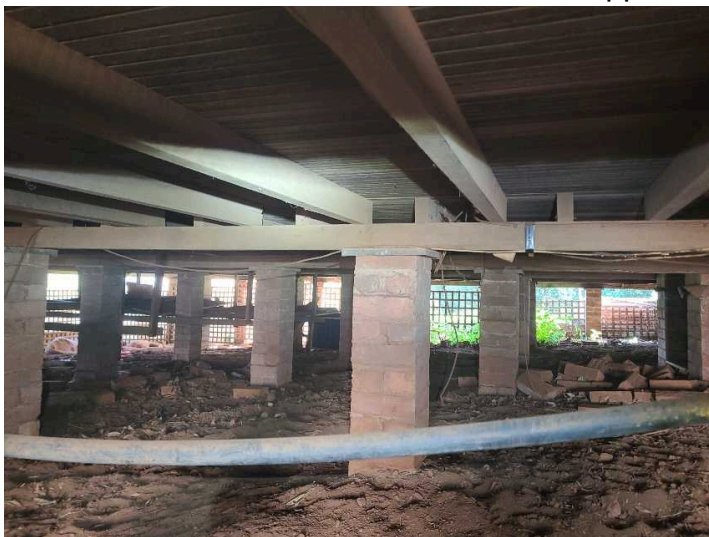
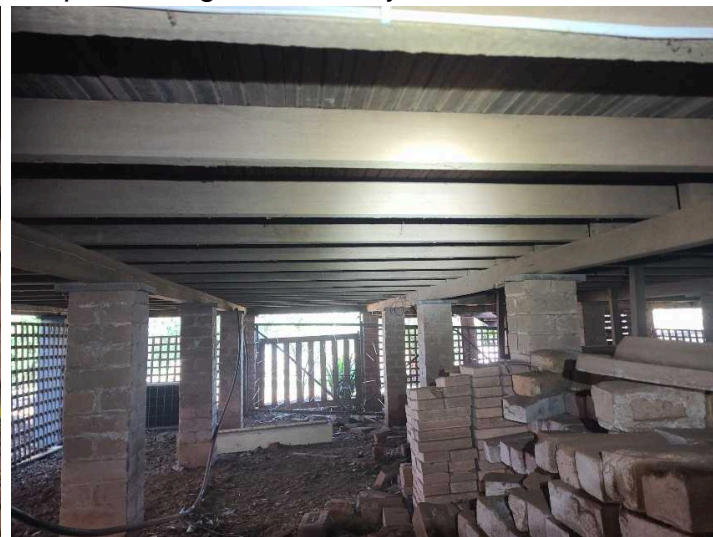
- The foundations appear to be performing satisfactorily.

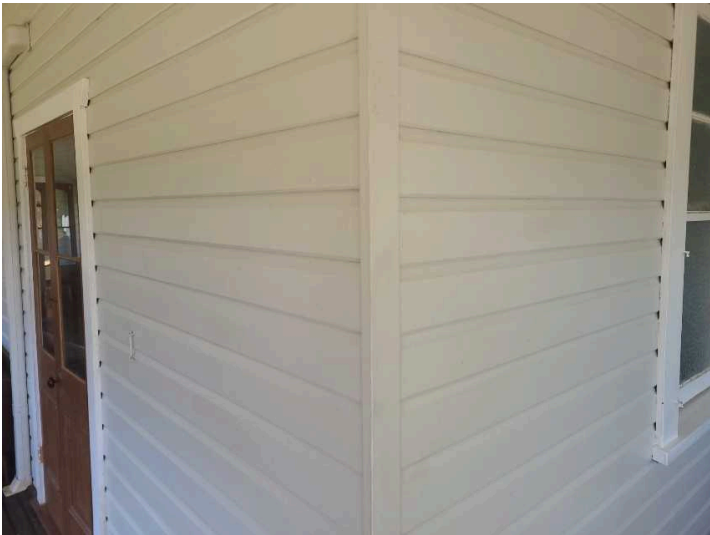
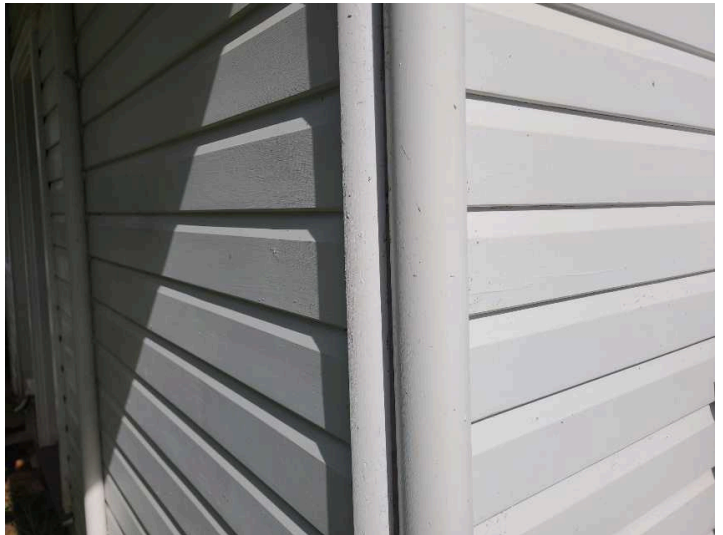
- The wall structure components appeared functional.
- Externals walls are of cladded timber frame construction.

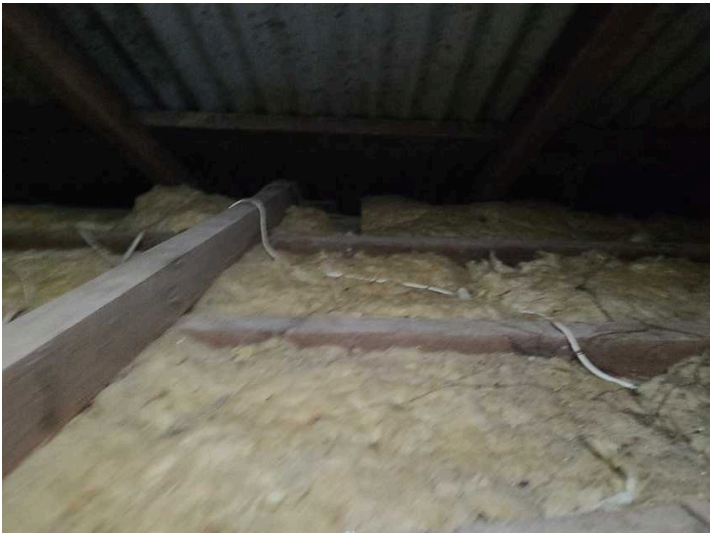
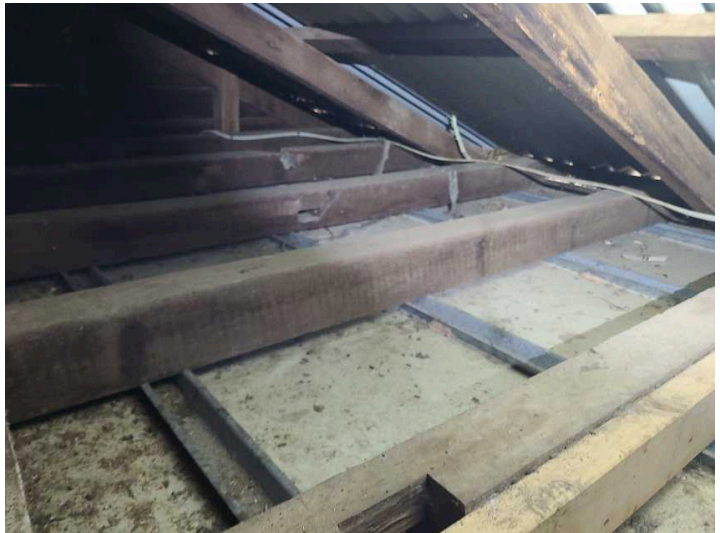
- The ceiling structure appeared functional.
- Due to the placement of insulation on the top of the ceilings it is not possible to fully inspect the condition of the ceiling structure and supports. Inspection was limited and based on what was visually accessible at the time of the inspection.

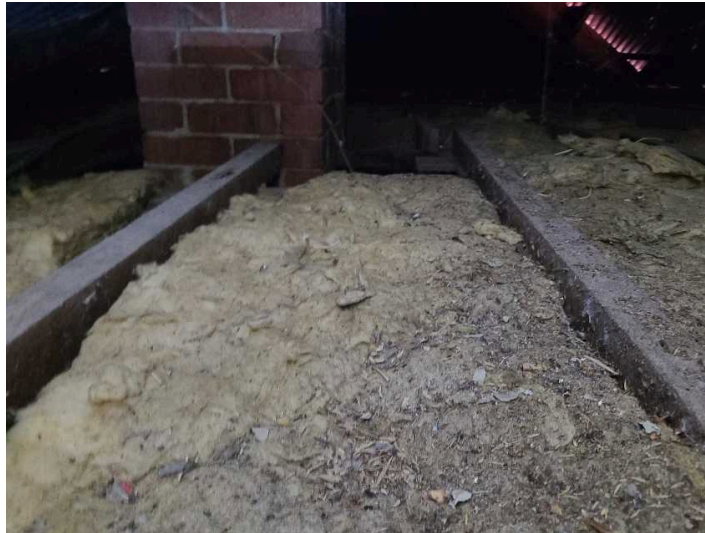
- Insulation averages about 75mm to 100mm in depth.
- Insulation appears adequate.

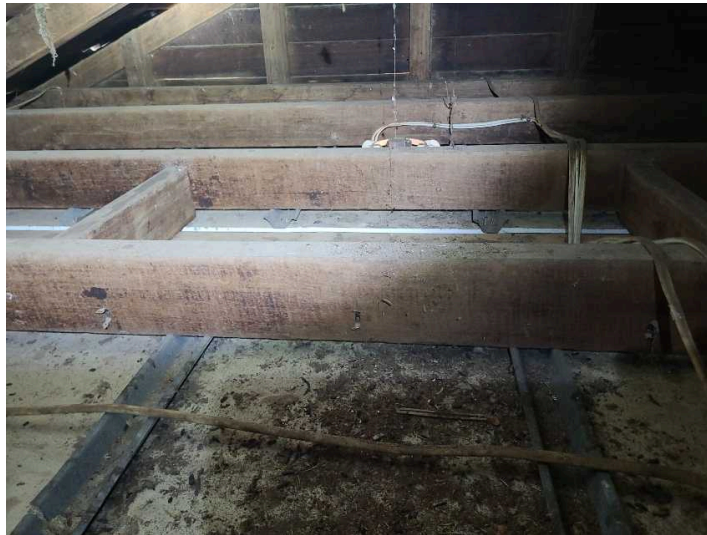
Granny flat

- There is no insulation on the ceiling in the roof space. Expect higher heating and cooling energy costs. It is recommended that insulation be added to improve the thermal efficiency of the home.

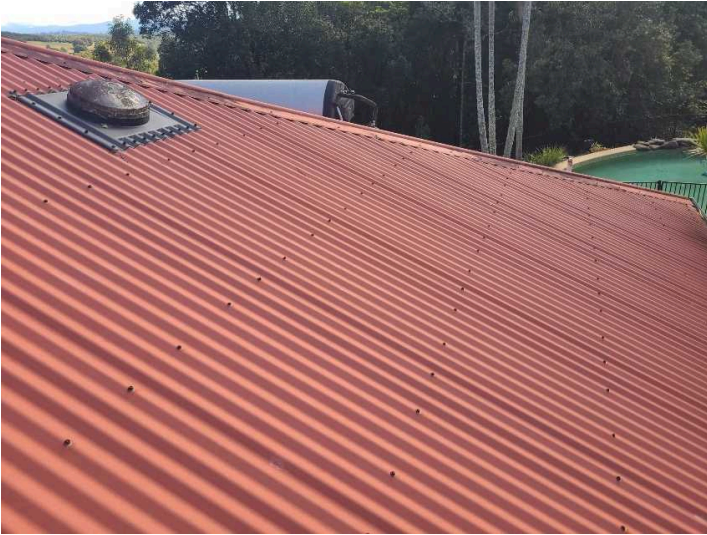
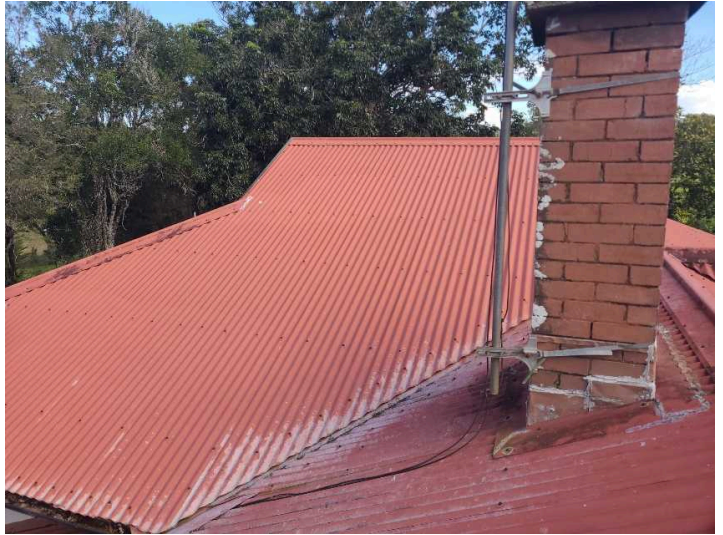
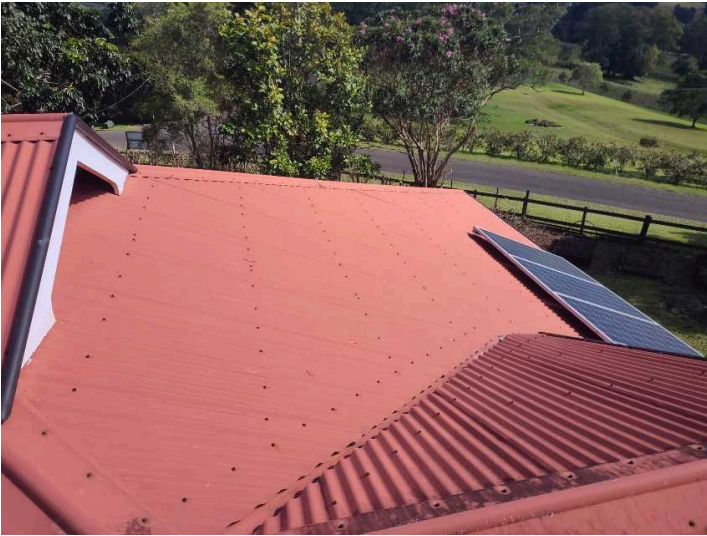
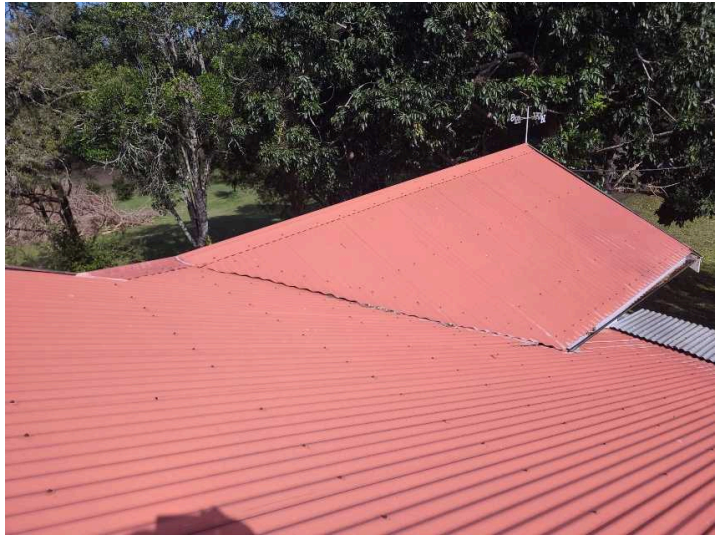
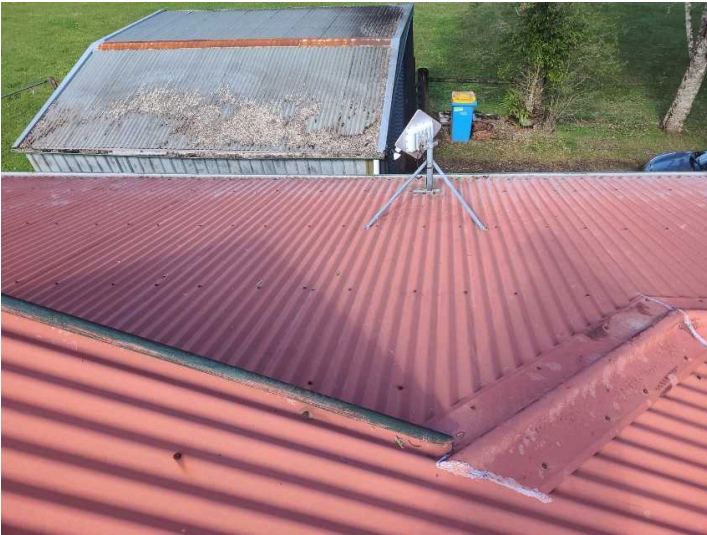
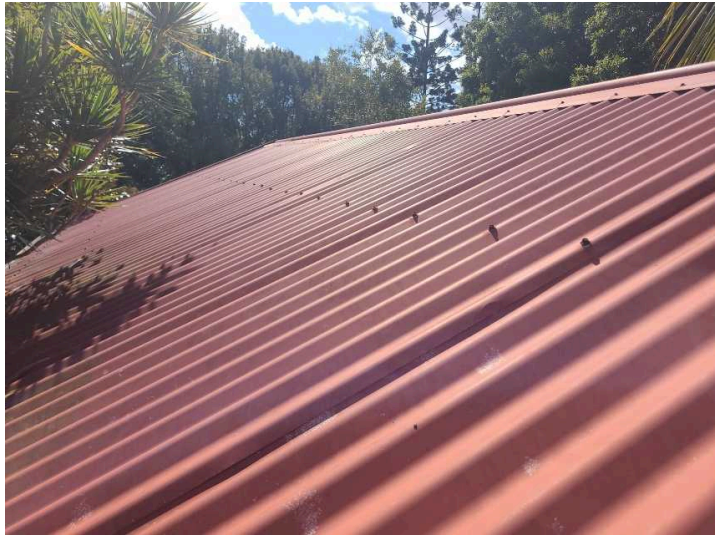
- The colourbond iron roof sheeting appears to be in satisfactory condition.

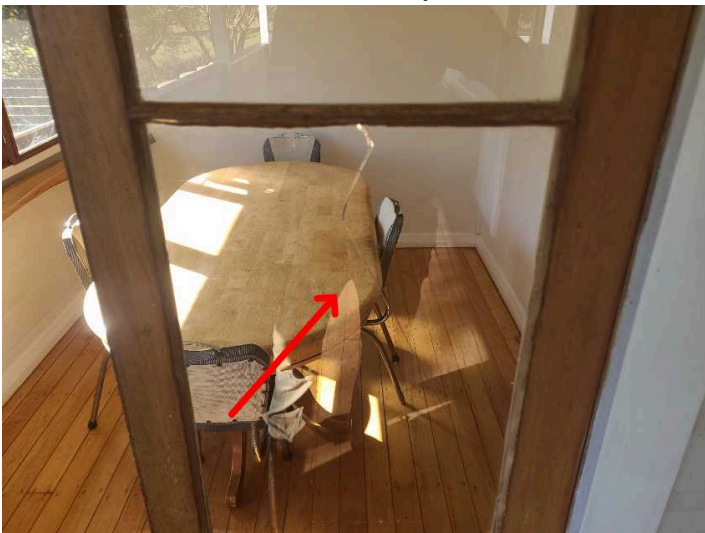
- Operated exterior doors were functional at the time of the inspection unless otherwise noted.
- Cracked glass on exterior door. Recommend repair.
- Decay noted. Maintenance in due course.

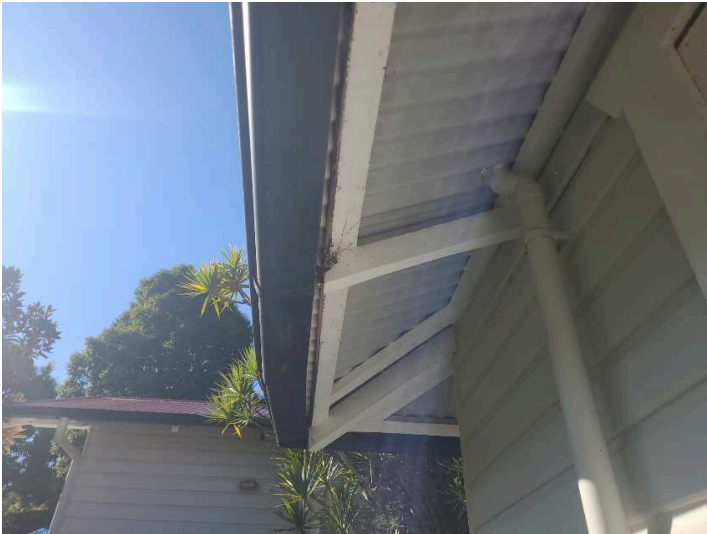
- The eaves are in satisfactory condition.
- Moisture damage, wood decay, observed. Recommend review for repair as necessary.

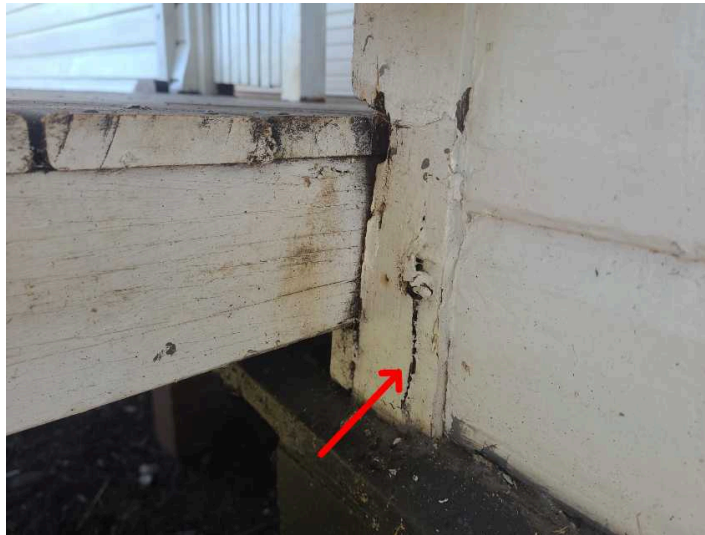
Granny flat

- External cladding appears to be in satisfactory condition relative to its age.
  - Some wood decay noted at the southwest side of the property.
- Recommend to have repaired and inspected for wood-destroying insect damage.

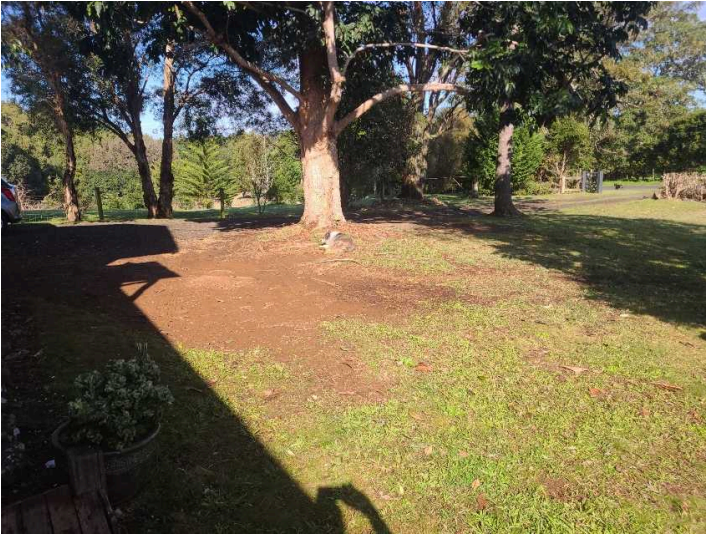
- Surface drainage conditions within 3 metres of the inspected structure appeared satisfactory.
- There are no drains located beneath the outdoor taps. This can cause water pooling if the taps were to leak. Recommend drains be installed beneath the taps. Where this is not possible it is important to ensure taps are well maintained to prevent leaks.

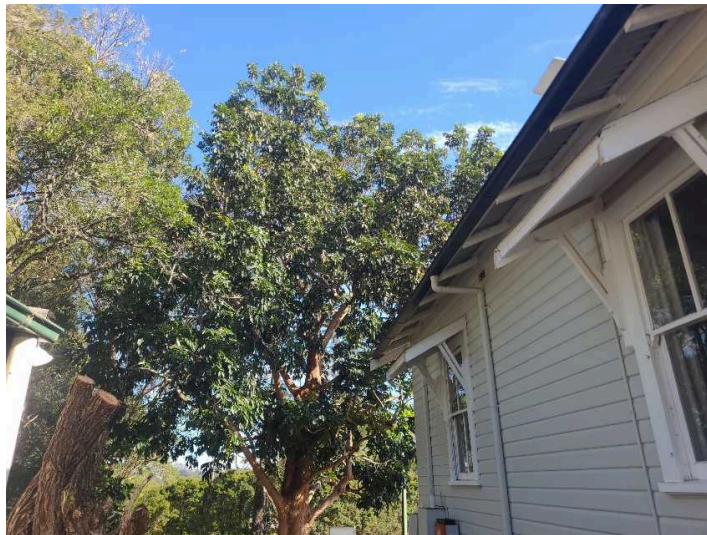
- Trees that begin to grow too close to or overhang property should be trimmed back; this will help reduce the frequency of having to clean out the gutters which should be done on a regular basis.

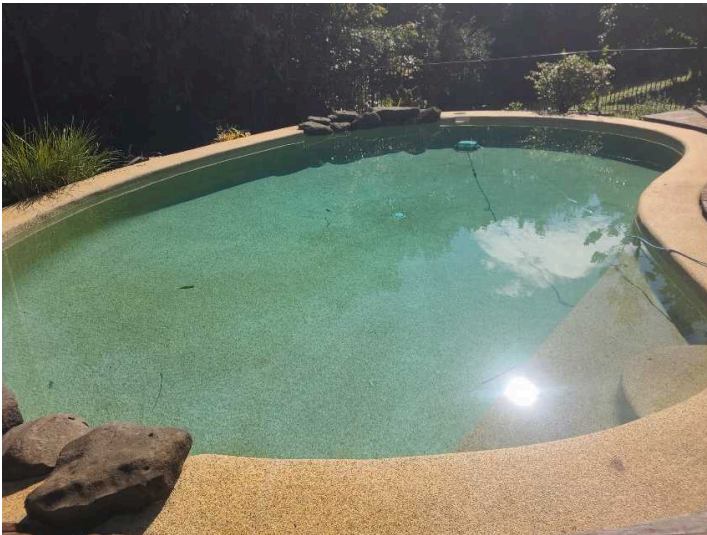
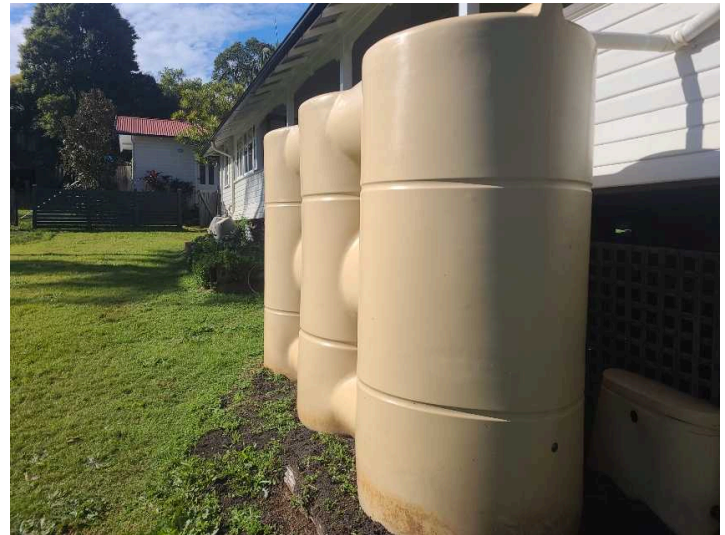
Ensure water tanks and pumps are free of leaks as this condition will create excessive moisture.

Condensation and dampness beneath poly water tanks is common. This condition causes excessive moisture conditions and should be monitored as part of an effective termite management plan.

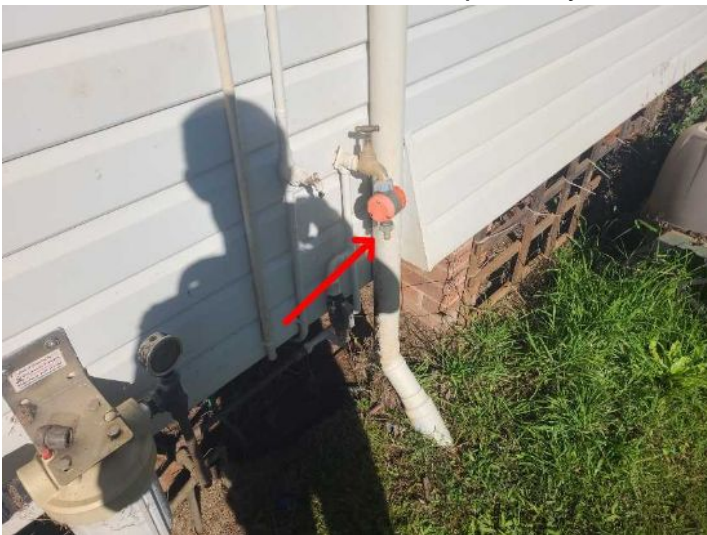
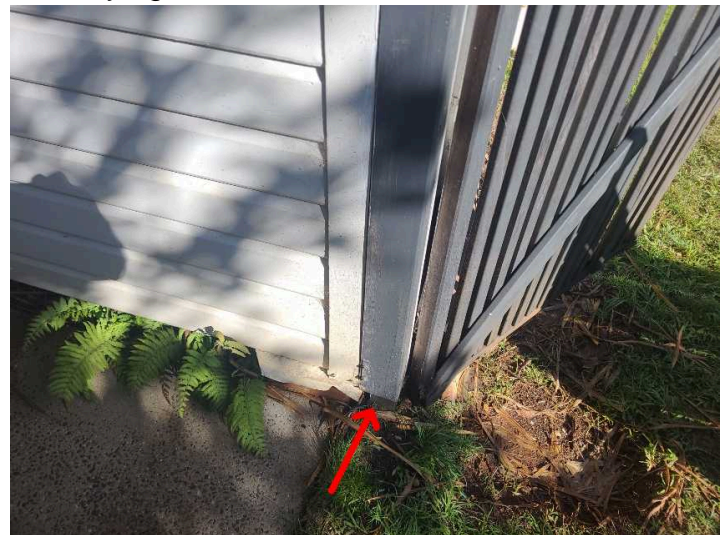
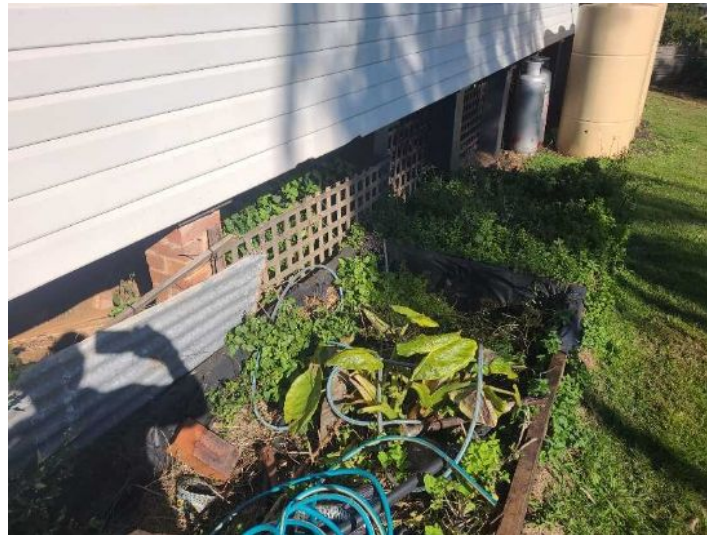
The fence posts are attached to the external wall of the home and could provide concealed access for timber pest, the post should be trimmed to allow at least 75mm clearance with the finished ground surface.

Prune or remove any plants that are in contact or proximity to home to eliminate pathways of wood destroying insects.

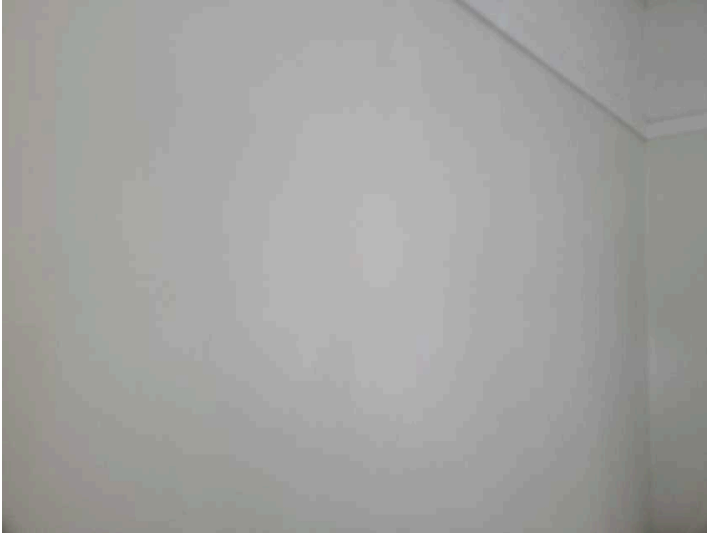
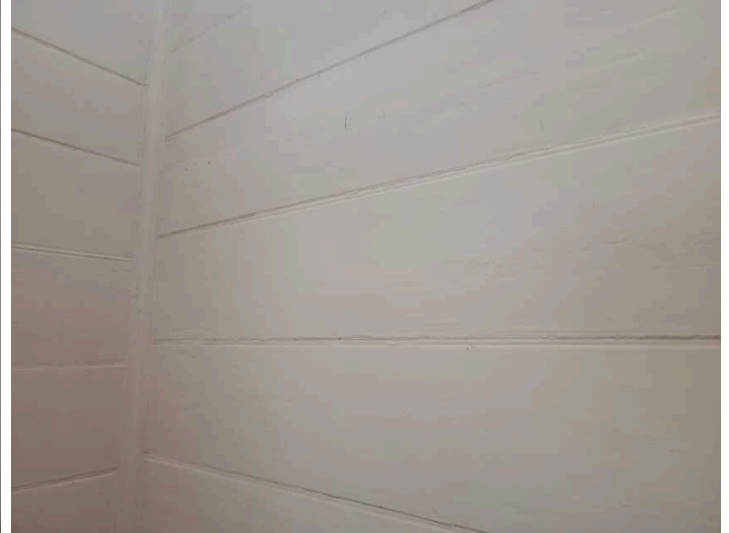
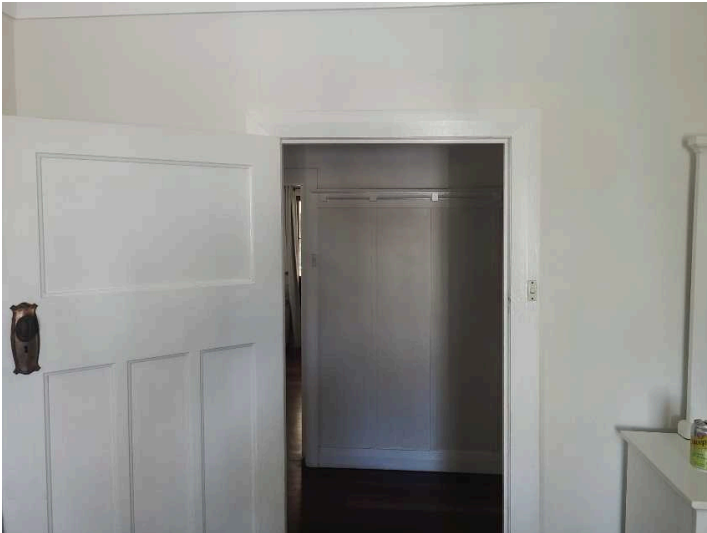
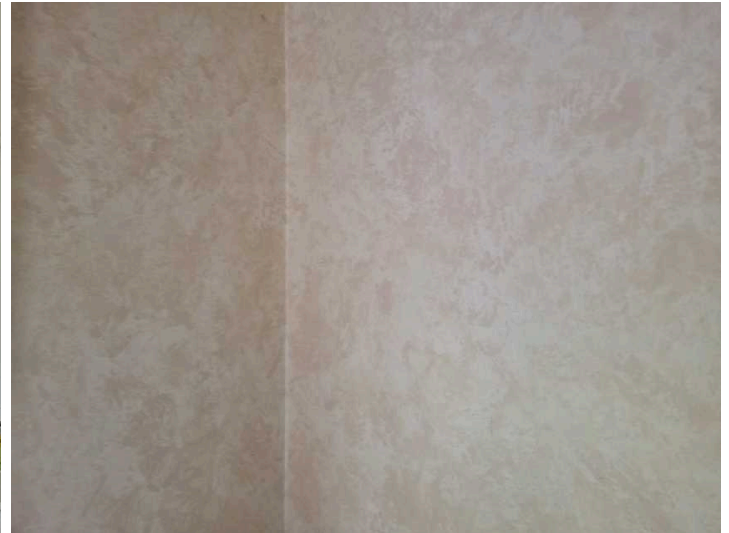
- Plasterboard/gyprock walls noted which appeared functional.
- The walls are clad in wood plank material.

- Timber skirting and door frames appear functional.

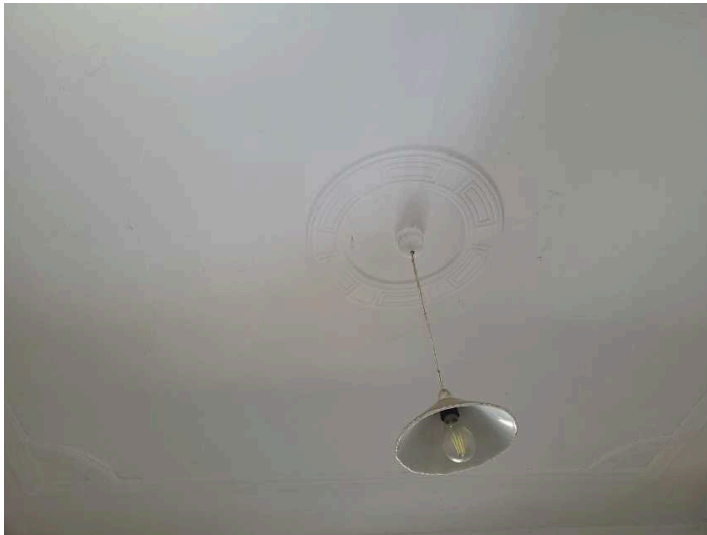
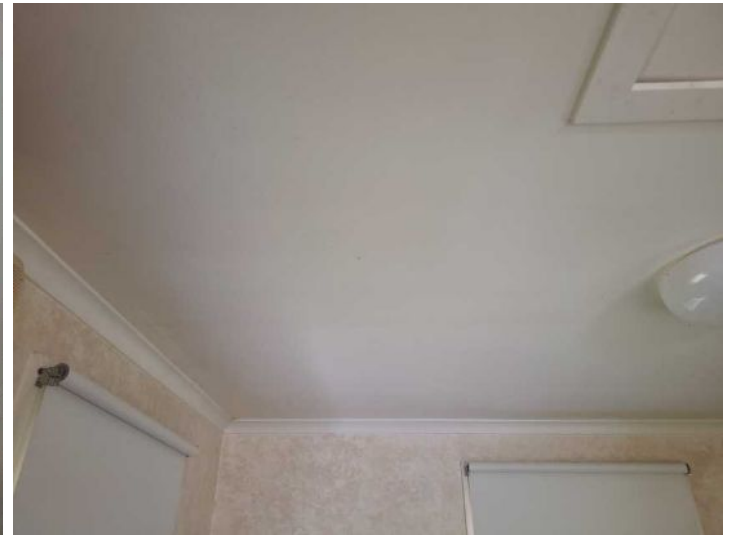
- There are platerglass ceilings in the property which appear functional.
- There are wood plank ceilings noted.

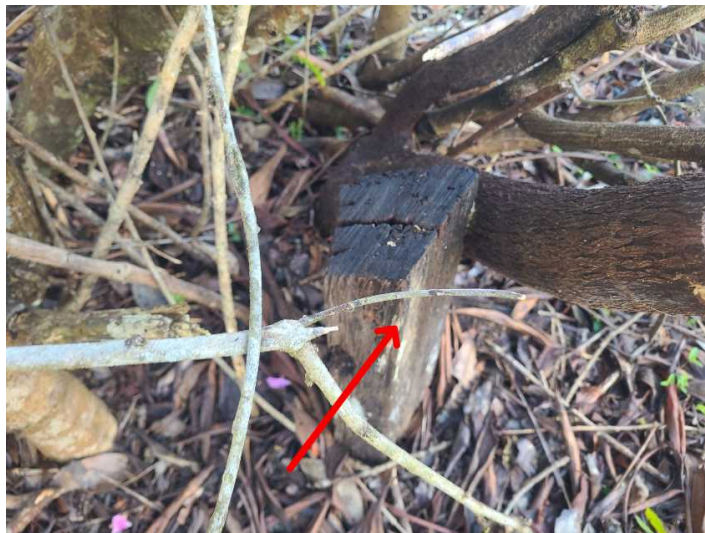
- There is landscaping/stored timber, or old tree stumps in contact with the ground that provides possible breeding grounds for subterranean termites. These should be monitored.

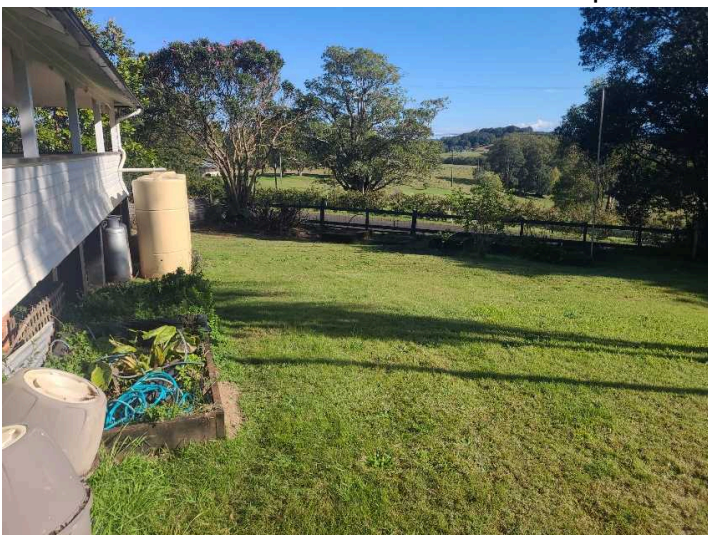
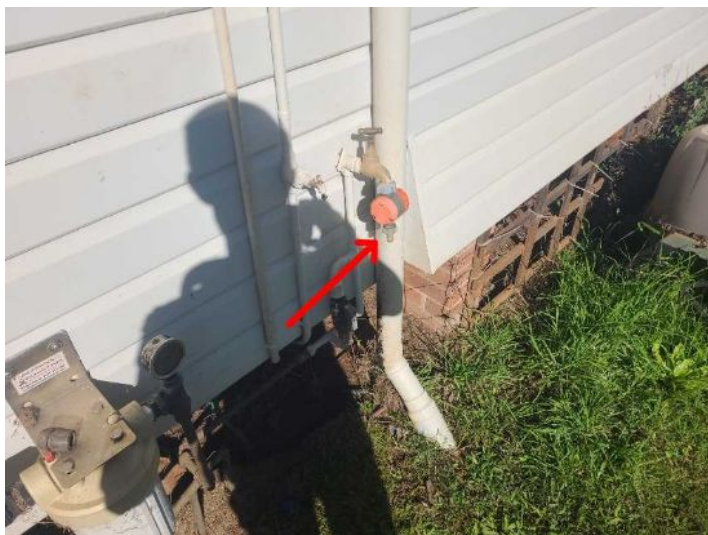
- It is important to redirect moisture away from the property to limit areas of excess moisture. Faulty gutters and downpipes in poor condition can cause water to seep into the foundations, causing conditions conducive to termites and fungal decay.
- Surface drainage conditions within 3 metres of the inspected structure appeared satisfactory.
- There are no drains located beneath the outdoor taps. This can cause water pooling if the taps were to leak. Recommend drains be installed beneath the taps. Where this is not possible it is important to ensure taps are well maintained to prevent leaks.

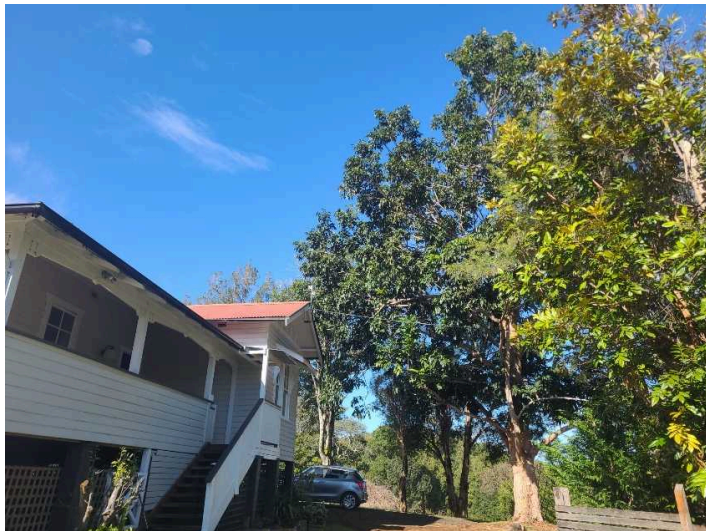
- There are tree branches touching the house structure, which can provide possible entry points/bridging for termites into the home. These should be pruned or removed.

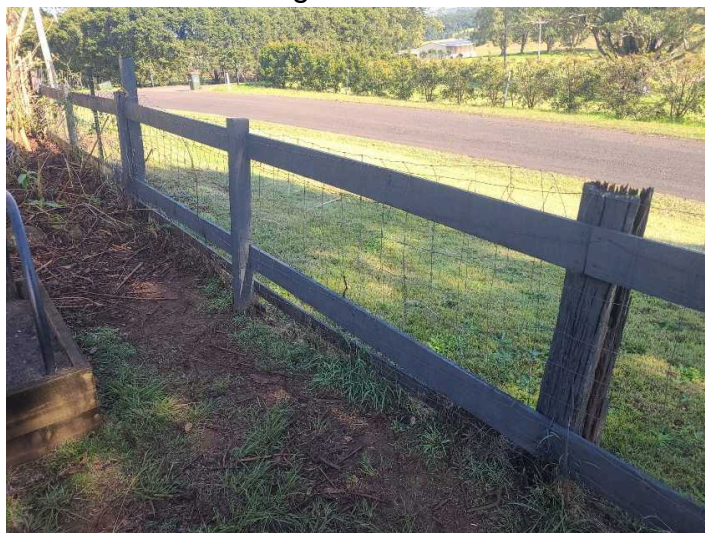
- Timber fences are in good condition.

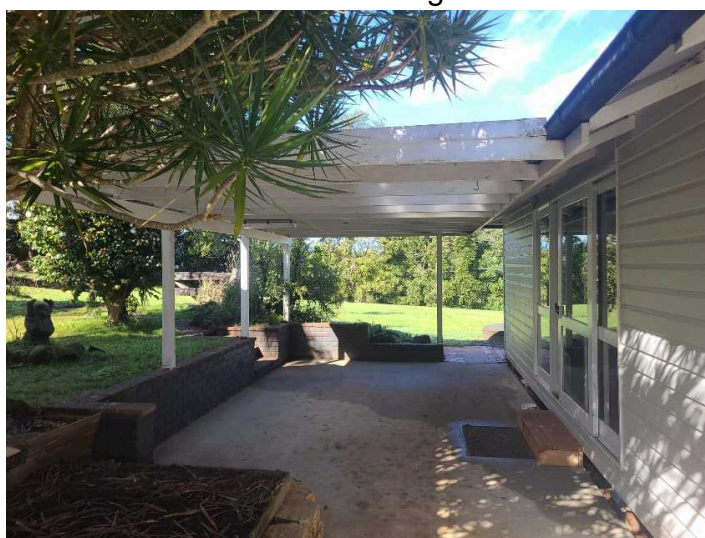
- The patio is in contact with the ground which may allow concealed termite access to the structure. Patio in good condition.

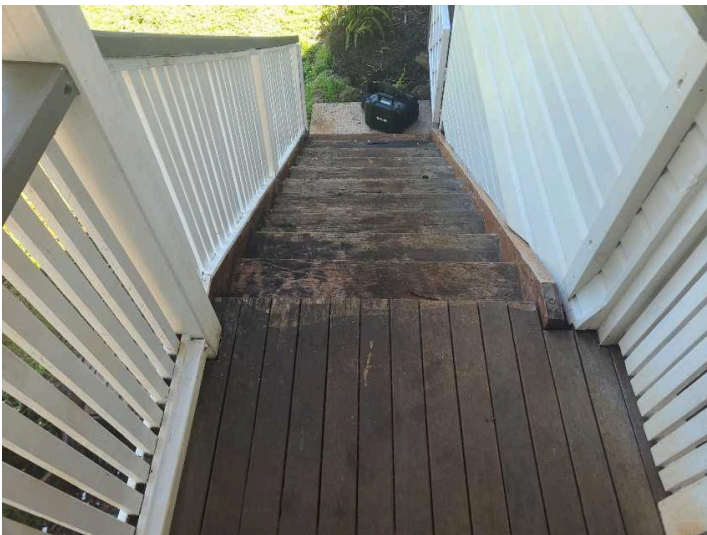
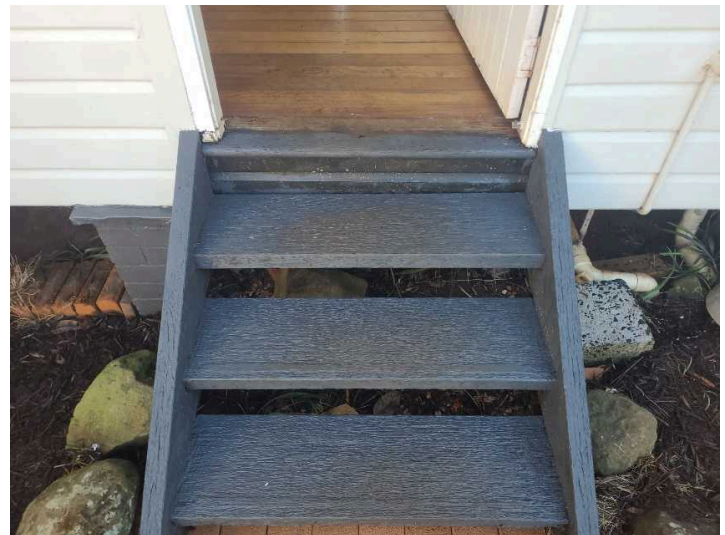
- Inspected steps were in good condition at the time of the inspection.

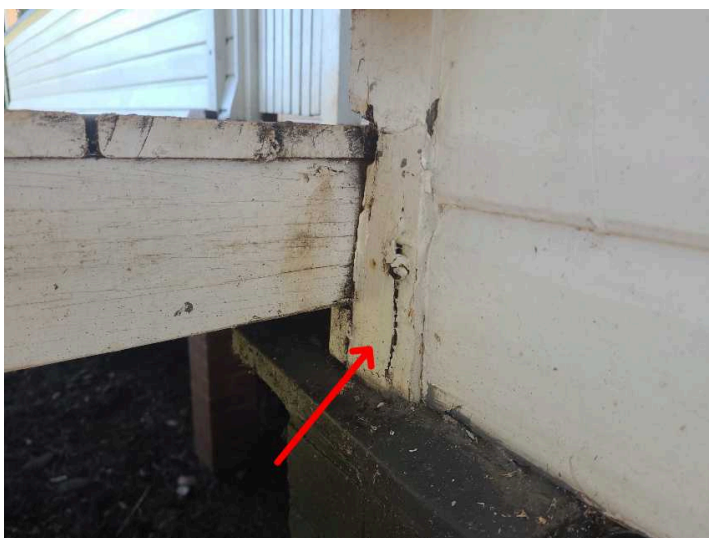
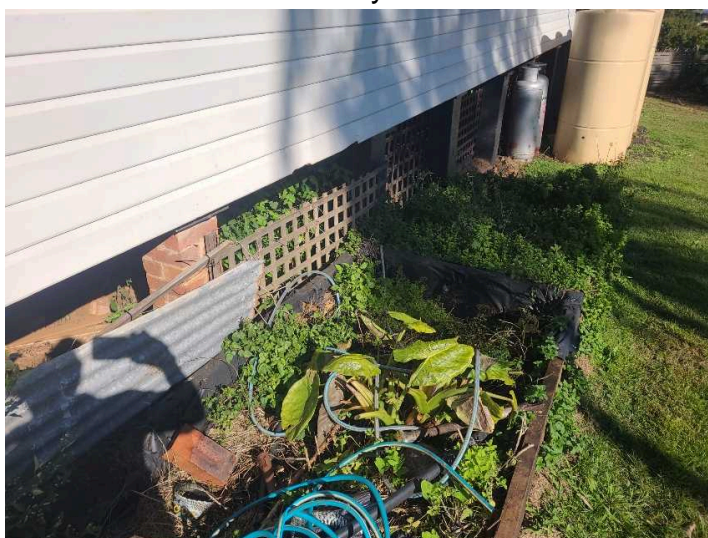
Granny flat

- Wood Decay damage noted in the southwest wall paneling.
- There are garden beds which are abutting external walls. This can result in water moisture affecting the structure over time. It is recommended that either the beds be removed or a water barrier be place between the garden bed and the external walls. If these beds are retained it is important that any watering is directed away from the building and kept to an absolute minimum and is controlled. These are a risk area for termite activity.

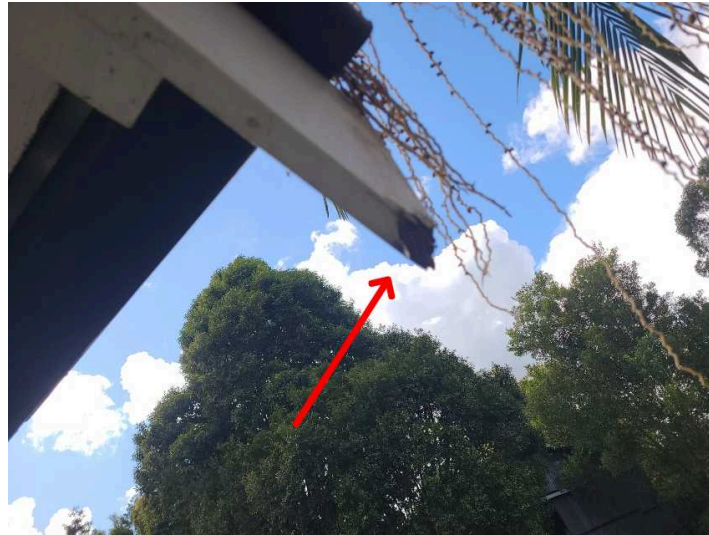
Granny flat

- Moisture damage, wood decay, observed. Recommend review for repair as necessary.

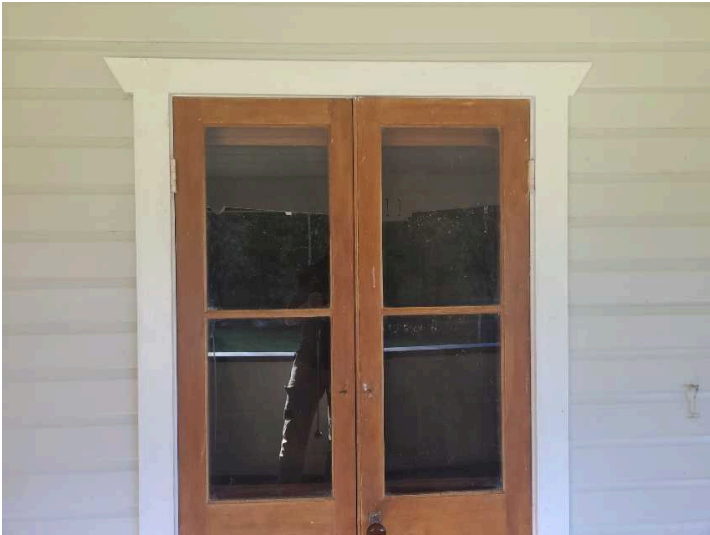
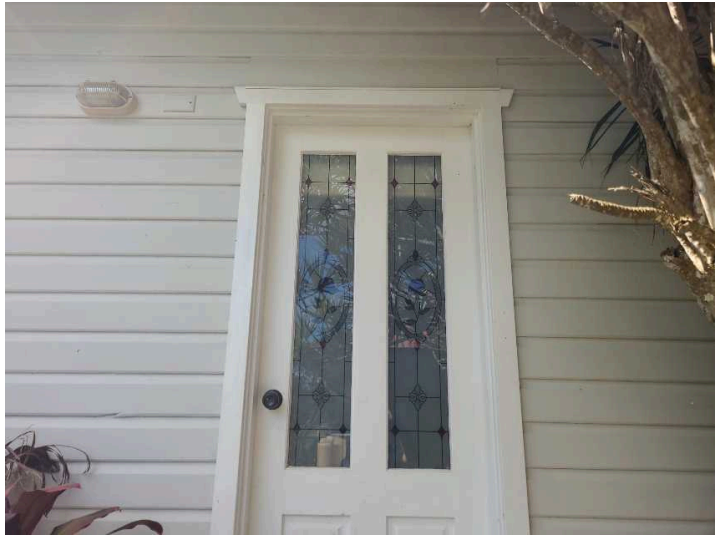
Granny flat

- Deterioration of wooden frames noted. While basic maintenance may prolong the life of these frames, replacement may be necessary at some point.

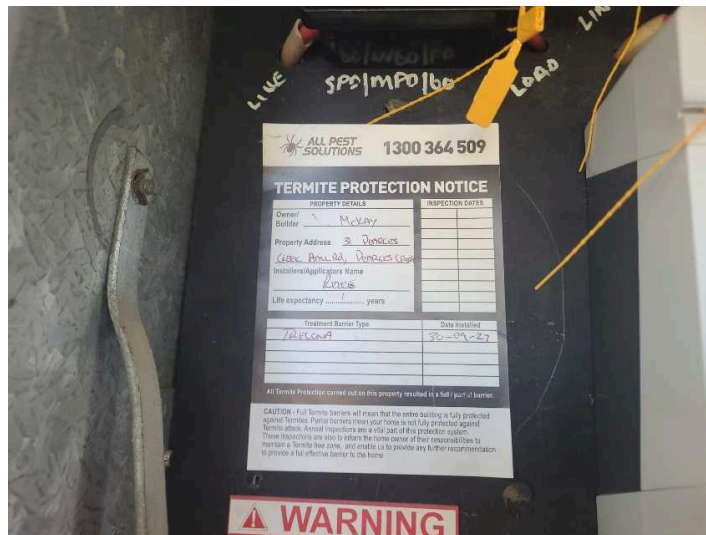
- It is recommended that any available records and associated paperwork from the current property owner is requested with regard to previous treatment.
- A termite management plan should be put in place. AS 3660.2 recommends that a routine inspection for termite management purposes be carried out at least annually.
- If termite activity or damage is noted it is possible that further termite damage may be present in concealed areas.
- There is a notice in the meter box to indicate that the home has a chemical barrier system installed in 2022. Trelona bait chemical was used.
