# Inspection Report

**105 Links Ave, East Ballina, NSW, 2478**

### Pest And Building Inspection

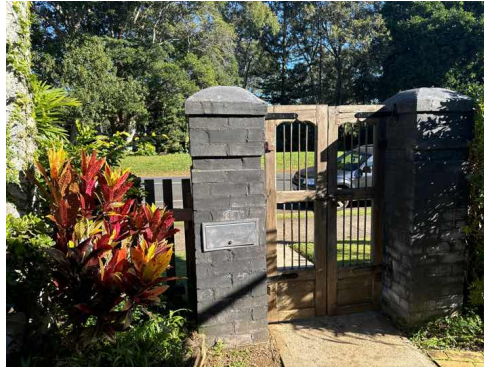
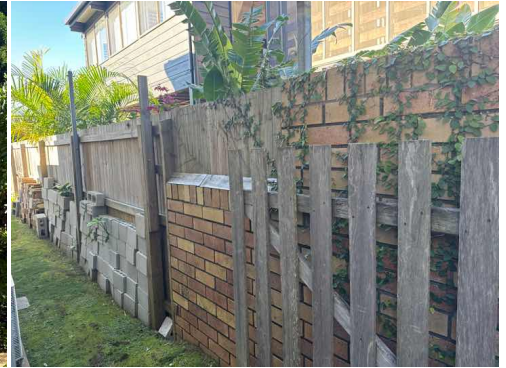
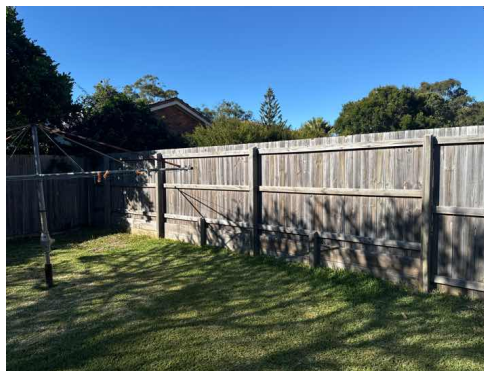
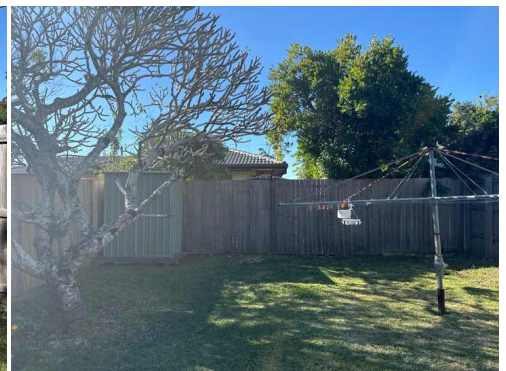
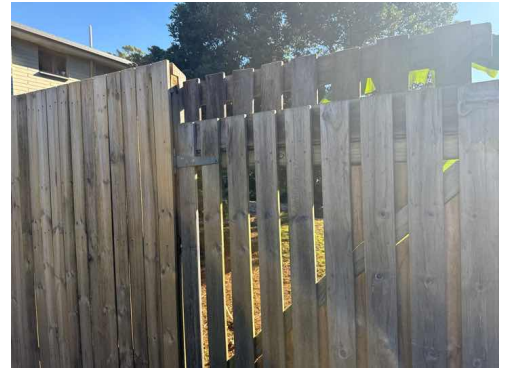
Of the visible areas, the general condition of the fences and gates is serviceable for the age of dwelling.

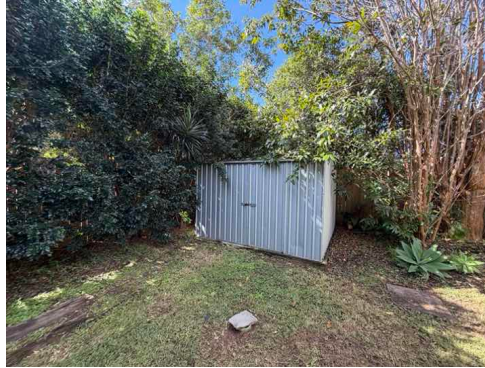
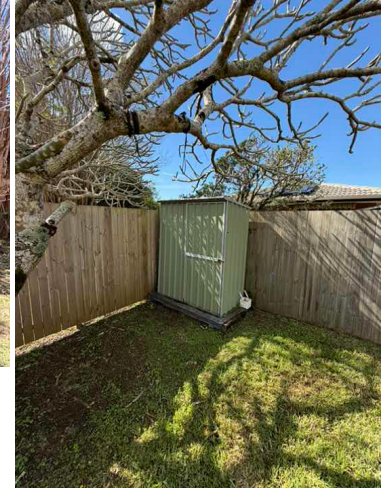
**Shed****Shed Condition**

The shed is in fair usable condition.

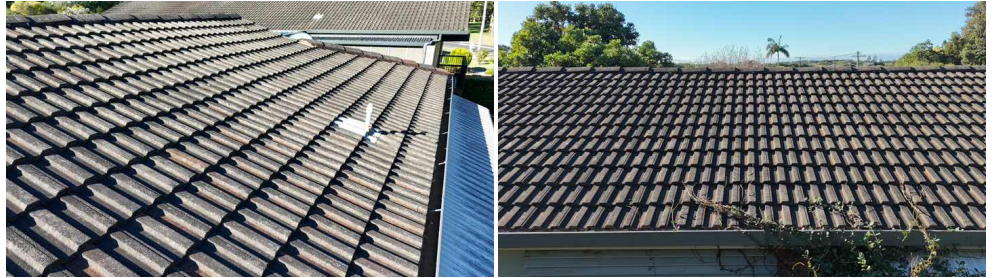
Of the visible areas, the general condition of the roof is in serviceable condition for the age.

Note: In the absence of rainfall there is no guarantee that the roof won't leak.

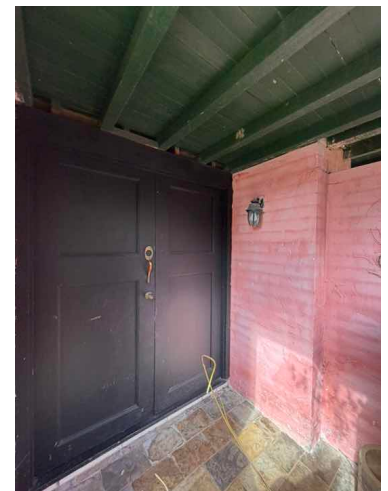
The entry porch serviceable or in reasonable or condition for the age of this dwelling.

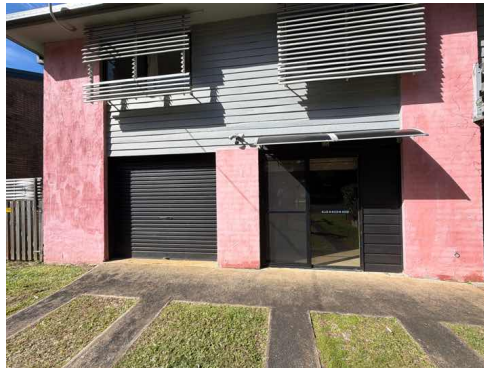
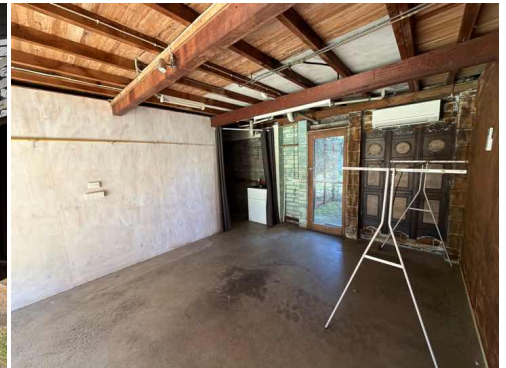
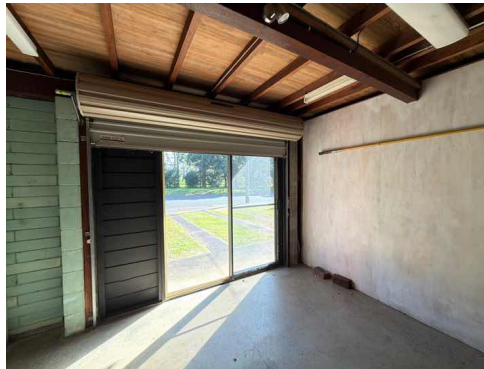
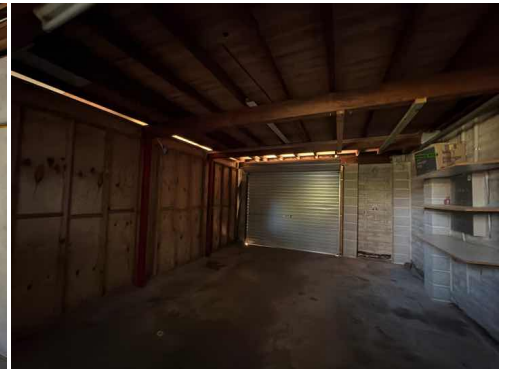
From the visible and accessible areas, the garage appears to be in a serviceable condition for the age of the property with no notable structural defects sighted.

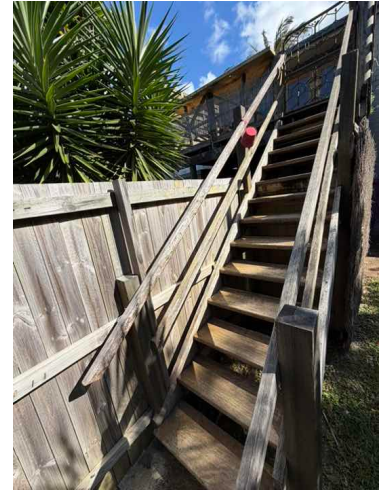
The stairs/steps appear to be serviceable with no notable defects.

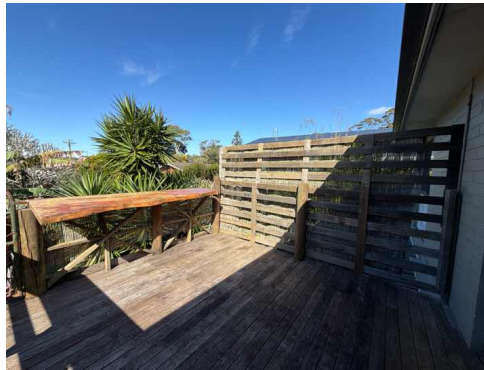
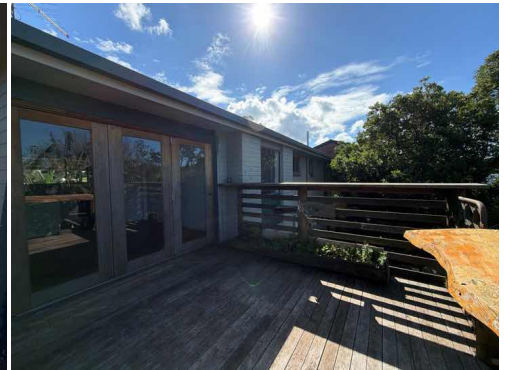
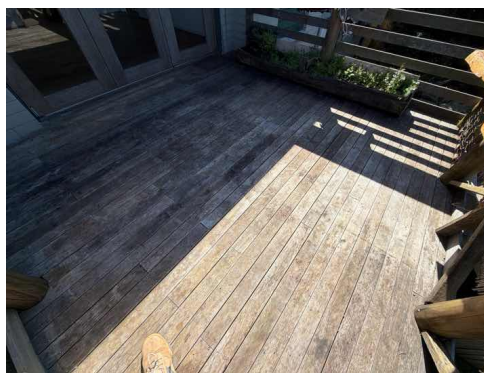
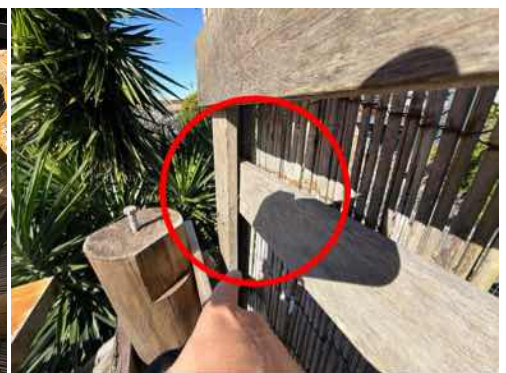
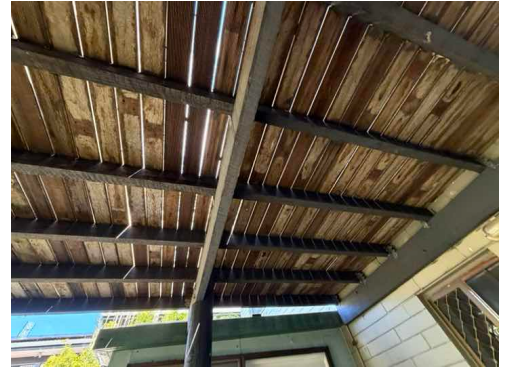
Of areas visible, the decking appears to be in a serviceable condition.

Of areas visible, minor defects and/or maintenance issues were visible. These will require assessment and subsequent repairs by a licensed tradesperson. Please read below for details. Please note that the inspector believes these to be of a minor nature relative to the age of the dwelling and or lack of proper and continual maintenance. Others, including other inspectors may differ in their opinions.

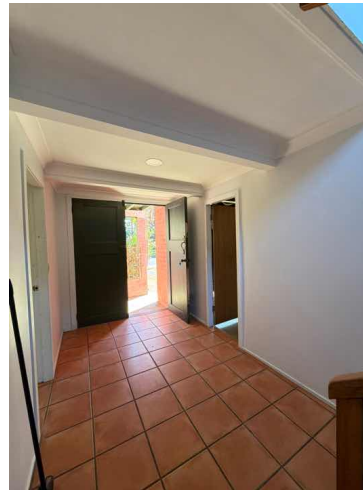
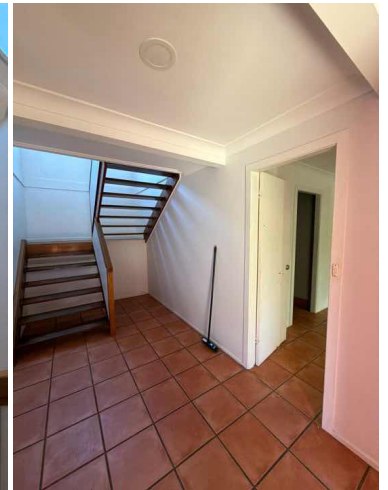
From the visible and accessible areas, this area appears to be in a serviceable condition for the age of the property with no notable structural defects sighted.

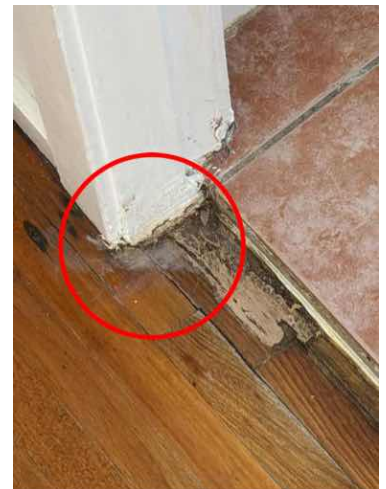
Stained timber flooring - This is normally due some water penetration. This will not be able to be removed and options include replacement, staining all the boards dark or lining same to cover. A qualified carpenter should be engaged for advice and recommendations.

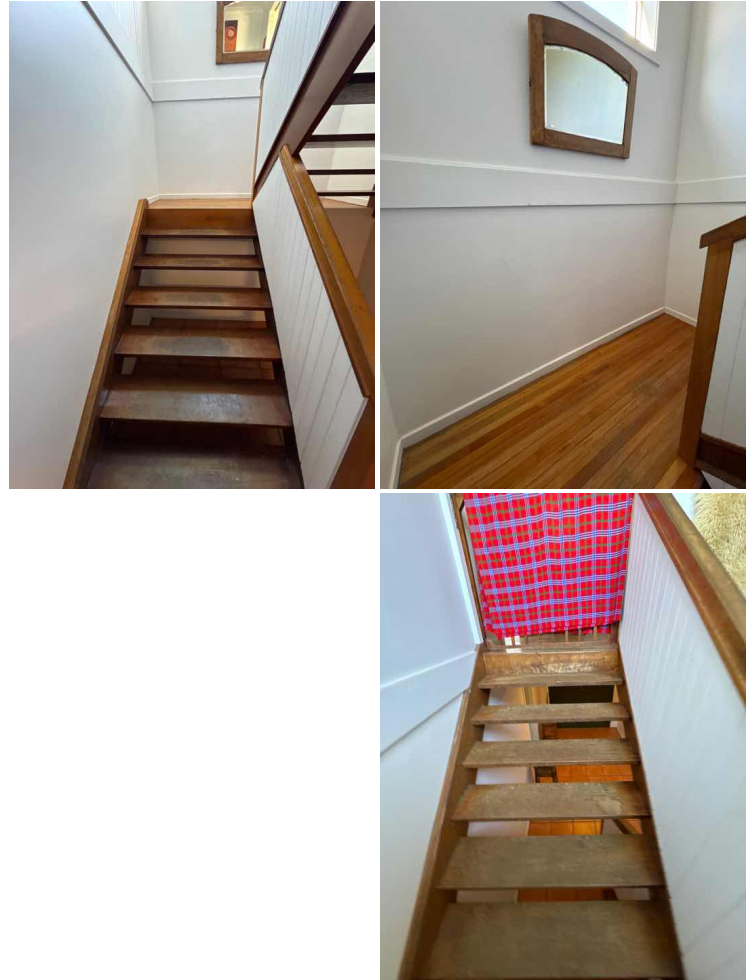
## **Internal Stair Case**

The internal staircase and components appear to be in a serviceable condition for the age with no notable defects sighted.

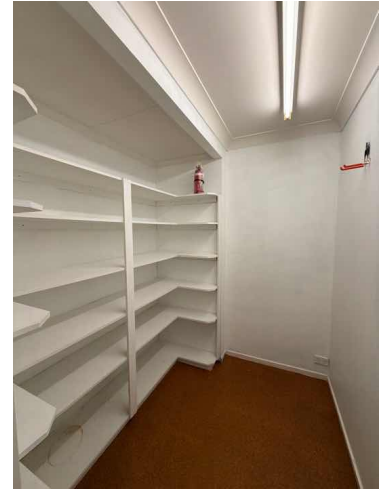
Of the visible areas, the general condition of the kitchen and pantry is serviceable or in reasonable condition for age of dwelling.
